REFERENCE: BR-0043

STATE OF NORTH CAROLINA
DEPARTMENT OF TRANSPORTATION
DIVISION OF HIGHWAYS
GEOTECHNICAL ENGINEERING UNIT

STRUCTURE
SUBSURFACE INVESTIGATION

COUNTY ROCKINGHAM
SITE DESCRIPTION REPLACE BRIDGE 780151 ON
US 15&NC 14 OVER US 29

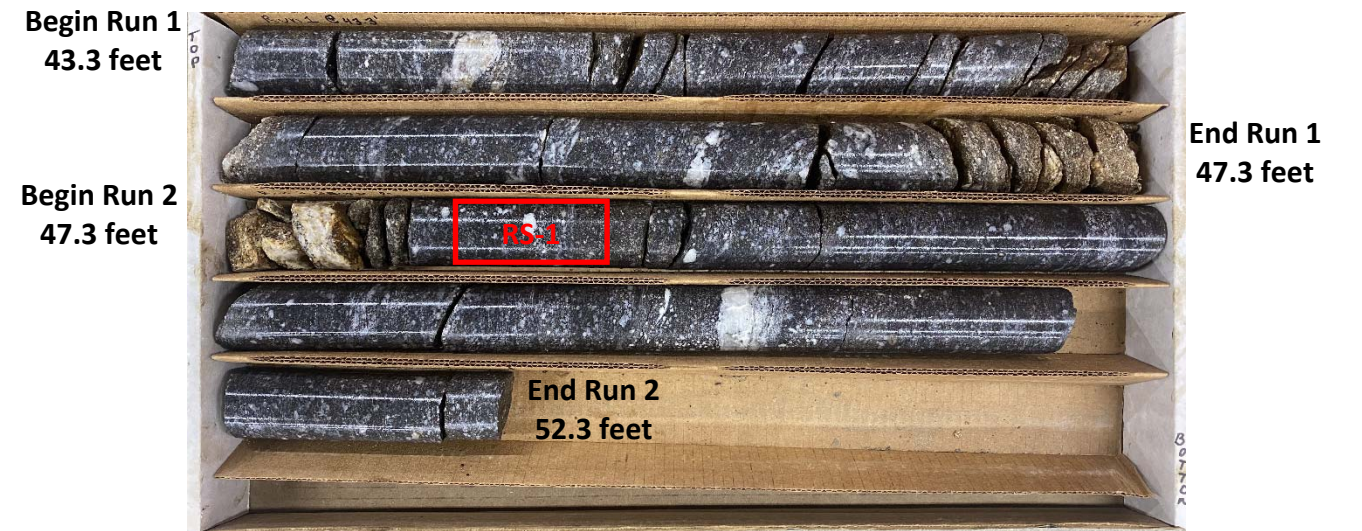
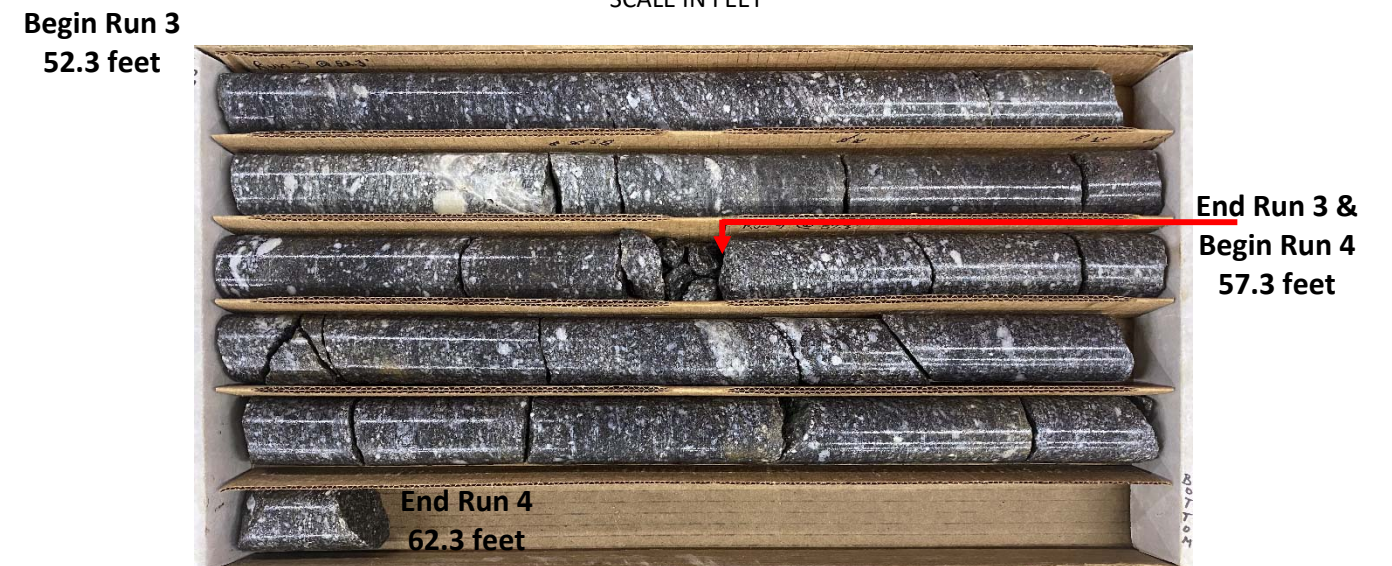
**CORE PHOTOGRAPHS:
BR-0043 | 67043.1.1
B1-A: -L- Station 25+84, 50' LT**

699.1	699.1	43.3	4.0	1:40/1.0 1:30/1.0 1:10/1.0 1:32/1.0	(3.8) 95%	(1.5) 38%		(4.2) 93%	(1.5) 33%		Begin Coring @ 43.3 ft
695	695.1	47.3	5.0	1:10/1.0 1:39/1.0 1:50/1.0 1:47/1.0	(4.4) 88%	(3.1) 62%	RS-1	(13.8) 95%	(9.9) 68%		Light Gray to Dark Gray, Fresh to Moderately Severe Weathering, Very Hard to Hard (BIOTITE GNEISS) with Close to Very Close Fracture Spacing GSI=30-50
690	690.1	52.3	5.0	1:37/1.0 1:49/1.0 1:58/1.0 1:55/1.0	(4.8) 96%	(3.5) 70%					Light Gray to Dark Gray, Fresh to Slight Weathering, Very Hard to Hard (BIOTITE GNEISS and SCHIST) with Close to Very Close Fracture Spacing RS-1: 48.0'-48.3', qu=5,015 psi, GSI=40-60
685	685.1	57.3	5.0	1:43/1.0 1:42/1.0 1:43/1.0 1:52/1.0 2:28/1.0	(5.0) 100%	(3.3) 66%

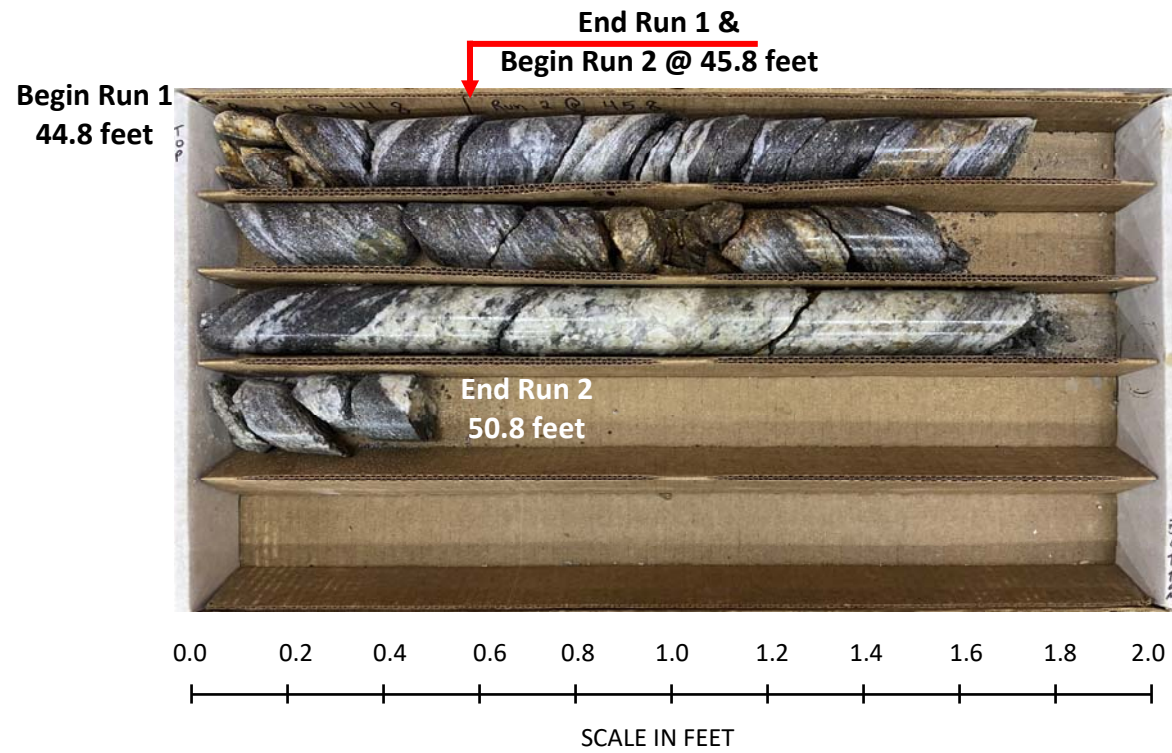
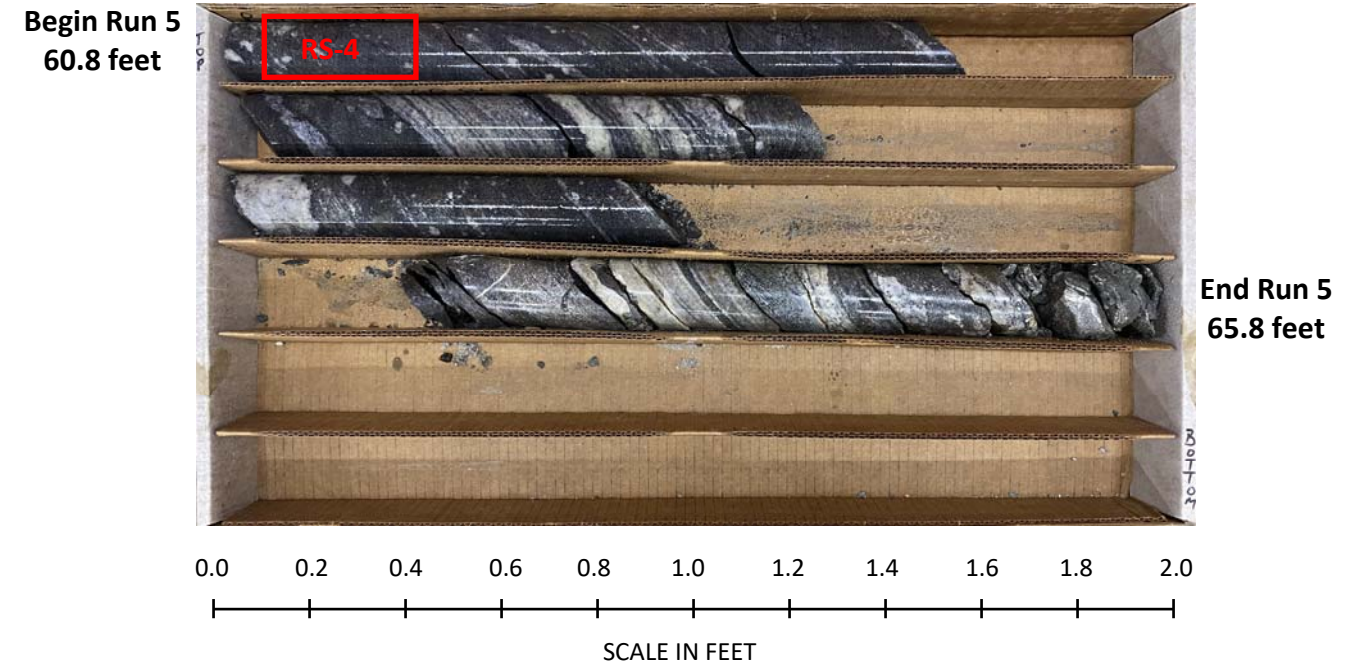
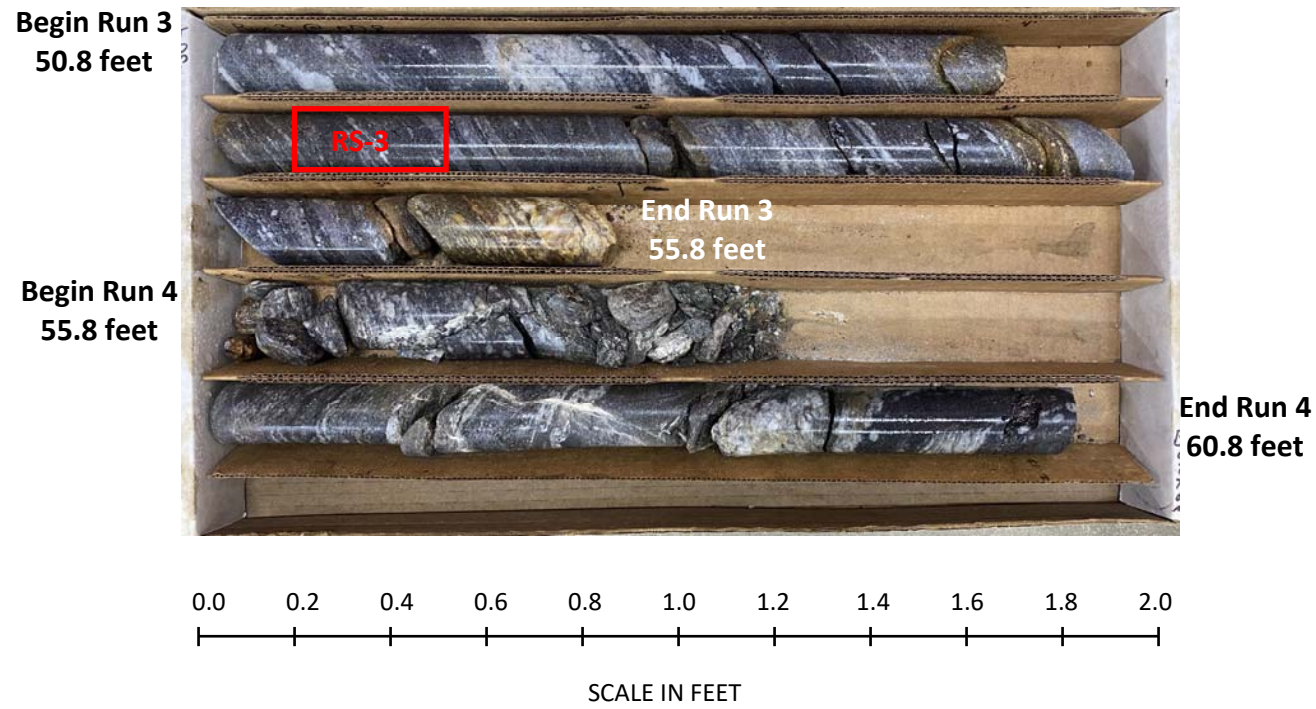
**CORE PHOTOGRAPHS:
BR-0043 | 67043.1.1
B1-B : -L- Station 25+85, 28' RT**

697.5	697.5	44.8	1.0	N=60/0.0 1:40/1.0	(1.0)	(0.0)		(12.8)	(4.3)		697.5	44.8
	686.5	45.8	5.0	1:22/1.0 1:22/1.0 1:20/1.0 1:59/1.0 2:31/1.0	100%	0%		80%	27%			
695

691.5	50.8	5.0	1:58/1.0 1:31/1.0 1:24/1.0 1:24/1.0 1:46/1.0	(4.3)	(1.8)	RS-3					
690												
	686.5	55.8	5.0	1:26/1.0 1:30/1.0 1:12/1.0 1:24/1.0 3:55/1.0	(2.9)	(1.1)						
685

681.5	60.8	5.0	2:11/1.0 1:57/1.0 2:07/1.0 1:59/1.0 2:09/1.0	(5.0)	(2.6)	RS-4	(5.0)	(2.6)		681.5	60.8
680												
	676.5	65.8									676.5	65.8

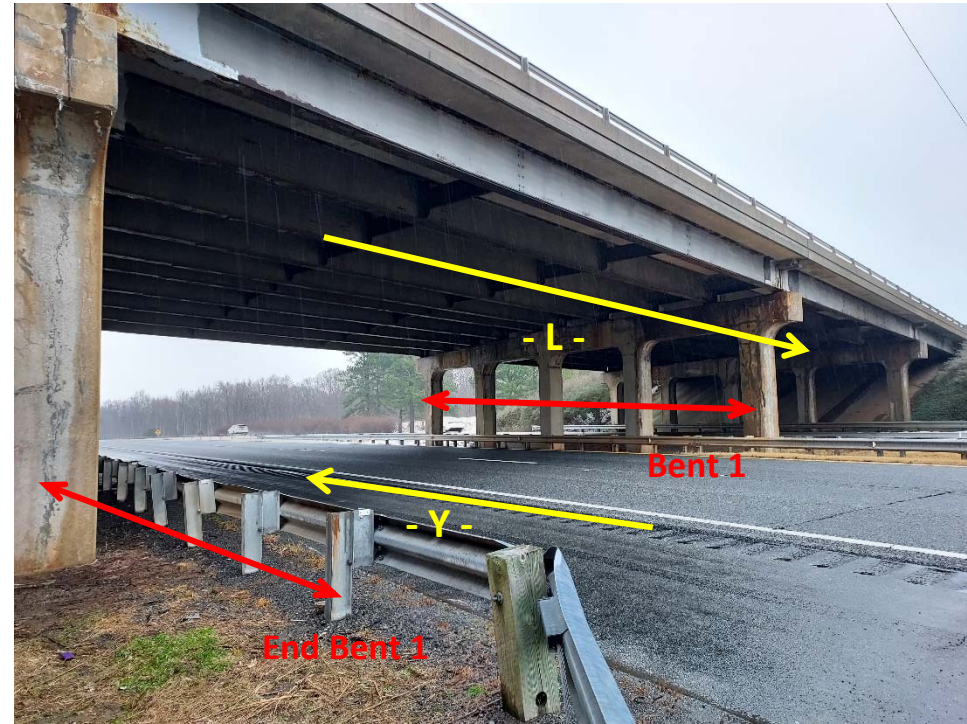
Photograph No. 1: View looking northeast at Bent 1

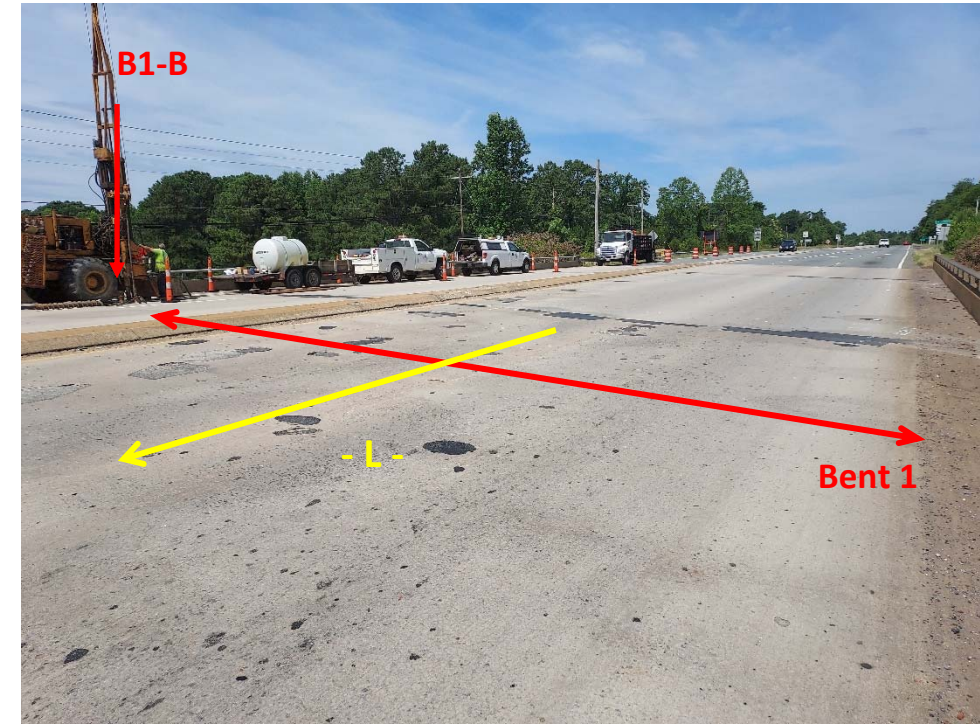
Photograph No. 3: View looking south-southwest at bent 1 on bridge deck

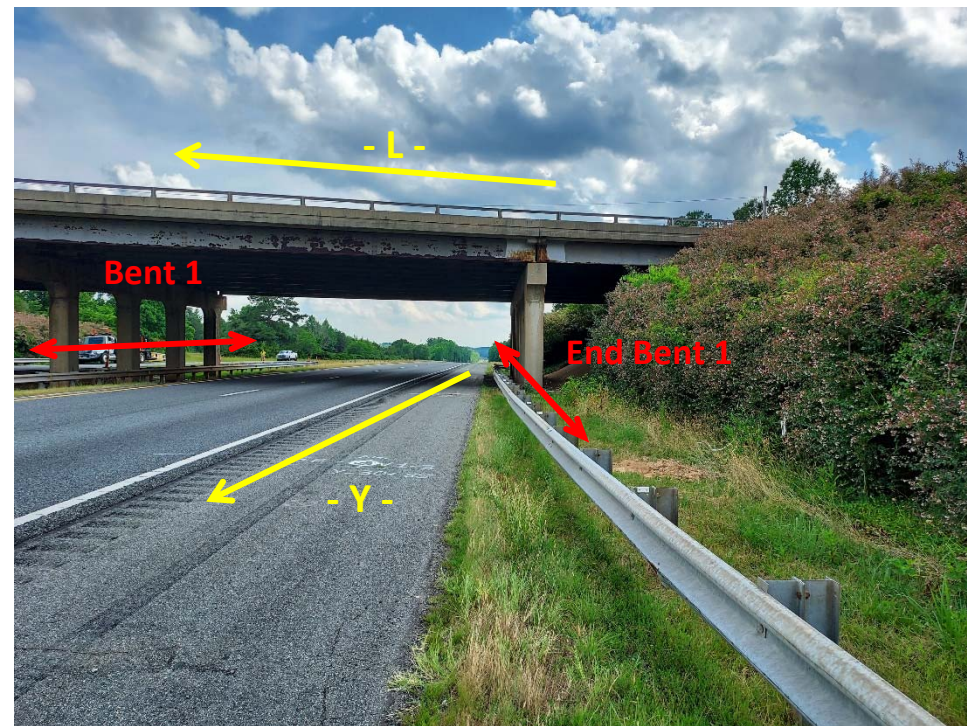
Photograph No. 2: View looking south along End Bent 1

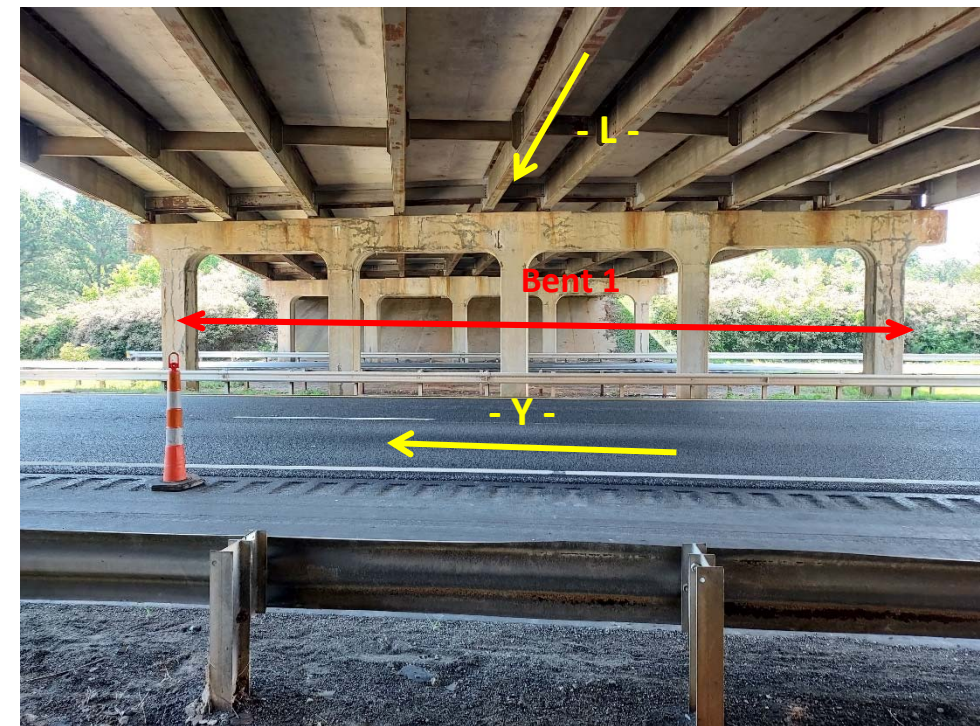
Photograph No. 4: Below bridge deck, looking at Bent 1
