REFERENCE: BR-0160

STRUCTURE  
SUBSURFACE INVESTIGATION

COUNTY BRUNSWICK  
 PROJECT DESCRIPTION REPLACE BRIDGE ON NC 179B  
OVER CALABASH RIVER BETWEEN SR 1810  
AND NC 179  
 SITE DESCRIPTION BRIDGE 15 AT -L- STATION  
21+77.5

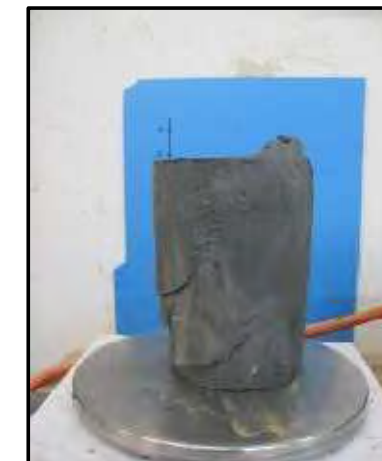
**CONSOLIDATED UNDRAINED TRIAXIAL TEST  
WITH PORE PRESSURE READINGS  
ASTM D4767-11**

Boring No.:	EB2-A	EB2-A
Depth (ft):	19.6-21.6	19.6-21.6
Sample No.:	ST-1	ST-1
Test No.	T1	T3
Deformation Rate (in/min)	0.002	0.002
Back Pressure (psi)	50.0	50.0
Consolidation Time (days)	1	1
Moisture Content (%) (INITIAL)	27.4	27.4
Total Unit Weight (pcf)	119.6	121.4
Dry Unit Weight (pcf)	93.9	95.3
Moisture Content (%) (FINAL)	30.3	26.4
Initial State Void Ratio, e	0.802	0.776
Void Ratio at Shear, e	0.784	0.748

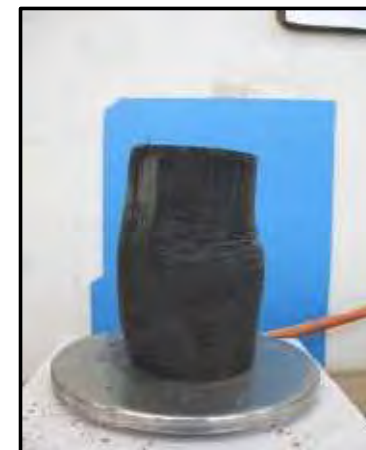
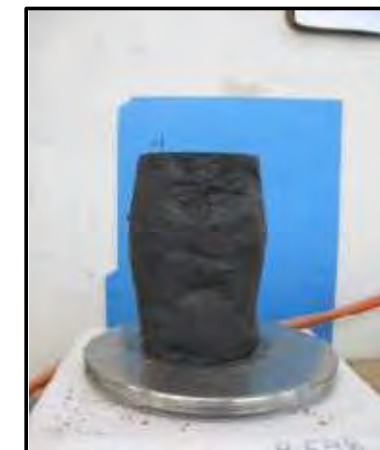
**CONSOLIDATED UNDRAINED TRIAXIAL TEST  
WITH PORE PRESSURE READINGS  
ASTM D4767-11**

Boring No.:	EB1-B	EB1-B
Depth (ft):	10-12	10-12
Sample No.:	ST-3	ST-3
Test No.	T1	T3
Deformation Rate (in/min)	0.002	0.002
Back Pressure (psi)	50.0	50.0
Consolidation Time (days)	1	1
Moisture Content (%) (INITIAL)	33.3	27.9
Total Unit Weight (pcf)	114.2	119.3
Dry Unit Weight (pcf)	85.6	93.3
Moisture Content (%) (FINAL)	28.5	36.8
Initial State Void Ratio, e	0.968	0.807
Void Ratio at Shear, e	0.934	0.717
