**North Carolina Department of Transportation**  
**Preliminary Site Assessment**  
**State Project: R-2707E**  
**WBS Element: 34497.1.2**  
**Cleveland County**

**Parcel 609**  
**Robert Gregory Randall**  
**4919 East Dixon Boulevard**  
**Kings Mountain, North Carolina**  
**May 20, 2019**

**Wood Environment and Infrastructure Solutions, Inc.**  
**Project: 1883R2707**

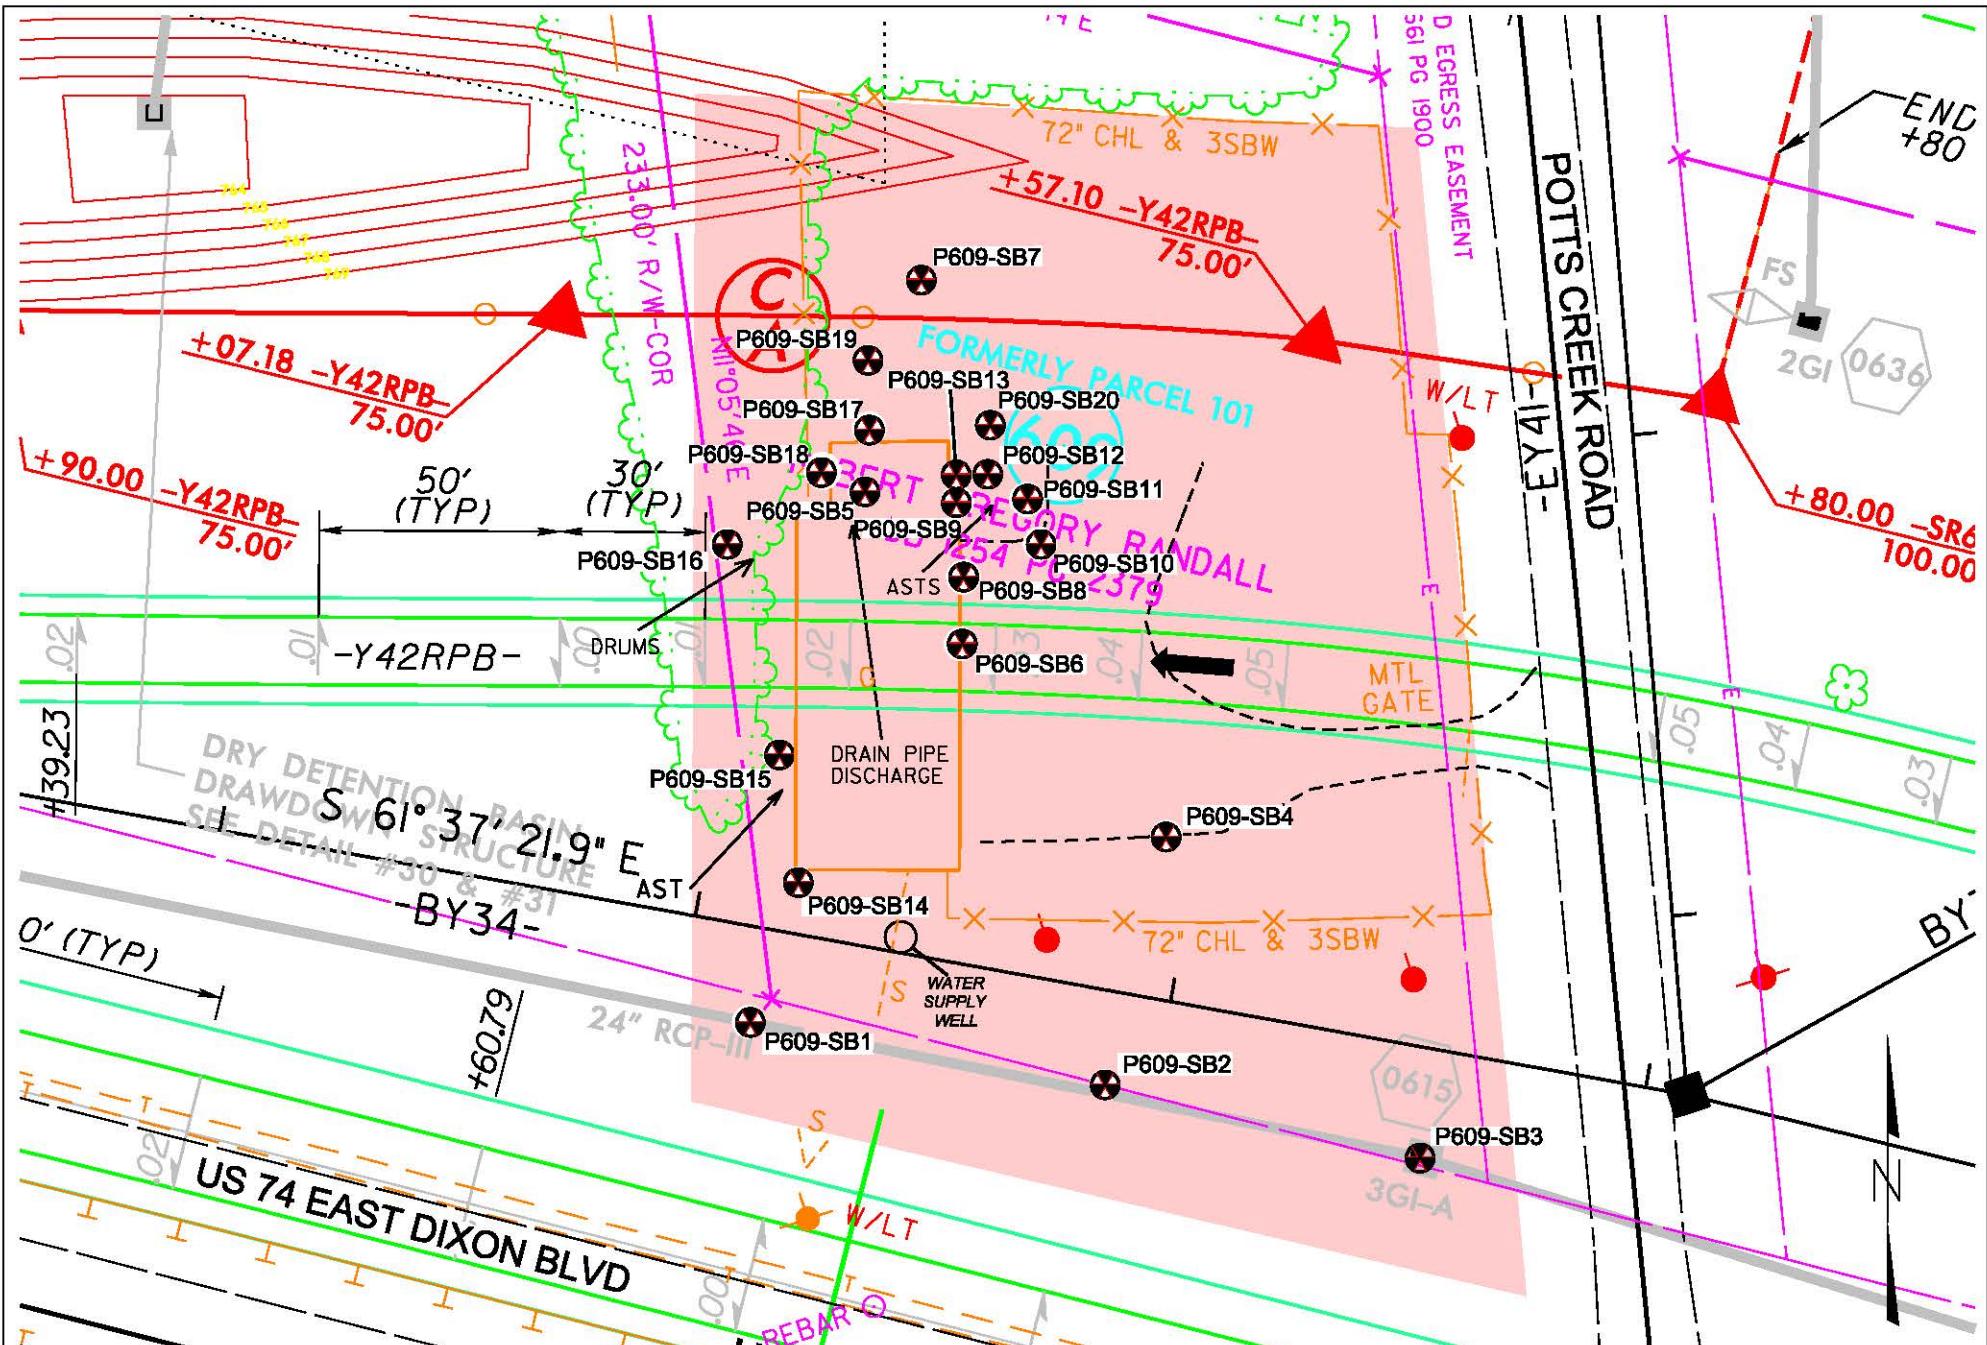
PREPARED BY: LHM	DATE: 5/13/19	CHECKED BY: HPC	DATE: 5/13/19	JOB NUMBER: 188322707	FIGURE: 2
------------------	---------------	-----------------	---------------	-----------------------	-----------

• BORING LOCATION  
■ AREA OF INVESTIGATION

AREA OF INVESTIGATION WITH SOIL BORING LOCATIONS - PARCEL 609  
ROBERT GREGORY RANDALL PROPERTY  
STATE PROJECT: R-2707E  
WBS ELEMENT: 34497.1.2  
CLEVELAND COUNTY, KINGS MOUNTAIN, NORTH CAROLINA

The parcel is located at 4919 East Dixon Boulevard along the northern side of East Dixon Boulevard as shown on the Vicinity Map, **Figure 1**. At the time of this PSA, the parcel was occupied by an auto repair facility (Cleveland Transmission Service). It is identified as Parcel 609 and Robert Gregory Randall (Site) within the NCDOT R-2707E design file. The parcel is in Kings Mountain of Cleveland County, North Carolina. The area of investigation within the parcel is shown on **Figure 2**.

Site geology was observed through the advancement of 20 shallow soil borings (P609-SB1 to P609-SB20). Borings P609-SB1 to P609-SB4 and P609-SB6 to P609-SB13 were advanced using a direct-push rig and targeted a total depth of four to eight feet below ground surface (bgs). Boring P609-SB7 encountered rig refusal at two feet bgs. Borings P609-SB5 and P609-SB14 to P609-SB20 were advanced using a stainless-steel hand auger due to limited rig access and targeted a total depth of three feet bgs. Boring P609-SB14 encountered refusal at 2.5 feet bgs. Figure 2 presents the boring locations and site layout. Soils encountered in the borings consisted mostly of red to tan to brown silty clays and sand. Petroleum odor and staining was observed in borings P609-SB5, P609-SB12, and P609-SB17. Groundwater was not encountered in the borings. Based on observations of topography of the Site vicinity, the groundwater flow direction is inferred to be generally to the north. Boring logs are presented in **Appendix B**.

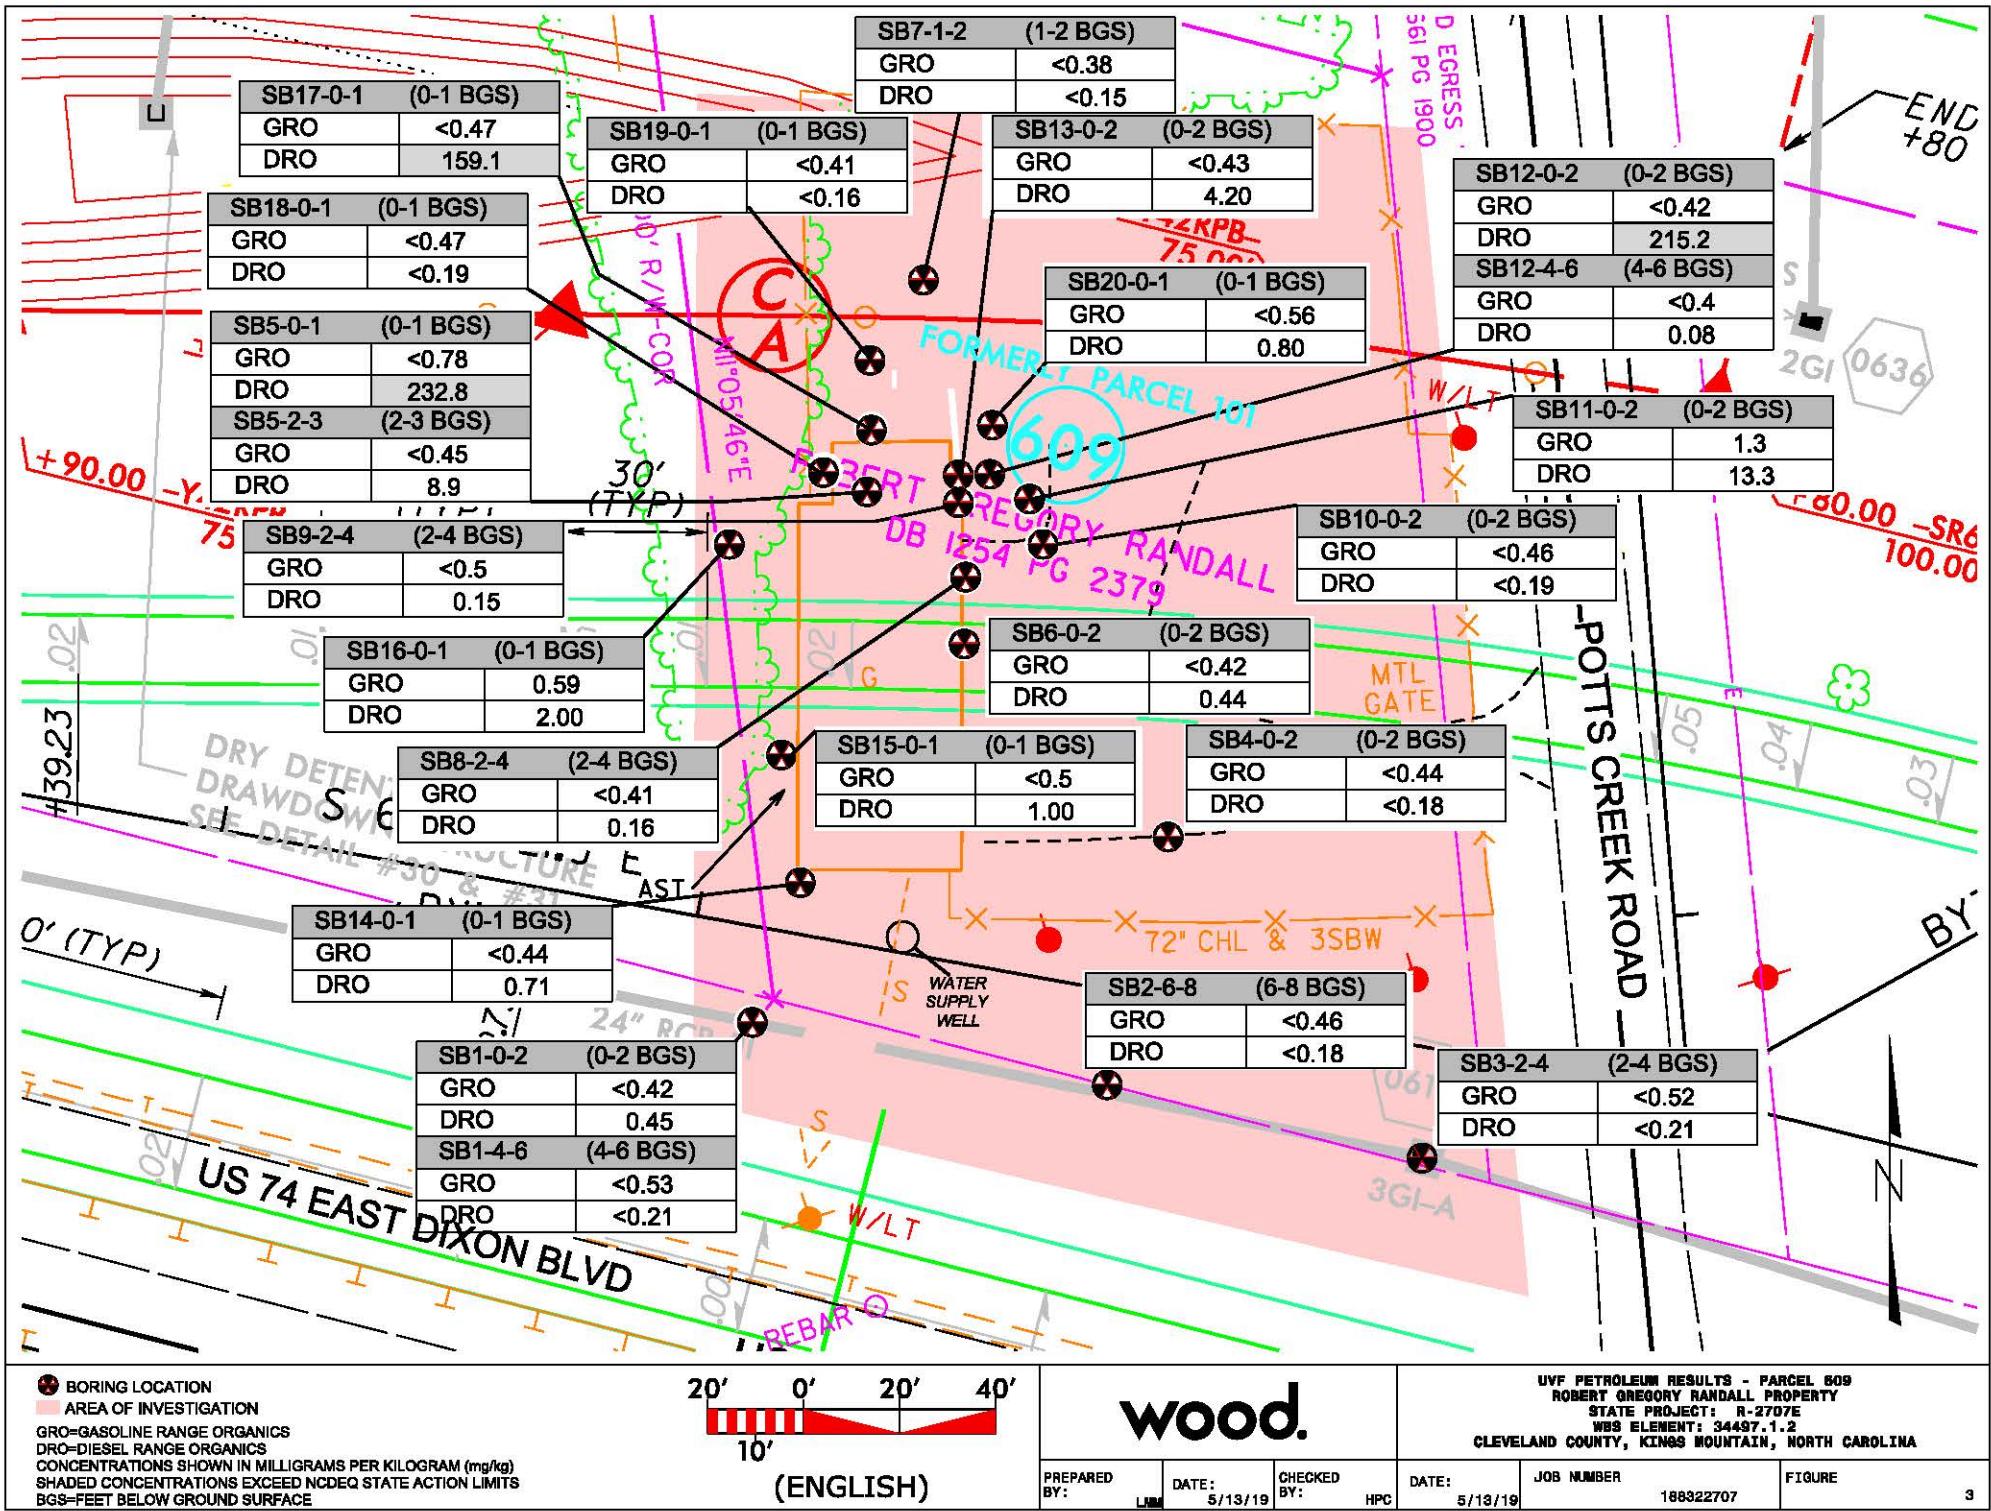
Results from the UVF petroleum soil analyses are presented in **Table 2**, with instrument generated tables in **Appendix D**. Several categories of analyses were measured such as: DRO, GRO, TPH, PAHs, and total aromatics. **Figure 3** presents the GRO and DRO results at each boring.

Elevated TPH values above the NCDEQ Action Limit of 50 milligrams per kilogram (mg/kg) for GRO were not detected in the 23 samples collected from the borings. Elevated levels above the NCDEQ Action Limit of 100 mg/kg for DRO were detected in samples P609-SB5-0-1 (232.8 mg/kg) located near the drain pipe discharge, P609-SB12-0-2 (215.2 mg/kg), located near the USTs along the western exterior of the building, and P609-SB17-0-1 (159.1 mg/kg) located near the drain pipe discharge. The hydrocarbon results from the QED QROS Hydrocarbon Analyzer are provided in Appendix D.

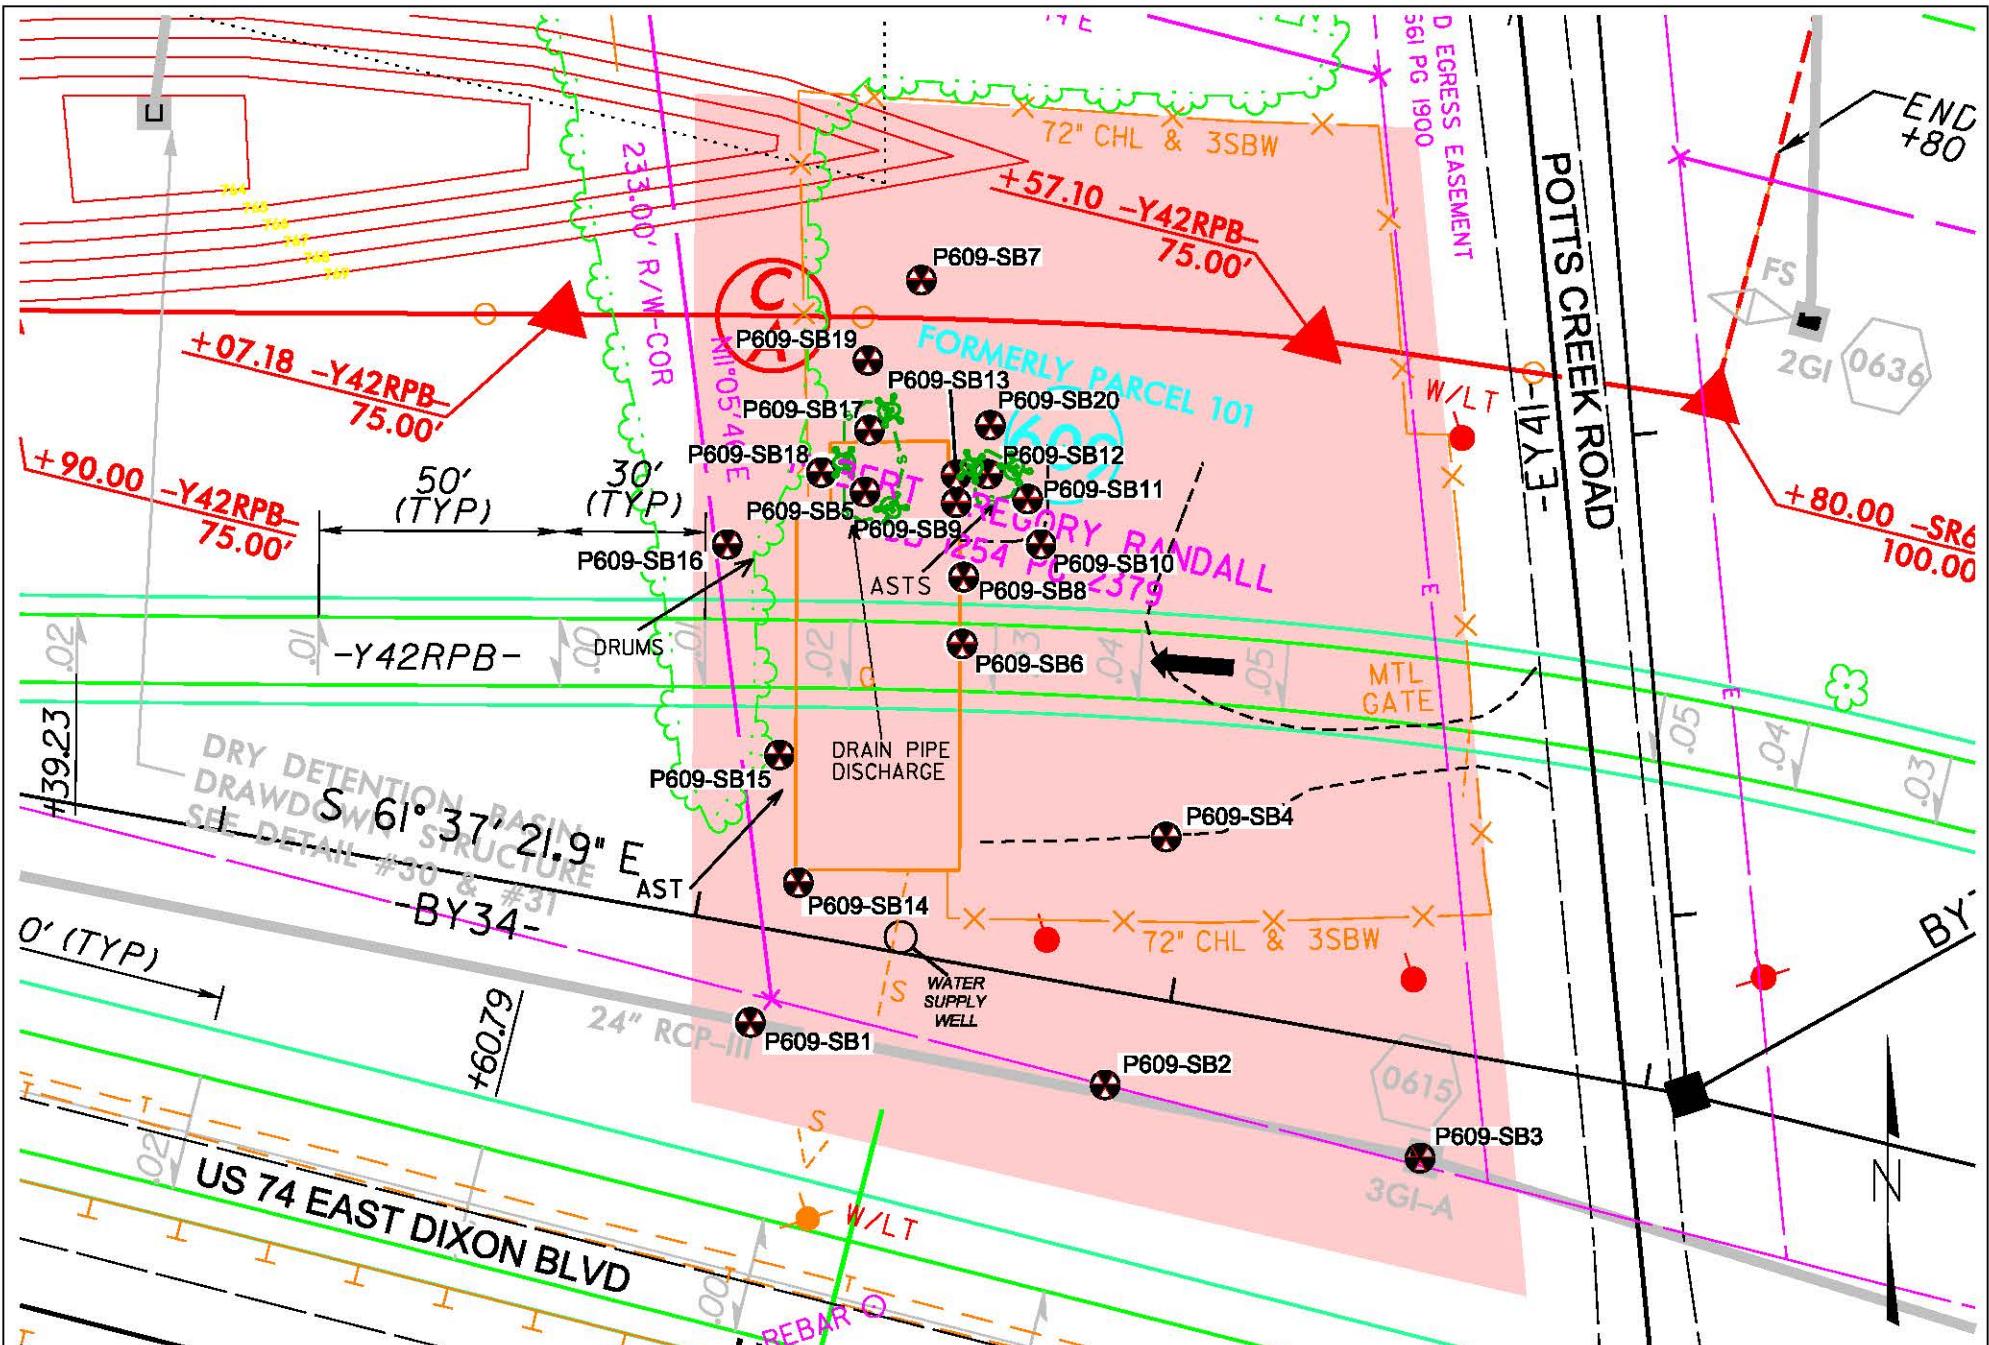
PREPARED BY: LHM DATE: 5/13/19 CHECKED BY: HPC DATE: 5/13/19 JOB NUMBER 188322707 FIGURE 4

The areas of petroleum-impacted soils appear to be located in two areas of the site; near the floor drain pipe discharge and borings P609-SB5 and P609-SB17 and near the USTs along the western exterior of the building and boring P609-SB12. The estimated areas of

impacted soils are shown on **Figure 4**. The estimated impacted soil volume for the area near borings P609-SB5 and P609-SB17 is 486 cubic feet (18 cubic yards) and the volume of the area near boring P609-SB12 is 145 cubic feet (5.4 cubic yards). Both soil volumes are based on an unsaturated thickness of two feet.

KNOWN CONTAMINATION AREA - PARCEL 609  
ROBERT GREGORY RANDALL PROPERTY  
STATE PROJECT: R-2707E  
WBS ELEMENT: 34497.1.2  
CLEVELAND COUNTY, KINGS MOUNTAIN, NORTH CAROLINA

Based on these PSA results, Wood recommends additional interior subsurface assessment be performed at the Site near the hydraulic lifts and floor drains inside the building after the building has been vacated by the current tenant. No further assessment is recommended for the exterior subsurface of the Site, unless additional surface staining is observed after the current tenant has removed materials and containers from the Site. It is understood the areas of impacted soils are located in areas to be impacted by construction activities. Special handling should be performed during excavation in these areas and impacted soil should be disposed properly offsite.

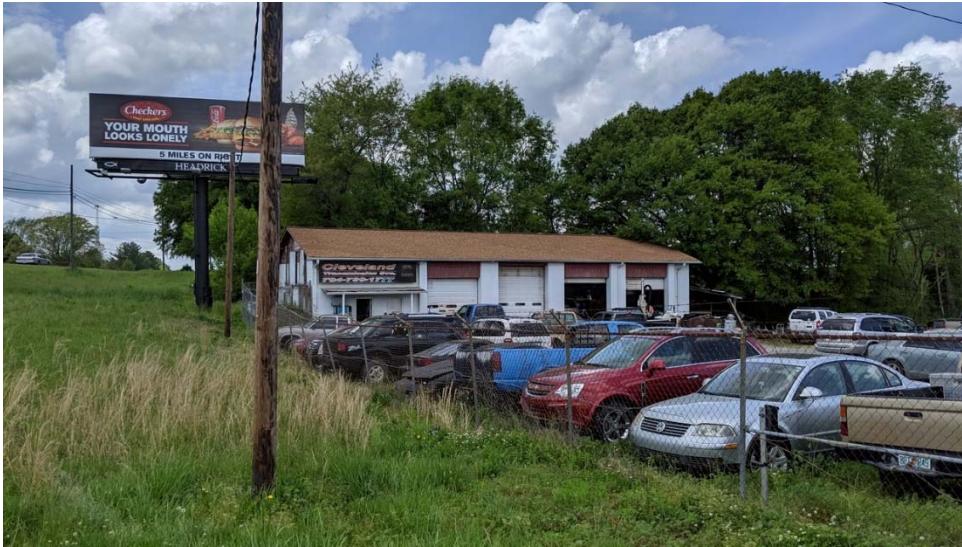
**PHOTO 1:**

View west of the front/east side of the site building and auto storage yard.

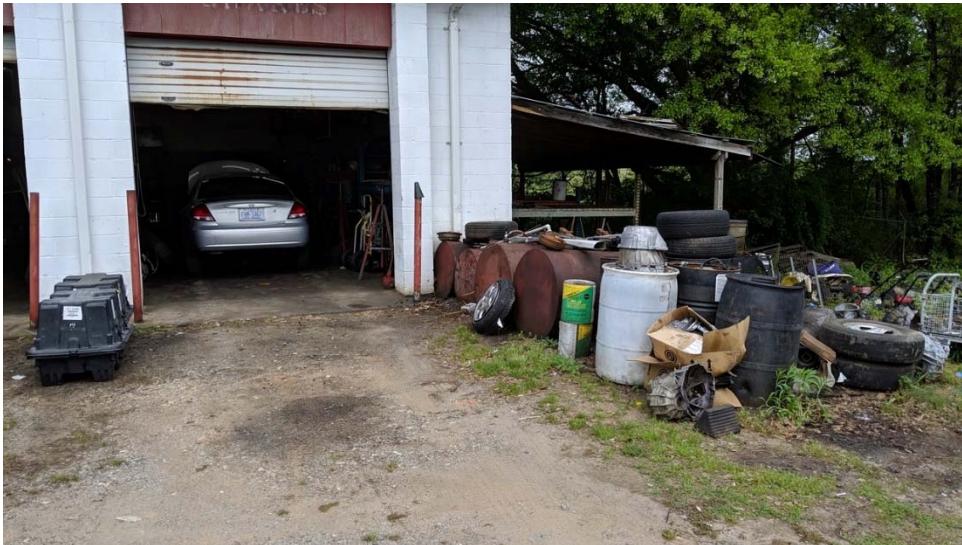
**PHOTO 2:**

View of a vehicle repair bay, ground surface staining, ASTs, and drums near the northeast corner of the Site building facing west.

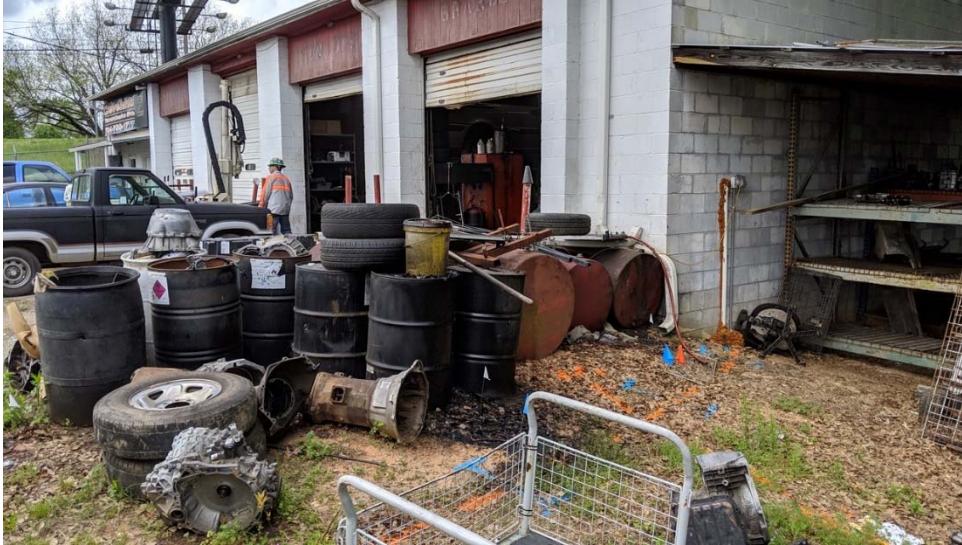
**PHOTO 3:**

View of vehicle repair bays, ground surface staining, ASTs, and drums near the northeast corner of the Site building facing southwest.

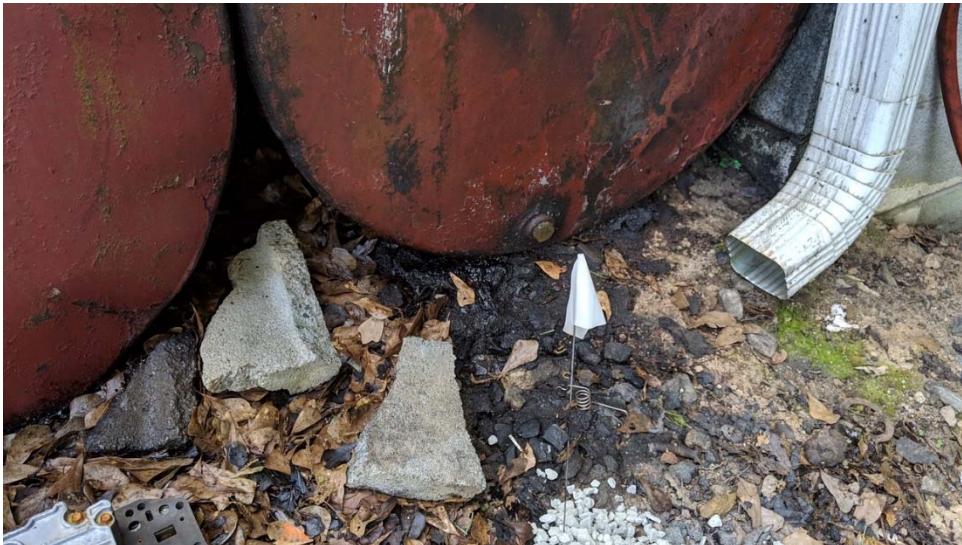
**PHOTO 4:**

View of staining near P609-SB13 and an AST at the northeast corner of the Site building.

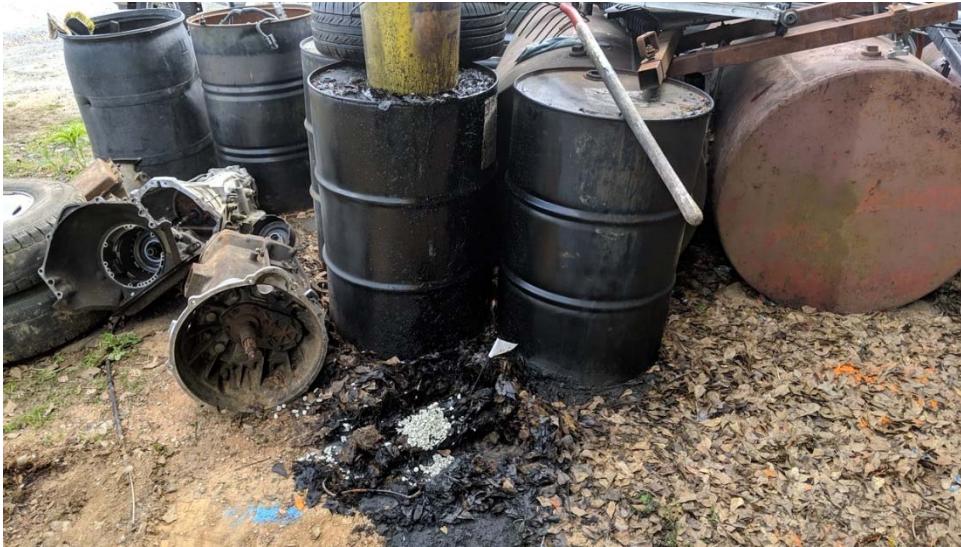
**PHOTO 5:**

View of staining near P609-SB12 and drums at the northeast corner of the Site building.

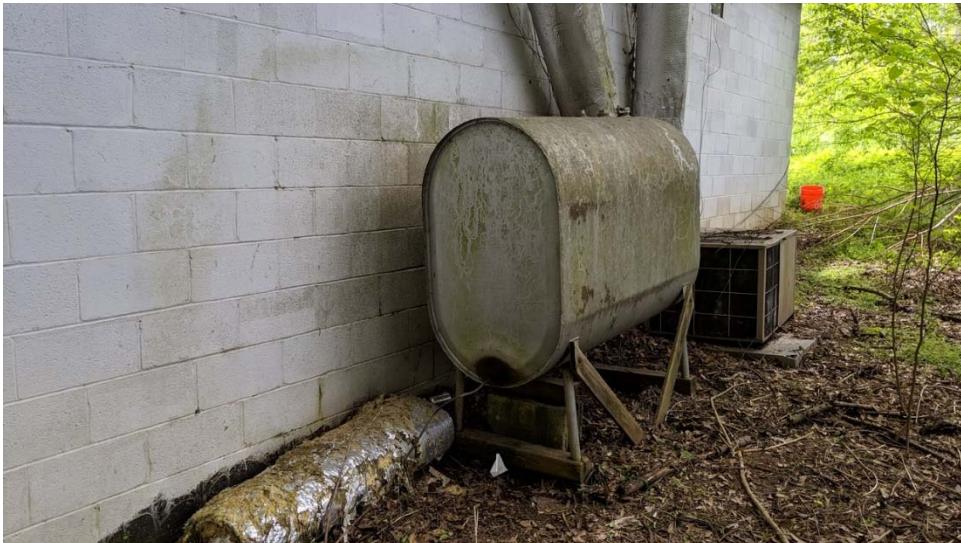
**PHOTO 6:**

View south of a heating oil AST on the west side of the Site building.

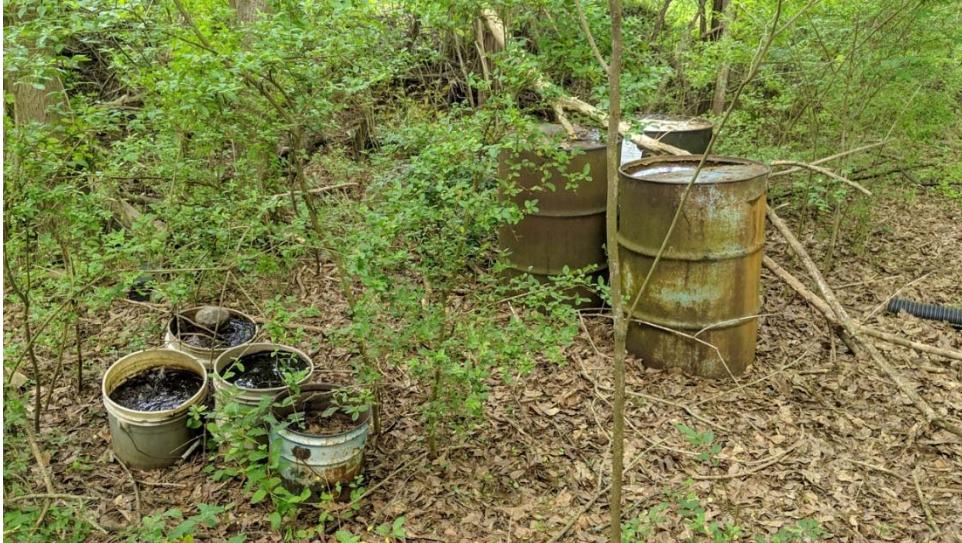
**PHOTO 7:**

View west of drums and buckets behind/west of the Site building.

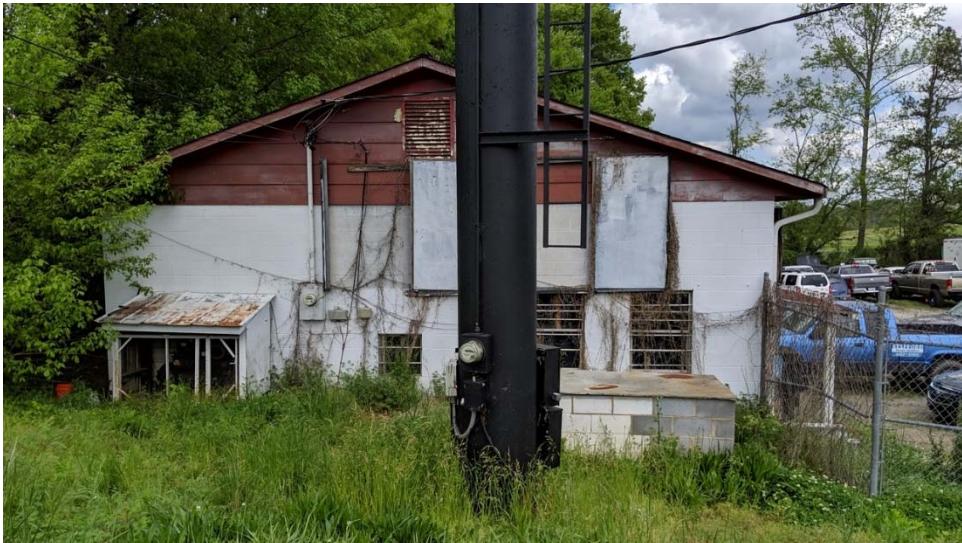
**PHOTO 8:**

View north of the south side of the site building. An air compressor can be seen left, and a water supply well can be seen right.

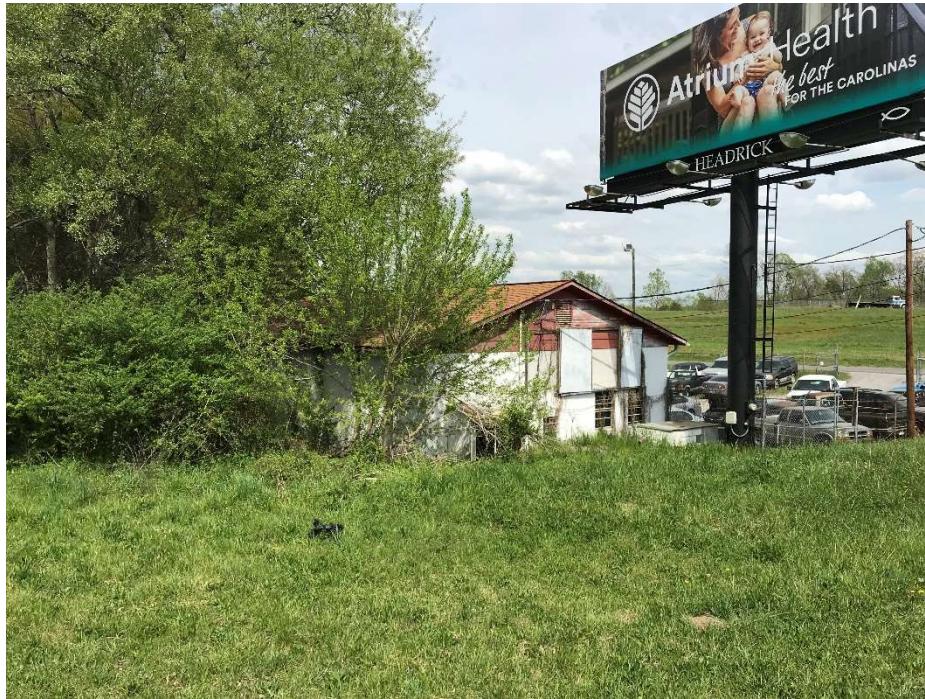
Photo 1: Looking North showing surface metal and obstructions

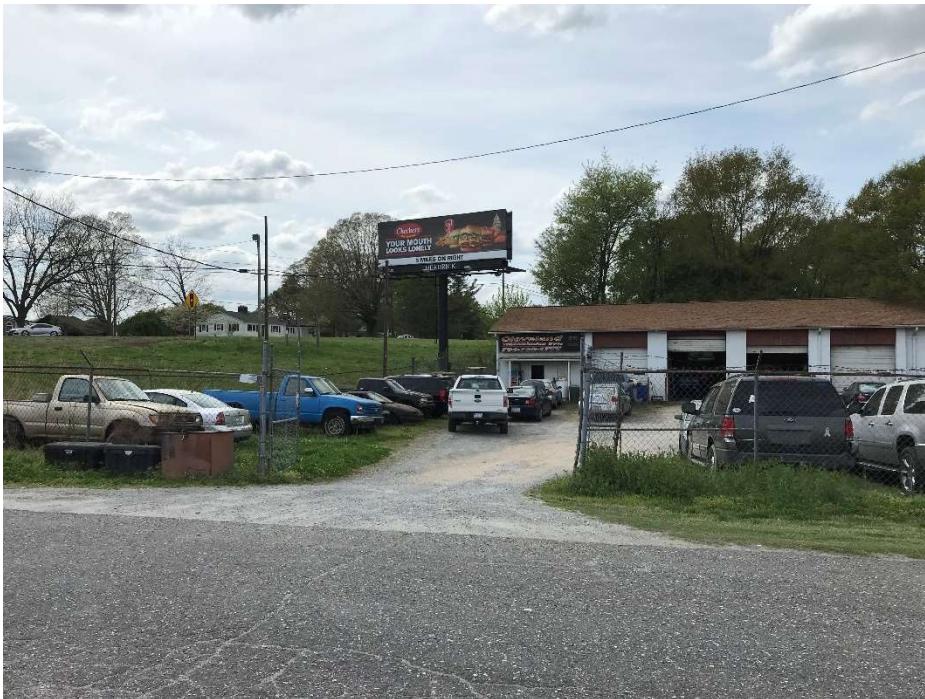
Photo 2: Looking West showing surface metal and obstructions

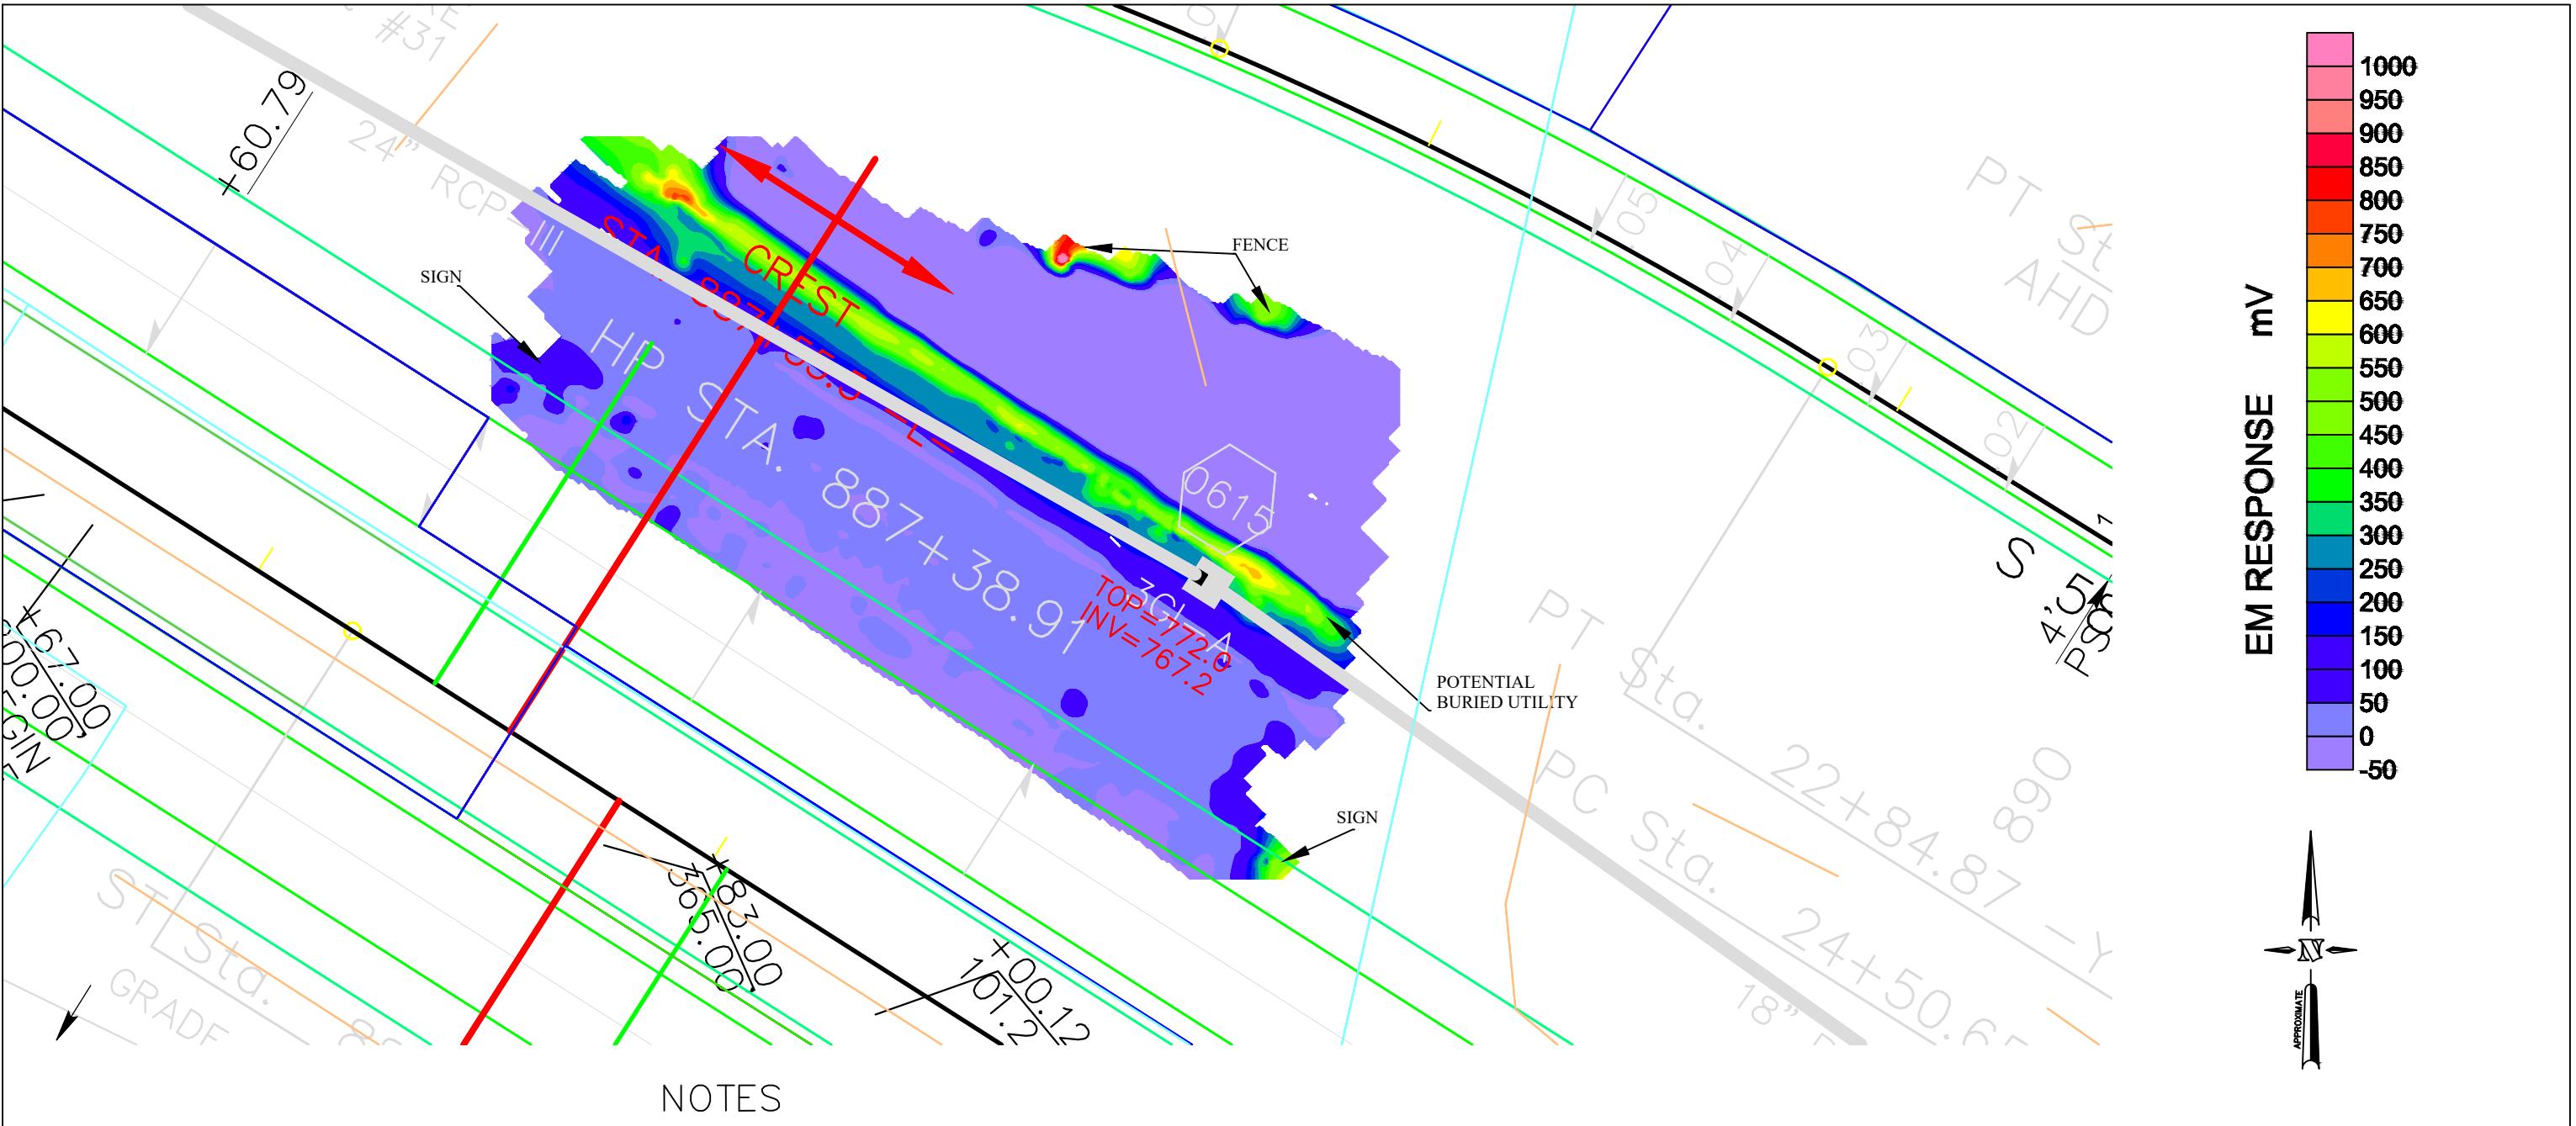
No subsurface anomalies were identified in the geophysical data that indicated the presence of USTs. The anomalies represented in Figure 1 are consistent with known metallic surface objects, utilities, and/or cultural interference. Although geophysical methods provide a high level of assurance for the location of subsurface objects, the possibility exists that not all features can or will be identified. Therefore, due caution should be used when performing any subsurface excavation, and GEL Solutions, LLC will not be liable for any damages that may occur. Descriptions of the technologies employed during this geophysical investigation are provided below.

2) FIELD SURVEY CONDUCTED ON 04.15.2019 - 04.18.2019.  
 3) GEOPHYSICAL DATA GENERATED USING AN IMPULSE RADAR CROSSOVER GPR SYSTEM CONFIGURED WITH A 170MHZ AND 600MHZ ANTENNA AND A GEONICS EM-61 TDEM SYSTEM. APPROXIMATE POSITIONING WAS PROVIDED USING TRIMBLE RTK/GPS.
