**North Carolina Department of Transportation  
Preliminary Site Assessment  
State Project: R-2707E  
WBS Element: 34497.1.2  
Cleveland County**

**Parcel 643  
Cassandra Everhart  
5040 East Dixon Boulevard  
Kings Mountain, North Carolina  
May 17, 2019**

**Wood Environment and Infrastructure Solutions, Inc.  
Project: 1883R2707**

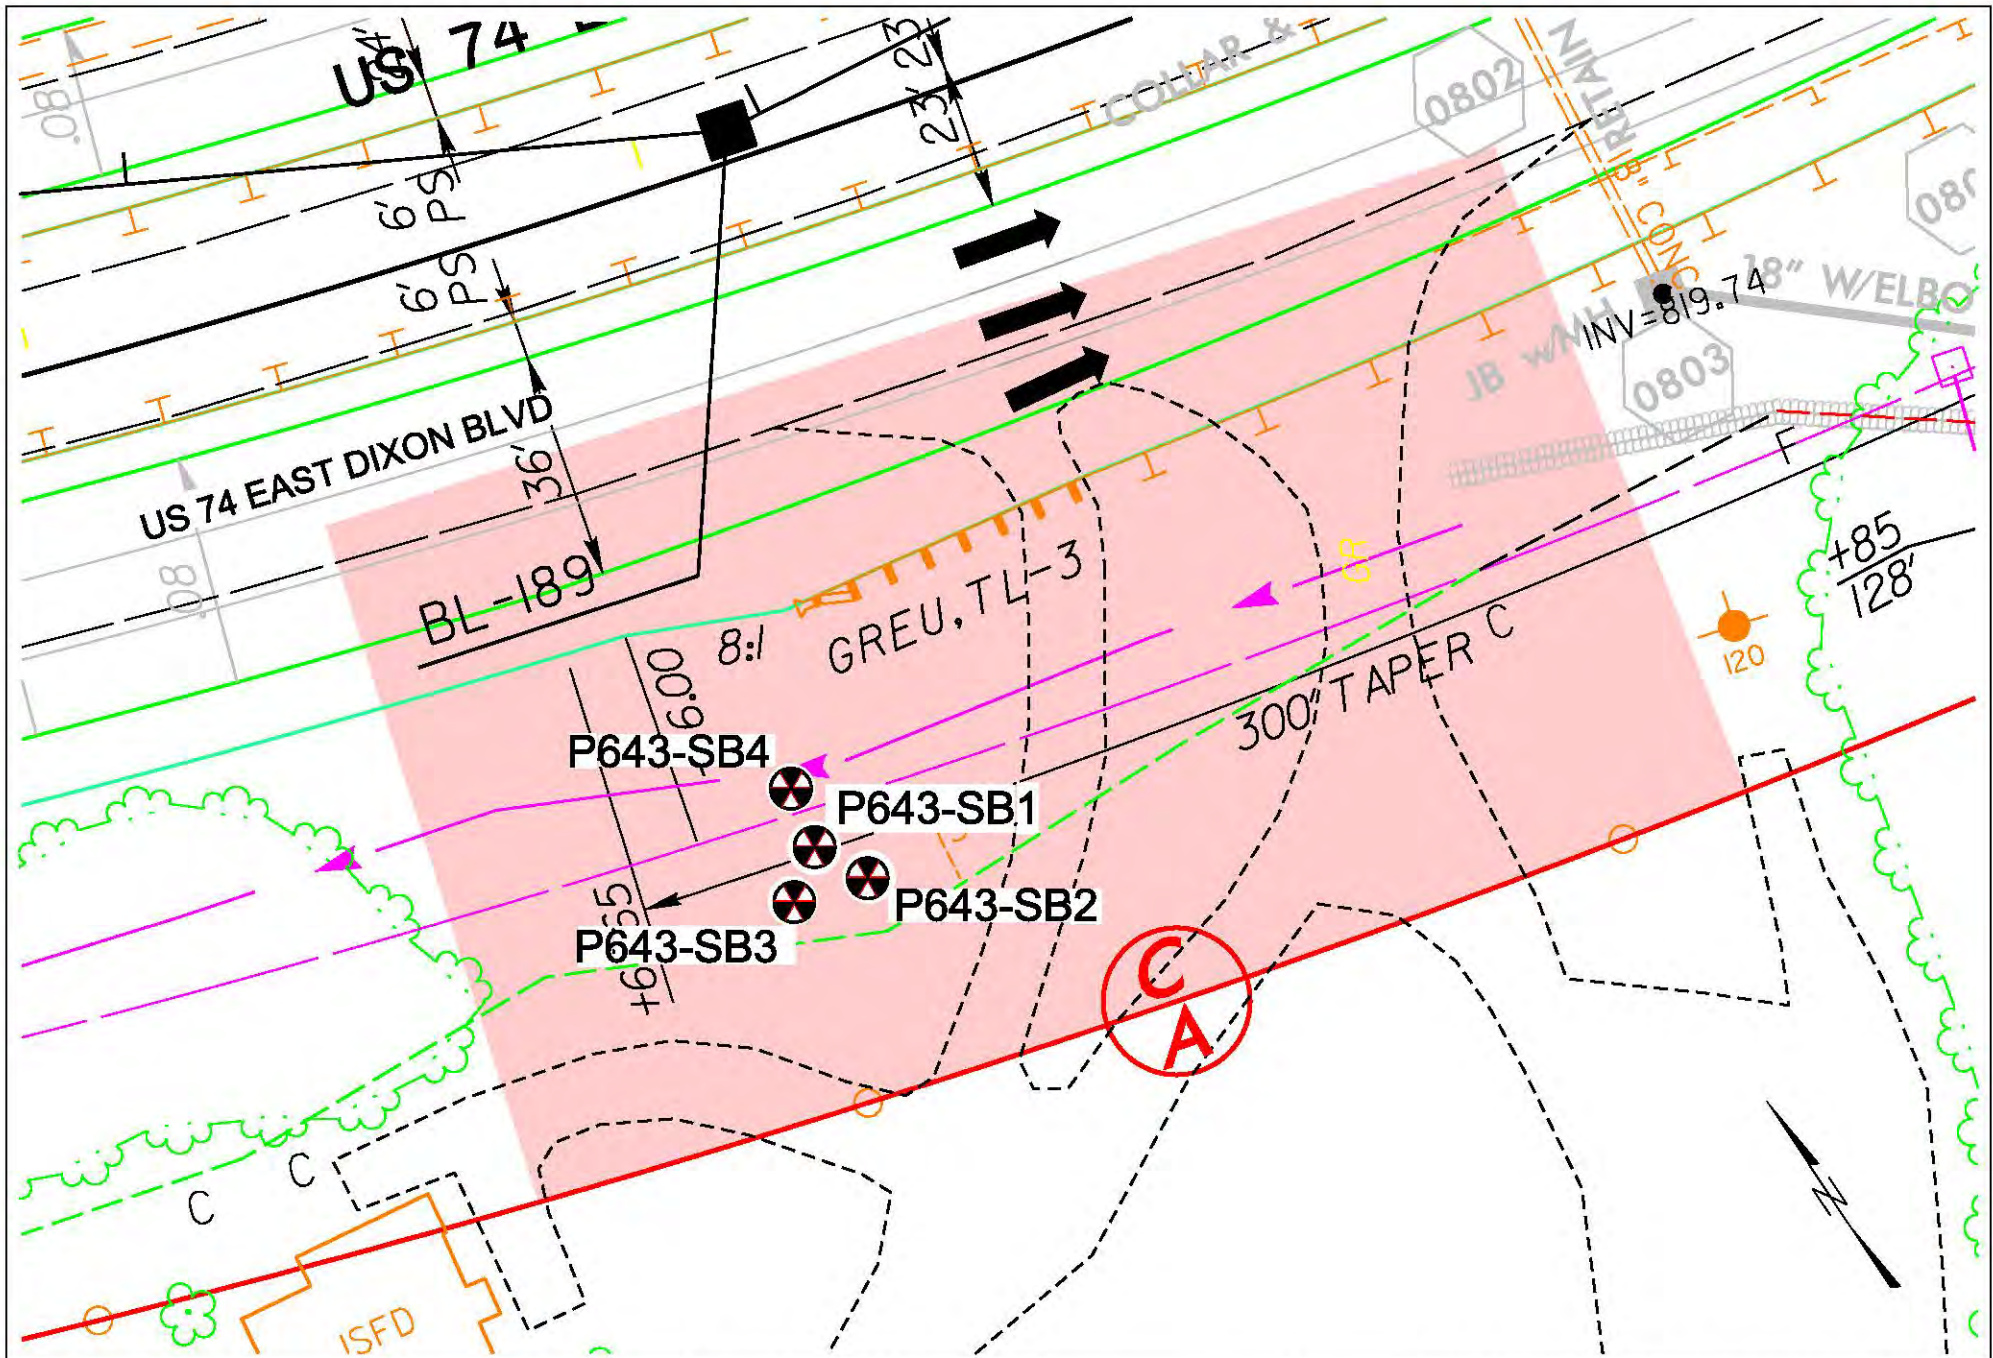
PREPARED BY: LMM	DATE: 5/13/19	CHECKED BY: HPC	DATE: 5/13/19	JOB NUMBER 188322707	FIGURE 2
---------------------	------------------	--------------------	------------------	-------------------------	-------------

Site geology was observed through the advancement of four shallow hand augered soil borings (P643-SB1 to P643-SB4). Figure 2 presents the boring locations and site layout. Boring depth targeted a total depth of three feet below ground surface (bgs) for the borings at the Site. Soils encountered in the borings consisted mostly of red to orange to brown clayey sandy silts. Petroleum odor and staining was observed in the boring P643-SB1 from 0 to 0.5 feet bgs. Groundwater was not encountered. Based on observations of topography of the Site vicinity, the groundwater flow direction is inferred to be generally to the southeast. Boring logs are presented in **Appendix B**.

AREA OF INVESTIGATION WITH SOIL BORING LOCATIONS- PARCEL 643  
 EVERHART PROPERTY  
 STATE PROJECT: R-2707E  
 WBS ELEMENT: 34497.1.2  
 CLEVELAND COUNTY, KINGS MOUNTAIN, NORTH CAROLINA

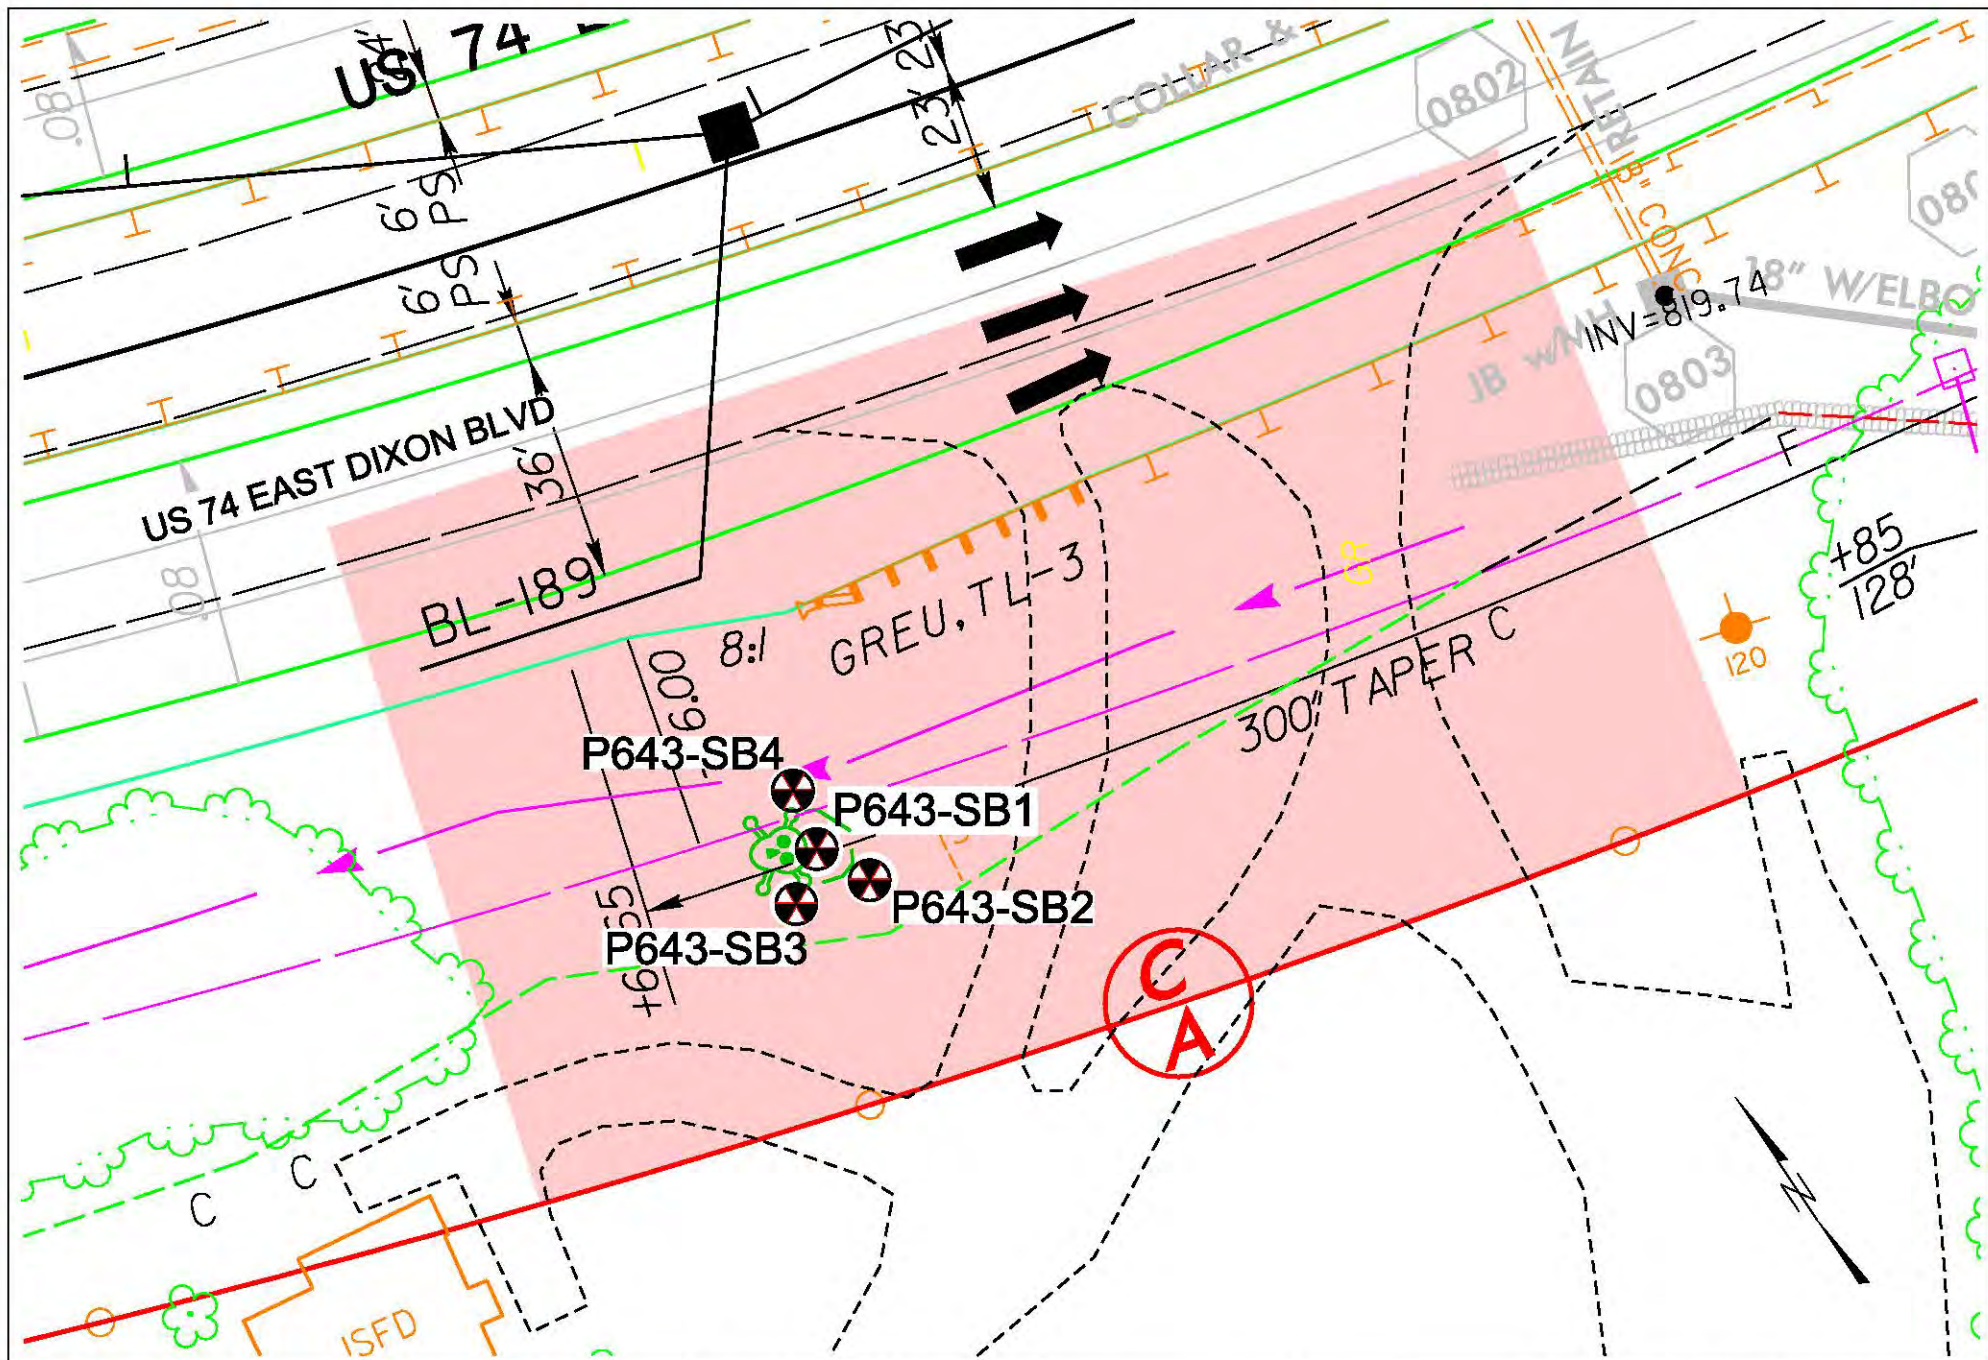
PREPARED BY:	DATE:	CHECKED BY:	DATE:	JOB NUMBER	FIGURE
LMM	5/13/19	HPC	5/13/19	188322707	4

The estimated area of impacted soil is shown on Figure 4. Estimated impacted soil volume for the heavily stained area near boring P643-SB1 is 8 cubic feet (0.3 cubic yards) based on an unsaturated soil thickness of 0.5 feet.

KNOWN CONTAMINATION AREA - PARCEL 643  
 EVERHART PROPERTY  
 STATE PROJECT: R-2707E  
 WBS ELEMENT: 34497.1.2  
 CLEVELAND COUNTY, KINGS MOUNTAIN, NORTH CAROLINA

Based on these PSA results, Wood does not recommend further assessment in the area of investigation. It is understood the area of impacted soils are located in areas to be impacted by construction activities. Special handling should be performed during excavation in this area and impacted soil should be disposed properly offsite.

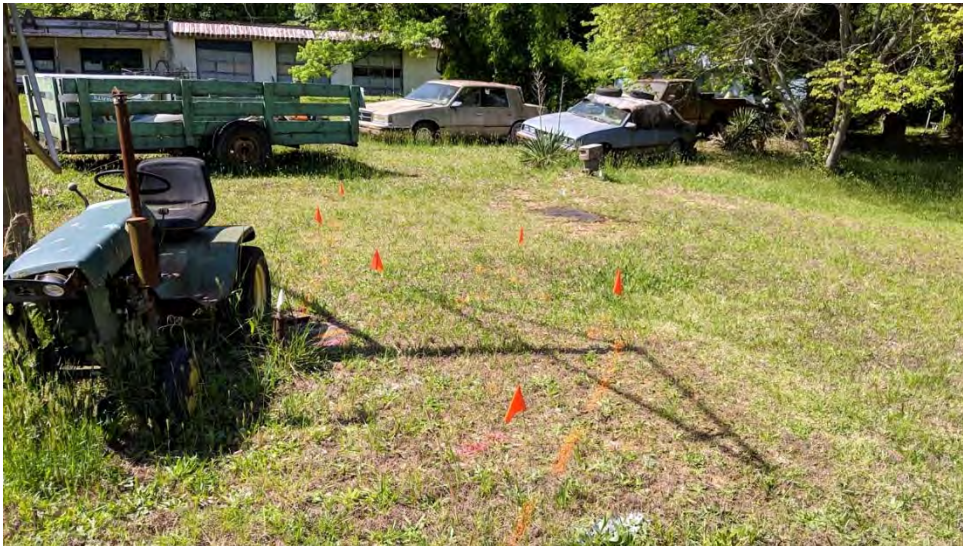
**PHOTO 4:**  
View of vehicles, equipment, and a located unknown utility line within the Area of Investigation on Site, facing south.

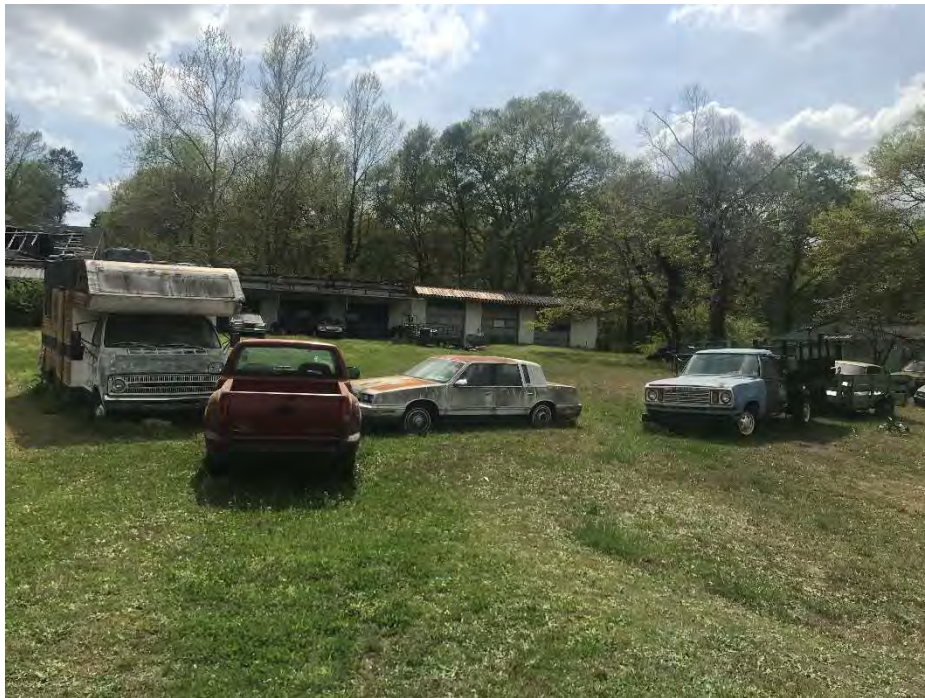
Photo 1: Looking South showing surface metal and obstructions

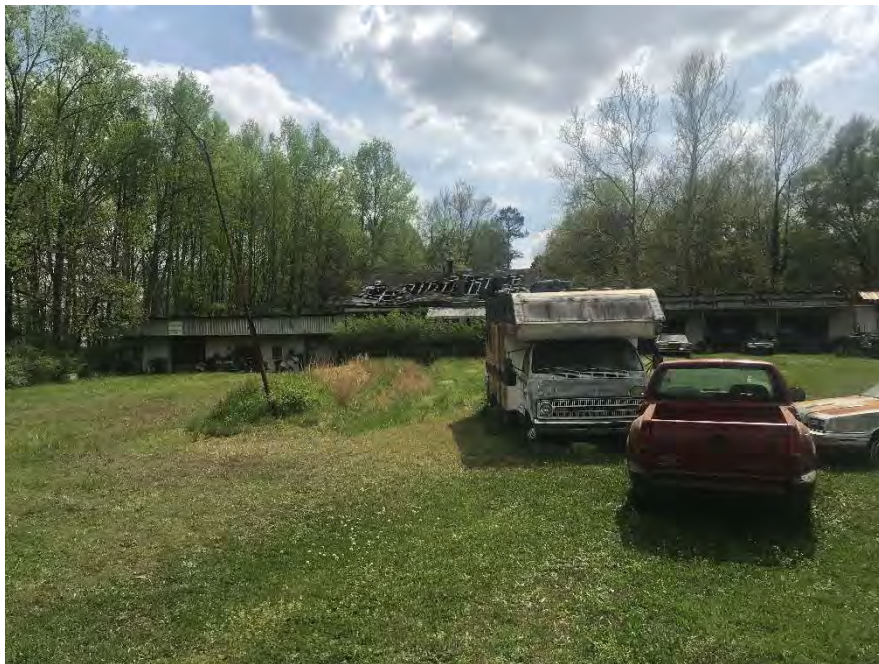
Photo 4: Looking South showing surface metal and obstructions

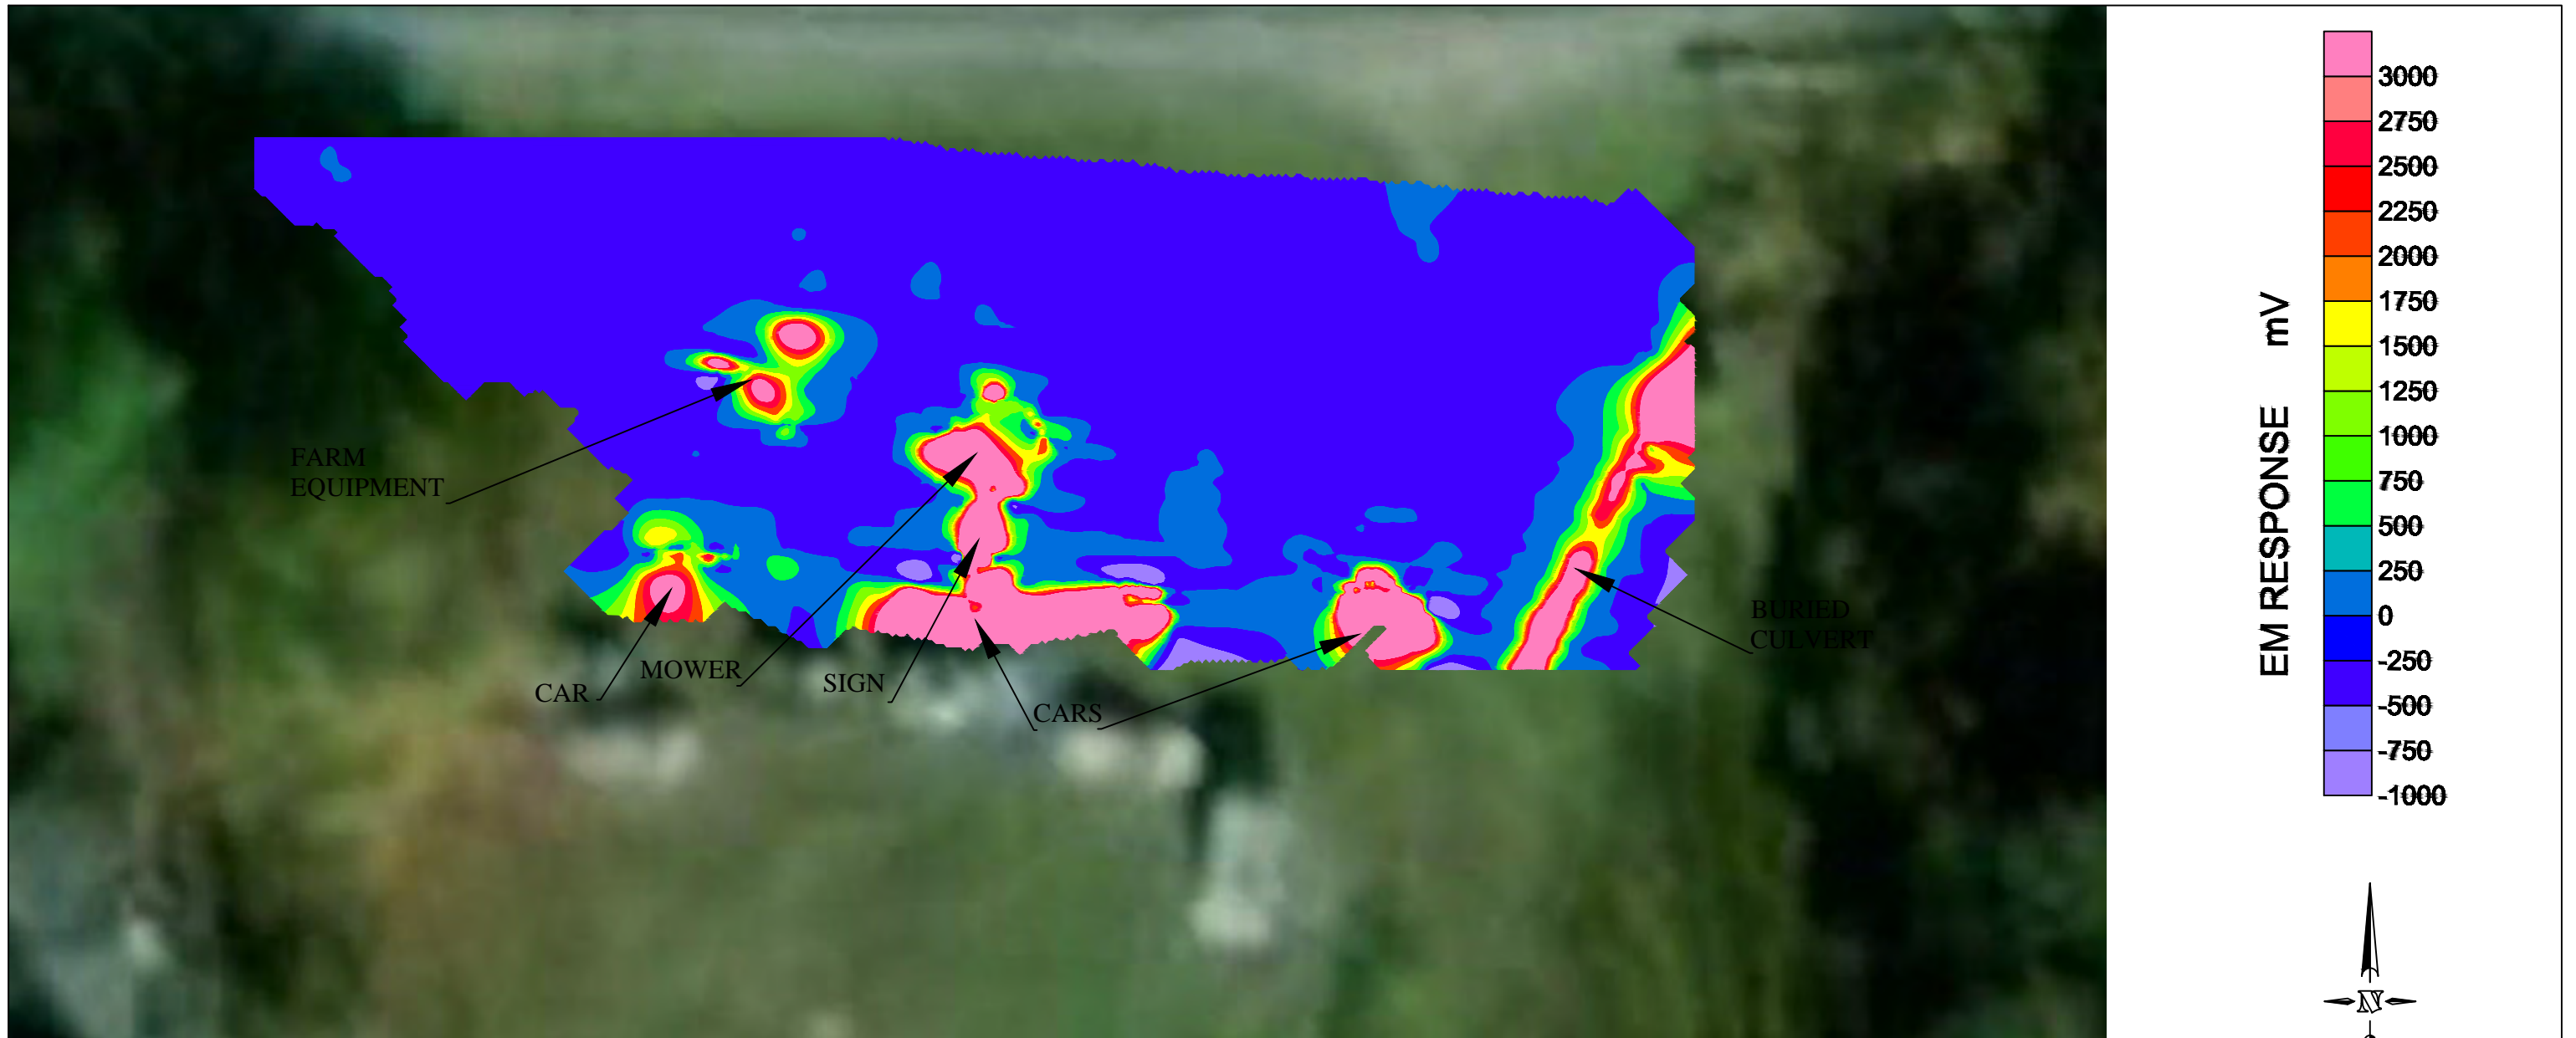
No subsurface anomalies were identified in the geophysical data that indicated the presence of USTs. The anomalies represented in Figure 1 are consistent with known metallic surface objects, utilities, and/or cultural interference. Although geophysical methods provide a high level of assurance for the location of subsurface objects, the possibility exists that not all features can or will be identified. Therefore, due caution should be used when performing any subsurface excavation, and GEL Solutions, LLC will not be liable for any damages that may occur. Descriptions of the technologies employed during this geophysical investigation are provided below.

There were no subsurface geophysical anomalies detected within the limits of Parcel #043 during this investigation that indicated the presence of USTs. The anomalies represented in the data shown on Figure 1 are indicative of known metallic surface features and/or cultural interference.

RESULTS OF GEOPHYSICAL INVESTIGATION

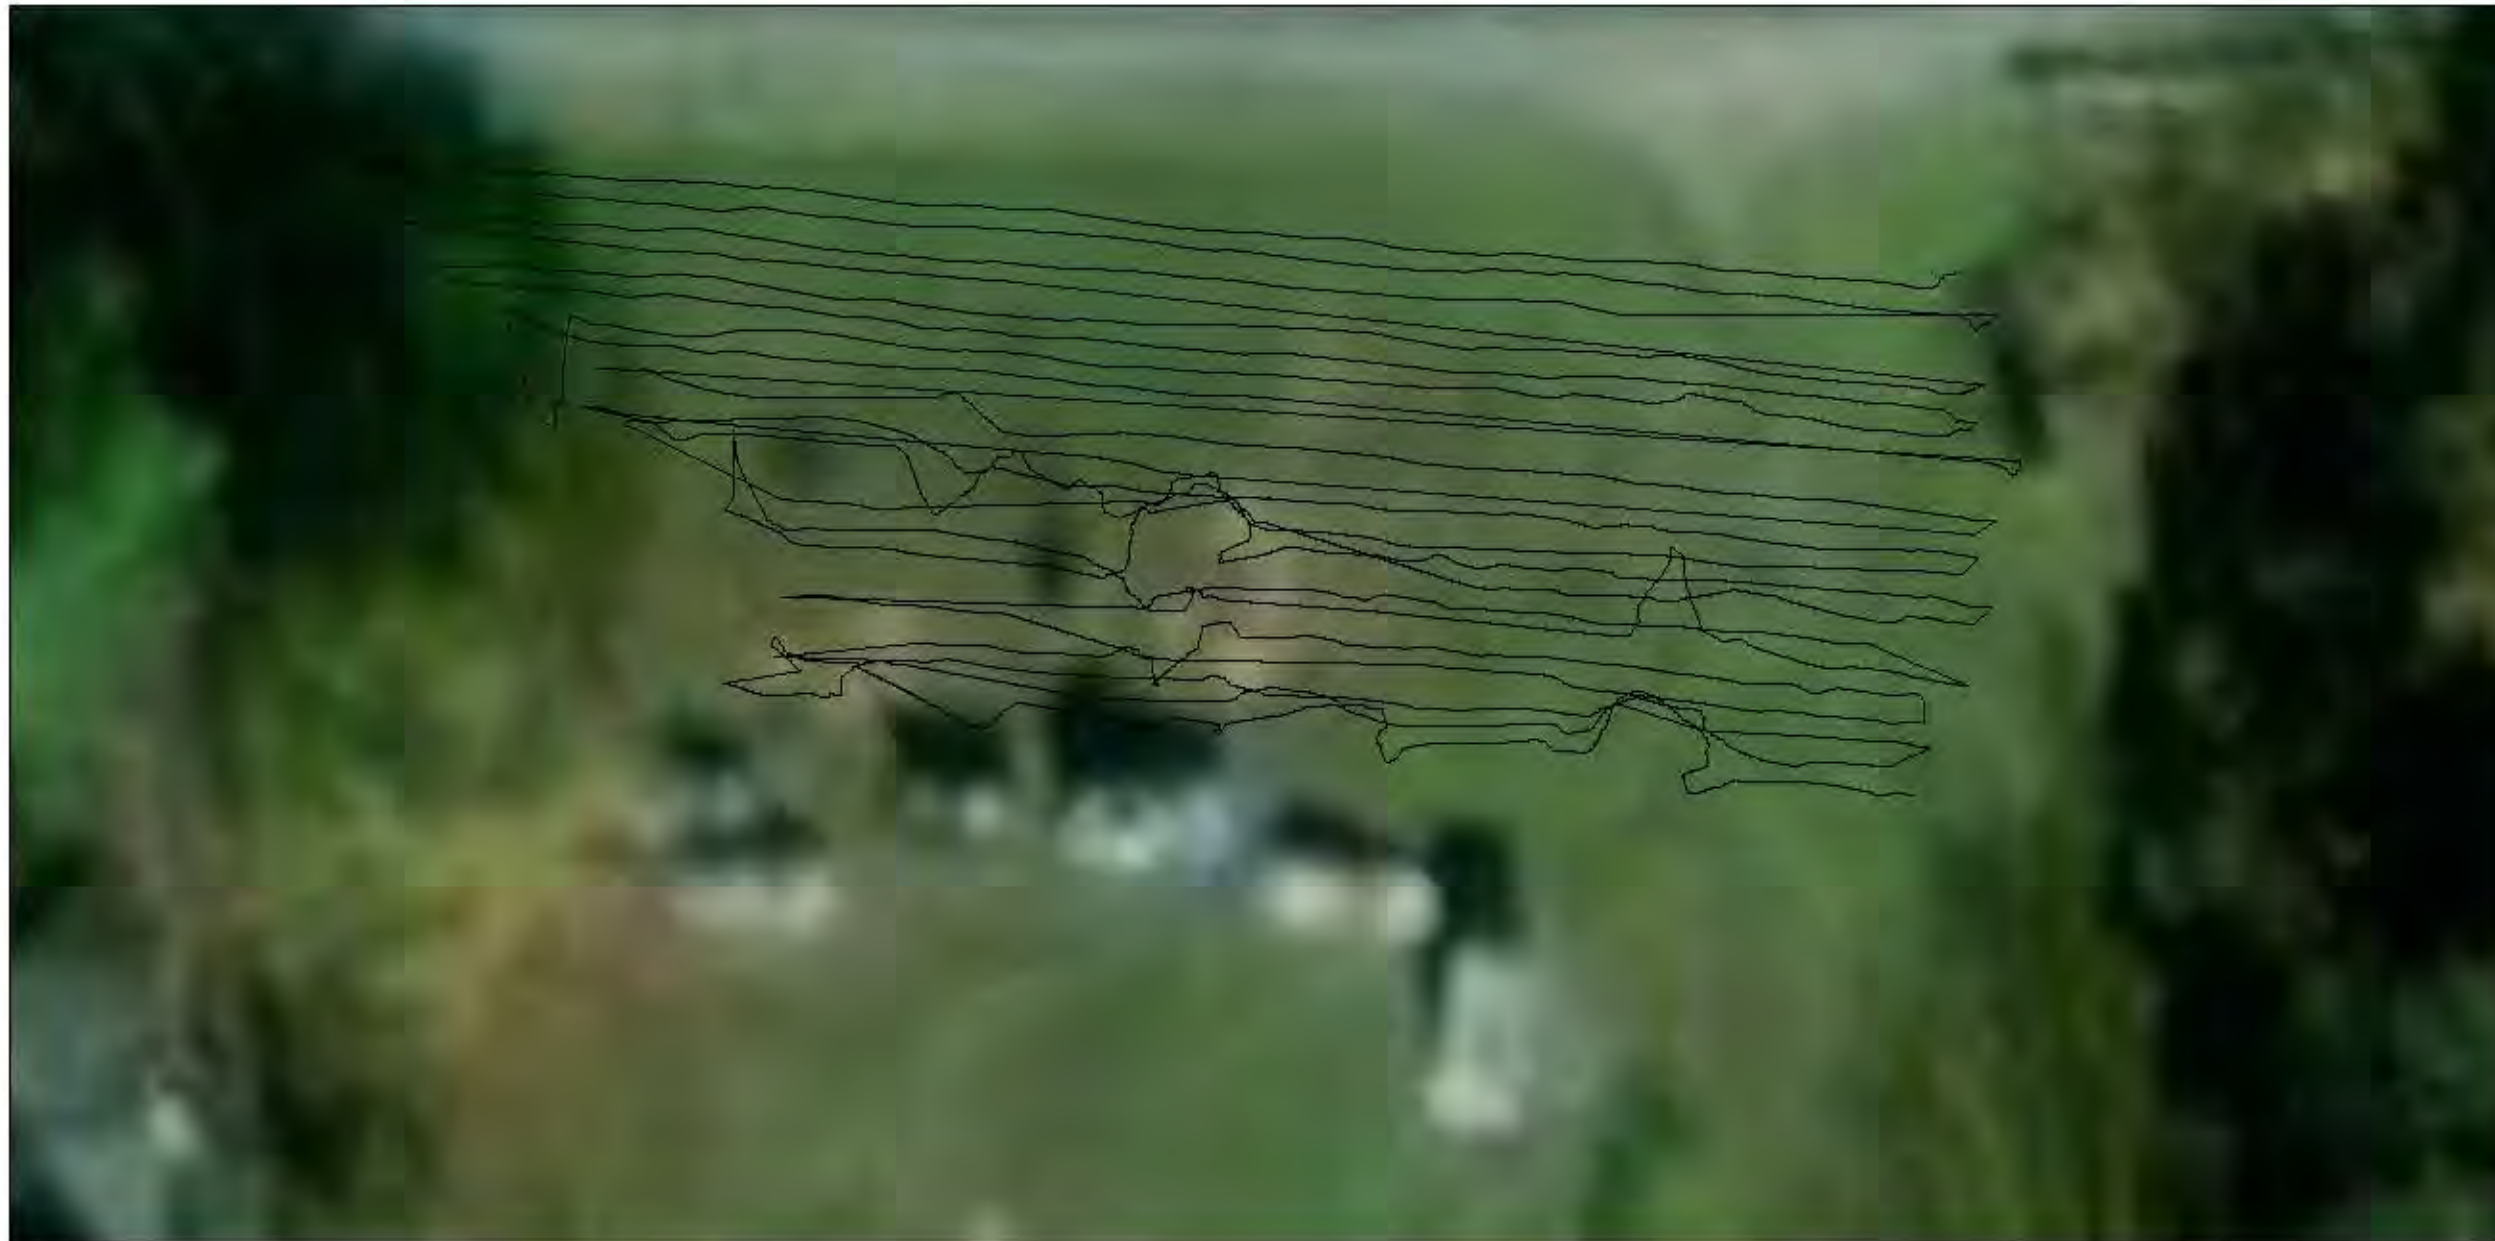
FIGURE  
2

RESULTS OF GEOPHYSICAL INVESTIGATION
