**North Carolina Department of Transportation
Preliminary Site Assessment
State Project: R-2707E
WBS Element: 34497.1.2
Cleveland County**

**Parcels 612 and 108
JoAnn C. Harmon and Heirs of Lester Harmon
4941 East Dixon Boulevard
Kings Mountain, North Carolina
May 17, 2019**

**Wood Environment and Infrastructure Solutions, Inc.
Project: 1883R2707**

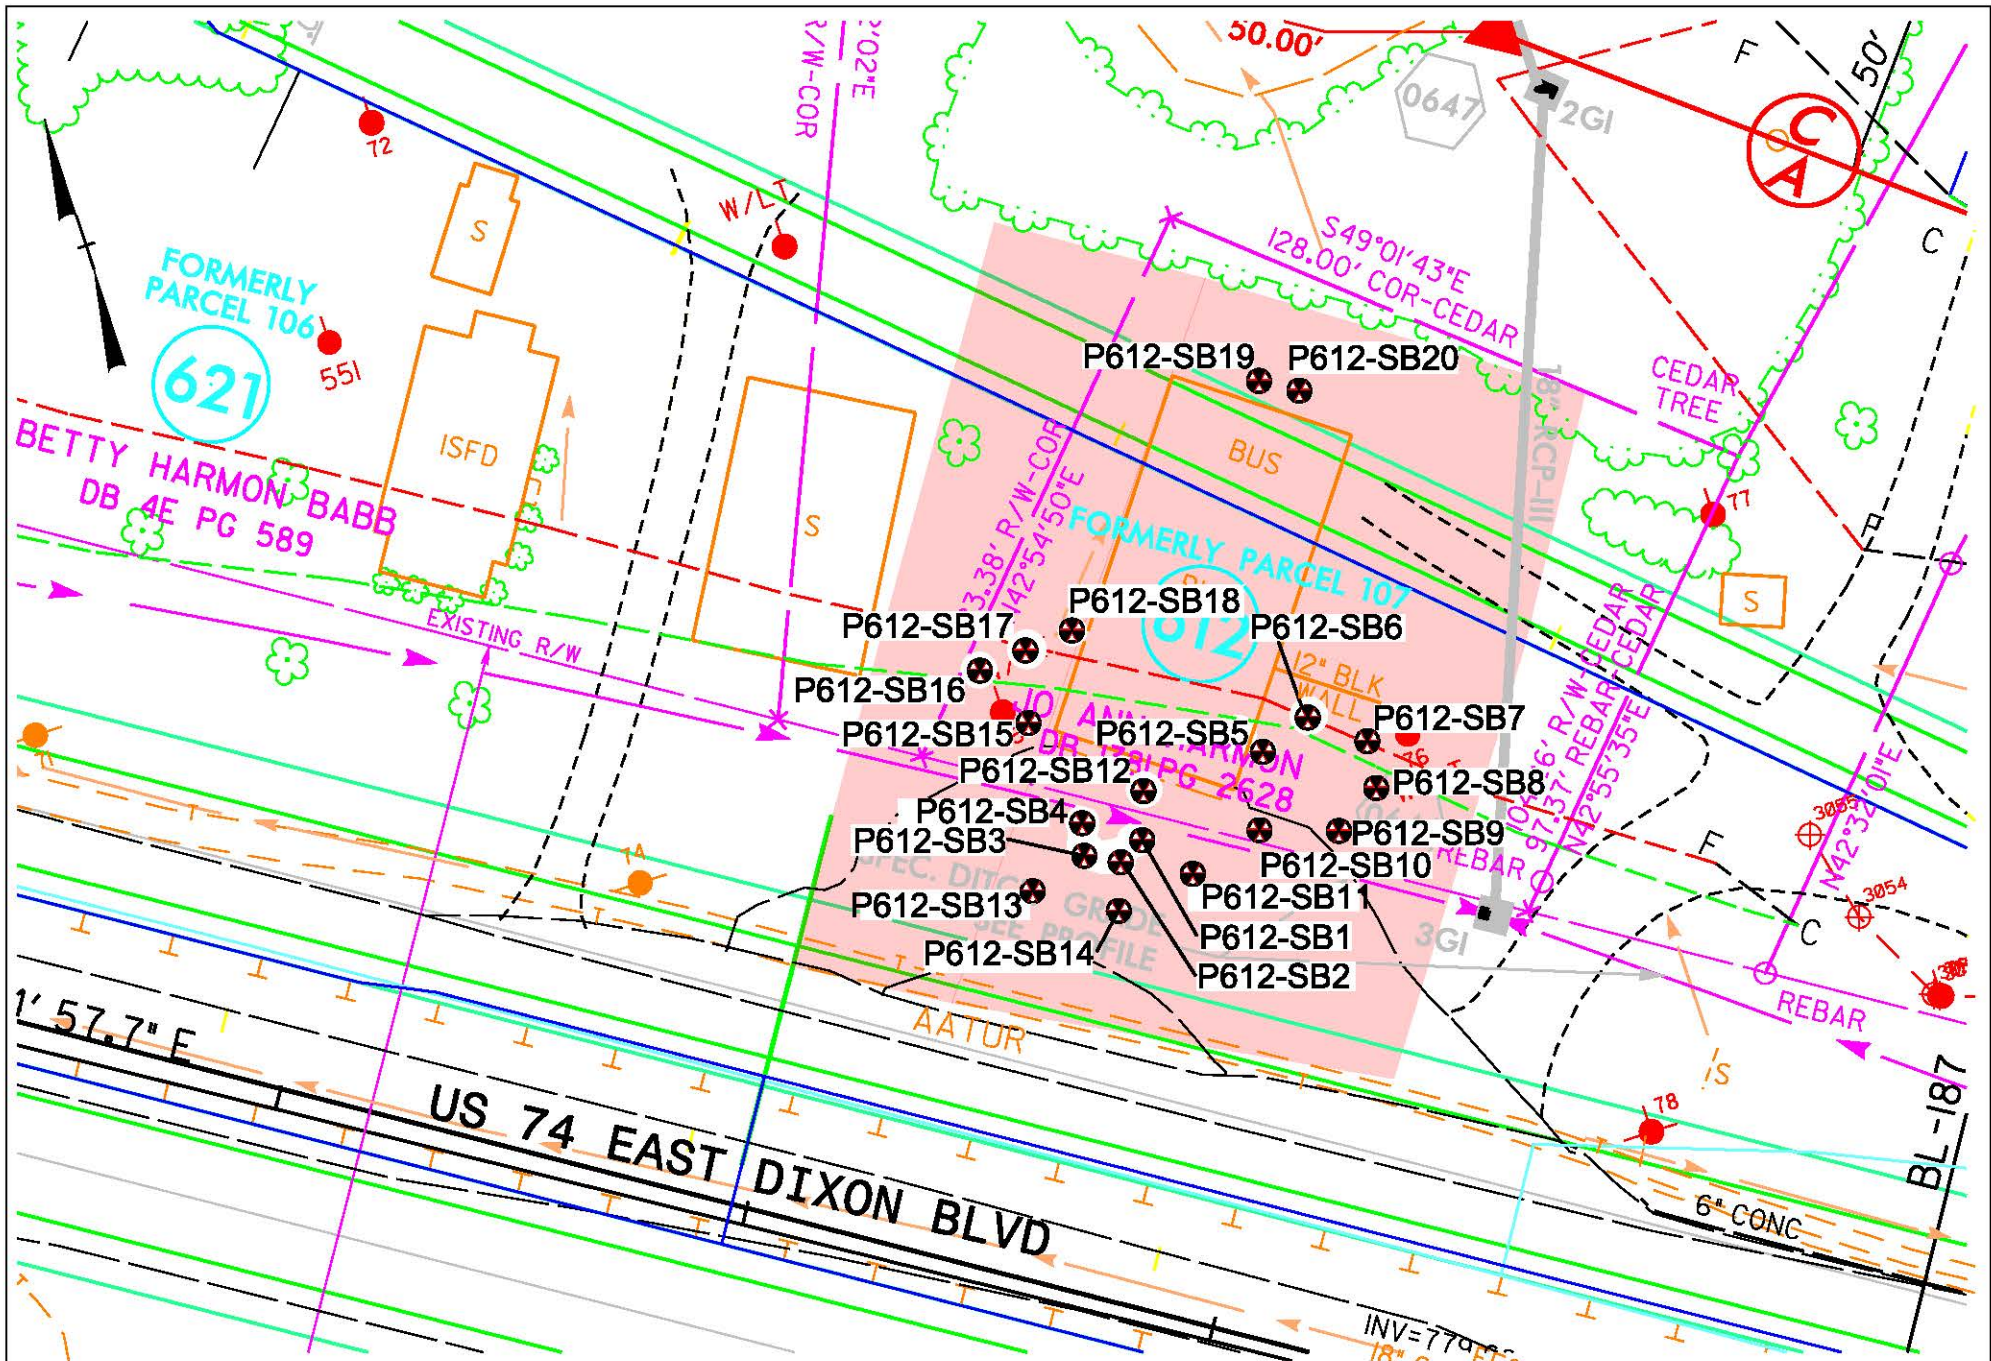
PREPARED BY:	DATE:	CHECKED BY:	DATE:	JOB NUMBER	FIGURE
LMM	5/13/19	HPC	5/13/19	188322707	2

Site geology was observed through the advancement of 20 shallow soil borings advanced via a direct-push rig (P612-SB1 to P612-SB20). Figure 2 presents the boring locations and site layout. The majority of the soil borings targeted a depth of eight feet below ground surface (bgs). Soil borings P612-SB2 (located near the suspected pump island) and P612-SB-5 (located near the three known USTs along the eastern exterior of the Site building) were advanced to a depth of 16 feet bgs and borings P612-SB18 (located near the heating oil AST), P612-SB19, and P612-SB20 (located near the air compressors) were advanced to a depth of four feet bgs. Soils encountered in the borings consisted mostly of red to brown

AREA OF INVESTIGATION WITH SOIL BORING LOCATIONS - PARCELS 612/108
 JOAHN HARMON PROPERTY
 STATE PROJECT: R-2707E
 WBS ELEMENT: 34497.1.2
 CLEVELAND COUNTY, KINGS MOUNTAIN, NORTH CAROLINA

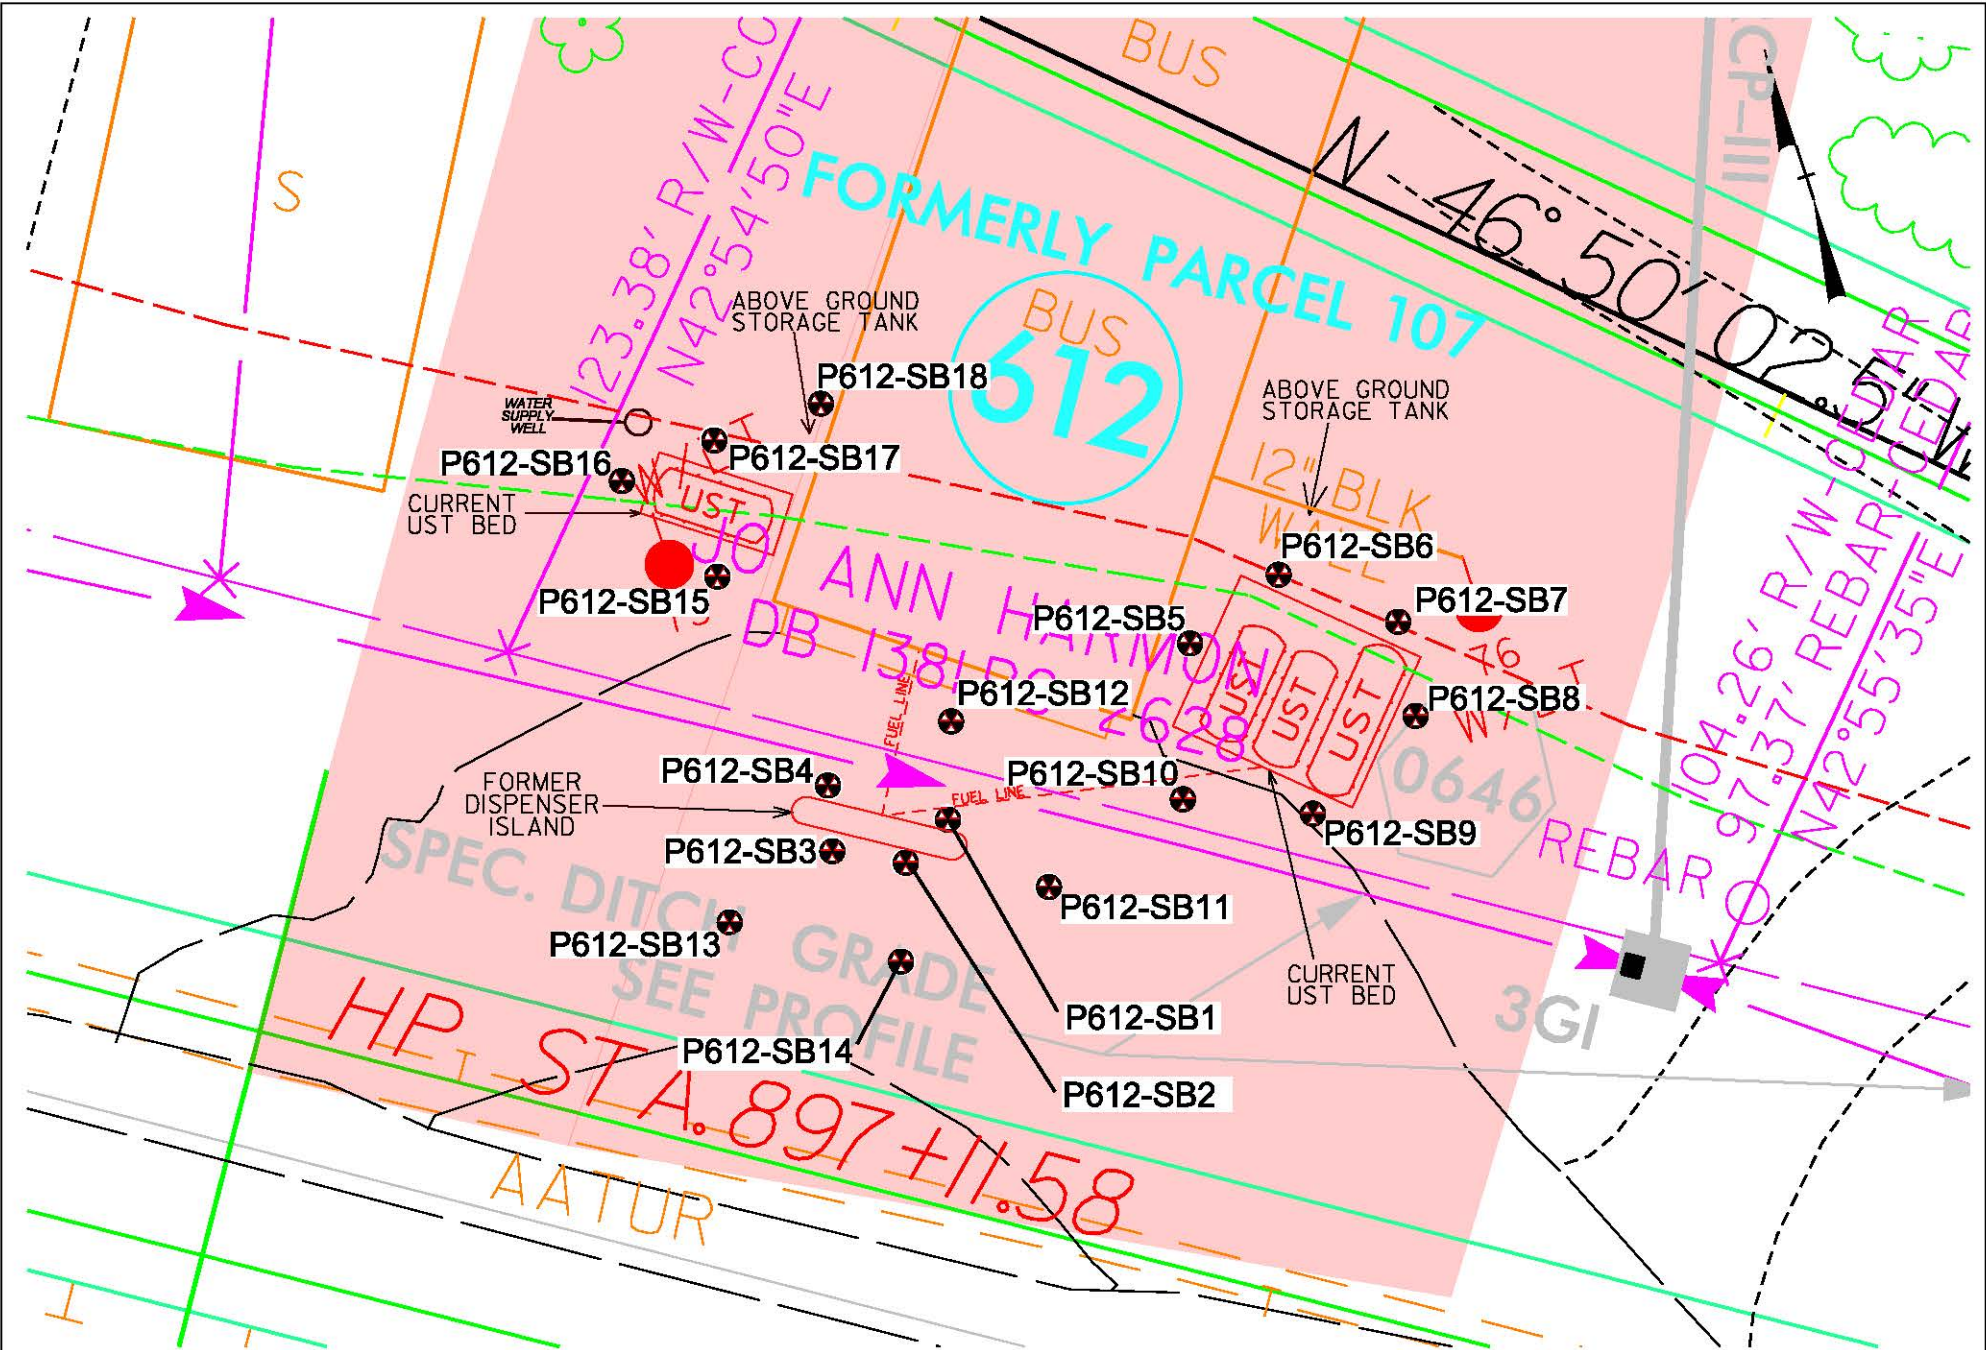
PREPARED BY: LMM	DATE: 5/13/19	CHECKED BY: HPC	DATE: 5/13/19	JOB NUMBER 188322707	FIGURE 3
---------------------	------------------	--------------------	------------------	-------------------------	-------------

The geophysical survey of the Site occurred between April 15 and 18, 2019. GEL performed a time-domain electromagnetic (TDEM) survey of the Site with a ground penetrating radar (GPR) survey conducted across select EM anomalies. The GEL geophysical report is presented as **Appendix C**. GEL reported nine anomalies within the area of investigation with four attributed to visible cultural features at the ground surface including a sign, a dumpster, an aboveground storage tank, and metal located at the surface. One anomaly was consistent with reinforced concrete (rebar or wire mesh) and the remaining four anomalies were indicative of known USTs. Three known USTs were identified along the eastern exterior of the Site building and one known UST was identified along the western exterior. The locations of the four known USTs are depicted on Figure 2.

UST SYSTEM AND SITE FEATURES - PARCELS 612/108
 JOANN HARRISON PROPERTY
 STATE PROJECT: R-2707E
 WBS ELEMENT: 34497.1.2
 CLEVELAND COUNTY, KINGS MOUNTAIN, NORTH CAROLINA

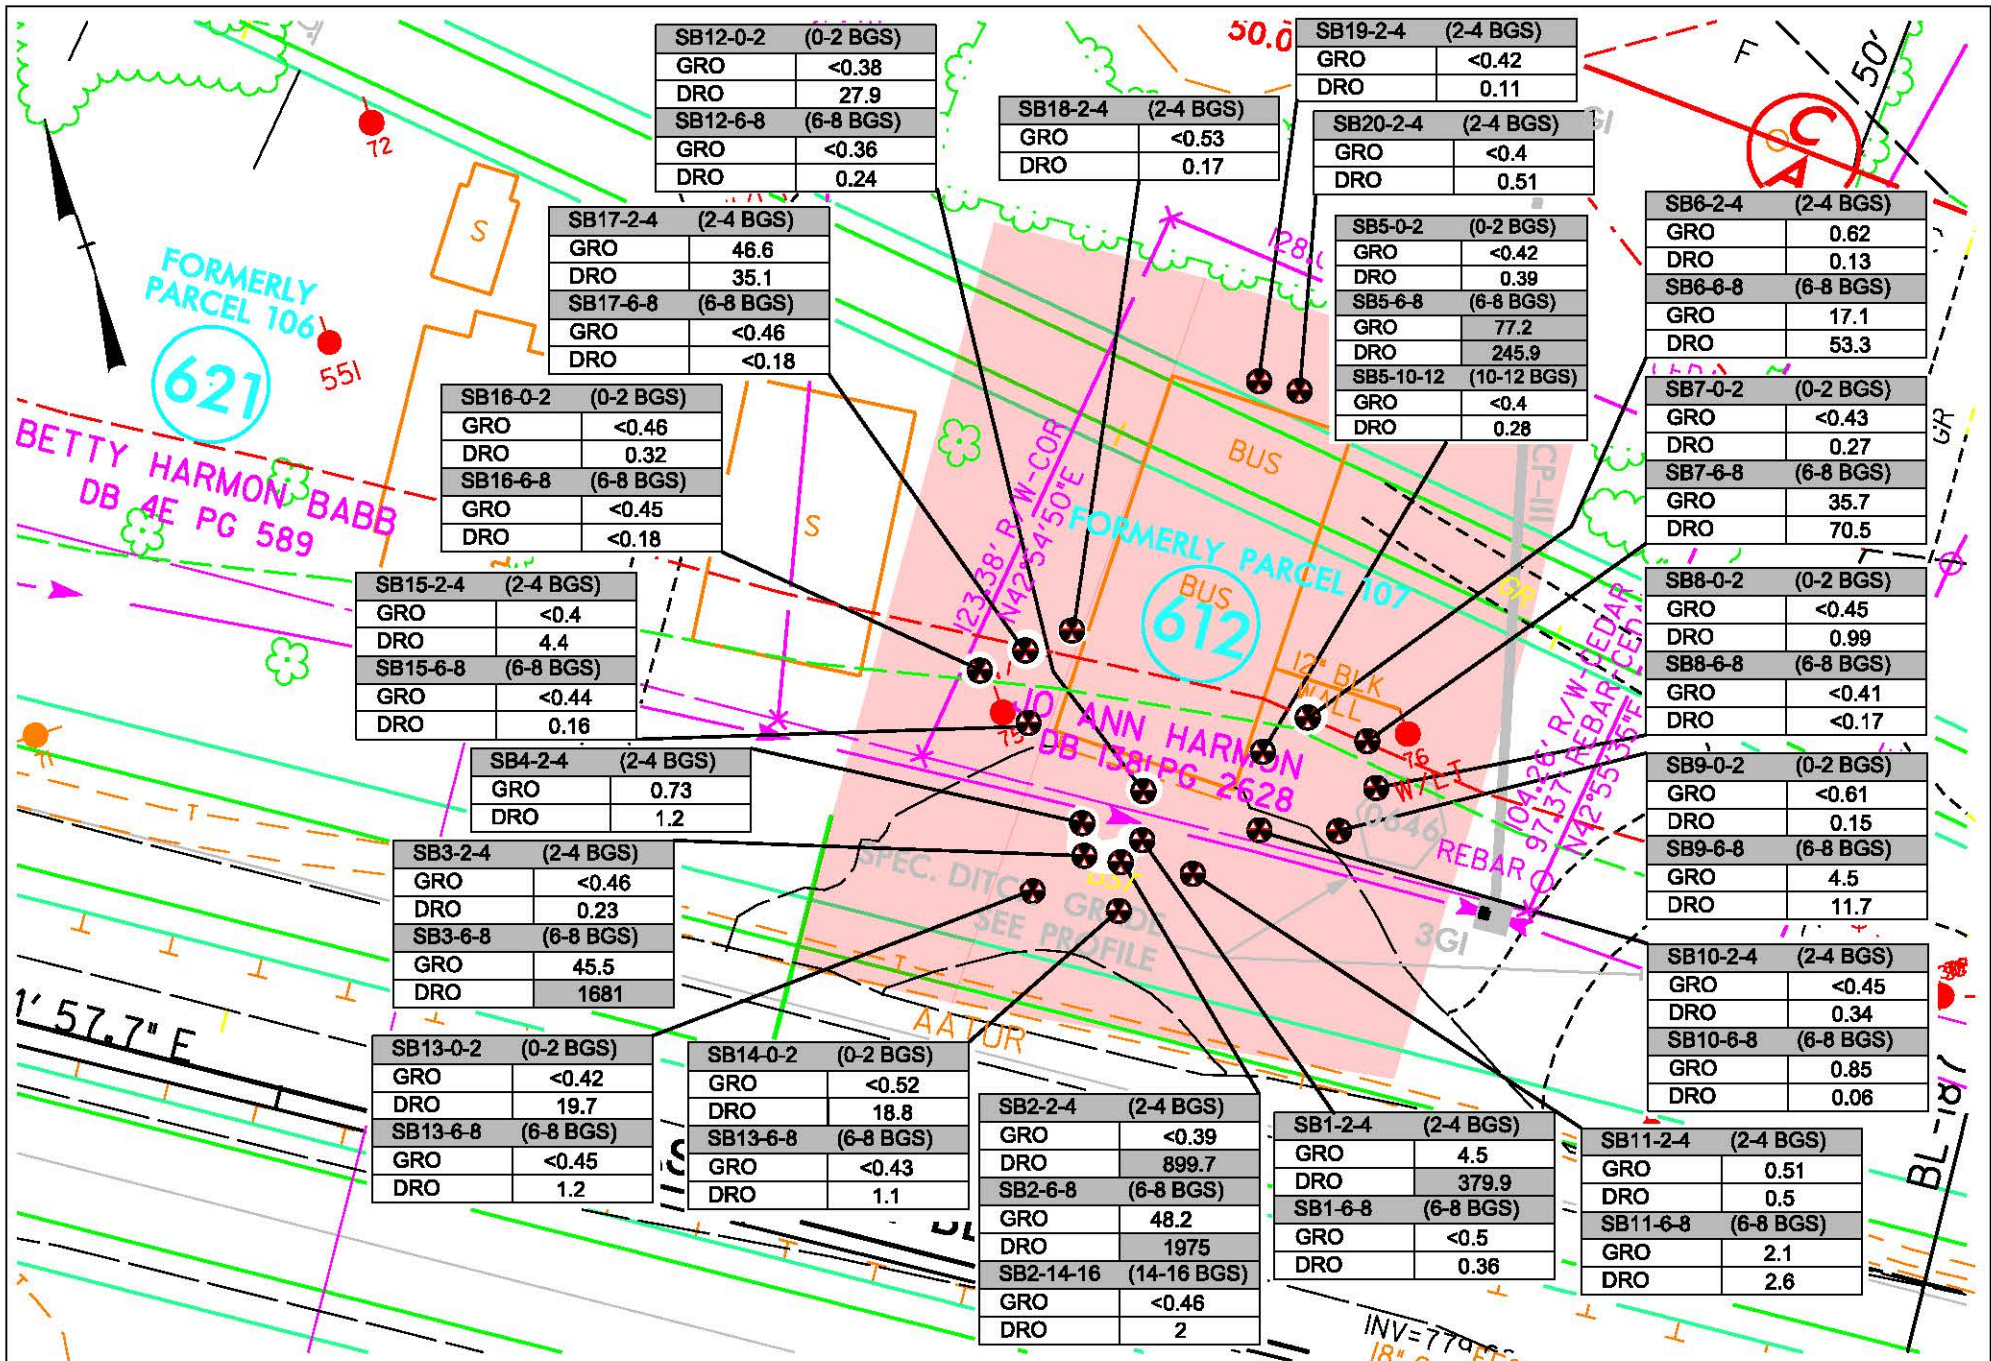
PREPARED BY: LUM	DATE: 5/13/19	CHECKED BY: HPC	DATE: 5/13/19	JOB NUMBER: 188322707	FIGURE: 4
------------------	---------------	-----------------	---------------	-----------------------	-----------

Results from the UVF petroleum soil analyses are presented in **Table 2**, with instrument generated tables in **Appendix D**. Several categories of analyses were measured such as: DRO, GRO, TPH, PAHs, and total aromatics. **Figure 3** presents the GRO and DRO results at each boring.

SB12-0-2	(0-2 BGS)
GRO	<0.38
DRO	27.9
SB12-6-8	(6-8 BGS)
GRO	<0.36
DRO	0.24

SB18-2-4	(2-4 BGS)
GRO	<0.53
DRO	0.17

SB19-2-4	(2-4 BGS)
GRO	<0.42
DRO	0.11

SB20-2-4	(2-4 BGS)
GRO	<0.4
DRO	0.51

UVF PETROLEUM RESULTS - PARCELS 612/106
 JOANN HARMON PROPERTY
 STATE PROJECT: R-2707E
 WBS ELEMENT: 34497.1.2
 CLEVELAND COUNTY, KINGS MOUNTAIN, NORTH CAROLINA

An Elevated TPH value above the NCDEQ Action Limit of 50 milligrams per kilogram (mg/kg) for GRO was detected in the sample collected from boring P612-SB5 at a depth of six to eight feet bgs (P612-SB5-6-8 at 77.2 mg/kg). Elevated TPH values above the NCDEQ Action Limit for GRO were not detected in the remaining 37 soil samples collected at the Site. However, TPH GRO was detected at 48.2 mg/kg in sample P612-SB2-6-8 and 45.5 mg/kg in sample P612-SB3-6-8 which were collected from borings near the former dispenser island and at 46.6 mg/kg in sample P612-SB17-2-4 which was collected near the known UST along the western building exterior.

Elevated TPH values above the NCDEQ Action Limit of 100 mg/kg for DRO were detected samples P612-SB1-2-4 (379.9 mg/kg), P612-SB2-2-4 (899.7 mg/kg), P612-SB2-6-8 (1,975 mg/kg), P612-SB3-6-8 (1,681 mg/kg), and P612-SB5-6-8 (245.9 mg/kg). Soil borings P612-SB1, P612-SB2, and P612-SB3 were located near the former dispenser island and boring P612-SB5 was located between the eastern building exterior and the three known USTs.

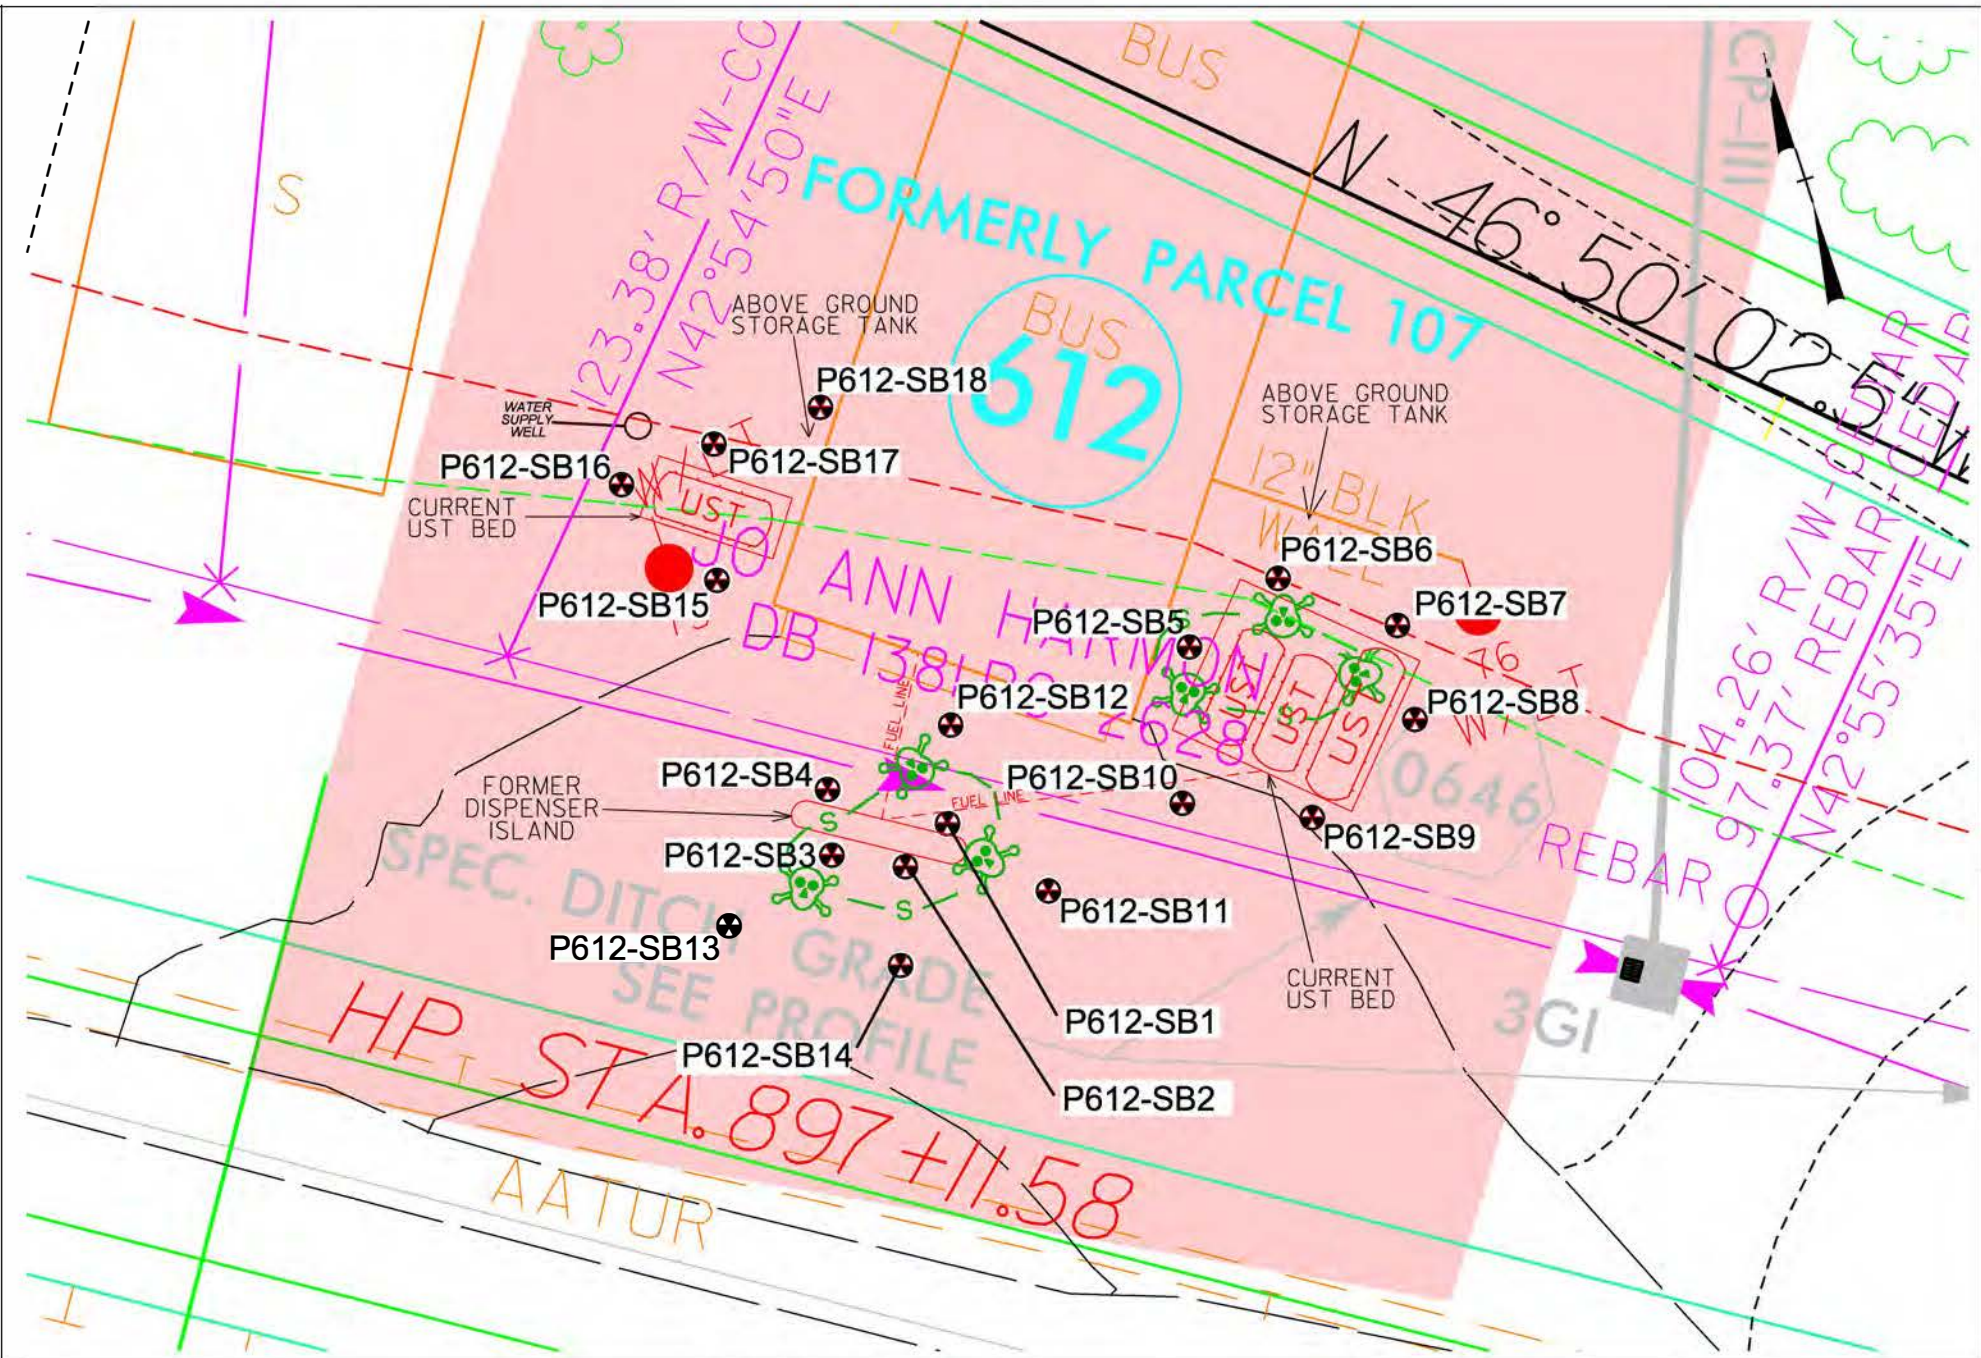
PREPARED BY:	DATE:	CHECKED BY:	DATE:	JOB NUMBER	FIGURE
LMM	5/13/19	HPC	5/13/19	188322707	5

Elevated TPH values above the NCDEQ Action Limit for DRO were not detected in the remaining 33 soil samples collected at the Site. The hydrocarbon results from the QED QROS Hydrocarbon Analyzer are provided in Appendix C. The estimated areas of petroleum-impacted soil is shown on **Figure 5**.

Estimated impacted soil volume for the area near the former dispenser island is 1,930 cubic feet (71.5 cubic yards) based on an average unsaturated thickness of 8.3 feet (average of assumed depths of impact of 5, 12, and 8 feet at borings P612-SB1, SB2, and SB3, respectively). The low estimate of impacted soil volume near the three known USTs located along the eastern Site building exterior is 690 cubic feet (25.5 cubic yards) based on an unsaturated thickness of 4 feet (impacted soil 6 to 10 feet bgs, assumed to be beneath the USTs). If the overburden soil (soil above the base of the USTs) is conservatively included in this calculation, the high estimate of impacted soil volume near the three known USTs located along the eastern Site building exterior is 1,730 cubic feet (64 cubic yards, not subtracting UST volume).

- BORING LOCATION
- AREA OF INVESTIGATION
- s— KNOWN CONTAMINATION - SOIL

Based on these PSA results, Wood does not recommend further assessment in the area of investigation. It is understood the four known USTs identified during the geophysical survey are located in areas to be impacted by construction activities. Wood recommends the current UST systems be removed in accordance with the NCDEQ guidelines with a release to soil anticipated beneath the four USTs (both the eastern and western UST areas). During the UST closure by removal petroleum-impacted soil that may be intercepted during the road construction should be excavated and disposed offsite. Wood can assist with UST system removal by selecting a qualified specialty contractor and providing oversight. Based on liquids being identified within at least one UST on Site, Wood recommends a vacuum truck be utilized to evacuate the contents of the USTs prior to their removal.

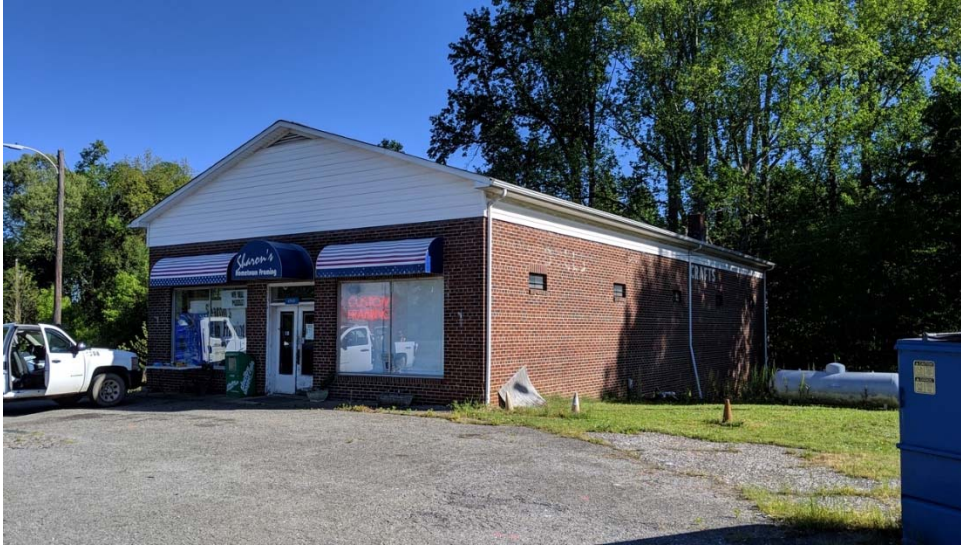
PHOTO 1:

View north of the front/south side of the current framing store (former gas station).

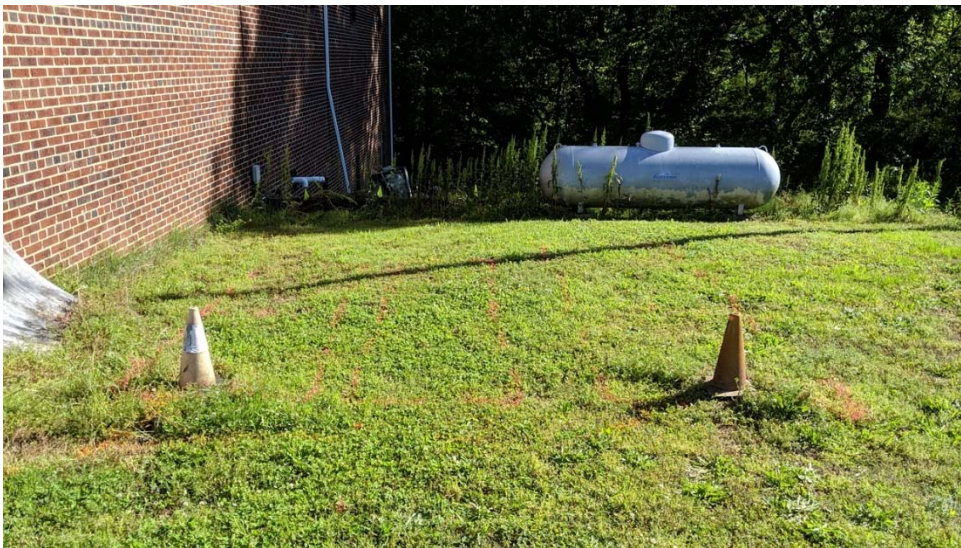
PHOTO 2:

View of the area east of the Site building where three known USTs are located. Fill ports were observed underneath the traffic cones shown. A propane AST can be seen in the background.

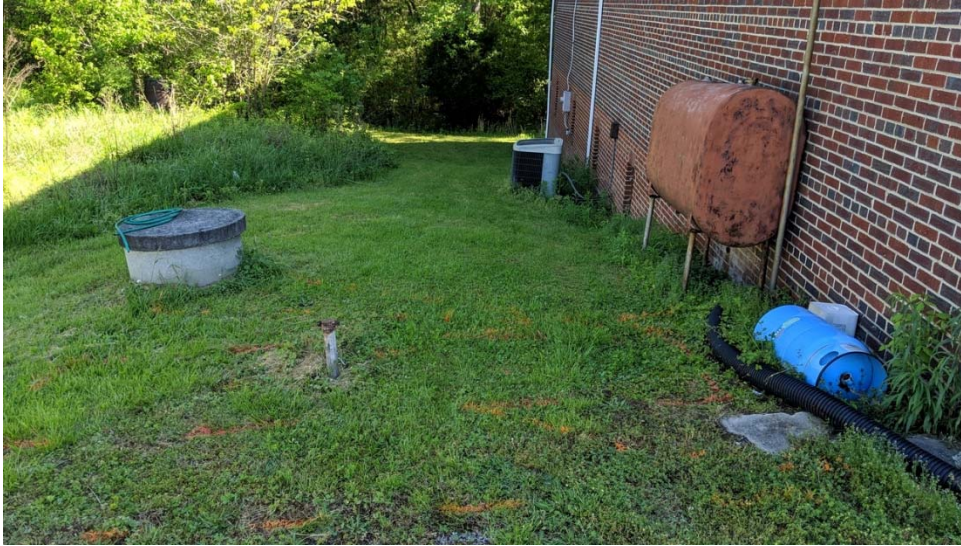
PHOTO 3:

Based on measurements collected during PSA activities, it is assumed the western known UST contains a minimum of three feet of liquid composed of a water and petroleum

View of the area west of the Site building where one known UST is located. An UST fill port, vent pipe, heating oil AST, and concrete housing for a water supply well can be seen.

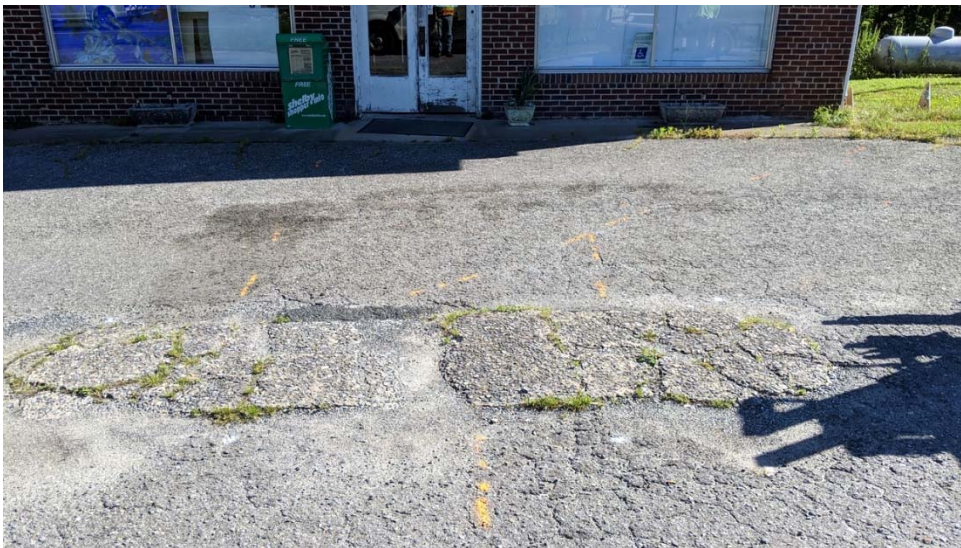
PHOTO 4:

View of the paved area in front/ south of the Site building where the former dispenser island is located.

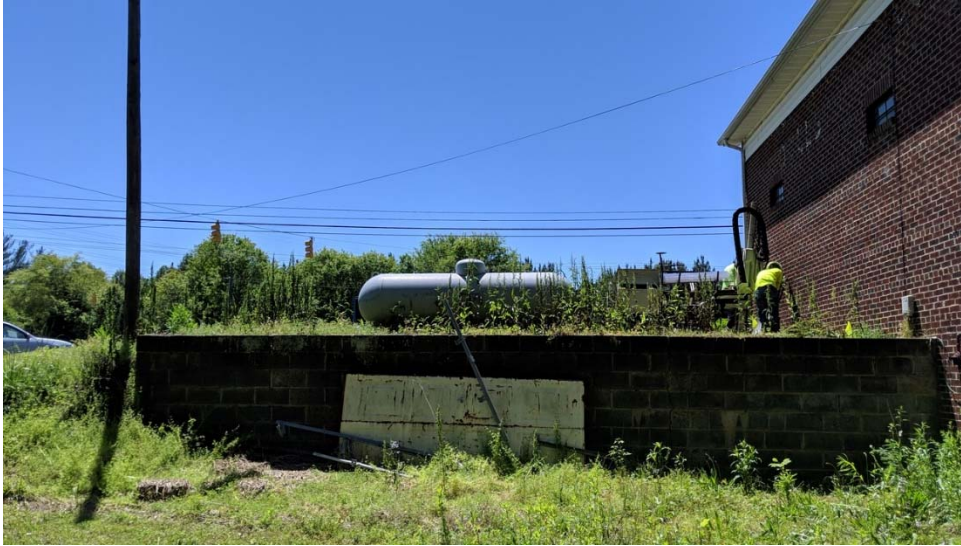
PHOTO 5:

View south of the retaining wall behind the area where the three known USTs are located east of the Site building.

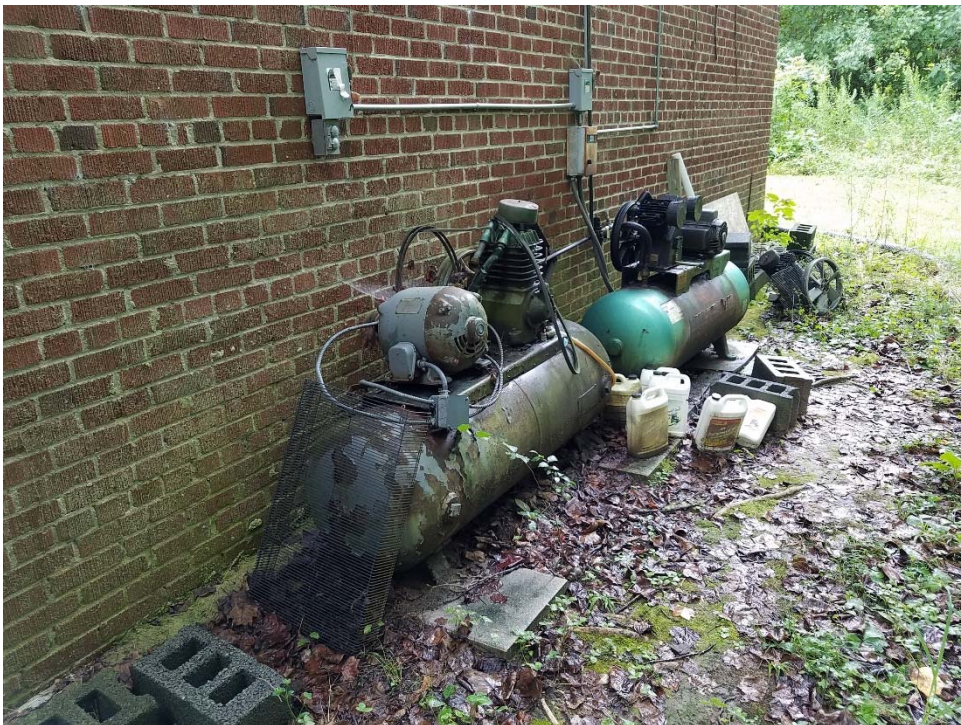
PHOTO 6:

View of two air compressors and stained soil on the back/ north side of the Site building.

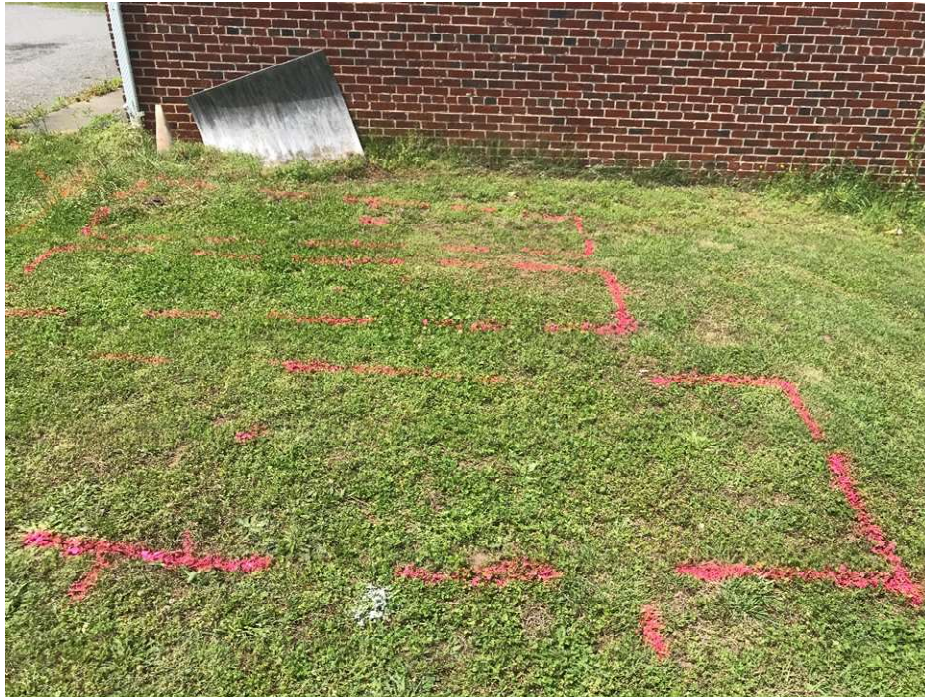
Photo 1: EM Anomaly – Known UST (x3)

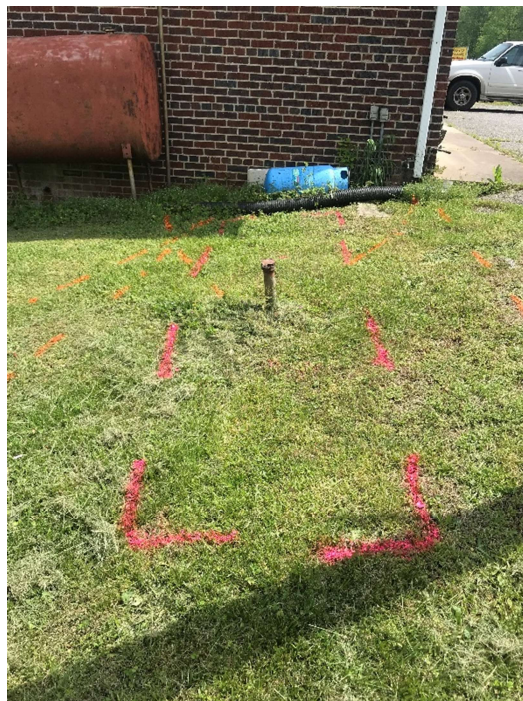
Photo 2: EM Anomaly – Known UST

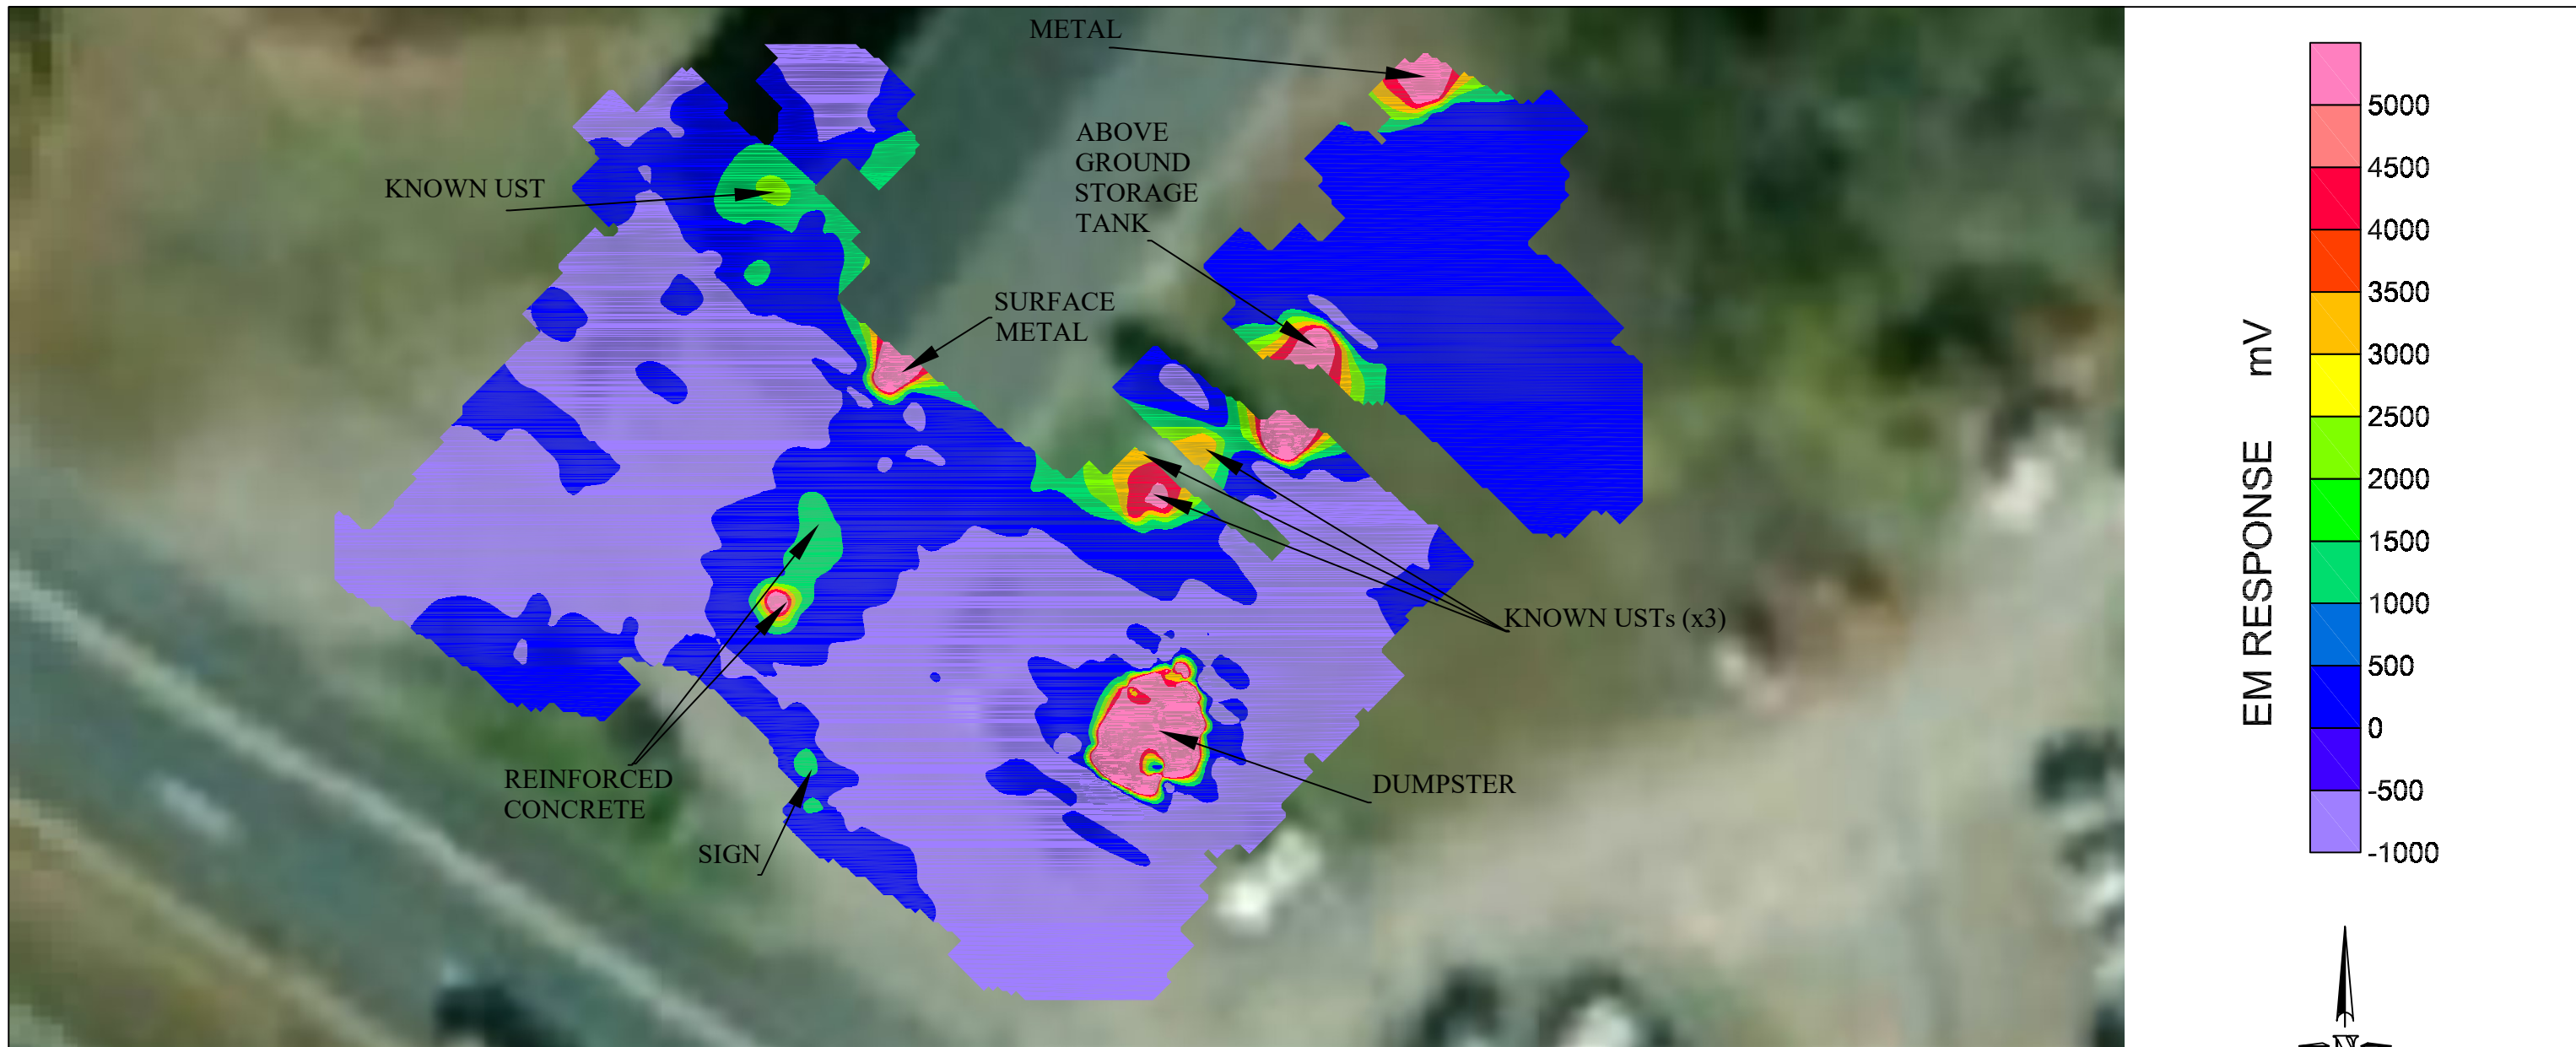
Four subsurface geophysical anomalies were detected during the investigation of Parcel #612 as depicted in Figure 1. The anomalies were indicative of a "Known USTs" with respect to the UST level of confidence rating system based on TDEM and GPR investigation. Figure 1 depicts the approximate location and size of the anomalies as well as the known metallic surface objects present at the time of the investigation. Known metallic surface objects in Figure 1 are noted with a brief identifiable description.

GEL ENGINEERING OF NC, INC. DBA GEL SOLUTIONS <i>an Affiliate of THE GEL GROUP, INC.</i> 55 SHILOH ROAD, SUITE E ASHEVILLE, NC 28803 (828) 782-3523 WWW.GEL-SOLUTIONS.COM	PROJECT: AMEC00419	GEOPHYSICAL INVESTIGATION FOR USTs PARCEL 612 4941 E. DIXON BLVD. KINGS MOUNTAIN, NORTH CAROLINA	RESULTS OF GEOPHYSICAL INVESTIGATION	FIGURE 1
	DATE: 4/25/19
