**North Carolina Department of Transportation
Preliminary Site Assessment
State Project: R-2707E
WBS Element: 34497.1.2
Cleveland County**

**Parcels 612 and 108
JoAnn C. Harmon and Heirs of Lester Harmon
4941 East Dixon Boulevard
Kings Mountain, North Carolina
May 17, 2019**

**Wood Environment and Infrastructure Solutions, Inc.
Project: 1883R2707**

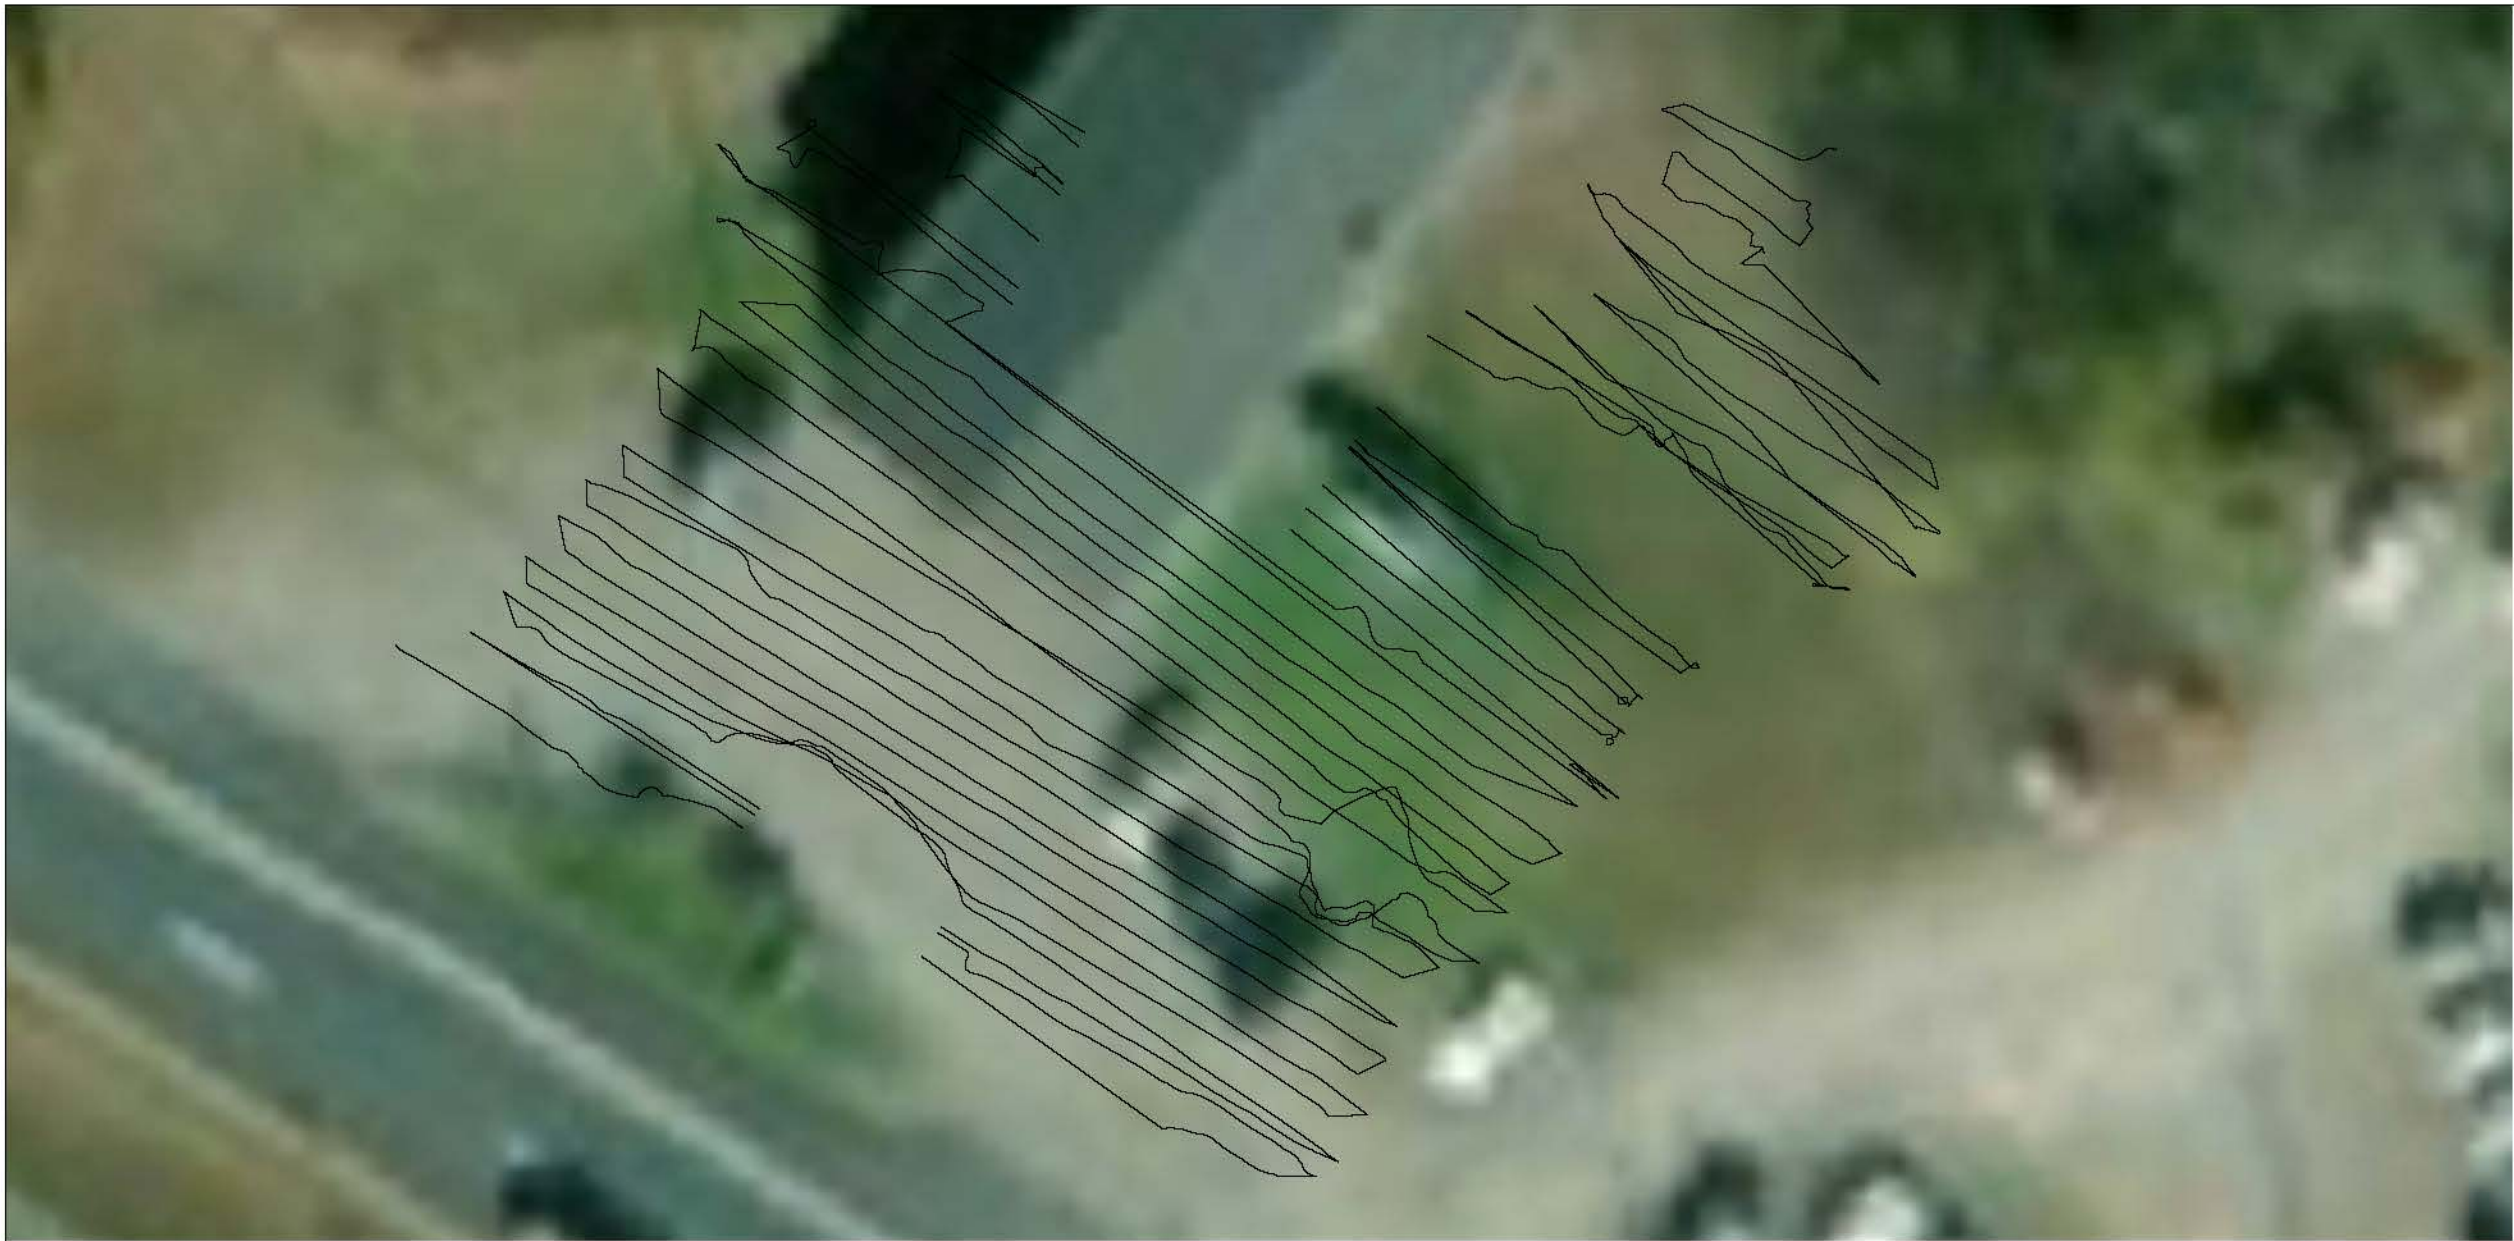
FIGURE
1

Four subsurface geophysical anomalies were detected during the investigation of Parcel #612 as depicted in Figure 1. The anomalies were indicative of a "Known USTs" with respect to the UST level of confidence rating system based on TDEM and GPR investigation. Figure 1 depicts the approximate location and size of the anomalies as well as the known metallic surface objects present at the time of the investigation. Known metallic surface objects in Figure 1 are noted with a brief identifiable description.

- 1) UNDERGROUND FEATURES WERE LOCATED USING VISUAL EVIDENCE, GROUND PENETRATING RADAR (GPR), AND TIME DOMAIN ELECTROMAGNETIC (TDEM) METHODS. OTHER BURIED FEATURES MAY EXIST BUT WERE NOT DETECTED DUE TO LIMITATIONS OF THE GEOPHYSICAL METHODS, SITE ACCESS, AUTHORIZED SCOPE-OF-WORK, AND/OR HIGH TARGET CONGESTION. THEREFORE, DUE CAUTION SHOULD BE USED WHEN PERFORMING SUBSURFACE EXCAVATION ACTIVITIES WHERE POTENTIAL CONFLICTS EXIST. GEL SOLUTIONS IS NOT RESPONSIBLE FOR DAMAGES THAT MAY OCCUR. IDENTIFYING THE LOCATION OF SOME FEATURES MAY ONLY BE POSSIBLE WITH VACUUM OR OTHER EXCAVATION METHODS.

Based on these PSA results, Wood does not recommend further assessment in the area of investigation. It is understood the four known USTs identified during the geophysical survey are located in areas to be impacted by construction activities. Wood recommends the current UST systems be removed in accordance with the NCDEQ guidelines with a release to soil anticipated beneath the four USTs (both the eastern and western UST areas). During the UST closure by removal petroleum-impacted soil that may be intercepted during the road construction should be excavated and disposed offsite. Wood can assist with UST system removal by selecting a qualified specialty contractor and providing oversight. Based on liquids being identified within at least one UST on Site, Wood recommends a vacuum truck be utilized to evacuate the contents of the USTs prior to their removal.
