TIP NO: P-5705A
WBS: 44475.1.1
COUNTY: Mecklenburg
DIVISION: Division 10
DESCRIPTION: Charlotte Wye Track Improvements

SUBJECT: **GeoEnvironmental Report for Planning**

Preliminary Site Assessment Report

RLF II East, LLC Property (Parcel PIN #11711112 – ROW Only)

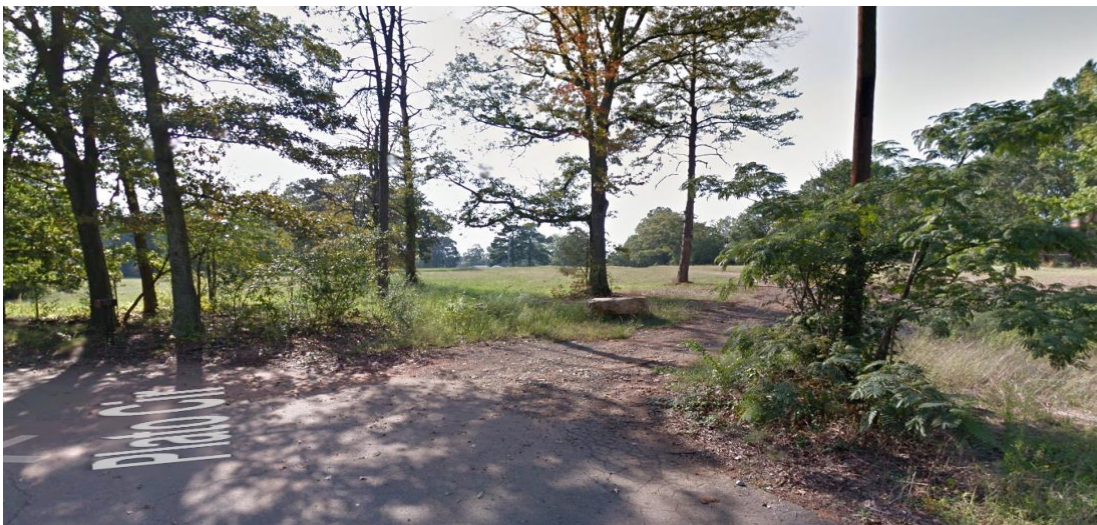
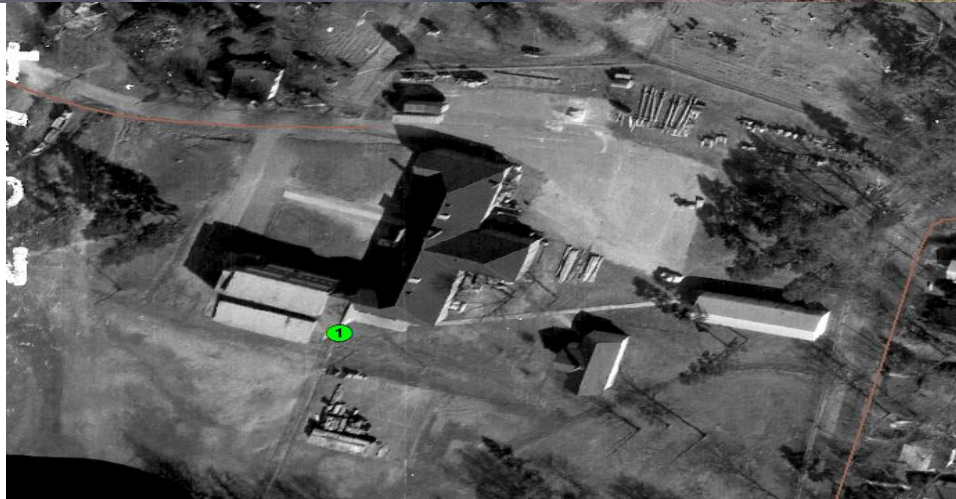
1)	Property Name Vacant Lot Formerly Plato Price Warehouse 4201 Morris Field Dr. Charlotte, NC 28208	Property Owner: City of Charlotte 600 E 4 th St. Charlotte, NC 28202
	Facility ID: 0-027361 Incident: N/A	UST Owner: City of Charlotte 600 E 4 th St. Charlotte, NC 28202

Top view toward the west circa 2011 (Google Streetview), Bottom view NCDOT historic photo 1974. This parcel is located on northeast corner of the Morris Field Road and Seymour Drive intersection. According to the UST Section Registry, there was a tank installed in 1959 and removed in 1993. Plato Price School was on this property from 1937 to the 1960's. Then, the school was used for storage under the name Plato Price Warehouse. Currently, there is no building or UST on site. **This site is anticipated to present low geoenvironmental impacts to the project.**

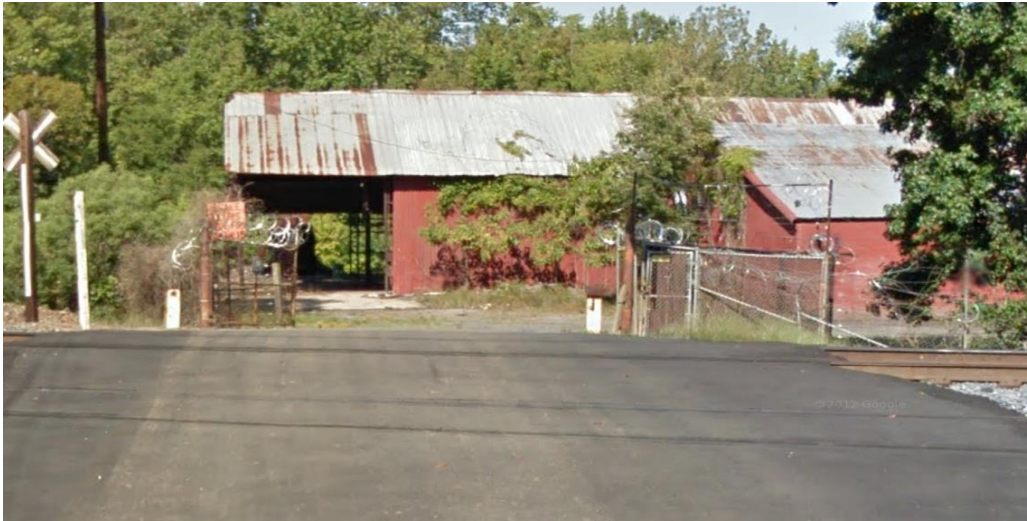
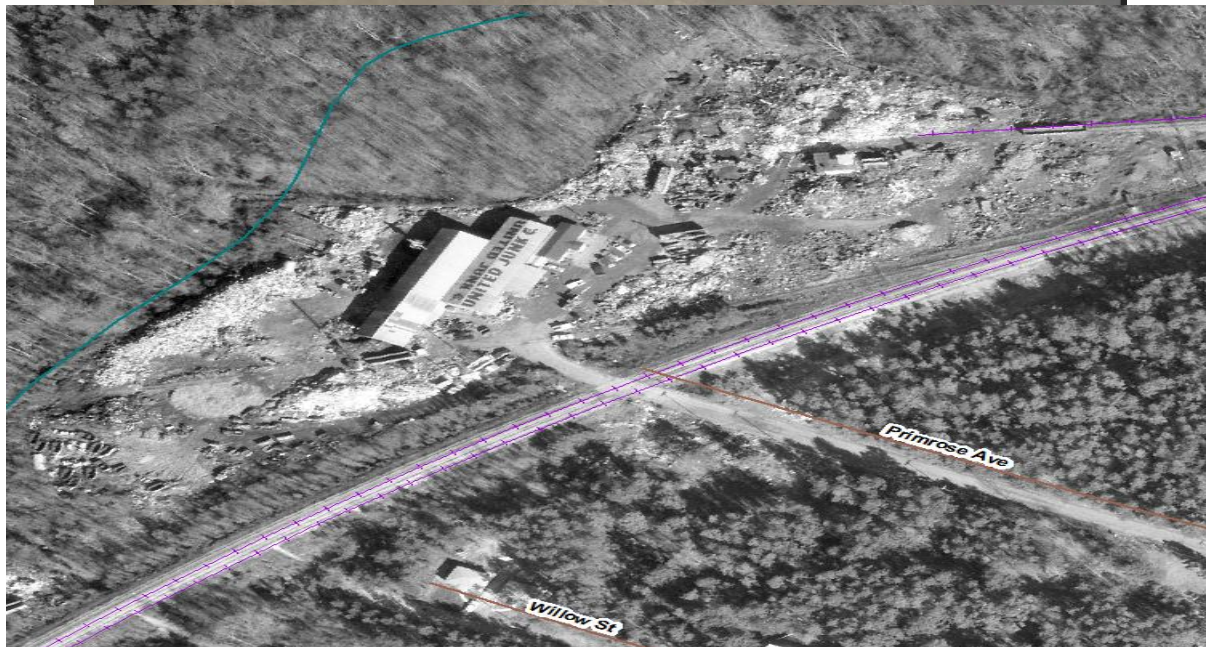
2)	Property Name Vacant Lot Formerly United Scarp, Inc. 3600 Primrose Ave Charlotte, NC 28208 Facility ID: UST# MO-2453 Incident: N/A	Property Owner: SFF Holdings LLC 2823 Providence Rd. Suite 323 Charlotte, NC 28211 UST Owner: N/A
----	---	---

Top view toward the northwest circa 2011 (Google Maps), Bottom view NCDOT historic photo 1974

This site is currently a vacant lot and is located at the western end of Primrose Avenue, west of the train track, it is the former location of United Scarp Inc. This facility does not appear in the UST Section Registry. The facility does appear in NCDEQ's groundwater database (UST # MO-2453). There is no incident or facility ID associated with it. According to the database the site was closed out in 1990 with no contamination. The buildings were razed between 2013 and 2014. **This site is anticipated to present low to moderate geoenvironmental impacts to the project.**

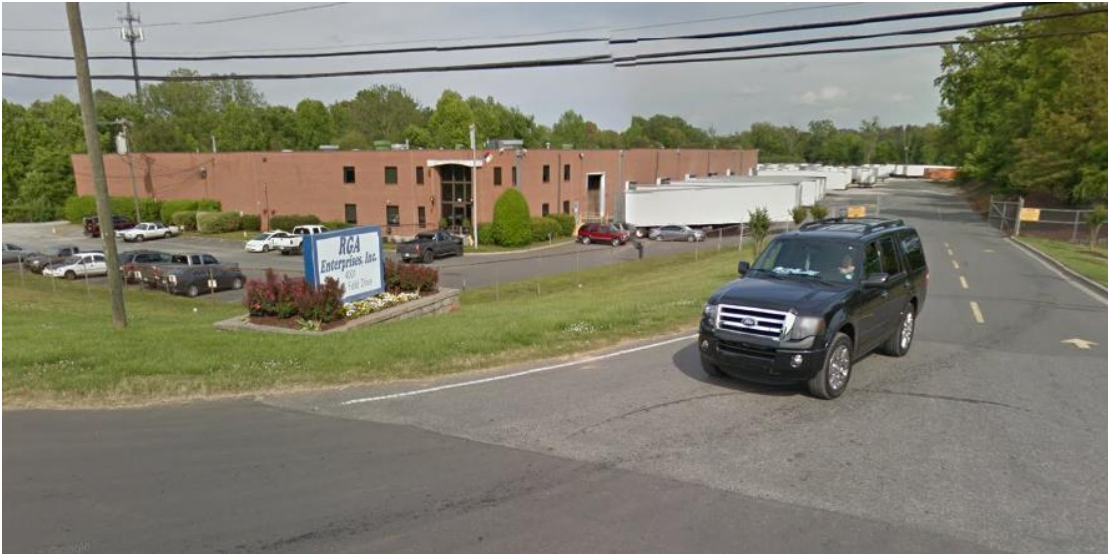
3) **Property Name**
RGA Enterprises
4001 Morris Field Dr.
Charlotte, NC 28208

View toward the northeast circa 2015 (Google Maps)

This facility is located on the south east quadrant of Morris Field Drive and the train track intersection. RGA Enterprises, Inc. is a manufacturer and wholesaler of household cleaning products. The back lot was graded in 2009 and is currently used for additional tractor trailer parking. This facility does not appear in the UST Section Registry there are no know groundwater incidents associated with this site, **This site is anticipated to present low geoenvironmental impacts to the project.**

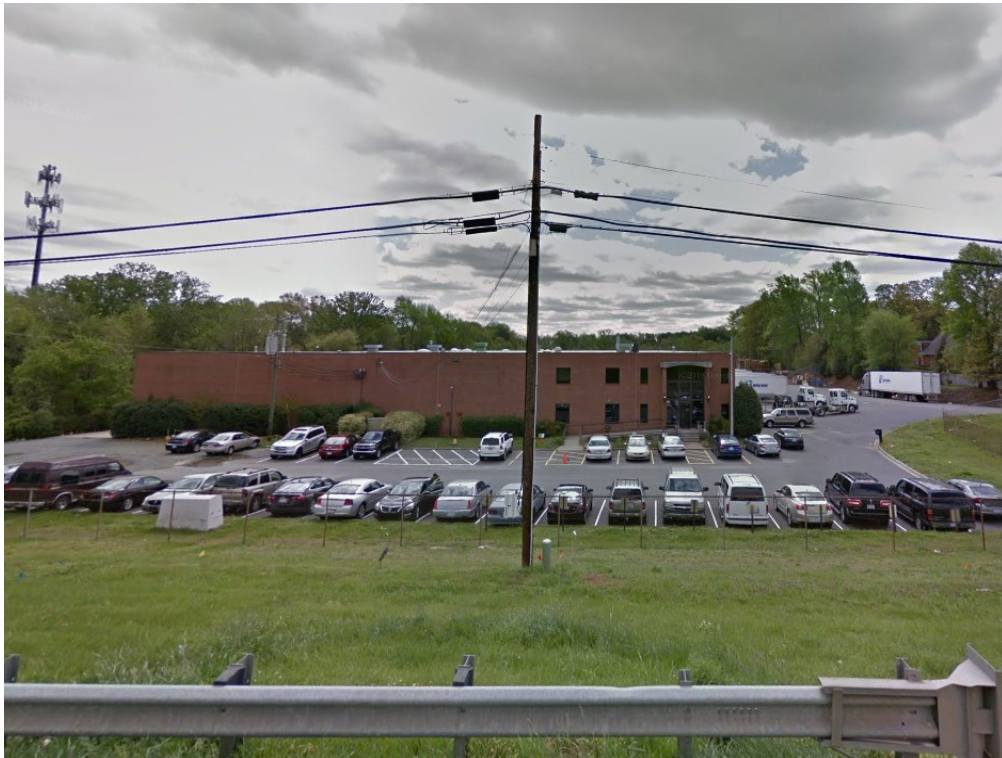
Photo 1

Overview of Parcel 1 prior to PSA activities.

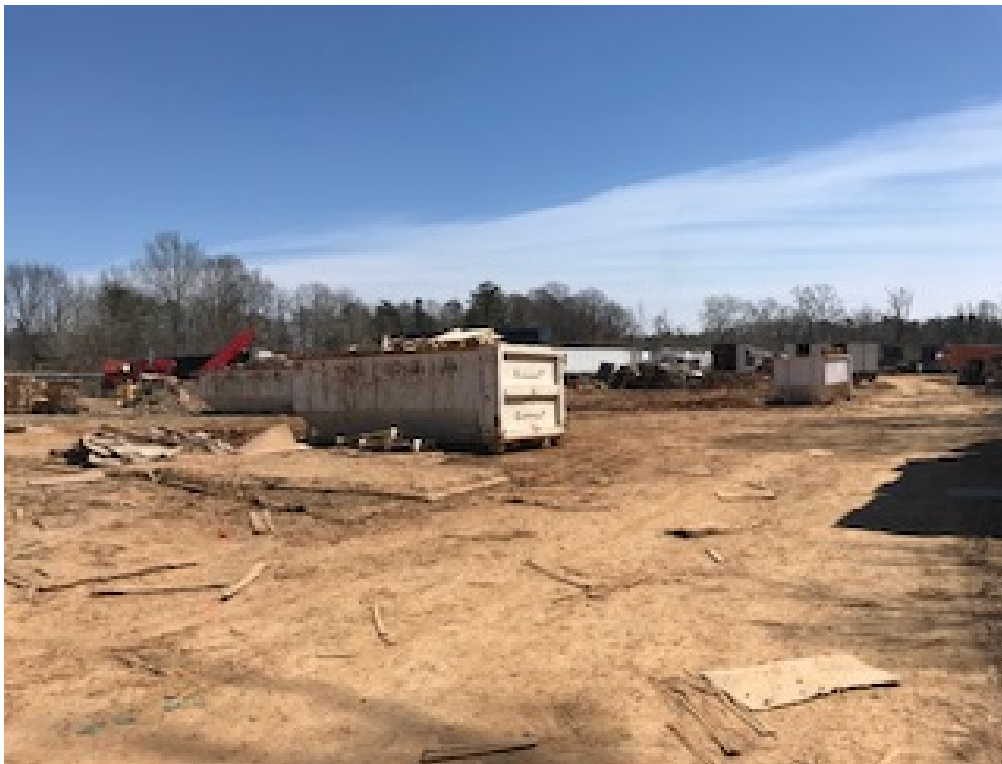
Photo 2

View of investigation area prior to PSA activities.

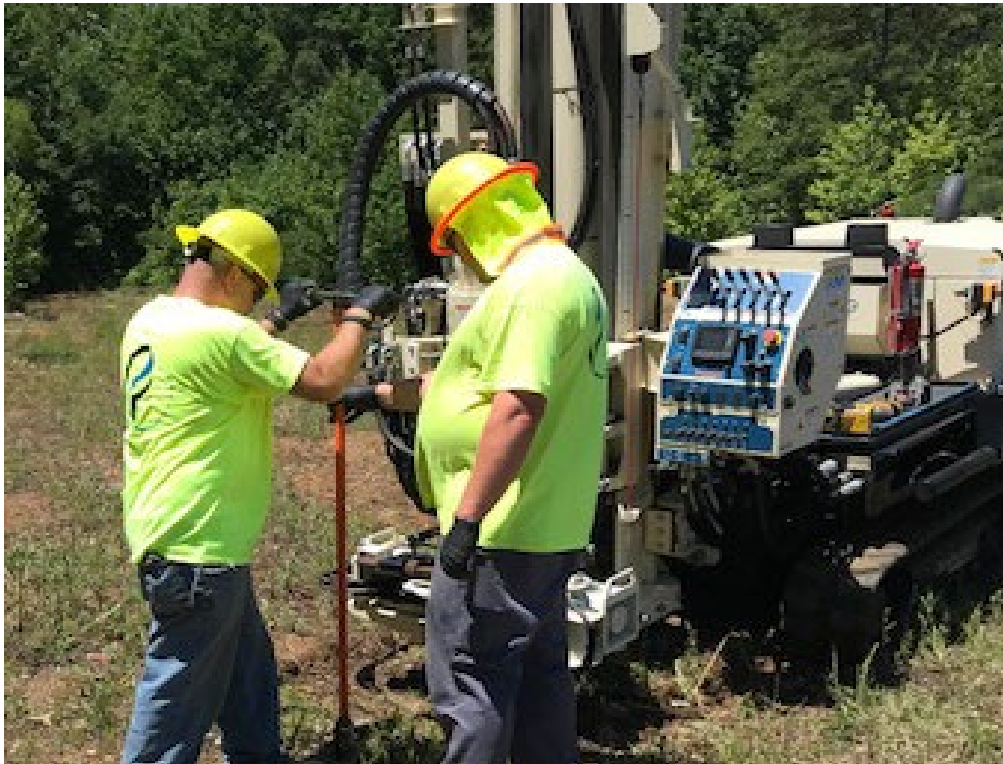
Photo 3

Photo shows CSI hand clearing for utilities.

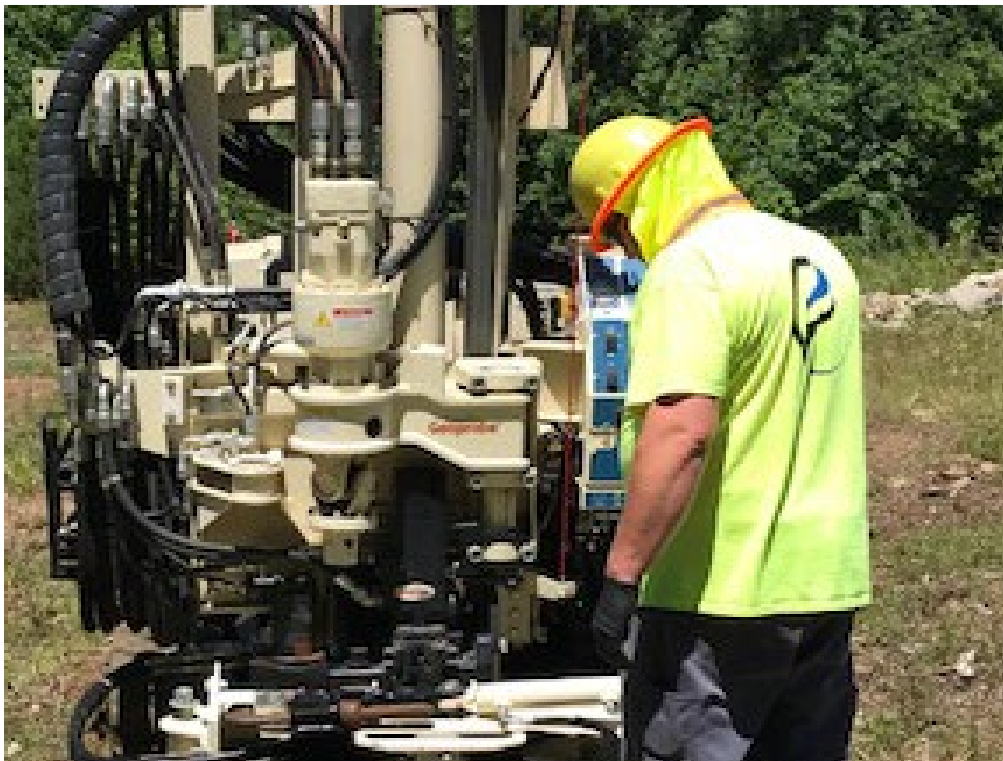
Photo 4

Photo shows CSI preparing to drill.

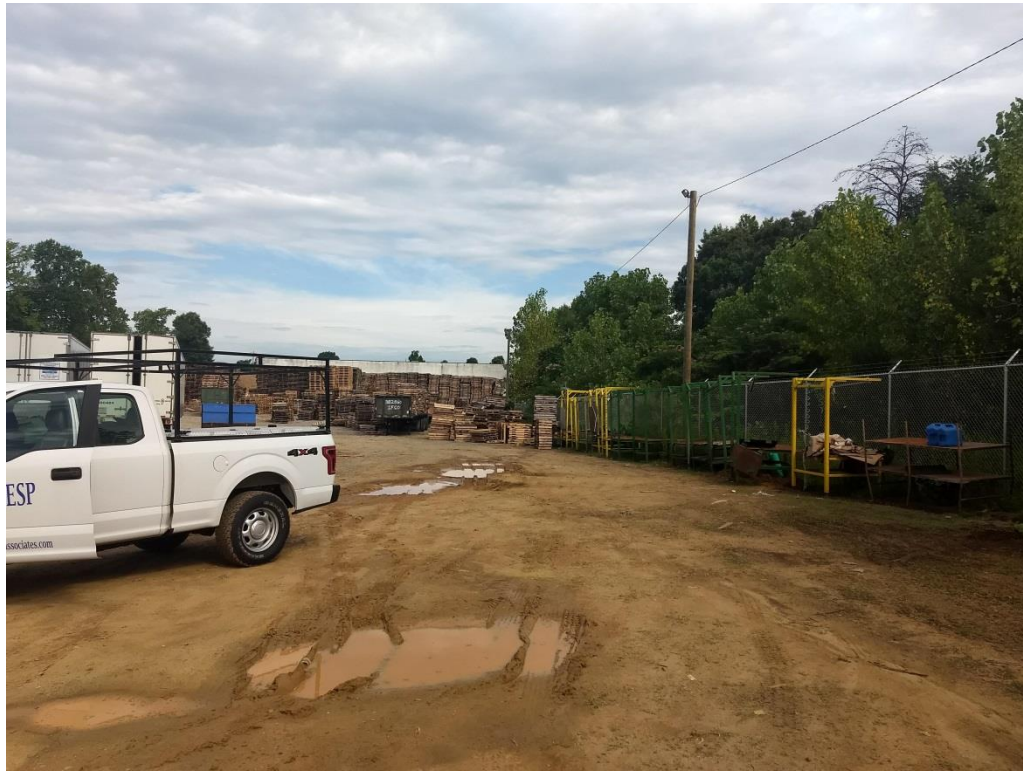
A. Photo from center of site, looking west.

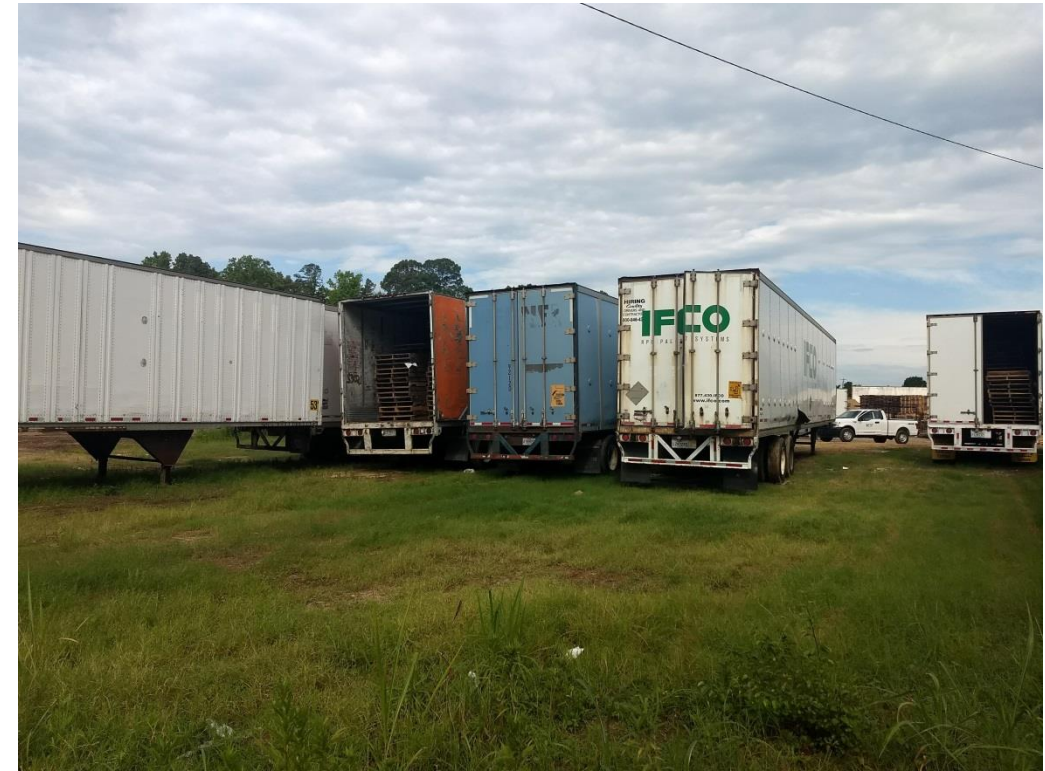
B. Photo from east side of site, looking west.

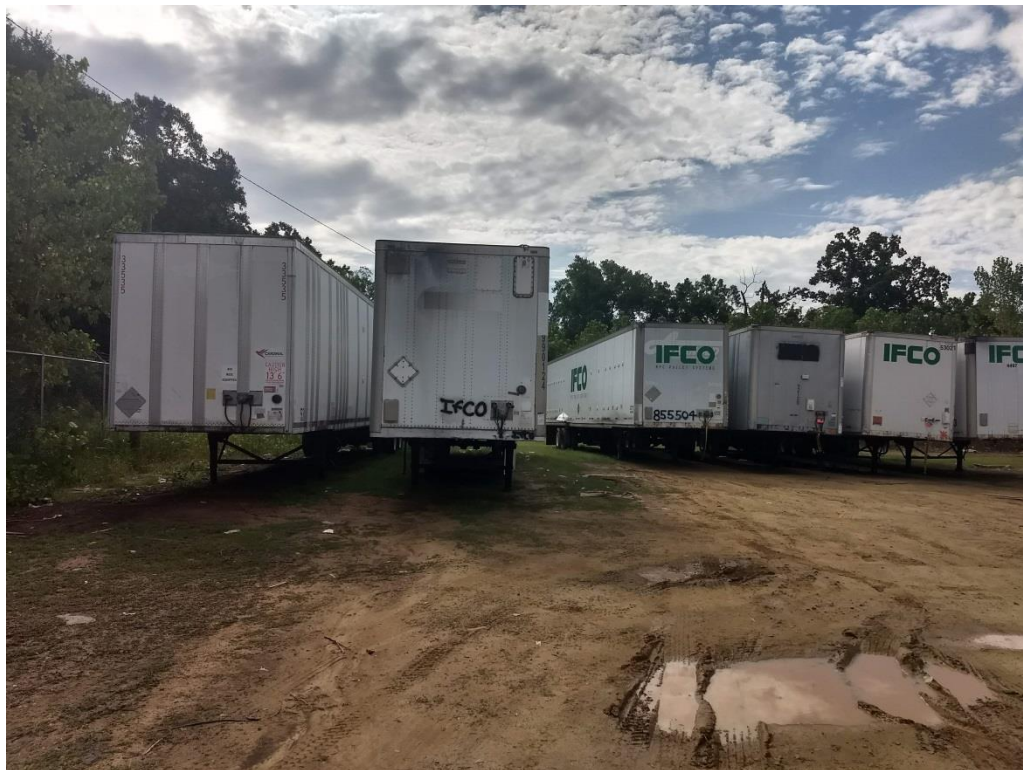
C. Photo from west side of site, looking east.

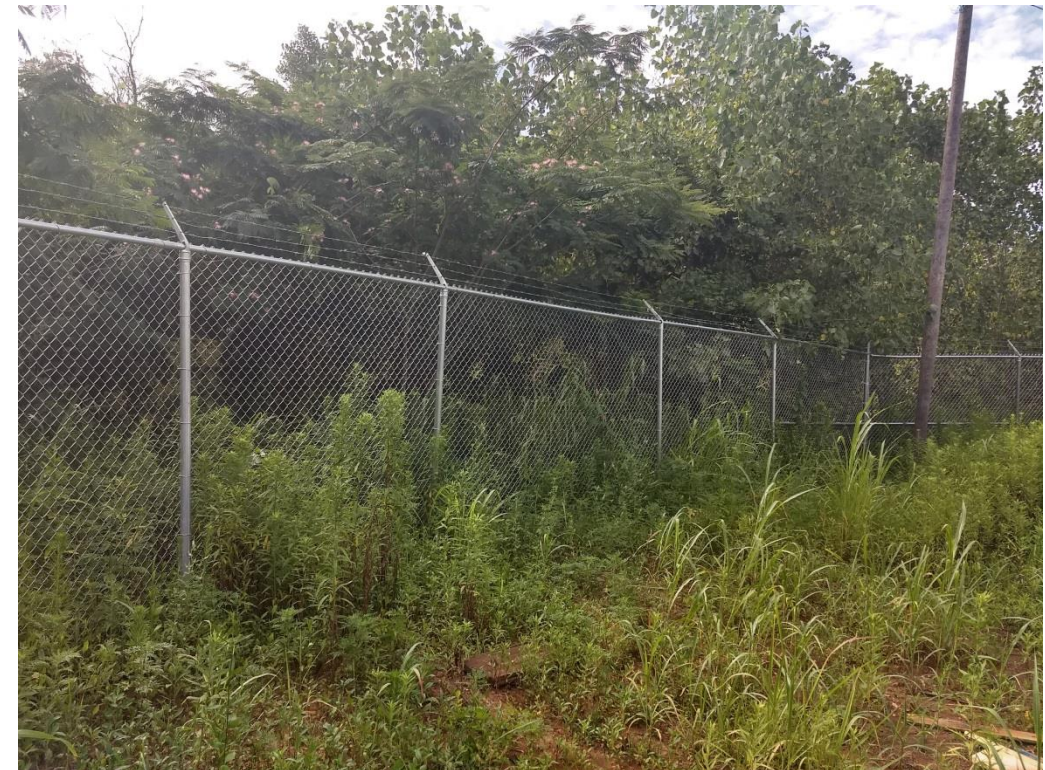
D. Photo showing fence on north side of site.

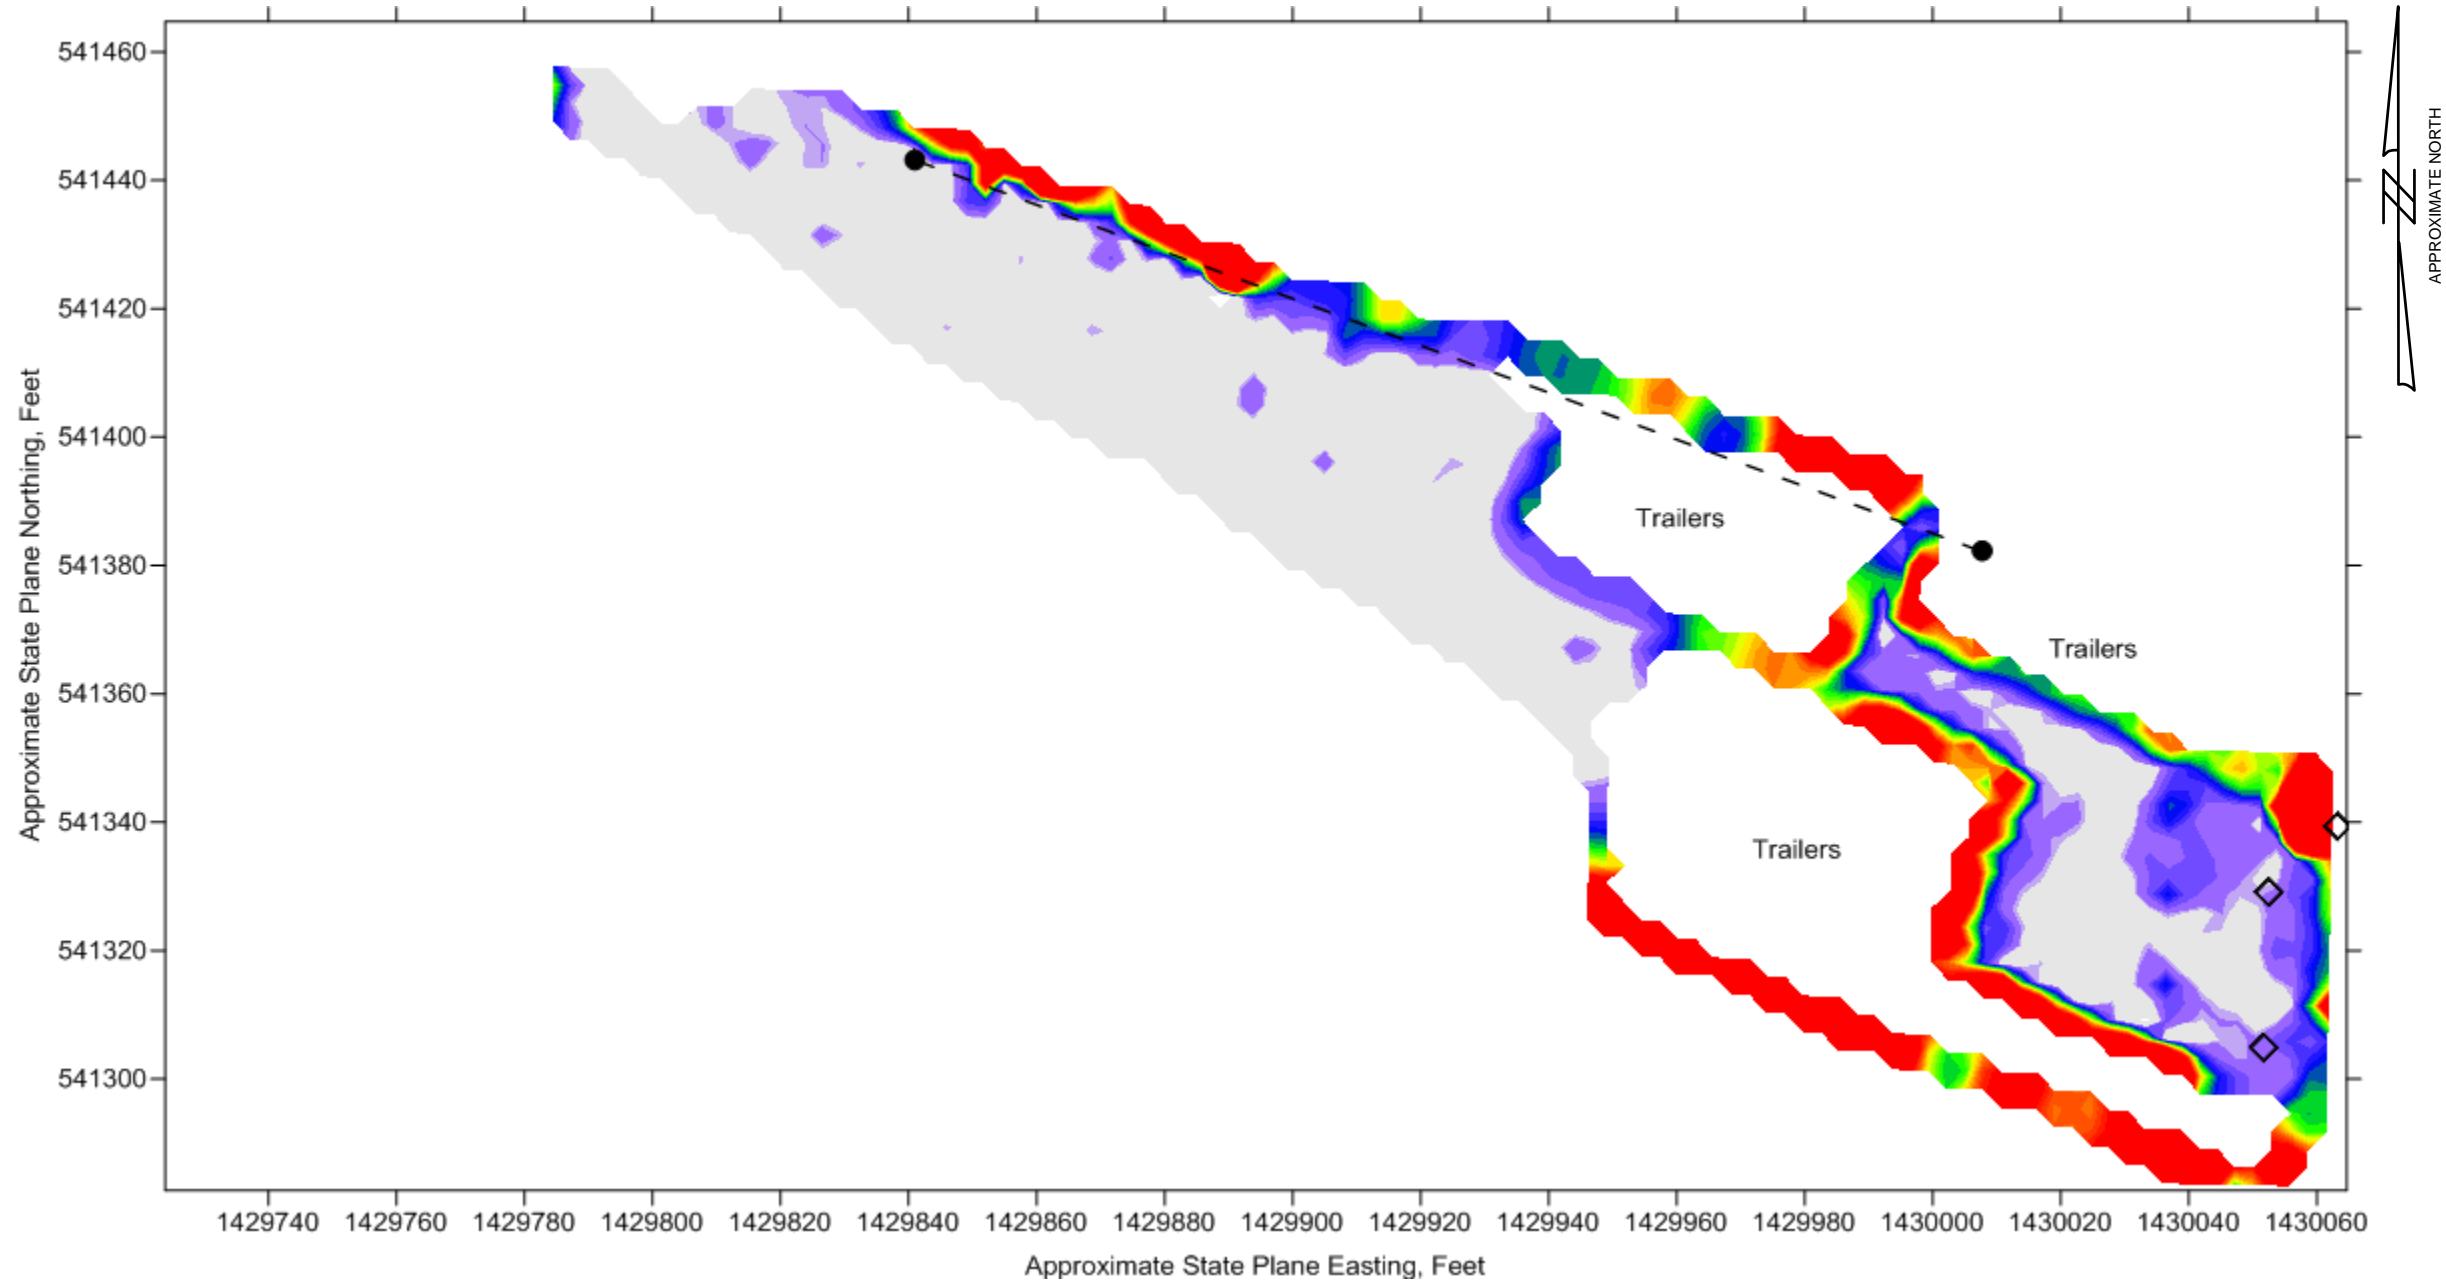
The EM61 data were gridded and contoured to produce plan view contour maps of the early time gate response (Figure 2) and the differential response (Figure 3). The differential response is calculated by subtracting the response of the bottom coil from the response of the top coil of the EM61. Typically, the differential response diminishes the response from smaller, near-surface metallic objects, thus emphasizing the response from deeper and larger metallic objects. The DGPS locations of observed site features were superimposed on the EM61 contour maps so that anomalies caused by site features such as metal objects on the ground surface could be recognized. Therefore, the above mentioned figures show the EM61 data and the site features that we observed and mapped in the field with DGPS; these figures do not necessarily show all existing site features.

EXPLANATION	
	Fence and fencepost
	Miscellaneous metal objects on ground surface
	EM61 data collection areas
