Reference: GeoEnvironmental Investigation Summary Letter TIP Number B-5985 WBS Number 47749.1.1 Parcel #006, Taylor Insurance Agency, Inc. No Physical Address PIN 939175070700 Lumberton, Robeson County, North Carolina WR Project No. 02191306.11

Geophysical Evaluation NCDOT U-5985 – Lumberton, NC

Re: Geophysical Evaluation – NCDOT U-5985 – Lumberton, NC

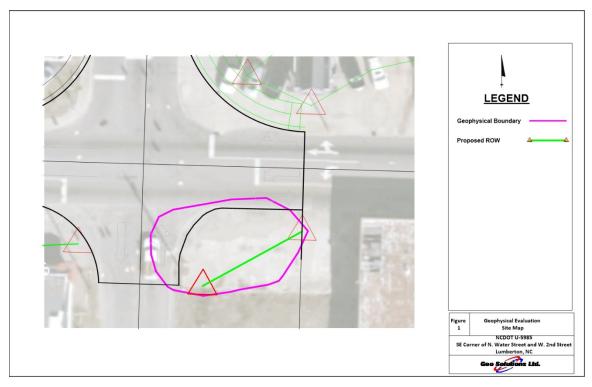
Figure 1. Site map of the area of the southeast corner of the NCDOT intersection widening project with the geophysical evaluation boundary delineated in magenta.

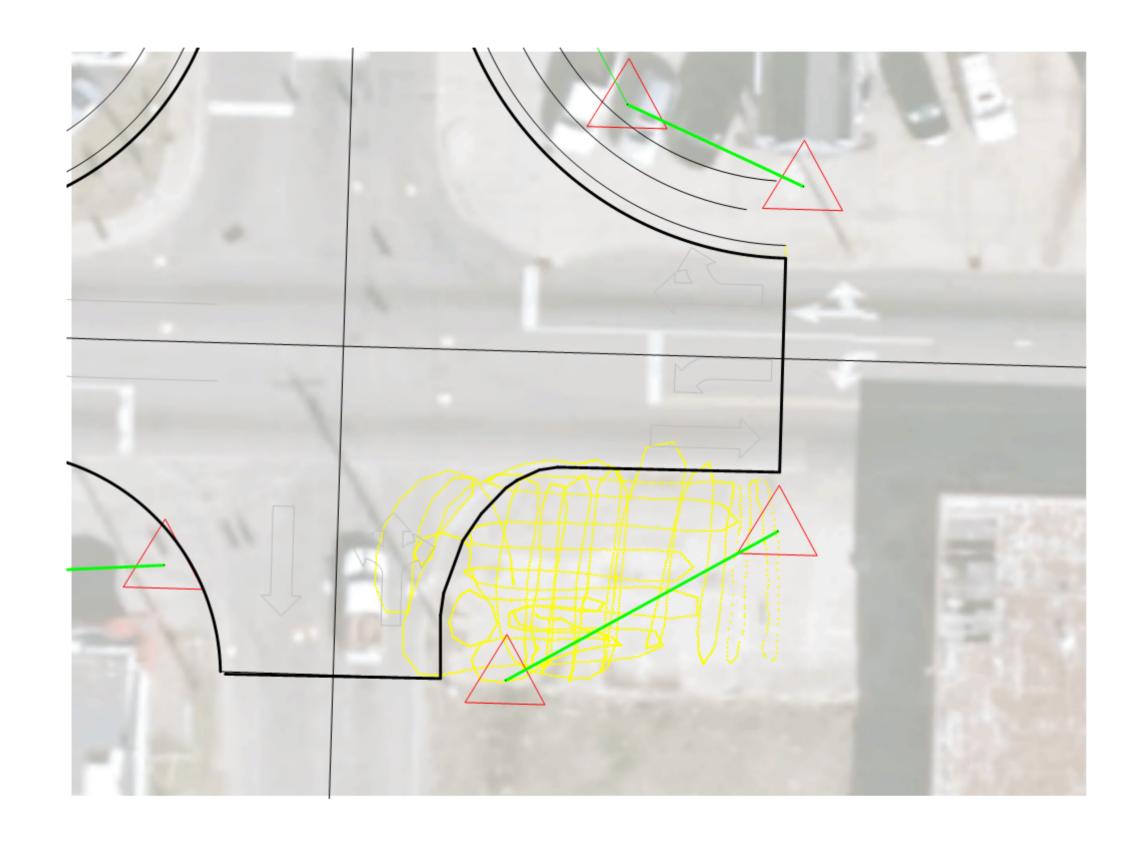
Hz data was chosen to create figures for this report as it provided the best contrast to background site conditions and was the frequency selected to display in the report of the earlier evaluation. Shown on Figure 3 and Figure 4 are the EM in-phase (metal detection) and apparent conductivity maps respectively with explanations for the anomalous conditions observed in the EM data. Here, anomalous conditions are shown as orange to red hues. The in-phase (metal detection) and apparent conductivity responses were indicative of the presence of probable USTs at the southern side of the area of evaluation at the NCDOT ROW. Shown on Figure 4 is an area of elevated apparent conductivity within the NCDOT ROW near the northwest side of the area of evaluation. This EM response is not characteristic of a UST moreover, there was no in-phase (metal detection) response in this area.

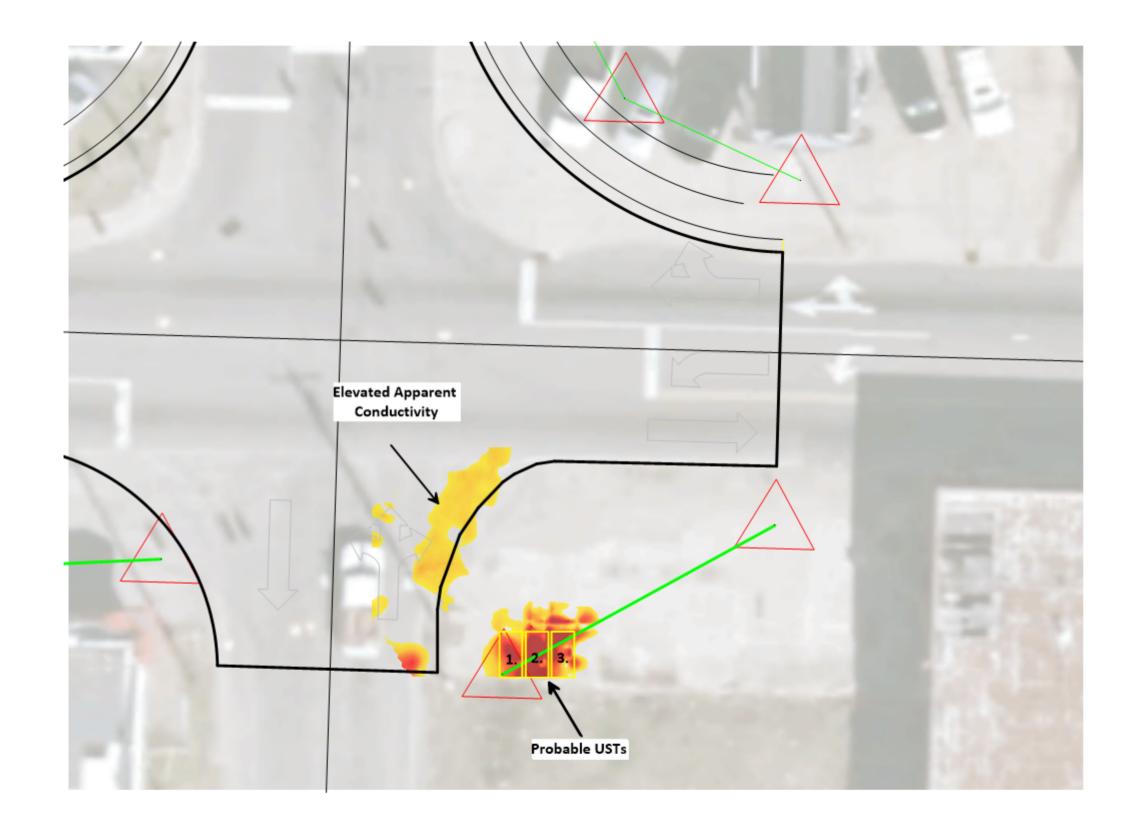
Figure 5 is a map documenting the results of the GPR evaluation. The anomalous area detected during the EM evaluation was further evaluated with GPR. Here, three (3) probable USTs were detected. Fill ports were visible at the surface on the southern end of the probable USTs. The probable USTs were identified in the field with orange ground-marking paint (Appendix A. Photographic Log). The dimensions of the each of the probable USTs were approximately 5'X4'. The distance to the closest UST from N. Water Street is approximately 14' and the distance from W. 2nd Street is approximately 28'. This is shown on Figure 5. Parallel GPR profiles were collected over the entire area of evaluation. A suspected unknown utility was detected near the northwest corner of the area of evaluation. This subsurface feature was identified in the field with white ground-marking paint. The location of this subsurface feature is also displayed on Figure 5. It is unknown if this suspected utility is related to the probable USTs. Shown on Figure 6 are cross sectional images of the probable USTs from the GPR data. The locations from which these GPR cross sections were collected are displayed on Figure 5. The top of the probable USTs were found to be between 2' and 2.5' below the land surface (bls). Figure 7 is a map

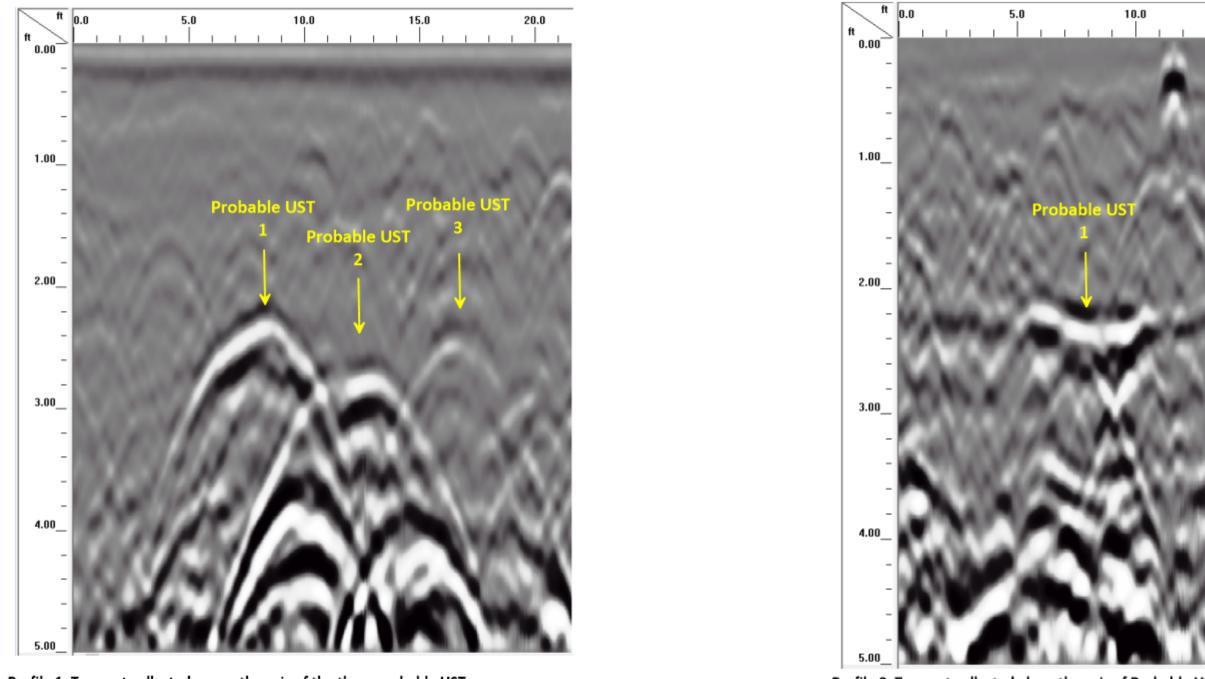
Profile 1. Transect collected across the axis of the three probable USTs.

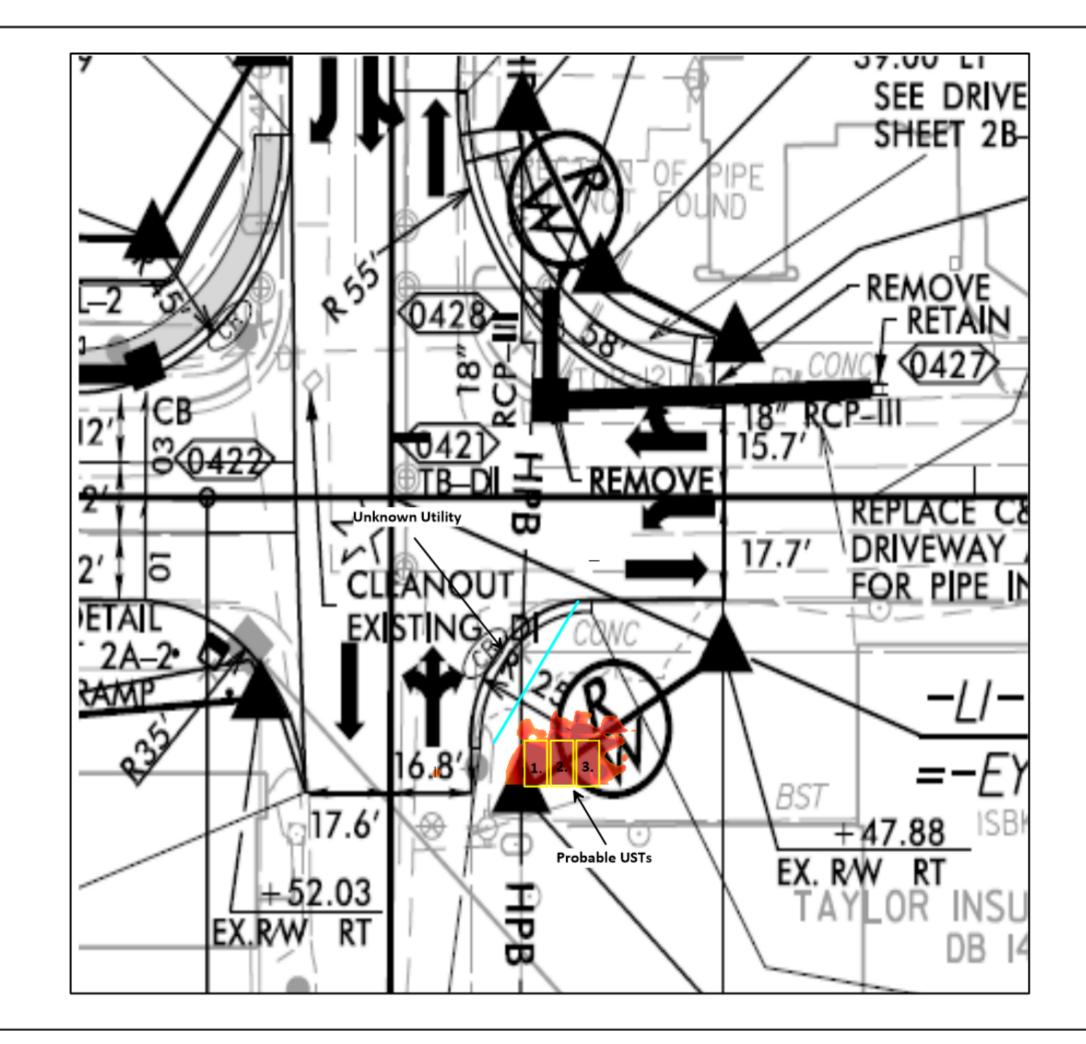
with the geophysical results overlaid on the NCDOT design plan. This figure displays the results of both the EM and GPR evaluations.

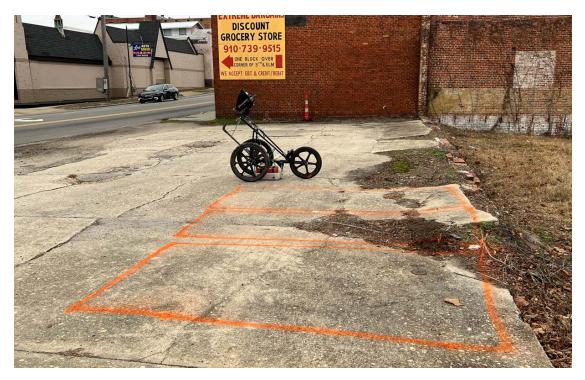
Photograph 1. Probable USTs identified with orange ground-marking paint.

Based upon the results of the EM and GPR surveys, three (3) probable USTs were identified along the southern proposed ROW line. The three USTs are estimated to be approximately five (5) feet in length and four (4) feet in diameter. Fill ports were observed at the southern end of the probable USTs.

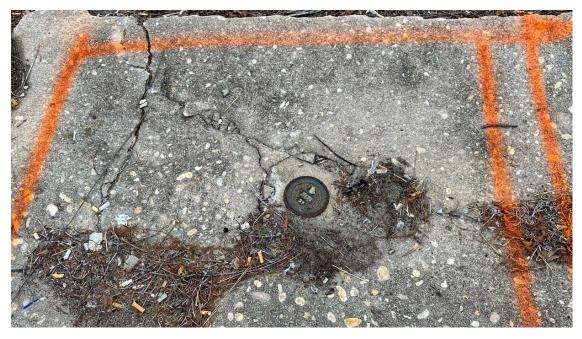
Photograph 2. Fill port visible at the surface.

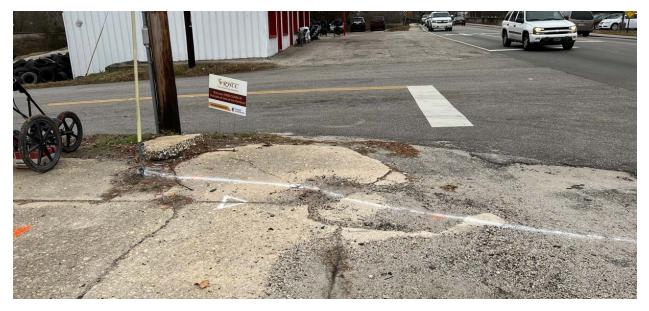
Photograph 3. Suspected unknown utility identified with white ground-marking paint.
