GEOENVIRONMENTAL PHASE II INVESTIGATION

TIP NUMBER B-5985

Parcel #005 – Charles & Billy Strickland
203 West 2nd Street
PIN 939165786200
Lumberton, Robeson County, North Carolina
WR Project No. 02191306.11

NCDOT U-5985 – Lumberton, NC

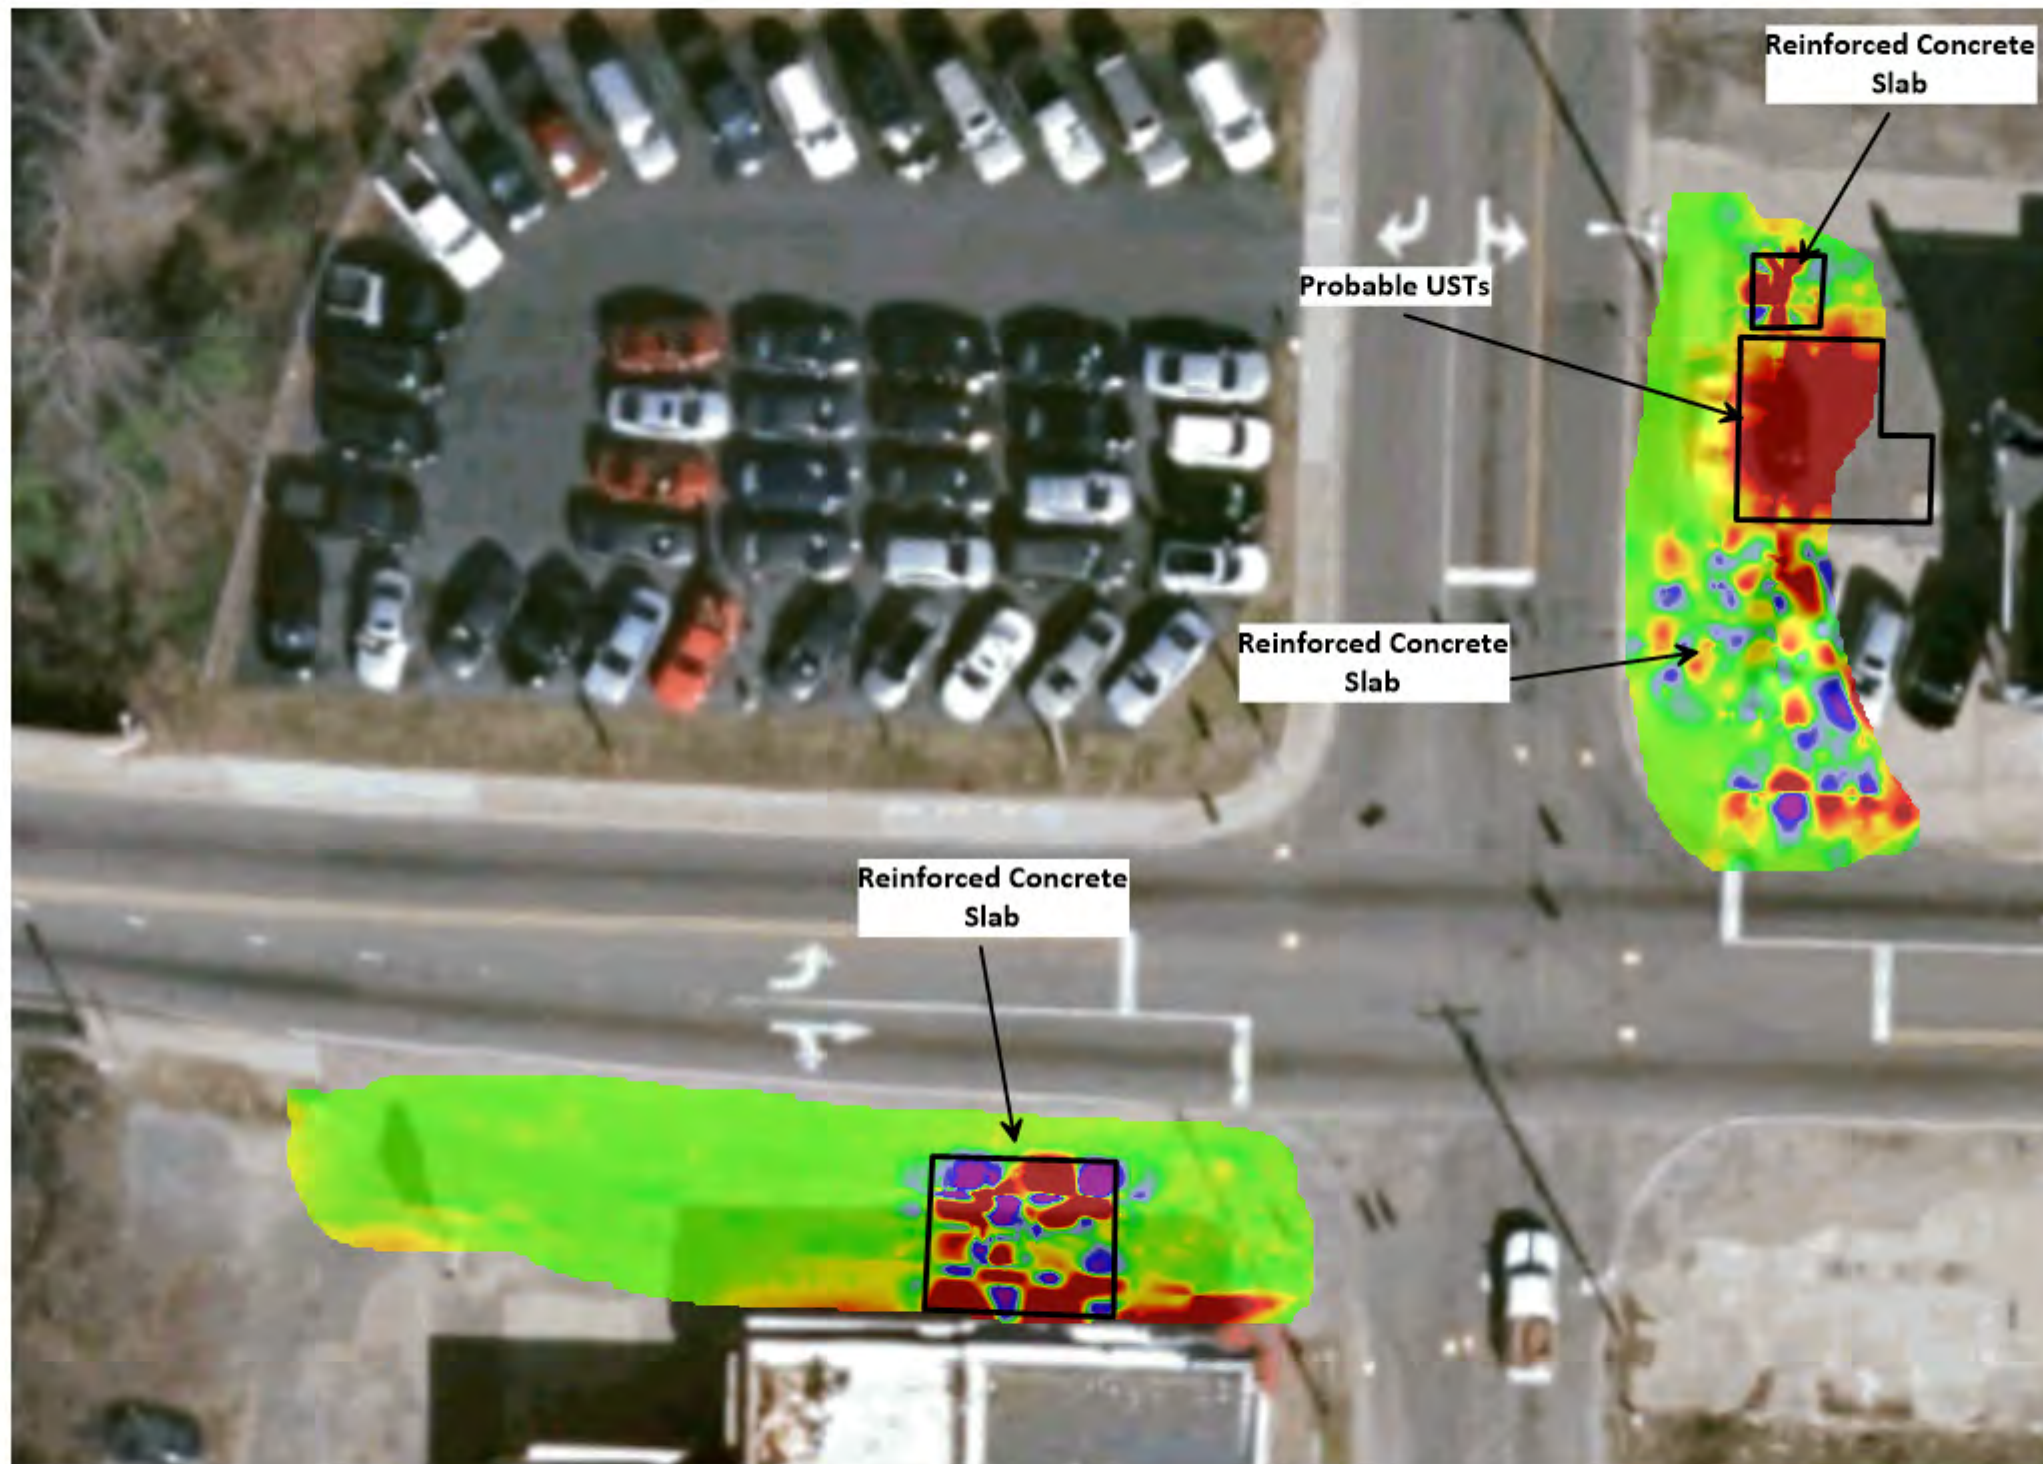
Figure 3

**Geophysical Evaluation
EM In-phase (Metal Detection)
Results Map**

EM in-phase and apparent conductivity maps respectively with explanations for the anomalous conditions observed in the EM data. Here, anomalous conditions are shown as orange to red and blue hues where the background site conditions are shown as light yellow and green hues. At the location of Parcel 005 along W. 2nd Street there was an elevated EM response in both in-phase and apparent conductivity near the center of the area of evaluation. The high variability from positive to negative responses shown as red and blue hues are typical for reinforced concrete. The in-phase and apparent conductivity response across the remainder of the site was very weak with no detections of large metal structures such as USTs. At the location of Parcel 006 along N. Water Street there was a very strong elevated in-phase and apparent conductivity response shown as red hues on Figures 3 and 4. This is consistent with the EM response to a large buried metallic structure such as a UST. There was an elevated EM response at the northern end of Parcel 006. This EM response is consistent with a small area of reinforced concrete. The southern half of Parcel 006 had an elevated in-phase and apparent conductivity response as well. The high variability from positive to negative responses shown as red and blue hues are typical for reinforced concrete. There was also a storm drain and sanitary sewer manhole in this area.

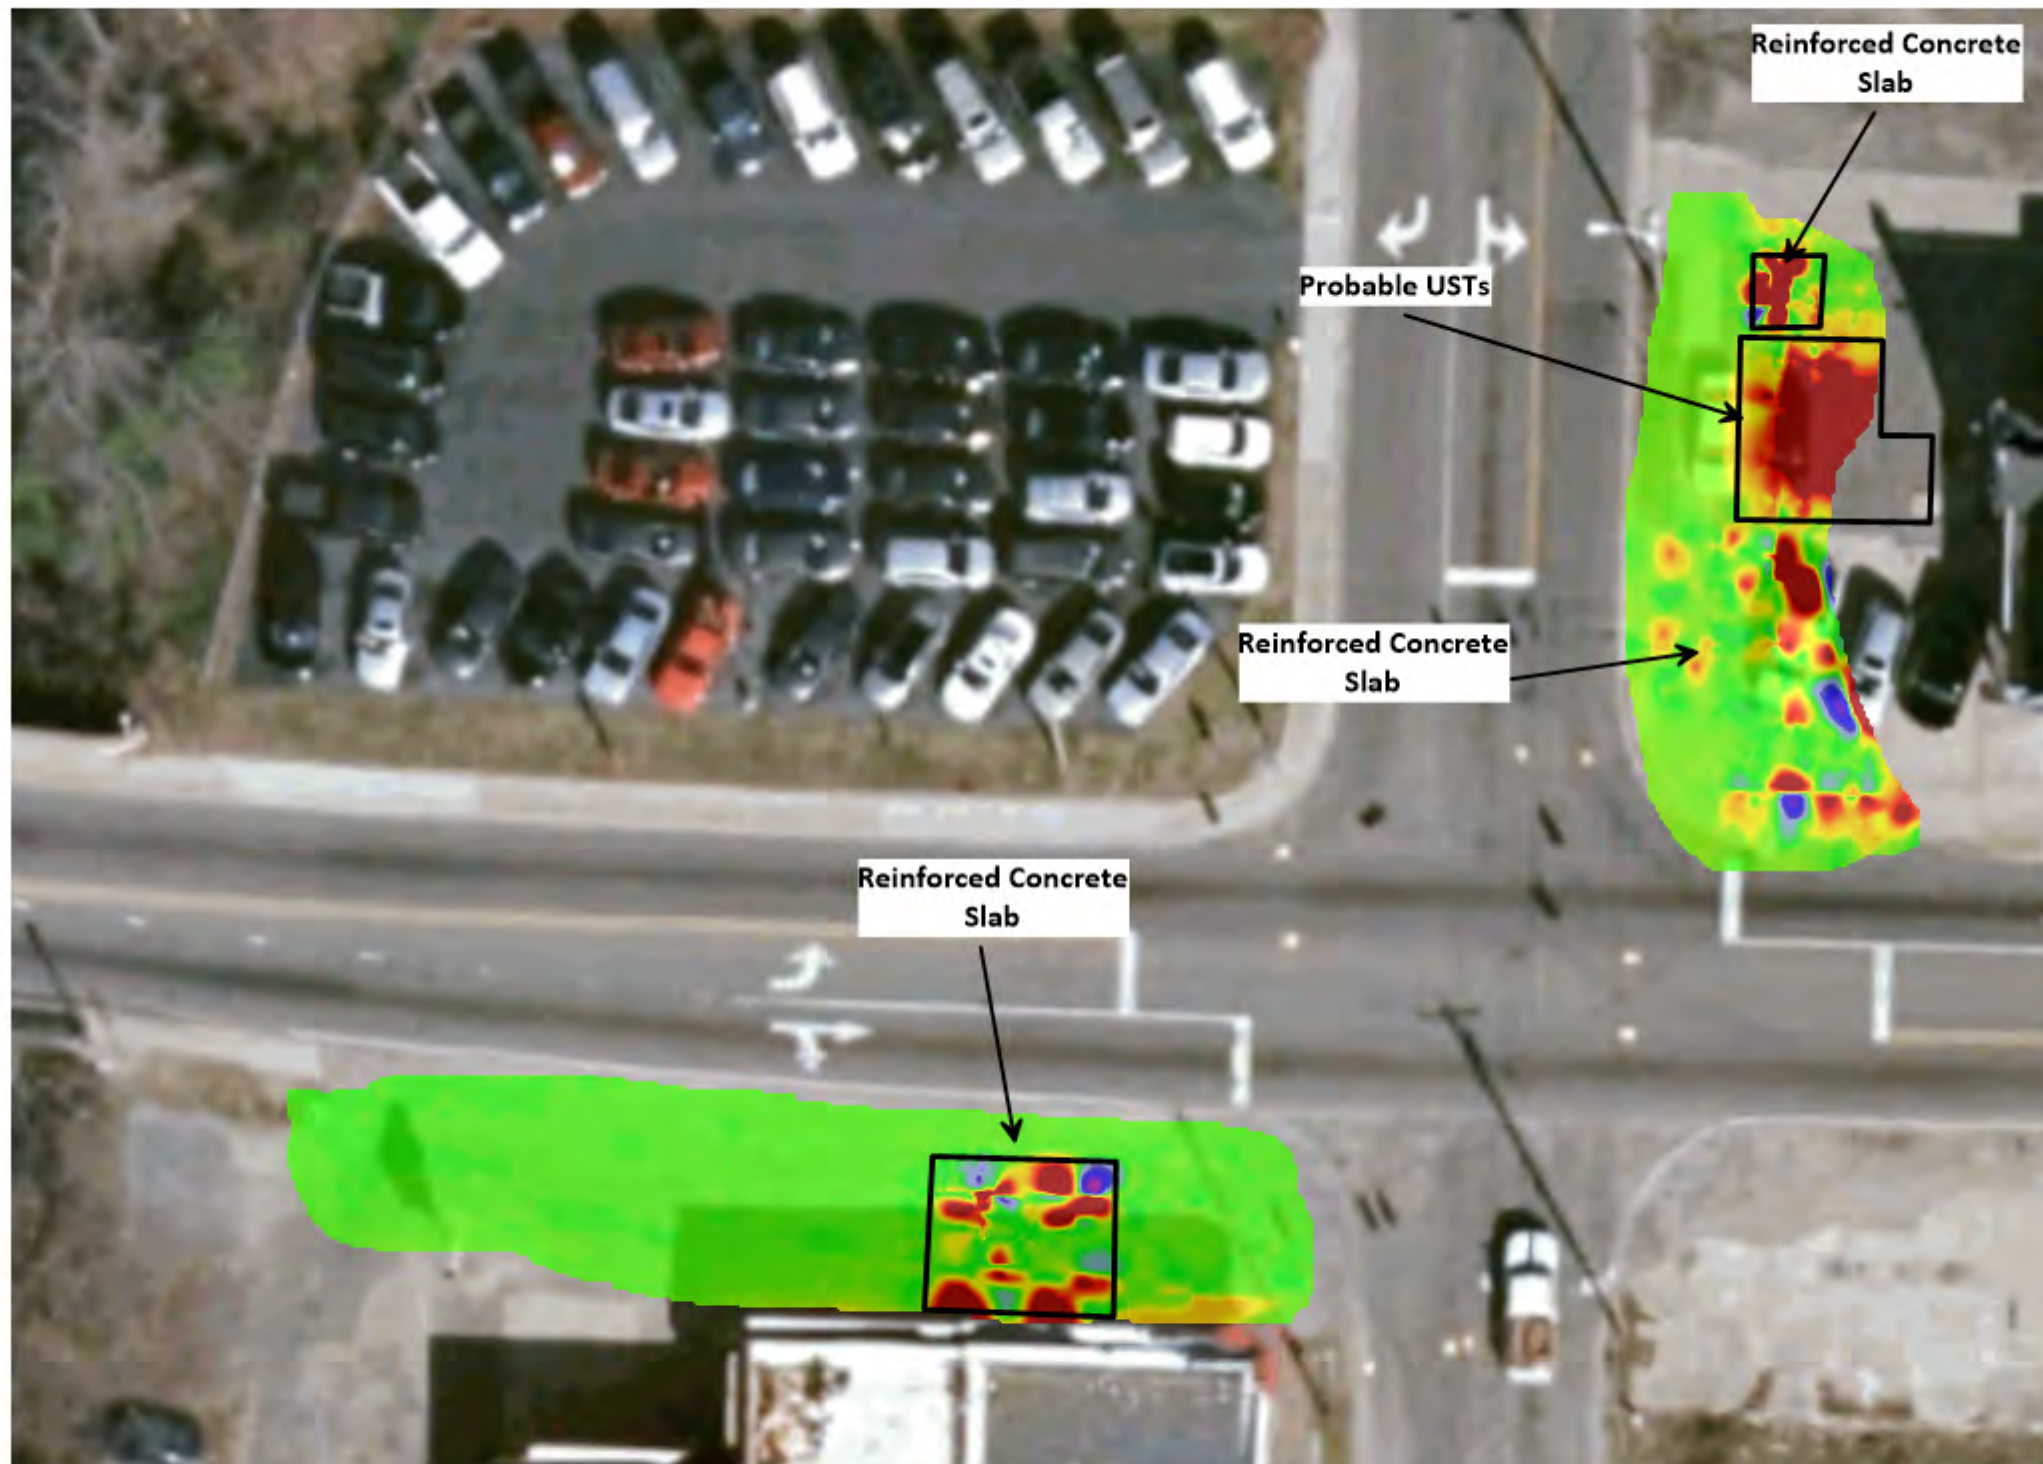
Figure 4

**Geophysical Evaluation
EM Apparent Conductivity
Results Map**

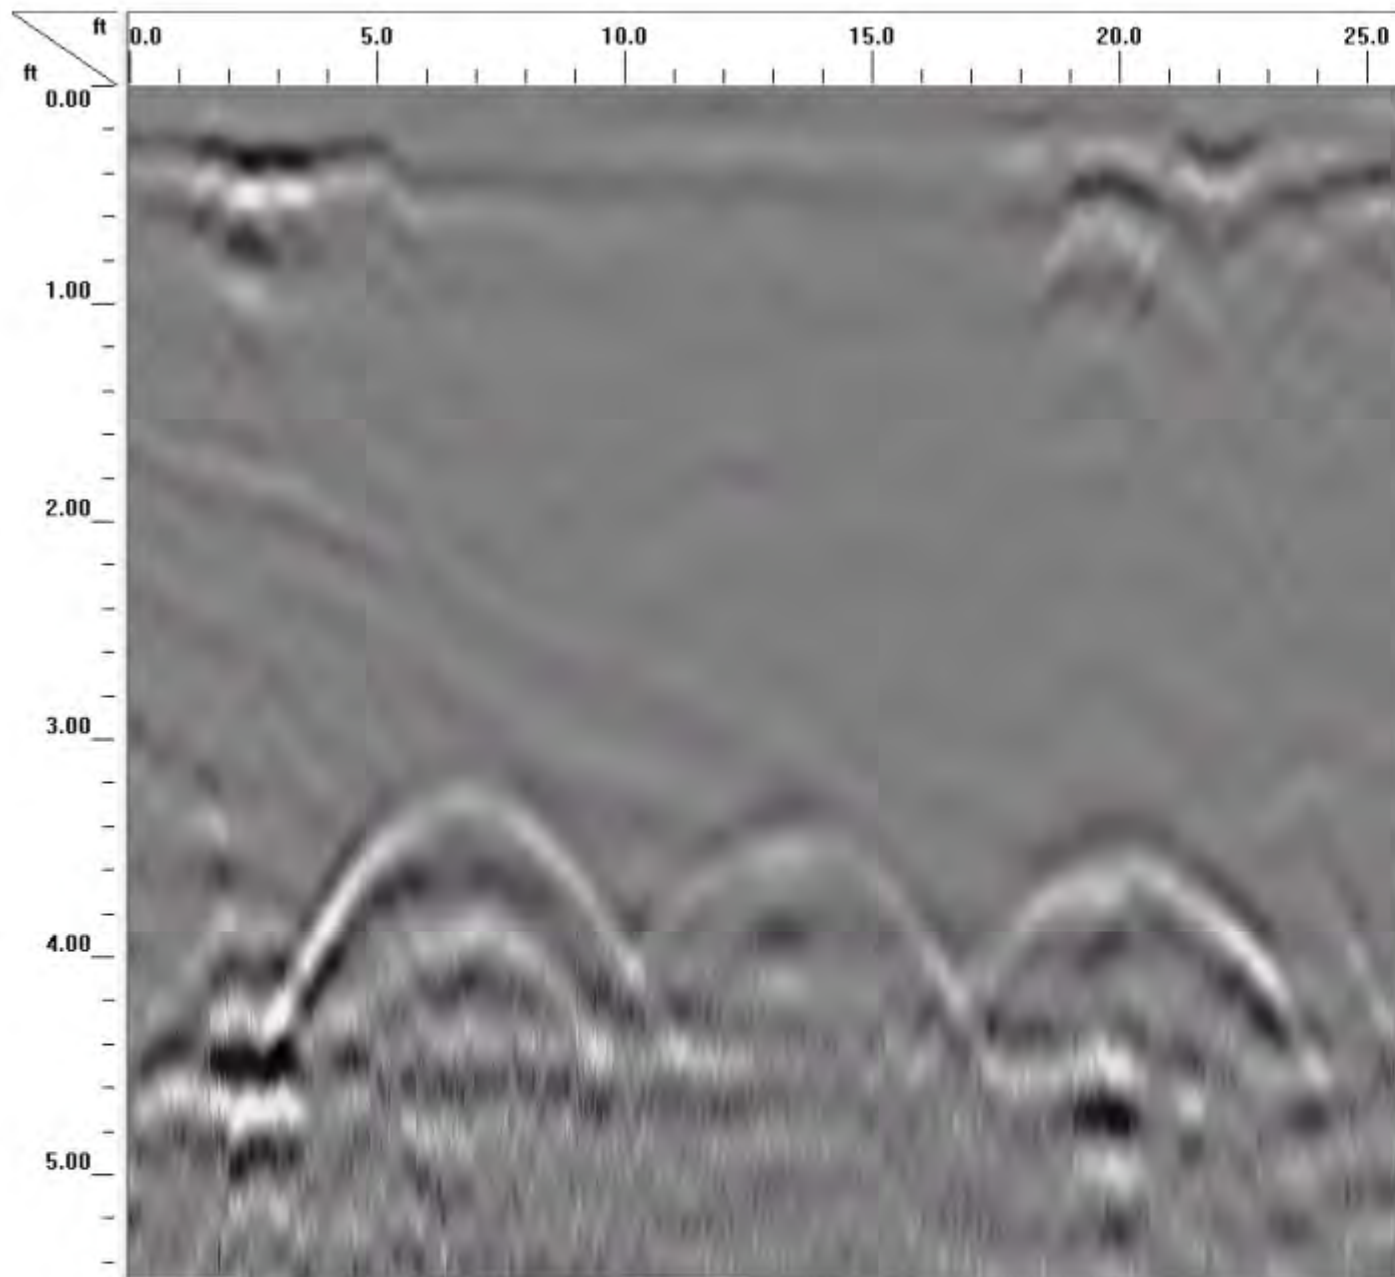
Profile 1. Transect collected across the north end of the probable USTs 1-3.

Figure 7	Ground-penetrating Radar Evaluation Cross Sections of Probable USTs.
NCDOT U-5985 N. Water Street and W. 2nd Street Lumberton, NC

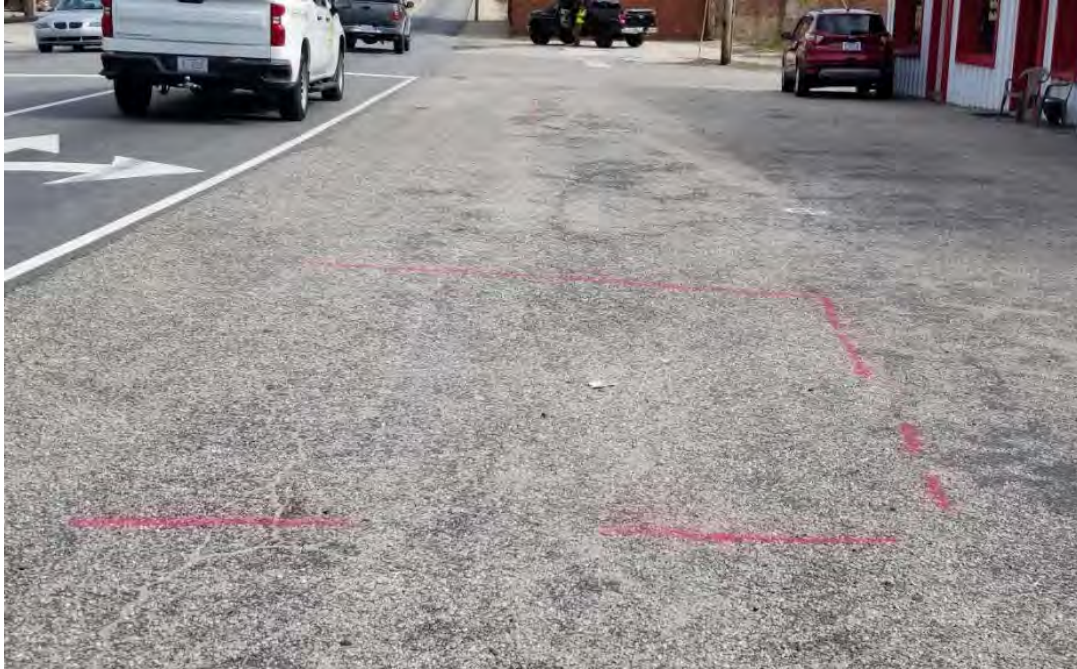
Photograph 1. Parcel 005 non-metallic GPR anomaly.

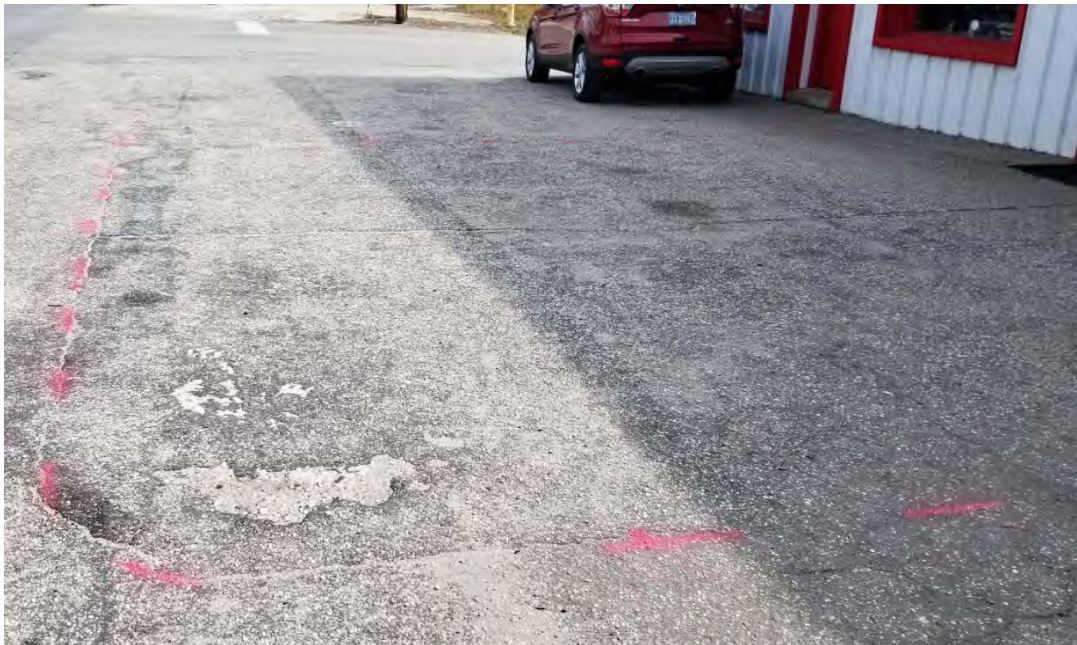
Photograph 2. Parcel 005 area of suspected reinforced concrete slab.

Figure 5 is a map documenting the results of the GPR evaluation. At Parcel 005 along W. 2nd Street, a suspected reinforced concrete slab was detected below the asphalt surface. GPR penetration was limited in this area due to the suspected metallic wire mesh. This was in the same area as the suspected reinforced concrete detected during the EM evaluation. There was an anomaly detected at the west end of the area of evaluation. Figure 6 is a cross section of this subsurface feature. This is not likely a metallic structure due to the lack of EM response in this area. This GPR anomaly is not characteristic of a metallic UST. The anomaly is likely related to conductive soil or fill in this area. These subsurface detections were identified in the field with pink ground marking paint (Appendix A. Photographic log).

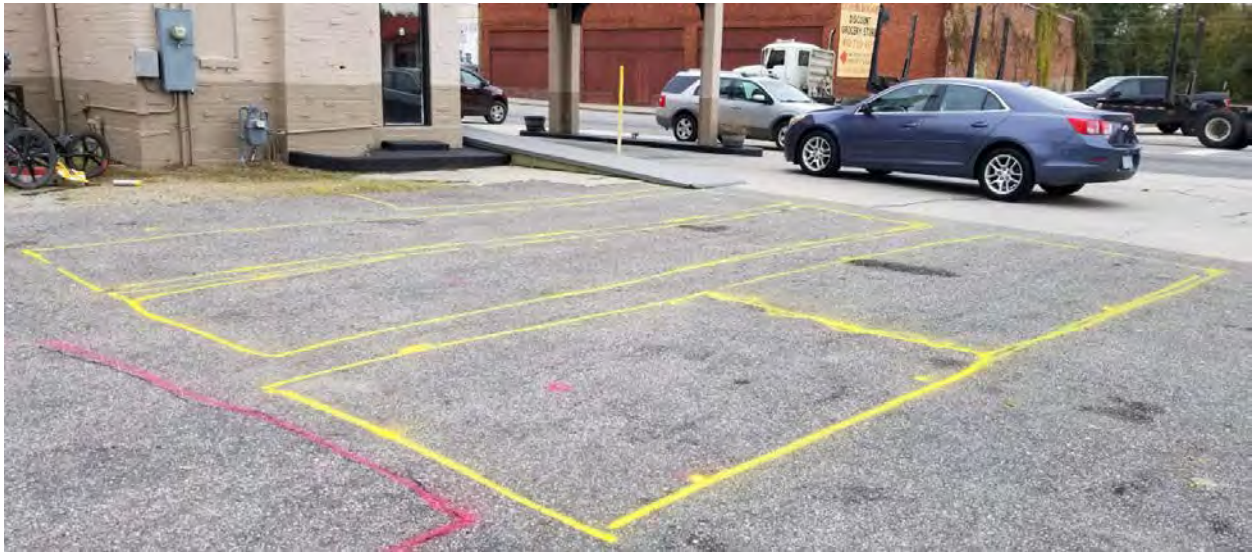
Photograph 3. Parcel 006 four (4) probable USTs.

At Parcel 006 along N. Water Street, four (4) probable USTs were detected with GPR in the area of the strong EM response. These probable USTs are shown on Figure 5 as yellow

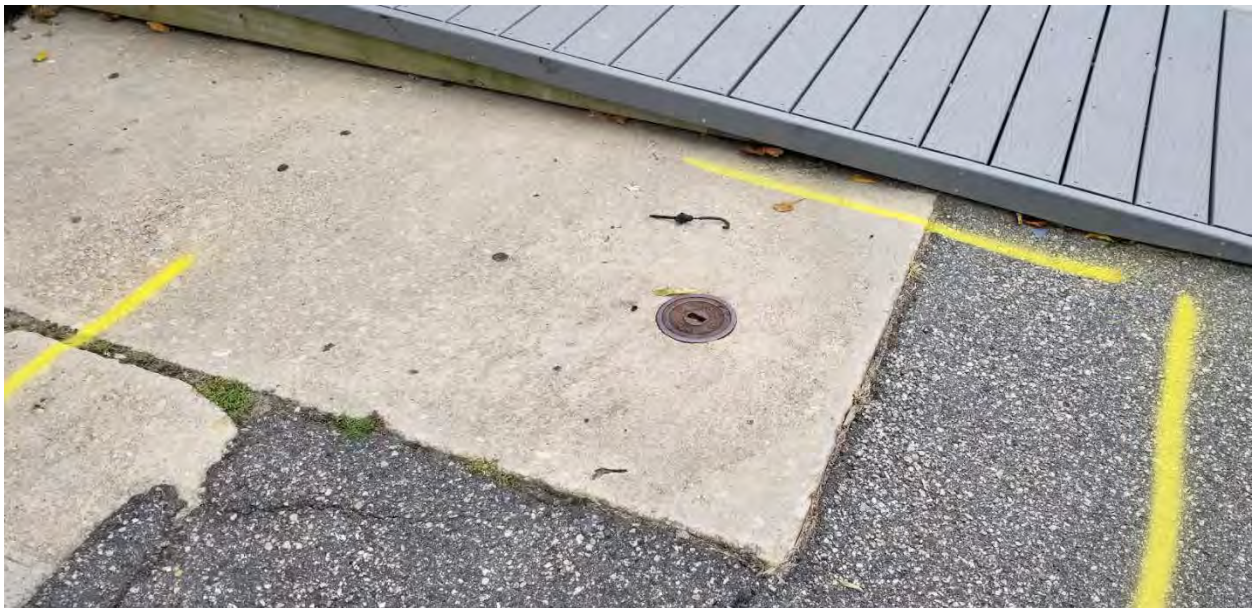
Photograph 4. Parcel 006 fill port on probable UST 4.

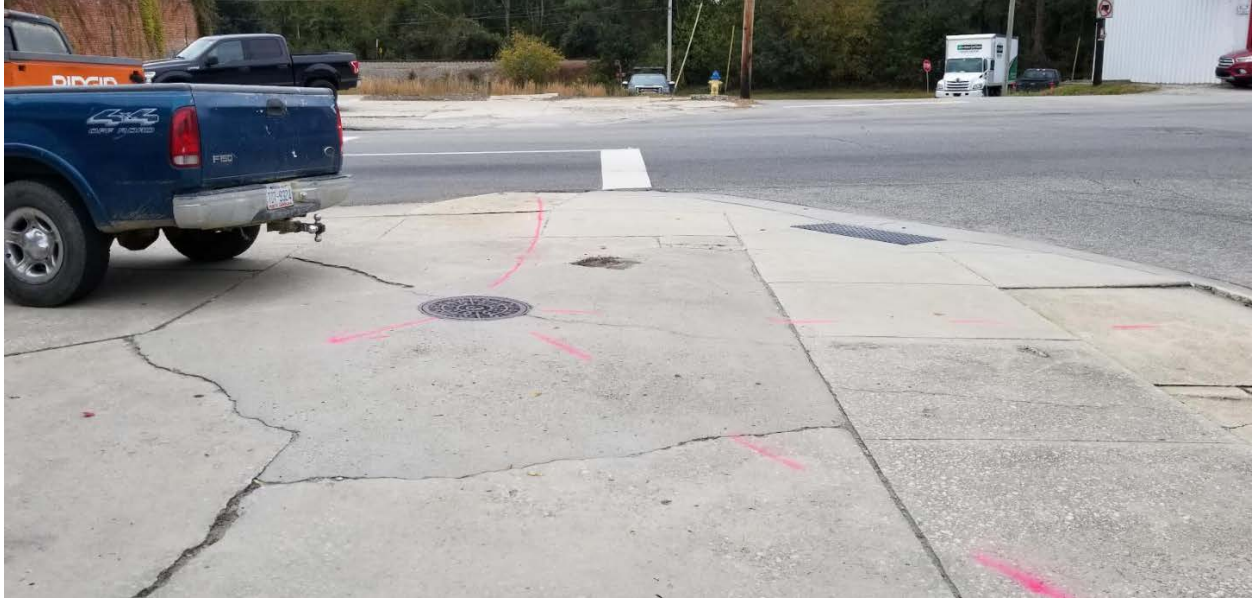
Photograph 5. Parcel 006 area of reinforced concrete, subsurface piping, storm drain, and manhole.

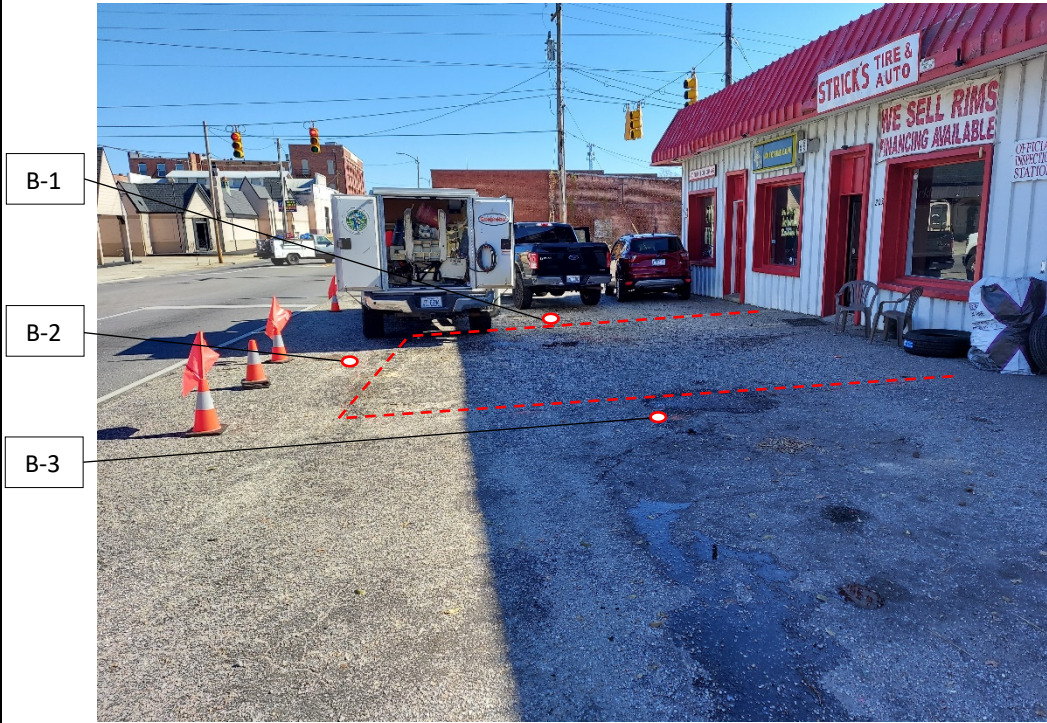
Photo No. 1

View of Borings B-1 through B-3 surrounding the concrete slab, facing east

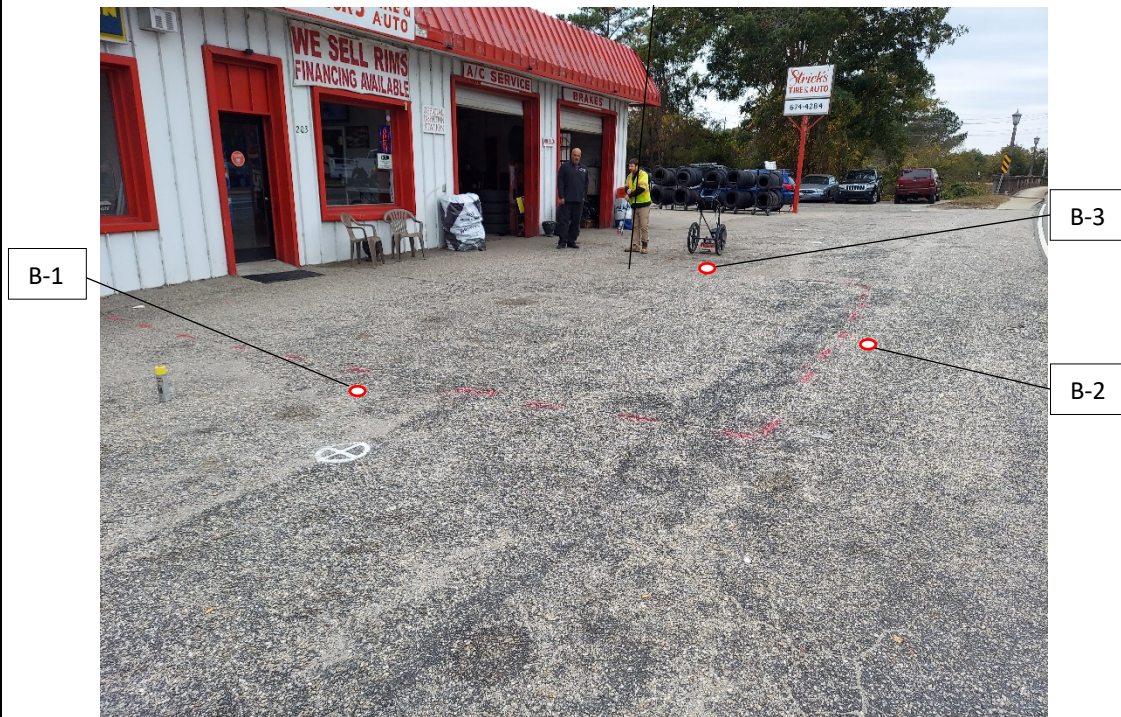
Photo No. 2

View of Borings B-1 through B-3 surrounding the concrete slab, facing west

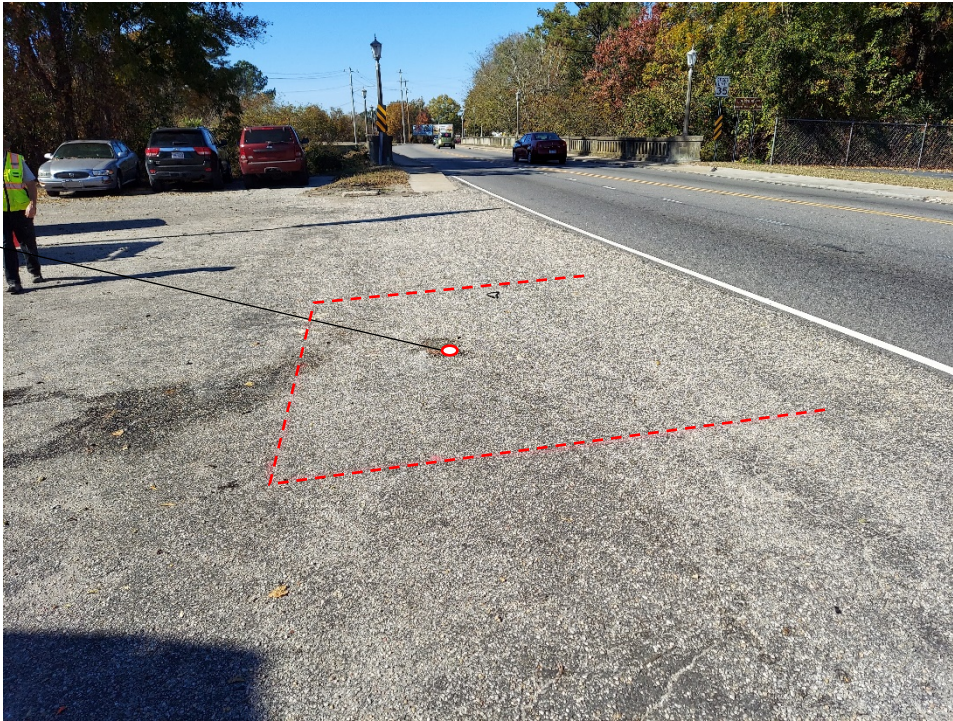
Photo No. 3

View of Boring B-4 advanced within the GPR anomaly on the western portion of the site, facing west

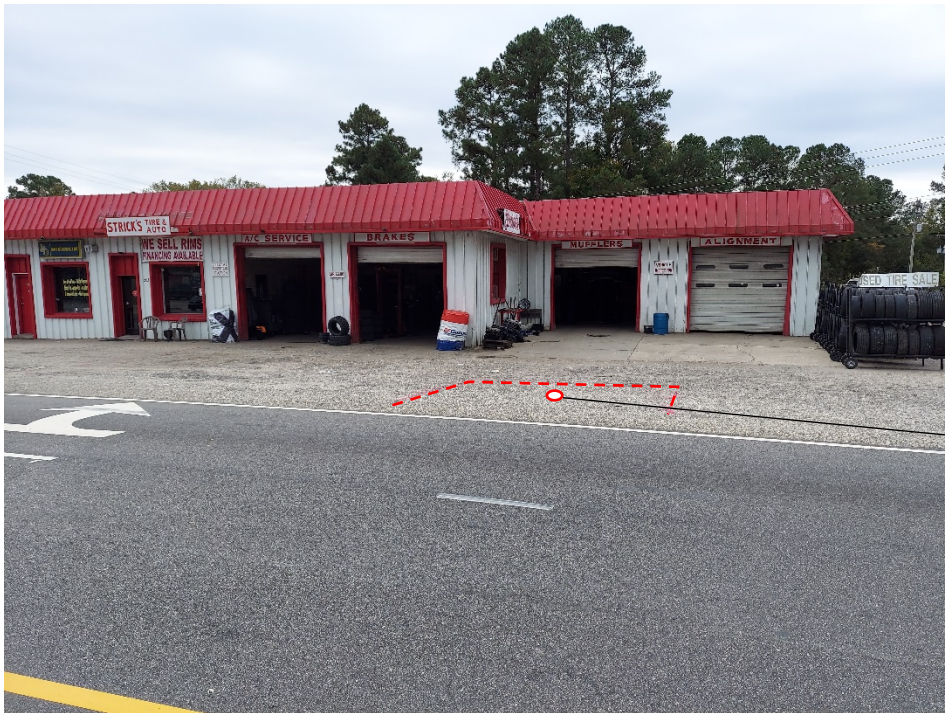
Photo No. 4

View of Boring B-4 advanced within the GPR anomaly on the western portion of the site, facing west

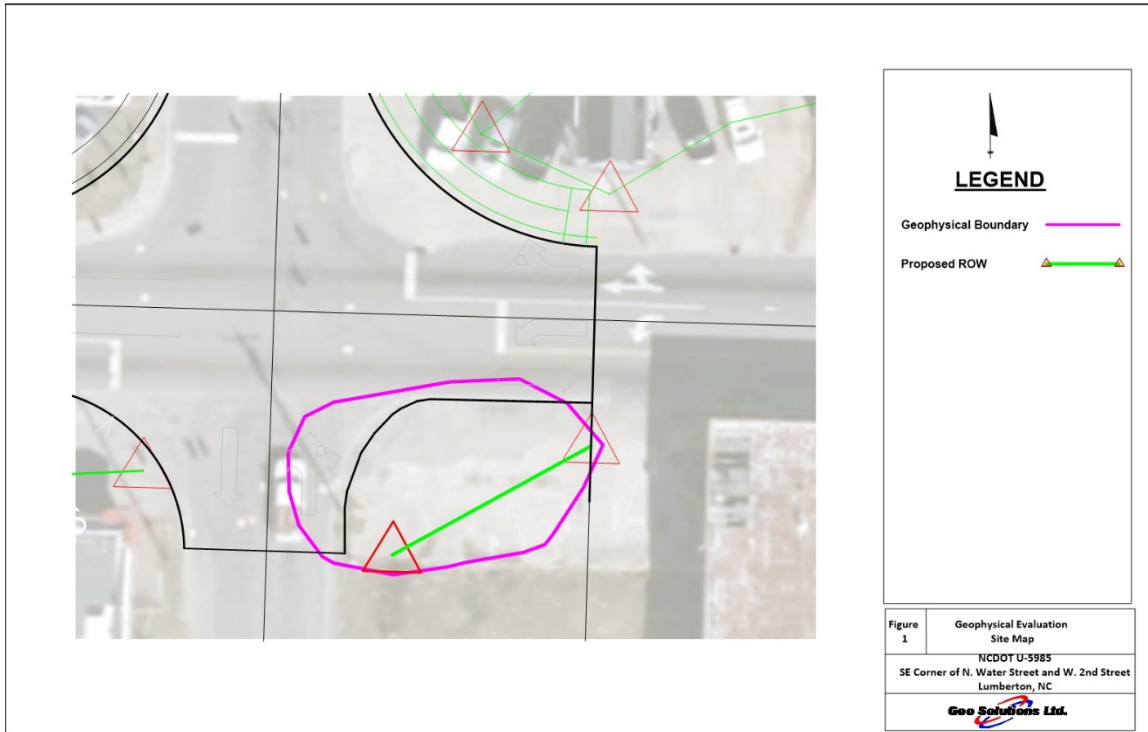
Figure 1. Site map of the area of the southeast corner of the NCDOT intersection widening project with the geophysical evaluation boundary delineated in magenta.

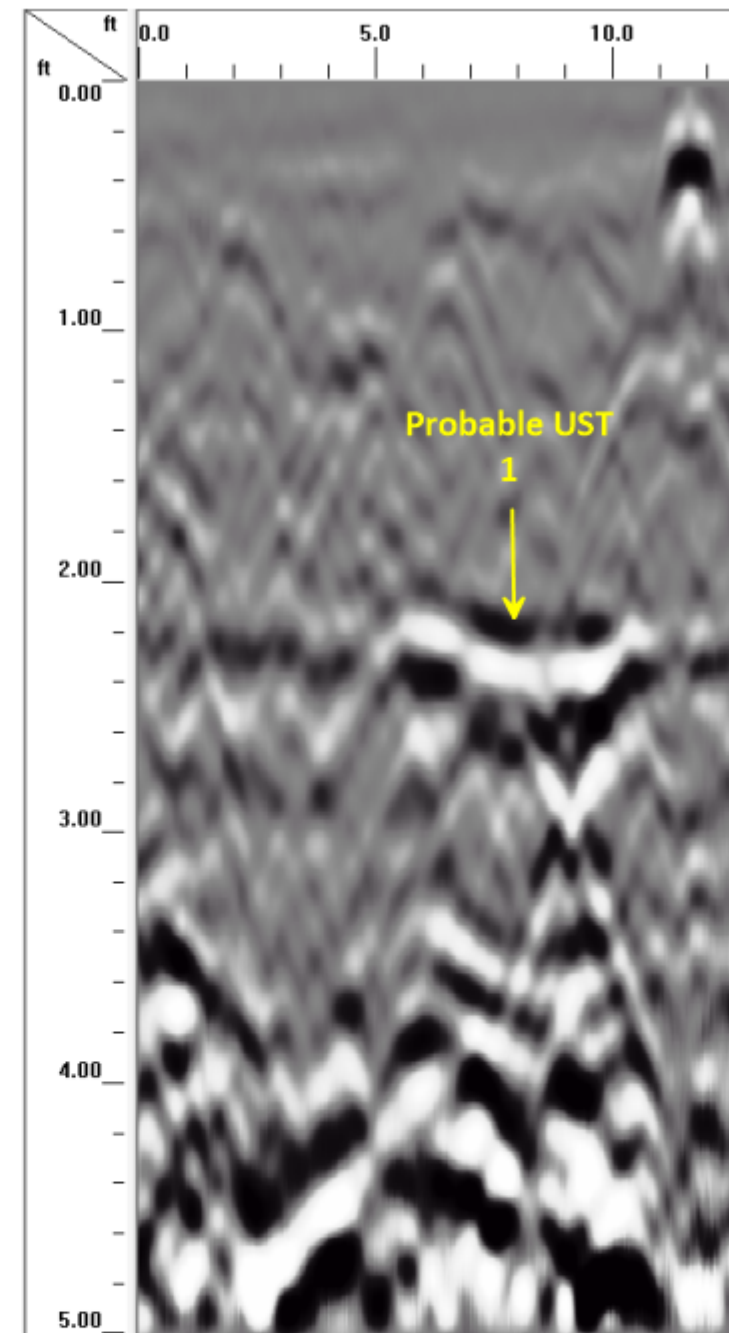
Profile 2. Transect collected along the axis of Probable UST 1.

Figure 6	Ground-penetrating Radar Evaluation Cross Sections of Probable USTs.
NCDOT U-5985 SE Corner of N. Water Street and W. 2nd Street Lumberton, NC

Based upon the results of the EM and GPR surveys, three (3) probable USTs were identified along the southern proposed ROW line. The three USTs are estimated to be approximately five (5) feet in length and four (4) feet in diameter. Fill ports were observed at the southern end of the probable USTs.

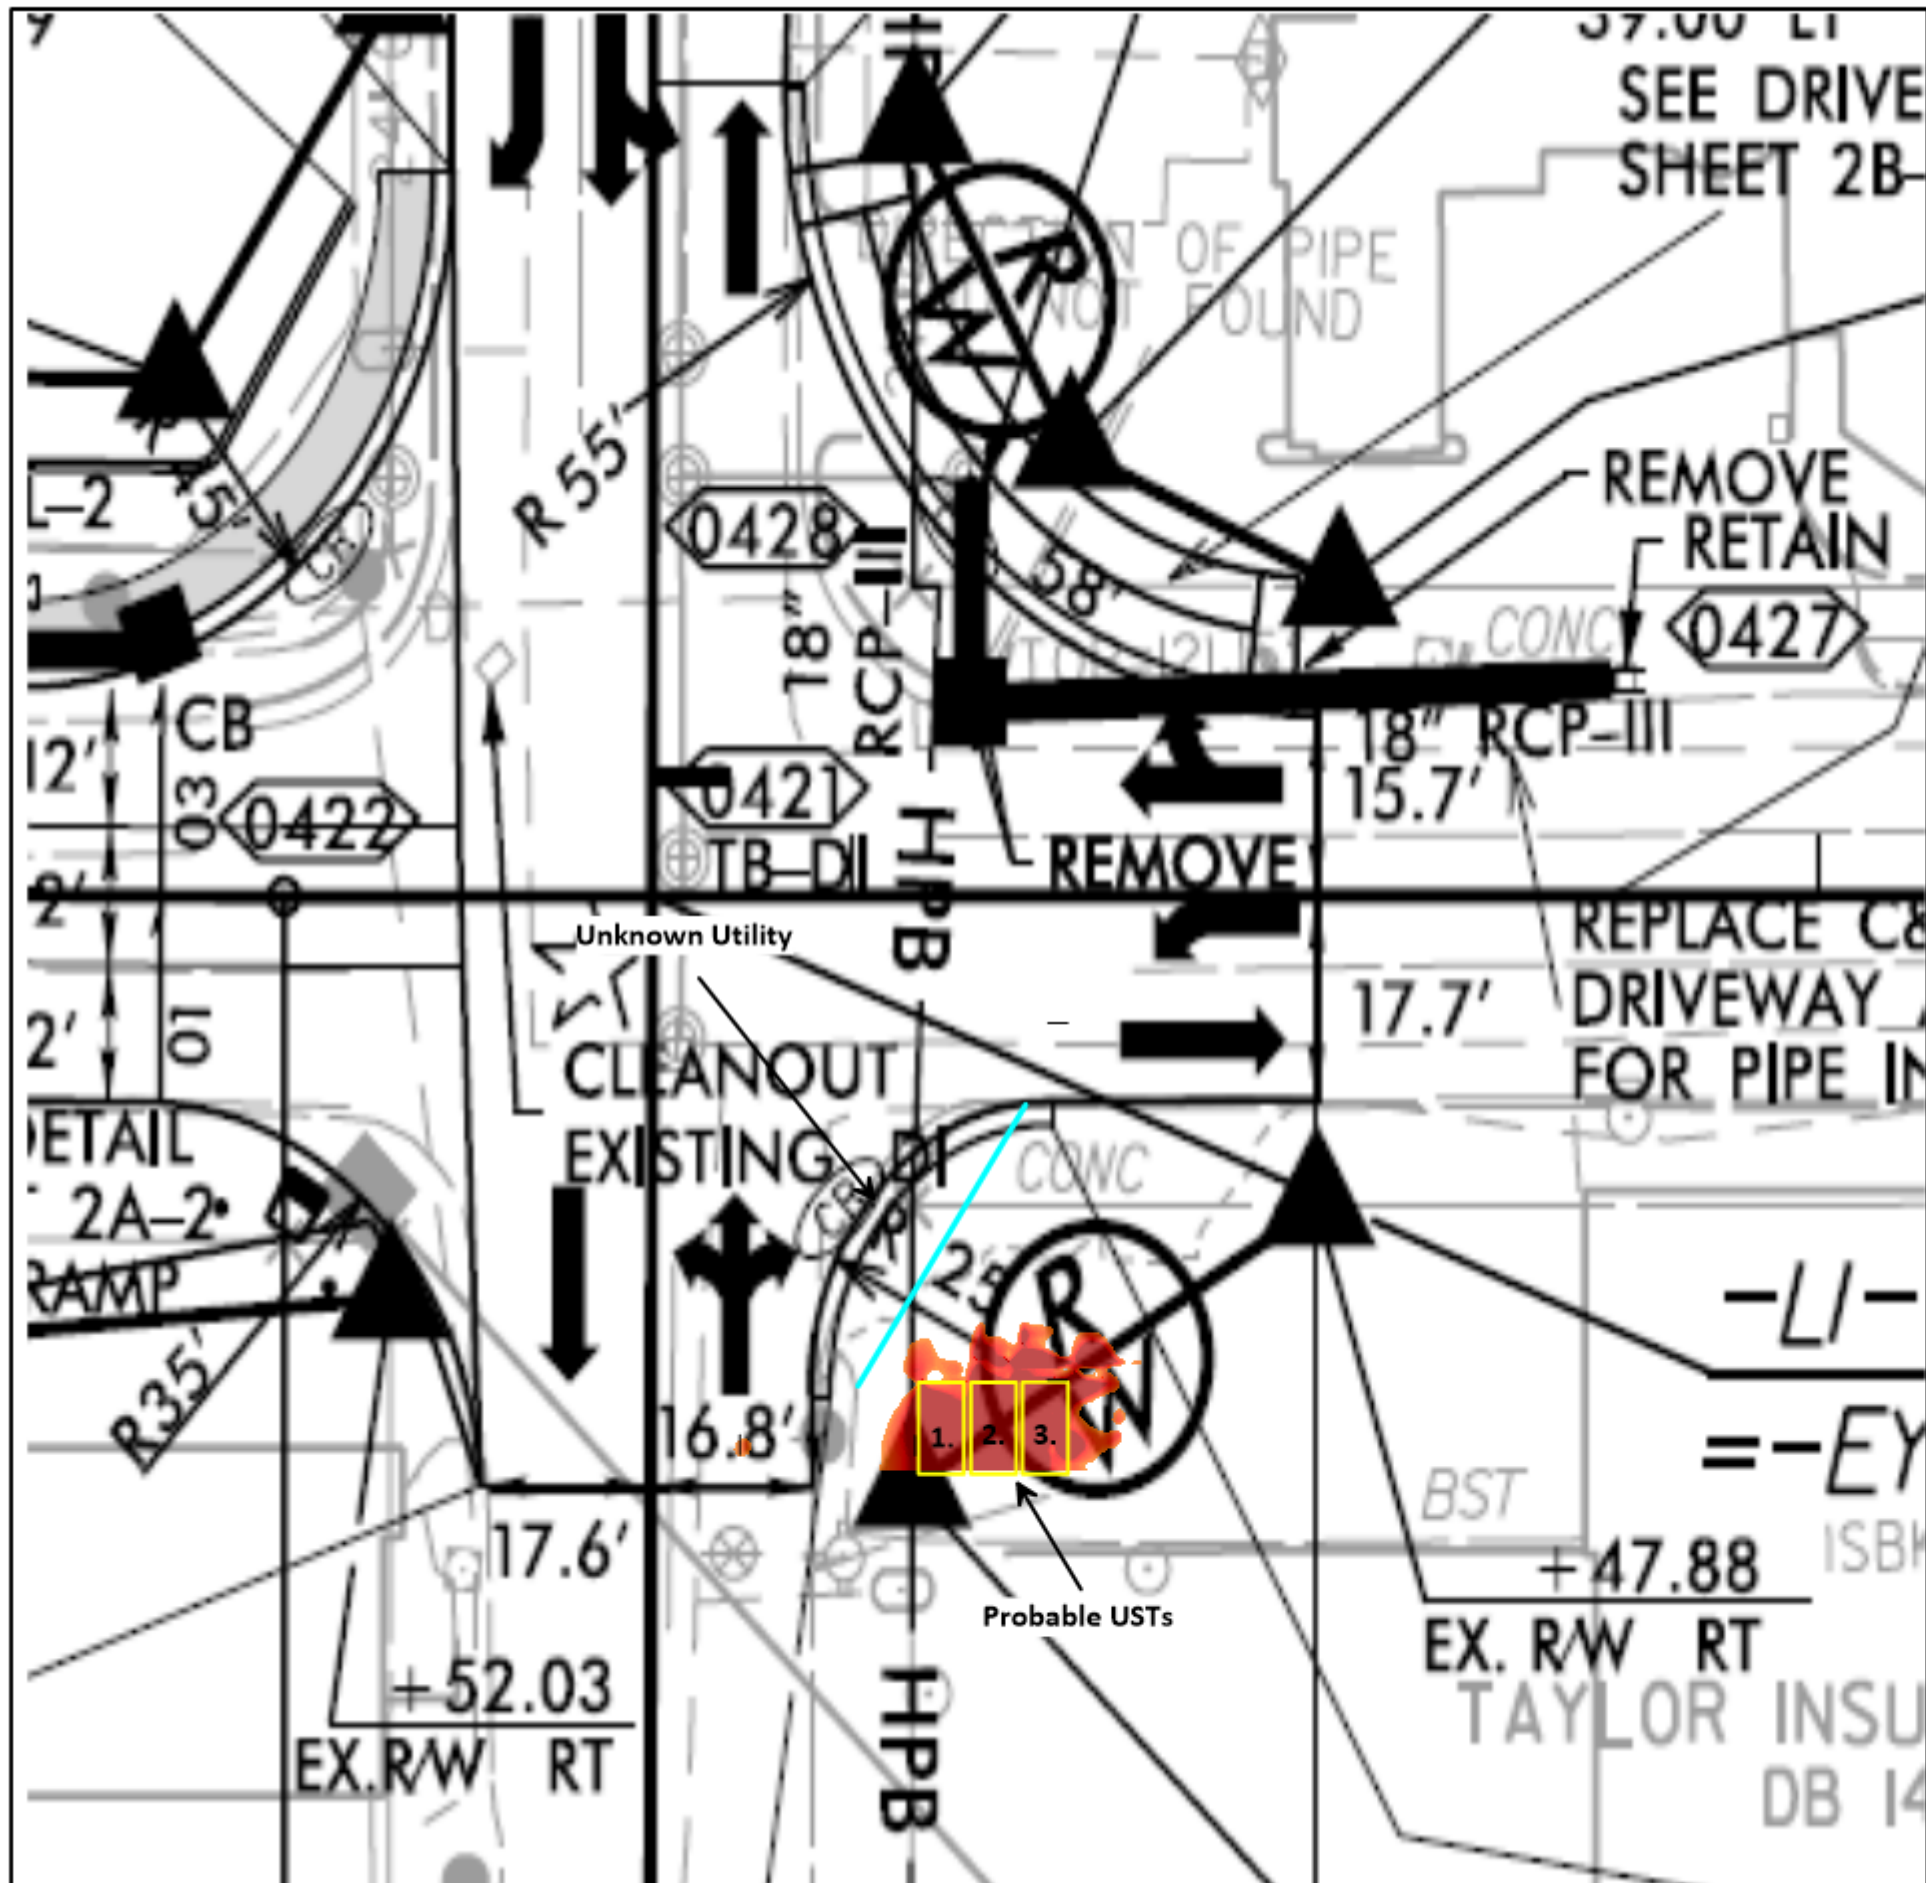
Figure 7 **Geophysical Evaluation**
 Geophysical Results Map overlaid
 on NCDOT Design Plan
 NCDOT U-5985
 SE Corner of N. Water Street and W. 2nd Street
 Lumberton, NC

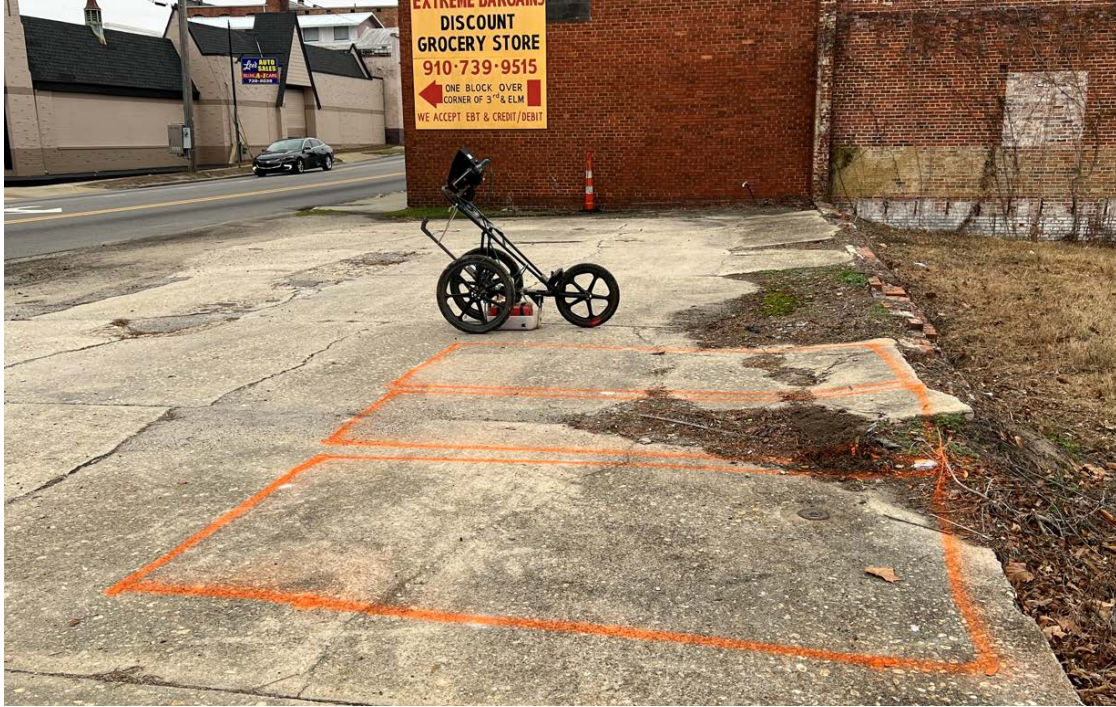
Photograph 1. Probable USTs identified with orange ground-marking paint.

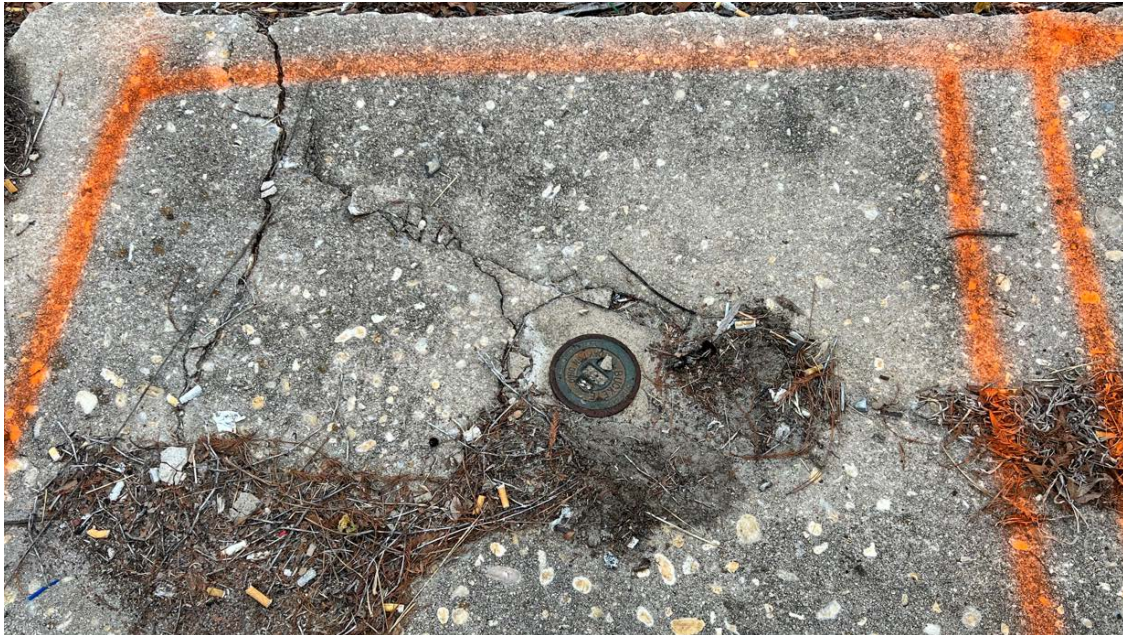
Photograph 2. Fill port visible at the surface.

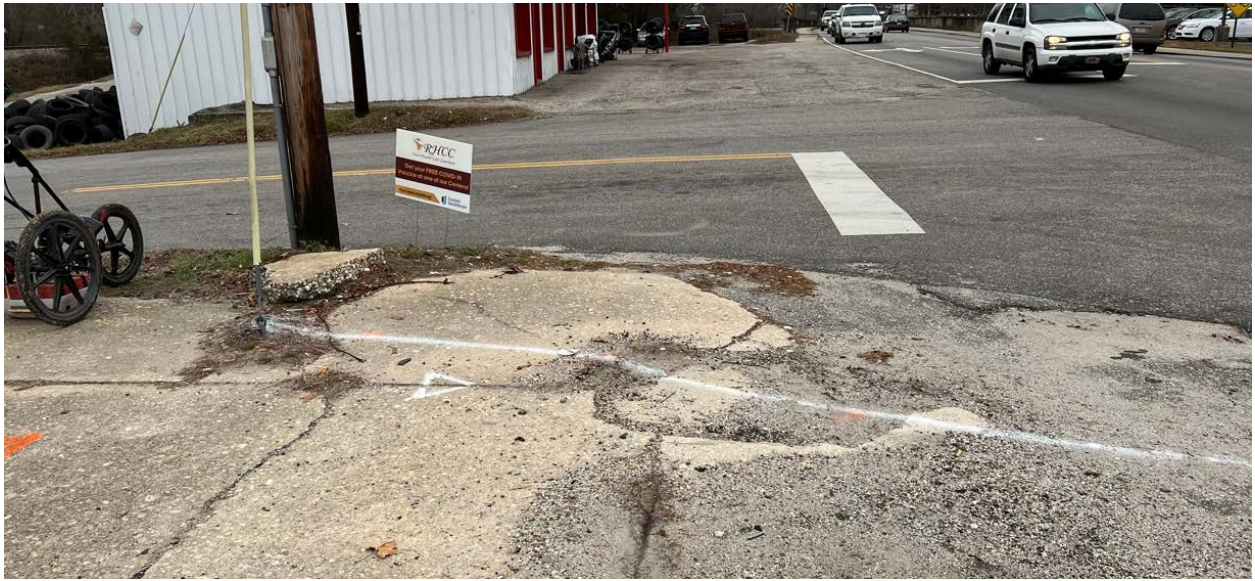
Photograph 3. Suspected unknown utility identified with white ground-marking paint.
