GEOENVIRONMENTAL PHASE II INVESTIGATION

TIP NUMBER B-5985

Parcel #005 – Charles & Billy Strickland
203 West 2nd Street
PIN 939165786200
Lumberton, Robeson County, North Carolina
WR Project No. 02191306.11

NCDOT U-5985 – Lumberton, NC

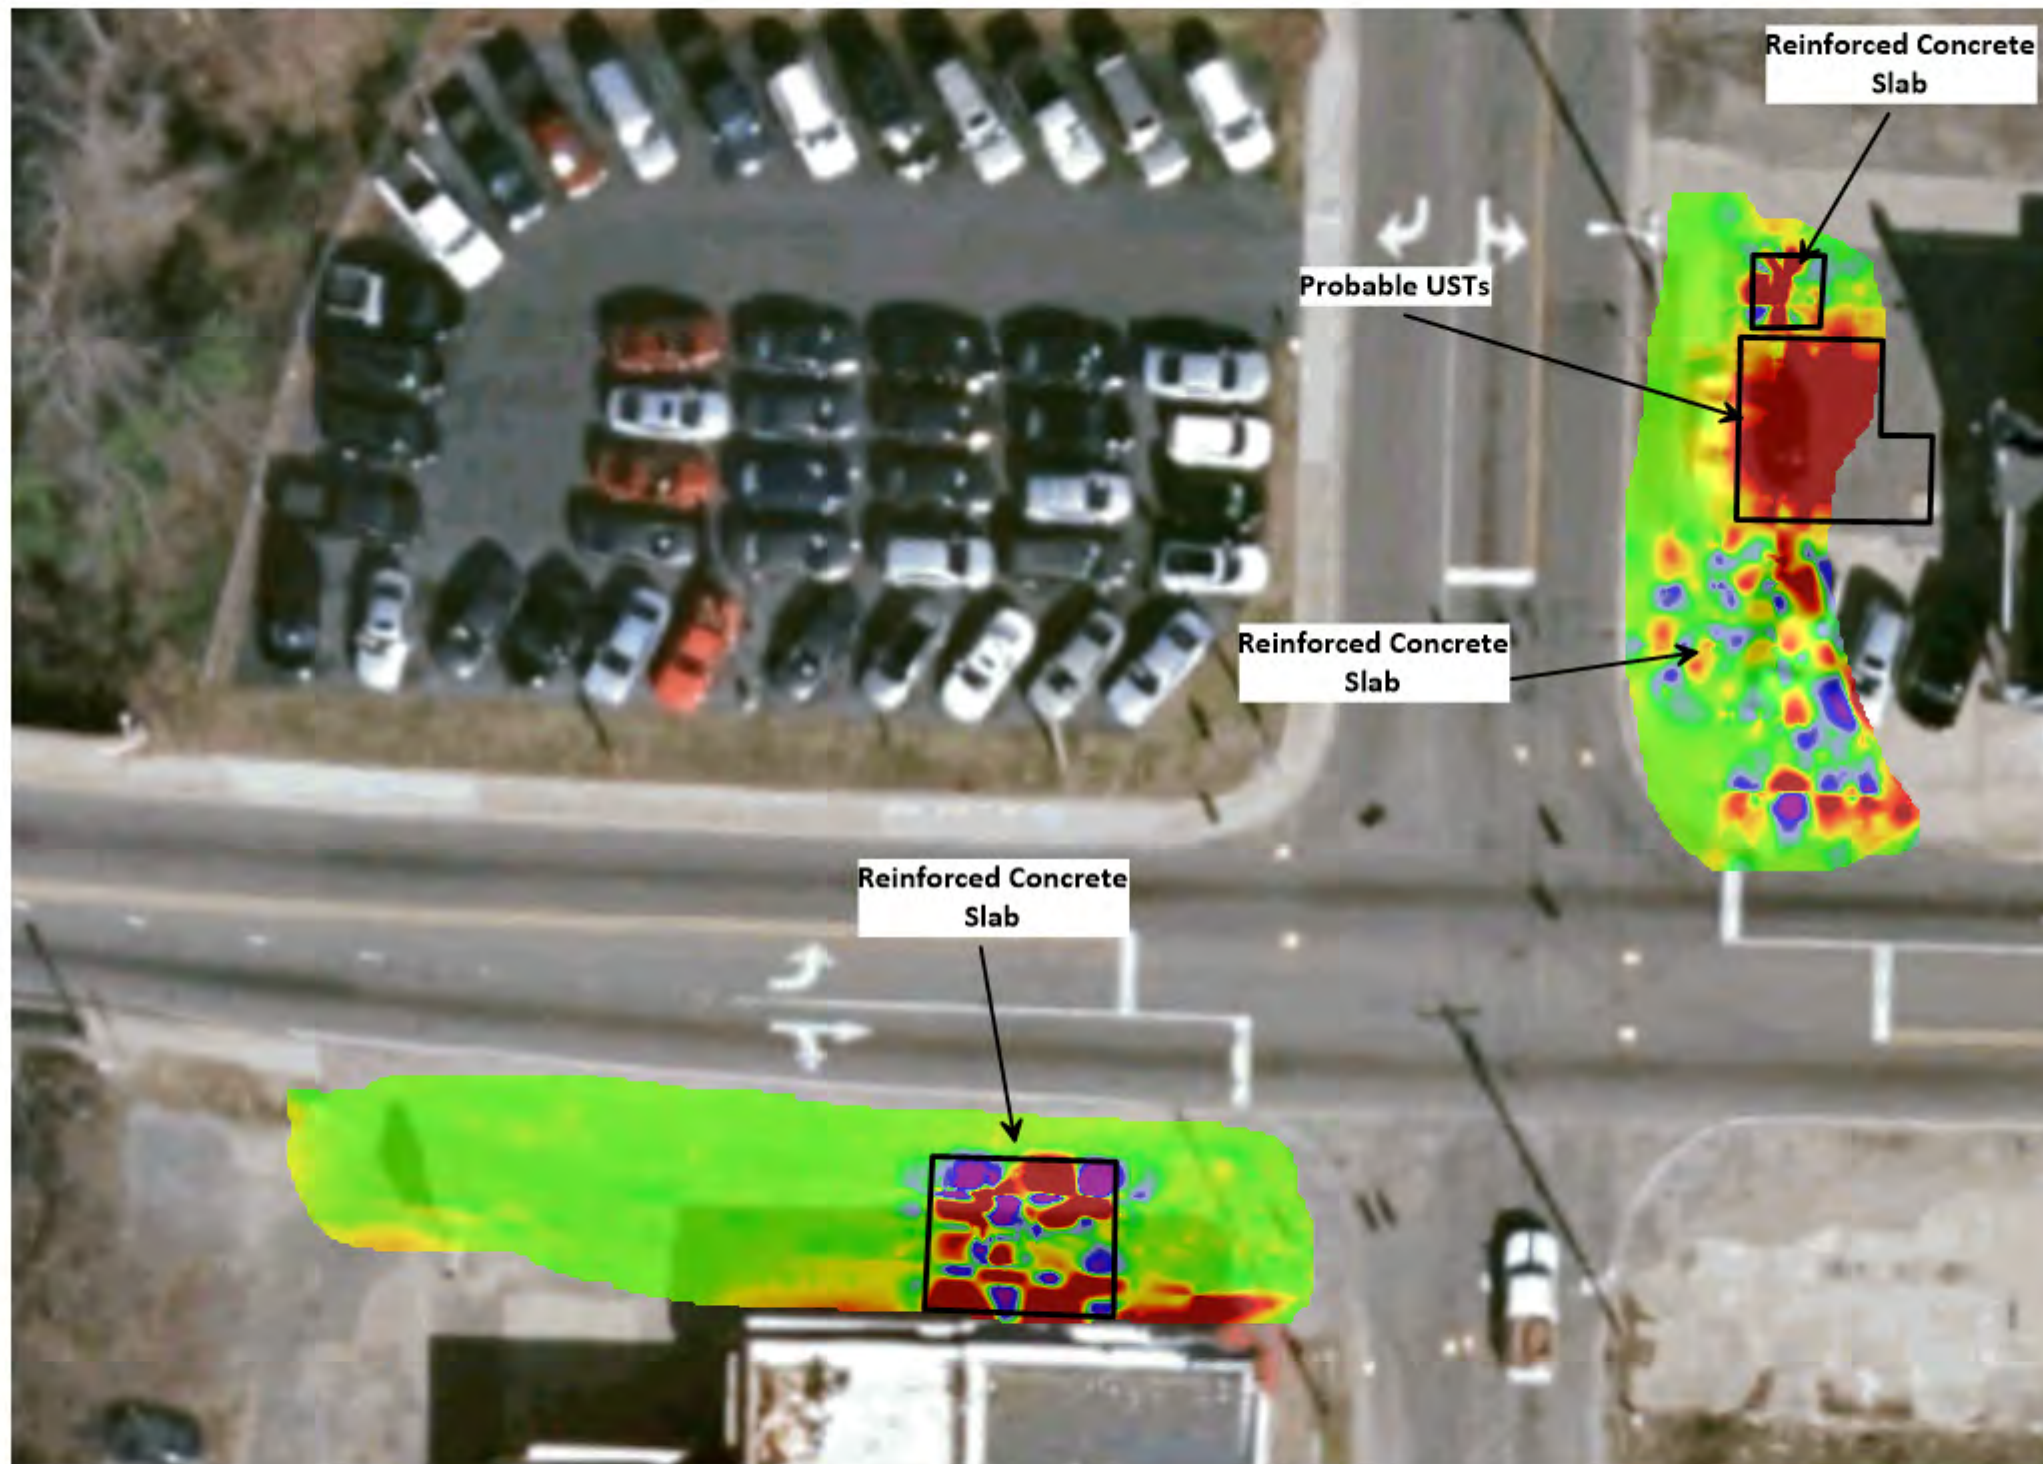
Figure 3

**Geophysical Evaluation
EM In-phase (Metal Detection)
Results Map**

EM in-phase and apparent conductivity maps respectively with explanations for the anomalous conditions observed in the EM data. Here, anomalous conditions are shown as orange to red and blue hues where the background site conditions are shown as light yellow and green hues. At the location of Parcel 005 along W. 2nd Street there was an elevated EM response in both in-phase and apparent conductivity near the center of the area of evaluation. The high variability from positive to negative responses shown as red and blue hues are typical for reinforced concrete. The in-phase and apparent conductivity response across the remainder of the site was very weak with no detections of large metal structures such as USTs. At the location of Parcel 006 along N. Water Street there was a very strong elevated in-phase and apparent conductivity response shown as red hues on Figures 3 and 4. This is consistent with the EM response to a large buried metallic structure such as a UST. There was an elevated EM response at the northern end of Parcel 006. This EM response is consistent with a small area of reinforced concrete. The southern half of Parcel 006 had an elevated in-phase and apparent conductivity response as well. The high variability from positive to negative responses shown as red and blue hues are typical for reinforced concrete. There was also a storm drain and sanitary sewer manhole in this area.

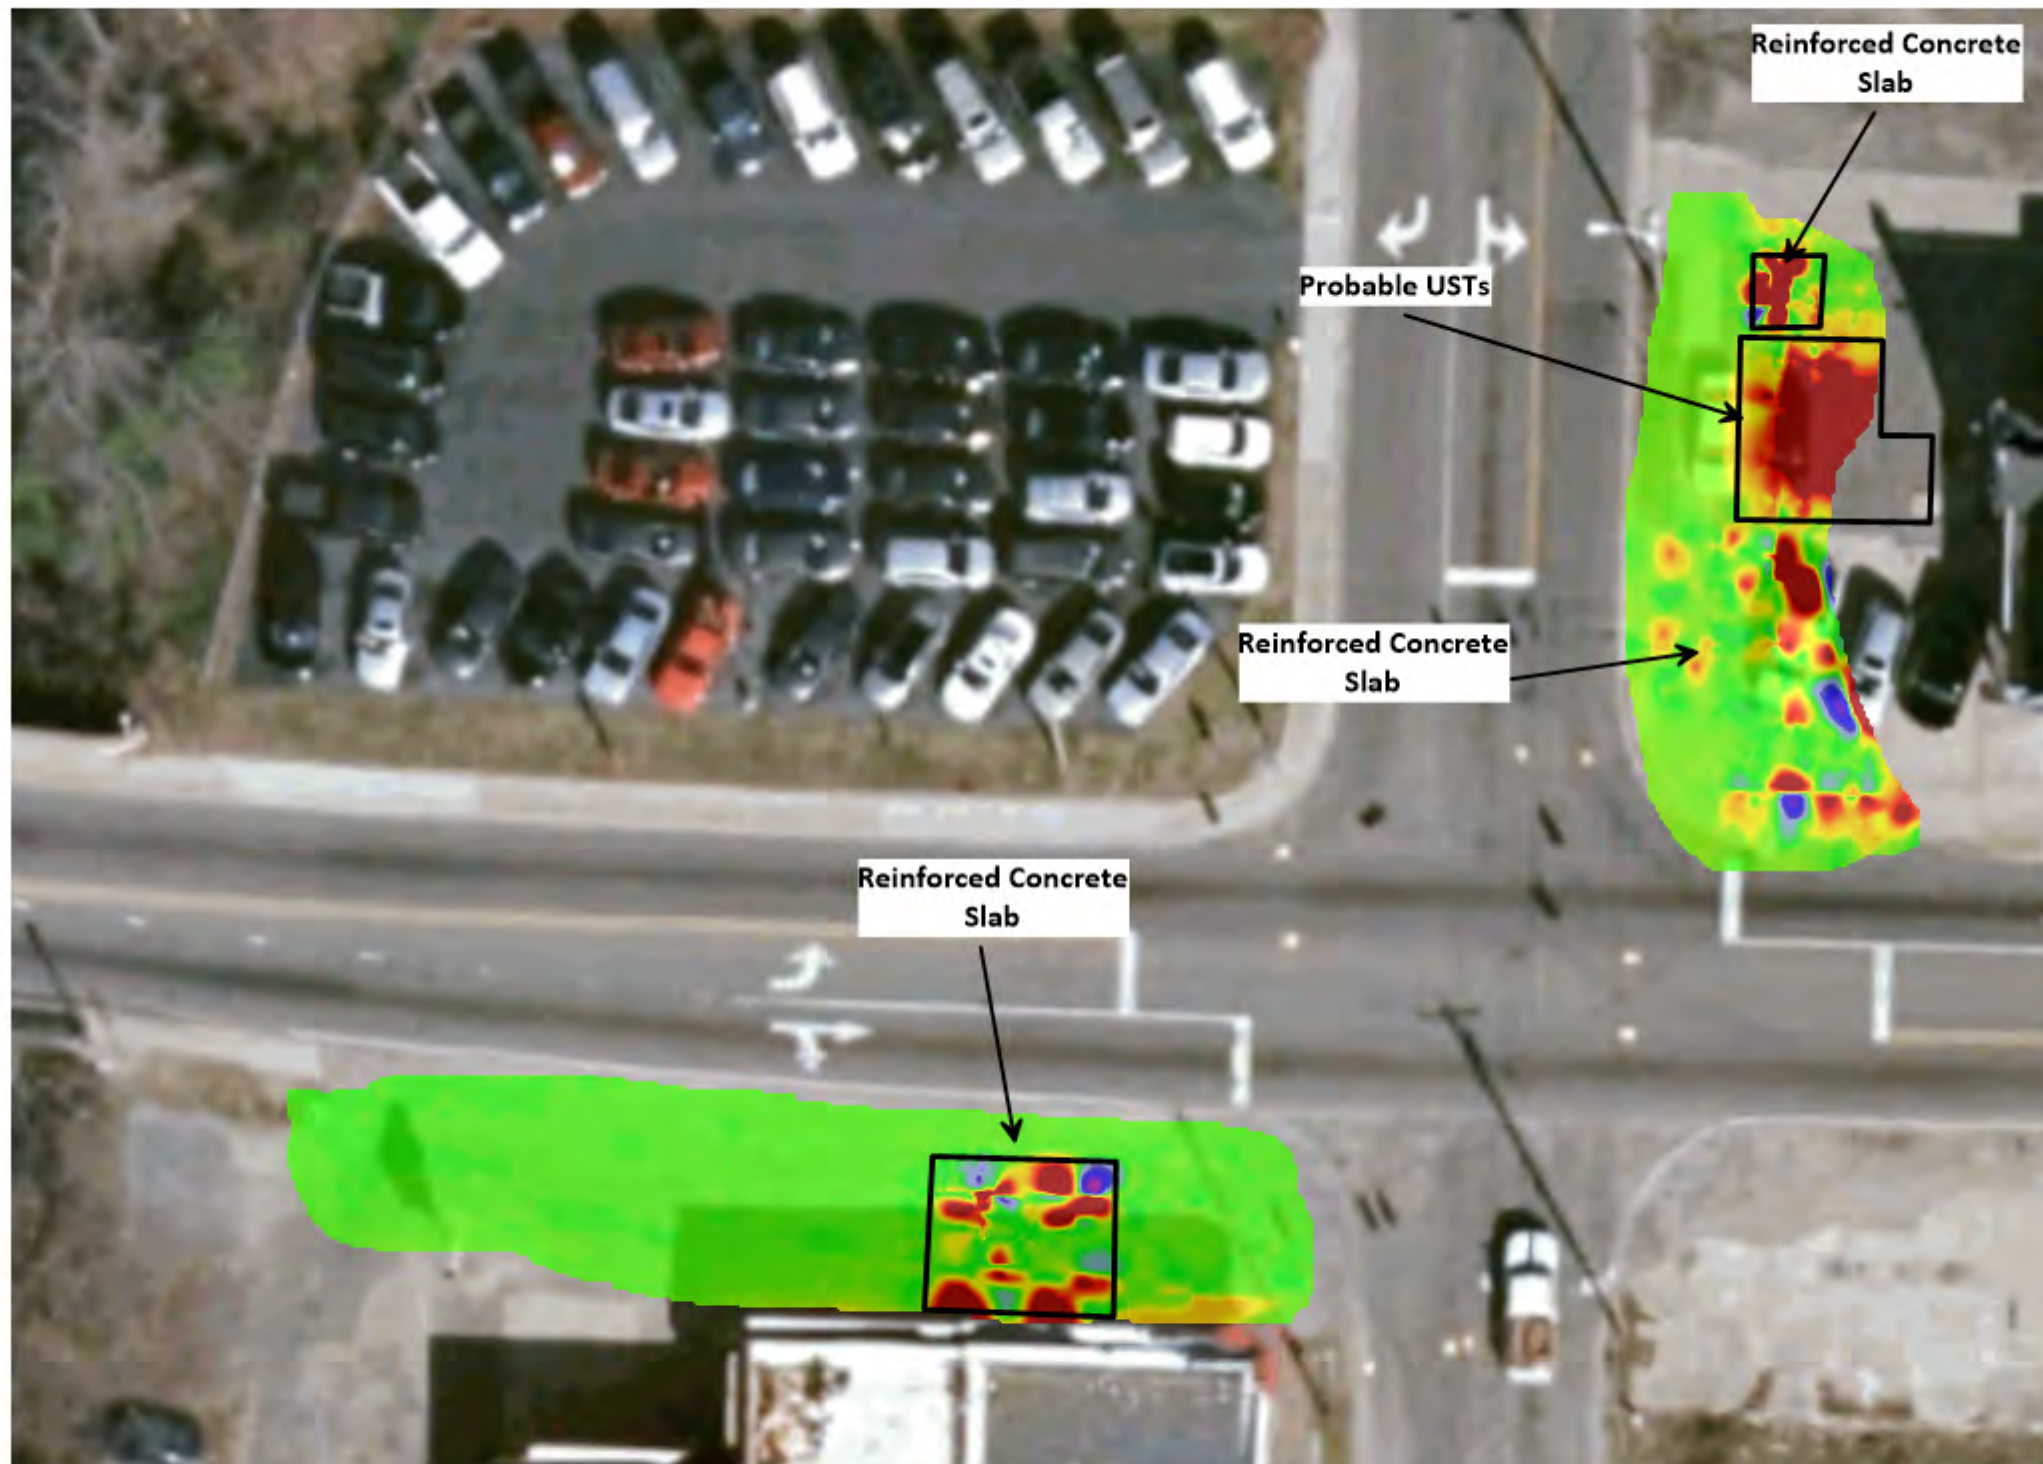
Figure 4

**Geophysical Evaluation
EM Apparent Conductivity
Results Map**

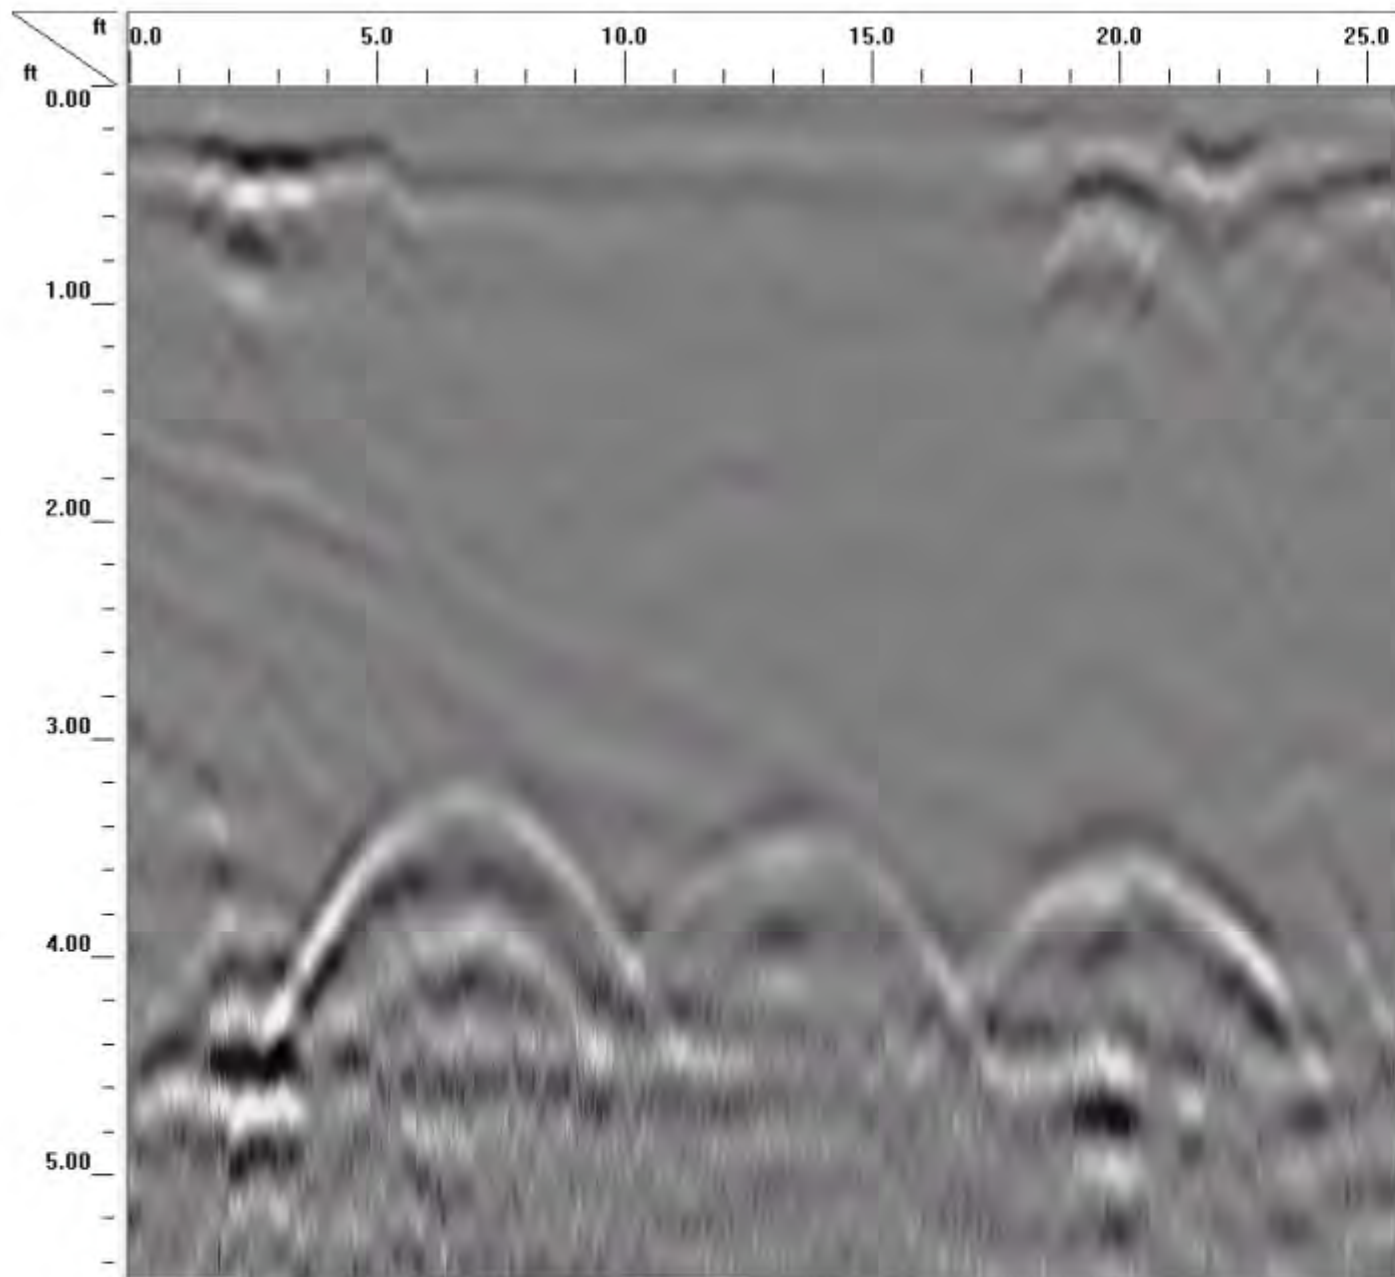
Profile 1. Transect collected across the north end of the probable USTs 1-3.

Figure 7	Ground-penetrating Radar Evaluation Cross Sections of Probable USTs.
NCDOT U-5985 N. Water Street and W. 2nd Street Lumberton, NC

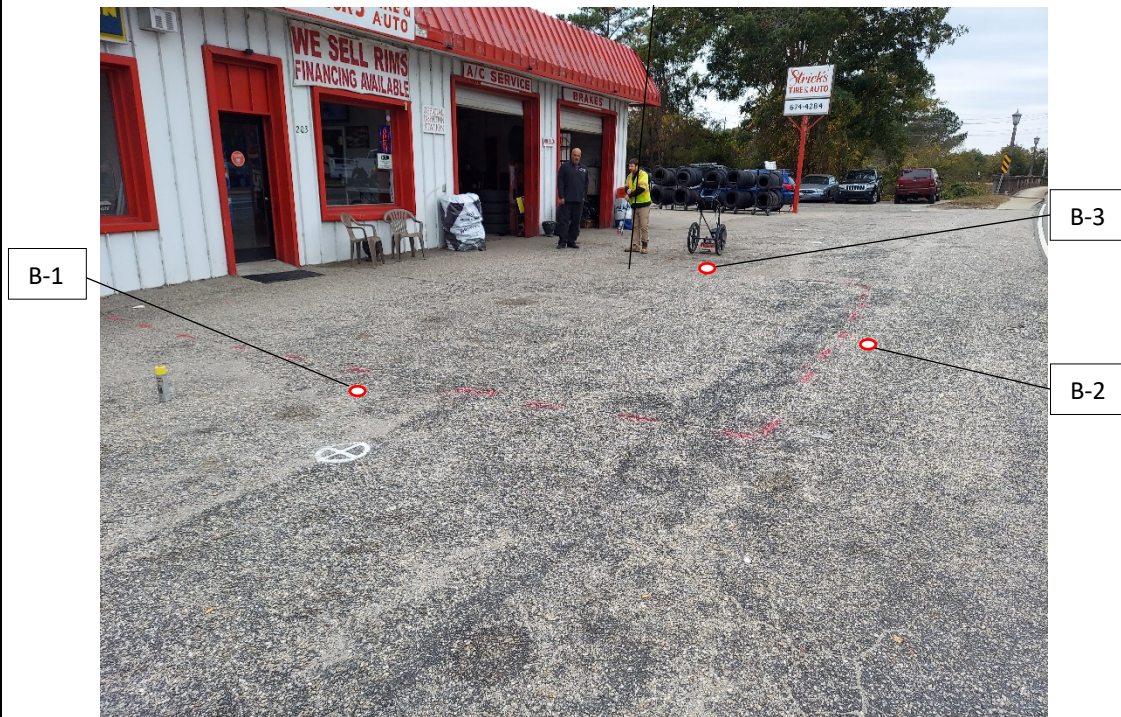
Photo No. 2

View of Borings B-1 through B-3 surrounding the concrete slab, facing west

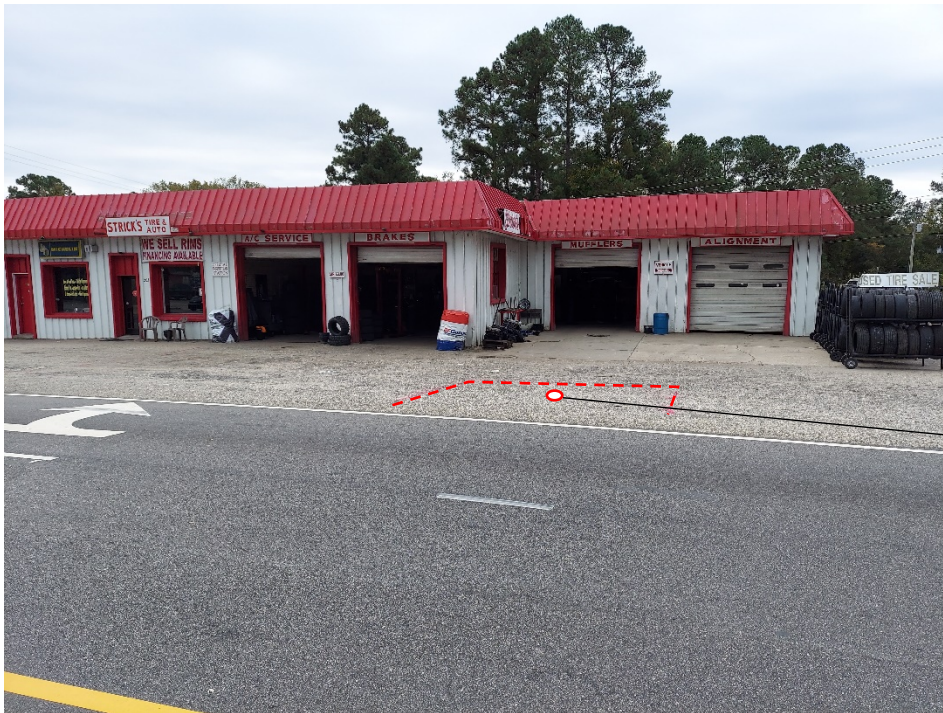
Photo No. 4

View of Boring B-4 advanced within the GPR anomaly on the western portion of the site, facing west

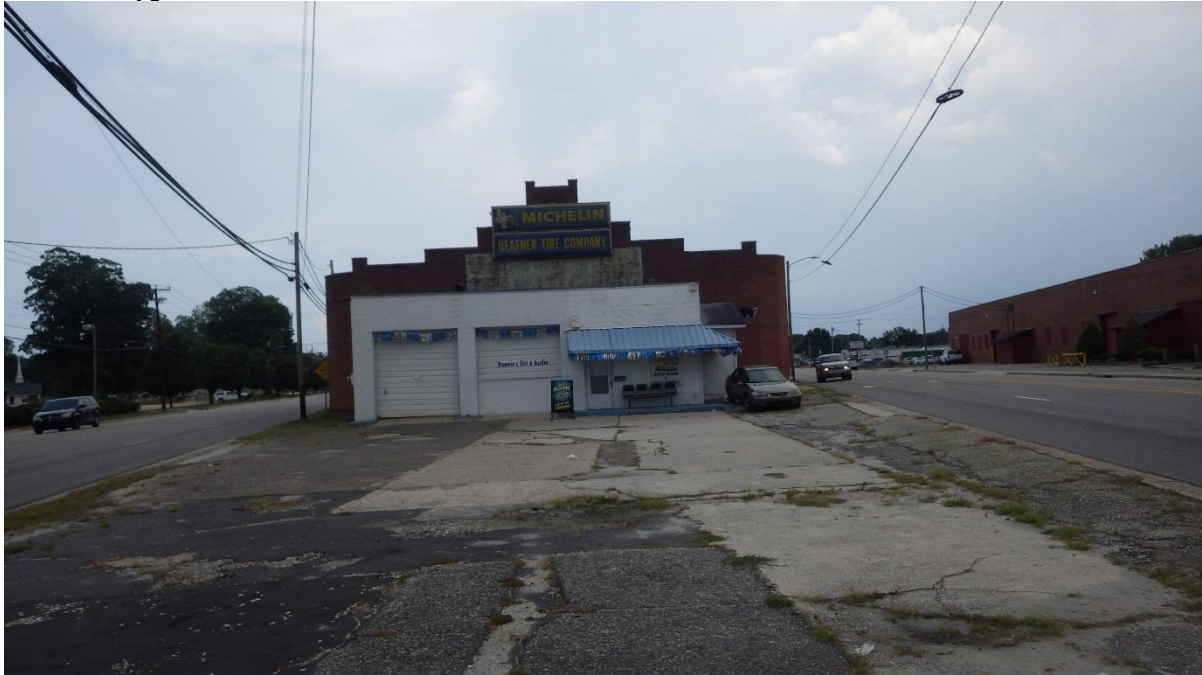
Anticipated Impacts: Low

This facility currently operates as an auto detail and body shop. It is located in the fork of W 2nd St & W 5th St. The current business (See Site # 3 red brick building) occupies both building on 2 separate parcels. The white brick building is the old gas station where the auto detailing is conducted. There is an outline of an old pump island on the western end of the property and 2 possible UST fill ports. The facility was not identified in the UST registry and there are no known incidents associated with it.

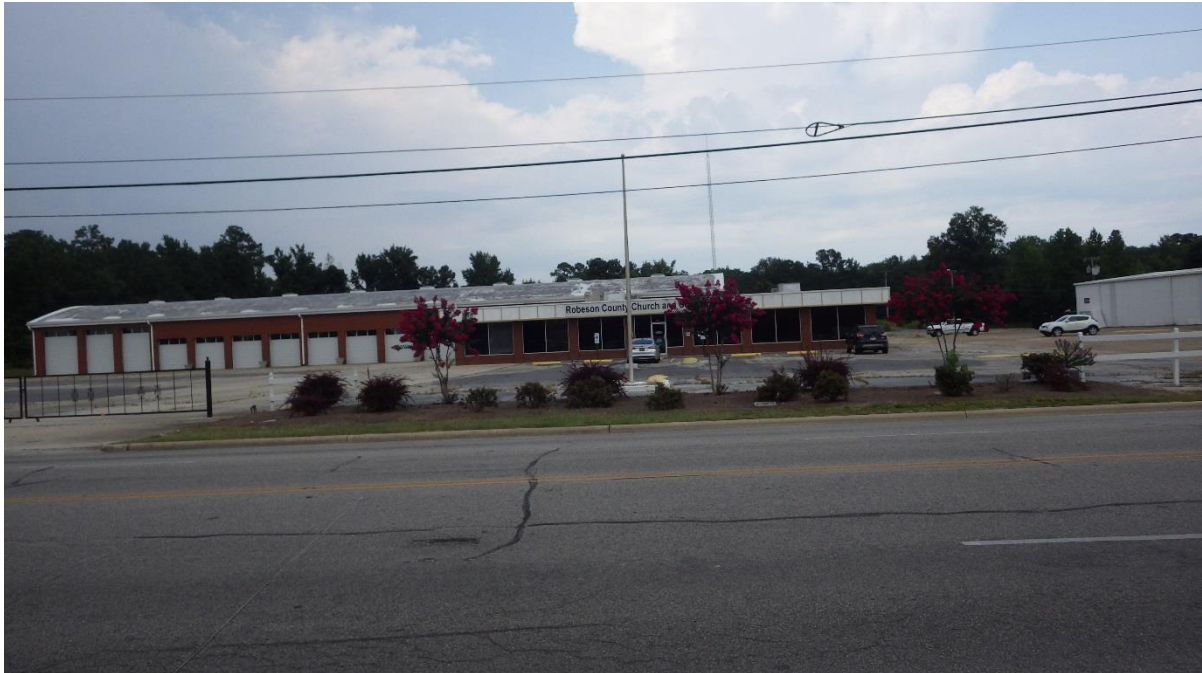
Anticipated Impacts: Low

This facility currently operates as a church and community center. It is located on the north side of W 5th St at the intersection with W 2nd St. It is the former location of Lumberton Ford Lincoln Mercury. According to the UST section registry one 500 gallon UST was removed in 1988. There are no known incidents associated with this site.

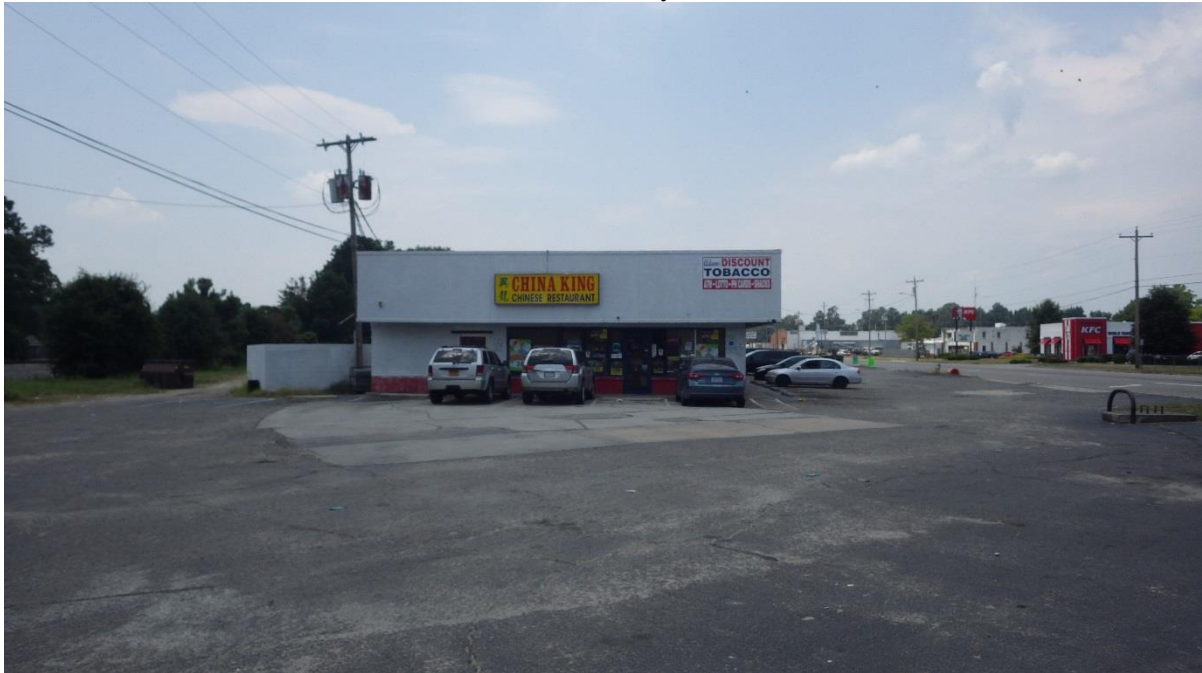
Anticipated Impacts: Low

This facility currently operates as a Chinese Restaurant. It is the former location of Short Stop 65. It is located in the southwest quadrant of NC 41 and W 2nd St. According to the UST registry two USTs were removed from the Address 502 W 2nd St in 1999. Incident 21930 is associated with the site and is still active. The former pump island outline was visible during the site investigation and several monitor wells were observed.

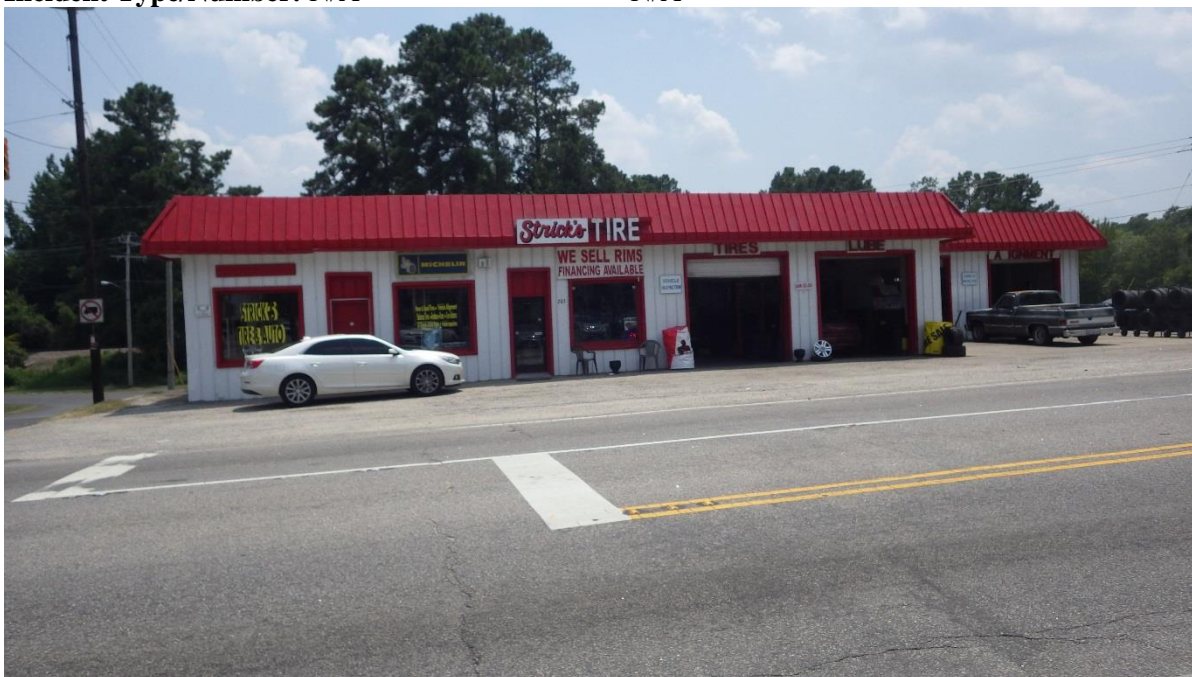
This facility currently operates as an auto repair shop. It is located in the southwest quadrant of W 2nd St and Water St. The facility is not listed in the UST section registry and there are no known incidents associated with it. No evidence of USTs or monitoring wells were observed during the site investigation. One used oil AST was observed in the back of the building.

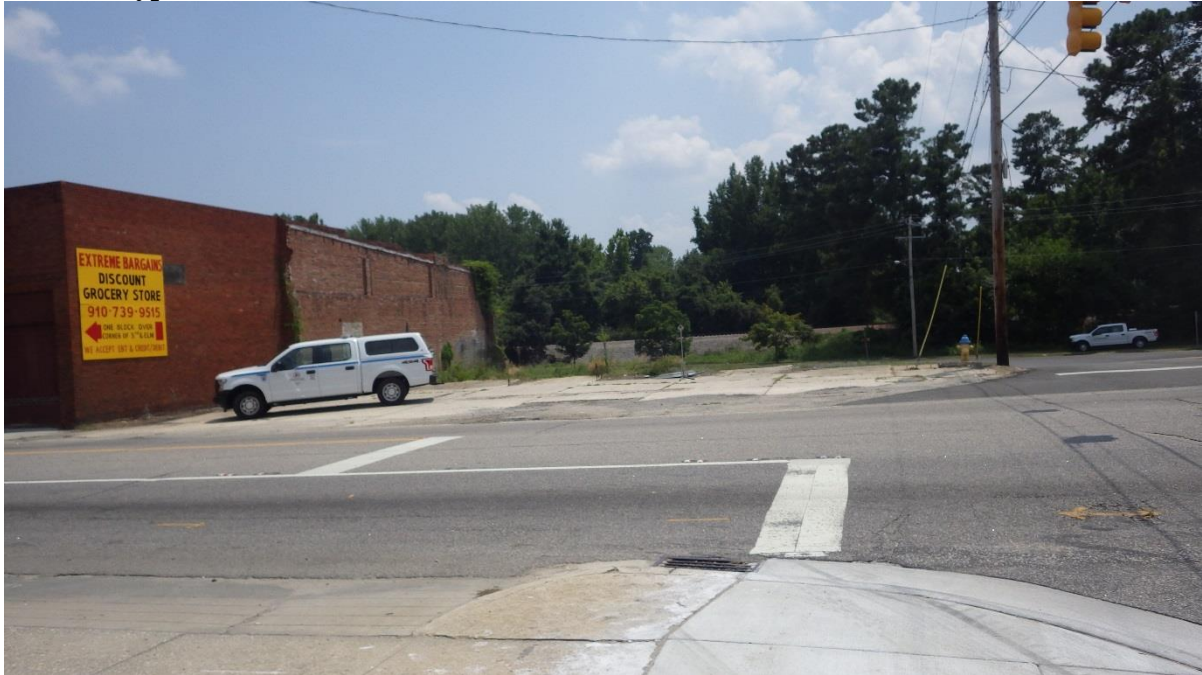
This site is currently a vacant lot with a concrete foundation. It is located on the southeast quadrant of W 2nd St and Water St. A possible pump island outline was observed during the site investigation. There is no other evidence of USTs and no monitoring wells were observed. The facility is not listed in the UST registry and there are no known incidents associated with it.

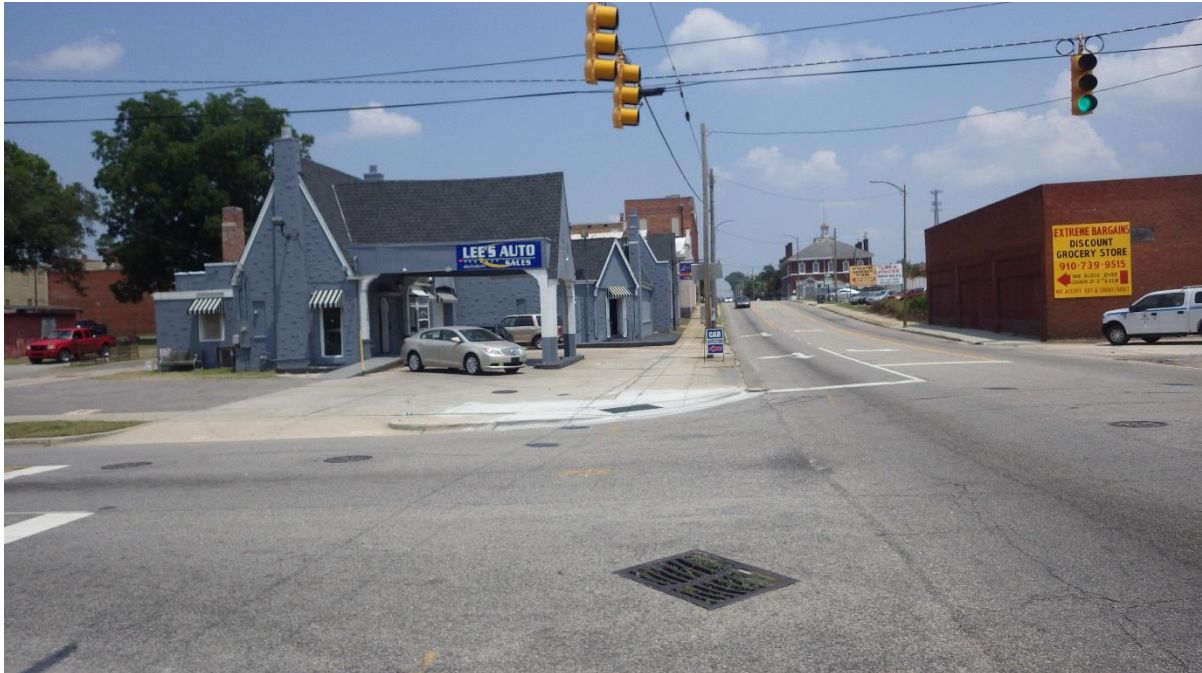
This former gas station currently operates as a used car dealer & auto repair shop. It is located in the northeast quadrant of W 2nd St and Water St. The facility is not listed in the UST section registry. Incident 42003 is associated with this facility and is still active. The incident database indicates that four regulated USTs were abandoned in place in 1988. Notice of regulatory requirements (NORR) sent 8/16. A possible fill port was observed near the Southwest corner of the building. Several monitoring wells were observed and appeared to be active.

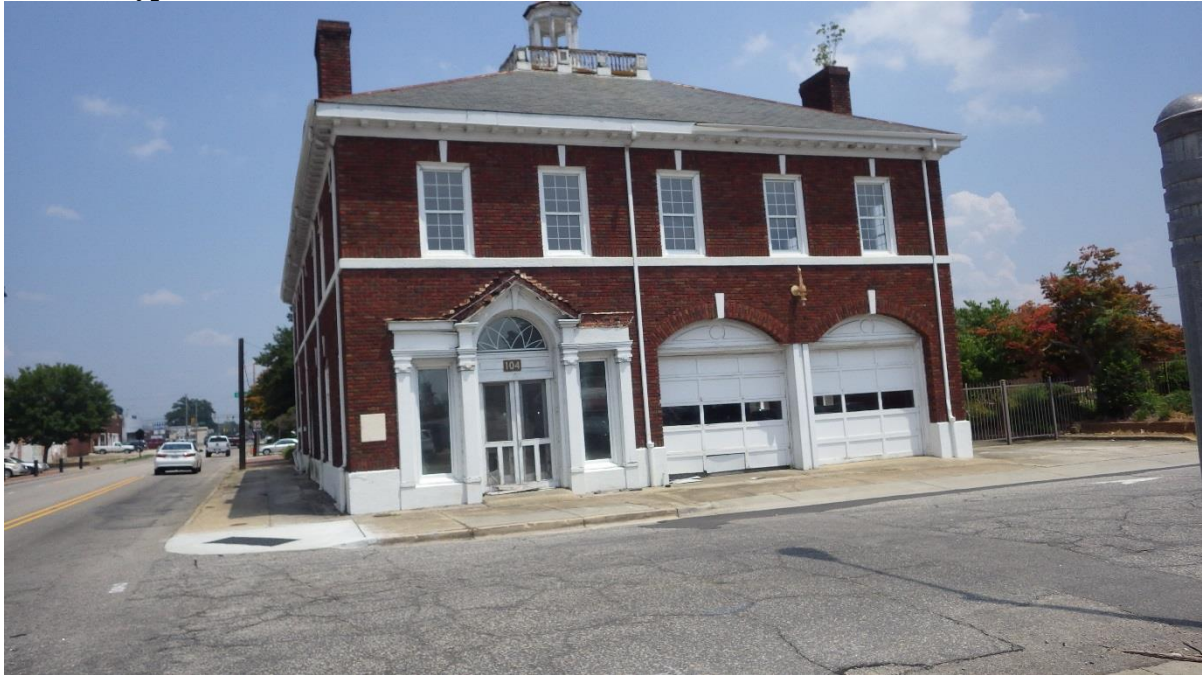
Anticipated Impacts: Low

This facility is the old Lumberton Fire Station. It is located southwest quadrant of 2nd St and Elm St. The facility is not listed in the UST registry and there are no known incidents associated with it. Two unknown valves or possible fill ports were observed in the side walk near the intersection. No other evidence of USTs and no monitoring wells were observed.

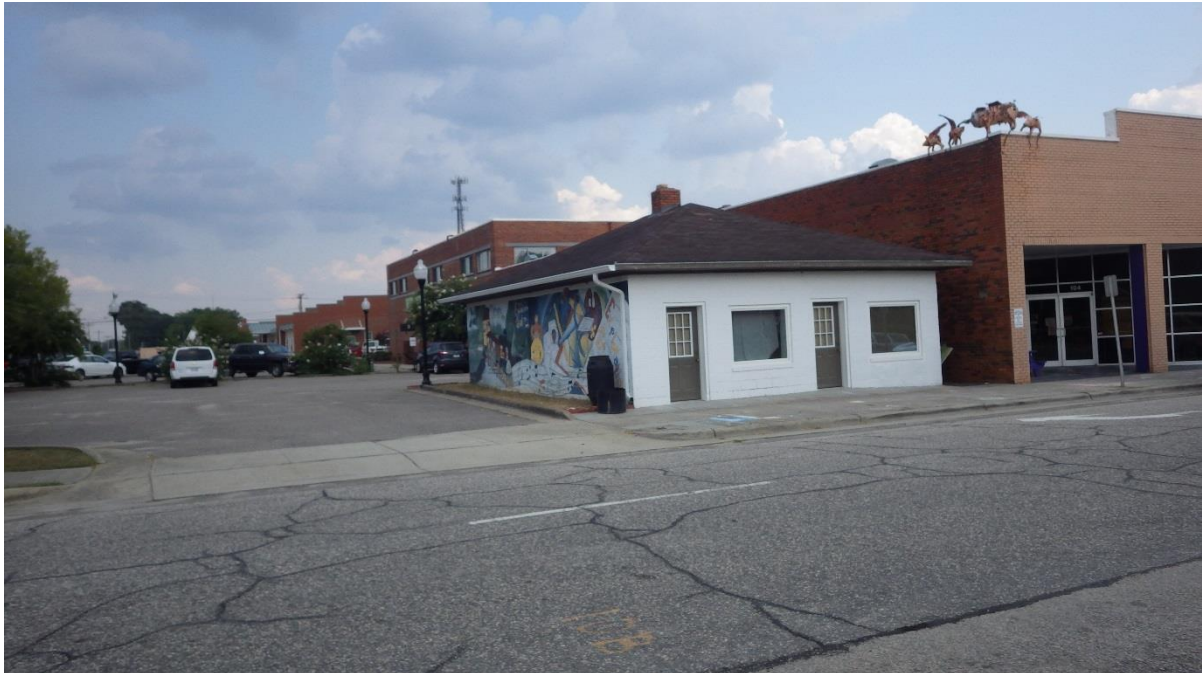
Anticipated Impacts: Low

This parking lot is the former location of Lloyd's Texaco. According to the UST section registry three USTs were removed in 1990, one UST removed in 1998 and three USTs removed in 2004. There are two incidents associated with this facility. Incident 6455 was closed out in 1998, Incident 29131 closed out in 2004 with notice of Residual Petroleum. UST closure not properly followed by City. Over excavation limited due to natural gas line and sidewalk along 2nd St. No monitoring wells were observed during site investigation.

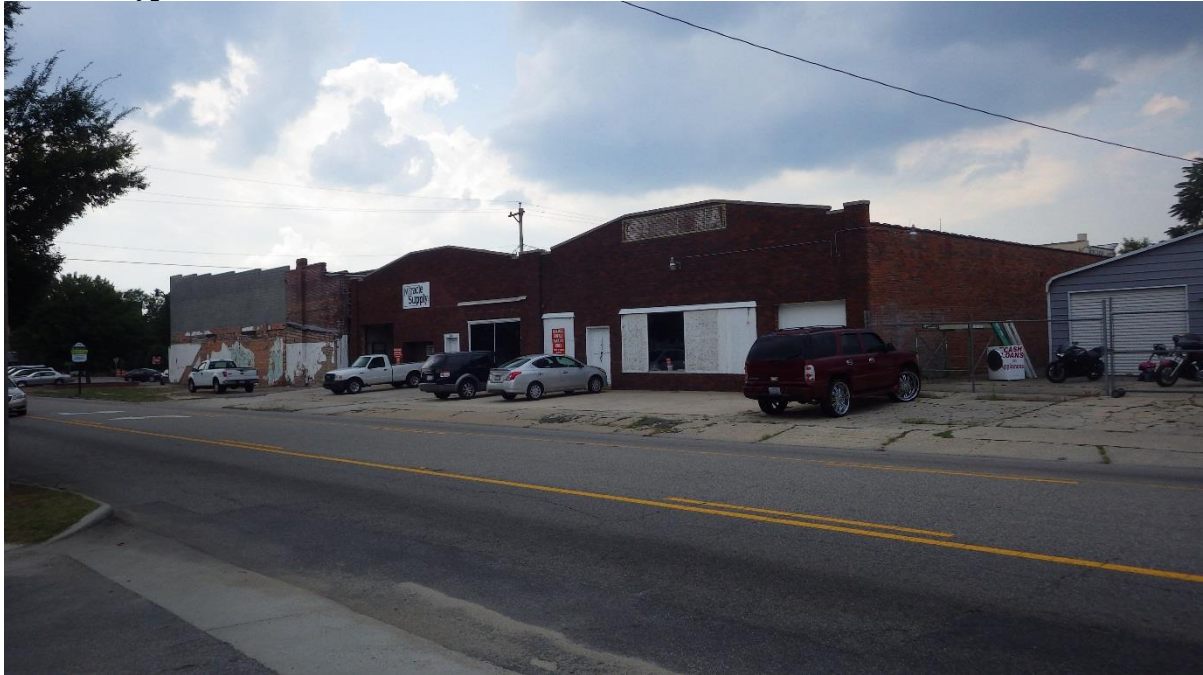
Anticipated Impacts: Low

This facility currently operates as a Janitorial wholesale Supply Co. It is located on the north side of E 2nd St approximately 180 feet east of Chestnut St. The facility is not listed in the UST section registry and there are no known incidents associated with it. During the site investigation a possible old pump island outline was observed in front of the building. There is no other evidence of USTs and no monitoring were observed.

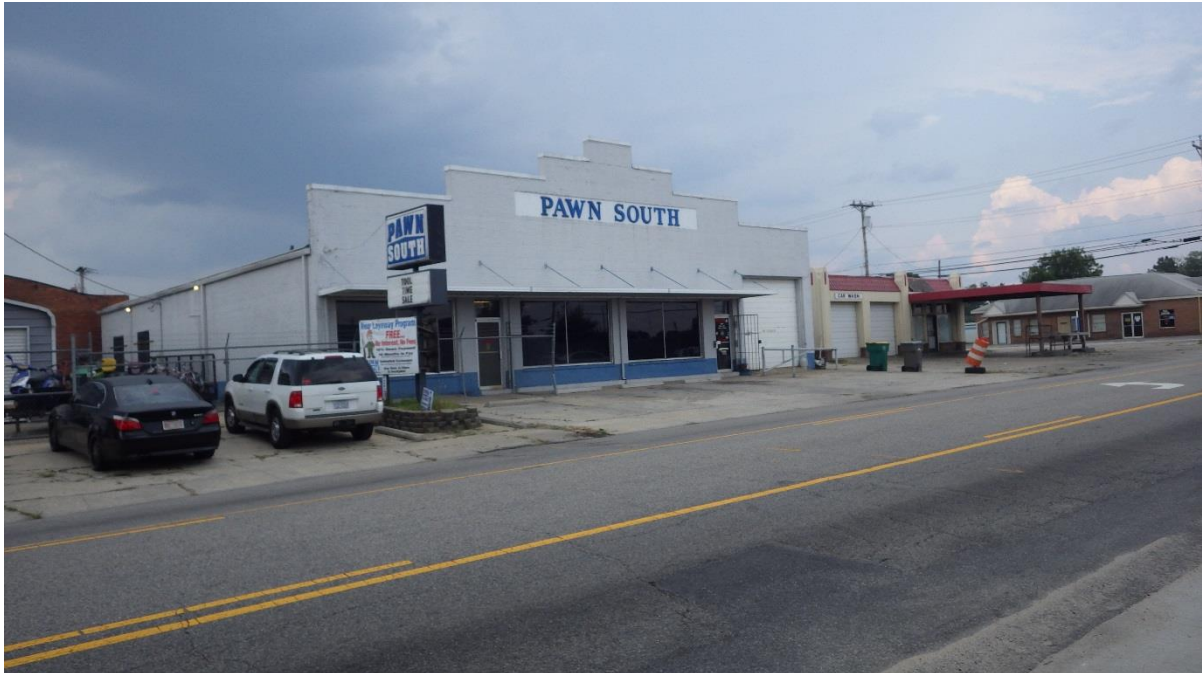
Anticipated Impacts: Low

This facility currently operates as a pawn Shop. It is the former location of Mac's of Lumberton Auto Parts. It is located on the north side of E 2nd St approximately 150 feet west of Walnut St. According to the UST section registry three USTs were removed. The closure date in the registry is incorrect. A possible old pump island outline was observed during the site investigation. No other evidence of USTs and no monitoring wells were observed.

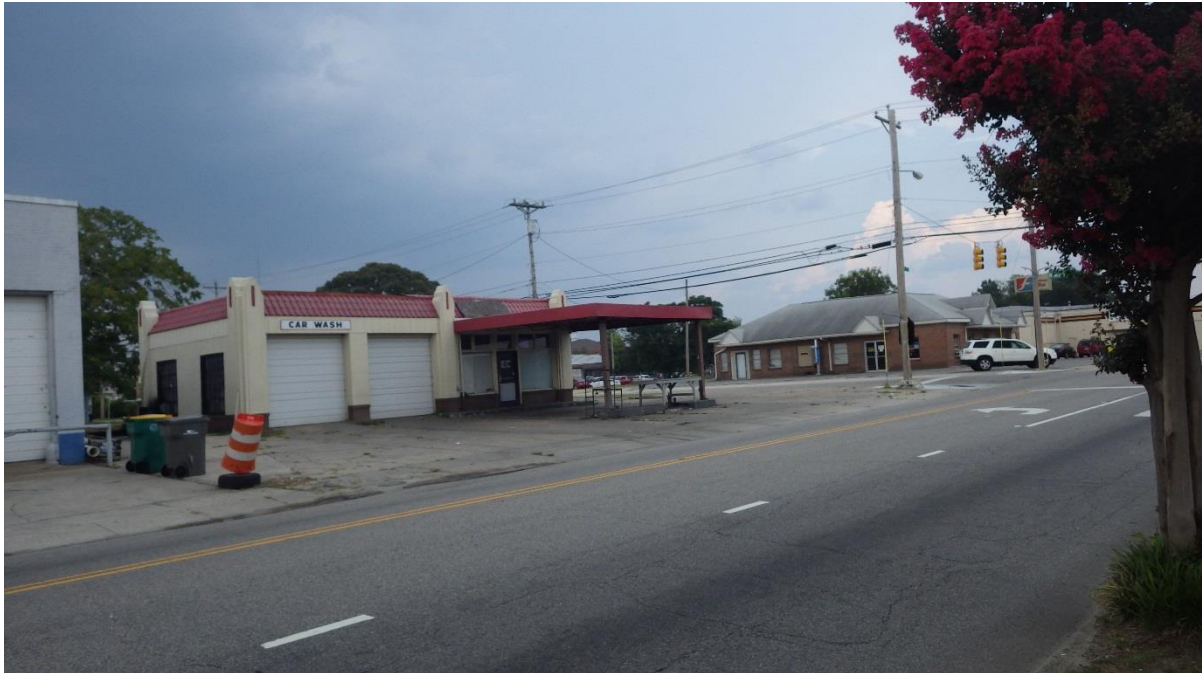
Anticipated Impacts: Low

This facility currently operates as an auto detail shop. It is the former location of Davis Exxon. It is located in the northwest quadrant of E 2nd St and Walnut St. According to the UST section registry five USTs were removed in 1998. Incident 29008 is associated with this facility and is still active. NORR Sent to property owner 2002. The former pump island is still in place with the pumps removed. No Evidence of USTs and no monitoring wells were observed.

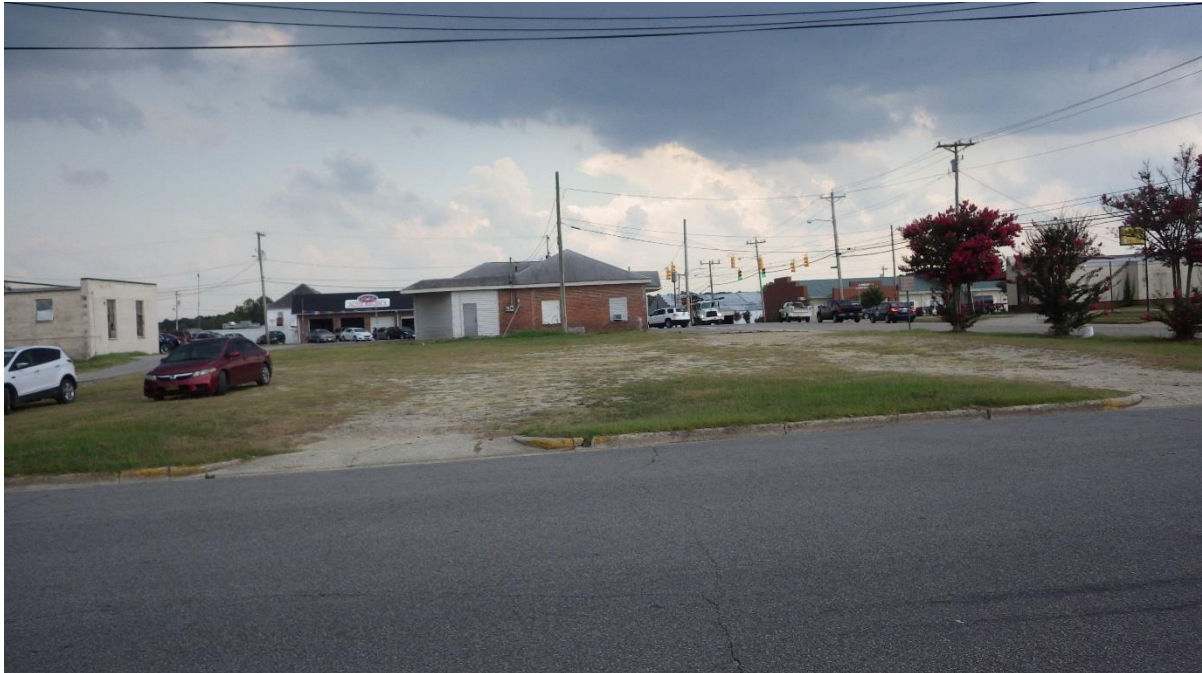
Anticipated Impacts: Low

This site is a vacant lot. It is located in the southeast quadrant of N Walnut St and E 3rd St. According to the UST section register one UST was removed in 1974. Two Possible UST fill ports were observed on the southern end of the property approximately 118 feet east of N Walnut St and 120 feet south of E 3rd St. No monitoring wells were observed. There are no known incidents associated with this site.
