**PROJECT SPECIAL PROVISIONS
GEOENVIRONMENTAL**

CONTAMINATED SOIL (12/13/2022)

October 25, 2022

Terracon Project No. 70207241

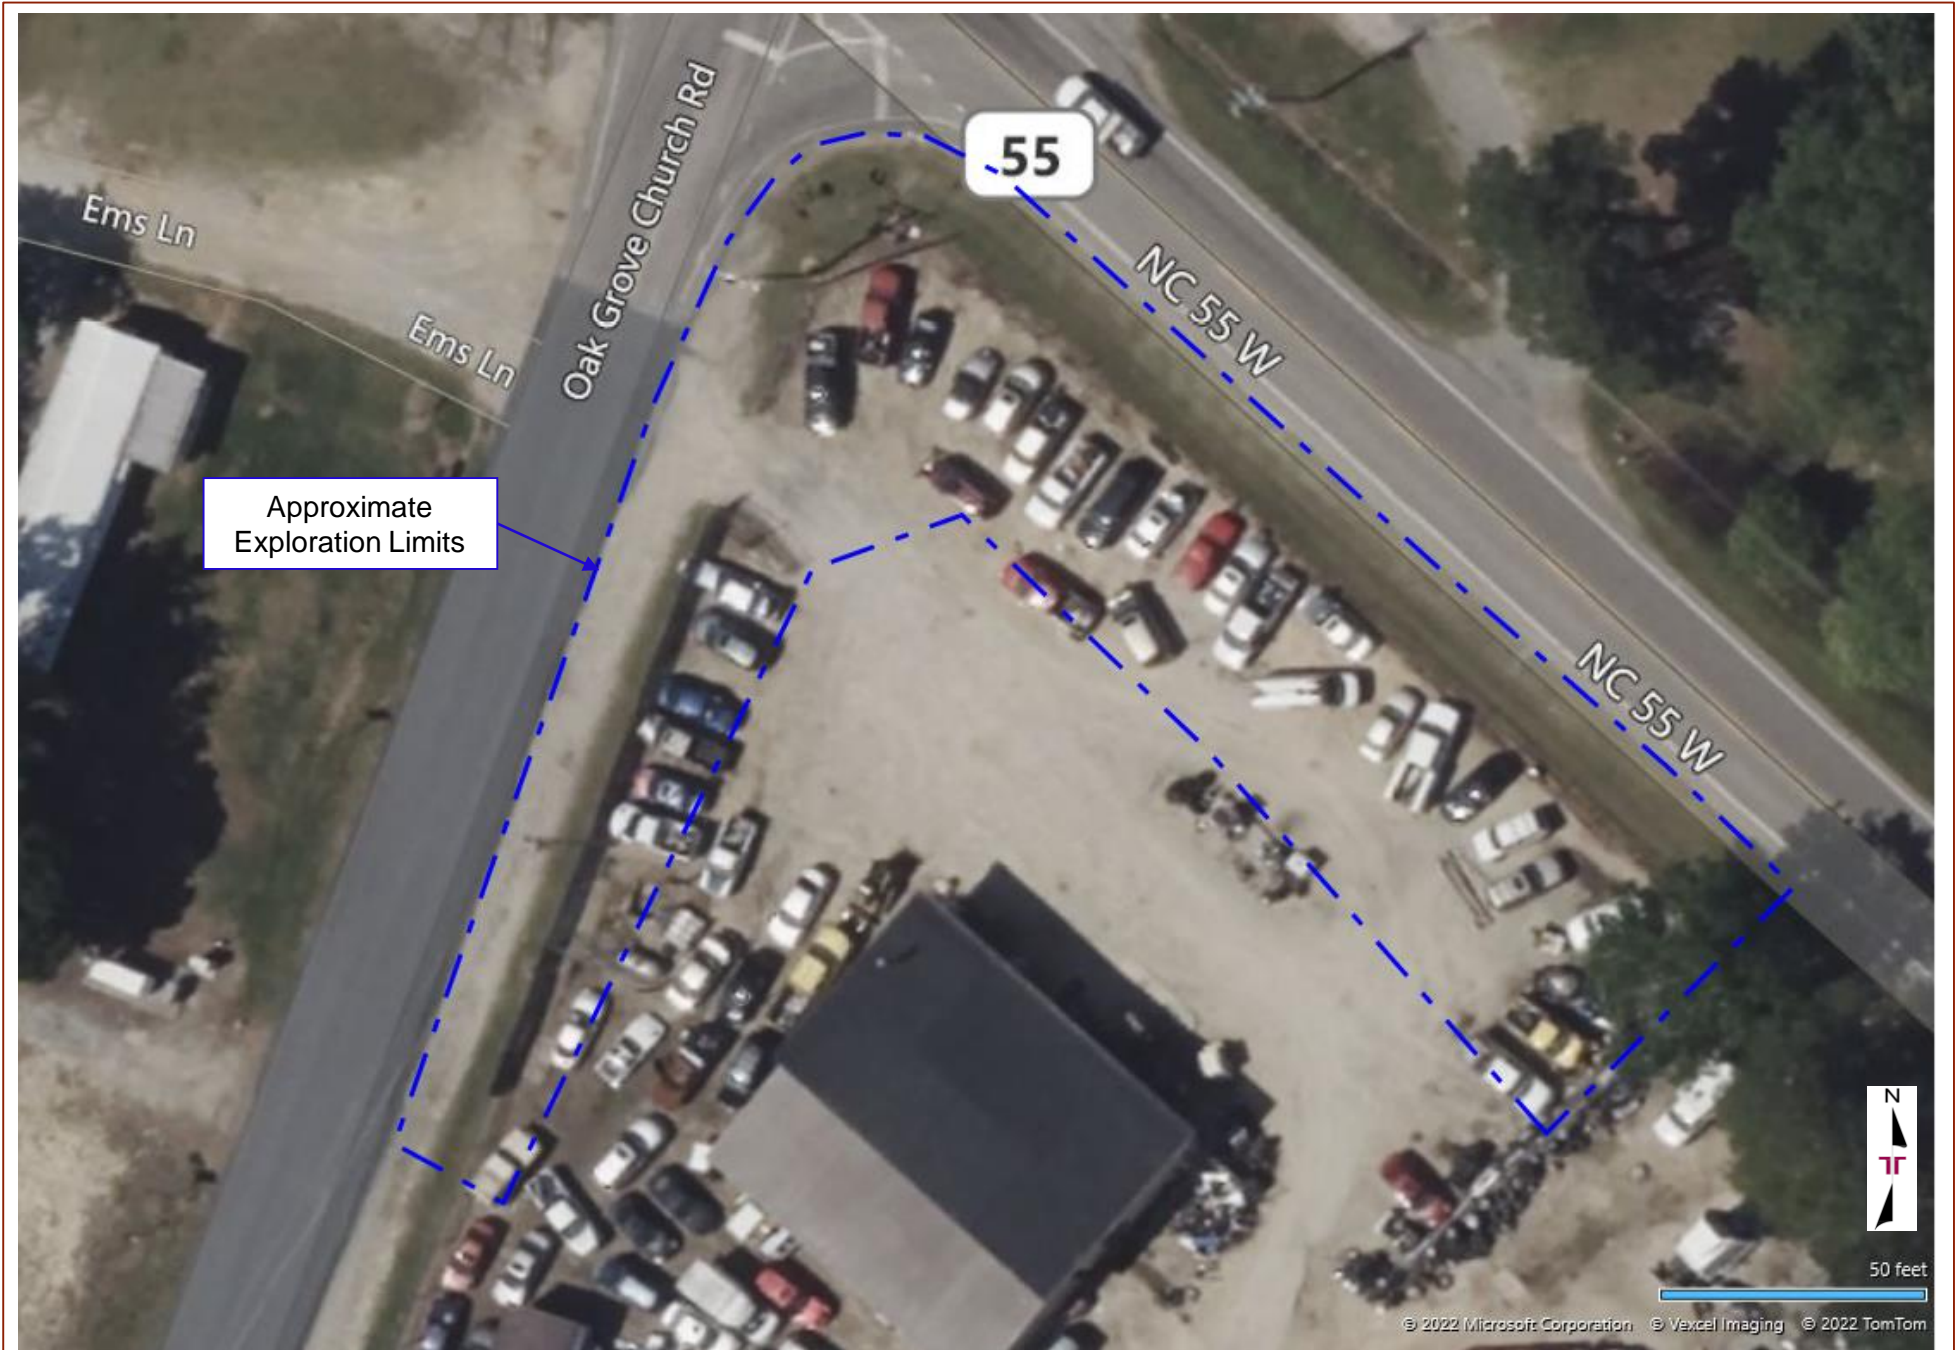
Figure No.: 2

Exploration Plan

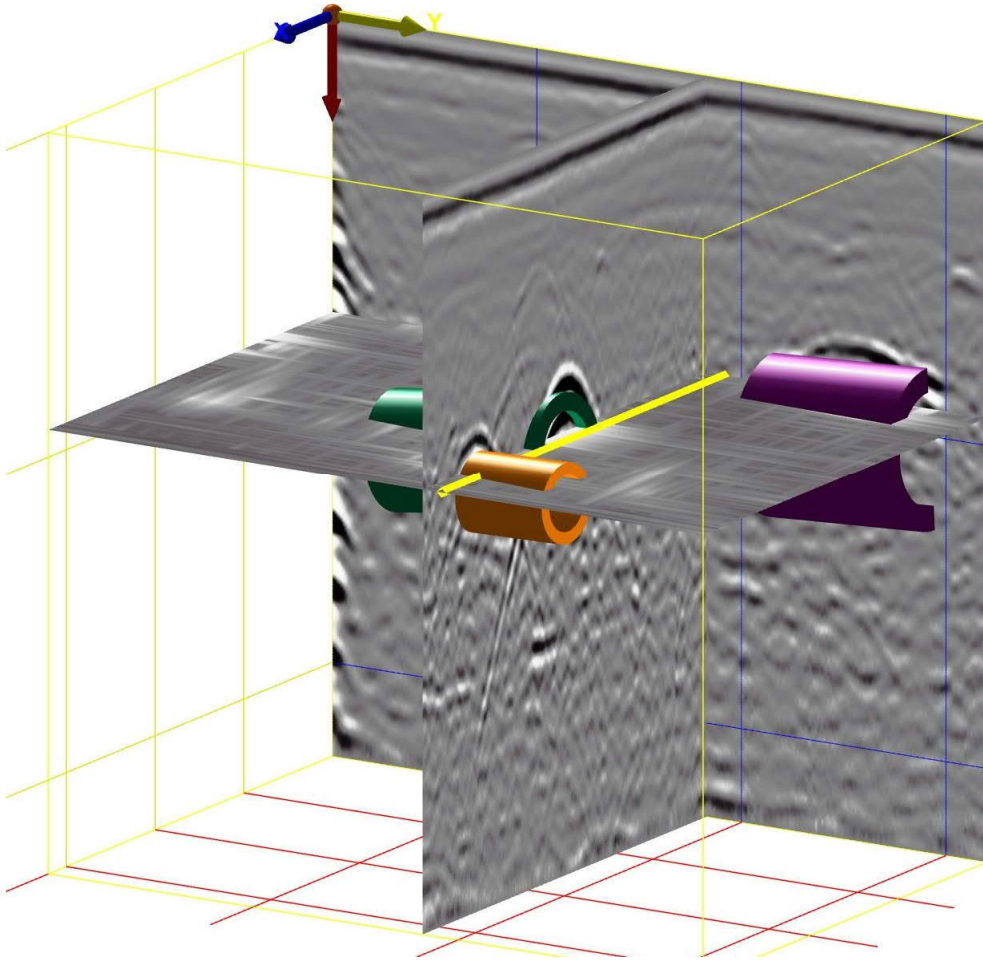
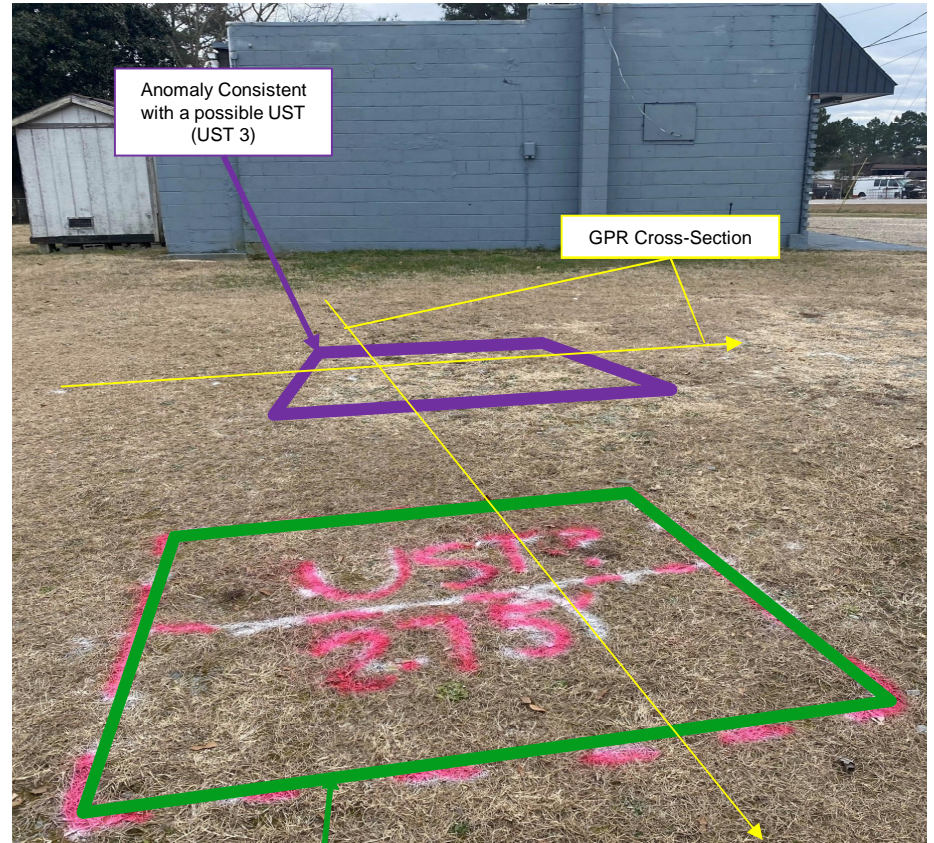
GPR Results

The depth of GPR signal penetration across the site was approximately 5 feet below the existing grade. While EM did not identify anomalies consistent with USTs, GPR identified these three anomalies that appeared to have a “beginning” and “end”, consistent with a UST or similar object. Complete results of our findings can be found in the attached Exhibits.

Anomaly Consistent with a possible UST (UST 3)

GPR Cross-Section

- Concentrations of BTEX, TPH-GRO, 16 EPA PAHs, and BaP were not detected above laboratory reporting limits in the soil borings at the site.
- Terracon recommends further explorations and/or test pit excavations in the vicinity of the possible USTs because they reside in the Proposed ROW at this site. Upon confirmation of the presence of the USTs, they should be excavated and removed in accordance with NCDEQ (2021) *Guidelines for Site Checks, Tank Closure, and Initial Response and Abatement* dated January 19, 2021. Impacted groundwater or soil identified during the UST removal activities should be managed and/or disposed of in accordance with applicable local and State requirements.

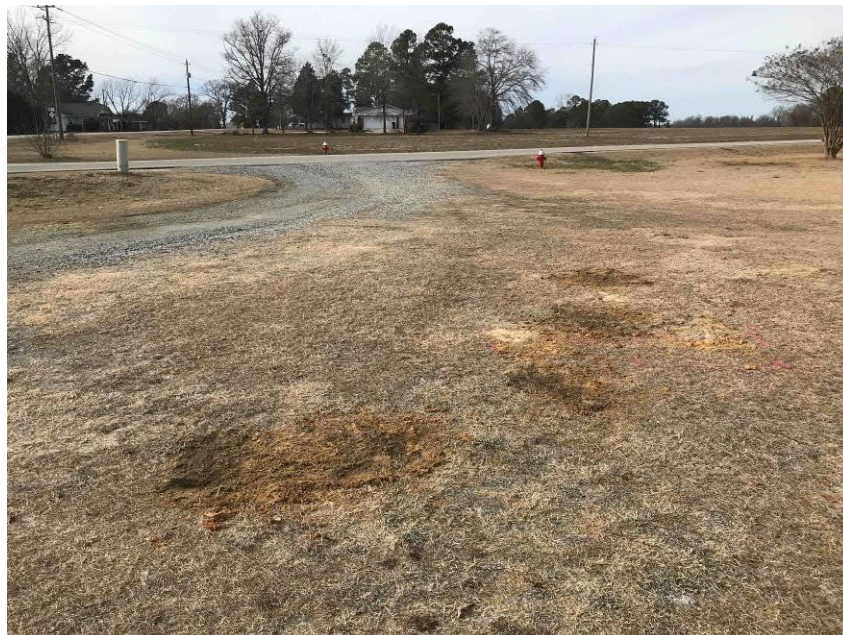
The geophysical investigation identified three possible USTs located north of the on-site building and within the proposed ROW area. The possible USTs measured approximately 5 feet long and were located approximately 2.5 feet below land surface (bls). This area of the site was covered by grass and surface features such as vent pipes or fill ports were not observed in association with the possible USTs. Fuel lines on the site were not identified in the geophysical investigation.

approximately 5 feet long and were located approximately 2.5 feet bls. Surface features such as vent pipes or fill ports were not observed in association with the possible USTs. Terracon was unable to confirm the existence of the USTs by advancing numerous borings via hand auger in the identified locations to approximate depths of 4 to 5 feet bls. After reviewing the soil sampling analytical results, it does not appear that petroleum releases have occurred from the possible USTs.

Photo #4 View of the locations of the possible underground store tanks identified in the geophysical investigation and the locations of the hand auger boring attempts to verify existence; facing northwest.

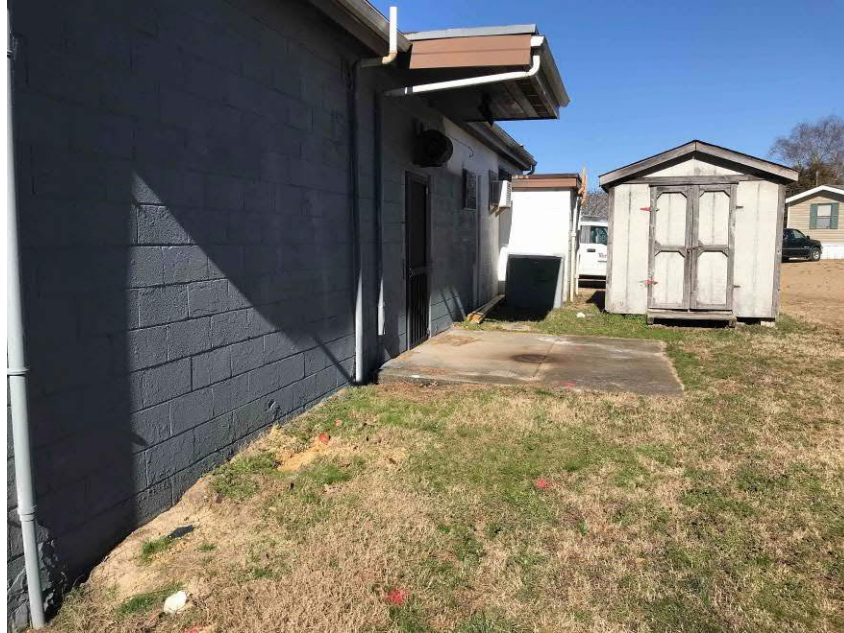
Photo #5 View of the eastern side of the on-site building and the underground sanitary sewer line located using a radiodetection pipe locator and marked with pink dots; facing north.

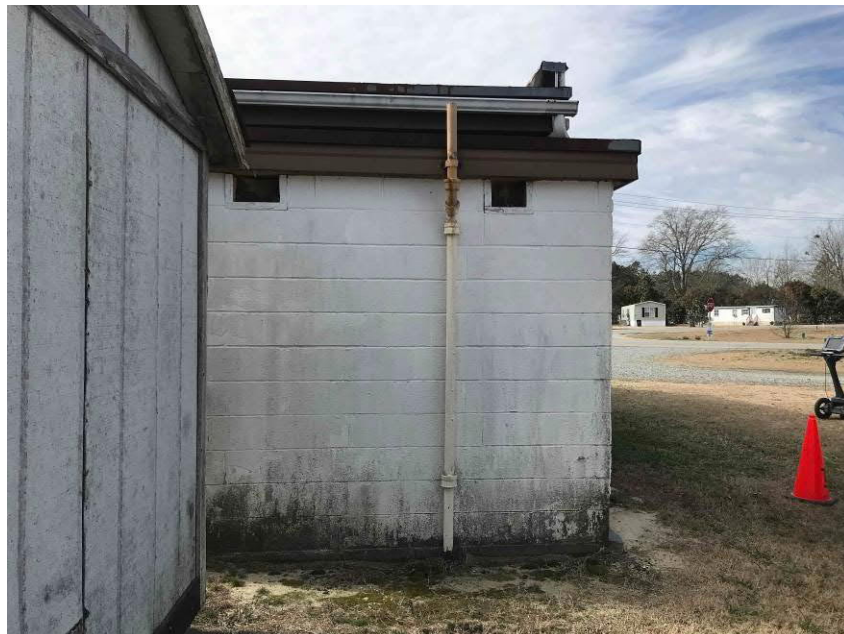
Photo #6 View of a vent pipe attached to eastern wall of the on-site building; facing west.

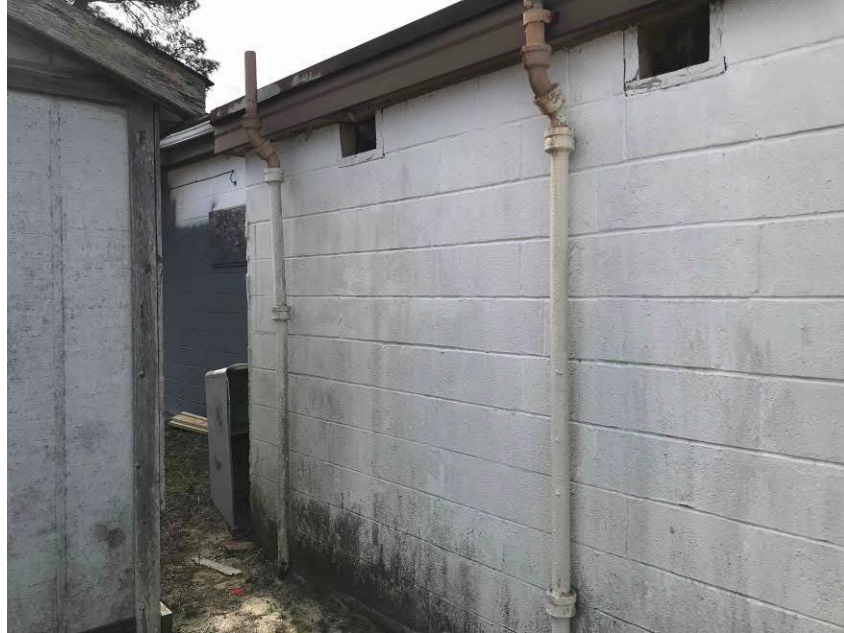
Photo #7 View of two vent pipes attached to eastern wall of the on-site building; facing south.

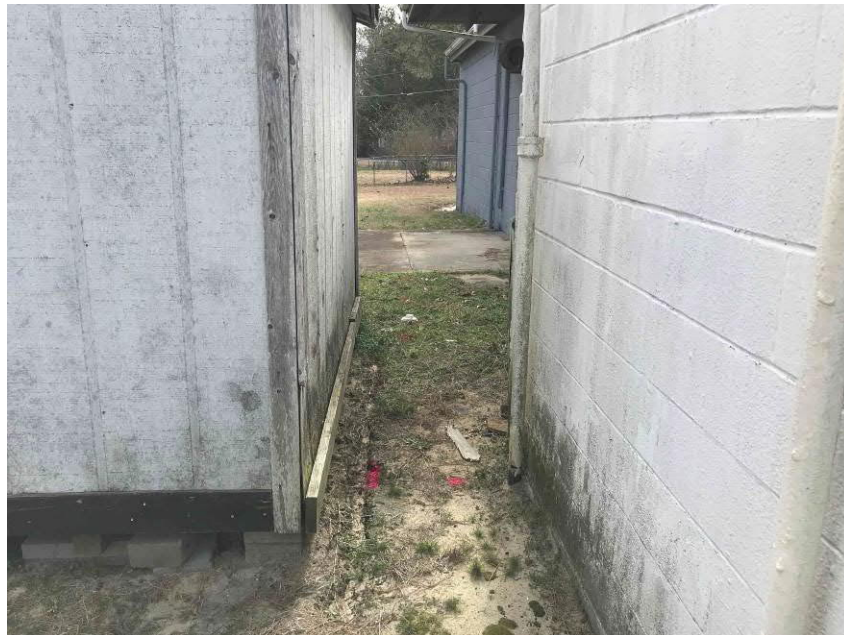
Photo #8 View of the apparent direction of vent pipes located using a radiodetection pipe locator; facing south.

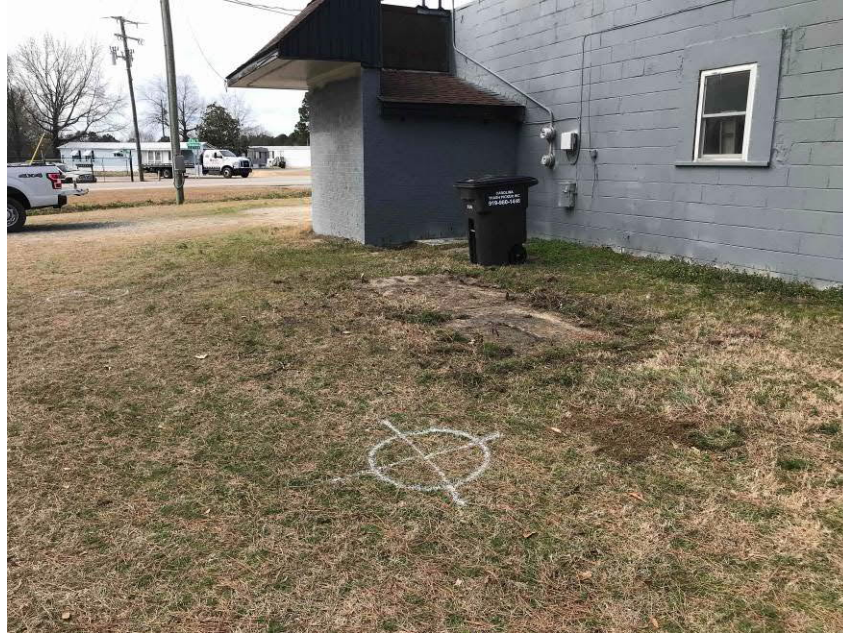
Terracon also identified evidence of a multi-compartment grease trap within the proposed ROW area and located south of the on-site building. Terracon was unable to identify evidence of the septic tank reported by the site owner, Ms. Myatt, to be located directly east and adjacent to the on-site building; however, several sanitary sewer vent pipes were observed attached to the eastern wall of the on-site building and connected by an underground sanitary sewer line that extended south and entered the on-site building on the southern side. The underground sanitary sewer line was located using a radiodetection pipe locator. Photographs of the site and relevant site features are in **Appendix B**.

Photo #9 View of the confirmed grease trap and the apparent sanitary sewer line exit location from the building (in between the window and electricity meter) located on the south side of the on-site building; facing west.
