Re: Phase II Preliminary Site Assessment Report
NC 55 from South of SR 1532 to North of NC 210
Parcel 29 - Carrie Bullard Property
4798 NC 55, Angier, Harnett County, North Carolina
TIP No. R-5705A
WBS Element: 46377.1.2

Phase II Preliminary Site Assessment Report

NC 55 from South of SR 1532 to North of NC 210
Parcel 29 - Carrie Bullard Property
4798 NC 55, Angier, Harnett County, North Carolina

TIP No. R-5705A

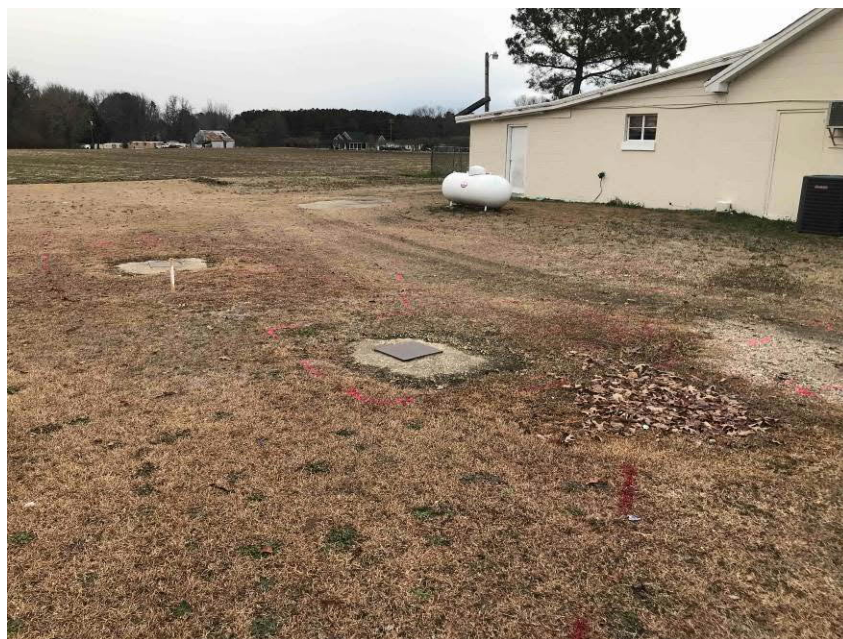
Photo #3 View of the two on-site probable USTs identified north of the on-site building in the geophysical investigation; facing northwest.

The geophysical investigation identified two probable metallic USTs located north of the on-site building and within the proposed ROW area. The probable USTs measured approximately 14 and 17 feet long and were located approximately 2.5 feet below land surface (bls). This area of the site was covered by grass and fill ports were observed in association with the probable USTs, although other surface features such as vent pipes were not observed. Terracon was unable to remove the fill port of the probable USTs to evaluate the presence of petroleum products within the USTs. Additionally, several possible fuel lines were identified in the geophysical investigation extending from the USTs to the southeast and southwest.

- Terracon does not recommend further assessment of the ROW at this site. However, based on the identified USTs and the detections of petroleum compounds, USTs and impacted soil and groundwater encountered during NCDOT's project should be managed and/or disposed in accordance with applicable local and State requirements. In addition, construction workers should be alert for potential soil and/or groundwater impacts at the site.

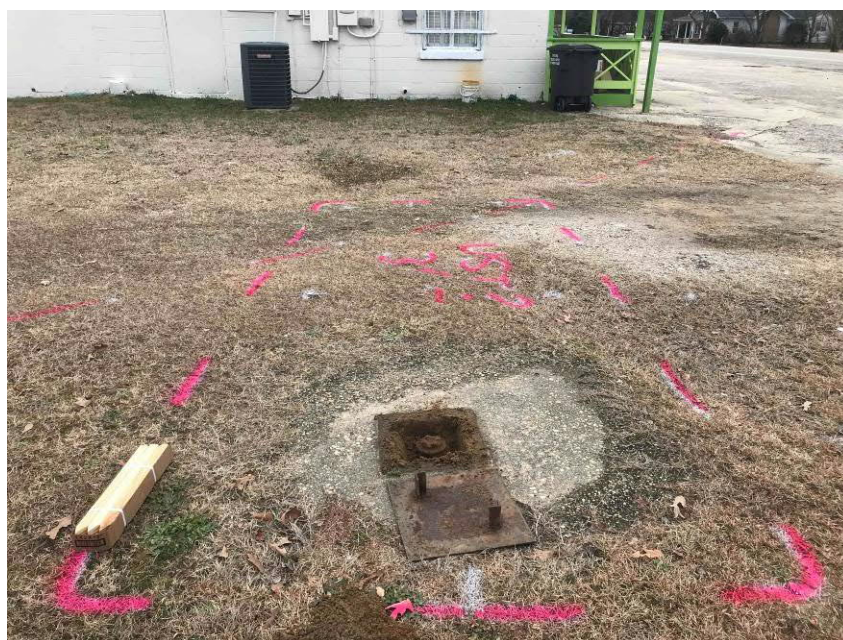
Photo #4 View of a typical exposed fill port for the on-site probable USTs; facing southeast.

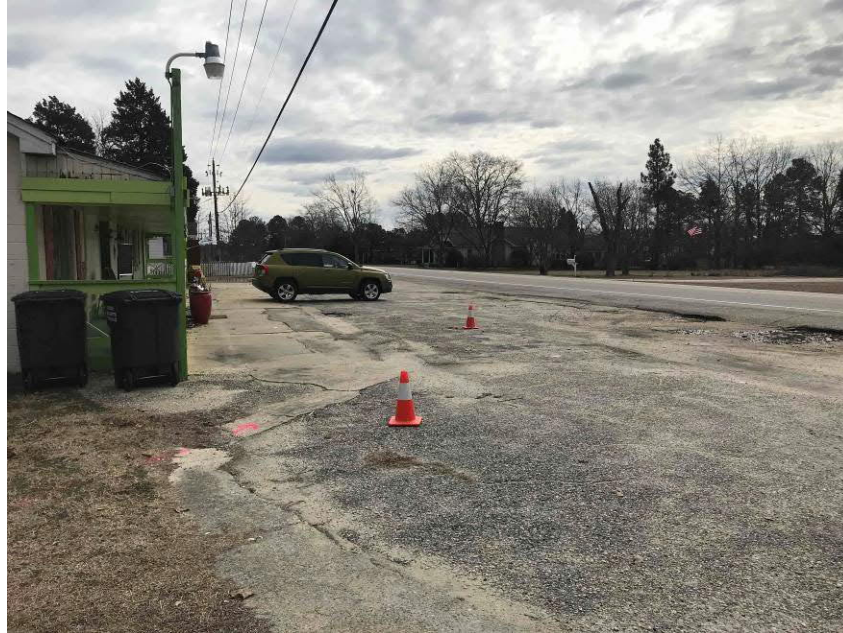
Photo #5 View of the possible fuel line extending from the probable USTs to western side of the on-site building; facing southeast.

While on-site for the soil sampling event, Terracon directed the driller to advance two borings, down-gradient of the probable USTs, in order to further assess the probable USTs, and three borings (one near each location) adjacent to the possible former fuel dispenser locations. Borings 29-SB-05 and 29-SB-06 were advanced on the eastern side of the probable USTs and borings 29-SB-03, 29-SB-04, and 29-SB-07 were advanced near the possible former fuel dispenser locations. Field screening of the soils and soil samples collected beside the probable USTs did not indicate a release has occurred. Field screening of the soils and soil samples collected beside the possible former fuel dispenser locations indicated a release had occurred near the former fuel dispenser evaluated by 29-SB-04; however, there was not an indication a release had occurred at the other two fuel dispenser locations. An additional boring, 29-SB-08, was advanced to evaluate the potential extent of contamination identified at 29-SB-04 along the possible fuel line to the USTs. Field screening of soil from 29-SB-08 did not indicate contamination extended along the possible fuel line to the USTs.

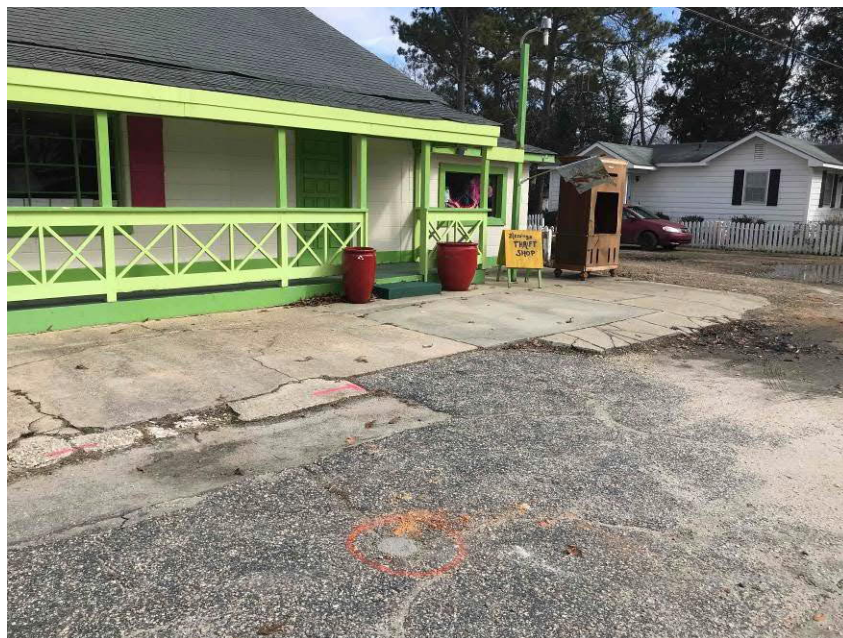
Photo #6 View of a typical possible former on-site fuel dispenser location west of the on-site building; facing east.

Terracon also identified three locations (two west of the on-site building and one north of the building) within the proposed ROW where former fuel dispensers were possibly located. The two locations west of the on-site building were identified by rectangular asphalt patches and the location north of the on-site building was identified by GPR. Photographs of the site and relevant site features are in **Appendix B**.

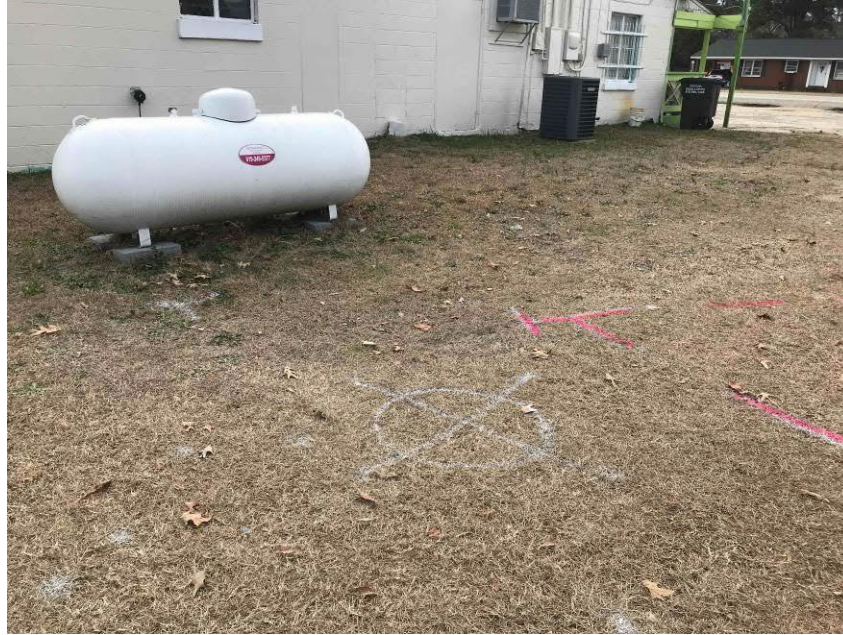
Photo #7 View of the possible former on-site fuel dispenser located north of the on-site building; facing east.
