Phase II Site Assessment Report
April 25, 2022
WBS Element: 45446.1.1
State Project: U-5312
Wilkes County

Parcel #: 021
Carolina West Wireless, Inc. Property
1858 US Hwy 421, Wilkesboro, NC, 28697
PIN #: 3848-90-5893
Facility ID No.: 00-0-0000005067
Groundwater Incident #: 30149

Seramur & Associates, PC
165 Knoll Drive
Boone, NC 28607

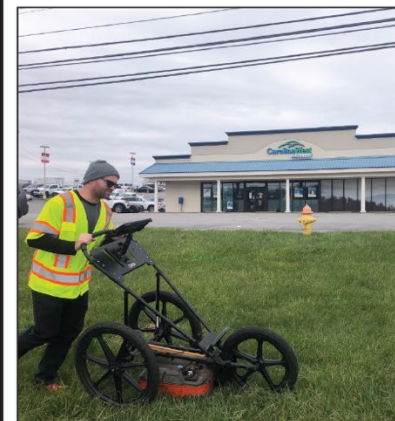
Photo 1. Collecting GPR data in Grid 1.

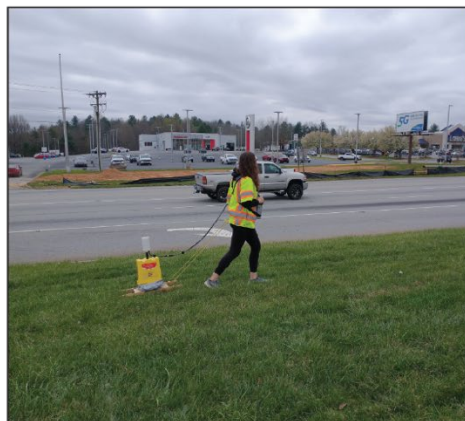
Photo 2. Collecting magnetometer data in Grid 1.

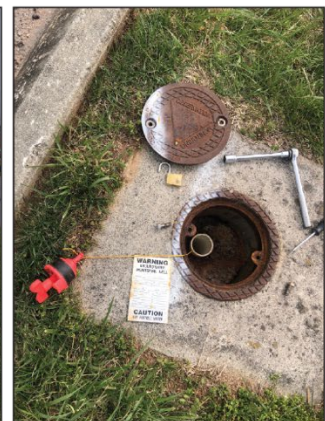
Photo 3. Monitoring Well located within the existing Right-of-Way.

Seramur & Associates does not recommend any further assessment work for Parcel #021. The monitoring well located within the existing R/W should be properly abandoned by a licensed well driller if this area is to be disturbed by the proposed road improvements.

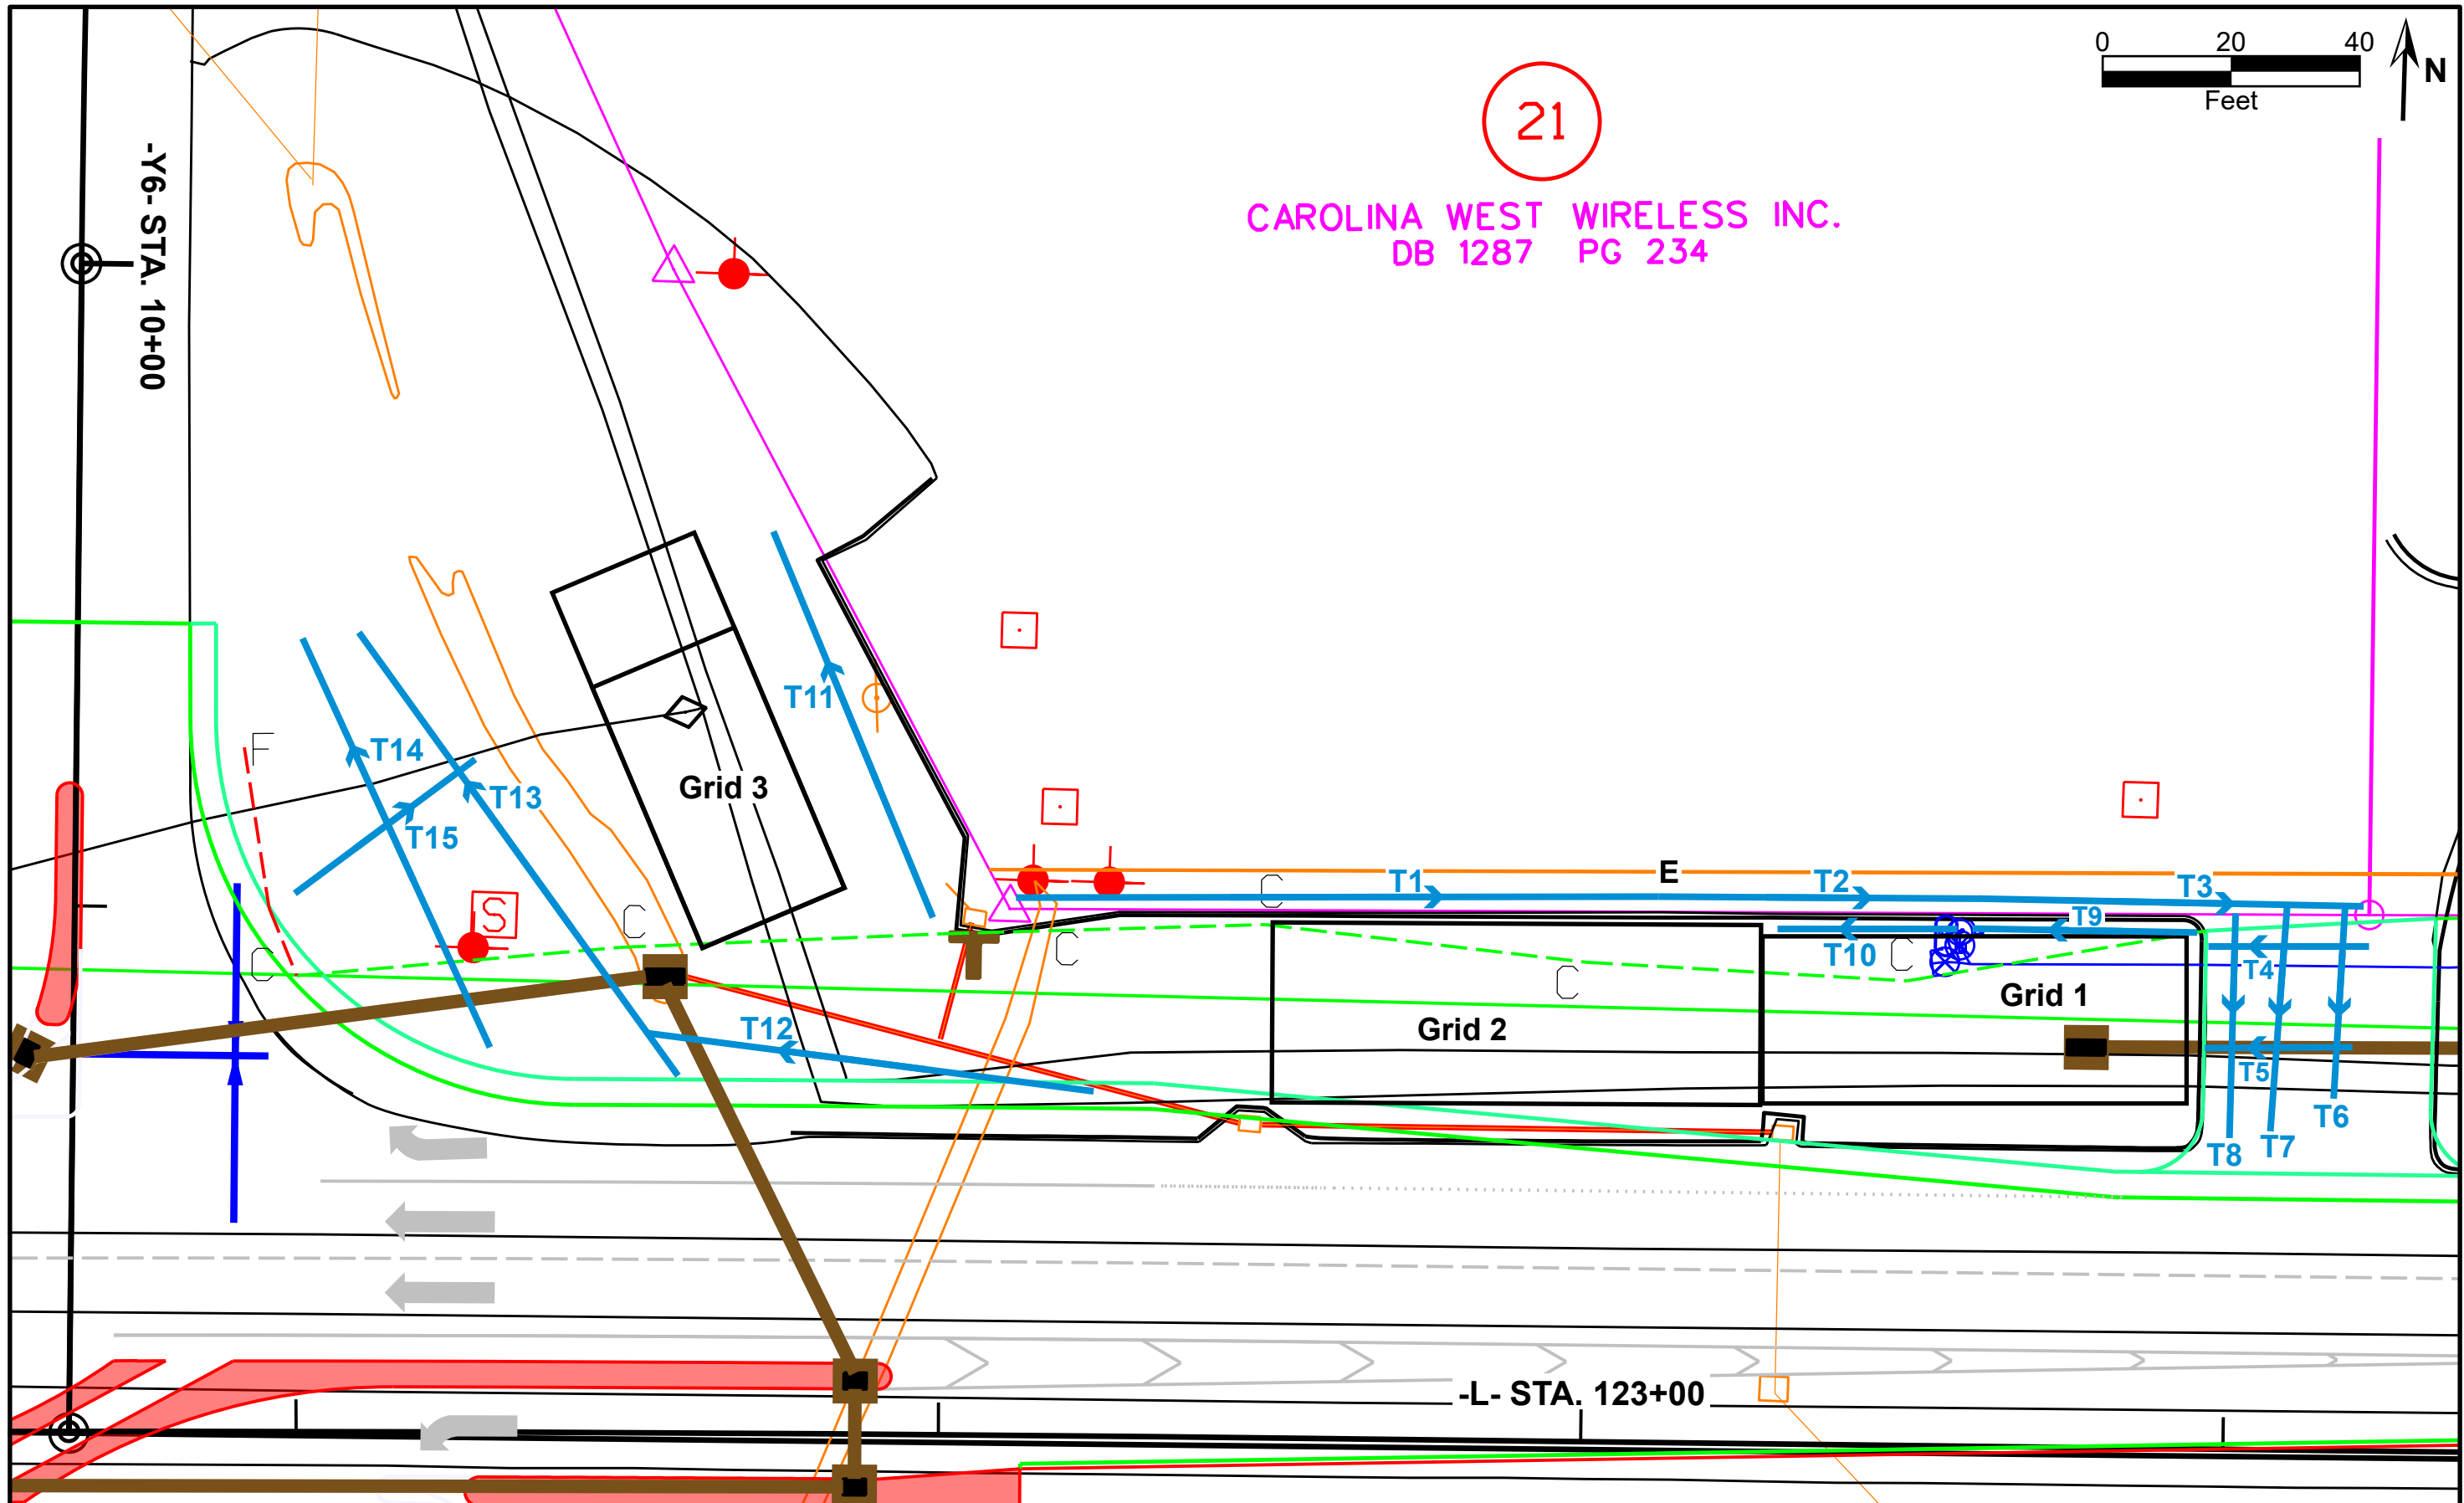
Seramur & Associates used the Pythagorean Theorem to establish three rectangular grids. Grids 1 and 2 covered the existing R/W along US Highway 421. Grid 3 was in the existing R/W on the

west side of the property along Dancy Road (Figure 3). Geophysical grid data was collected along transects at a two-foot spacing. The magnetometer transects were stopped short of the northern end of Grid 3 because of the potential interference in the data that would have been caused by a Sheepsfoot Roller and steel sewer lines waiting to be installed.

Fifteen additional transects of GPR data were collected in the areas that were unable to be covered with grid data (Figure 3). A Schonstedt GA-72Cd Magnetic Locator was also used to survey these transects for magnetic anomalies that could be related to a former UST System.

<p>Figure 3 Site Plan with Geophysical Grid and Transect Locations</p>	<p>State Project: U-5312 Wilkes County, NC</p>	<p>Carolina West Wireless, Inc. Property 1858 US Hwy 421 Wilkesboro, NC</p>	<p>Parcel #021 Facility I.D. #: 00-05067</p>	<p>Seramur & Associates, PC Boone, NC</p>
---	--	---	--	---

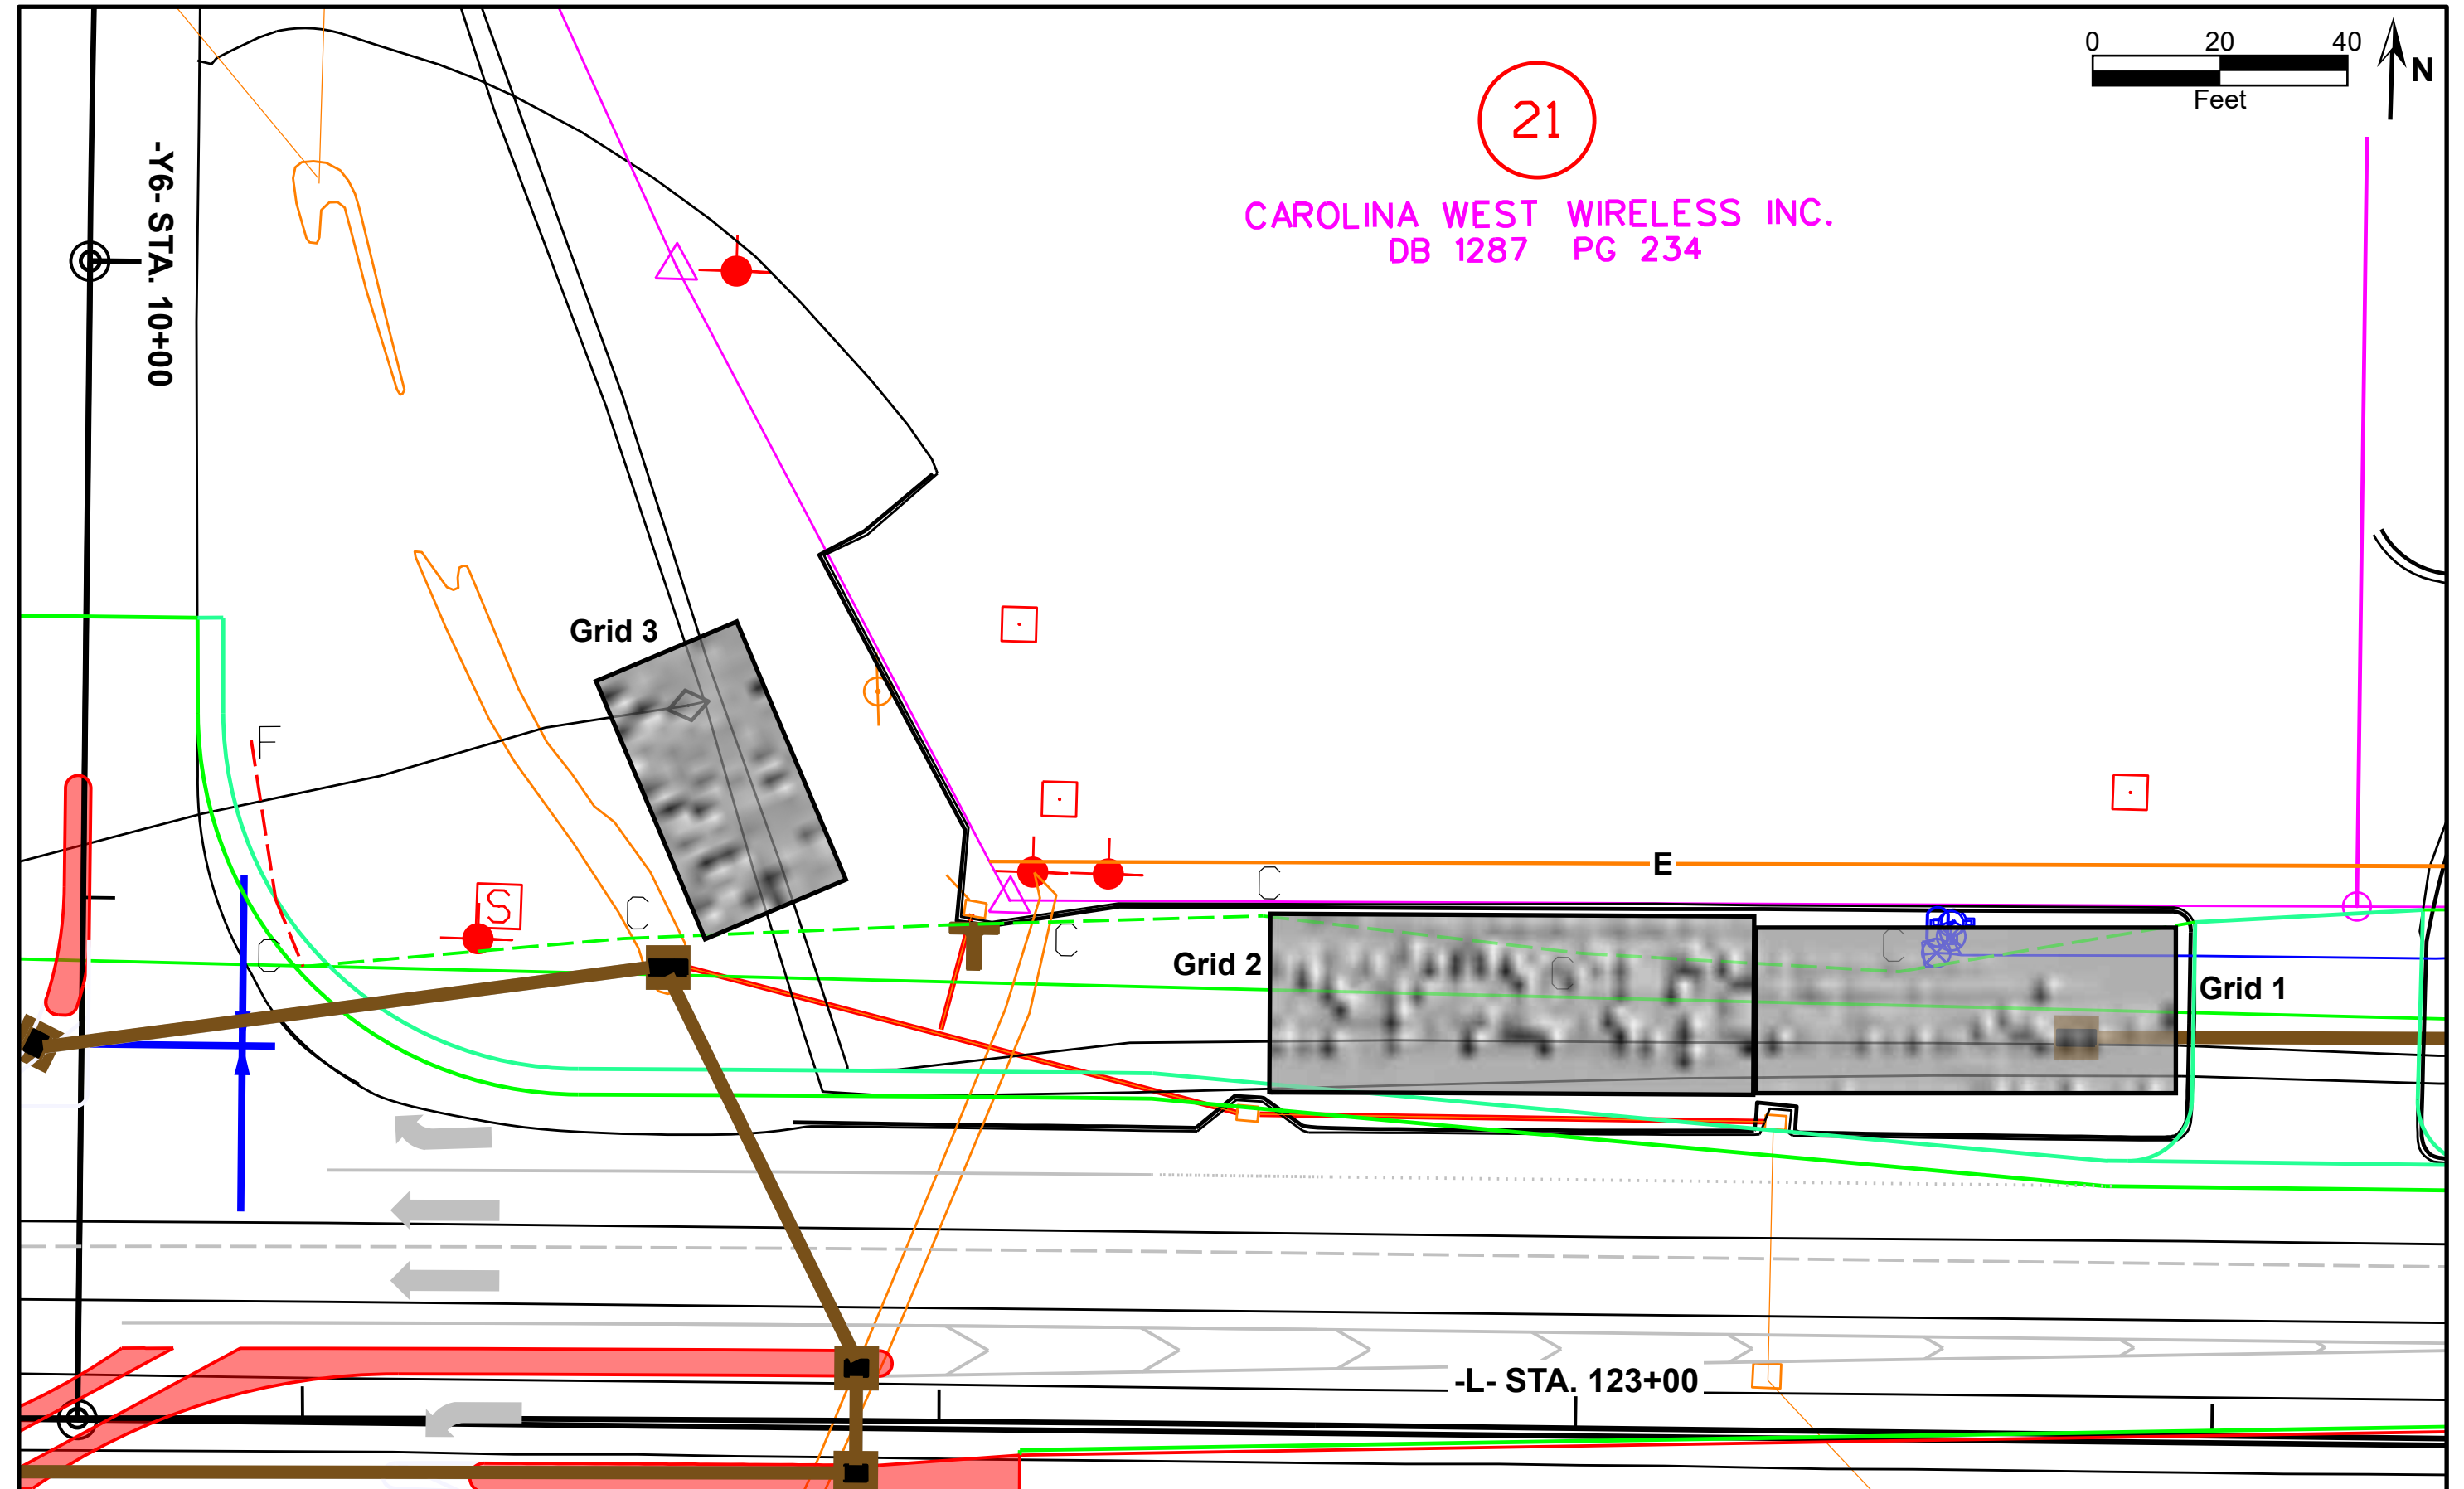
The magnetometer data was collected with a GEM Systems GSM-19W Walking Overhauser magnetometer. The data was compiled in Excel spreadsheets and a grayscale hillshade map of the magnetic data was drafted using Golden Software's Surfer® modeling program. The lighter shades are lower magnetic readings, and the darker colors are higher magnetic readings (Figure 4). Ferrous objects in the subsurface have a magnetic field distinct from the surrounding soil and produce magnetic anomalies on the contour maps.

The magnetic data for the three grids show dispersed patterns of variable magnetic readings, but large magnetic anomalies that might indicate remnants of a former UST system were not observed (Figure 4). The magnetic data collected along the fifteen transects did not indicate the presence of a UST.

<p>Figure 4 Magnetometer Survey Hillshade Map</p>	<p>State Project: U-5312 Wilkes County, NC</p>	<p>Carolina West Wireless, Inc. Property 1858 US Hwy 421 Wilkesboro, NC</p>	<p>Parcel #021 Facility I.D. #: 00-05067</p>	<p>Seramur & Associates, PC Boone, NC</p>
--	--	---	--	---

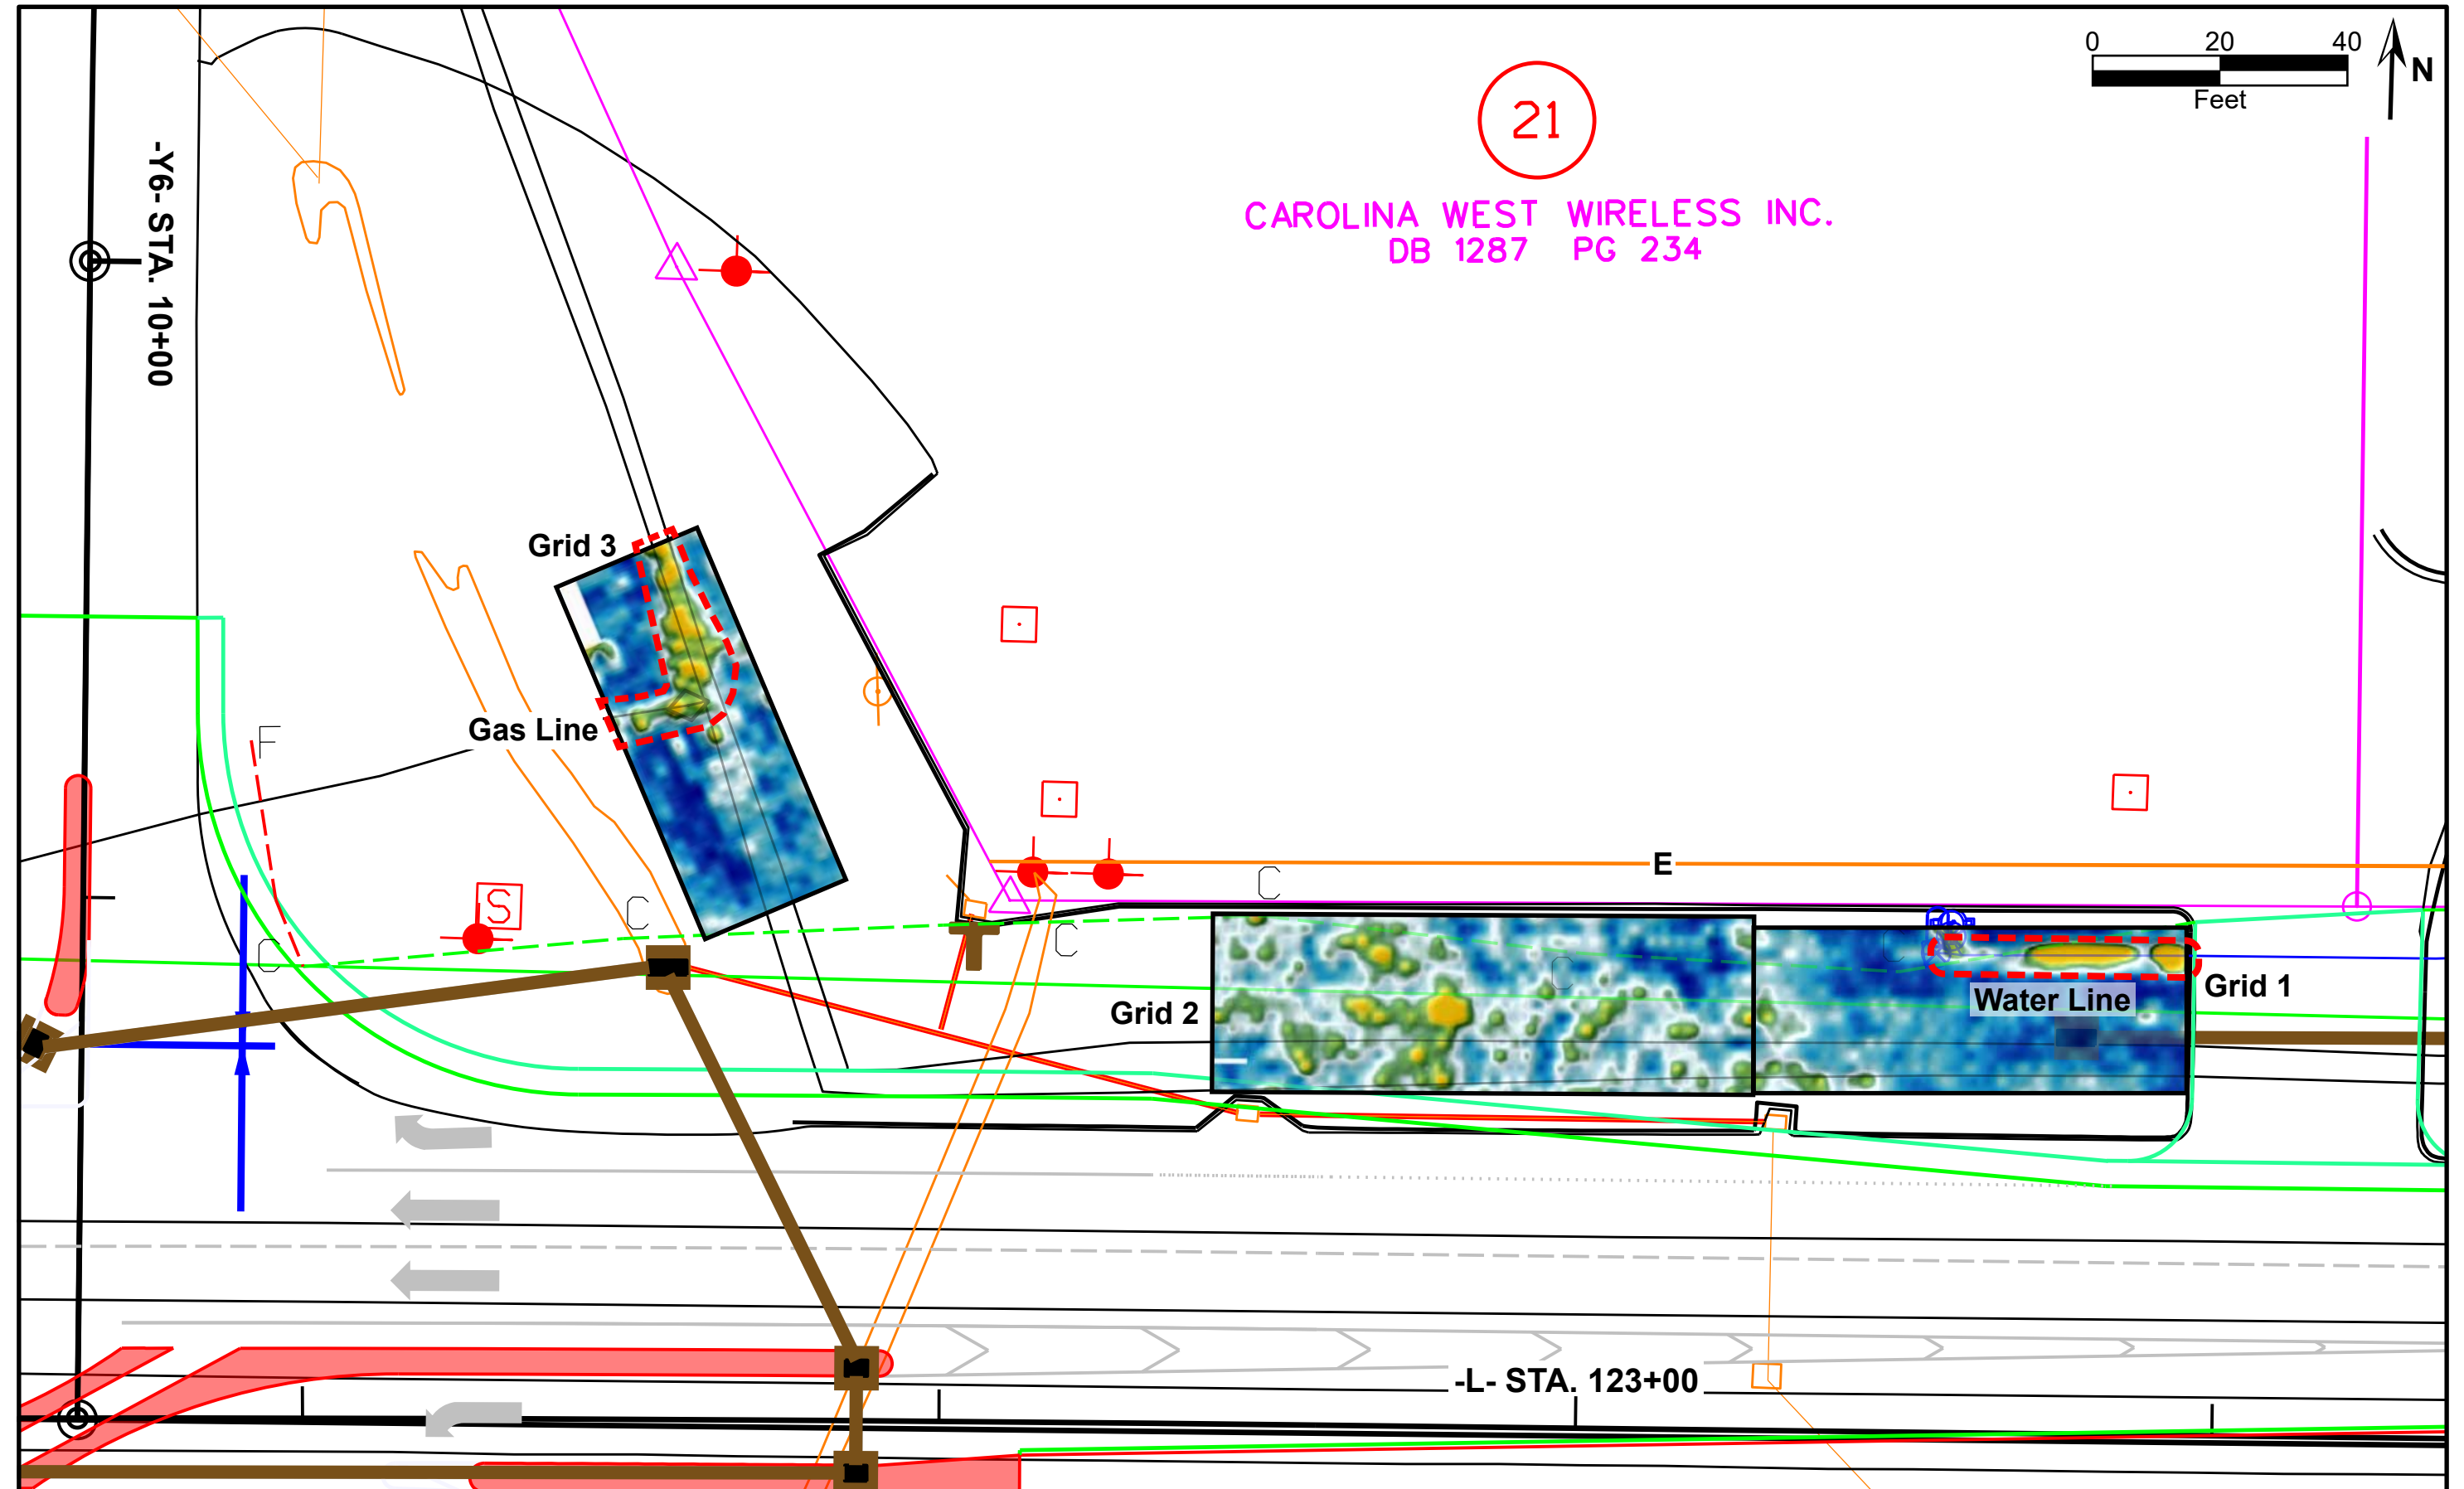
The only notable anomalies on the deep GPR depth slices (3.7-4.0 feet) are related to the water line in Grid 1 and the gas line in Grid 3 (Figure 7). The GPR profiles for Transects 12 through 15 show a buried surface 1-2 feet deep in the southwest corner of the property (Figure 8c and 8d). Transects 1, 6, 7, 8, 13 and 14 cross utility lines which appear at depths between 2.5 and 4 feet. Other than these features, the GPR profiles show continuous horizontal reflections.

<p>Figure 7 Deep GPR Depth Slices (3.7 to 4.0 ft.)</p>	<p>State Project: U-5312 Wilkes County, NC</p>	<p>Carolina West Wireless, Inc. Property 1858 US Hwy 421 Wilkesboro, NC</p>	<p>Parcel #021 Facility I.D. #: 00-05067</p>	<p>Seramur & Associates, PC Boone, NC</p>
---	--	---	--	---

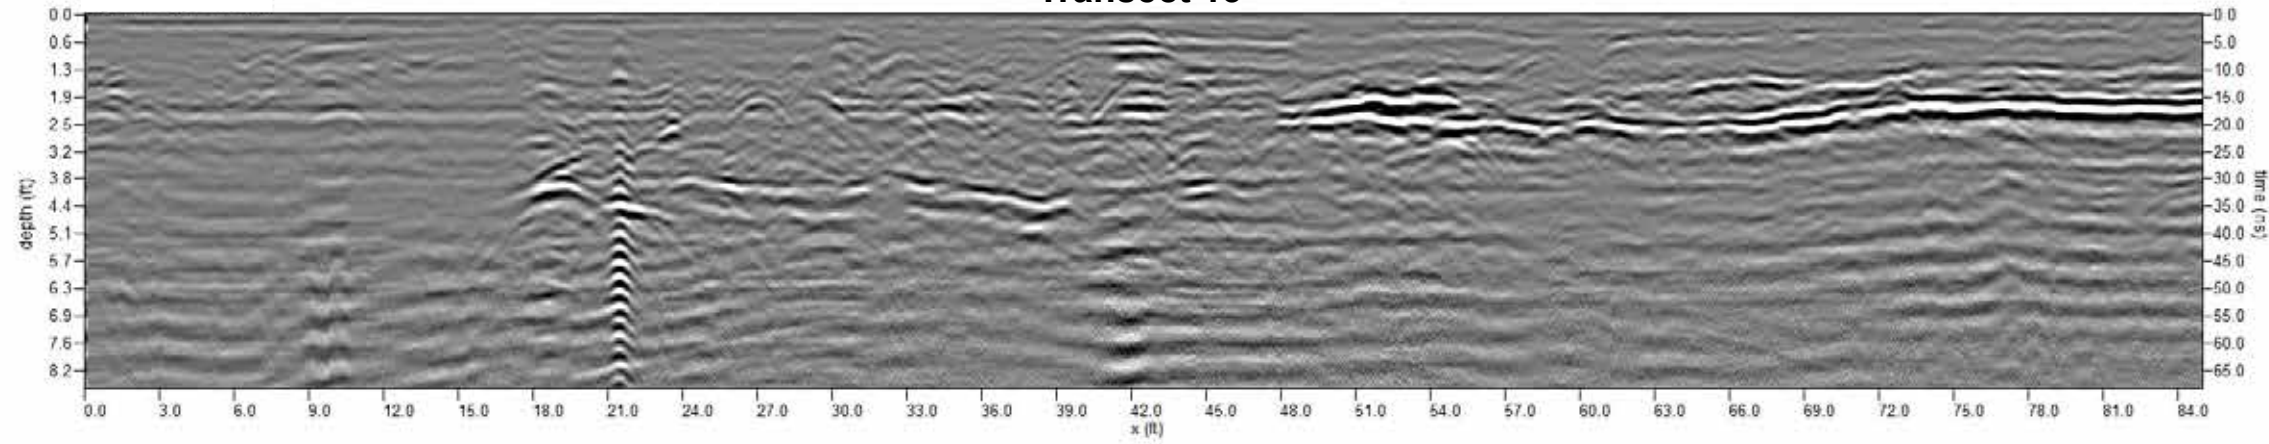
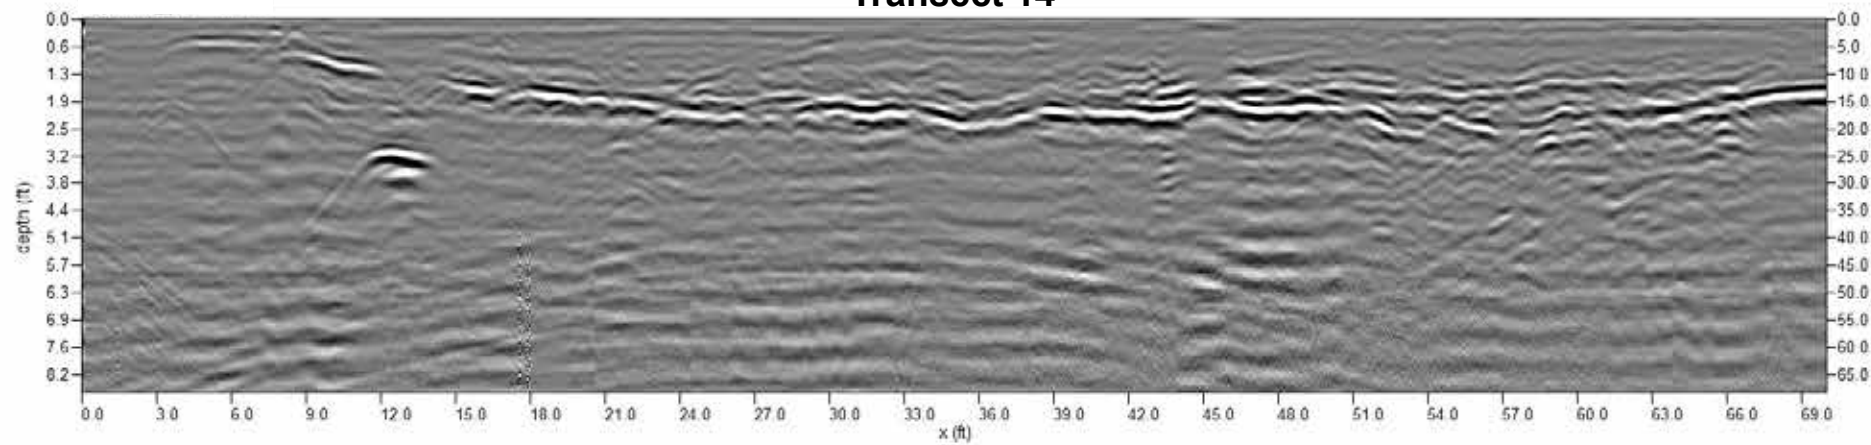
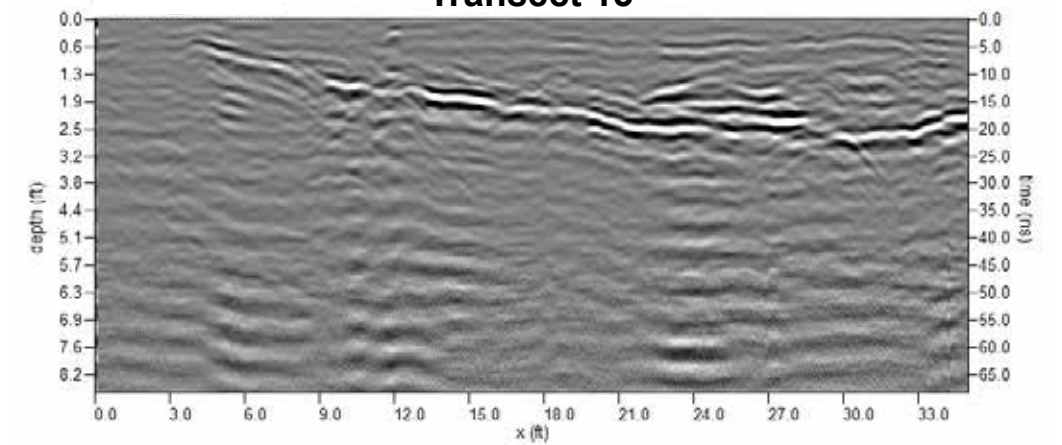
Figure 8c

GPR Transect Profiles 13 through 15
