PRELIMINARY SITE ASSESSMENT

SR 1100 (BRAWLEY SCHOOL ROAD) IMPROVEMENTS
TIP NO. R-3833C, WBS NO. 34554.2.4

NCDOT PARCEL NO. 74

OWNER: COUNTRY ROADS OF THE CAROLINAS, LLC
2861 CHARLOTTE HIGHWAY
MOORESVILLE, IREDELL COUNTY, NORTH CAROLINA

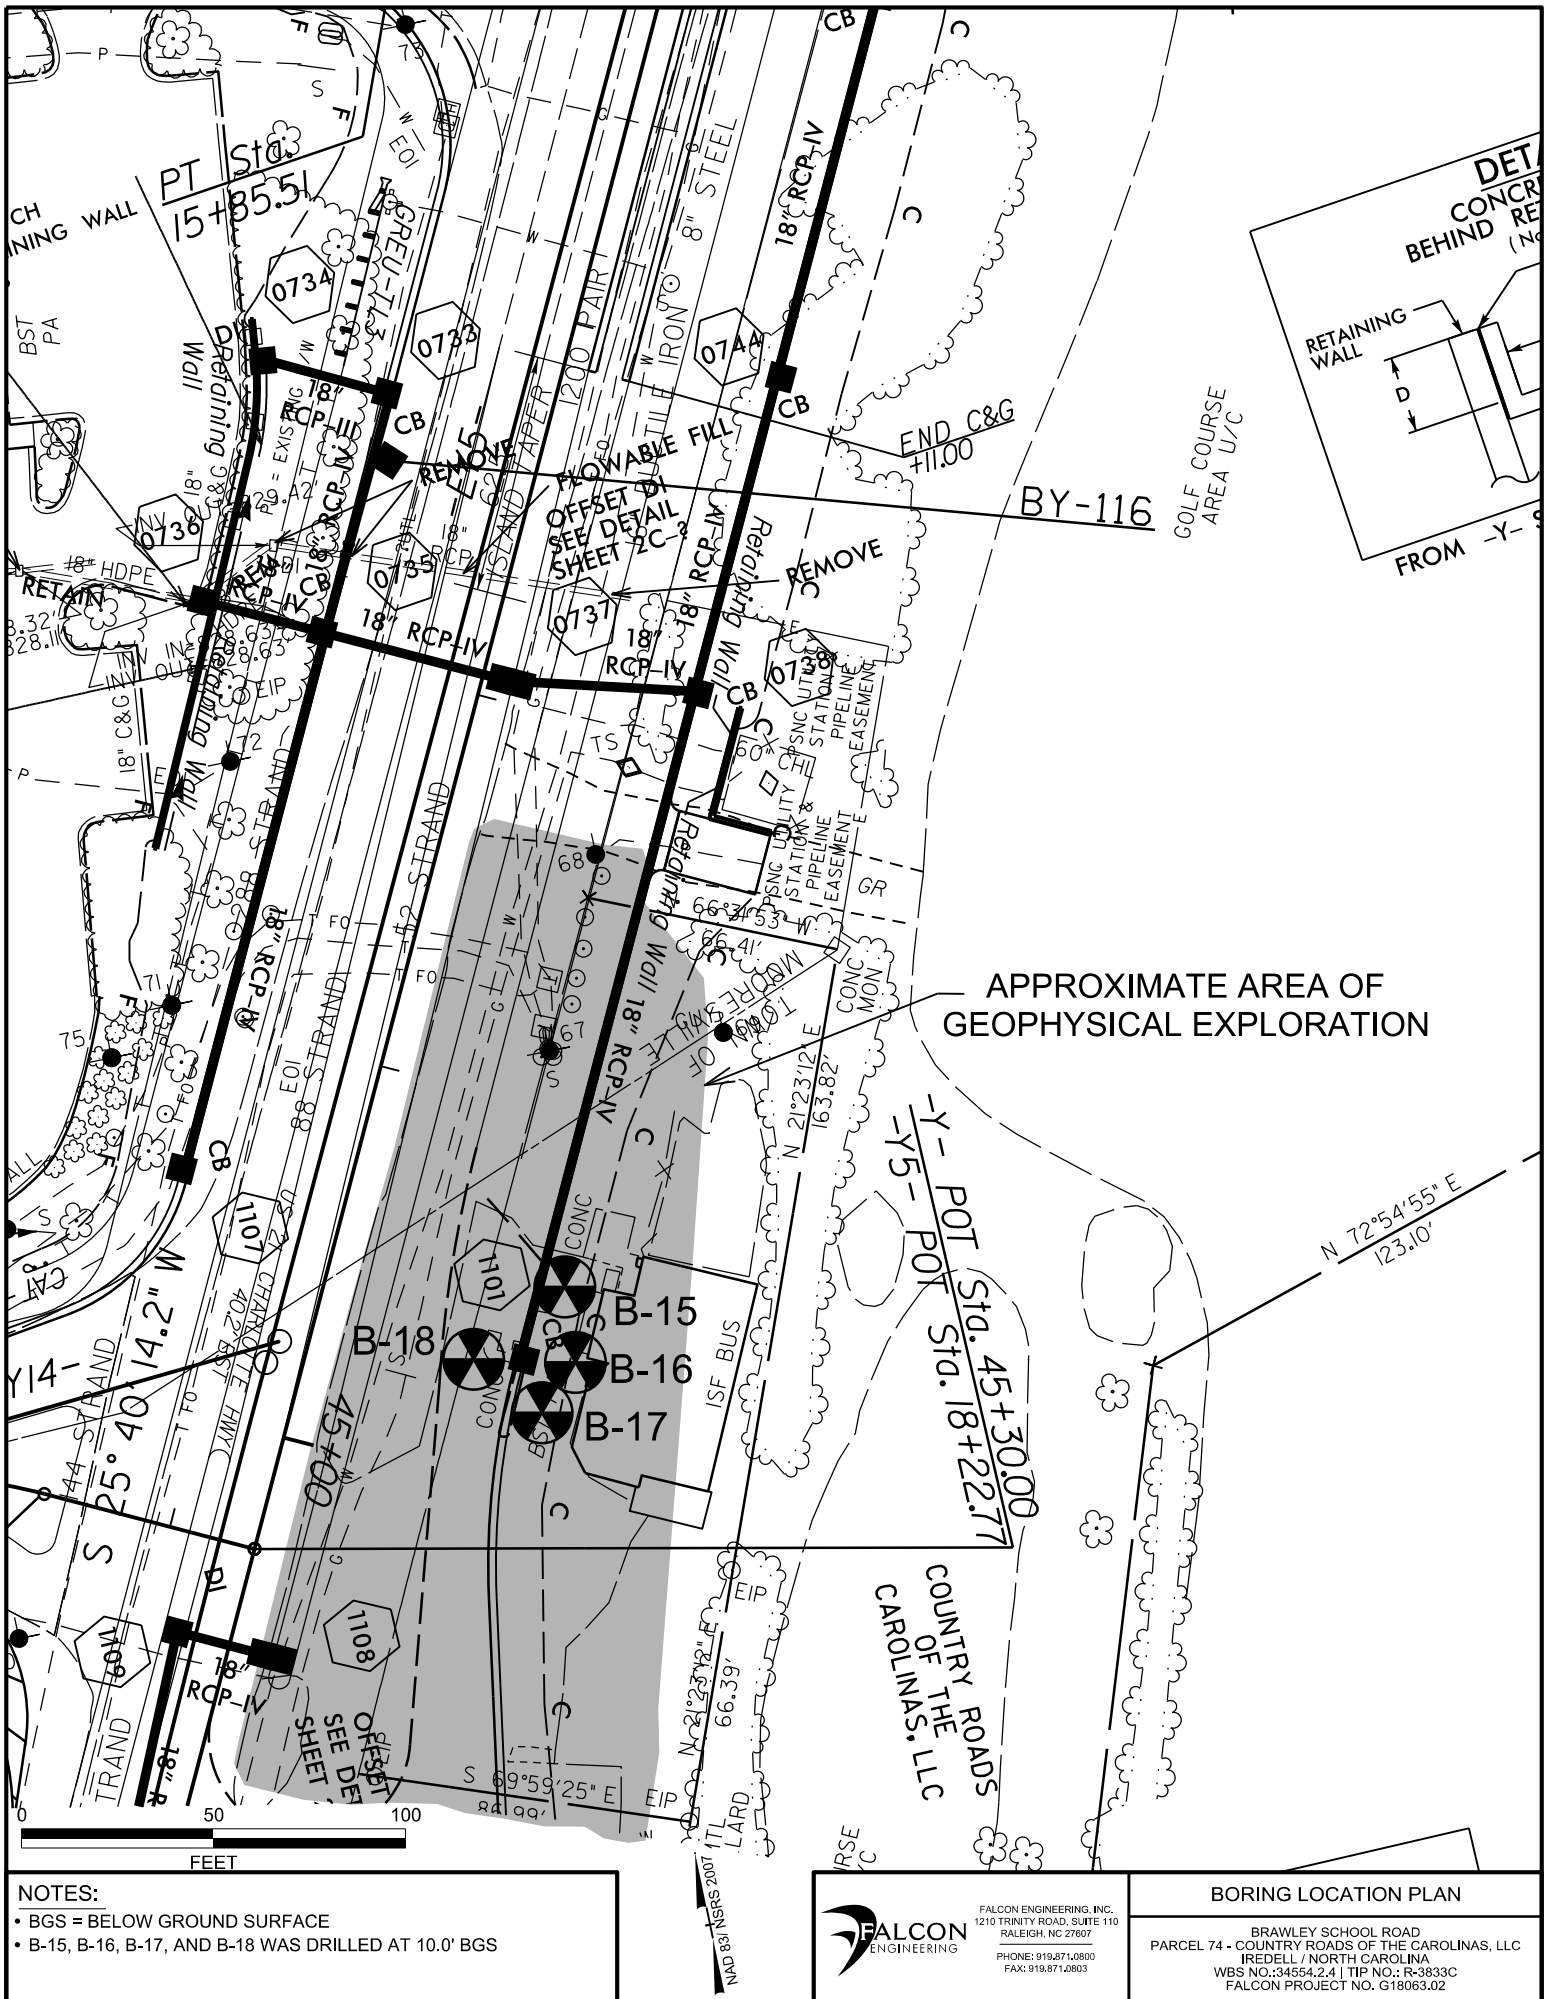
BORING LOCATION PLAN
 BRAWLEY SCHOOL ROAD
 PARCEL 74 - COUNTRY ROADS OF THE CAROLINAS, LLC
 IREDELL / NORTH CAROLINA
 WBS NO: 34554.2.4 | TIF NO: R-3833C
 FALCON PROJECT NO. G18063.02

Falcon and our subcontractor advanced four borings (B-15, B-16, B-17, and B-18) to 10 feet below ground surface in the area of the suspect former dispenser island. Groundwater was not observed. Please see the Boring Location Plan in the attachments for a visual depiction of the boring locations. The coordinates (latitude and longitude) that correspond to the boring locations are shown below in Table No. 1 Boring Coordinates.

- BGS = BELOW GROUND SURFACE
- B-15, B-16, B-17, AND B-18 WAS DRILLED AT 10.0' BGS

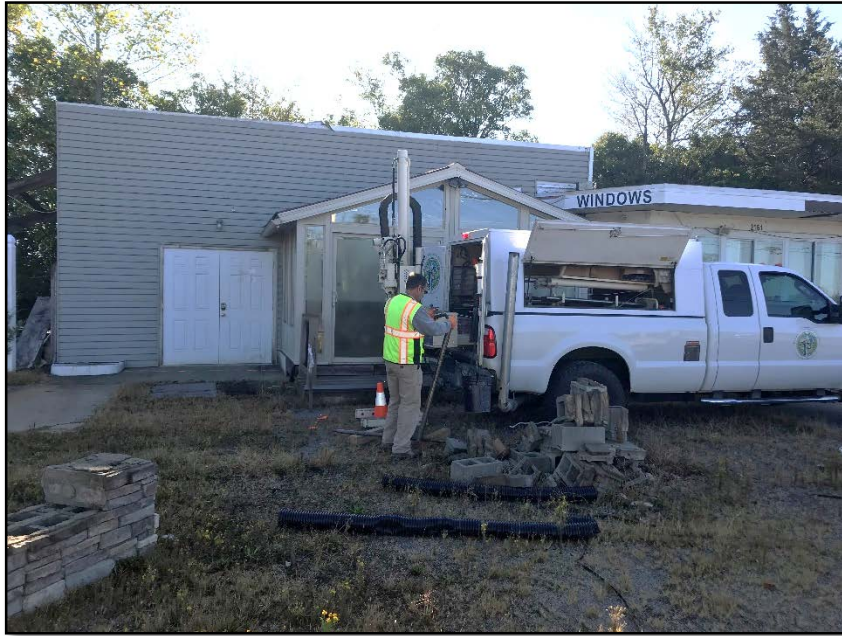
Photograph No. 1: General view of Boring B-15.

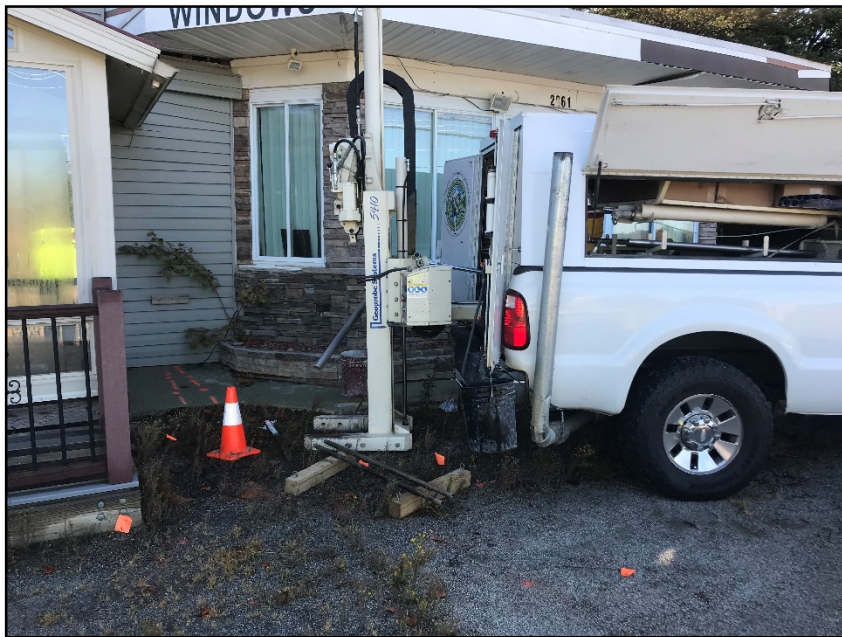
Photograph No. 2: General view of Boring B-16.

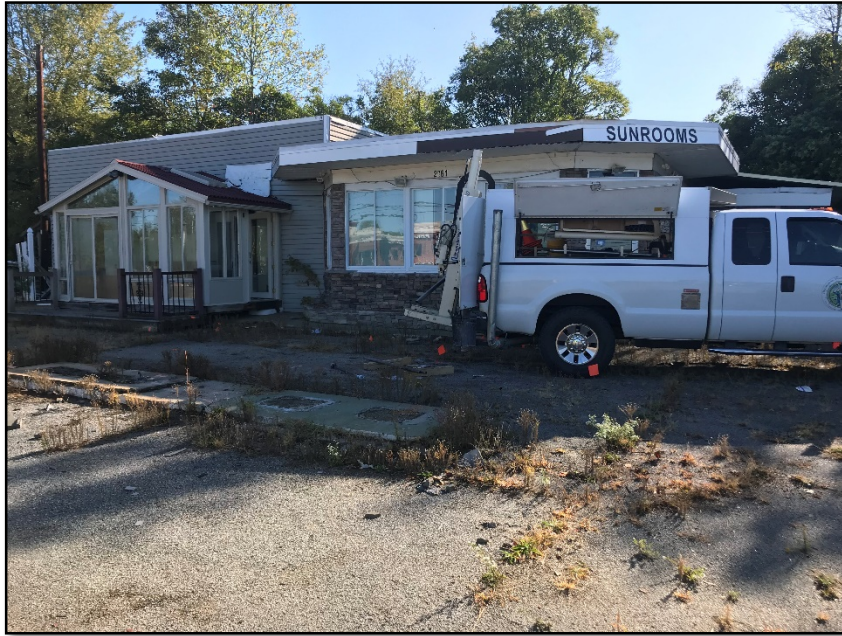
Photograph No. 3: General view of Boring B-17.

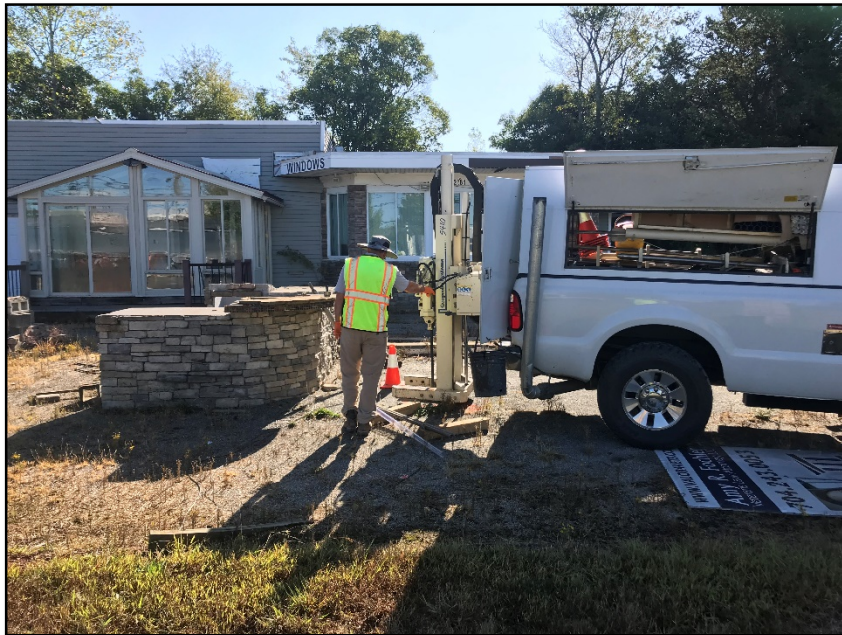
Photograph No. 4: General view of Boring B-18.

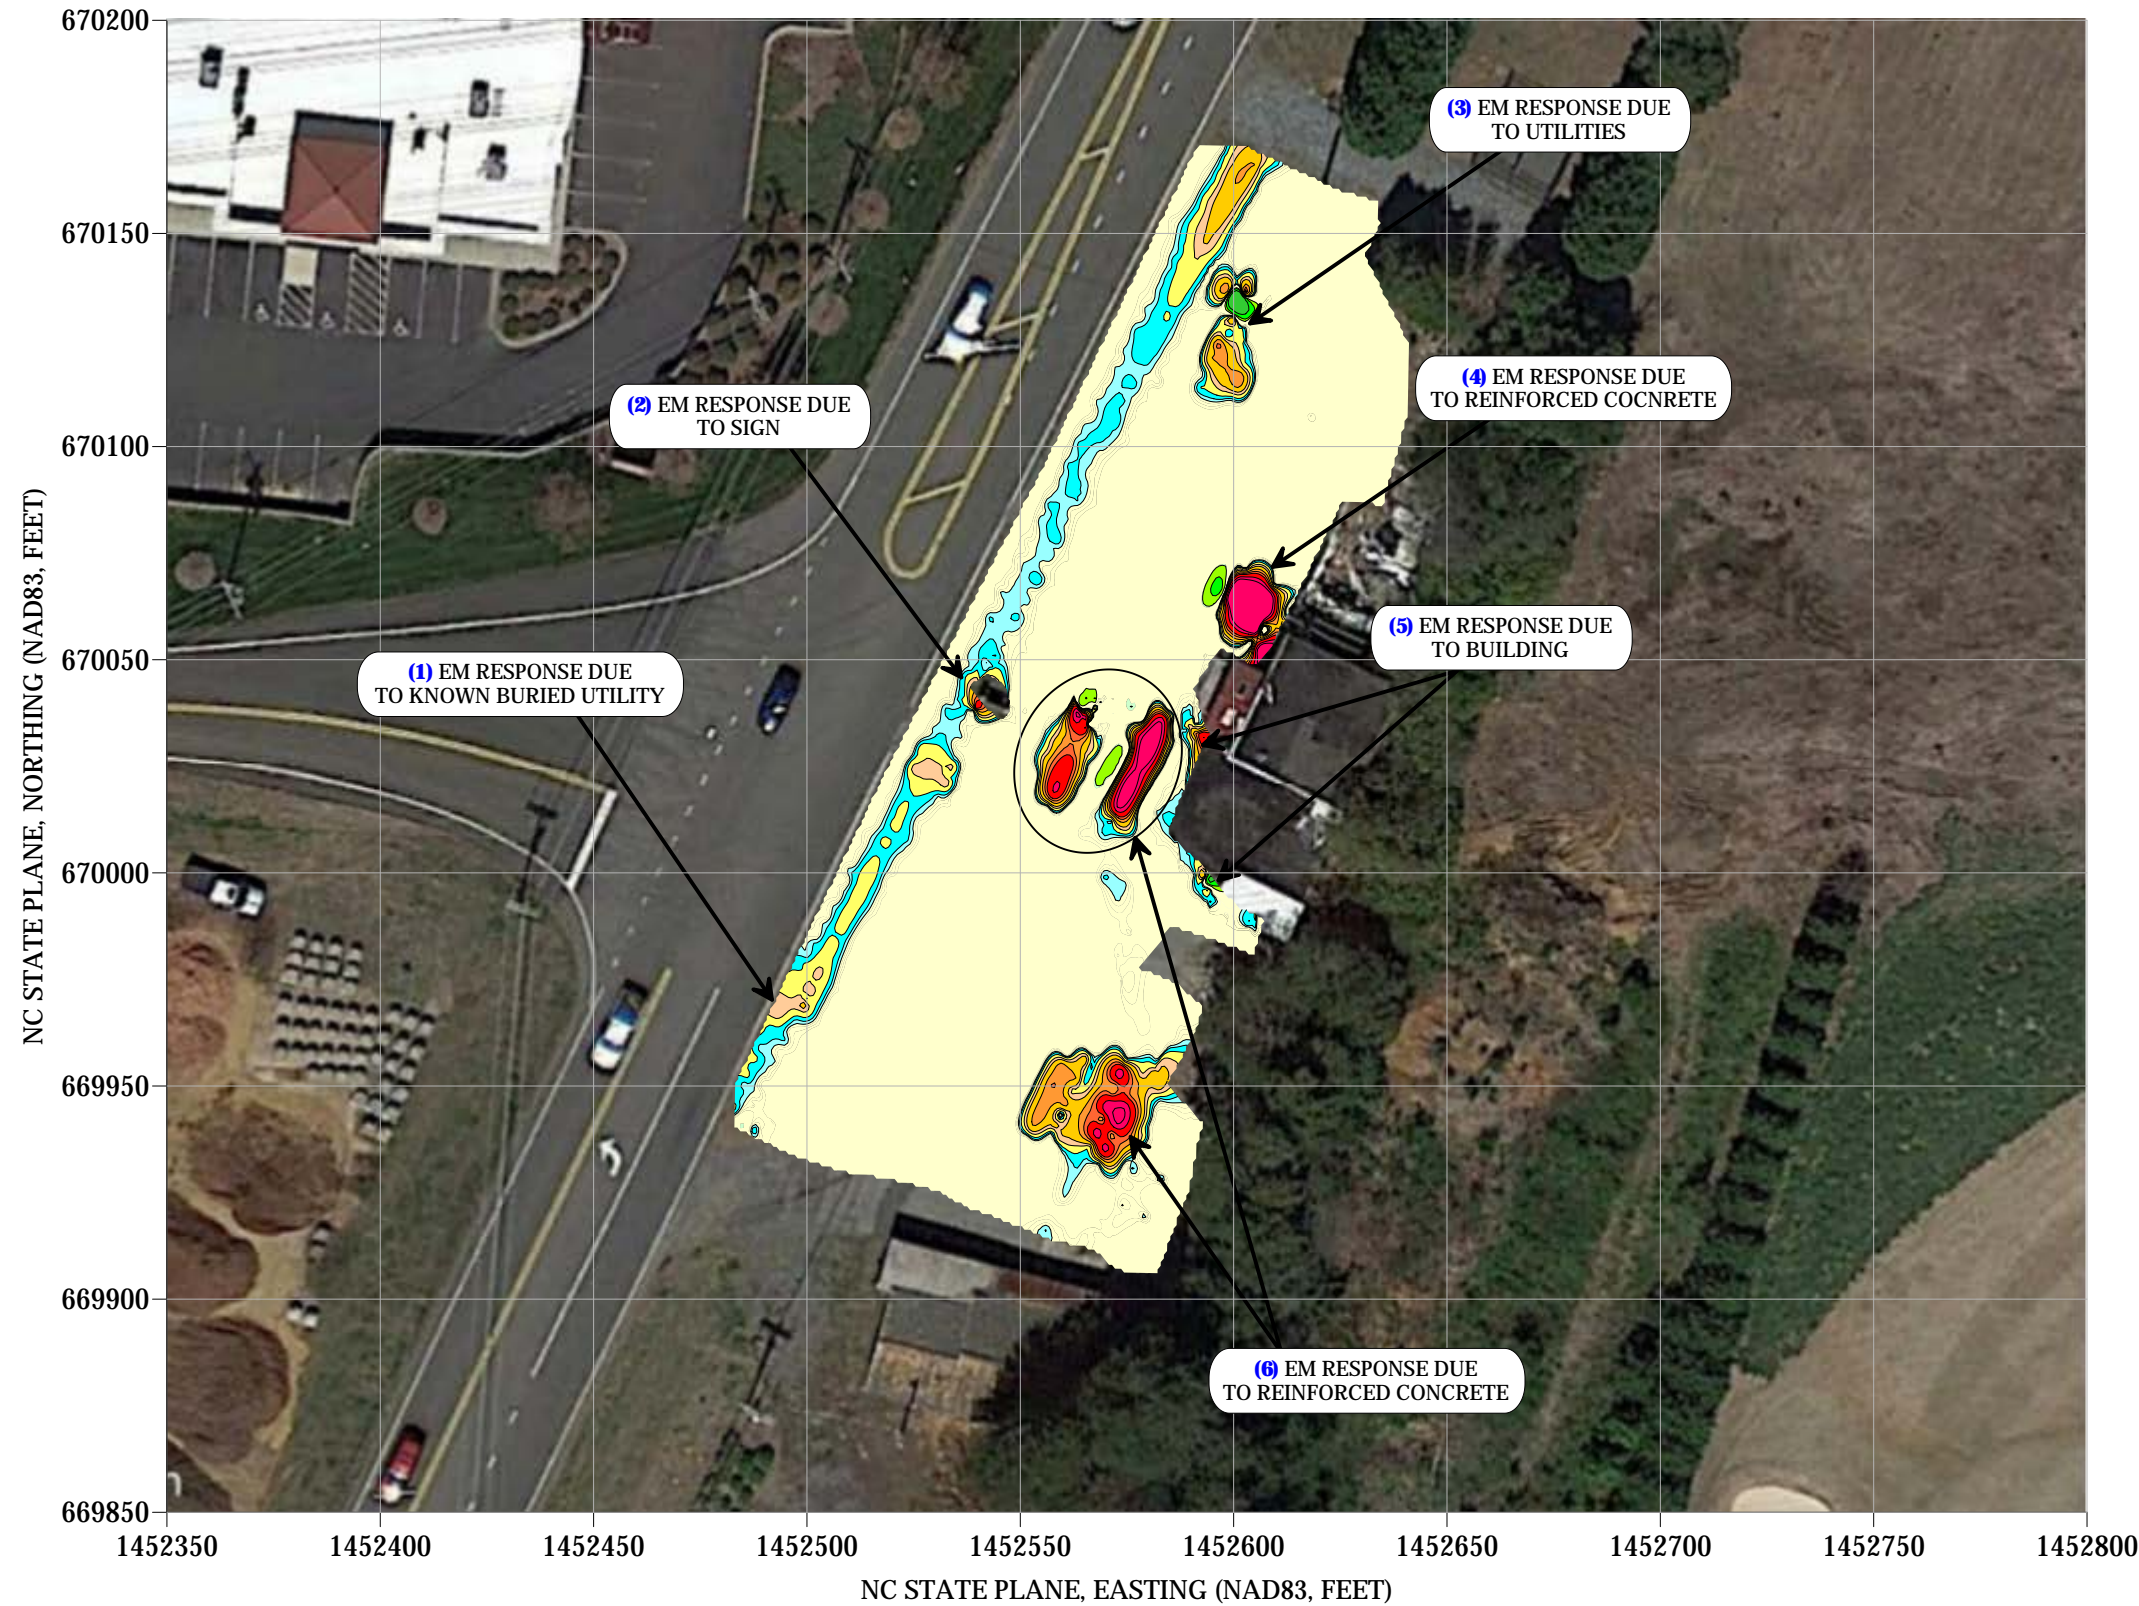
EM61 METAL DETECTION RESULTS

A contour plot of the EM61 results obtained across the survey area at the property is presented in **Figure 2**. Each EM anomaly is numbered for reference in the figure. The following table presents the list of EM anomalies and the cause of the metallic response, if known:

Metallic Anomaly #	Cause of Anomaly	Investigated with GPR
1	Known Buried Utility	
2	Sign	
3	Utilities	
4	Reinforced Concrete	✓
5	Building	
6	Reinforced Concrete	✓

NO EVIDENCE OF METALLIC USTs WAS OBSERVED.

The contour plot shows the differential results of the EM61 instrument in millivolts (mV). The differential results focus on larger metallic objects such as USTs and drums. The EM data were collected on August 11, 2019, using a Geonics EM61-MK2 instrument. Verification GPR data were collected using a GSSI SIR 4000 controller equipped with a 350 MHz HS antenna on August 12, 2019.

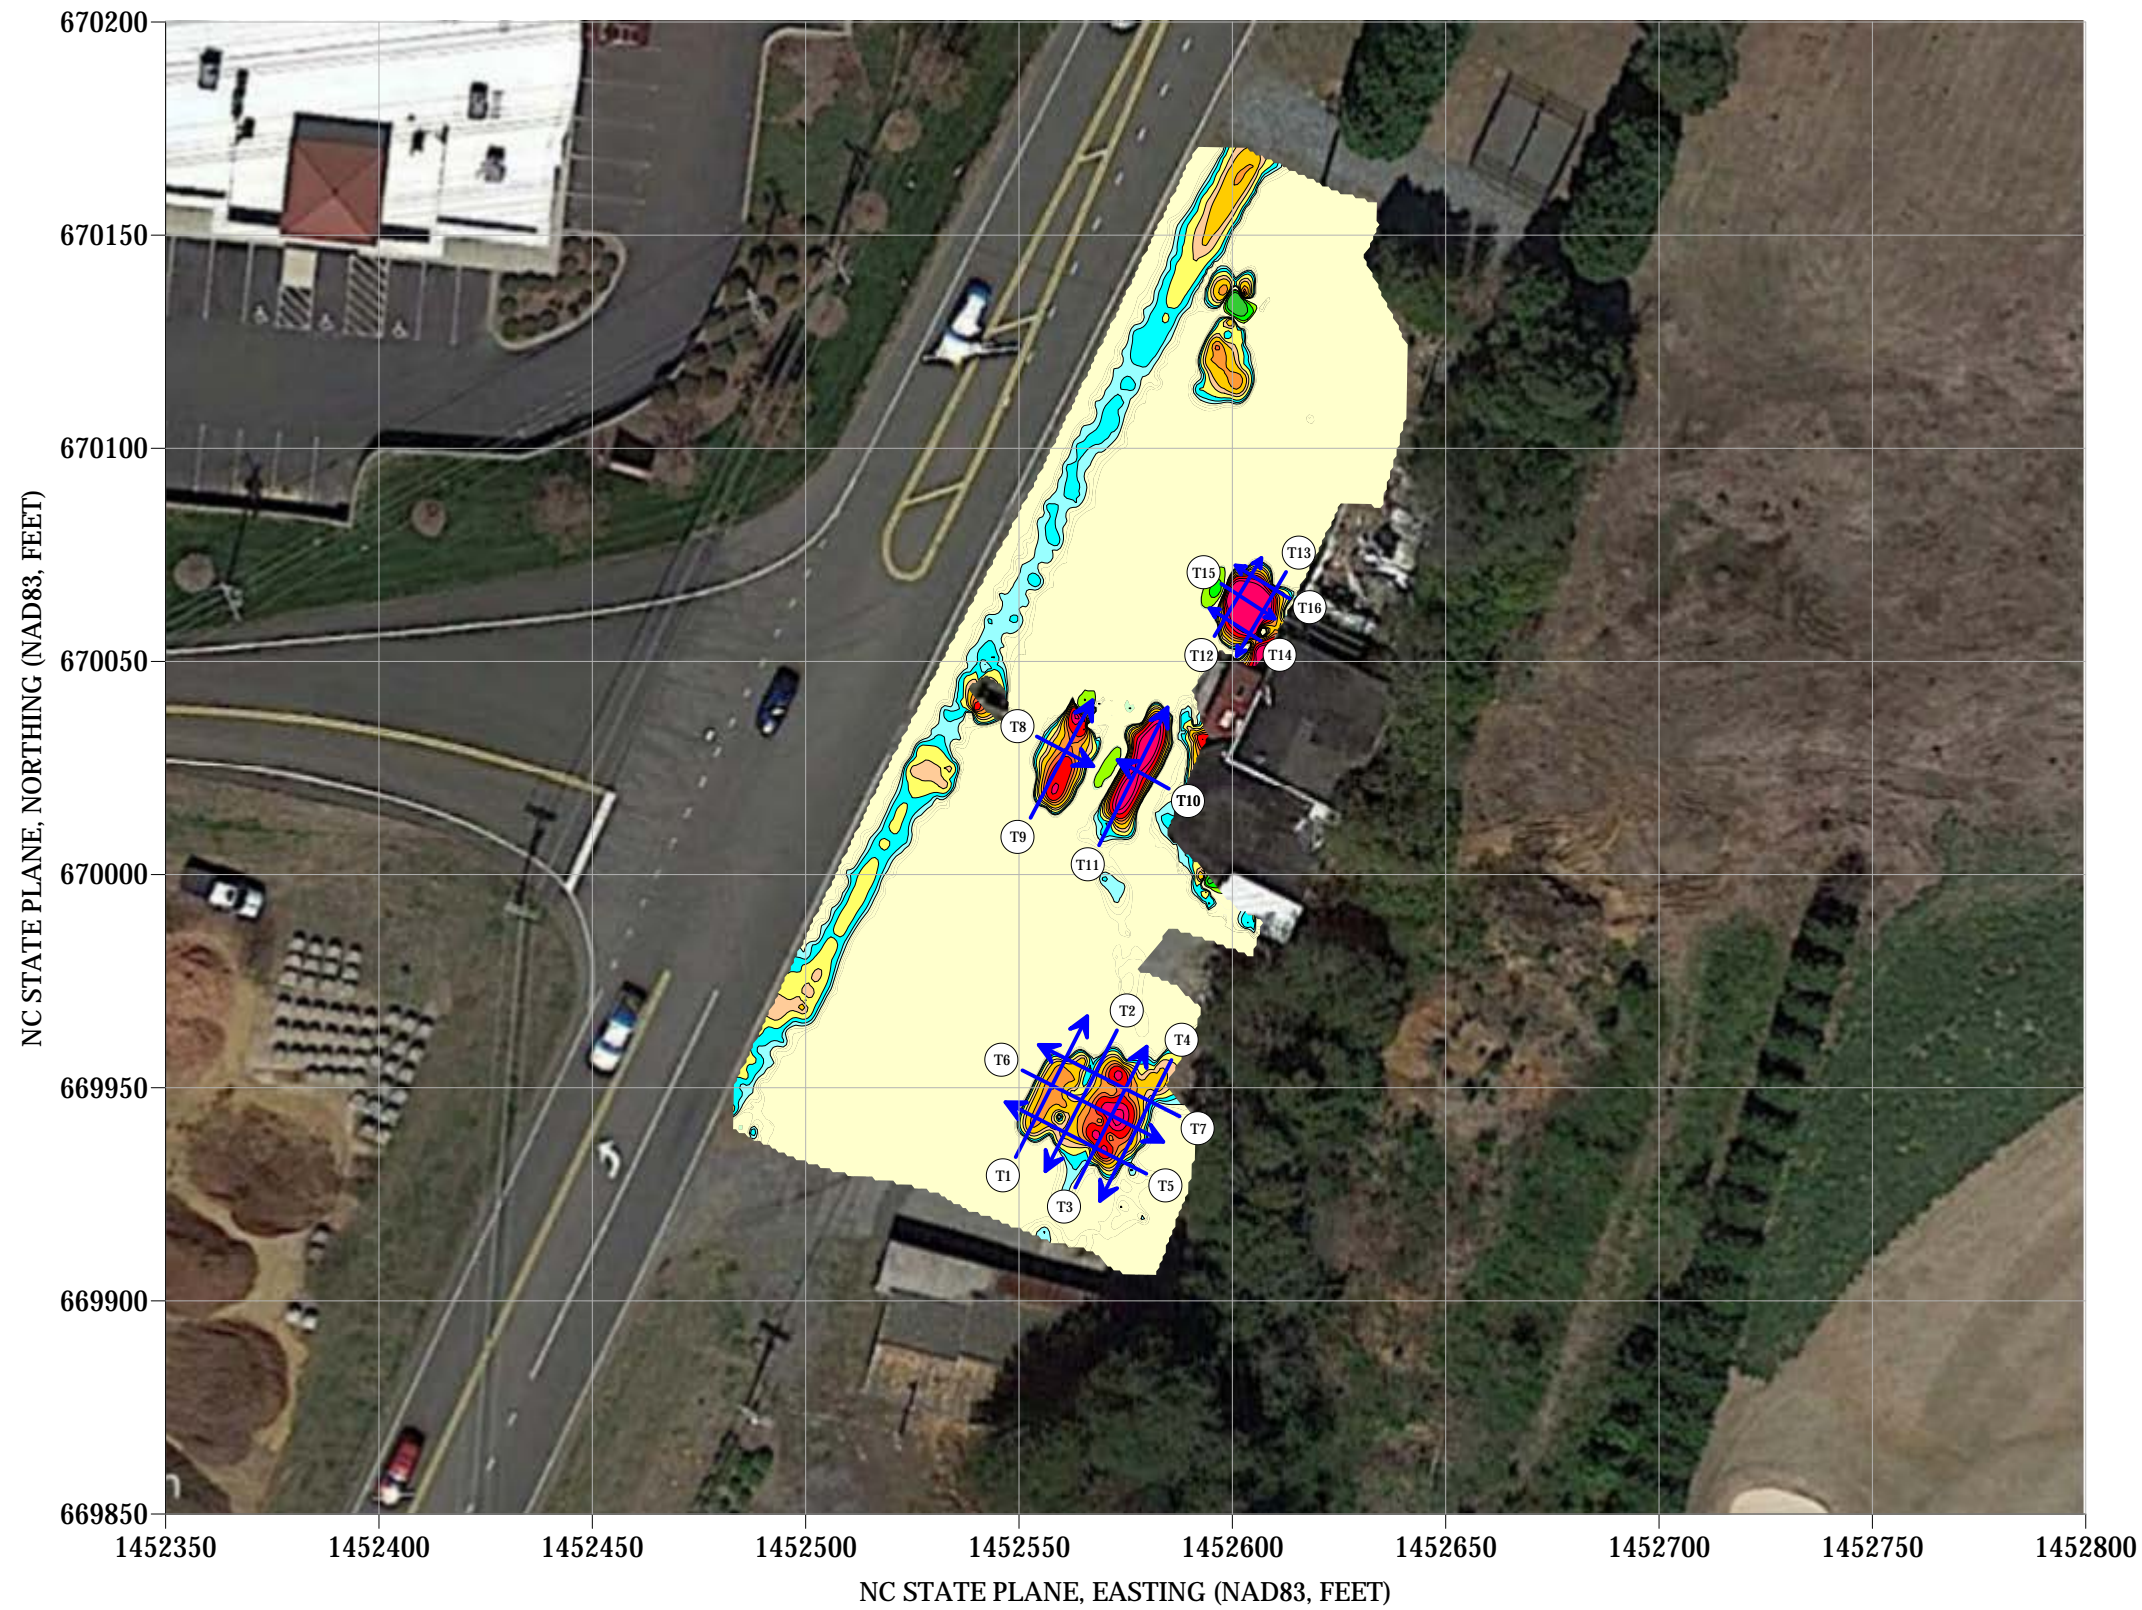
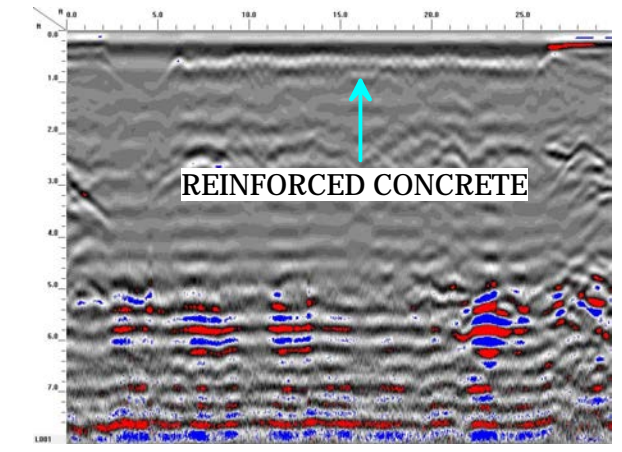
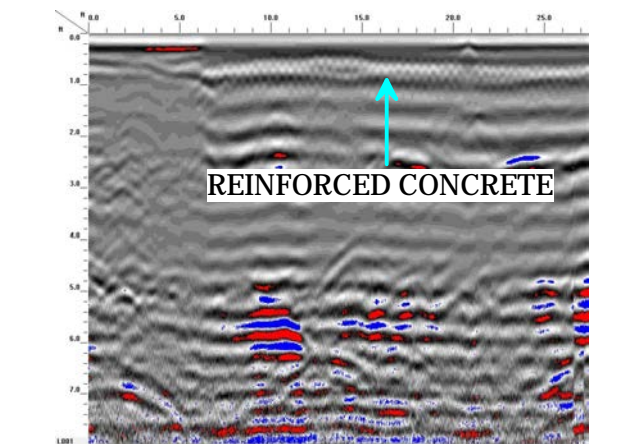
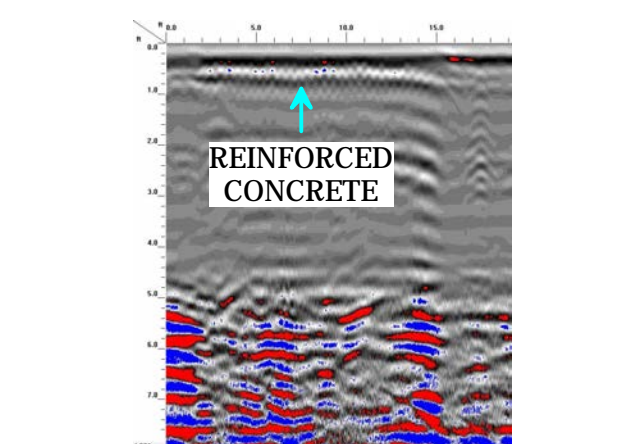
LOCATIONS OF GPR TRANSECTS

GPR Transects 1-16 were performed in a grid-like fashion across EM Anomalies 4 and 6. These transects confirmed the presence of reinforcement within the concrete slab. No evidence of any significant buried structures such as USTs was observed.

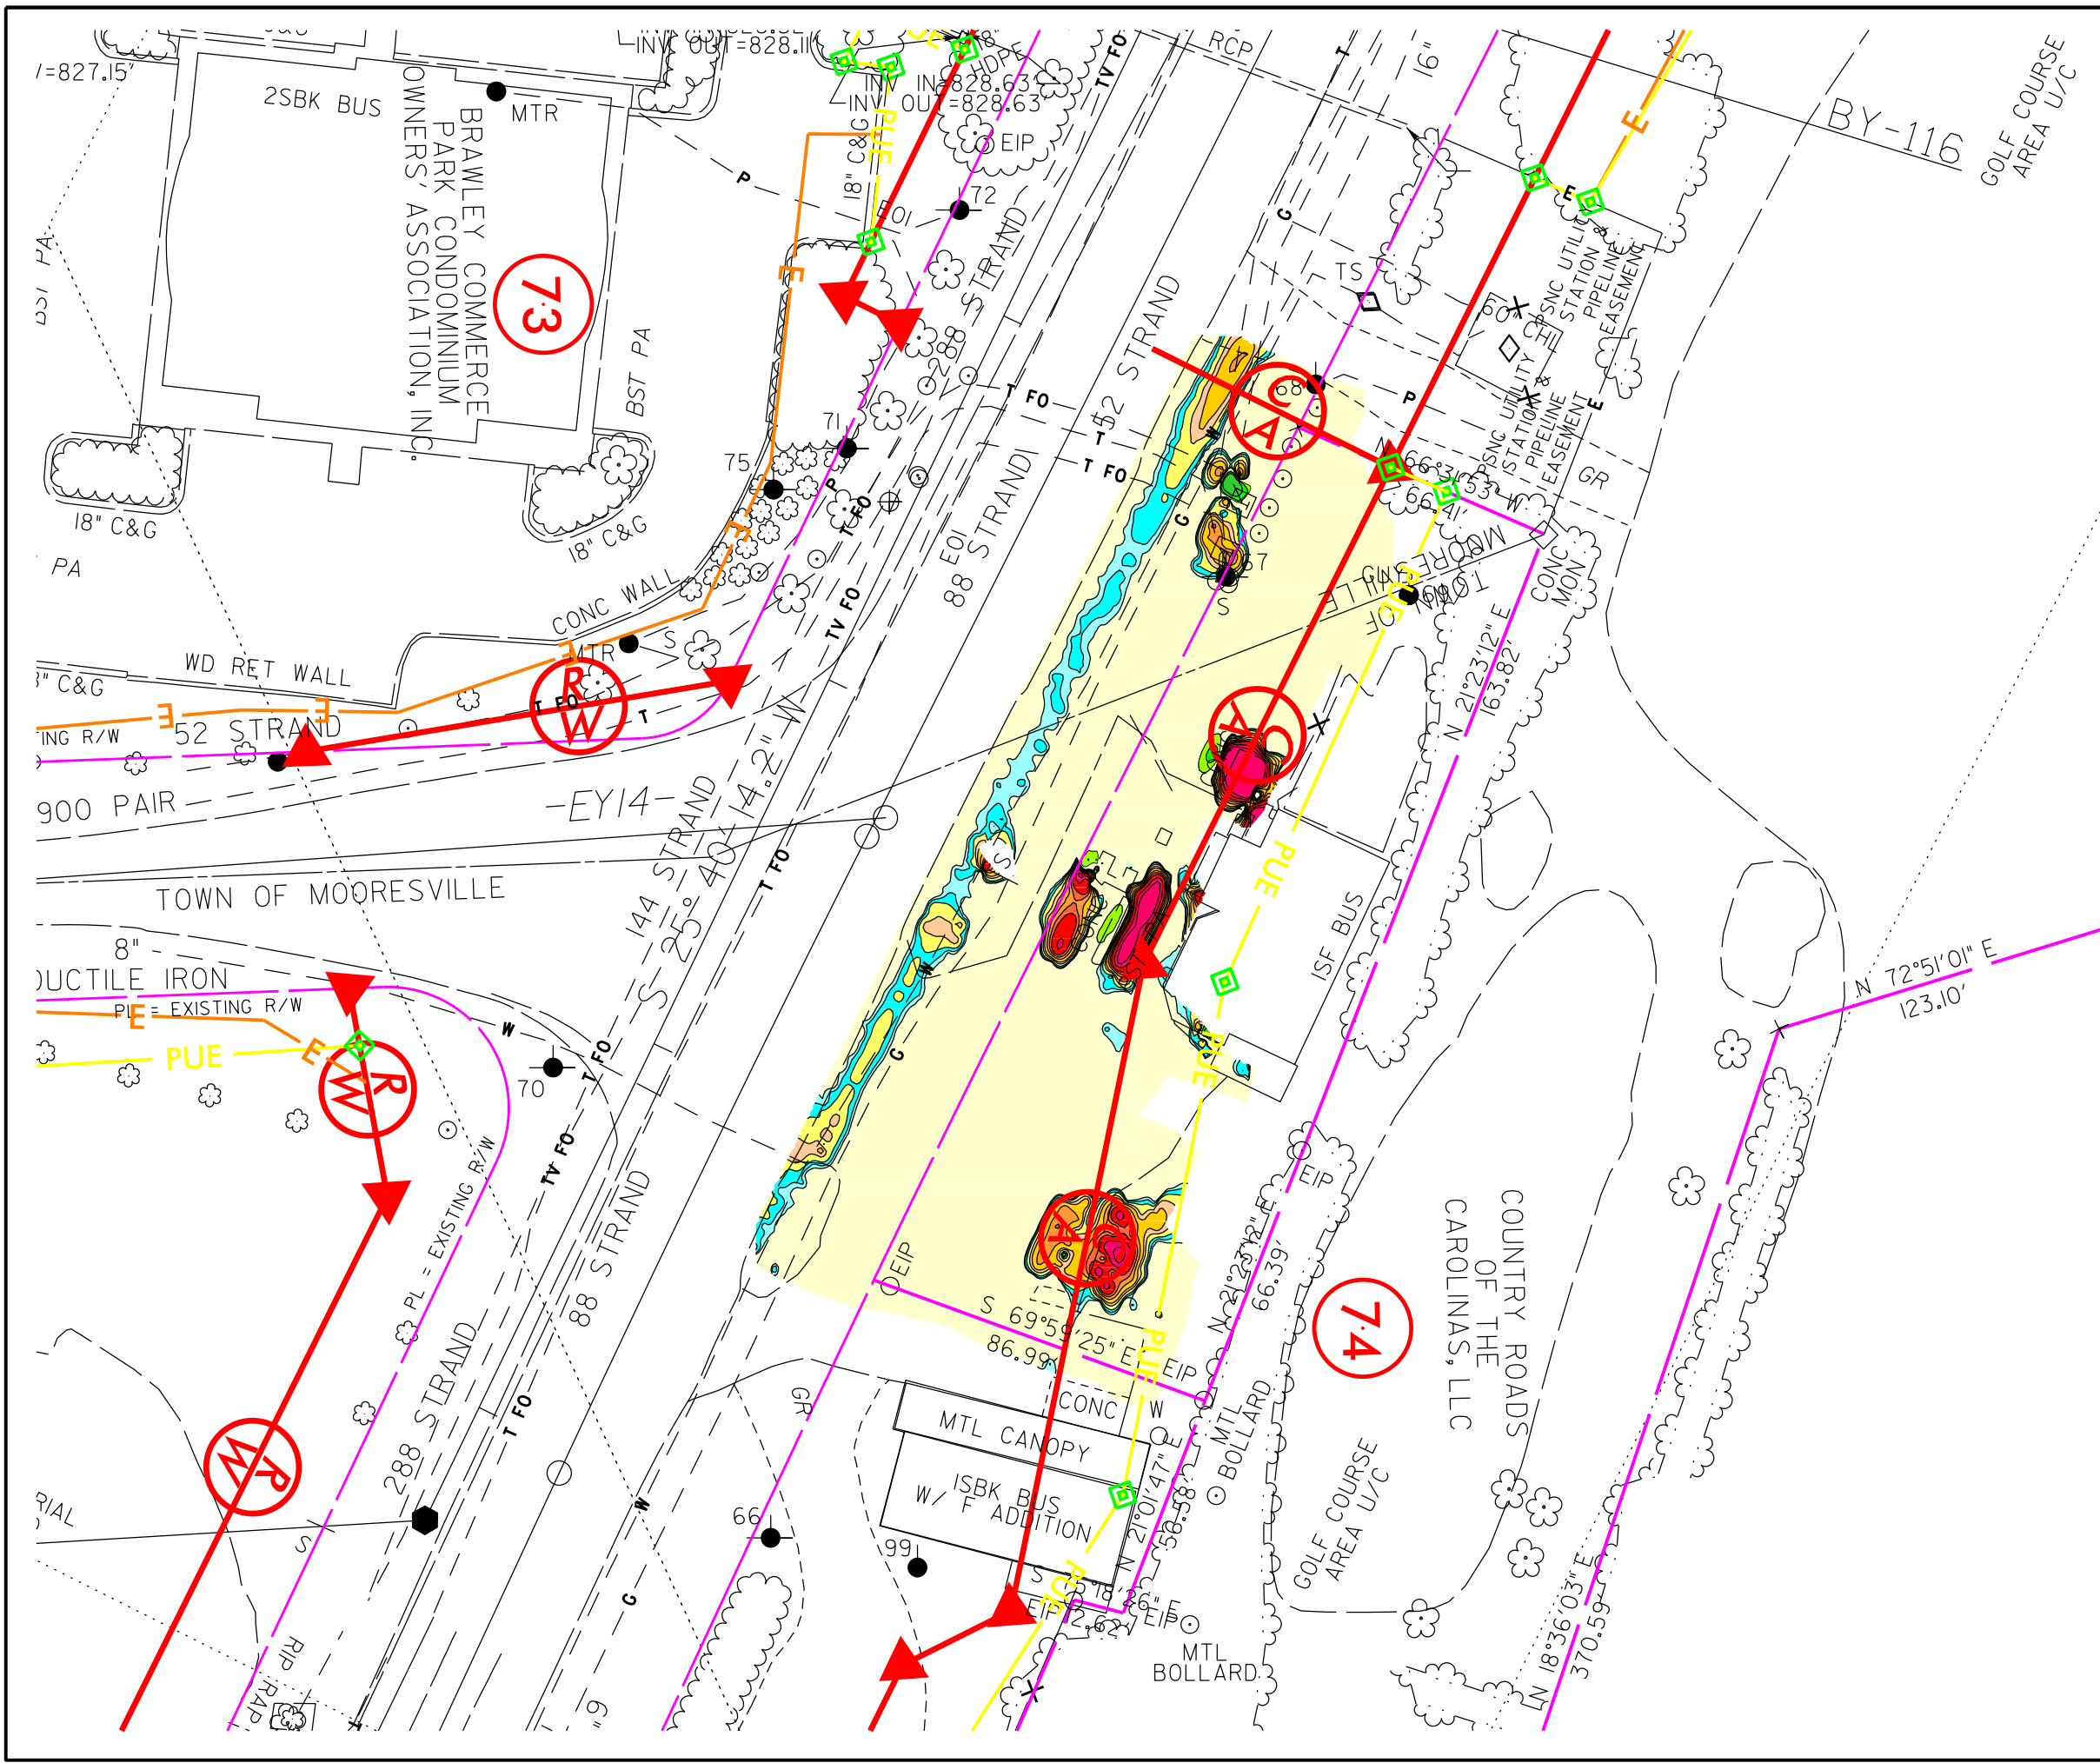
Collectively, the geophysical data did not record any evidence of metallic USTs within the survey area at Parcel 74. **Figure 4** provides an overlay of the metal detection results on the NCDOT MicroStation engineering plans for reference.

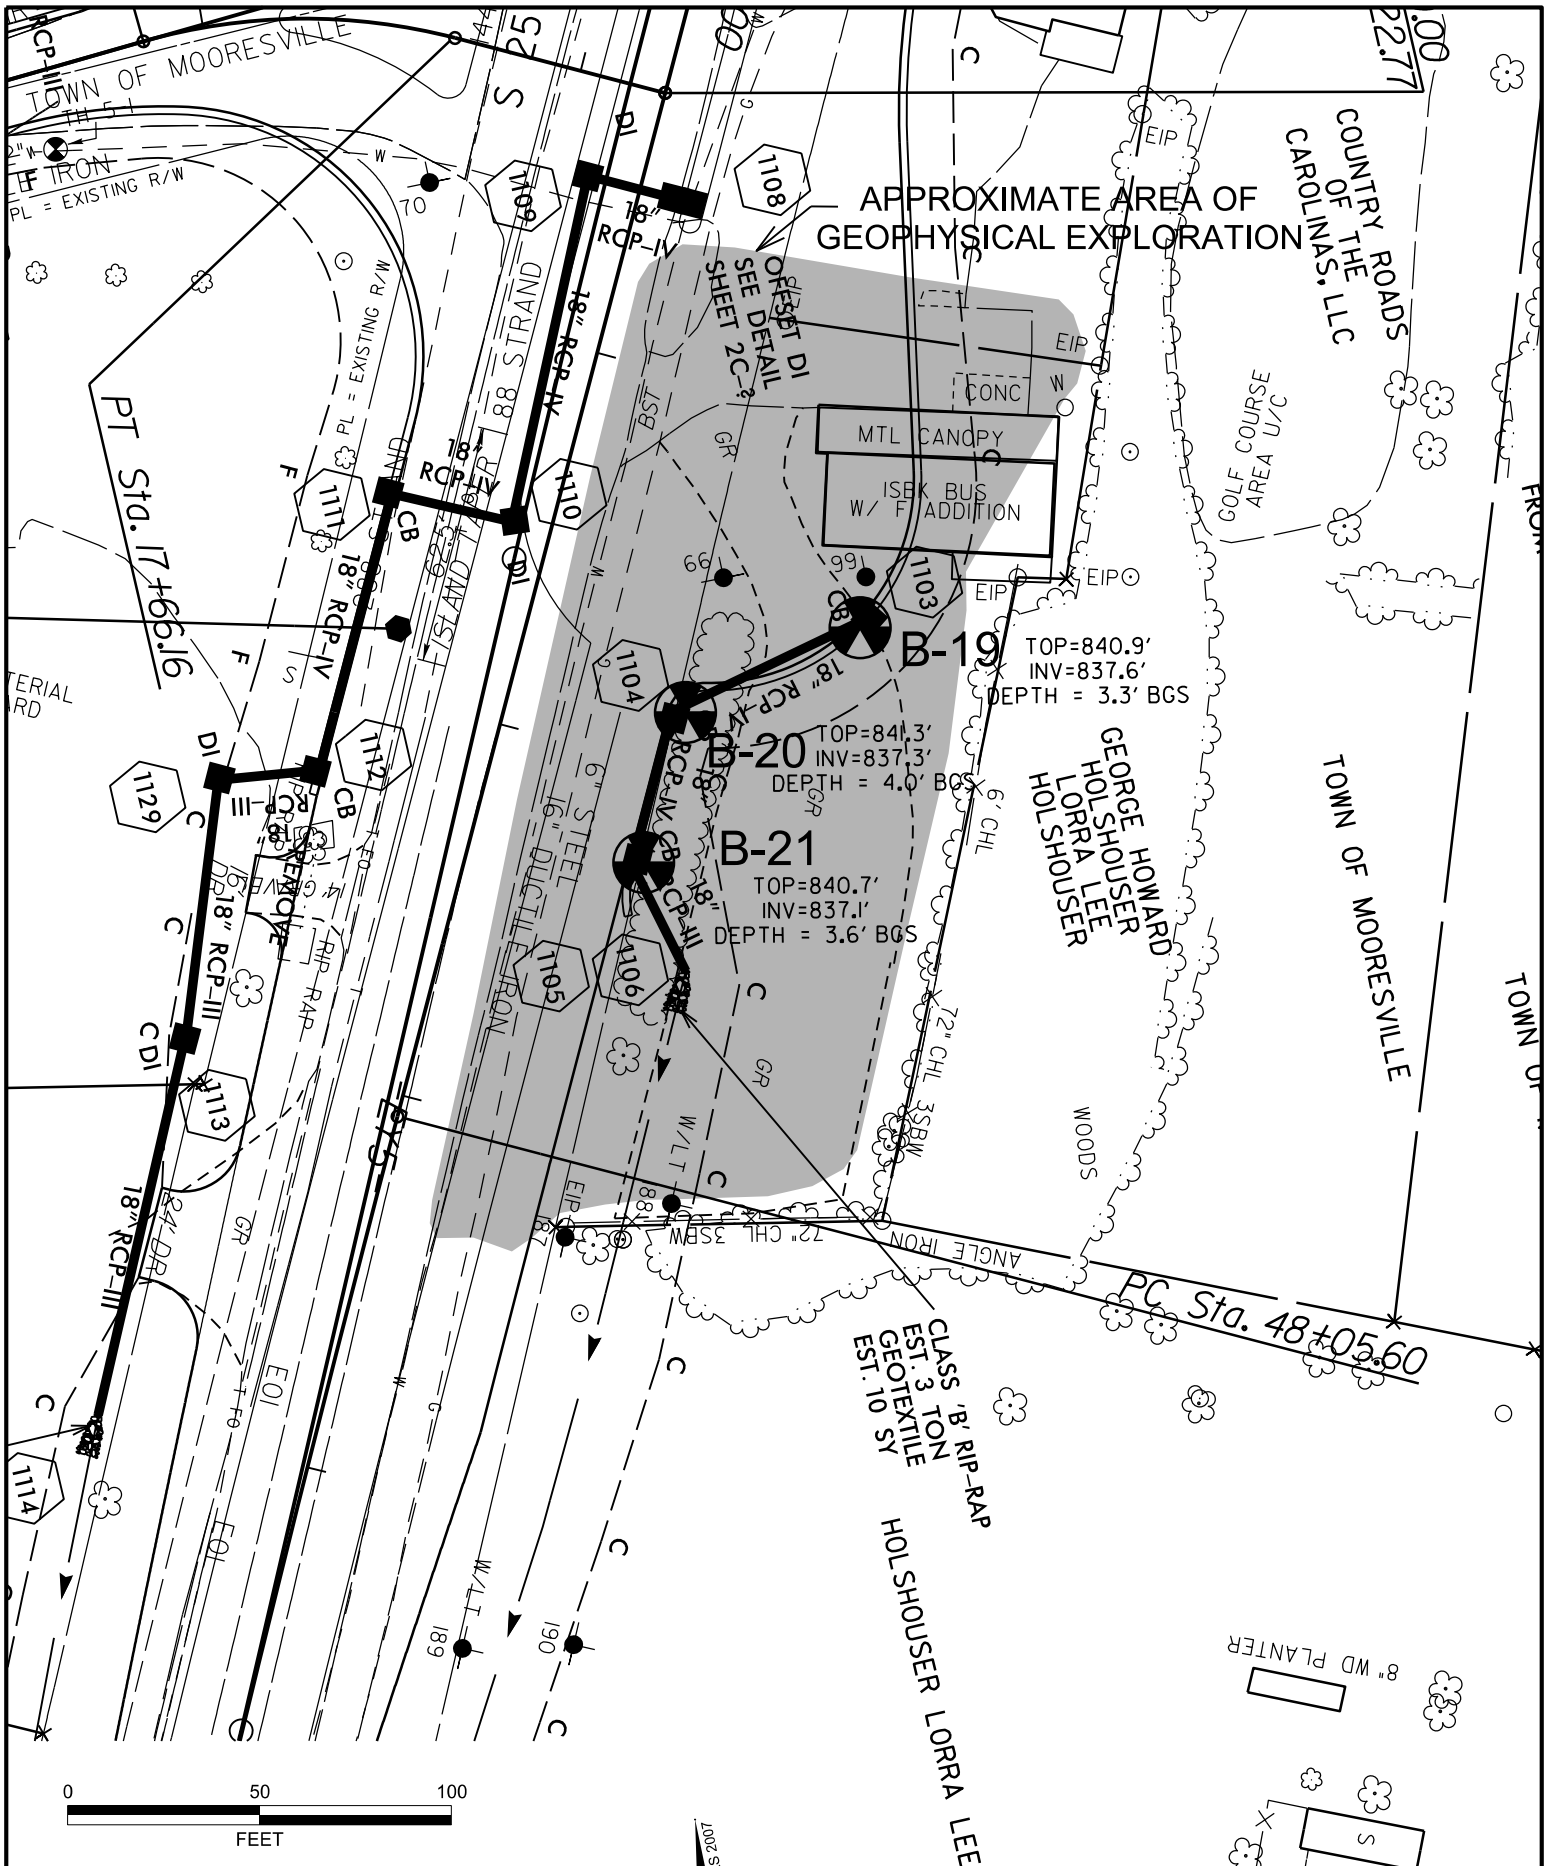
BORING LOCATION PLAN
BRAWLEY SCHOOL ROAD
PARCEL 76
GEORGE HOWARD & LORRA LEE HOLSHOUSER
IREDELL / NORTH CAROLINA
WBS NO.: 34554.2.4 | TIP NO.: R-3833C
FALCON PROJECT NO. G18063.02

Falcon and our subcontractor advanced three borings (B-19, B-20, and B-21) to the proposed excavation depth of the drainage features, utilities, or roadway/ditch cut being assessed. Groundwater was not observed. Please see the Boring Location Plan in the attachments for a visual depiction of the boring locations. The coordinates (latitude and longitude) that correspond to the boring locations are shown below in Table No. 1 Boring Coordinates.

B-19
TOP=840.9'
INV=837.6'
DEPTH = 3.3' BGS

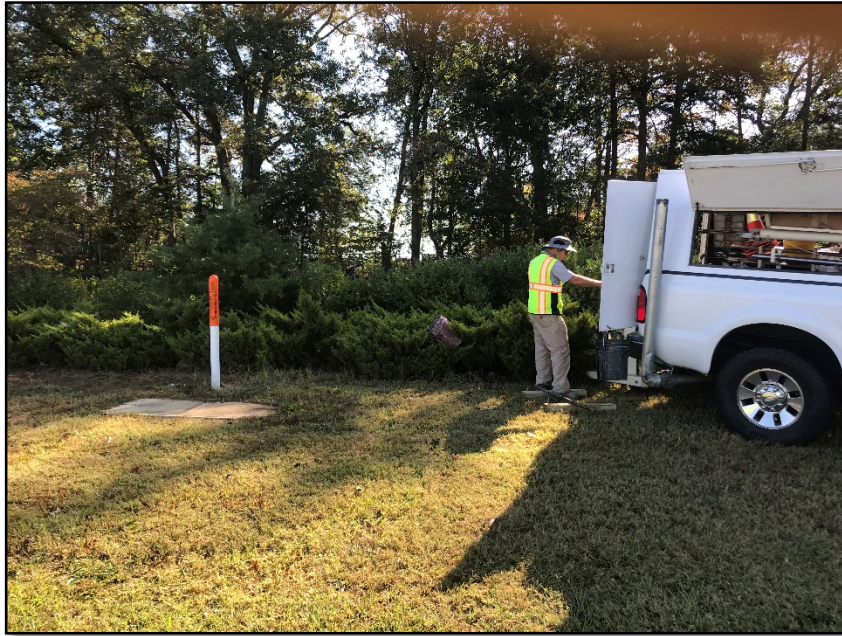
Photograph No. 1: General view of Boring B-19.

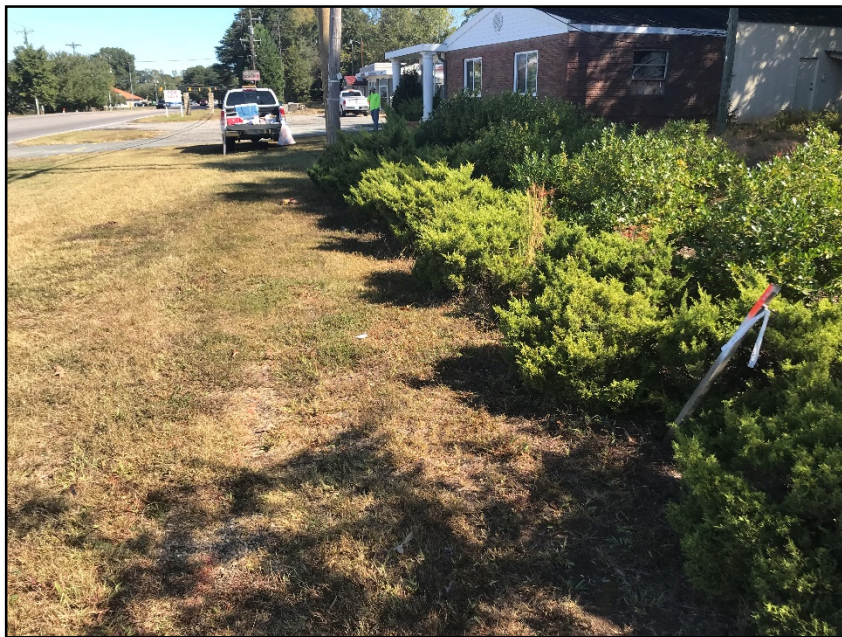
Photograph No. 2: General view of Boring B-20.
