PRELIMINARY SITE ASSESSMENT

SR 1100 (BRAWLEY SCHOOL ROAD) IMPROVEMENTS
TIP NO. R-3833C, WBS NO. 34554.2.4

NCDOT PARCEL NO. 74

OWNER: COUNTRY ROADS OF THE CAROLINAS, LLC
2861 CHARLOTTE HIGHWAY
MOORESVILLE, IREDELL COUNTY, NORTH CAROLINA

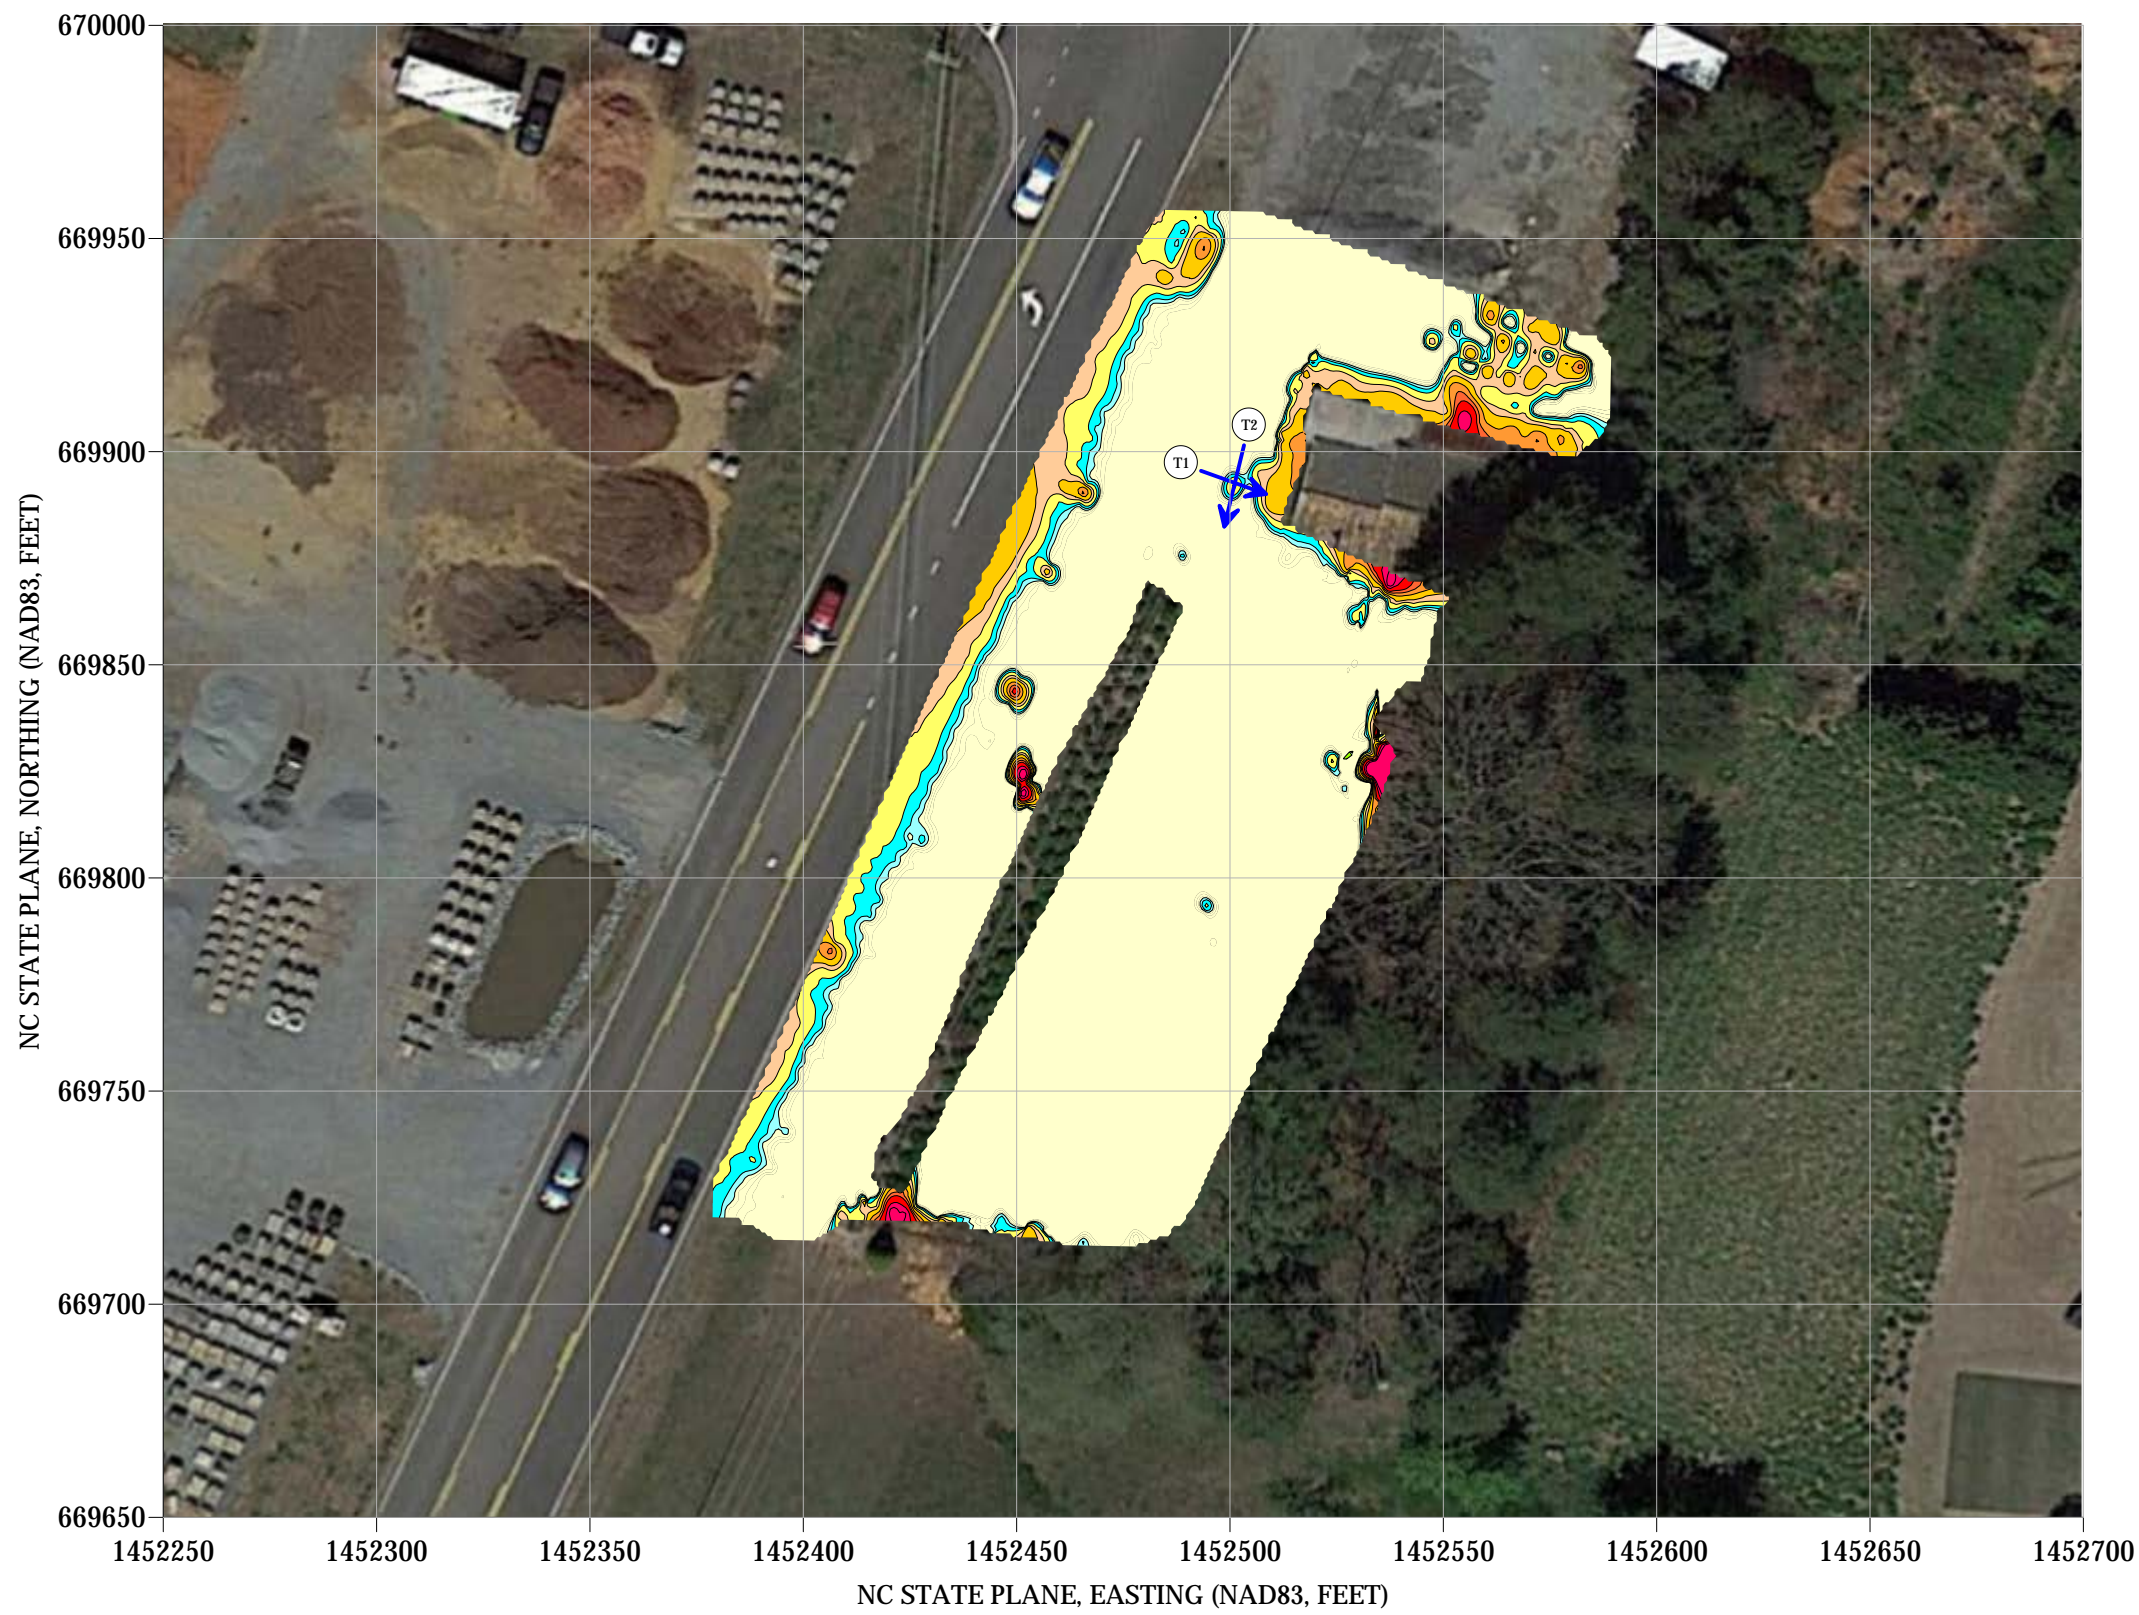
LOCATIONS OF GPR TRANSECTS

GPR Transects 1-2 were performed across the suspected septic tank (EM Anomaly 3), just west of the building. These transects showed lateral reflectors, consistent with what is typically observed with septic tanks. The suspected septic tank (Suspected Septic Tank #1) was approximately 9 feet long by 6.5 feet wide. **Figure 4** provides the location and size of the suspected septic tank overlain on an aerial, along with ground-level photographs.

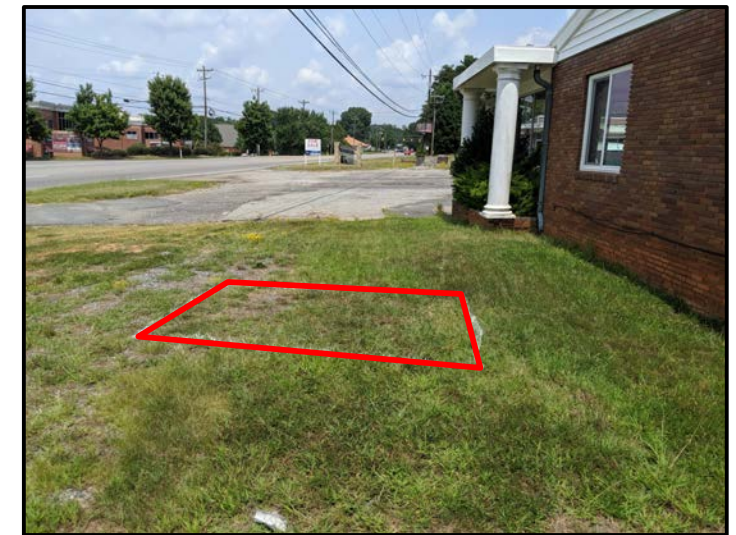
LOCATION OF ONE SUSPECTED SEPTIC TANK

View of One Suspected Septic Tank Facing Approximately East

View of One Suspected Septic Tank Facing Approximately North
