**PROJECT SPECIAL PROVISIONS  
GEOENVIRONMENTAL**

**CONTAMINATED SOIL (5/26/2022)**

## GEOENVIRONMENTAL PHASE II INVESTIGATION

NCDOT PARCEL 002  
QUALITY OIL COMPANY  
KERNERSVILLE – KERNERSVILLE LOOP FROM SR 1969 (PINEY GROVE RD) TO NC 150 (N. MAIN ST)  
743 PINEY GROVE RD  
FORSYTH COUNTY, NORTH CAROLINA  
WBS NUMBER 47138.1.1  
TIP NUMBER U-6003  
FORSYTH COUNTY PIN # 6887-40-2970.000

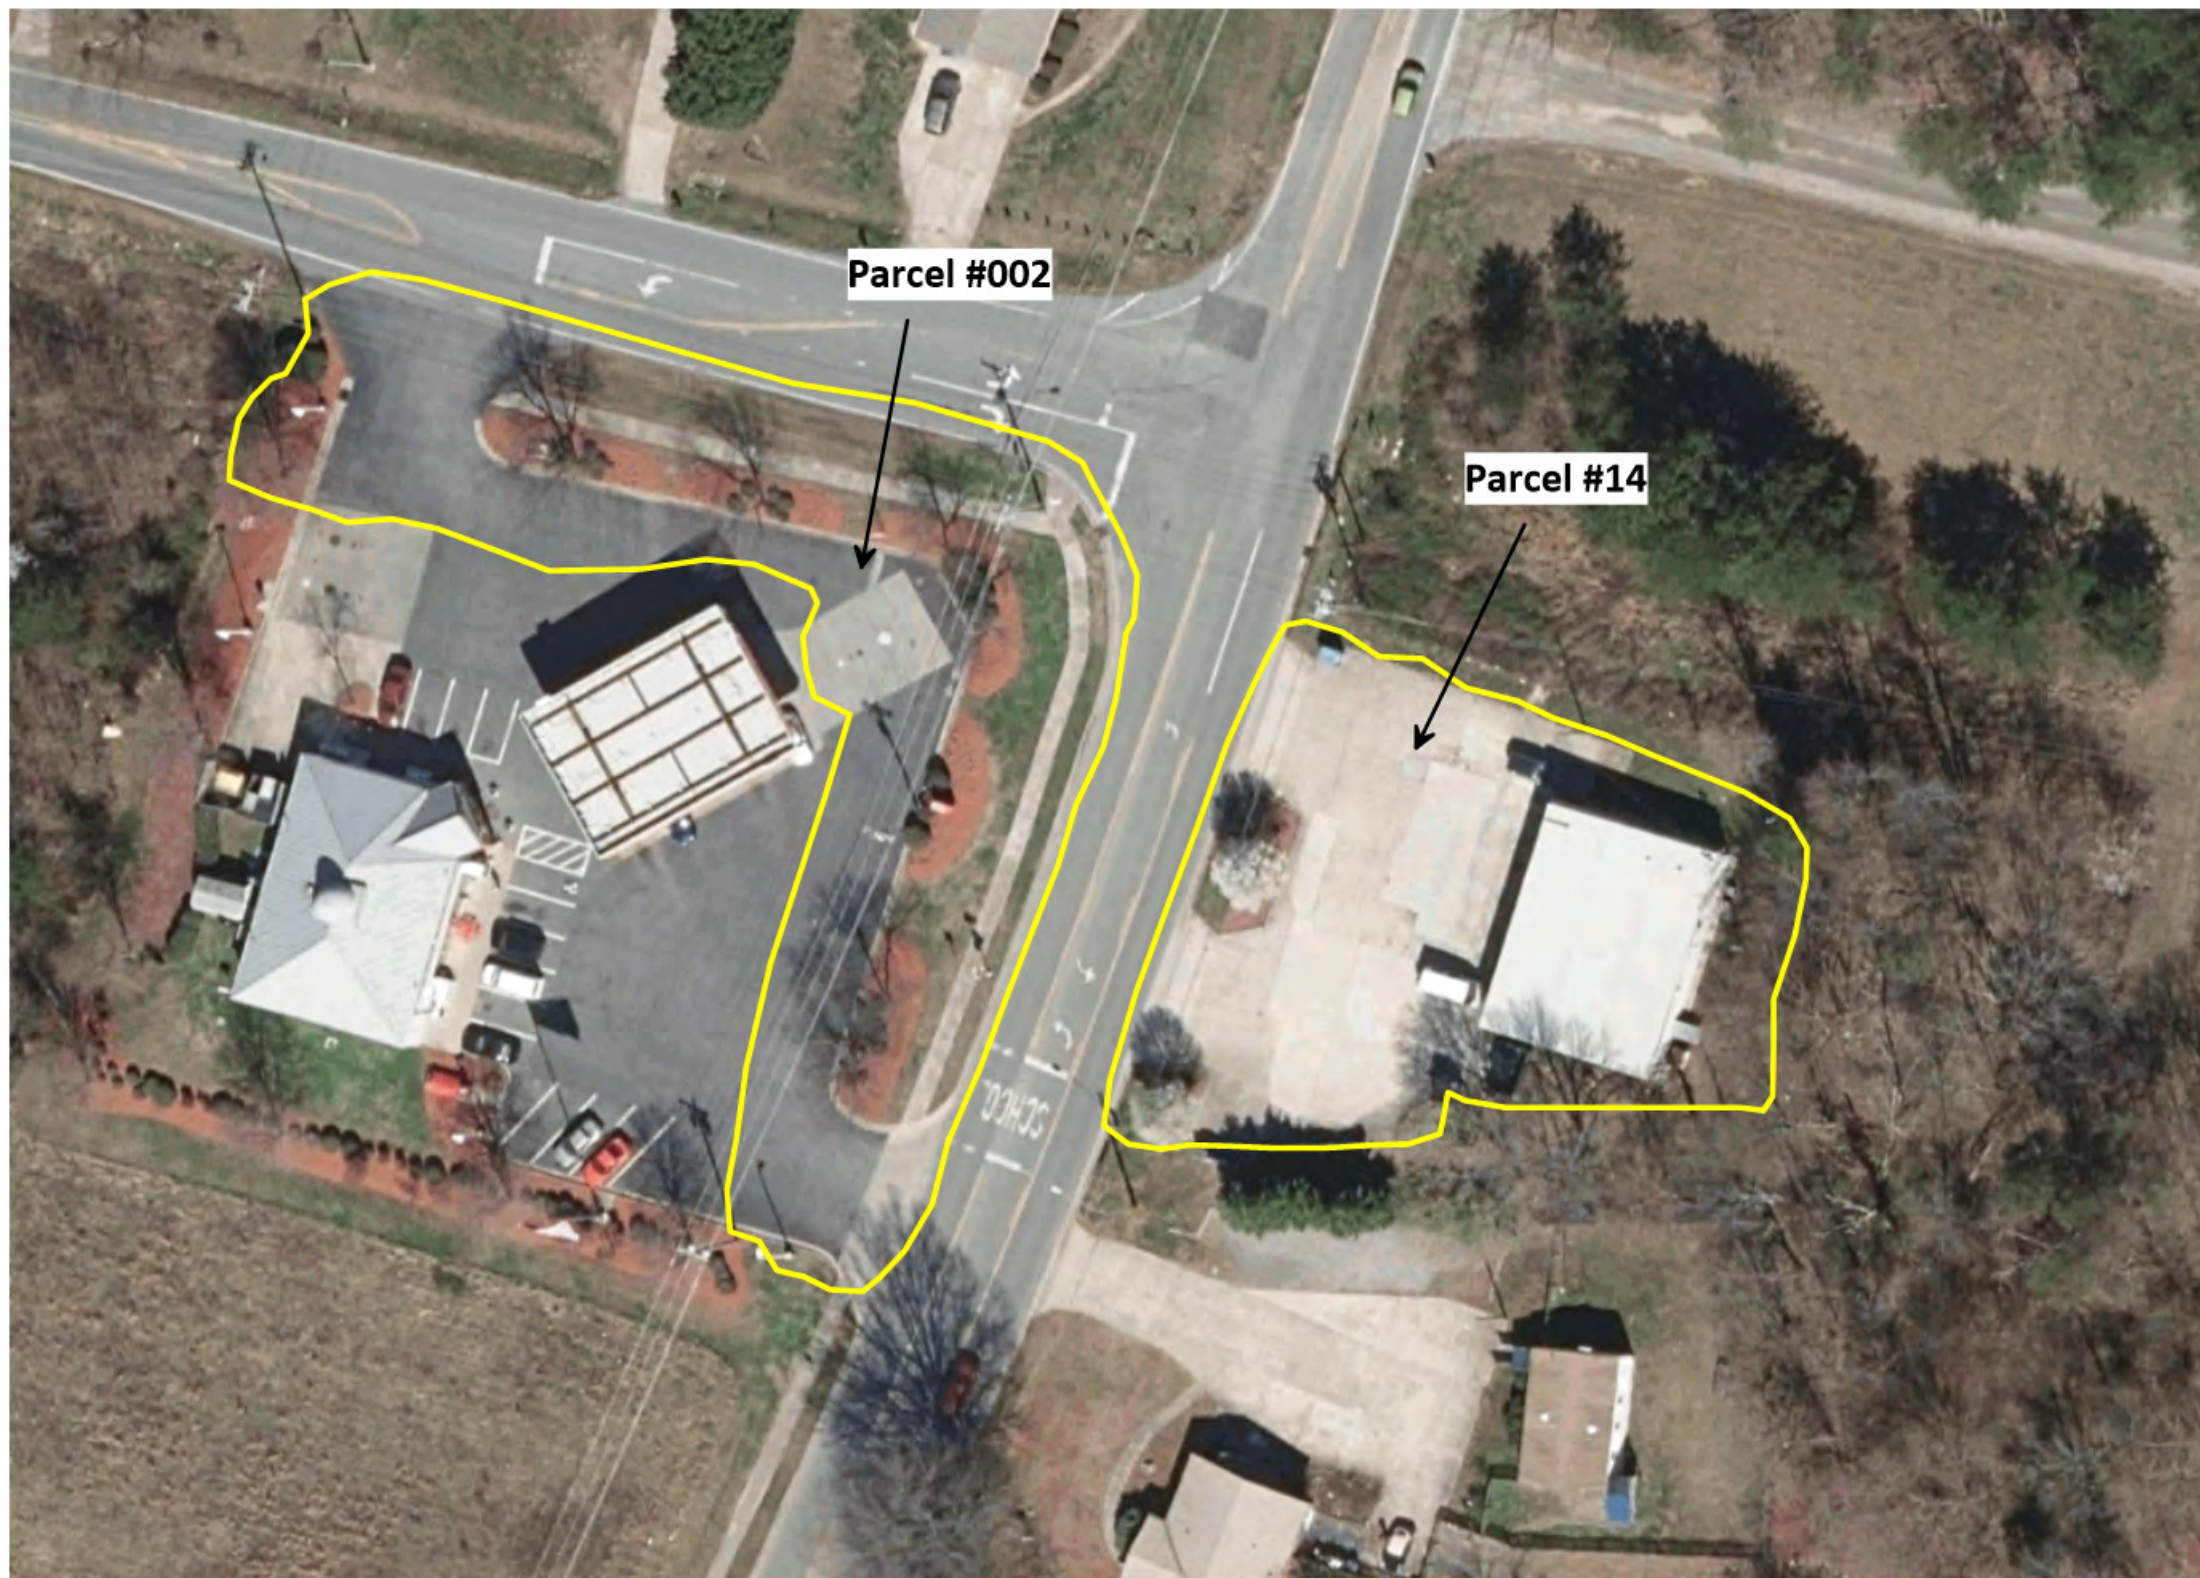
Figure 4	Geophysical Evaluation EM In-phase (Metal Detection) Results Map
	NCDOT U-6003 Linville Springs Rd and Piney Grove Rd Kernersville, NC
<i>Geo Solutions Ltd.</i>

Geo Solutions completed an EM evaluation of the site with parallel profiles spaced approximately 3 feet apart over both sites (Figure 2). Once adequate survey coverage was achieved, the EM field data were post-processed to produce a comma separated variable (CSV) file that was then transferred to a laptop computer. These data were then processed using software developed by Geophex to calculate the apparent conductivity and in-phase values for each EM frequency collected (1470Hz, 4110 Hz, 9810 Hz, 32,190 Hz, 60000 Hz, and 90030 Hz). Typically, the in-phase data (sometimes referred to as the metal detection mode) is more representative of buried metallic materials whereas the apparent conductivity is more representative of non-metallic conductive buried materials. The apparent conductivity response can also be elevated in the presence of large metal features. By evaluating both the in-phase and apparent conductivity responses, the horizontal extents of conductive and metallic materials can be characterized. All the frequencies were evaluated and the 9,810 Hz data was chosen to create figures for this report as it provided the best contrast to background site conditions. Shown on Figure 3 and Figure 4 are the EM in-phase and apparent conductivity maps respectively with explanations for the anomalous conditions observed in the EM data. Here, anomalous conditions are shown as

orange to red and blue hues where the background site conditions are shown as light yellow and green hues. At the location of Parcel #014 the presence of reinforced concrete across the parking lot of the site caused a strong in-phase EM response. These areas of both strong negative and positive responses are typical of EM data collected over reinforced concrete. A known abandoned UST basin is present on site. The dispensers have been abandoned as well. In these areas where the excavation occurred, the area was covered over with non-reinforced concrete. At Parcel #002 a known active UST is present within the geophysical boundary. Here, the EM response was very weak in both the in-phase and apparent conductivity data. This would indicate that the UST is not constructed of steel. The UST is likely composed of fiberglass. A strong EM response was detected at the location of a metal sign and alarm system for the UST. There is another UST at the southwest side of Parcel #002 but it is located outside of the geophysical boundary and planned ROW.

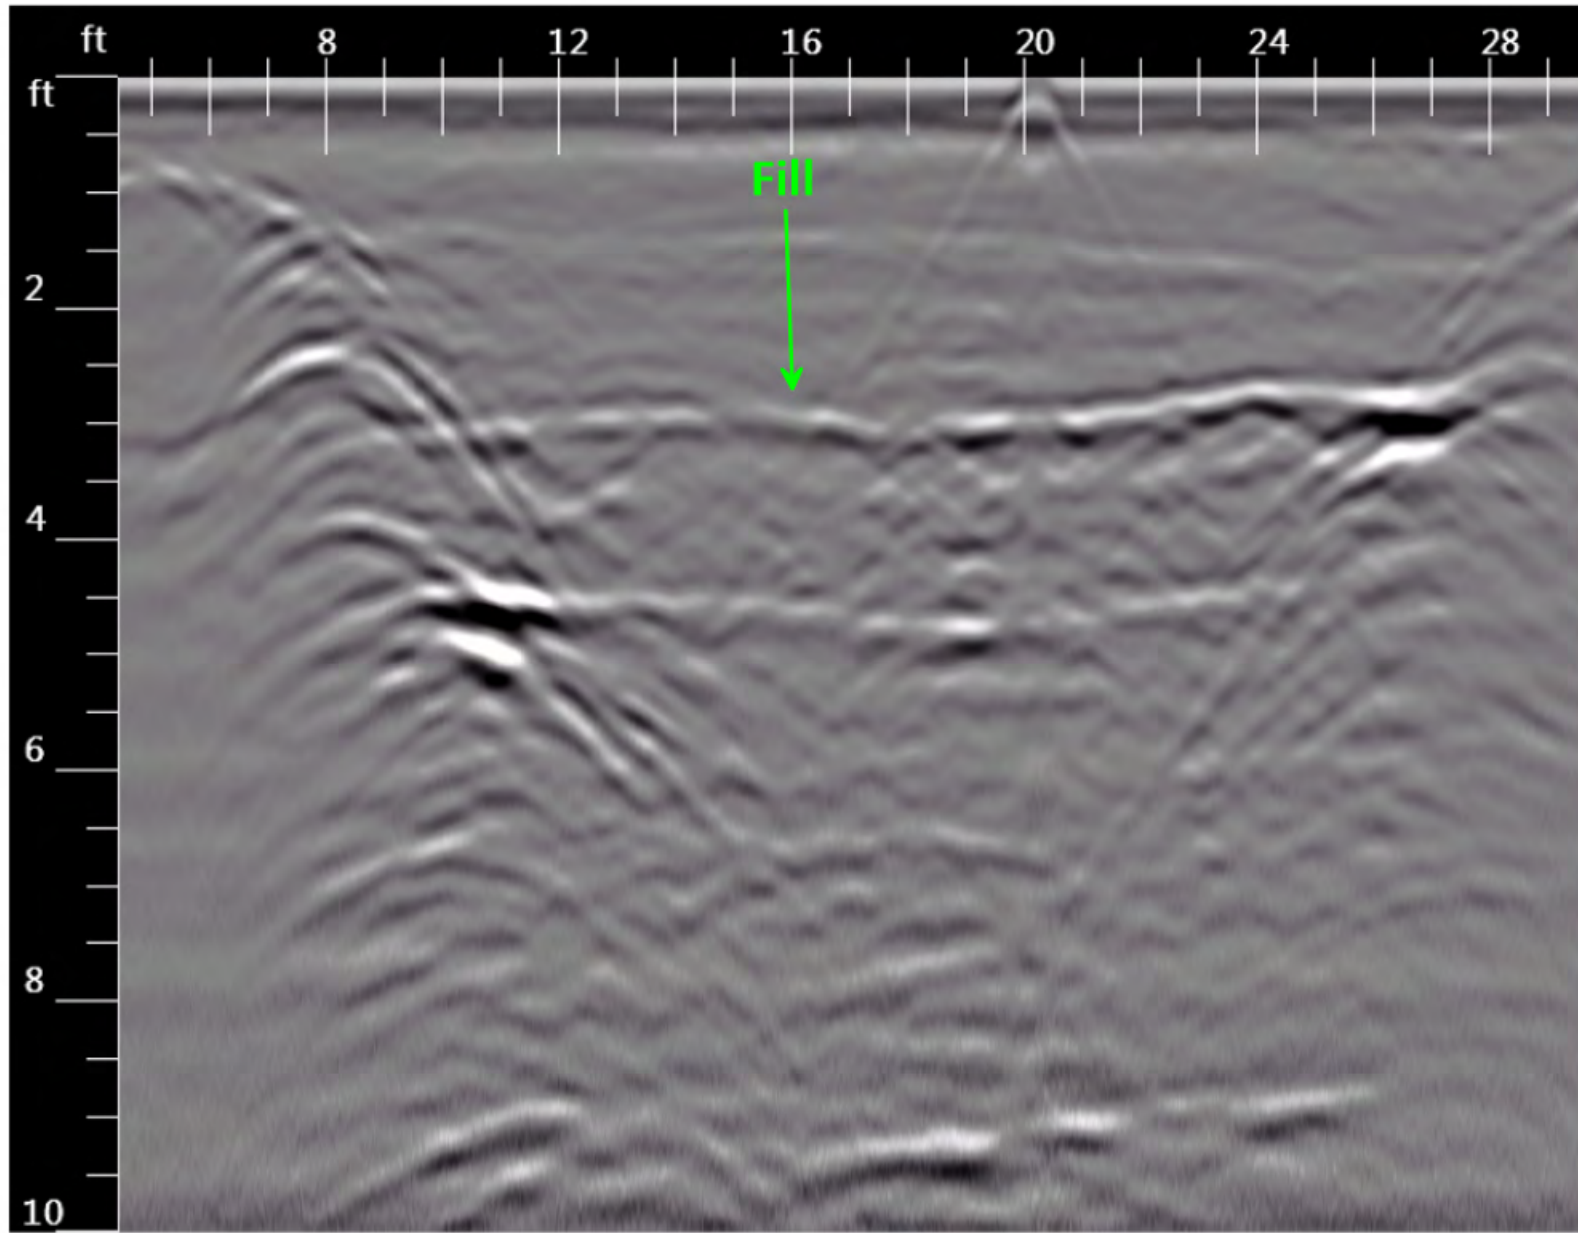
Transect collected across known abandoned UST Basin at Parcel # 014

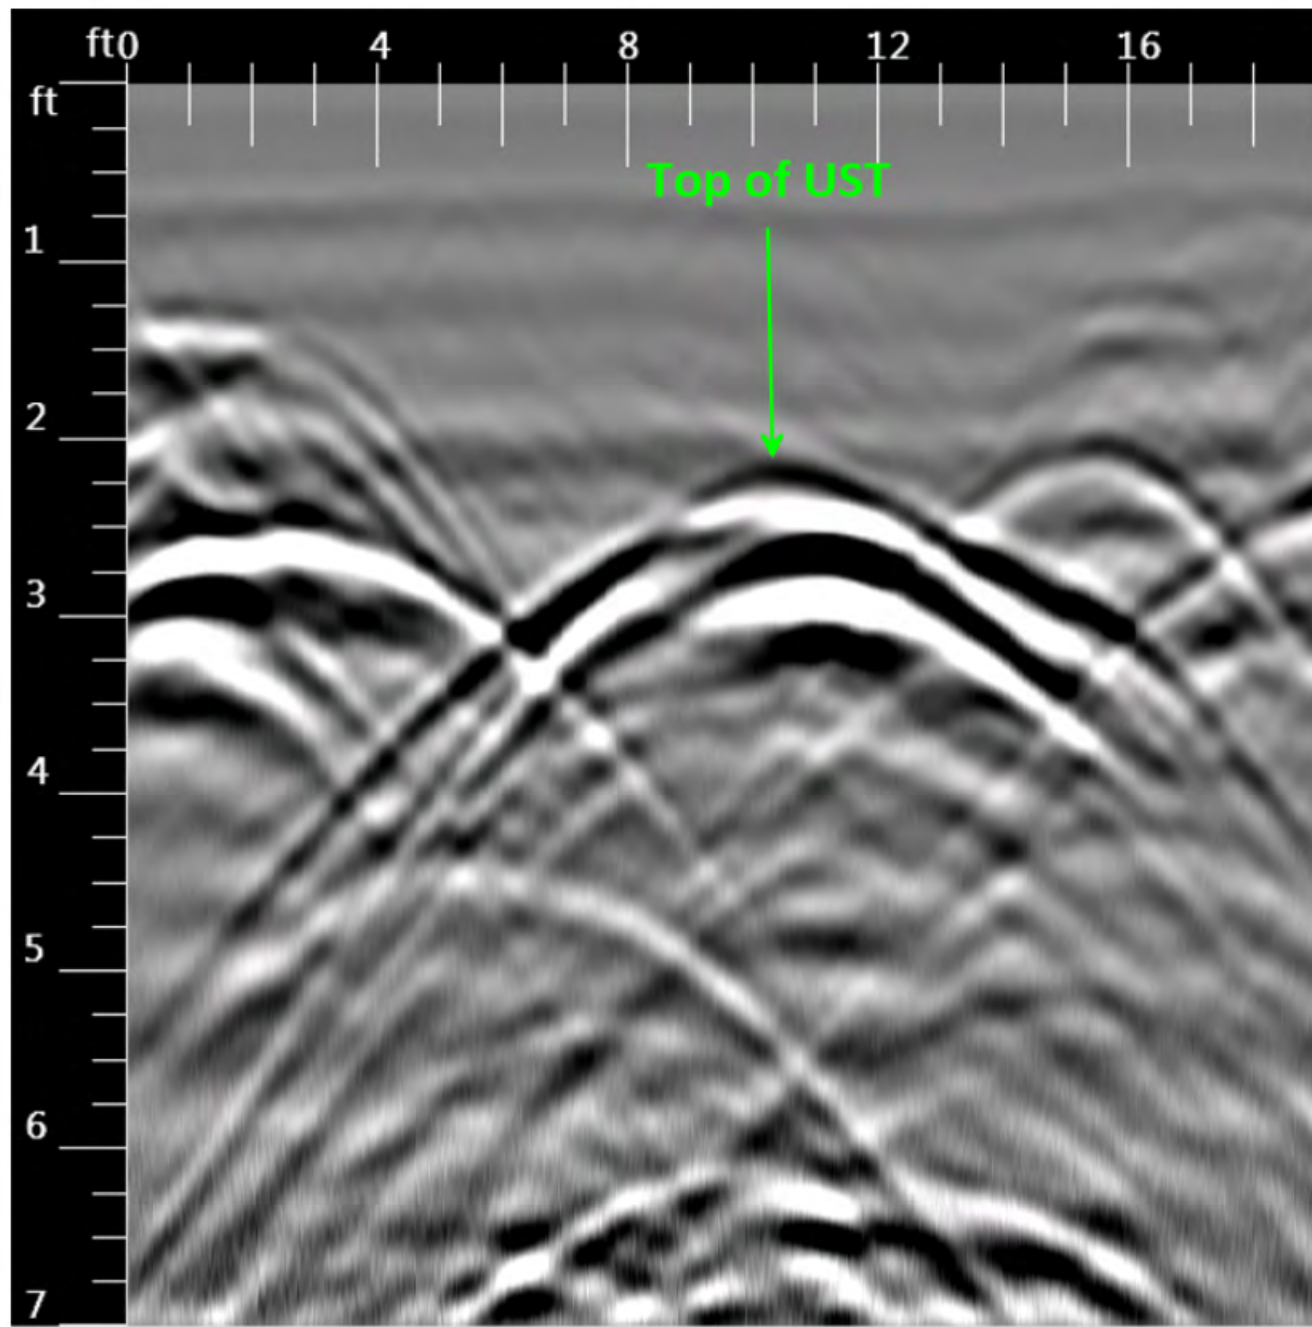
Figure 7	Geophysical Evaluation Ground-penetrating Radar Cross Section of Known UST at Parcel # 02
	NCDOT U-6003 Linville Springs Rd and Piney Grove Rd Kernersville, NC

Transect collected across known UST at Parcel # 2.  
Suspected to be composed of Fiberglass

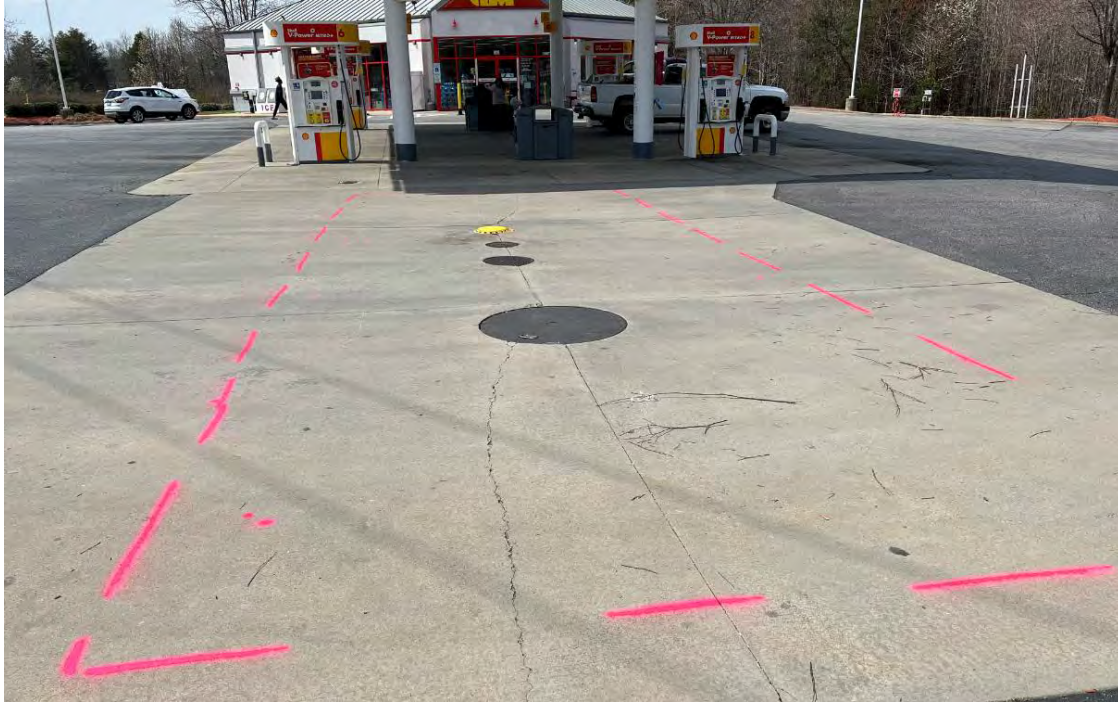
Photograph 1. Known active UST at Shell Station property.

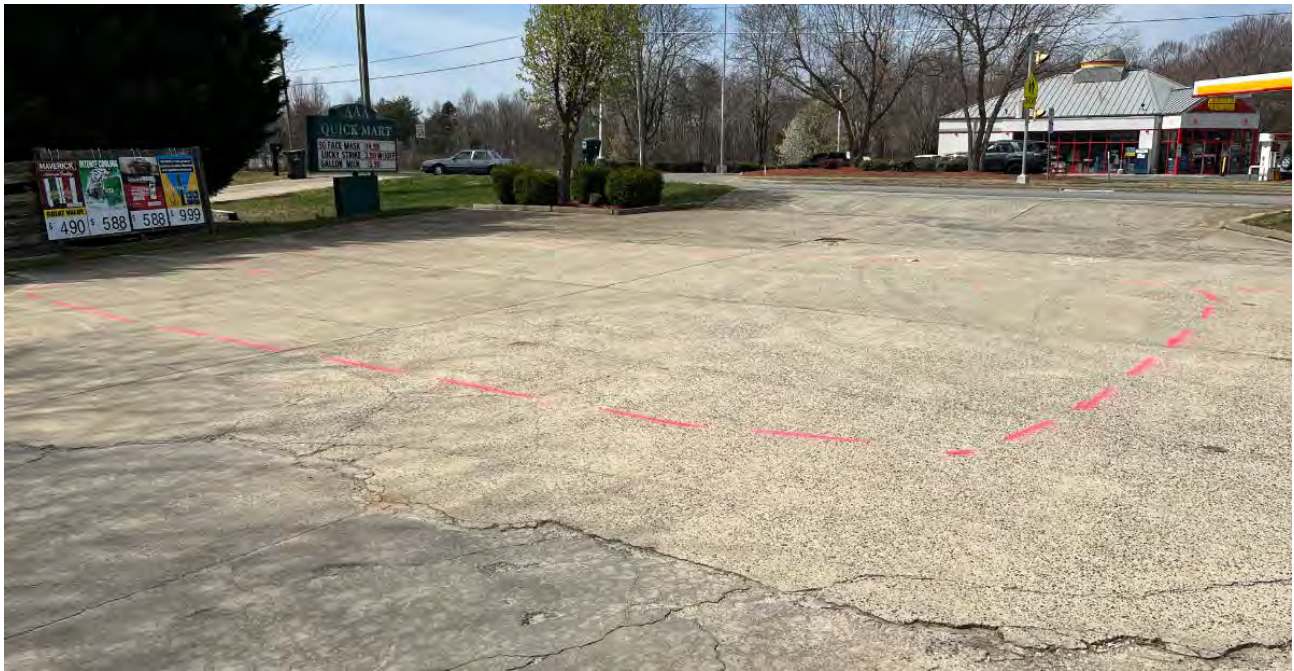
Photograph 2. Known abandoned UST Basin at the Quick Mart property.

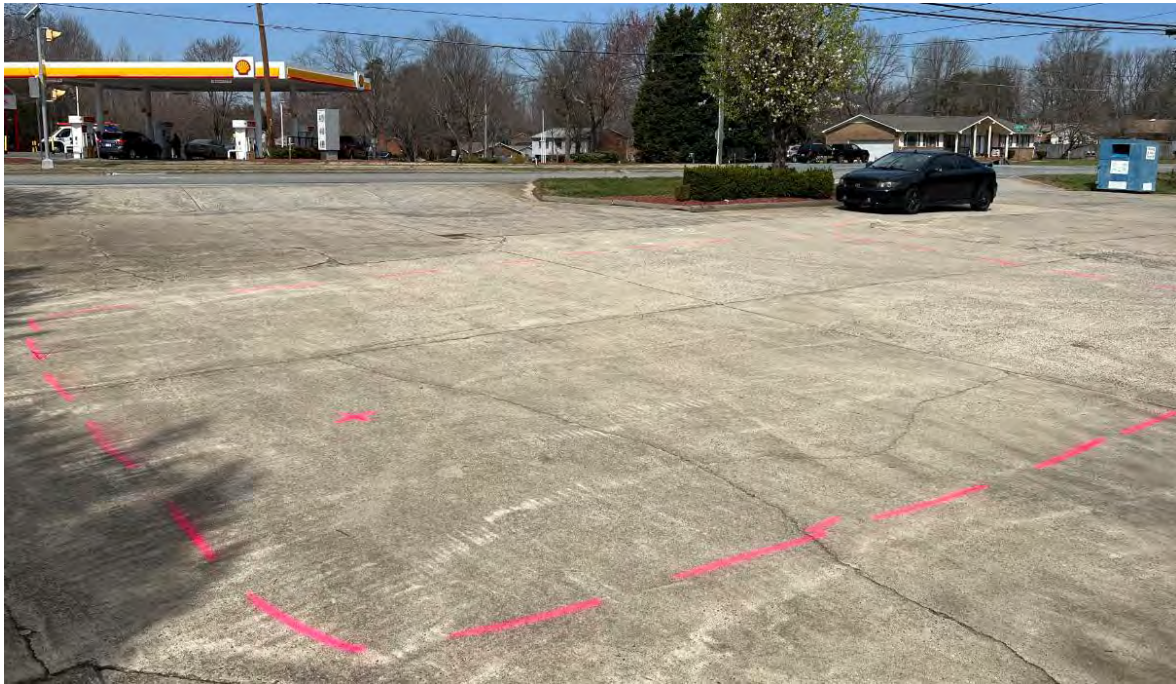
Photograph 3. Known abandoned UST Basin look toward former fuel dispensers at the Quick Mart property.

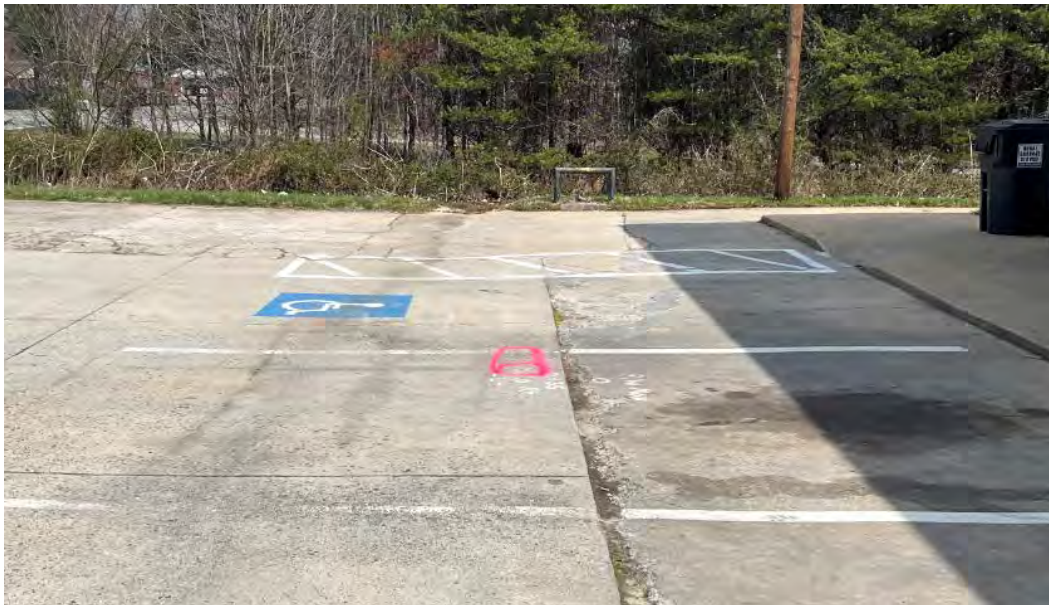
Photograph 4. Small Anomaly at Quick Mart property.

Figure 5 is a map documenting the results of the GPR evaluation. At Parcel #014 the known abandoned UST basin, fuel line trench, and abandoned dispenser basin was delineated with pink ground-marking paint. A small anomaly was detected near the west side of the building. There were no subsurface structures detected at Parcel #014. At Parcel #002 the known active UST was detected with GPR. This appears to be a single tank with multiple fuel cells. The approximate dimensions of the UST are 14 ft x 35 ft. The footprint of the UST and vent lines were marked with pink ground paint. Appendix A. is photographic log of these site features. Shown on Figure 6 are cross sectional images of the UST basin and dispenser basin at Parcel #014. Figure 7 is a cross sectional image of the known active UST at Parcel #002.

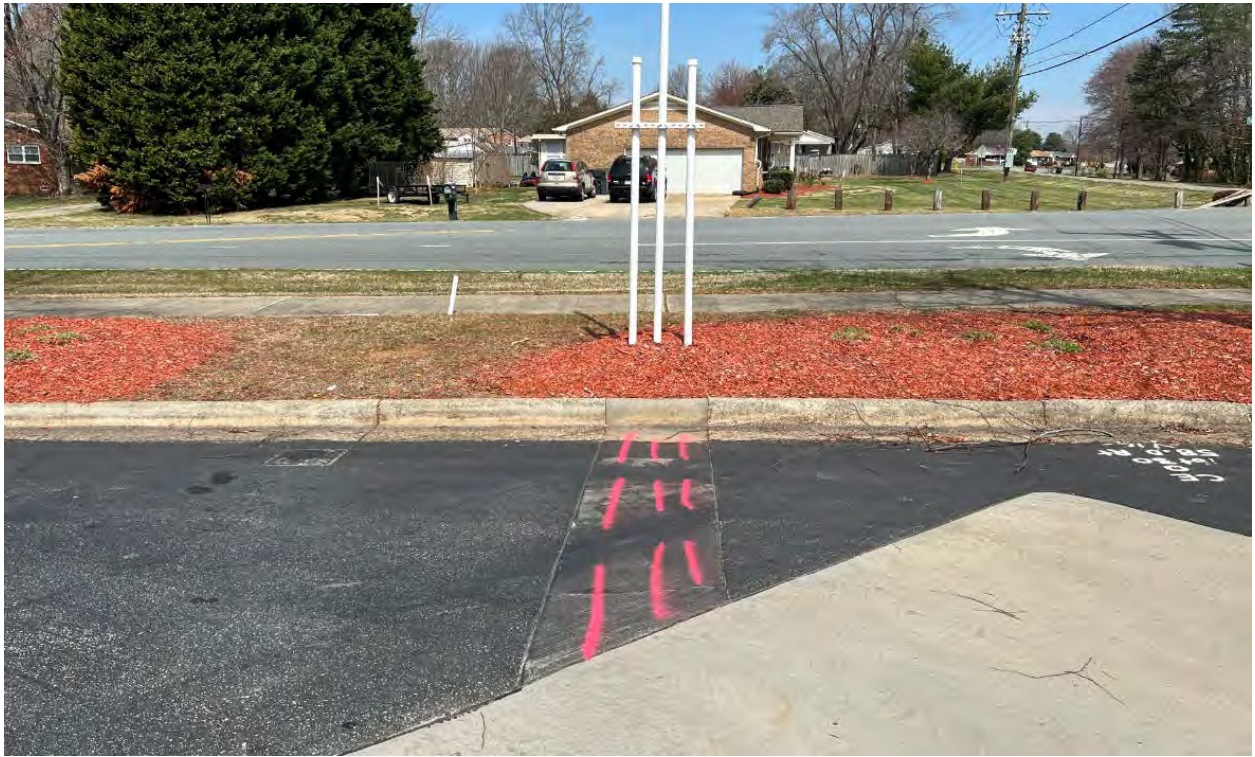
Photograph 5. Vent line at Shell Station property.

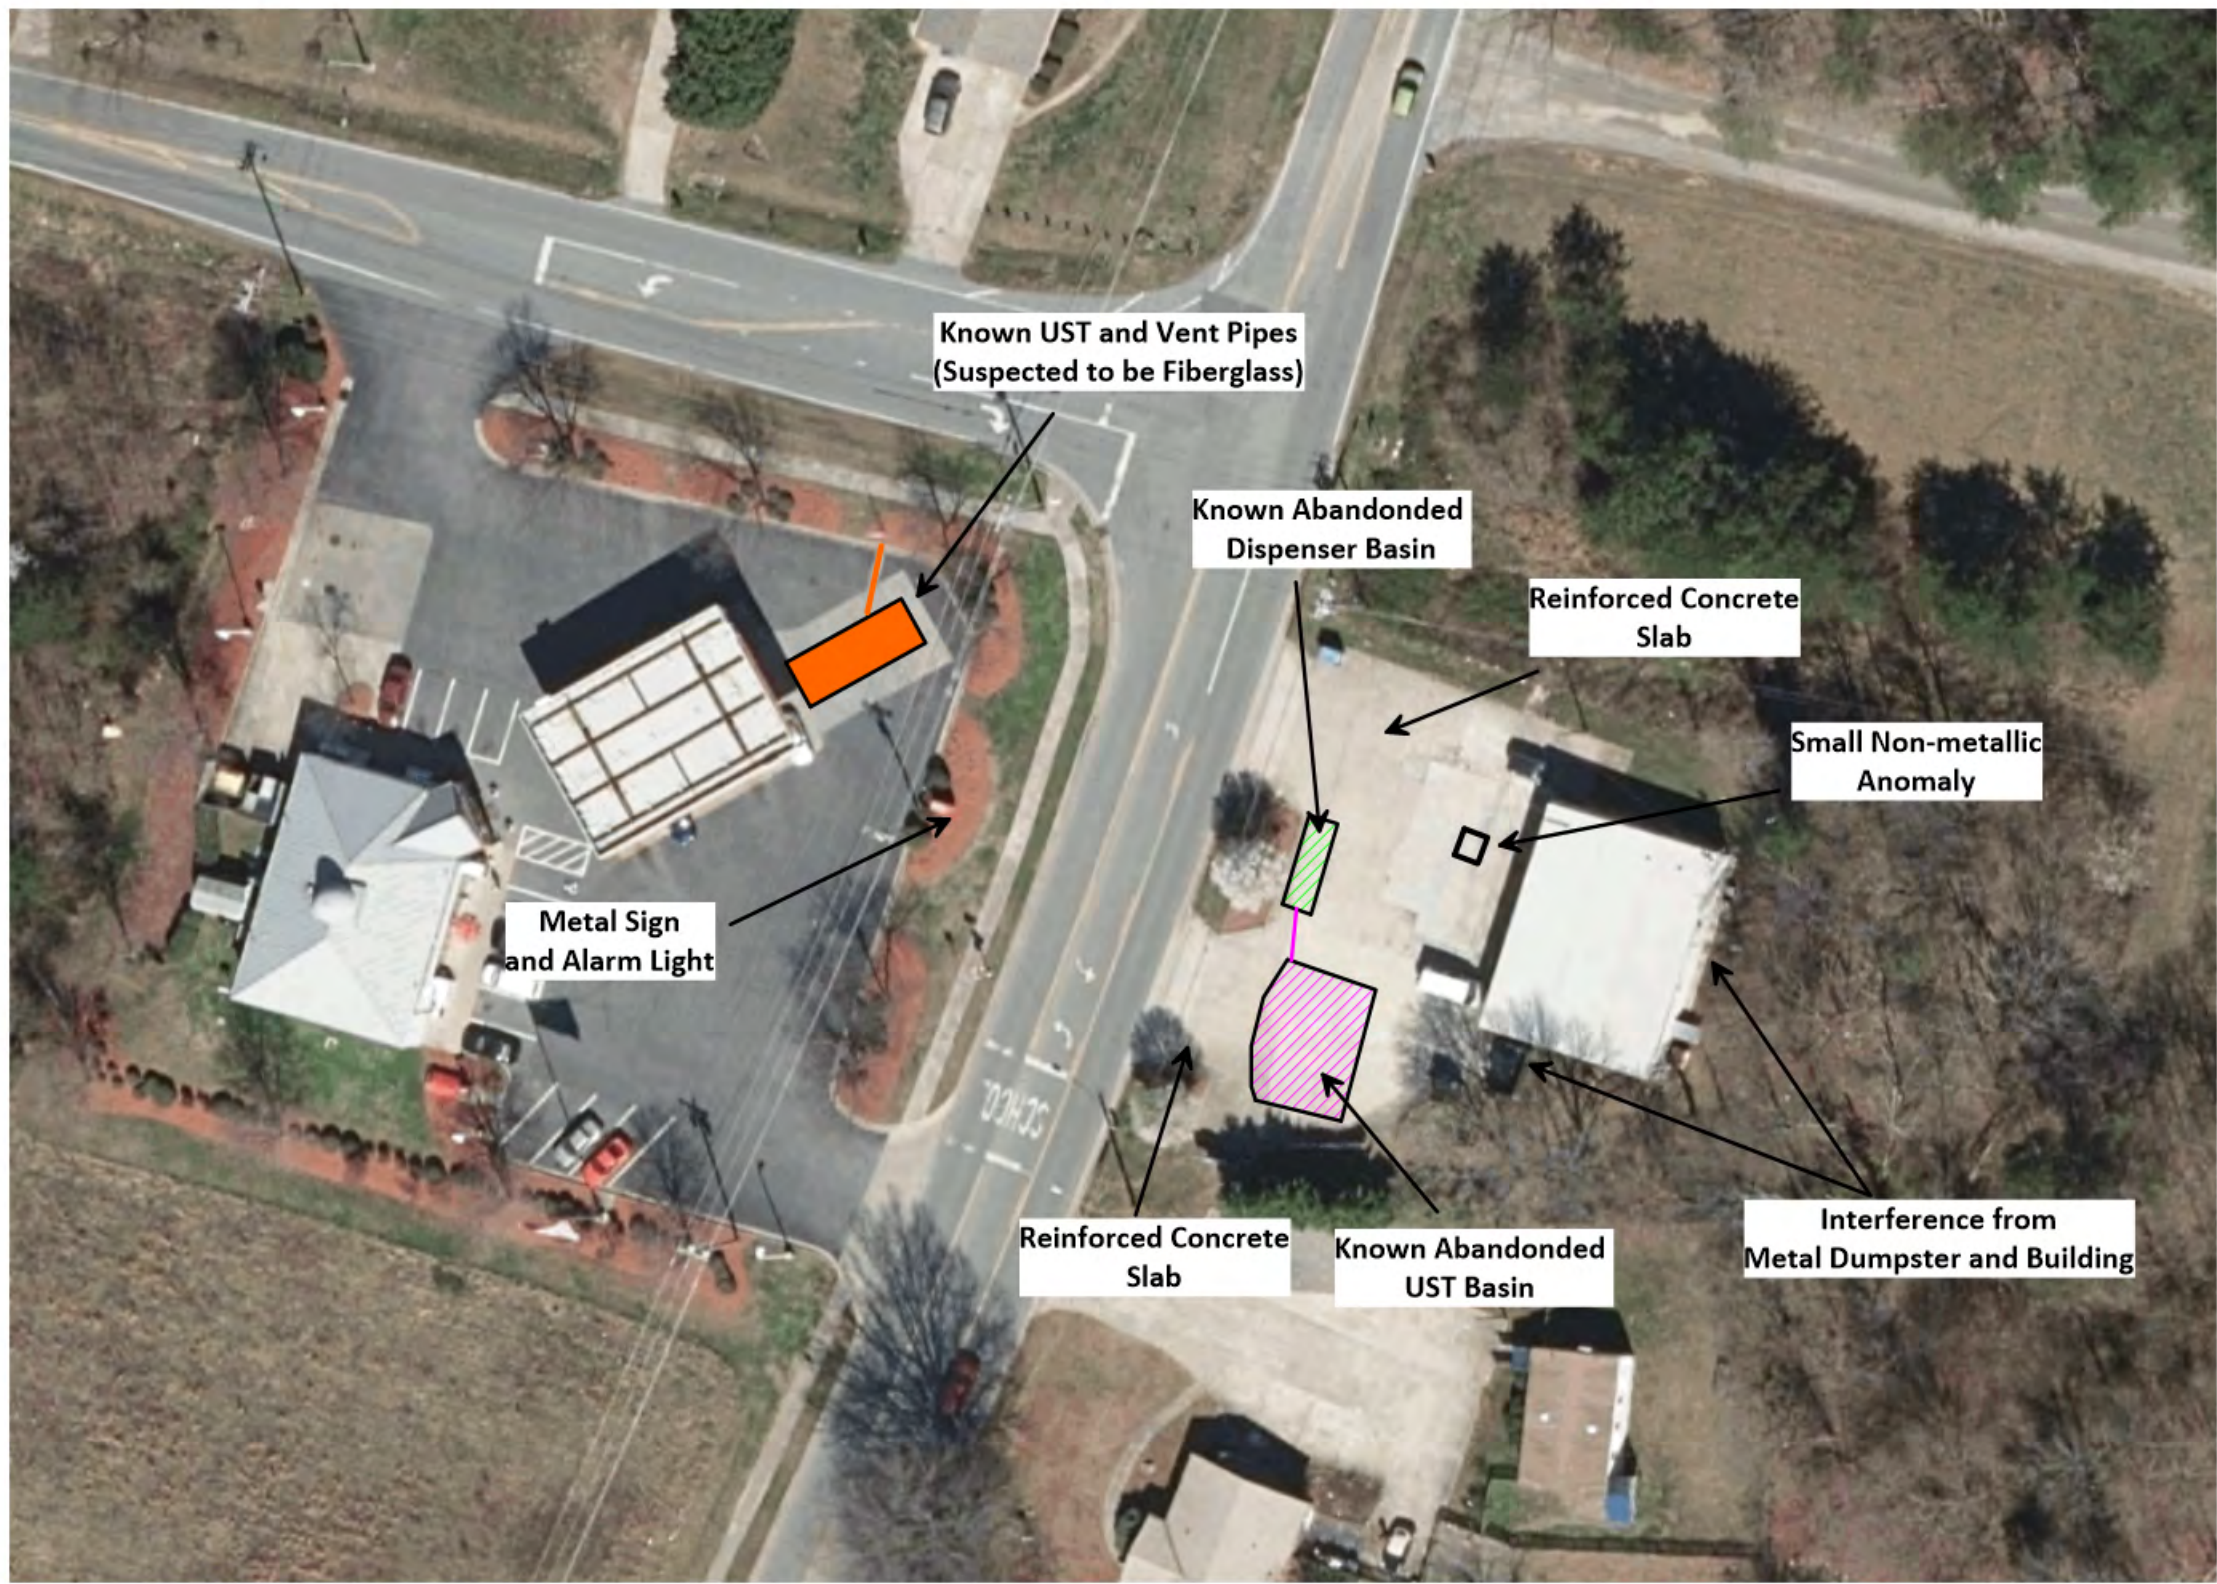
Figure 5	Geophysical Evaluation Ground-penetrating Radar Results Map NCDOT U-6003 Linville Springs Rd and Piney Grove Rd Kernersville, NC

- Known UST
- Known Abandoned UST Basin
- Known Abandoned Fuel Dispenser Area
- UST Vent Lines
- Abandoned Product Lines Basin (No Lines in Place)
- Small GPR Anomaly

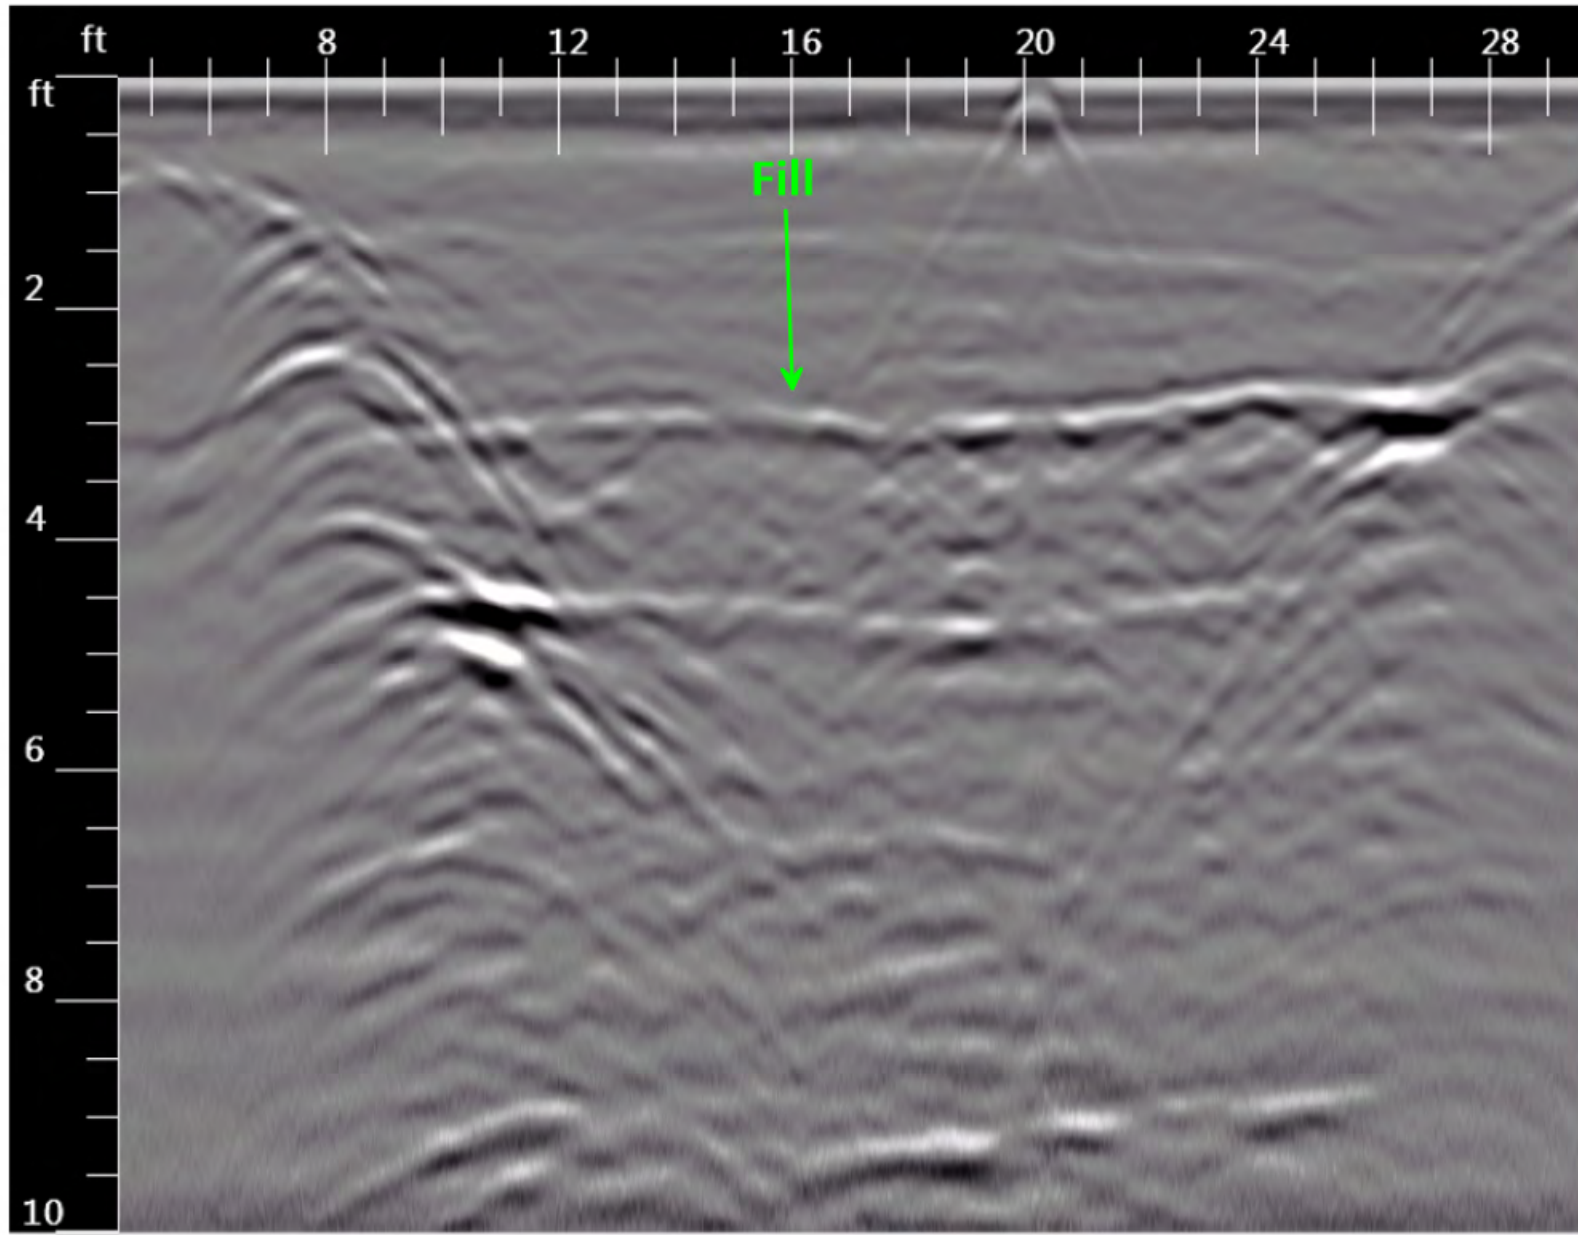
Transect collected across known abandoned UST Basin at Parcel # 014

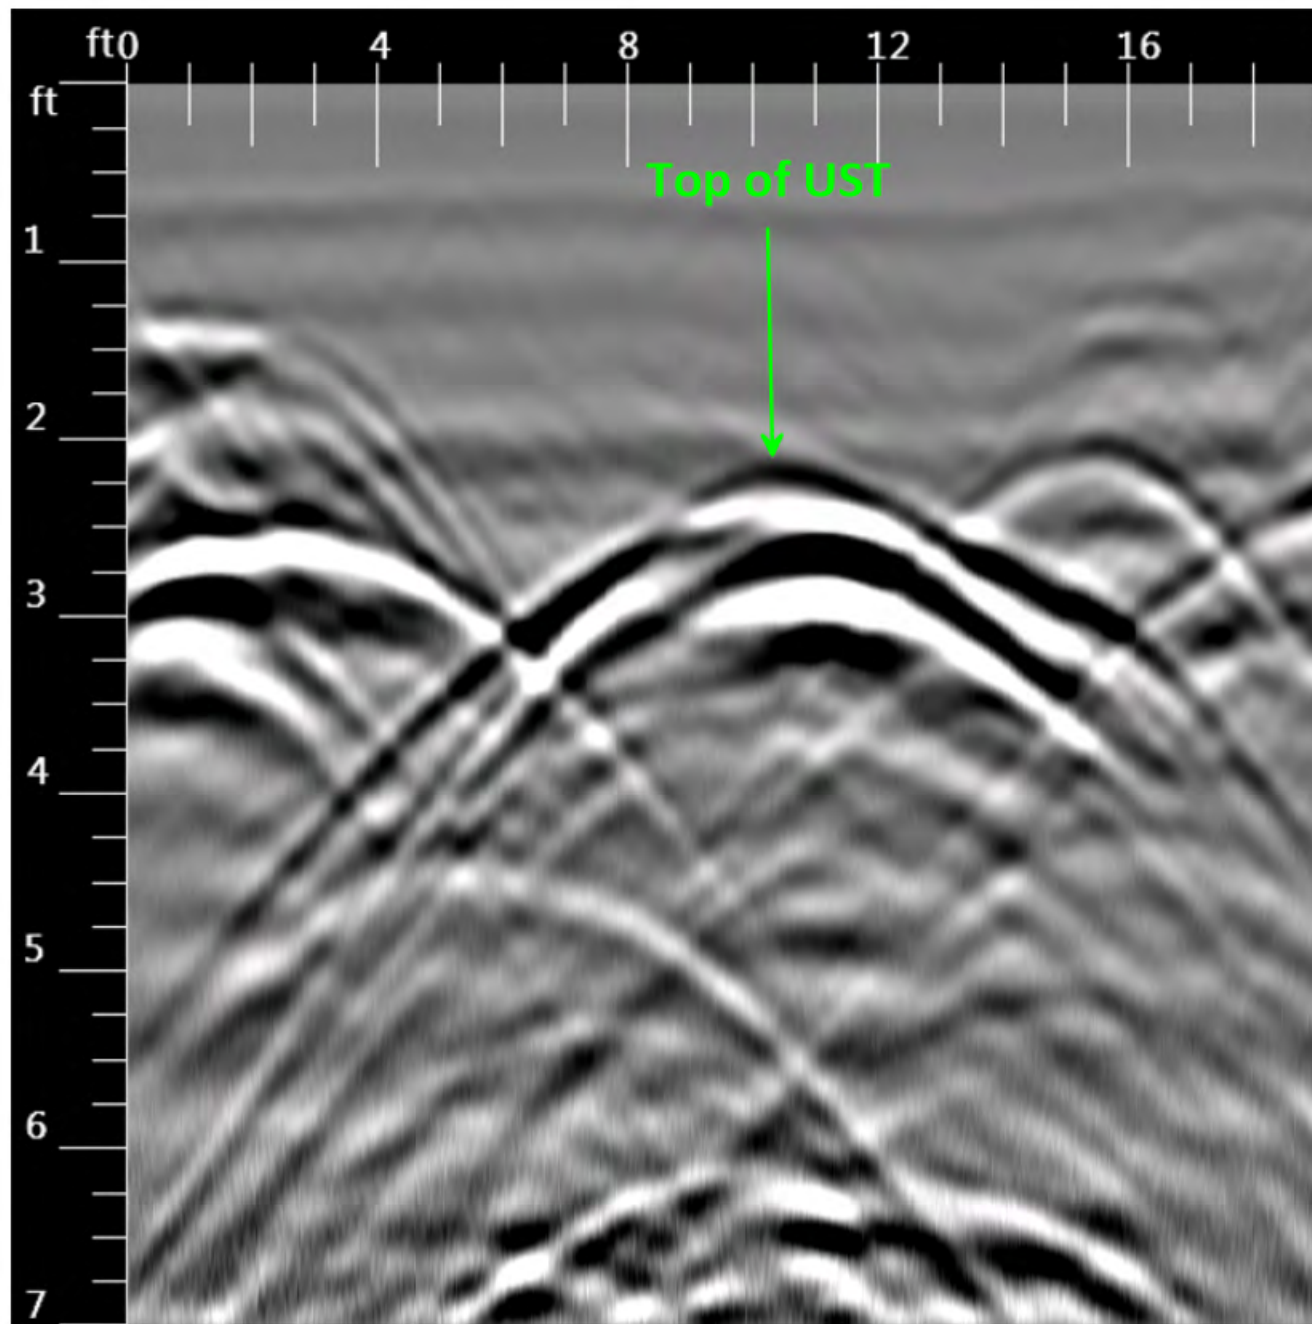
Figure 7	Geophysical Evaluation Ground-penetrating Radar Cross Section of Known UST at Parcel # 02
	NCDOT U-6003 Linville Springs Rd and Piney Grove Rd Kernersville, NC

Transect collected across known UST at Parcel # 2.  
 Suspected to be composed of Fiberglass

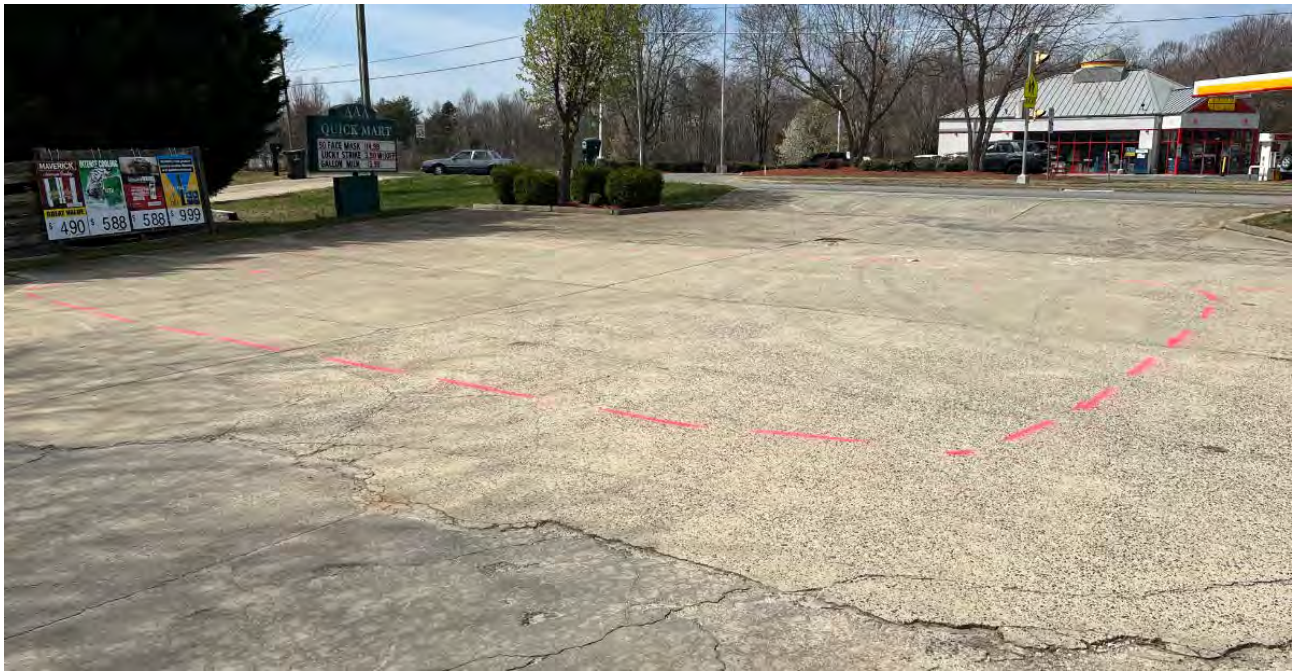
Photograph 2. Known abandoned UST Basin at the Quick Mart property.

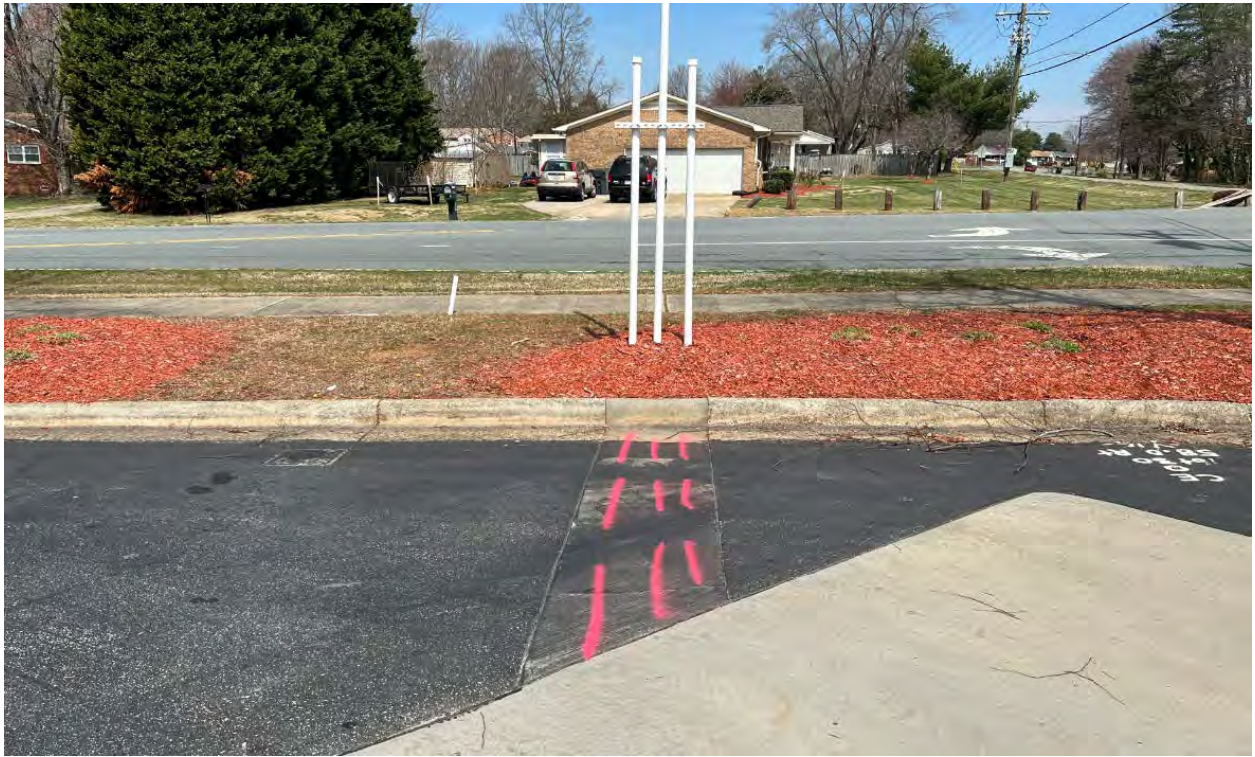
Photograph 5. Vent line at Shell Station property.

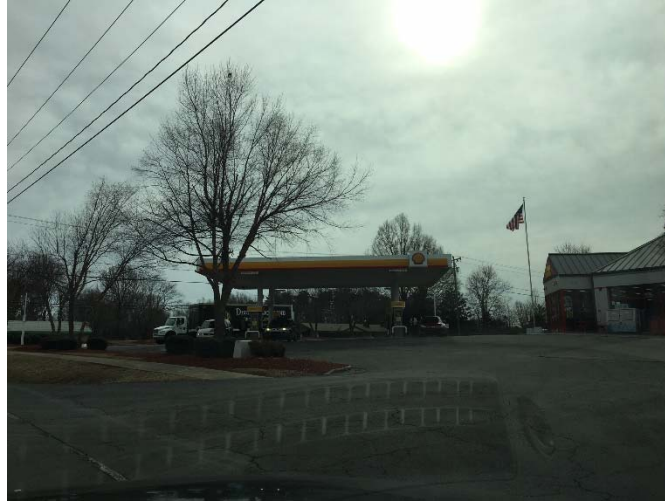
- 
- 1) **Property Owner** **NCDOT PIN: 6887-40-0932.00**  
Shell/Piney Grove Hardware/Quality Mart Quality Oil Company  
743 Piney Grove Road Incident No. 14435  
Kernersville, NC 27284  
Facility ID: 00-2-0000016019

This current gas station and convenience store is located on the west side of Piney Grove Road. According to the UST Section Registry there are three (3) tanks currently onsite (1 – 12,000 gallon diesel, 1- 10,000 gallon gasoline, & 1 – 15,000 gallon gasoline tanks). The current gasoline tanks were all installed on or about March 2000 and the diesel tank on or about December 2006. A total of four (4) historic tanks (1-1,000 gallon kerosene & 3-3,000 gallon gasoline tanks) were installed in 1967 and removed in 1994. This property appears in the Underground Storage Tank (UST), Leaking Underground Storage Tank (LUST) and LUST TRUST database. According to the ERIS database search, groundwater has been impacted with dissolved-phase petroleum compounds which were from the former onsite UST system and extends in the upgradient, lateral and downgradient directions. Soil contamination goes to 17 feet deep, approximately 2,500 tons. Due historic and current business practice, LUST and registry database inclusion this site has been included in this report.

**This site is anticipated to present moderate GeoEnvironmental impacts to the project.**

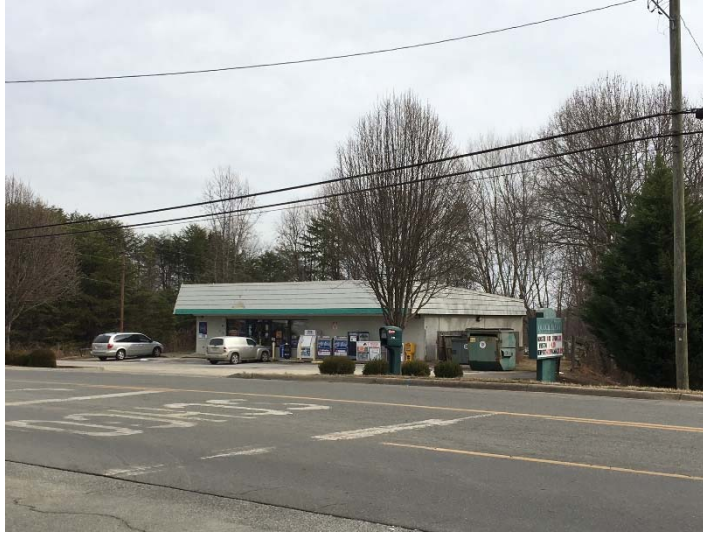
- 
- 2) **Property Owner**  
The Pantry #278  
744 Piney Grove Road  
Kernersville, NC 27284  
Facility ID: 00-0-000015059
- NCDOT PIN: 6887-40-2970.00**  
Malik M & Nyla Aslam  
Incident No. 30428

This current convenience store is located on the east side of Piney Grove Road. According to the UST Section Registry a total of two (2) historic tanks (2-10,000 gallon gasoline tanks) were installed in 1980 and removed in August of 2004. This property appears in the UST, LUST, LUST TRUST, and FUEL STATIONS database. According to the ERIS database search, the groundwater monitoring event conducted in May 2015 indicated a number of the 12 monitoring wells contained petroleum constituents exceeding NCDEQ 2L Standards. Groundwater data indicated a general decrease of contaminant concentration between February 2013 and January 2015, however with a “fairly small plume.” The groundwater data indicated some migration of the source downgradient but the majority of the in-use water supply wells are located upgradient and side-gradient of the source area. Continued maintenance and change out of booms were recommended. Due historic business practice, LUST and registry database inclusion this site has been included in this report.

**This site is anticipated to present moderate GeoEnvironmental impacts to the project.**
