**PROJECT SPECIAL PROVISIONS  
GEOENVIRONMENTAL**

**CONTAMINATED SOIL (5/26/2022)**

## GEOENVIRONMENTAL PHASE II INVESTIGATION

NCDOT PARCEL 002  
QUALITY OIL COMPANY  
KERNERSVILLE – KERNERSVILLE LOOP FROM SR 1969 (PINEY GROVE RD) TO NC 150 (N. MAIN ST)  
743 PINEY GROVE RD  
FORSYTH COUNTY, NORTH CAROLINA  
WBS NUMBER 47138.1.1  
TIP NUMBER U-6003  
FORSYTH COUNTY PIN # 6887-40-2970.000

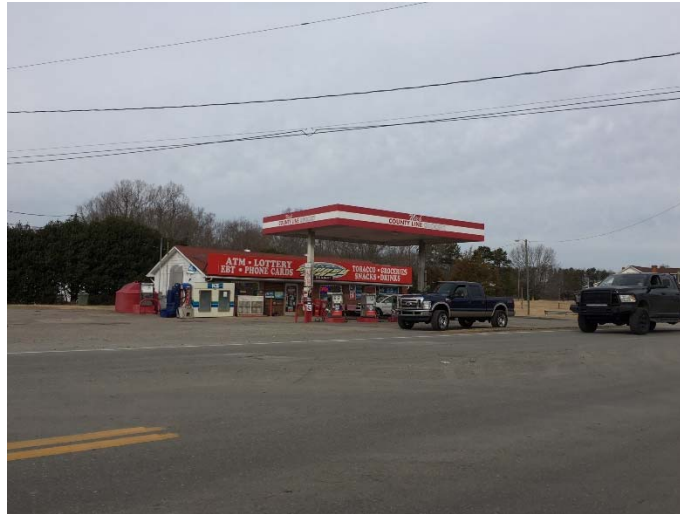
**4) Property Owner NCDOT PIN: 6886-88-3894.00**

This current gas station and convenience store is located on the west side of North Main Street. According to the UST Section Registry there are three (3) tanks currently onsite (3 – 6,000 gallon gasoline tanks). The current gasoline tanks were all installed on or about October 1989. This property appears in the UST and FUEL STATIONS database. Due historic and current business practice, UST/FUEL STATIONS and registry database inclusion this site has been included in this report.

**This site is anticipated to present low GeoEnvironmental impacts to the project.**

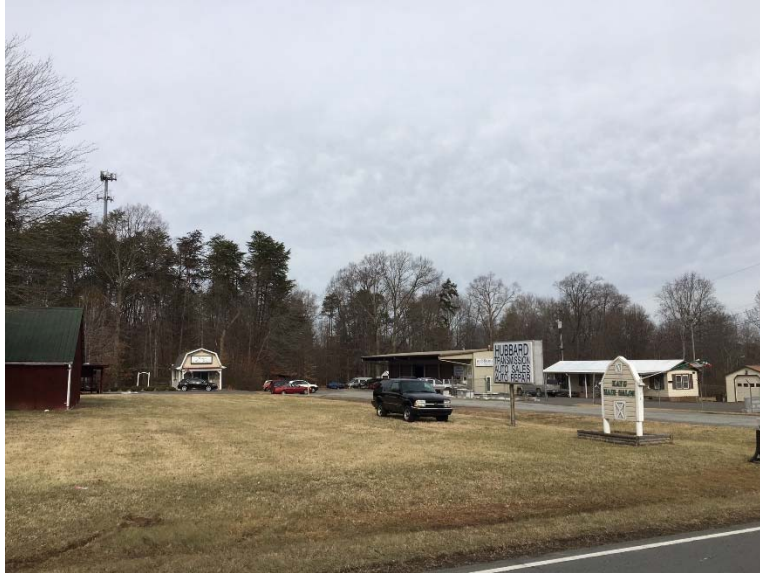
5)	<b>Property Owner</b>	<b>NCDOT PIN: 6886-78-7548.00</b>
	Hubbard Transmission & Auto Repair	Same
	933 N Main Street	
	Kernersville, NC 27284

This current auto service and repair business is located on the west side of North Main Street. There is no current UST Section Registry listing under this address or name, however it may be documented under different ownership or PO Box and further evaluation may be warranted. It was also not listed in any ERIS databases either. Although no spills nor registry database records were documented, this site has been included in this report based on site reconnaissance and business practice.

**This site is anticipated to present low GeoEnvironmental impacts to the project.**
