# PRELIMINARY SITE ASSESSMENT

SR 1100 (BRAWLEY SCHOOL ROAD) IMPROVEMENTS  
TIP NO. R-3833C, WBS NO. 34554.2.4

NCDOT PARCEL NO. 76

## METALLIC UST INVESTIGATION: PARCEL 76 NCDOT PROJECT R-3833C

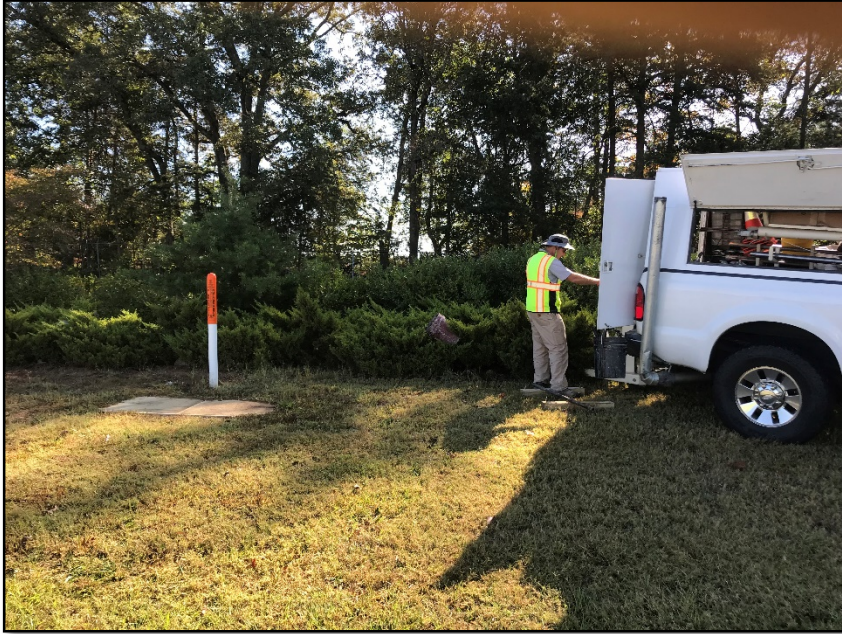
Photograph No. 1: General view of Boring B-19.

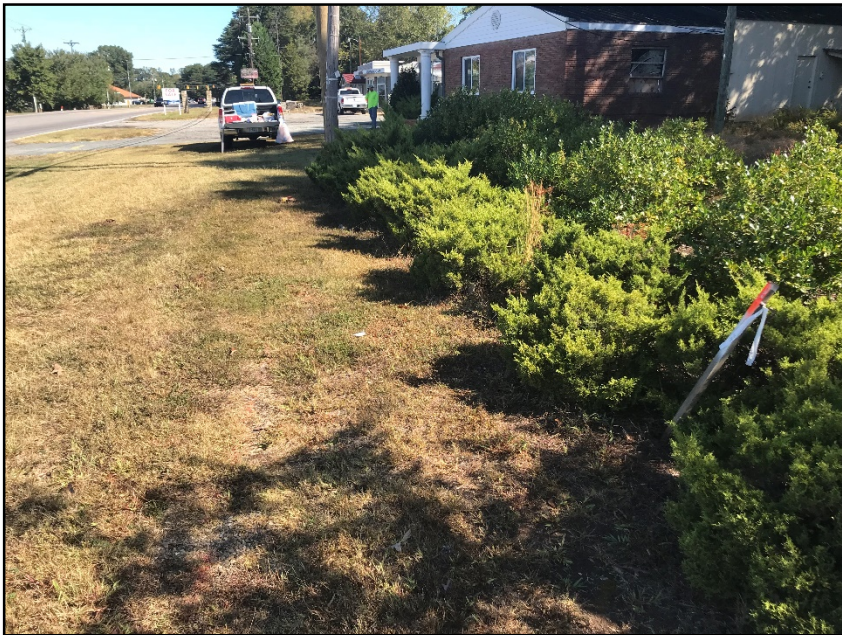
Photograph No. 2: General view of Boring B-20.

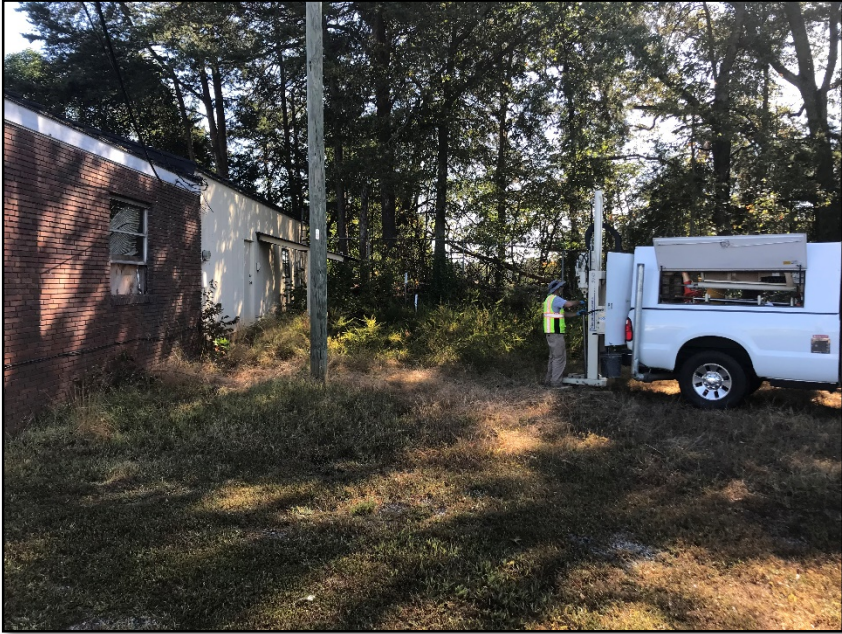
Photograph No. 3: General view of Boring B-21.

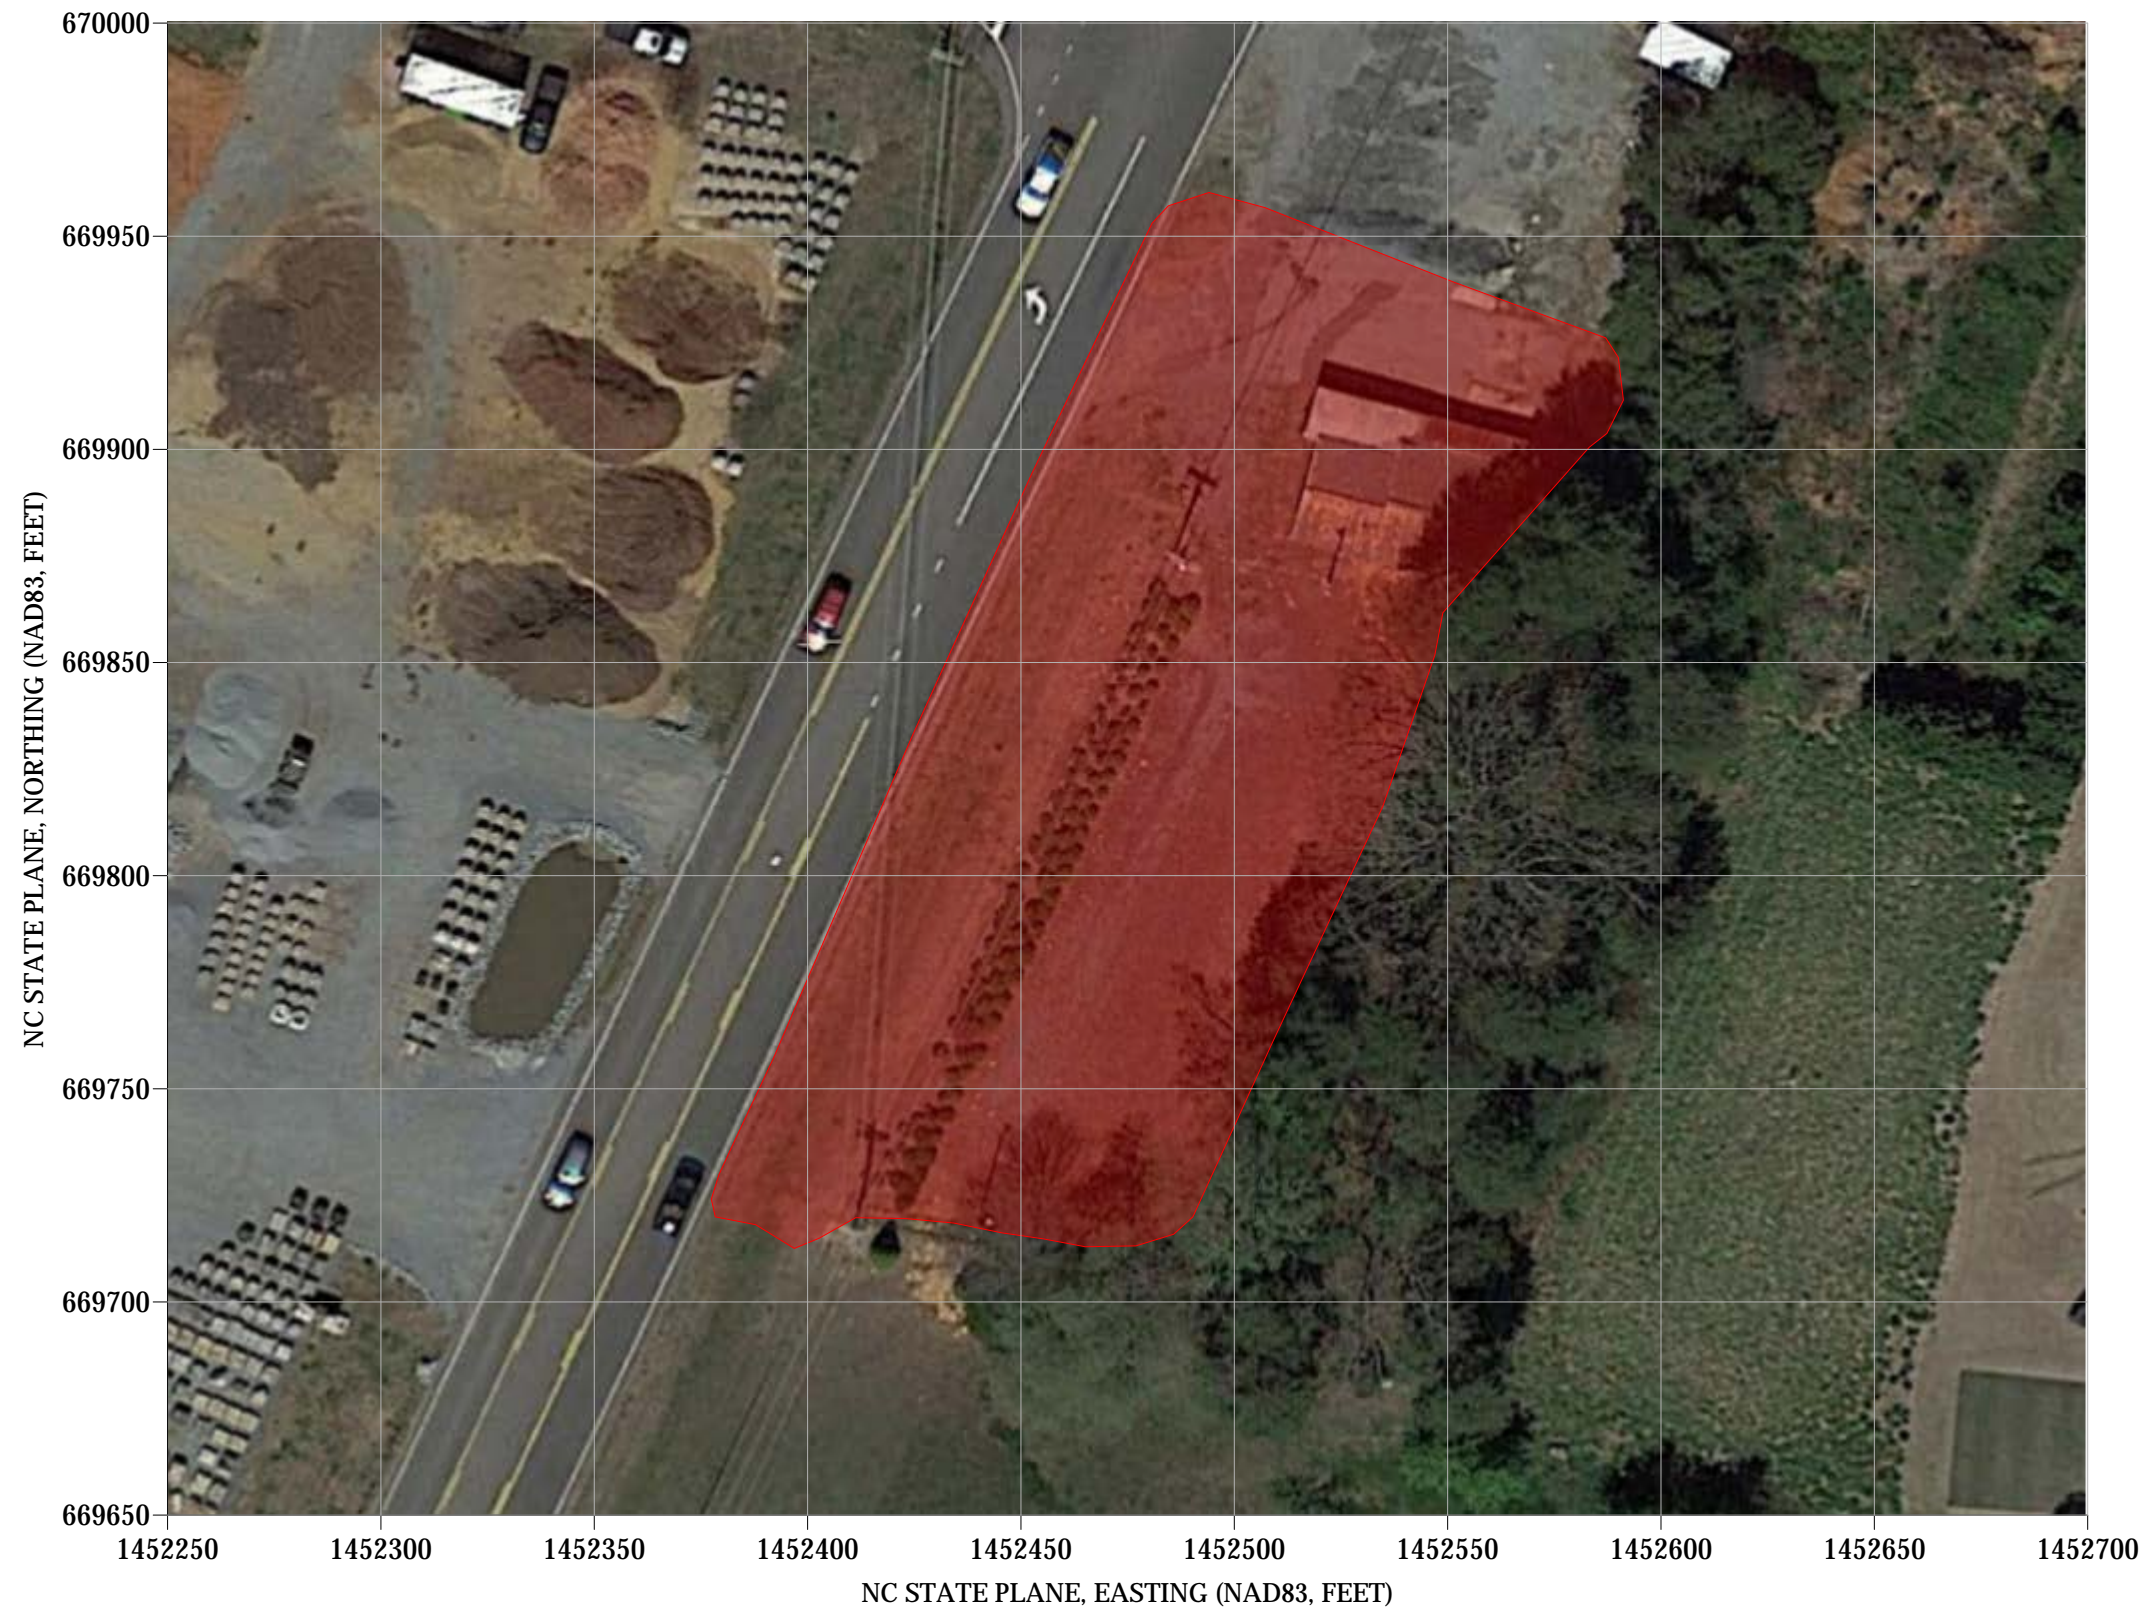
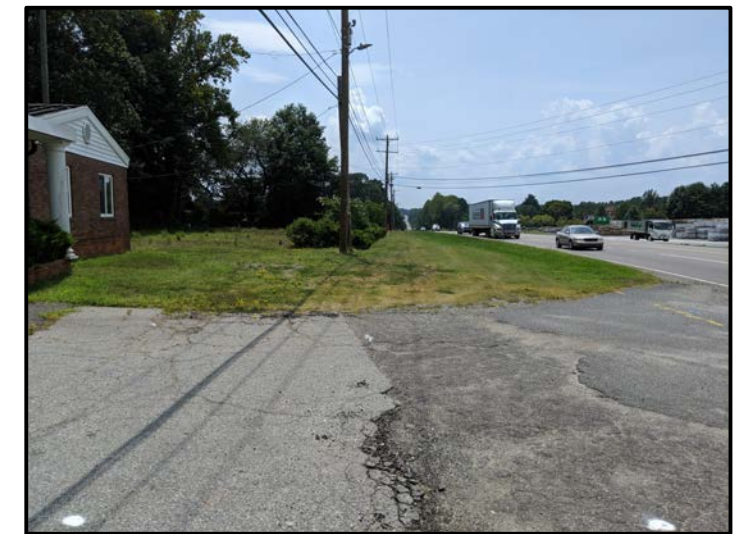
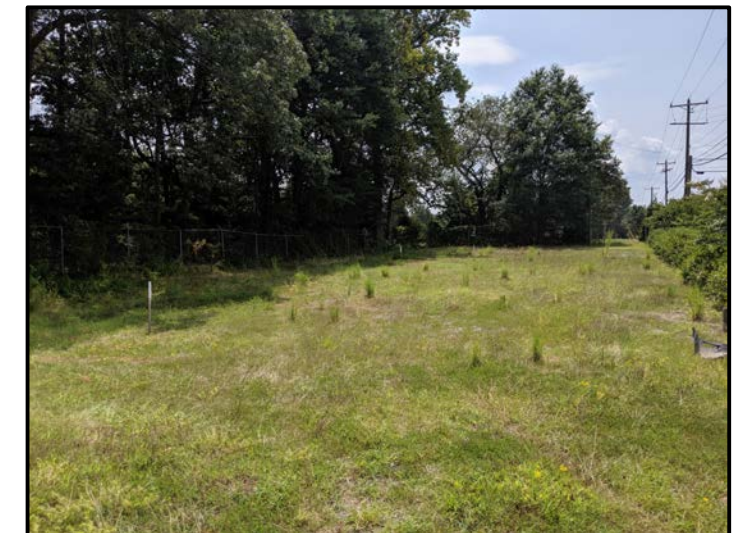
CLIENT  
FALCON ENGINEERS  
**FIGURE 1**

The site included a vacant building surrounded by concrete, grass, and asphalt surfaces. As per discussions with the property owner, there is possibly a septic tank just west of the building. An aerial photograph showing the survey area boundaries and ground-level photographs are shown in **Figure 1**.

View of Survey Area  
(Facing Approximately South)

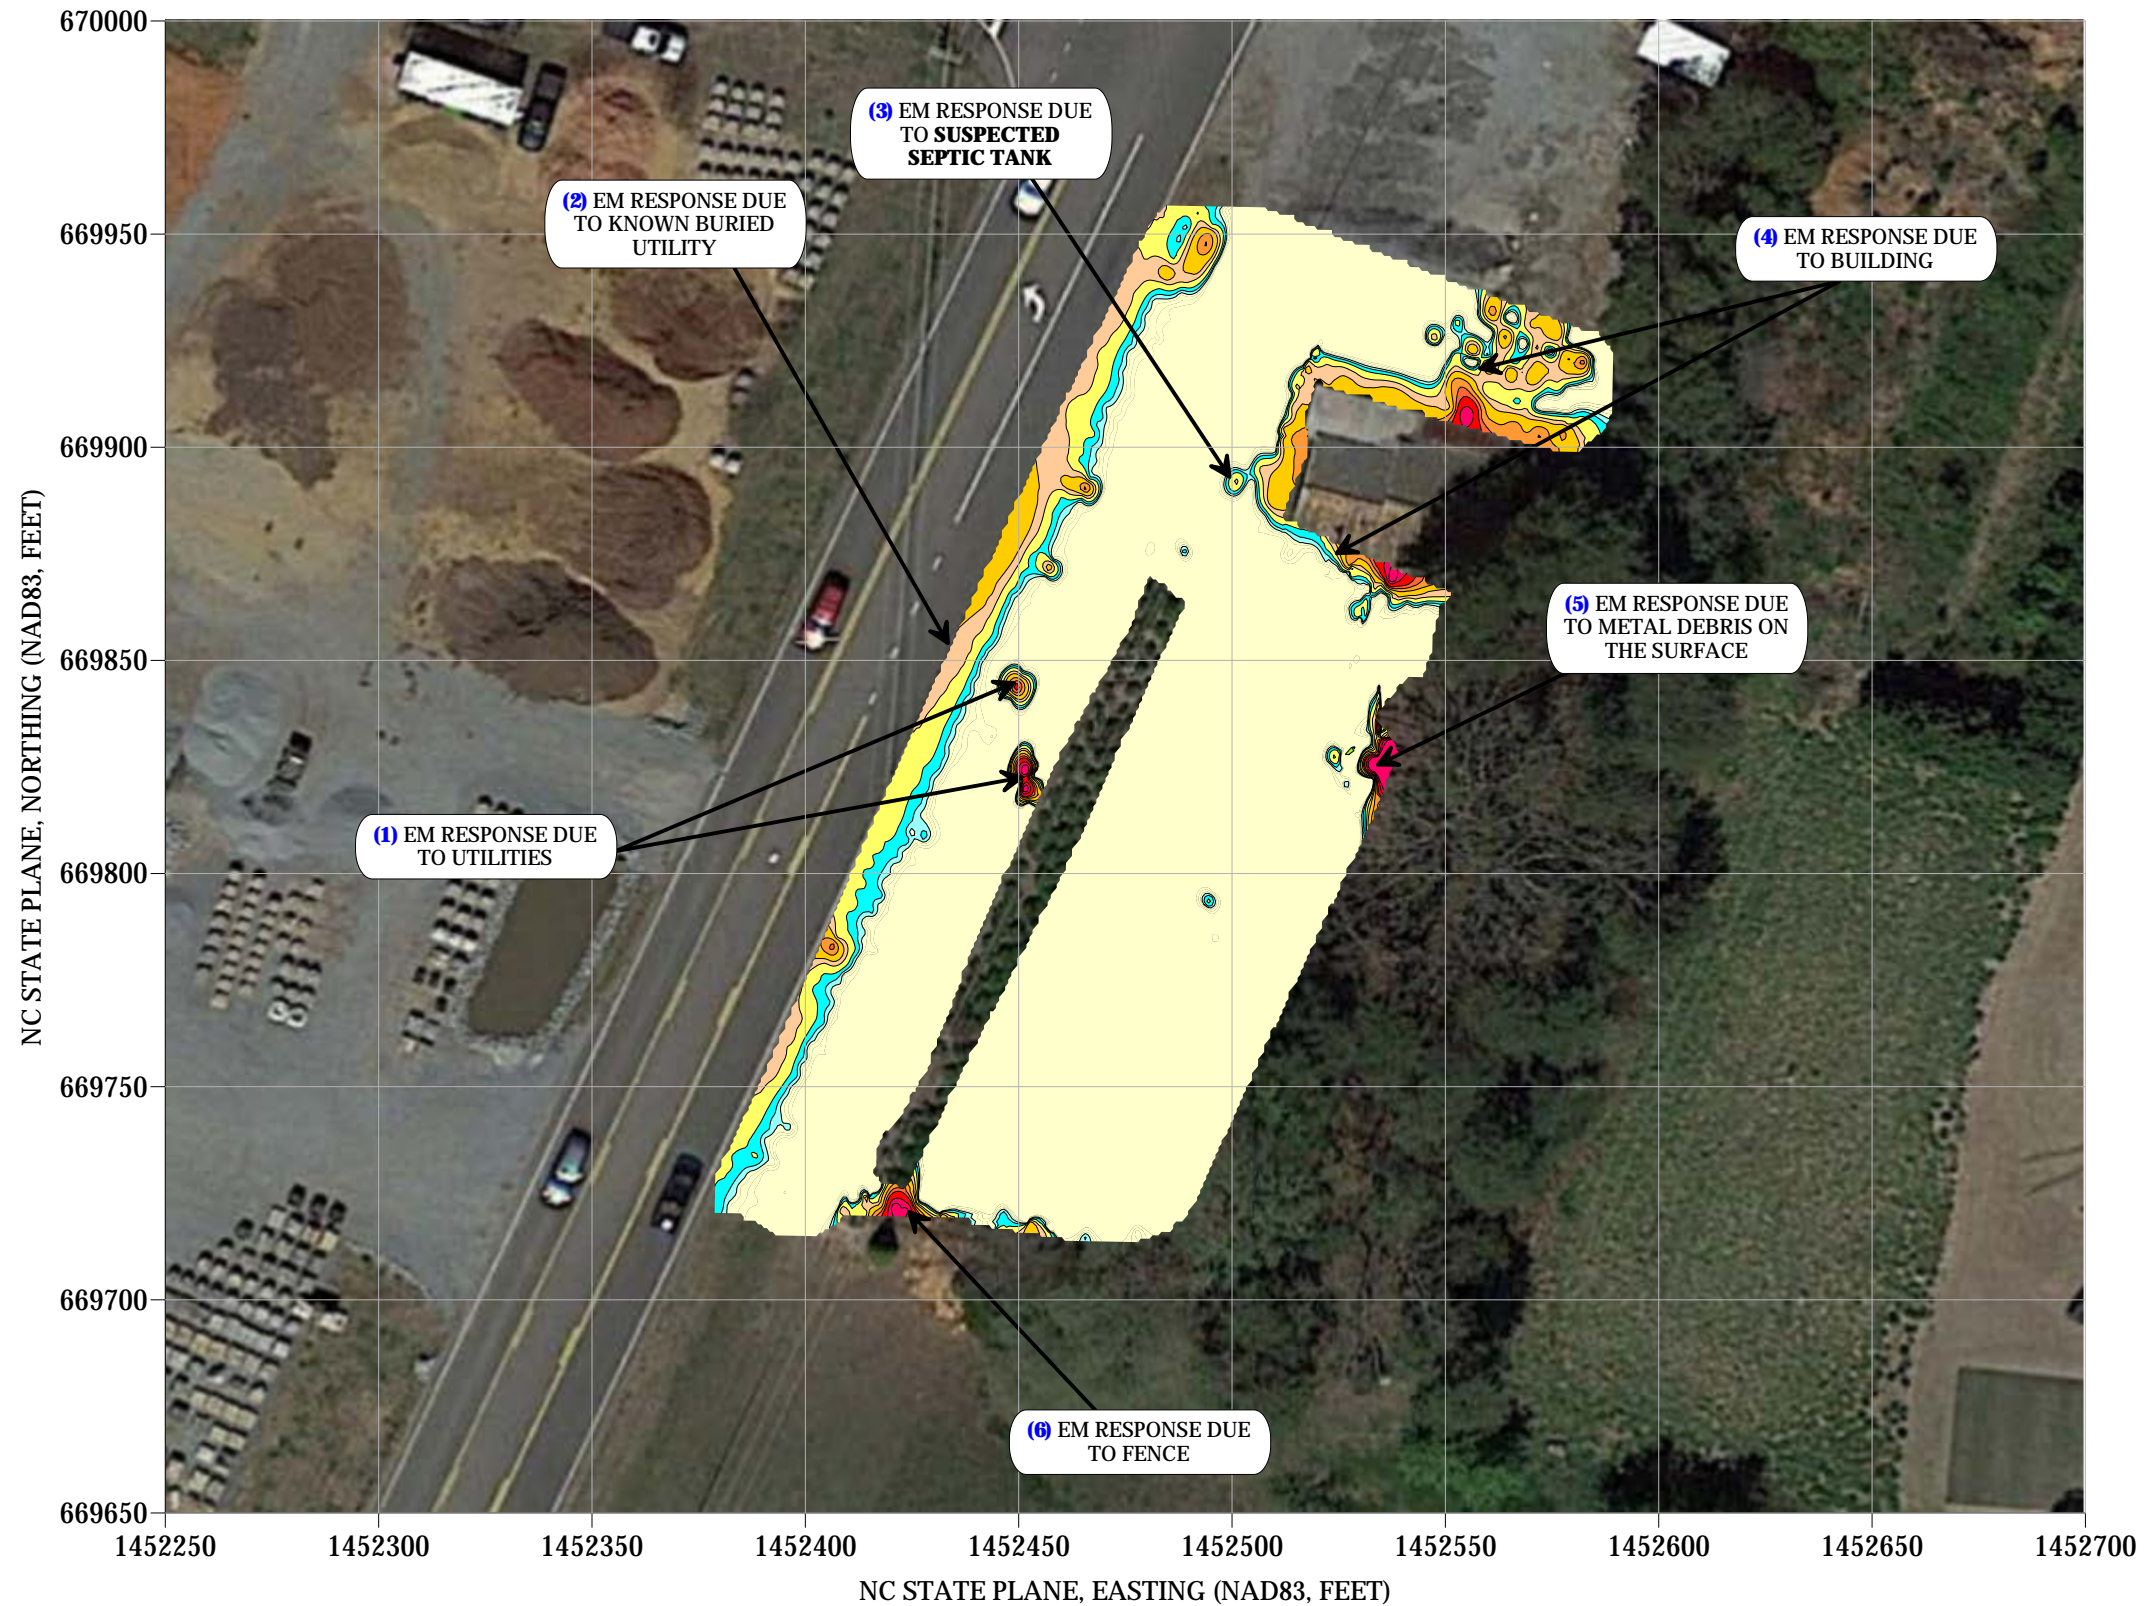
CLIENT  
FALCON ENGINEERS  
**FIGURE 2**

A contour plot of the EM61 results obtained across the survey area at the property is presented in **Figure 2**. Each EM anomaly is numbered for reference in the figure. The

The majority of the EM anomalies were directly attributed to visible cultural features at the ground surface, including utilities, a building, metal debris on the surface, and a fence. EM Anomaly 2 was associated with a known buried utility. This was consistent with site plans provided by the NCDOT, the NC 811 markings on the site, and the other parcels surveyed for this project. As such, the utility was confirmed with reconnaissance GPR only. No formal transects were saved and the utility will not be discussed in the GPR results section. EM Anomaly 3 was associated with a suspected septic tank and was further investigated with GPR.

## EVIDENCE OF ONE SUSPECTED SEPTIC TANK WAS OBSERVED.

The contour plot shows the bottom coil results of the EM61 instrument in millivolts (mV). The bottom coil presents a higher-amplitude response to any metal identified by the instrument. Differential data (difference between top and bottom coils) were not used for this parcel due to overhead electrical interference. The EM data were collected on August 11, 2019, using a Geonics EM61-MK2 instrument. Verification GPR data were collected using a GSSI SIR 4000 controller equipped with a 350 MHz HS antenna on August 12, 2019.

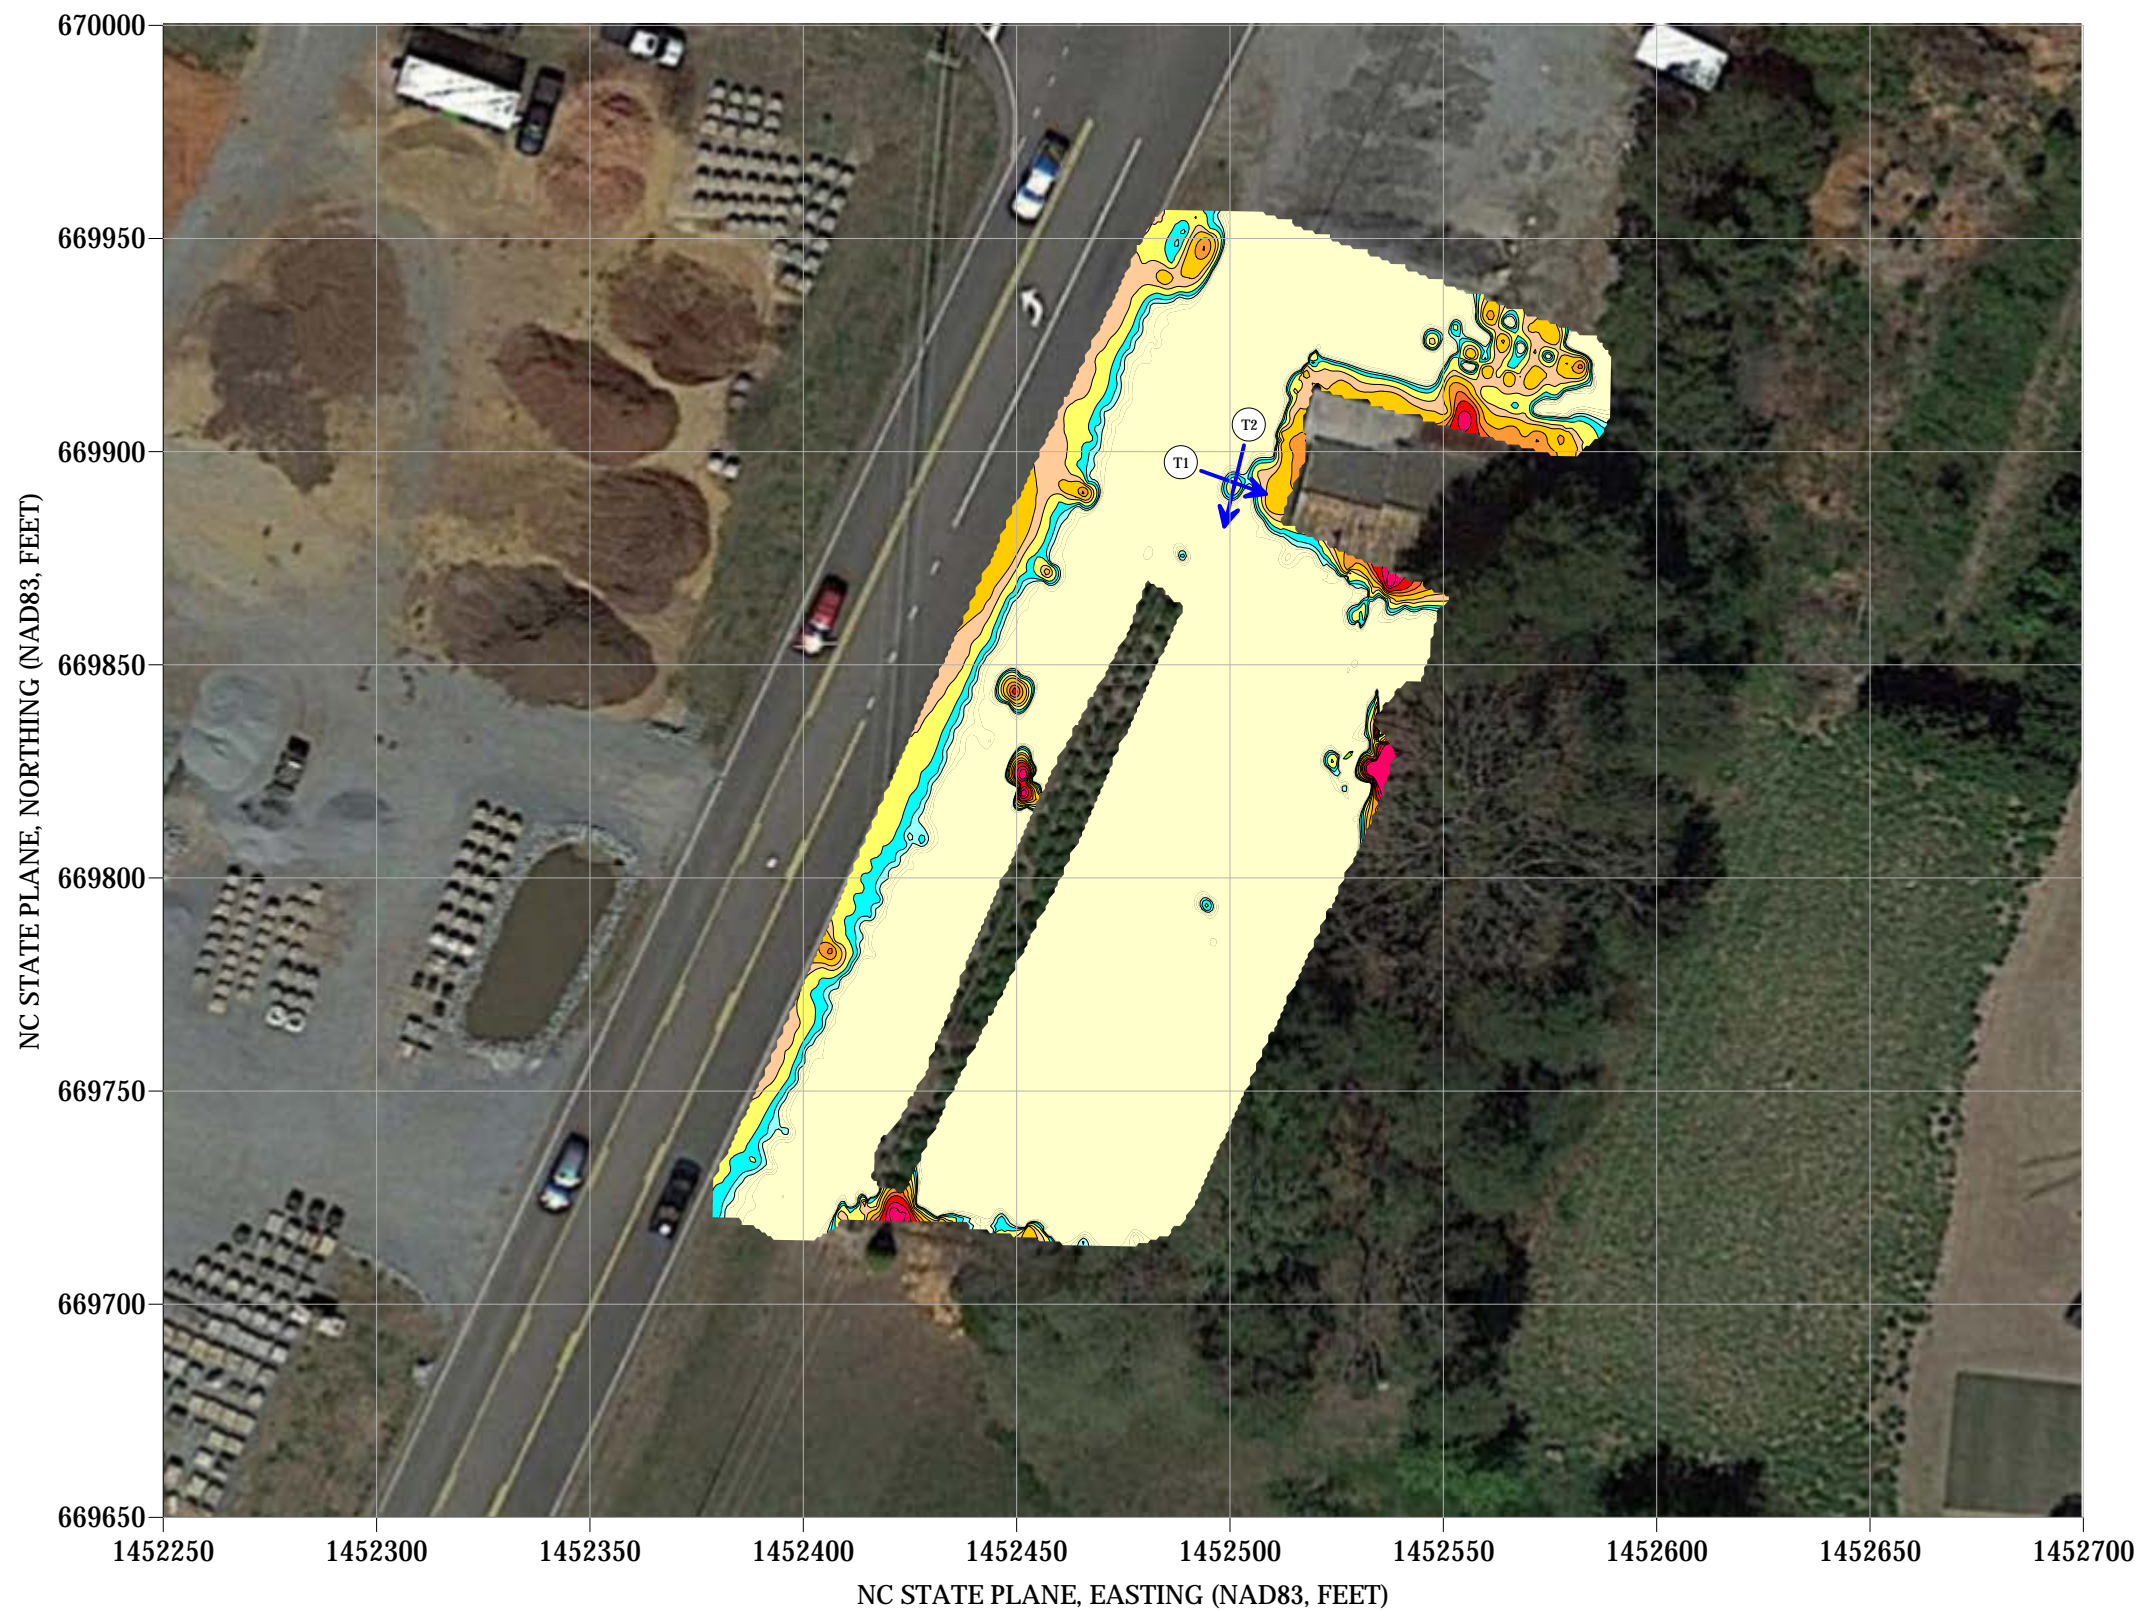
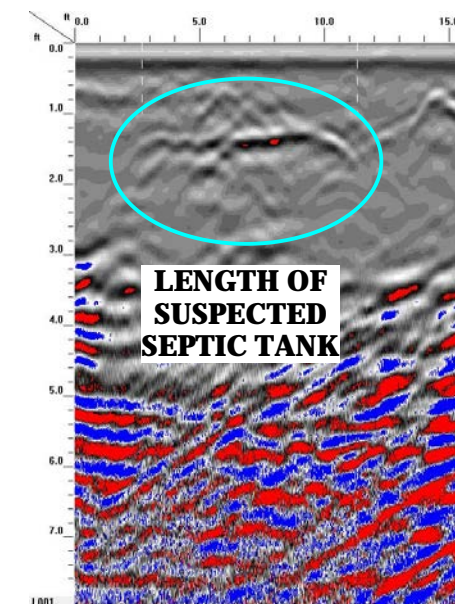
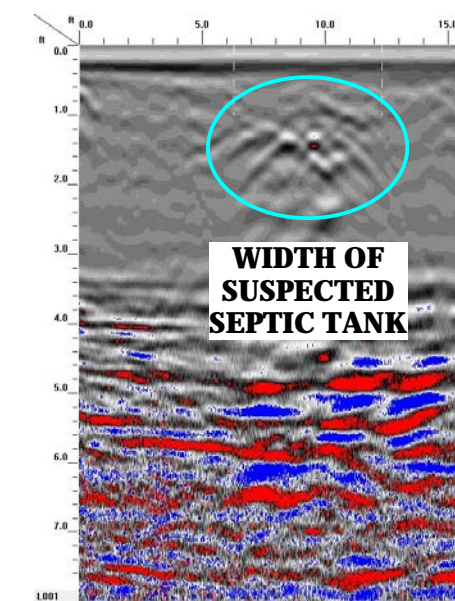
**FIGURE 3**

**Figure 3** presents the locations of the formal GPR transects performed at the property as well as the transect images. A total of two formal GPR transects were performed at the site.

GPR Transects 1-2 were performed across the suspected septic tank (EM Anomaly 3), just west of the building. These transects showed lateral reflectors, consistent with what is typically observed with septic tanks. The suspected septic tank (Suspected Septic Tank #1) was approximately 9 feet long by 6.5 feet wide. **Figure 4** provides the location and size of the suspected septic tank overlain on an aerial, along with ground-level photographs.

GPR TRANSECT 1 (T1)

GPR TRANSECT 2 (T2)

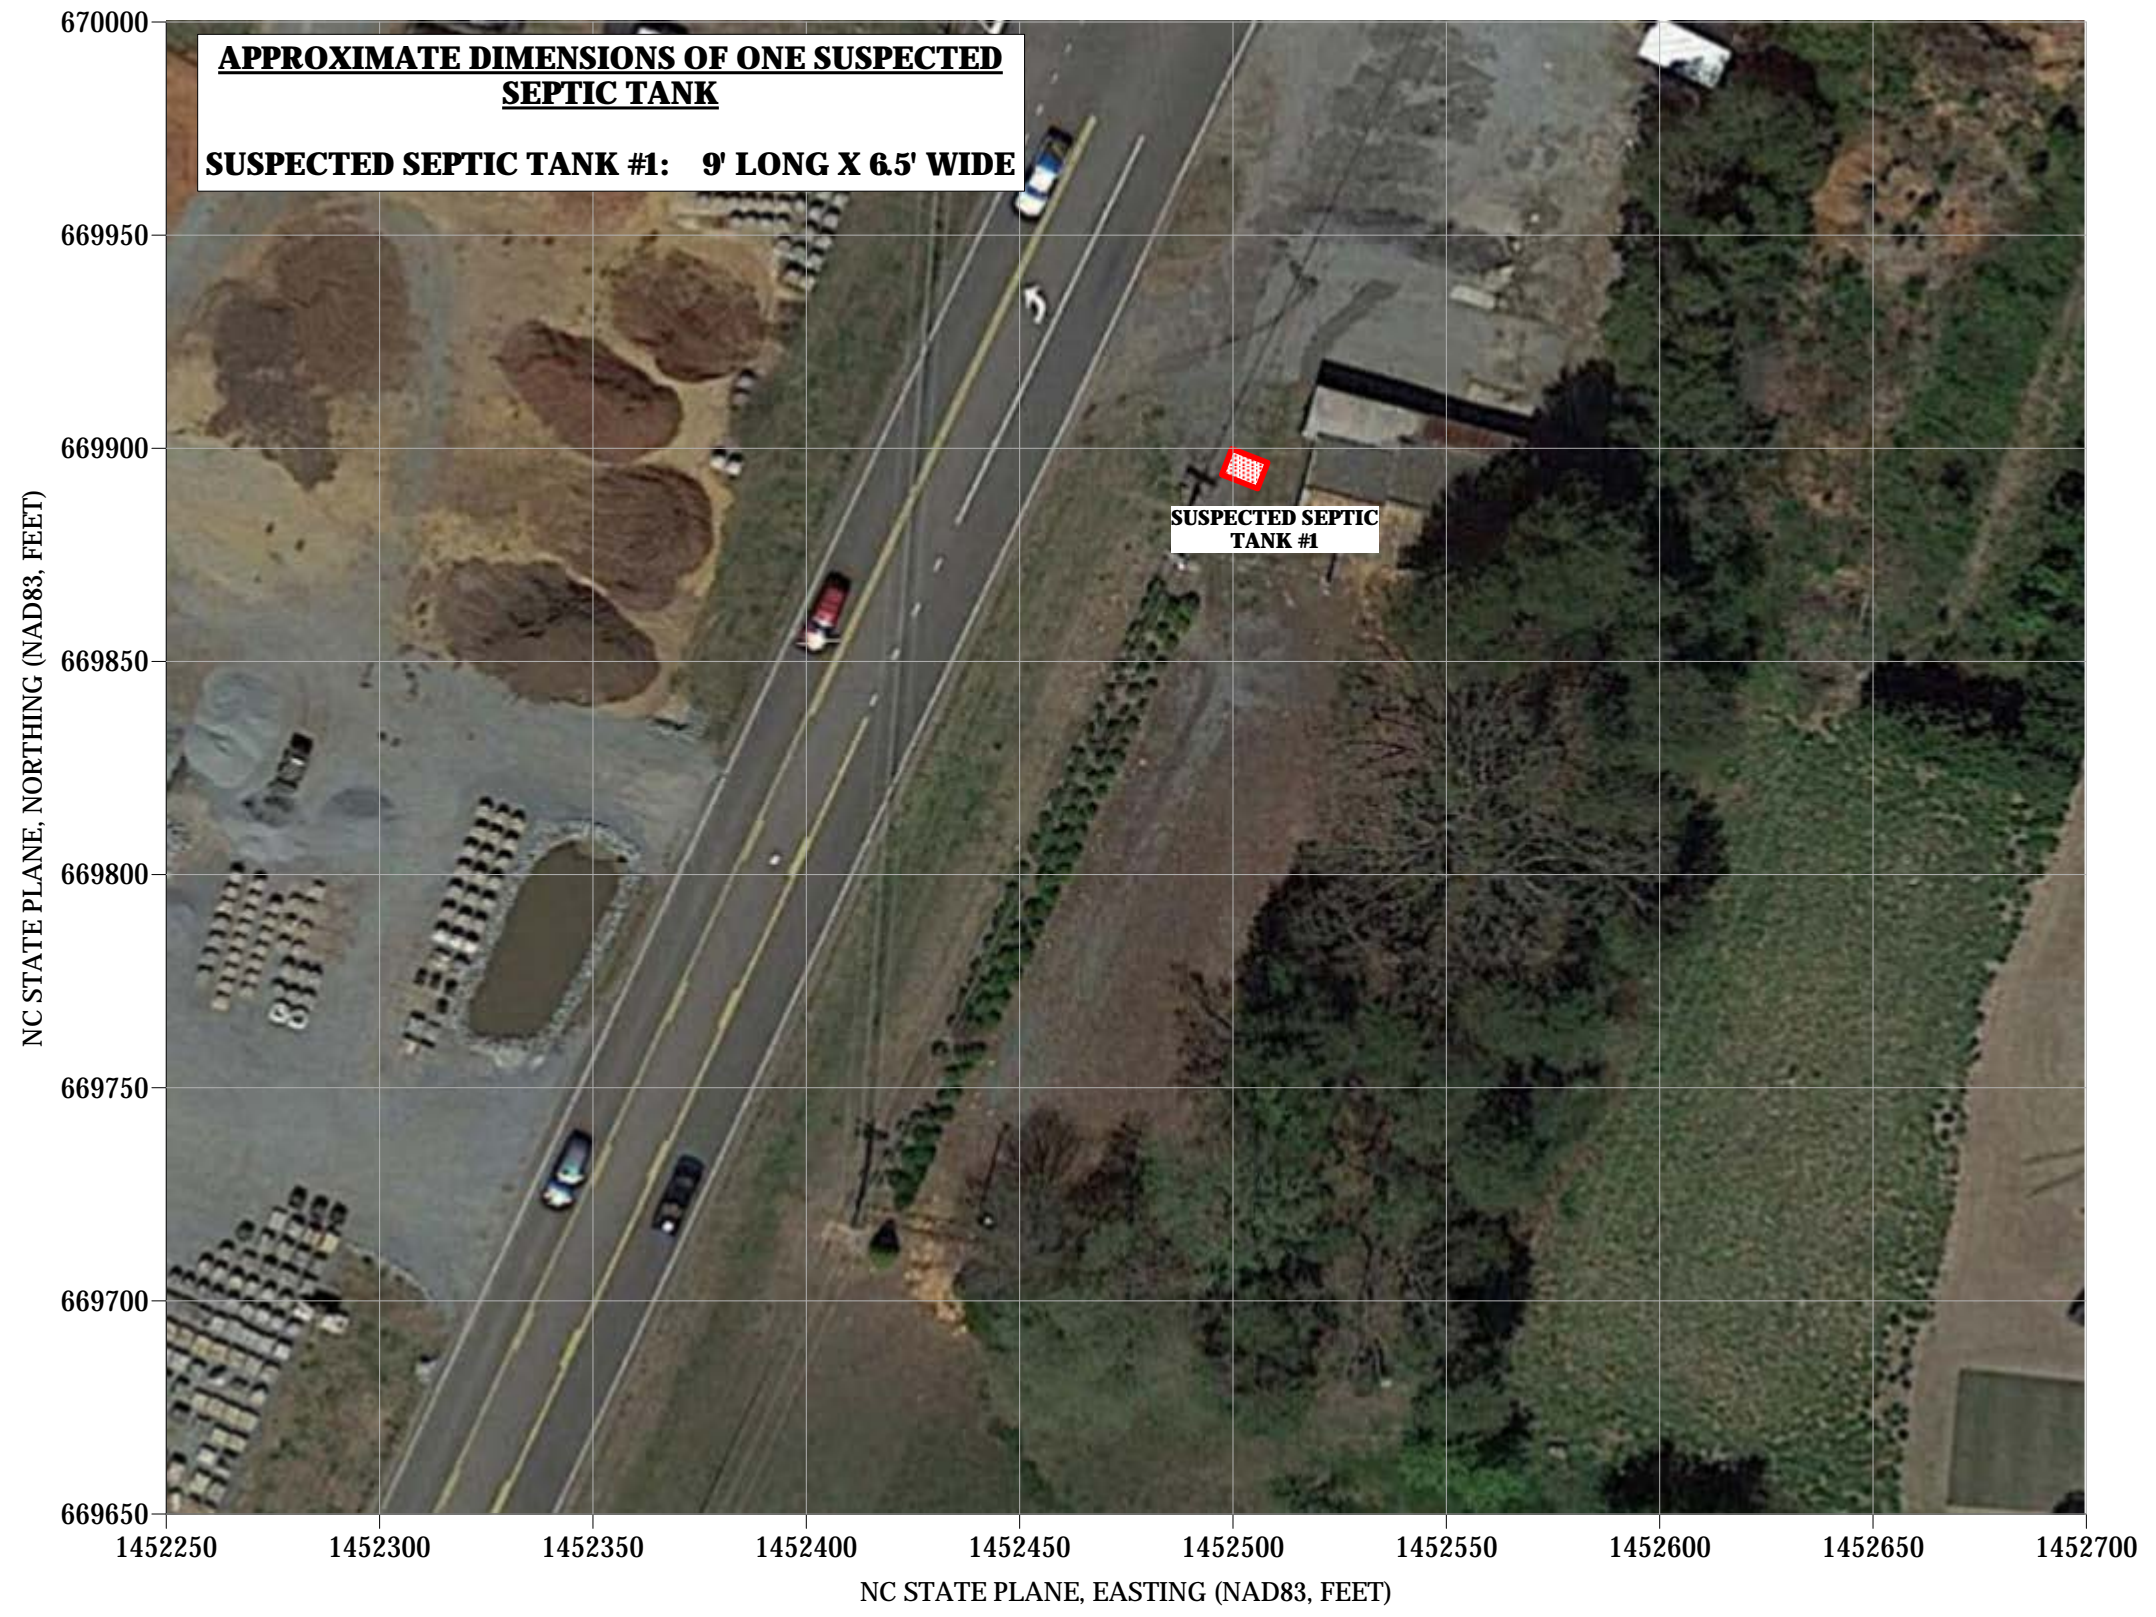
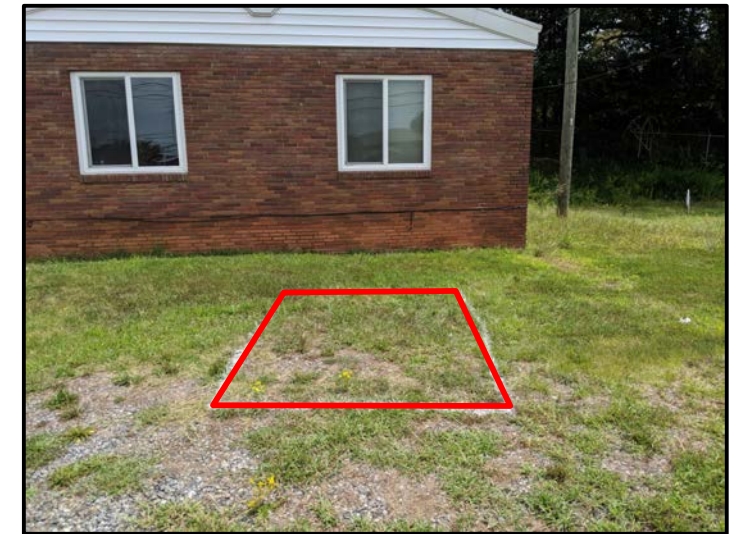
CLIENT  
FALCON ENGINEERS  
**FIGURE 4**

View of One Suspected Septic Tank Facing Approximately East

View of One Suspected Septic Tank Facing Approximately North

TITLE  
**PARCEL 76 - LOCATION AND SIZE OF  
ONE SUSPECTED SEPTIC TANK**

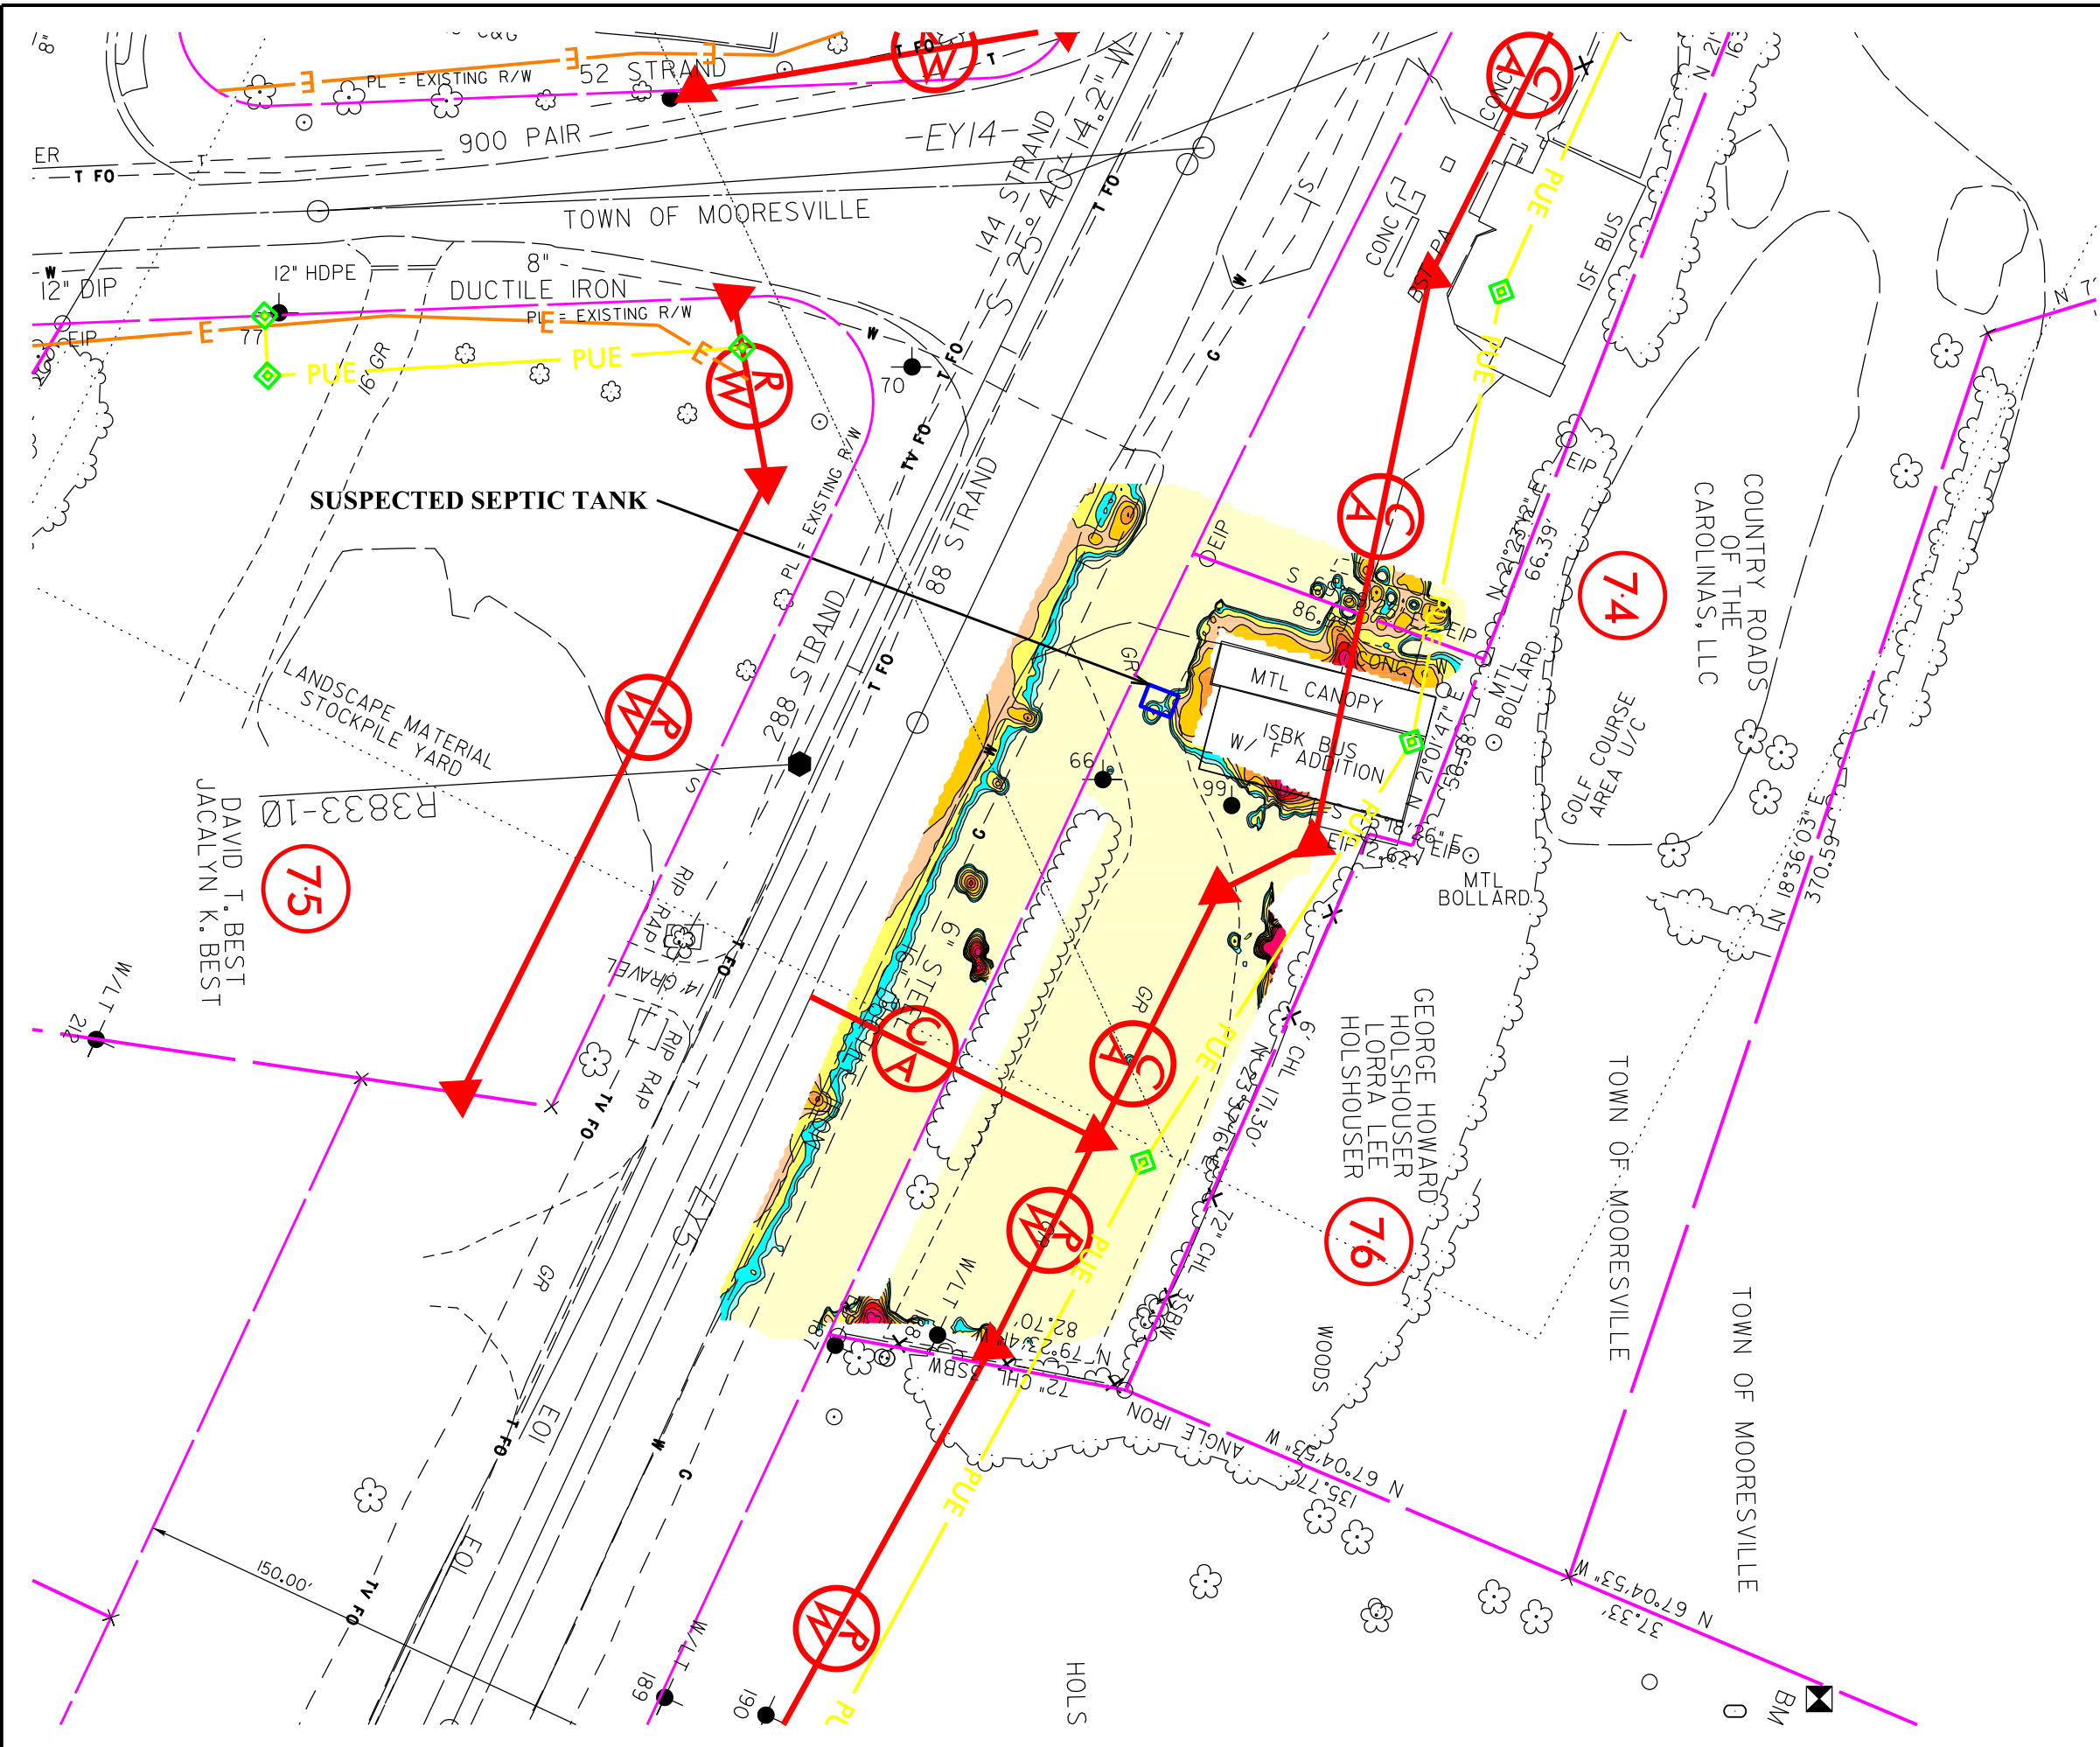
Collectively, the geophysical data recorded evidence of one suspected septic tank within the survey area at Parcel 76. **Figure 5** provides an overlay of the metal detection results

and the location of the suspected septic tank on the NCDOT MicroStation engineering plans for reference.

<p>TITLE  <b>OVERLAY OF METAL DETECTION RESULTS AND ONE SUSPECTED SEPTIC TANK ON NCDOT ENGINEERING PLANS</b></p>	
<p>PROJECT  <b>PARCEL 76          MOORESVILLE, NORTH CAROLINA          NCDOT PROJECT R-3833C</b></p>	
<p>503 INDUSTRIAL AVENUE          GREENSBORO, NC 27406          336.335.3174 (p) 336.691.0648 (f)          License # C1251 Eng. / #C257 Geology</p>	
<p>DATE: 09-06-2019</p>	<p>REVISION NO. 0</p>
<p>PYRAMID PROJECT NO. 2019-260</p>	<p>FIGURE NO. 5</p>
