PRELIMINARY SITE ASSESSMENT

SR 1100 (BRAWLEY SCHOOL ROAD) IMPROVEMENTS
TIP NO. R-3833C, WBS NO. 34554.2.4

NCDOT PARCEL NO. 74

Re: **Preliminary Site Assessment**
SR 1100 (Brawley School Road) Improvements
TIP No. R-3833C, WBS No. 34554.2.4
Parcel No. 74
Owner: Country Roads of the Carolinas, LLC
2861 Charlotte Highway
Mooresville, Iredell County, North Carolina

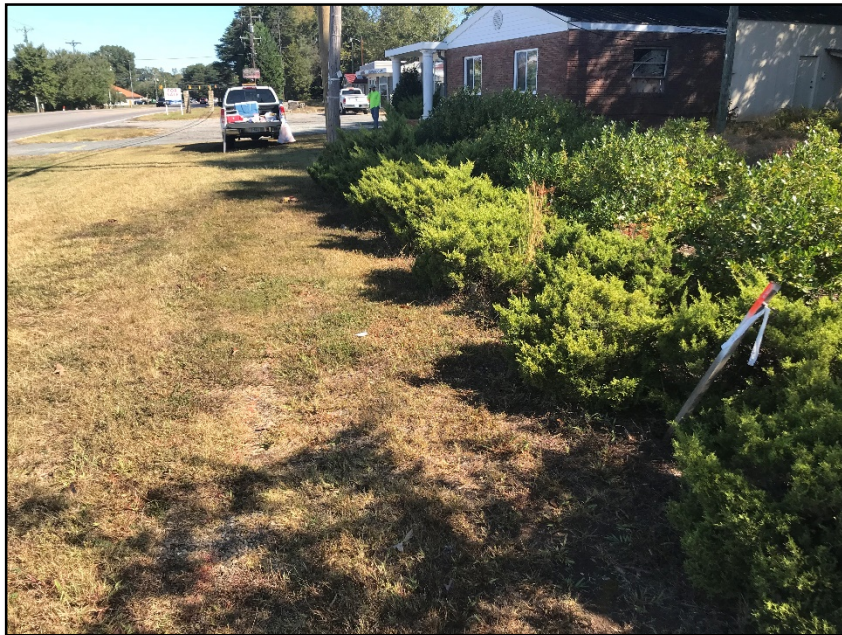
Photograph No. 2: General view of Boring B-20.
