Re: Phase II Investigation Report
Davidson Asbestos Site
NC DOT State Project No. U-5907
WBS Element #46452.1.1
Davidson, Mecklenburg County, North Carolina
H&H Job No. ROW-603

Phase II Investigation Davidson Asbestos Site

Davidson, Mecklenburg County
North Carolina

H&H Job No. ROW-605
State Project U-5907
WBS Element #46452.1.1
April 16, 2020

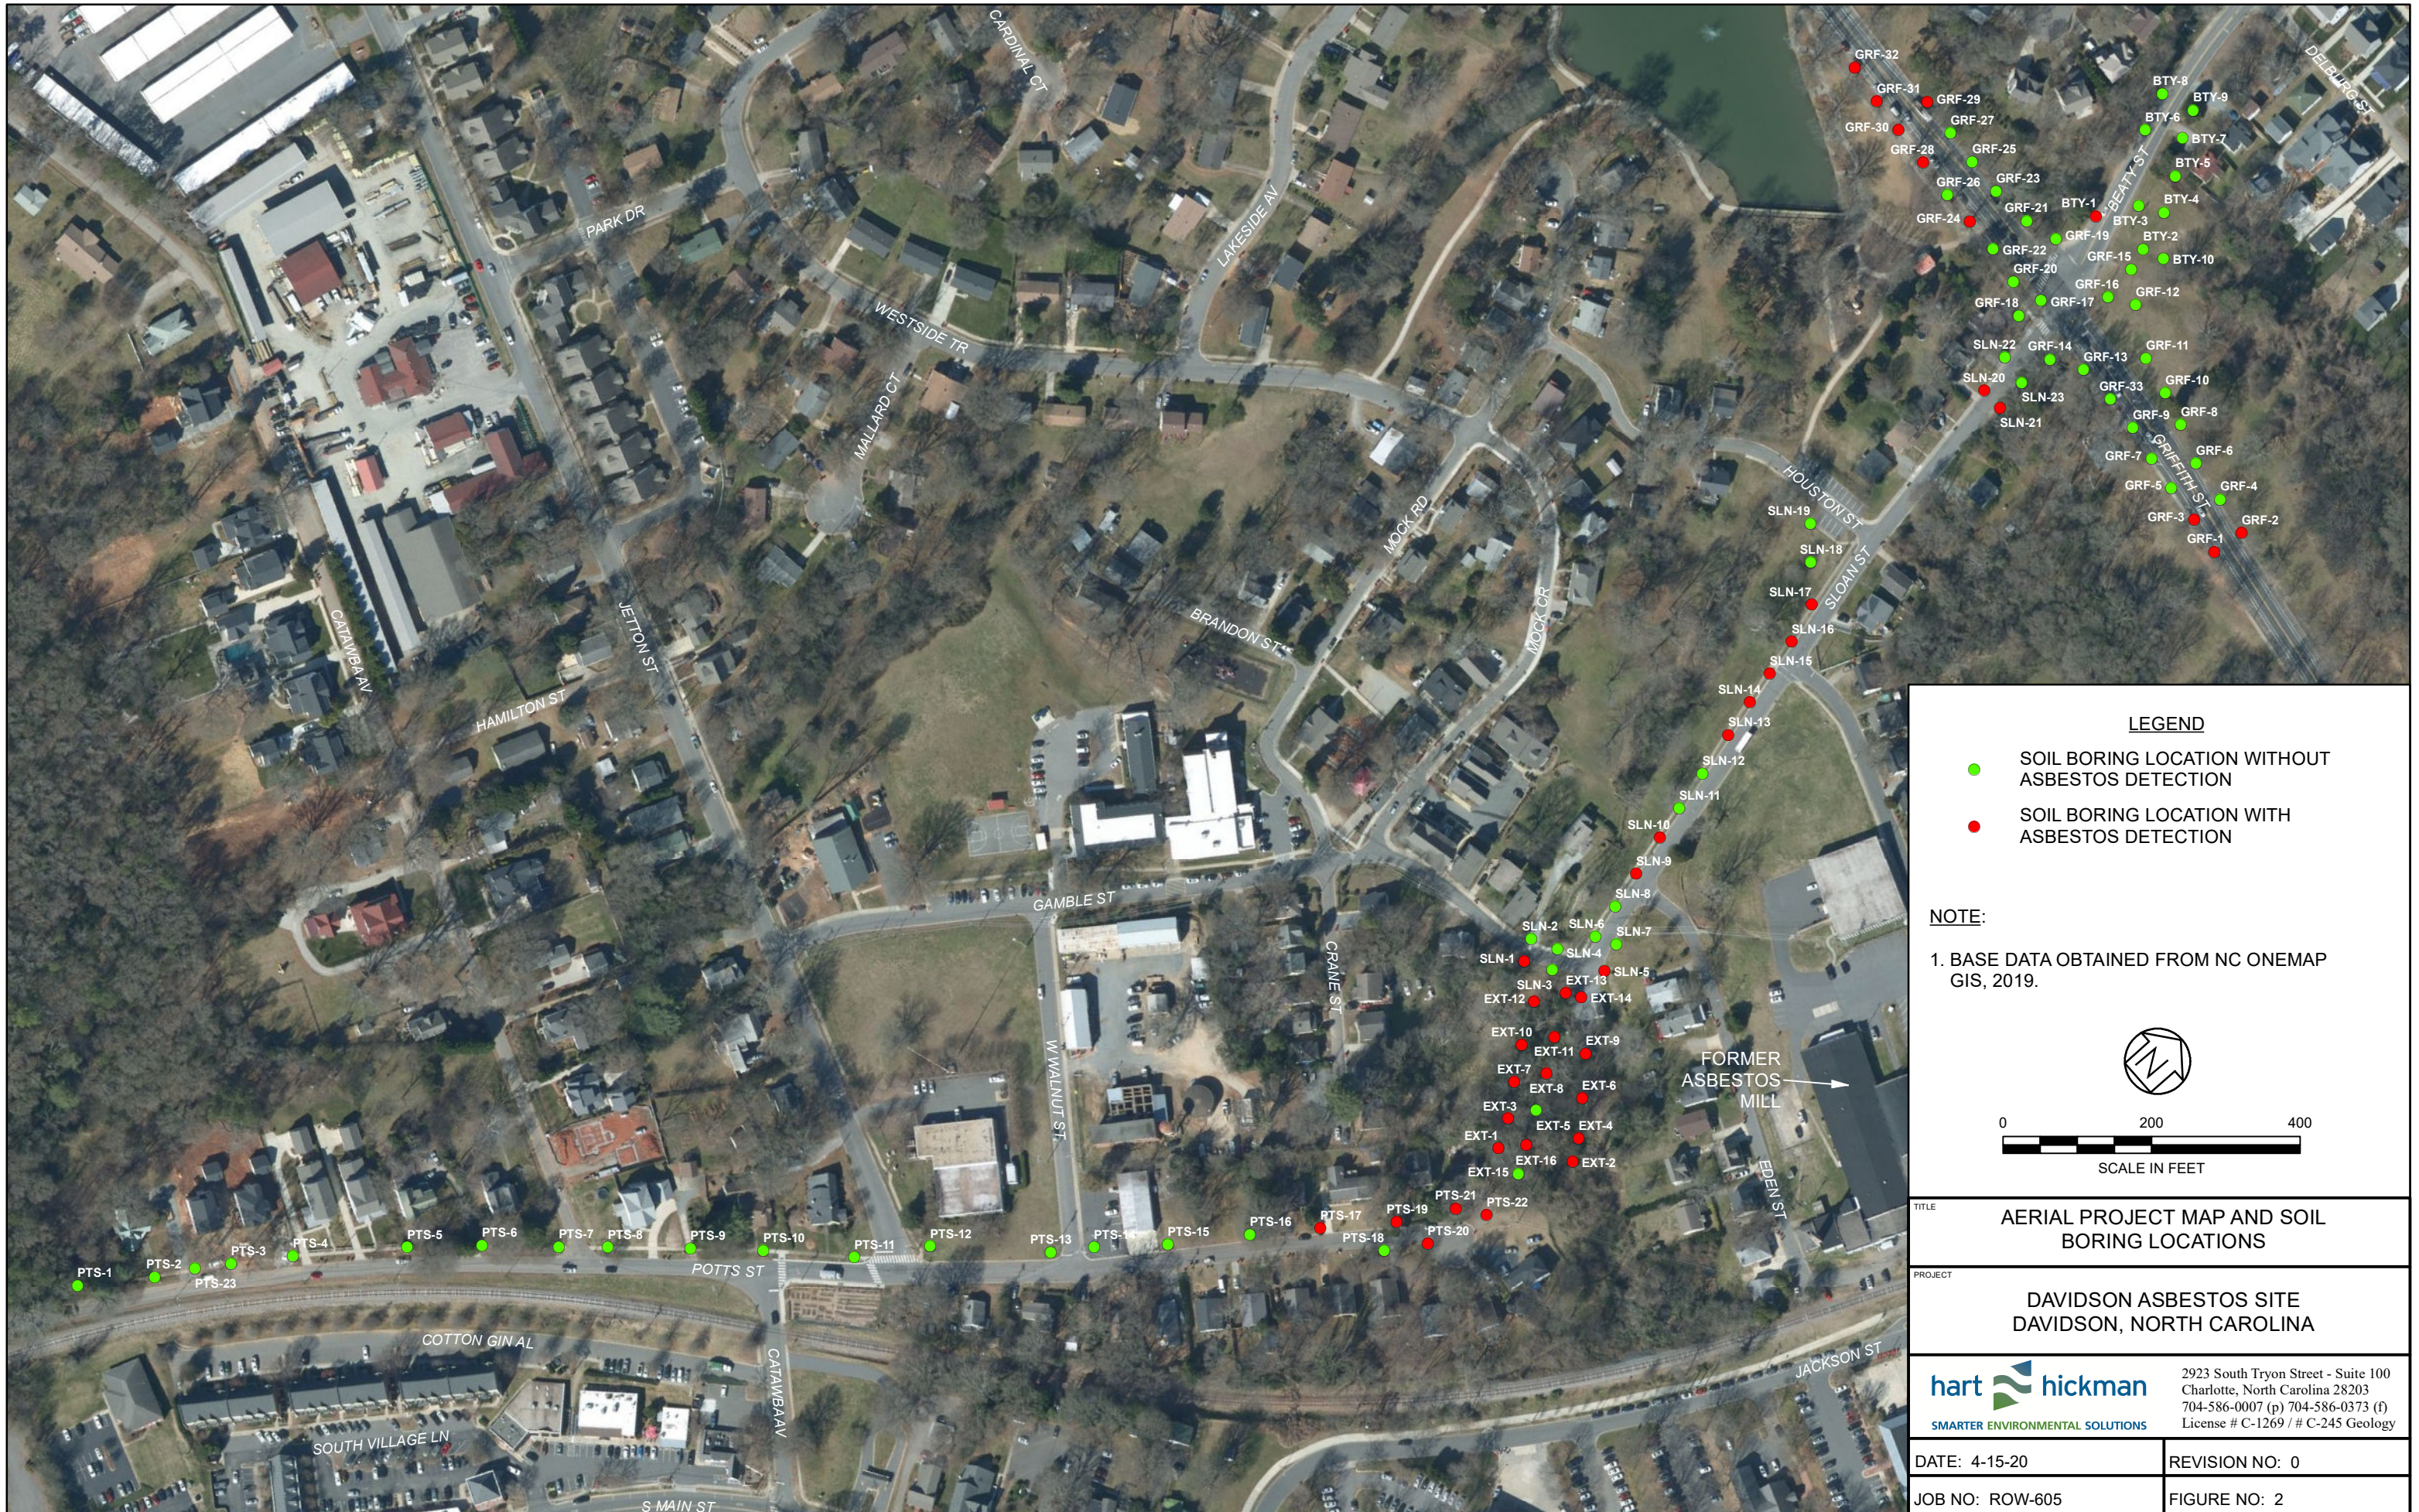
LEGEND	
●	SOIL BORING LOCATION WITHOUT ASBESTOS DETECTION
●	SOIL BORING LOCATION WITH ASBESTOS DETECTION
NOTE:	
1. BASE DATA OBTAINED FROM NC ONEMAP GIS, 2019.

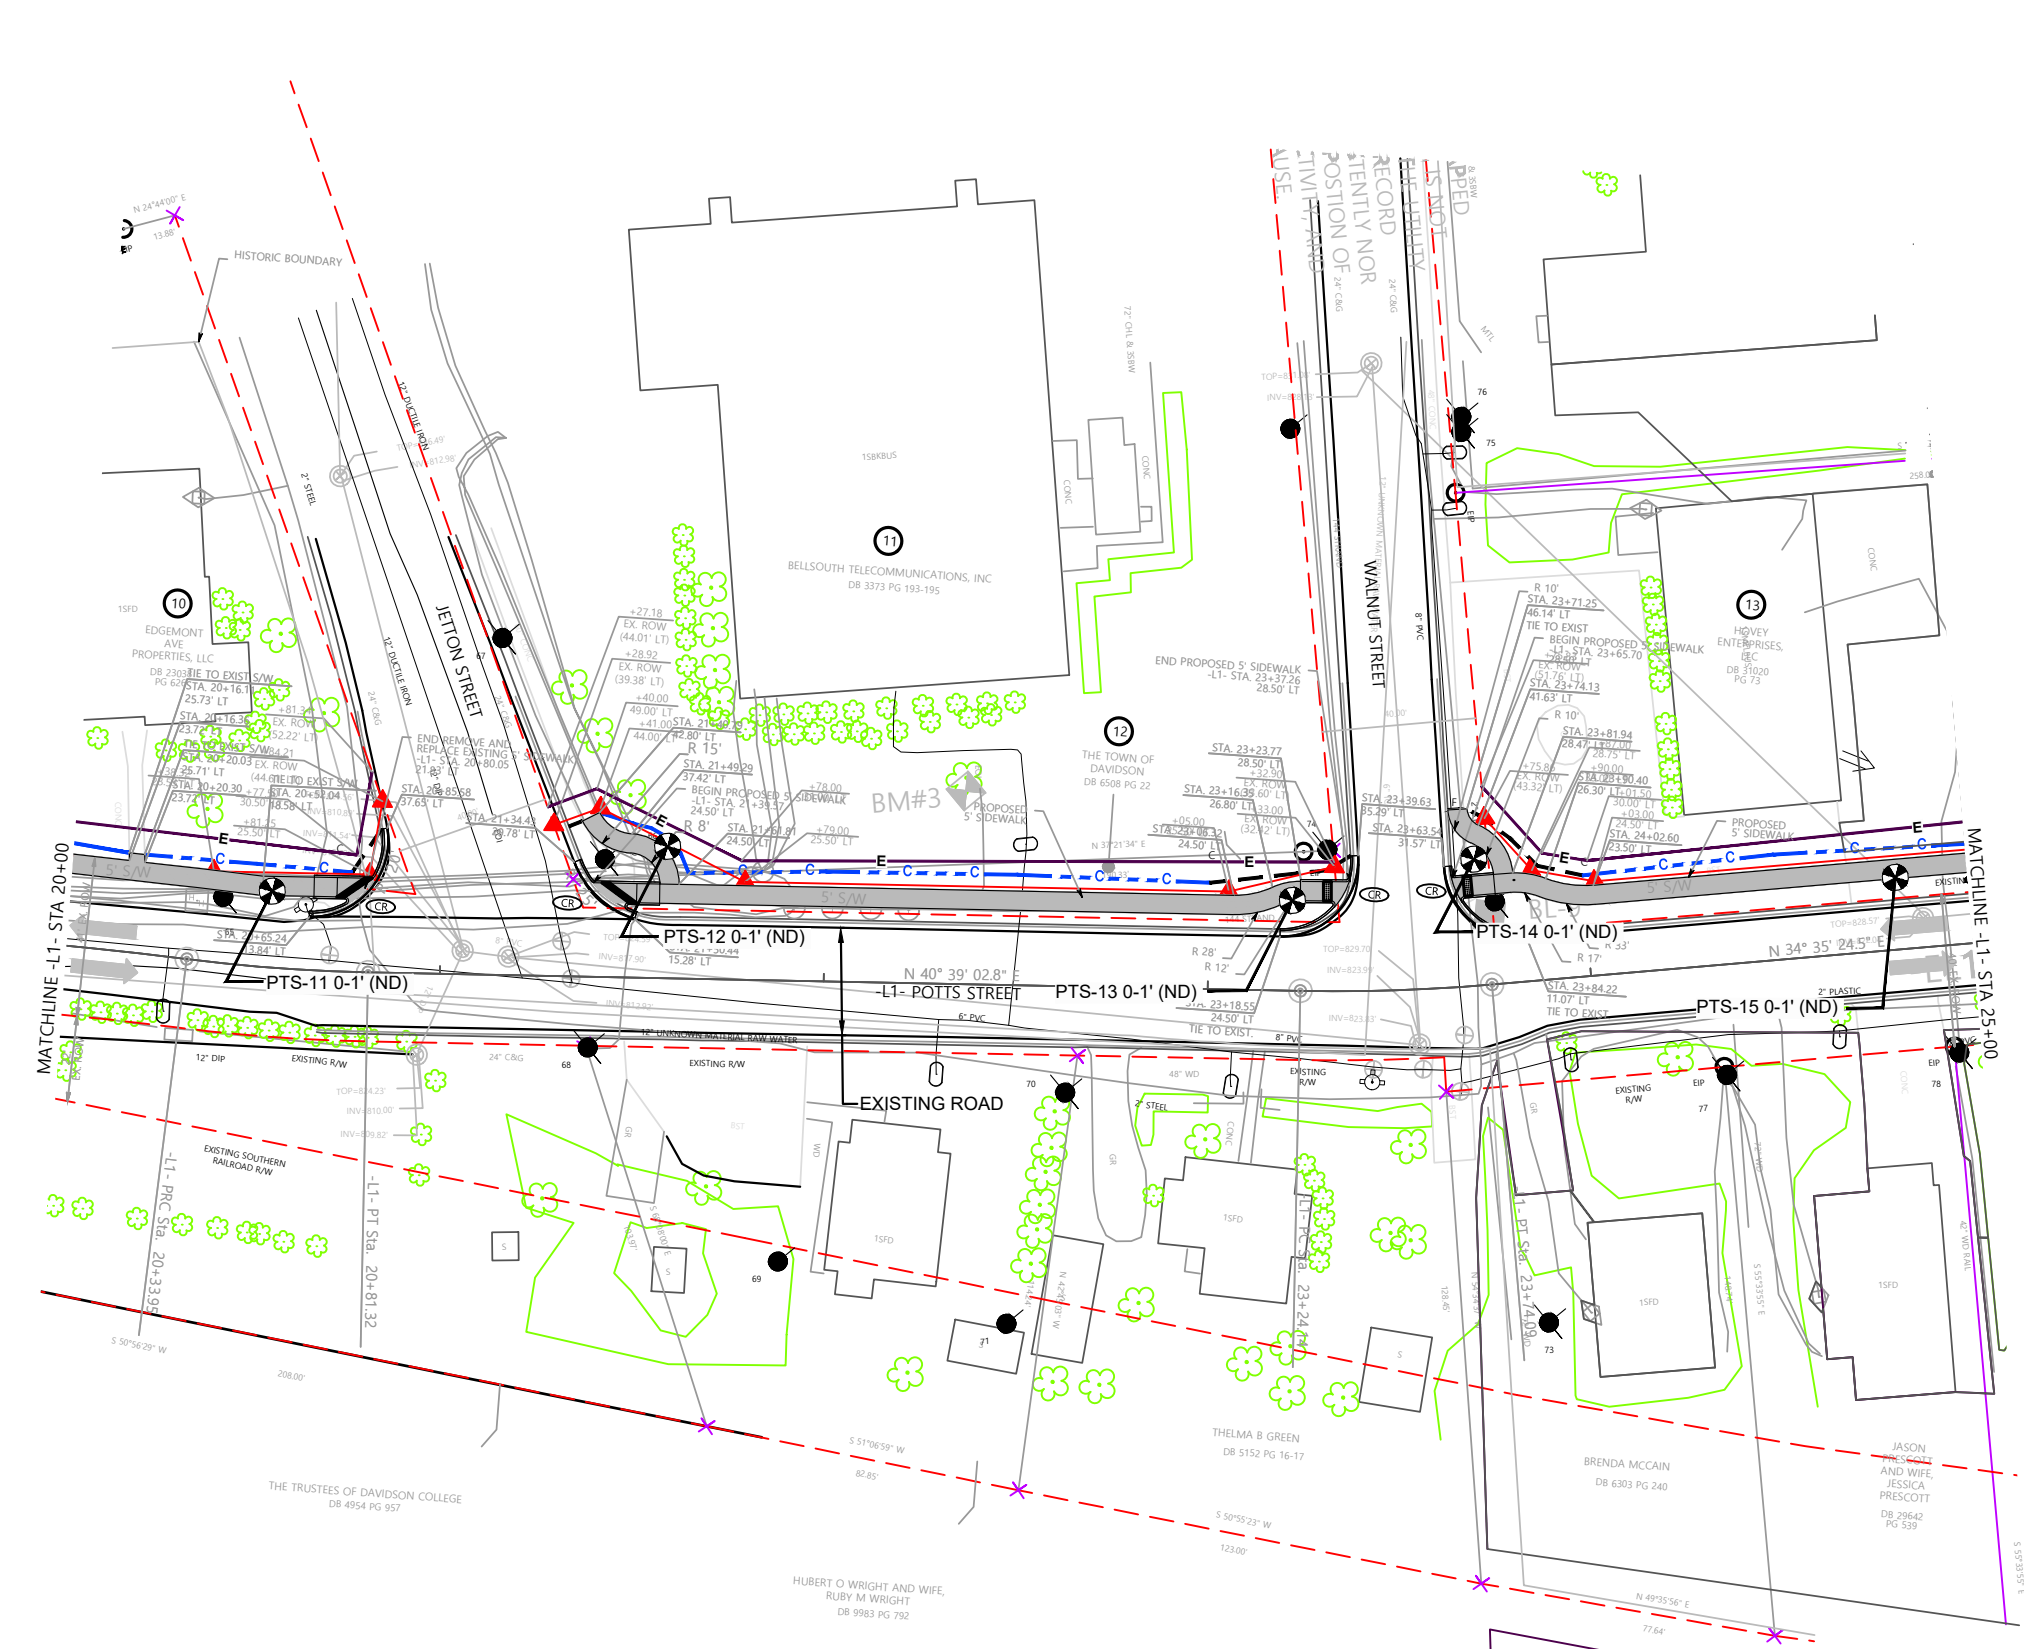
S:\AAA-Master Projects\Projects\NC DOT Right-of-Way -ROW\ROW-605 Mecklenburg County Soil Asbestos\Report\Figures\DWG 2-12-20\ROW-605 Site layout overall.dwg, FIG 3C, 4/16/2020 2:12:43 PM, jdemmer

- LEGEND**
- PROPERTY LINE
 - VEGETATION / WOODED
 - - - EXISTING RIGHT-OF-WAY
 - ▲— PROPOSED RIGHT-OF-WAY
 - U—U— PROPOSED UTILITY EASEMENT
 - E—E— PROPOSED CONSTRUCTION EASEMENT
 - - - C - - - PROPOSED CUT LINE
 - - - F - - - PROPOSED FILL LINE
 - ② NC DOT PARCEL ID
 - ⊗ SOIL SAMPLE LOCATION
 - PROPOSED SIDEWALK
 - PTS-14 0-1 SAMPLE ID/DEPTH
 - (ND) ASBESTOS NOT DETECTED
 - (POSITIVE) ASBESTOS DETECTED

- NOTES:**
- SAMPLES COLLECTED BETWEEN 12/2/19 AND 12/6/19
 - SEE TABLE 2 FOR ASBESTOS ANALYTICAL METHODS AND RESULTS

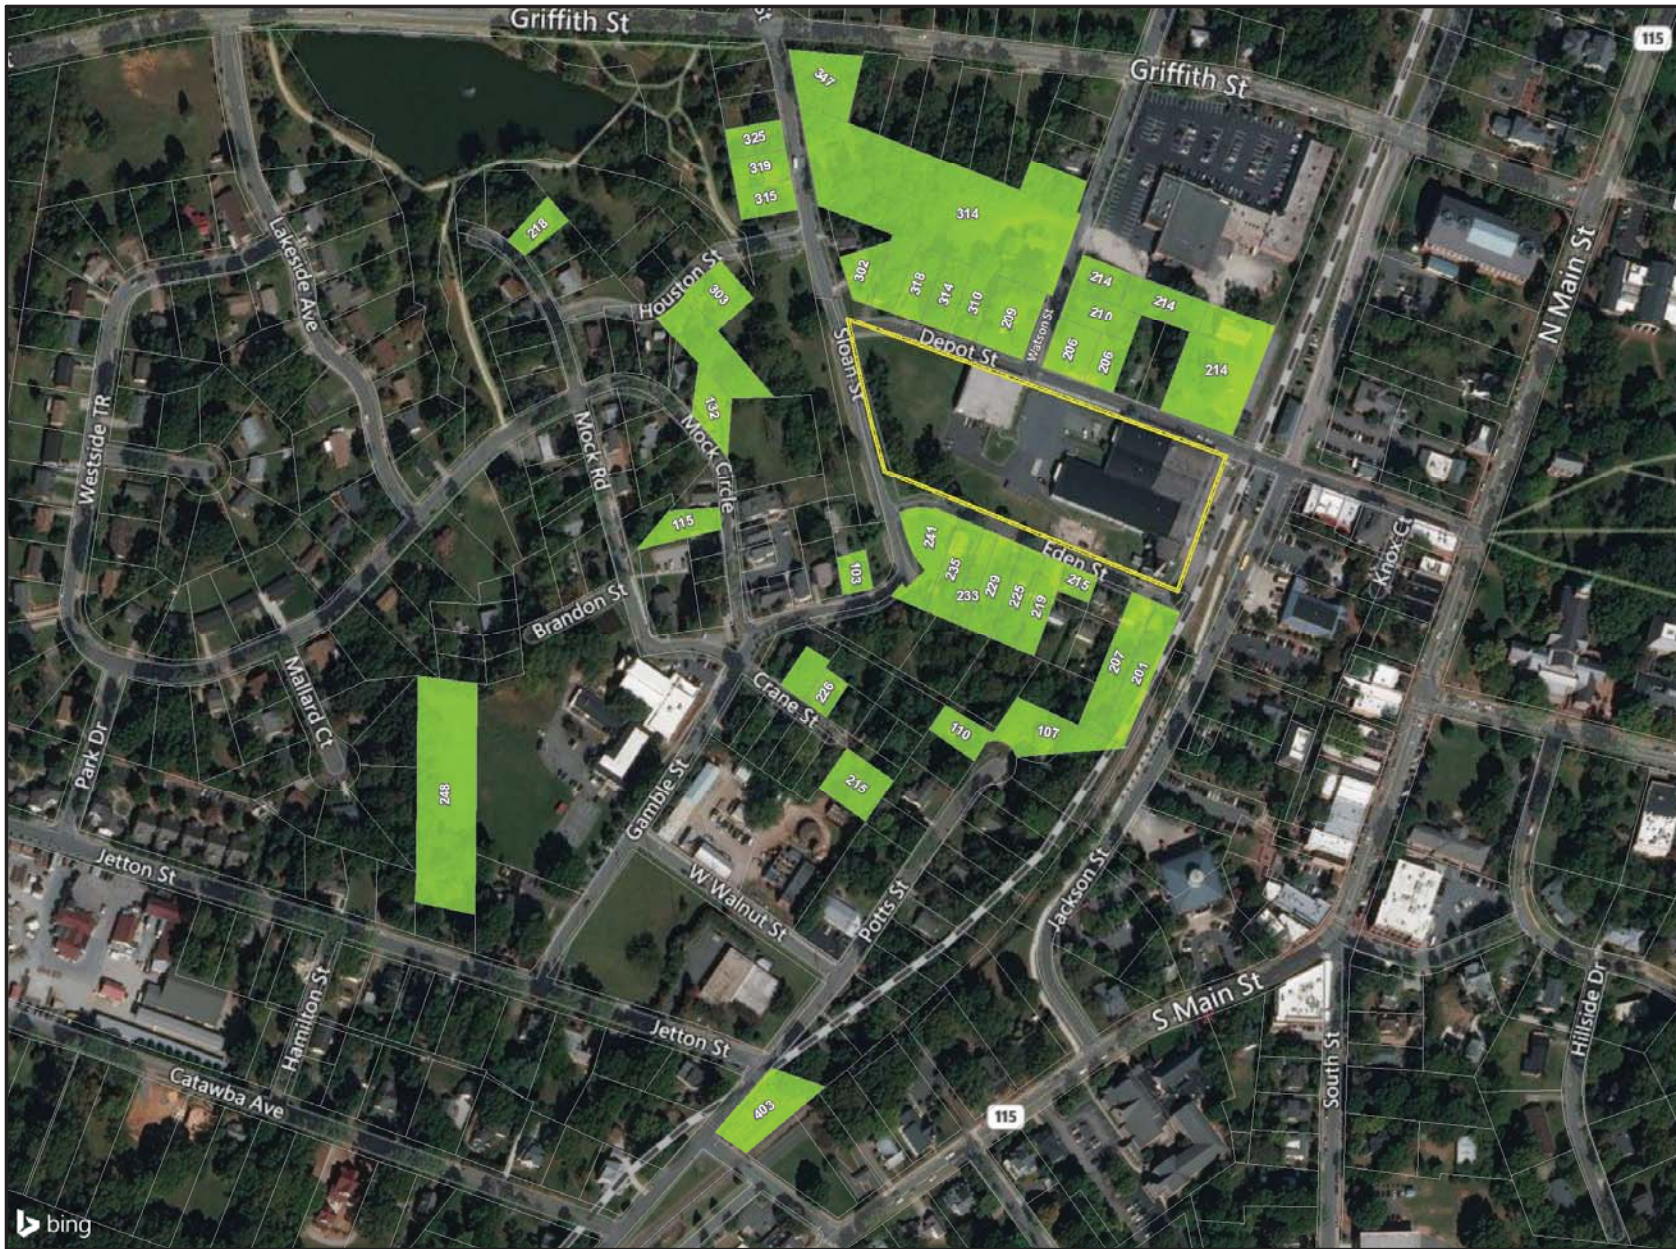
From May 8 to September 22, 2017, EPA and ER conducted removal and restoration at 32 parcels located in neighborhoods around the former mill site. The removal included excavation and disposal of ACM and asbestos-contaminated soil. Restoration included installation of snow fencing and asbestos hazard tape marker layer in the excavated areas and backfill, topsoil, sod, mulch, and rock, depending on the surface before excavation. Sod was watered for 2 weeks in those areas where sod was installed.

- Legend**
- Parcels with Removal Activities
 - Parcel Boundary
 - Former Asbestos Mill Boundary

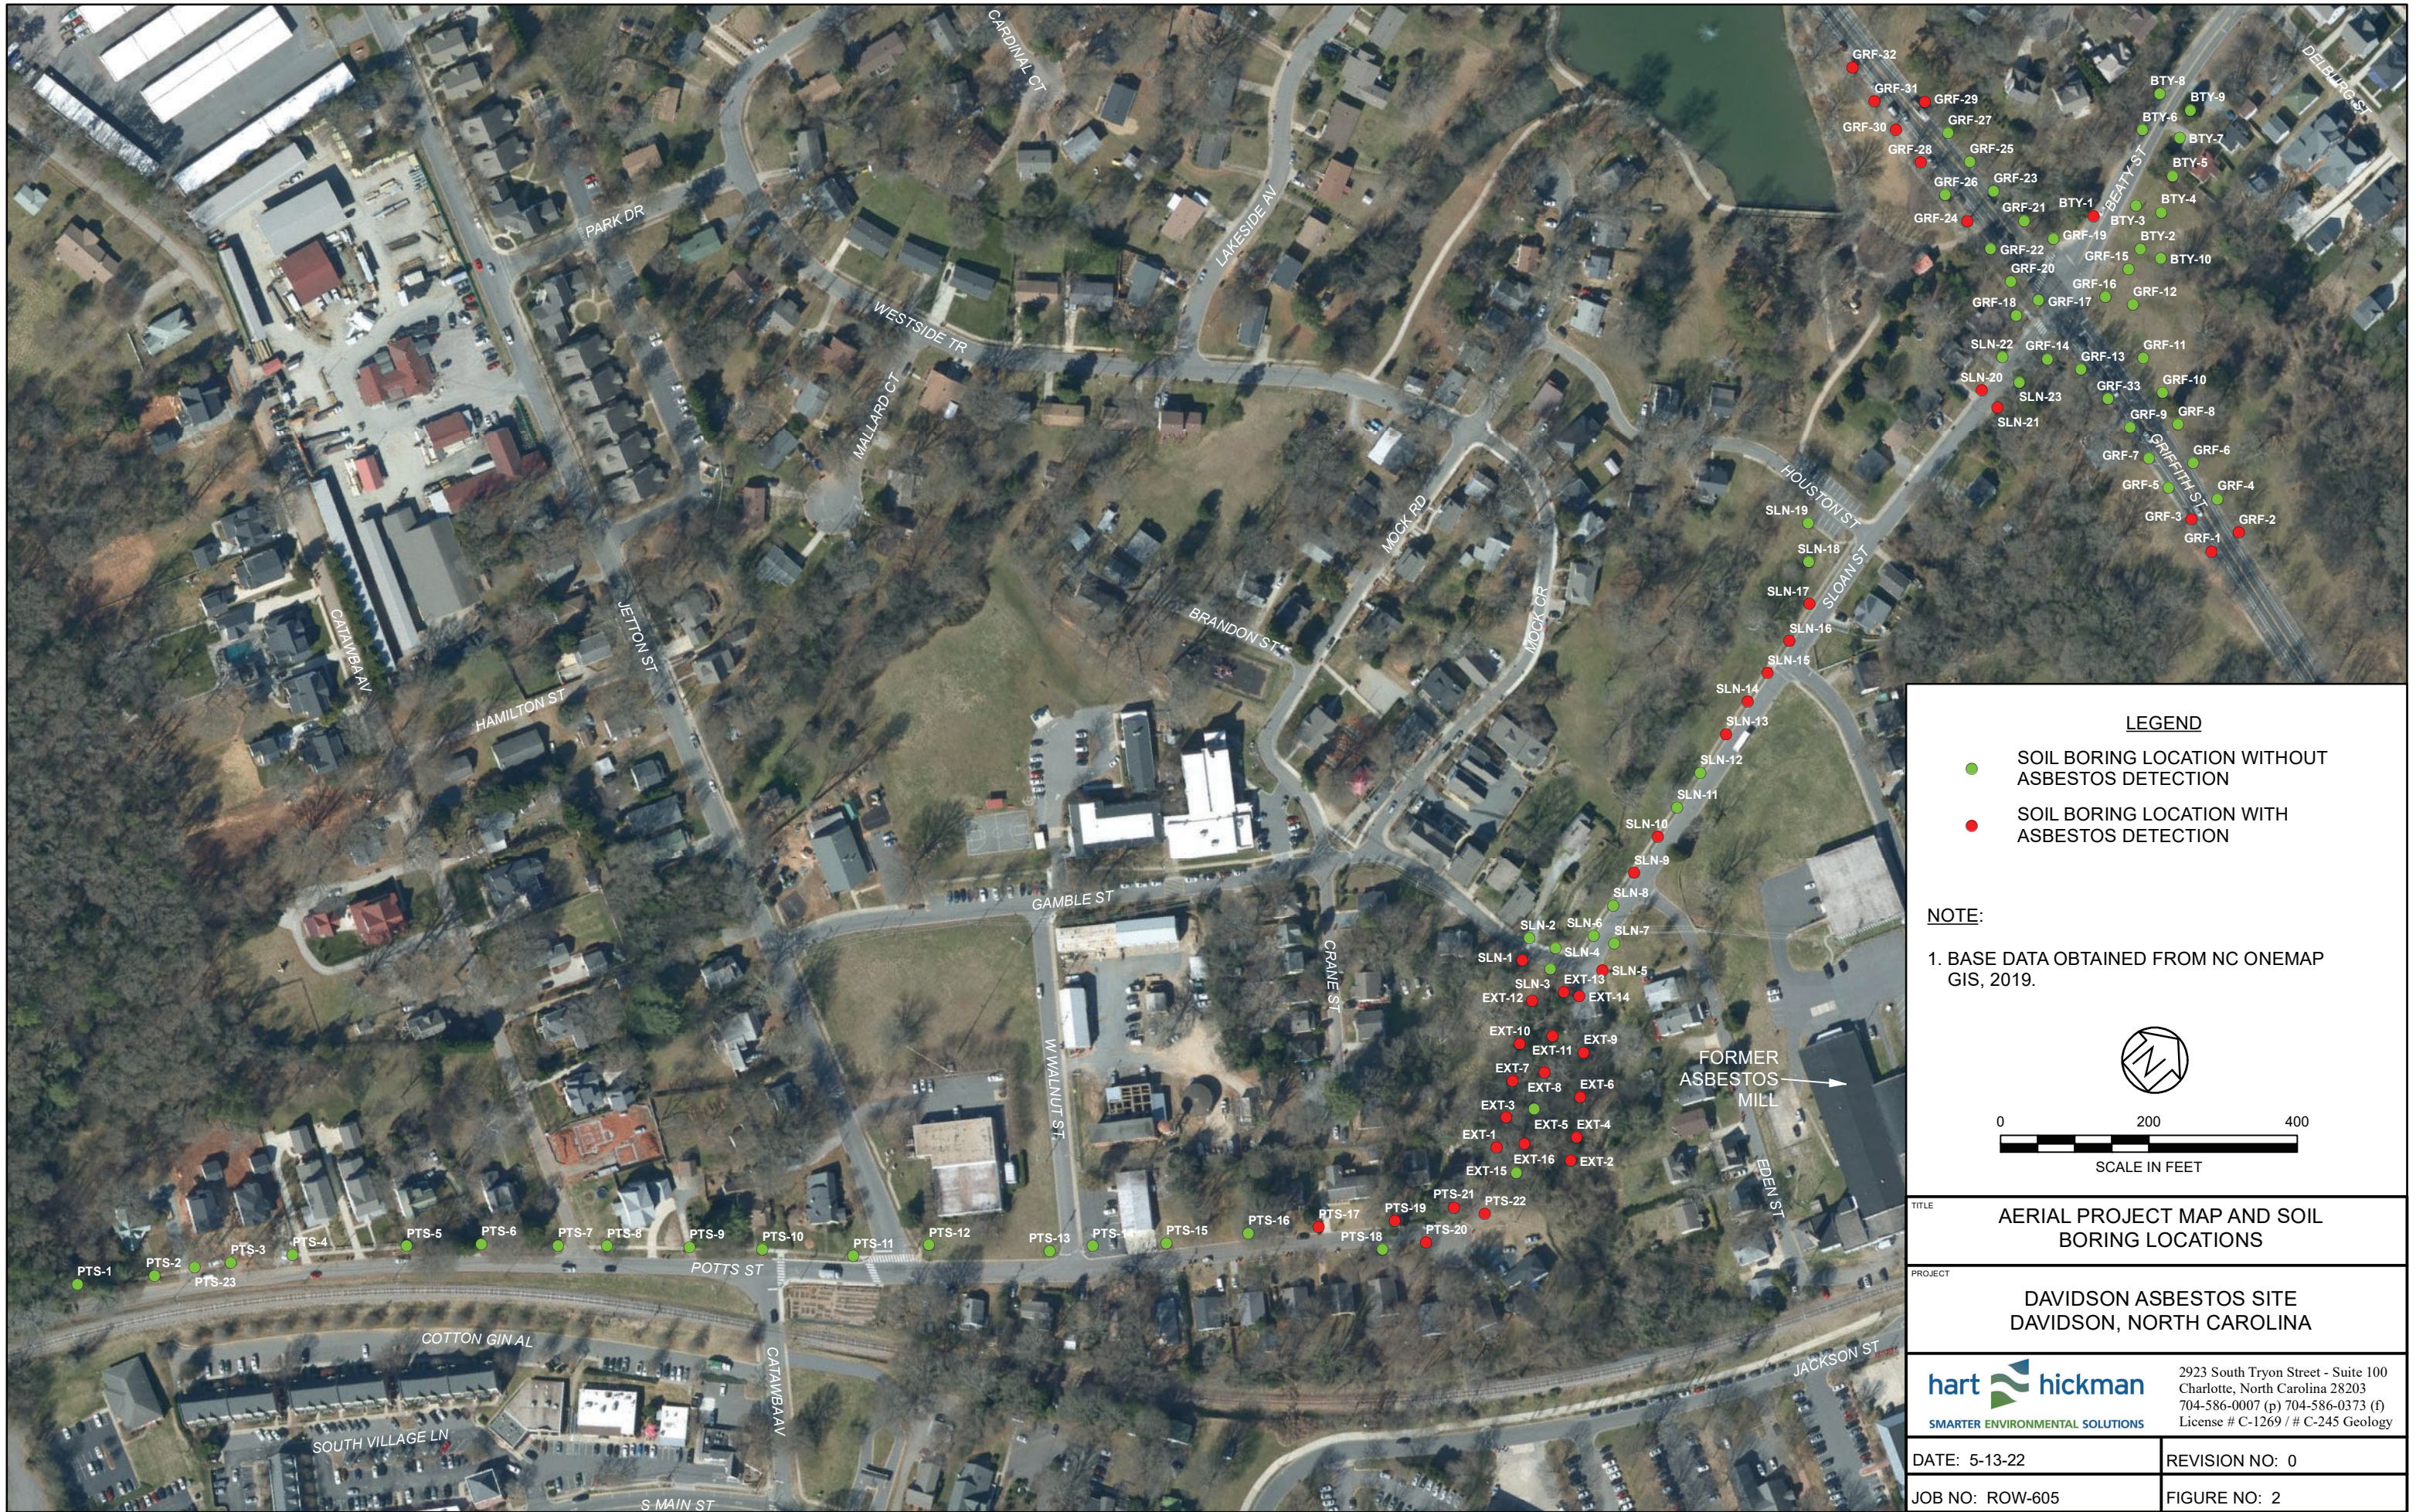
2923 South Tryon Street - Suite 100 Charlotte, North Carolina 28203 704-586-0007 (p) 704-586-0373 (f) License # C-1269 / # C-245 Geology	
DATE: 5-13-22		REVISION NO: 0	
JOB NO: ROW-605		FIGURE. 1

- SOIL BORING LOCATION WITHOUT ASBESTOS DETECTION
- SOIL BORING LOCATION WITH ASBESTOS DETECTION

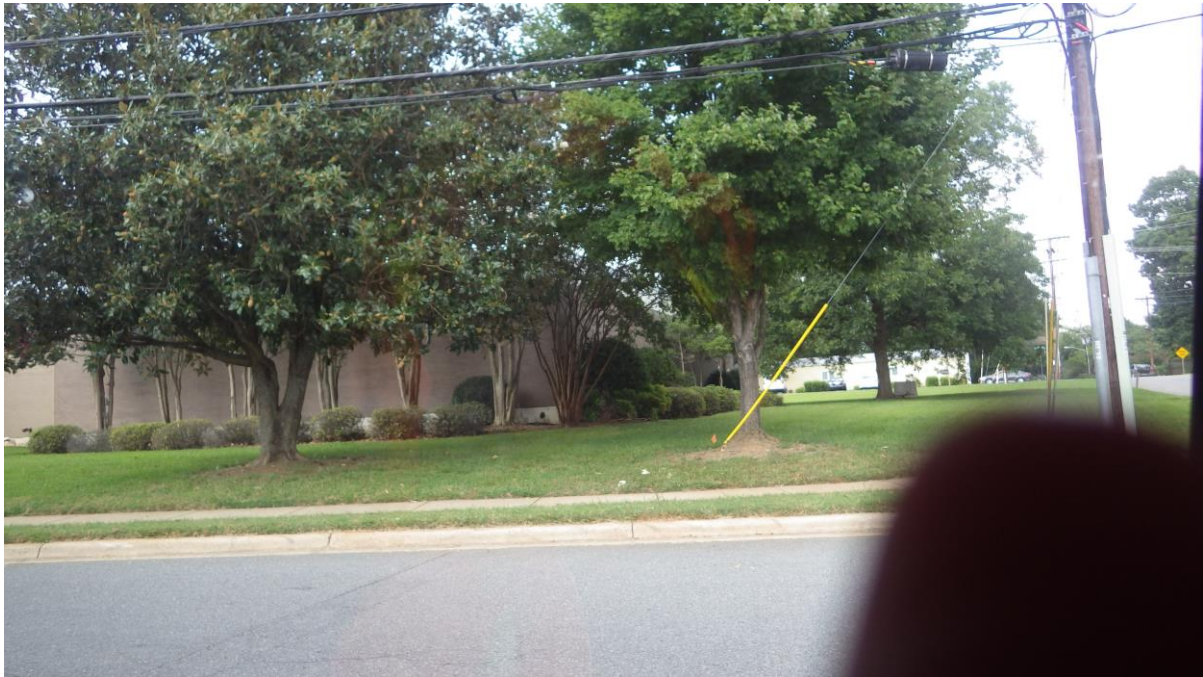
Anticipated Impacts: Low

This parcel is currently the site of a telecommunications facility (image view northward). The site currently has a 3,500-gallon diesel fuel above ground storage tank (AST) along the north-northeastern side of the building. NCDEQ Incident Number 27140 was assigned to this parcel with respect to an emergency generator UST Incident that was closed out c. 1998. (This site may include the following facility whose location is unclear: Southern Bell-GLC 22545, Facility Id: 0- 017309, Bellsouth Telecommunications Inc. 7825 Red Top Road, Karen J Rhyne MacClenny). The current design of the project proposes to install a multiuse trail/sidewalk along the southwestern edge of the property-the proposed design does not impact the current AST.

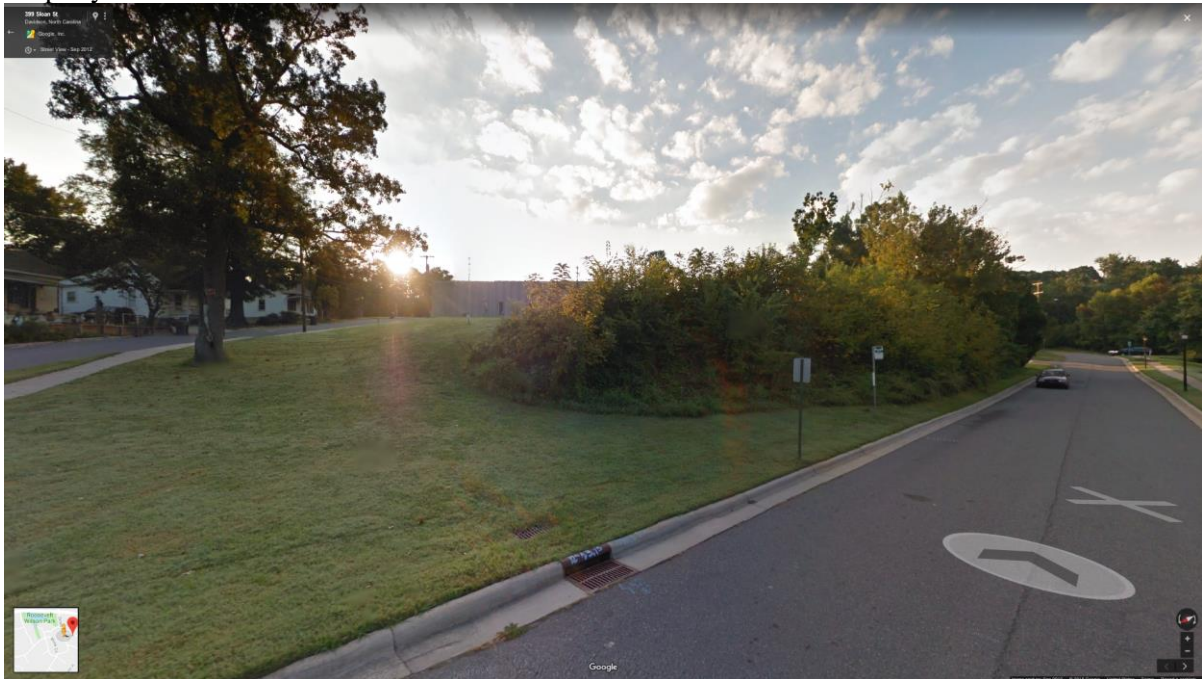
Anticipated Impacts: Low

This parcel is the former site of Metrolina Warehouse that was an asbestos product manufacturing facility (image view southeastward). It is currently used for other purposes including Crossfit, Rumor Mill Market, Sofas and Cheers, Flying Fish Seafood, and No Kidding Goat Soaps. The 4.74 acre site has a status of Active Eligible to become a Brownfields Property. The site formerly produced asbestos containing material (ACM) products utilizing asbestos and created waste containing asbestos. The current DOT design of the project proposes to install a multiuse trail/sidewalk along the western side of Sloan St., across Sloan St. from the parcel. That design does not impact the 301 Depot St. parcel boundaries, however, several neighboring parcels have reportedly been impacted by ACM that was perhaps either disposed or used as structural fill. Potentially the soil underlying existing pavement has also been impacted. The areas where soil is proposed to be disturbed by construction of the design could require testing, and/or disposal, and/or engineering controls during construction. The presence of ACM in the project area, therefore, has a moderate to high impact on the project.
