Phase II Site Assessment Report
May 12, 2023
WBS Element: 44354.1.R1
State Project: U-5783
Henderson County

Parcel #: 019
Duane and Margaret McKibbin Family Limited Partnership Property
1734 Brevard Road, Hendersonville, NC 28792
PIN #: 9558893840
Facility ID #: 00-0-0000017491
Groundwater Incident #: 14520 (Closed 2017)

Seramur & Associates, PC
165 Knoll Drive
Boone, NC 28607

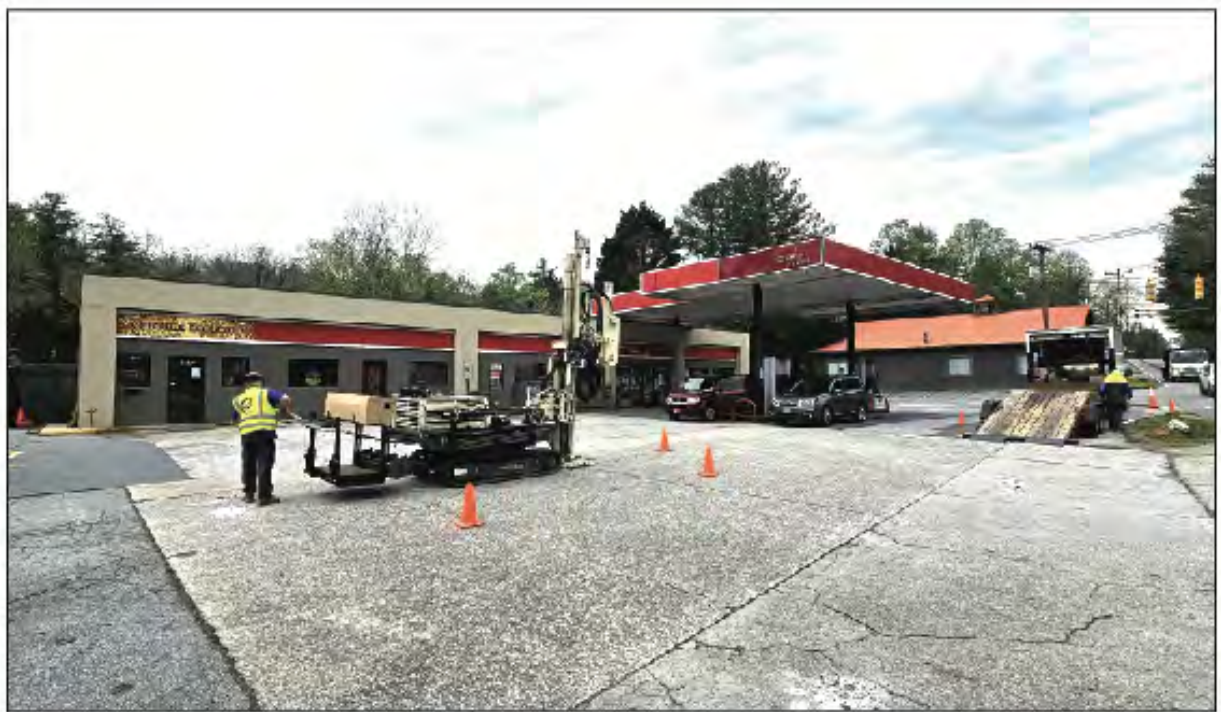
Photo 1. View to the southwest across Parcel #019. Geoprobe is drilling boring B-5.

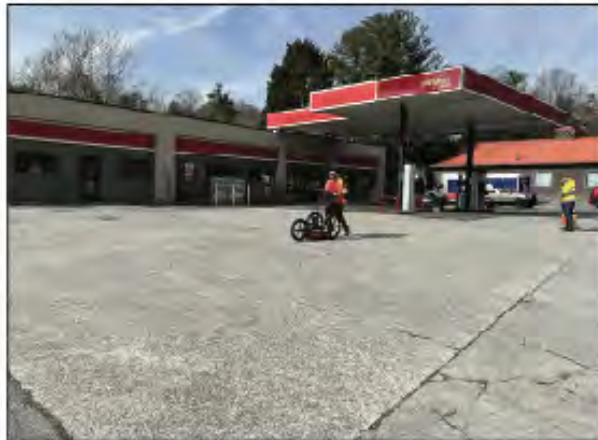
Photo 2. Collecting GPR data at Parcel #019.

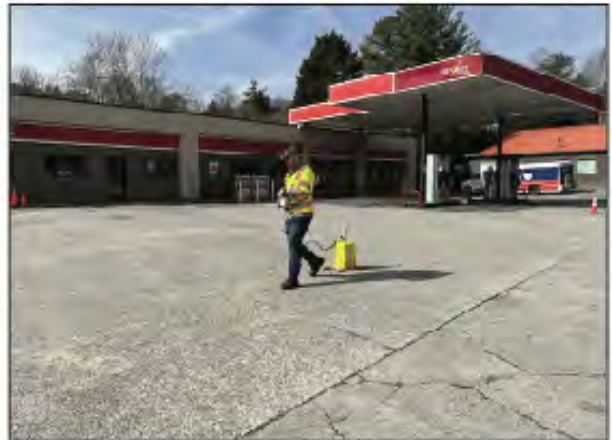
Photo 3. Collecting magnetometer data Parcel #019.

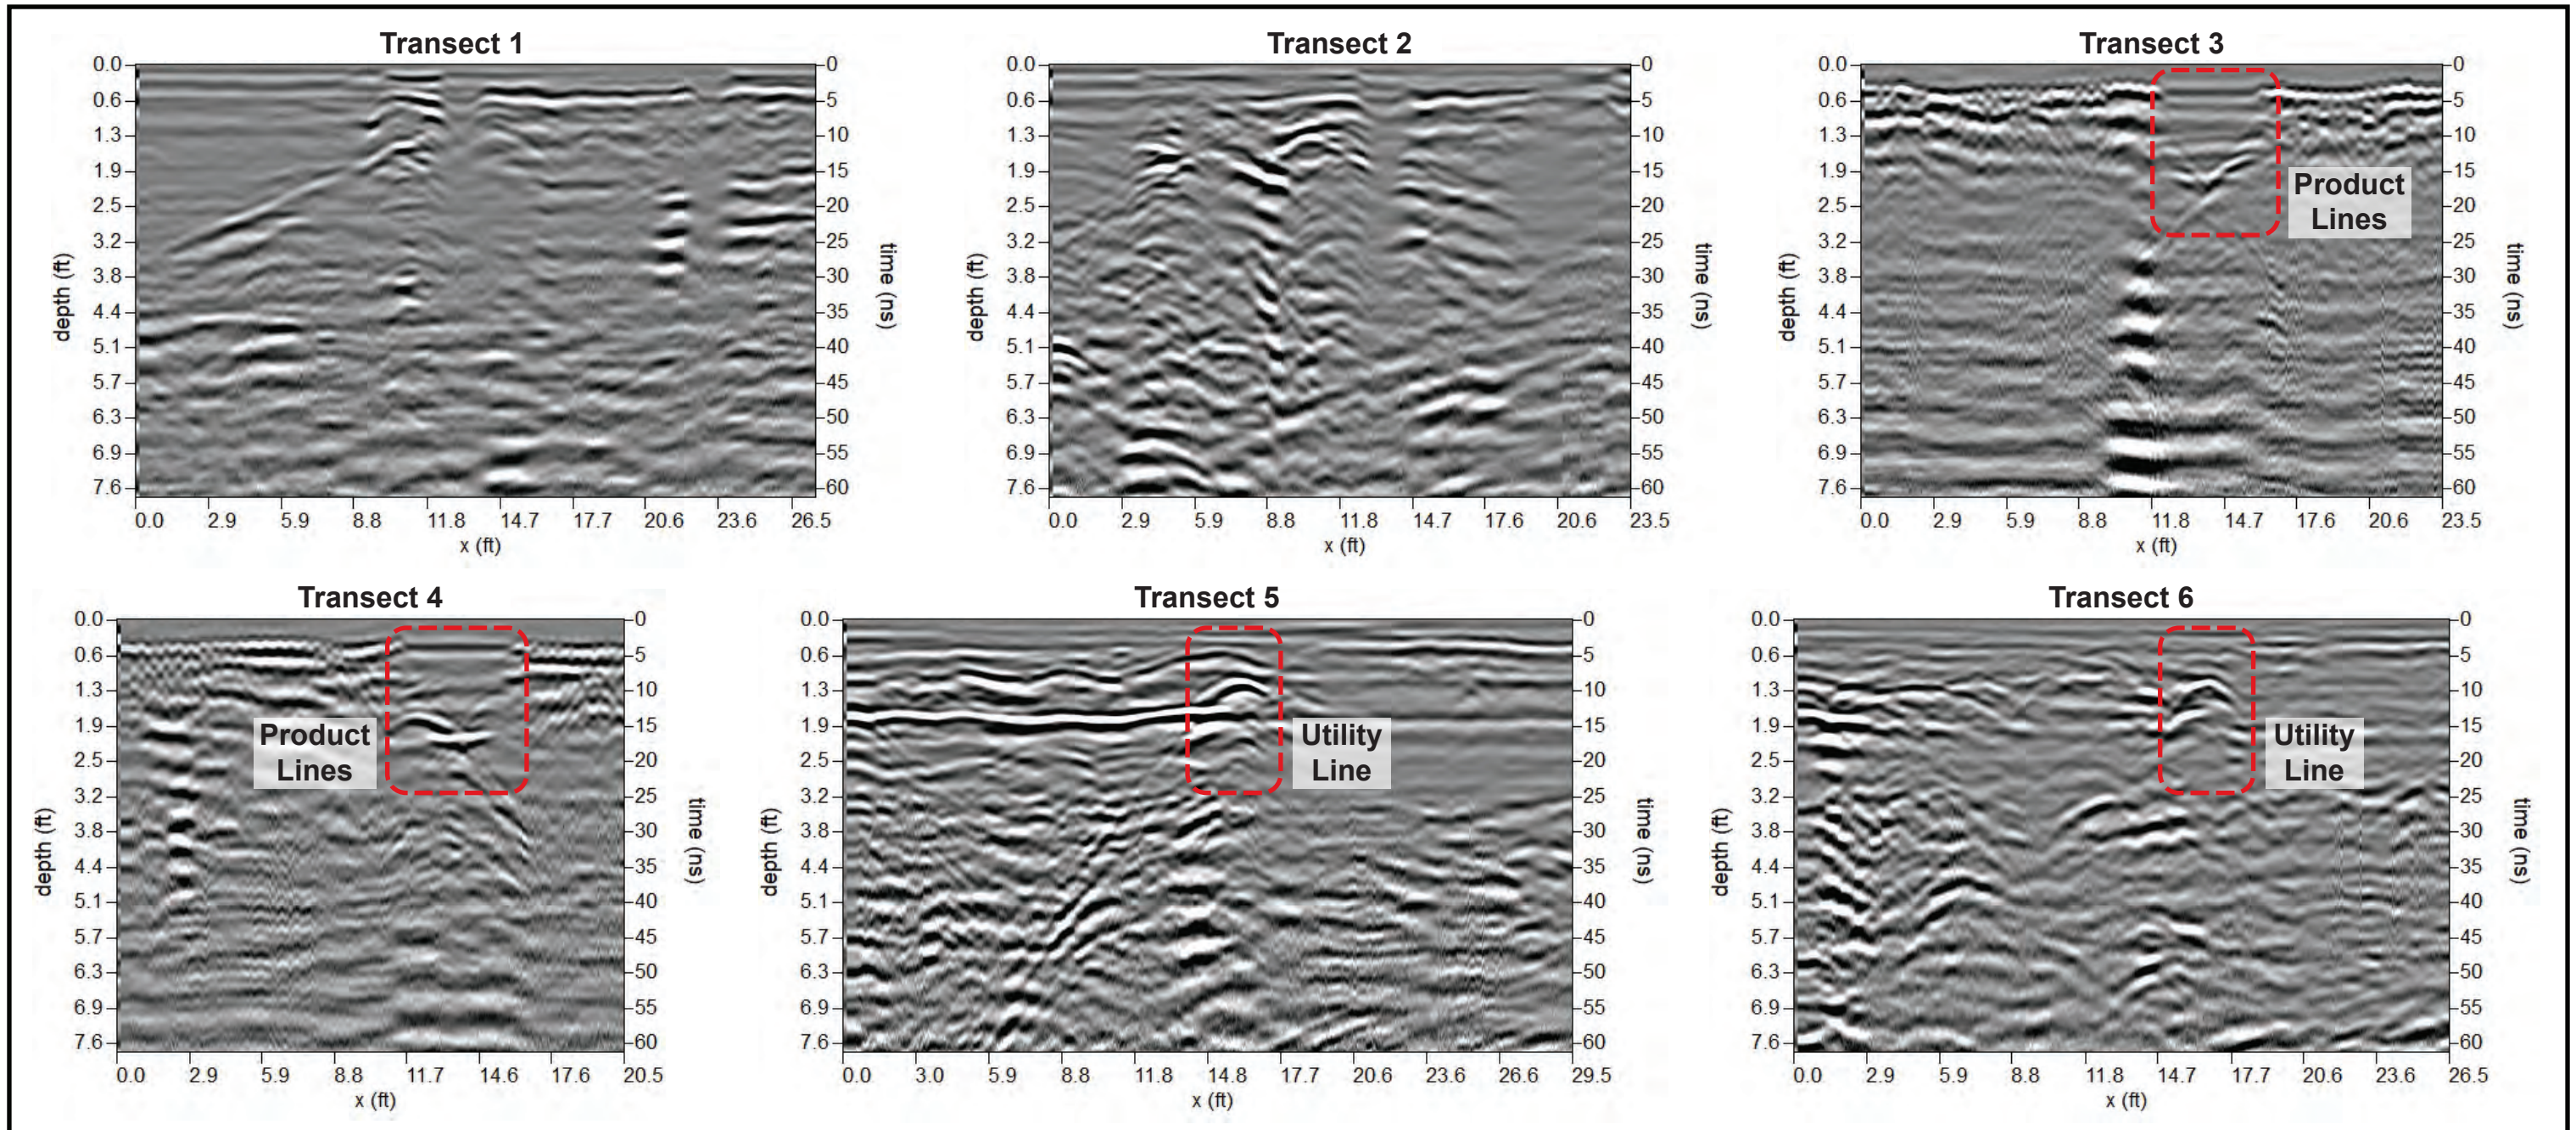
The Ground Penetrating Radar (GPR) data was collected with a Geophysical Survey Systems, Inc. UtilityScan GPR System with a 350 MHz hyperstacking antenna. This GPR system is equipped with a calibrated survey wheel. The GPR data was downloaded and saved onto a computer. The GPR grid and transect data has been processed and modeled using GPR Slice® software. The GPR data processing included adjusting time zero, completing a background removal and adjusting the time variable gain to enhance deep reflections. Three-dimensional models of the GPR grid data were produced with GPR Slice® software. Three time slices (or depth slices) were imaged in each 3D model at depths of 0.2 to 0.5 feet, 2.0 to 2.3 feet and 3.4 to 3.7 feet (Figures 6, 7, & 8). Each depth slice is a horizontal slice or plan view of the reflections across a 0.3-foot thickness of the subsurface. For example, the deep GPR depth slices show reflections in the radar data between depths of 3.4 and 3.7 feet. The profiles of the GPR transects show the subsurface directly under the path of the antenna to a depth of about 8.0 feet (Figures 9a and 9b).

GPR Transects 1 and 2 were collected over a steel plate on the east side of the store building. A structure is present at this location in the 2000's. Transects 3 and 4 were collected over the product lines in a North-South direction in contrast to the grid transects which were collected in an East-West direction. These transects show the product lines with reinforced concrete surrounding them. Transects 5 and 6 were collected on the west side of the gas station building. These transects appear to cross a utility line (Figure 9a). Transect 7 was collected north of Grid 1 and appears to show chaotic backfill that could be related to the former UST pit. Transects 8 and 9 begin over the chaotic backfill from the potential former UST system and extend across the area underneath the canopy, crossing the product lines (Figure 9b). No abandoned USTs or unexpected gas station infrastructure was observed in any of the Transects collected at Parcel #019.

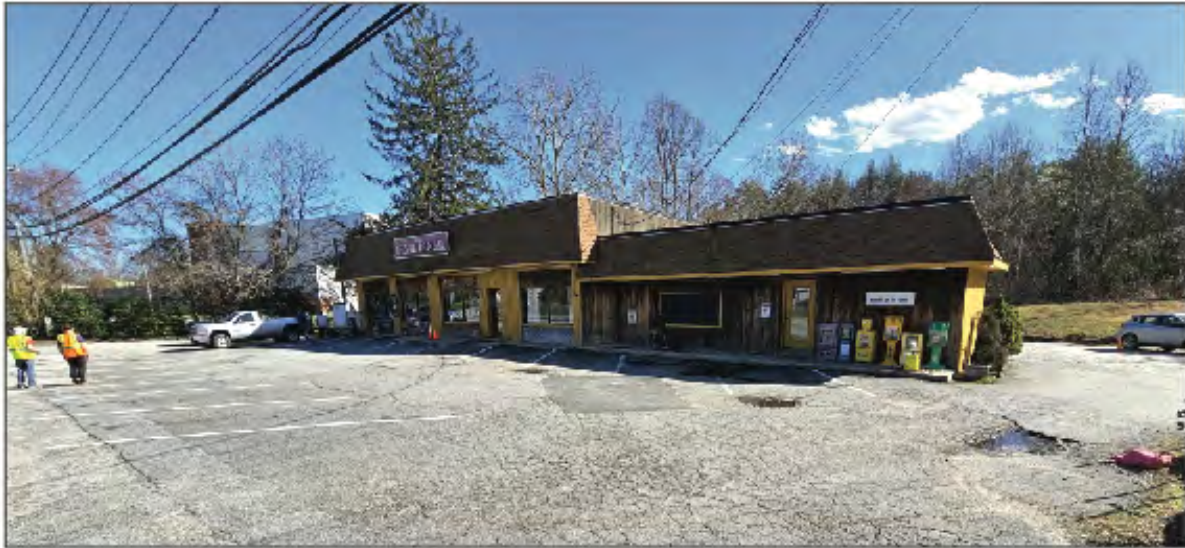
Photo 1. View to the southeast across Parcel #019B.

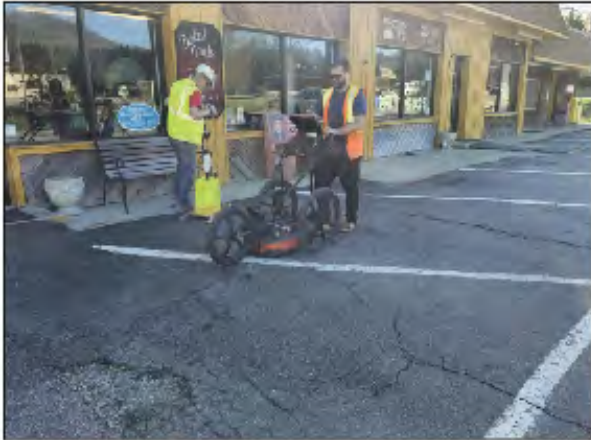
Photo 2. Collecting GPR data at Parcel #019B.

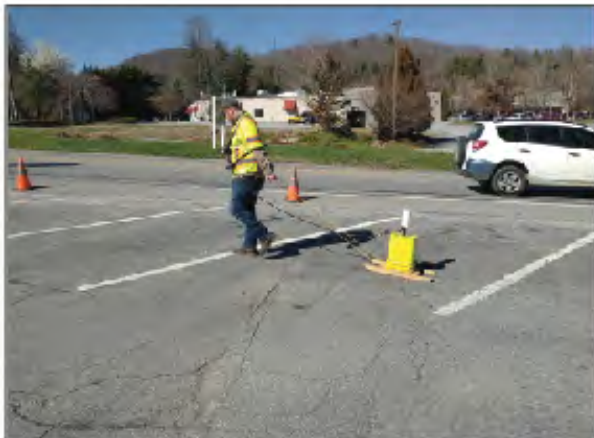
Photo 3. Collecting magnetometer data at Parcel #019B.

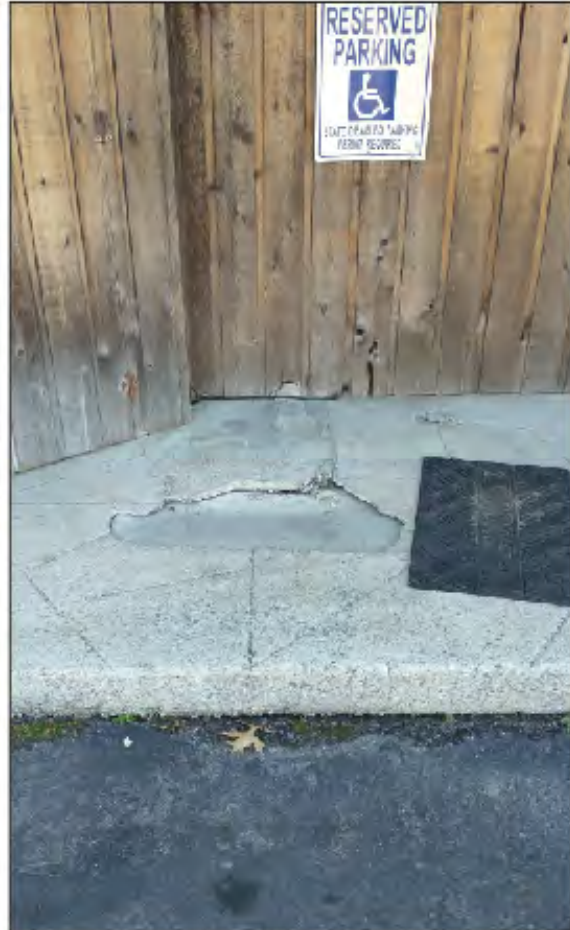
Photo 4. Patched concrete showing possible former dispenser.
