**SUBJECT: Preliminary Site Assessment Report
Parcel 46, Priscilla Harb & Michelle Moore
WBS Element No. 54035.1.1, TIP No. U-5757
NC 8 (Winston Road) from 9th Street to SR 1408 (Biesecker Rd) in
Lexington. Widen to multi lanes
Kleinfelder Project No. 20201105.001A**

**PRELIMINARY SITE ASSESSMENT REPORT
PARCEL 46, PRISCILLA HARB & MICHELLE MOORE
PARCEL 11332E0000022
1409 WINSTON ROAD
LEXINGTON, DAVIDSON COUNTY, NORTH CAROLINA**

**NCDOT WBS ELEMENT 54035.1.1
STATE PROJECT U-5757
NC 8 (WINSTON RD) FROM 9TH STREET TO SR 1408
(BIESECKER RD) IN LEXINGTON. WIDEN TO MULTI LANES**

**PRELIMINARY SITE ASSESSMENT REPORT
PARCEL 47, PRISCILLA HARB & MICHELLE MOORE
PARCEL 11332E0000021A
1458 OLD US HIGHWAY 52
LEXINGTON, DAVIDSON COUNTY, NORTH CAROLINA**

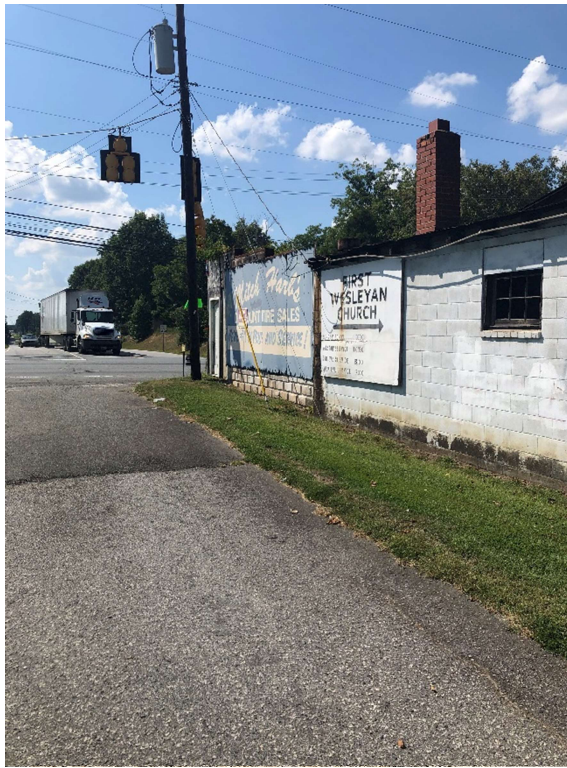
View facing northwesterly toward the intersection of Biesecker Road and NC Highway 8 (Winston Road), the southwestern corner of Parcel 46.

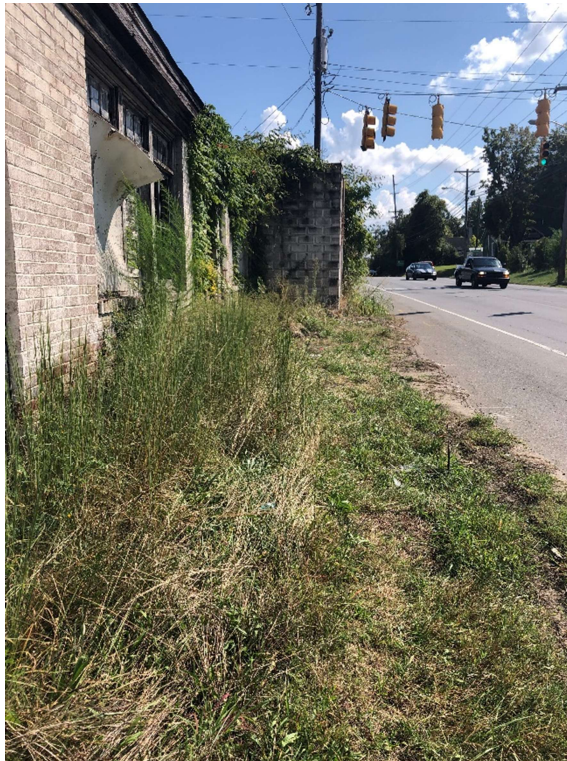
View facing southerly along NC Highway 8 (Winston Road) and the western border of Parcel 46.

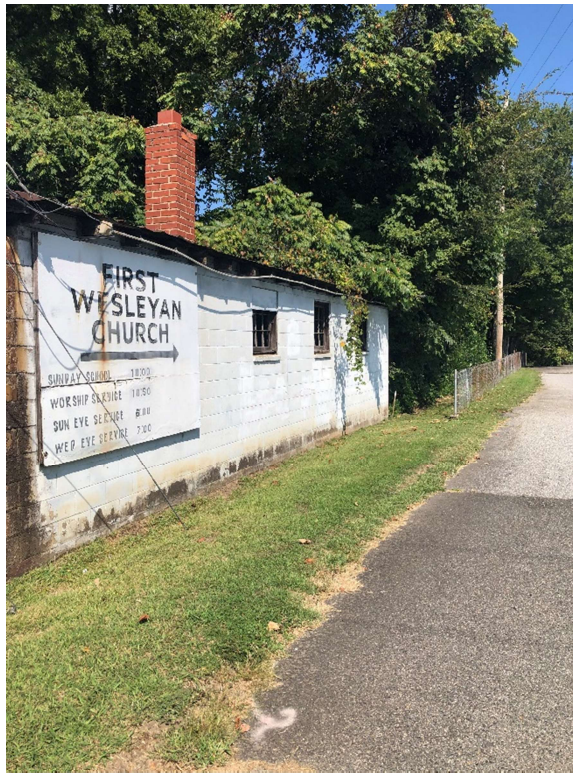
View facing easterly along the southern boundary of Parcel 46.

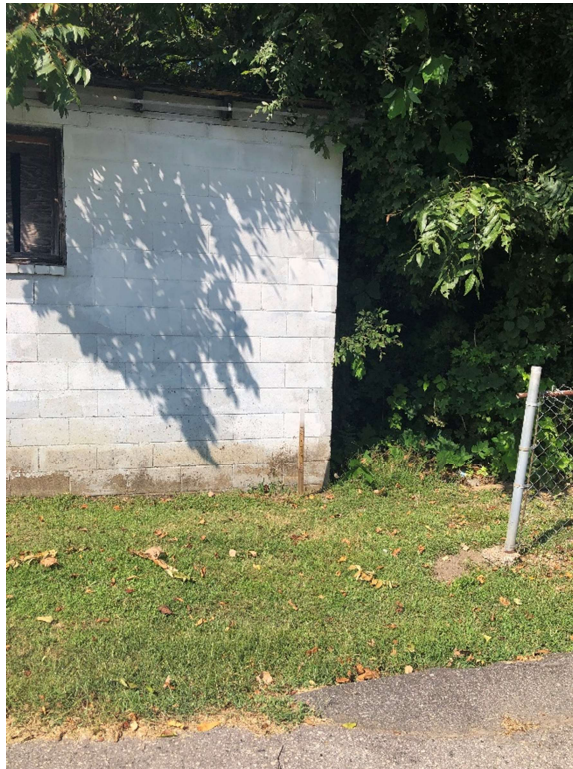
View facing northerly of the southeastern corner of the vacant building on Parcel 46, toward soil boring P46-B2.

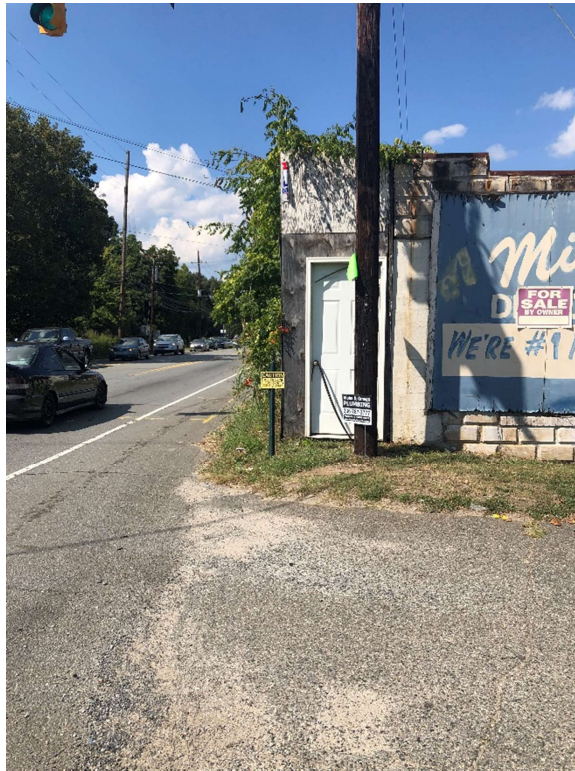
View facing northerly along the western boundary of Parcel 46, NC Highway 8 (Winston Road), and the southwestern corner of the vacant building on Parcel 46, toward soil boring P46-B3.

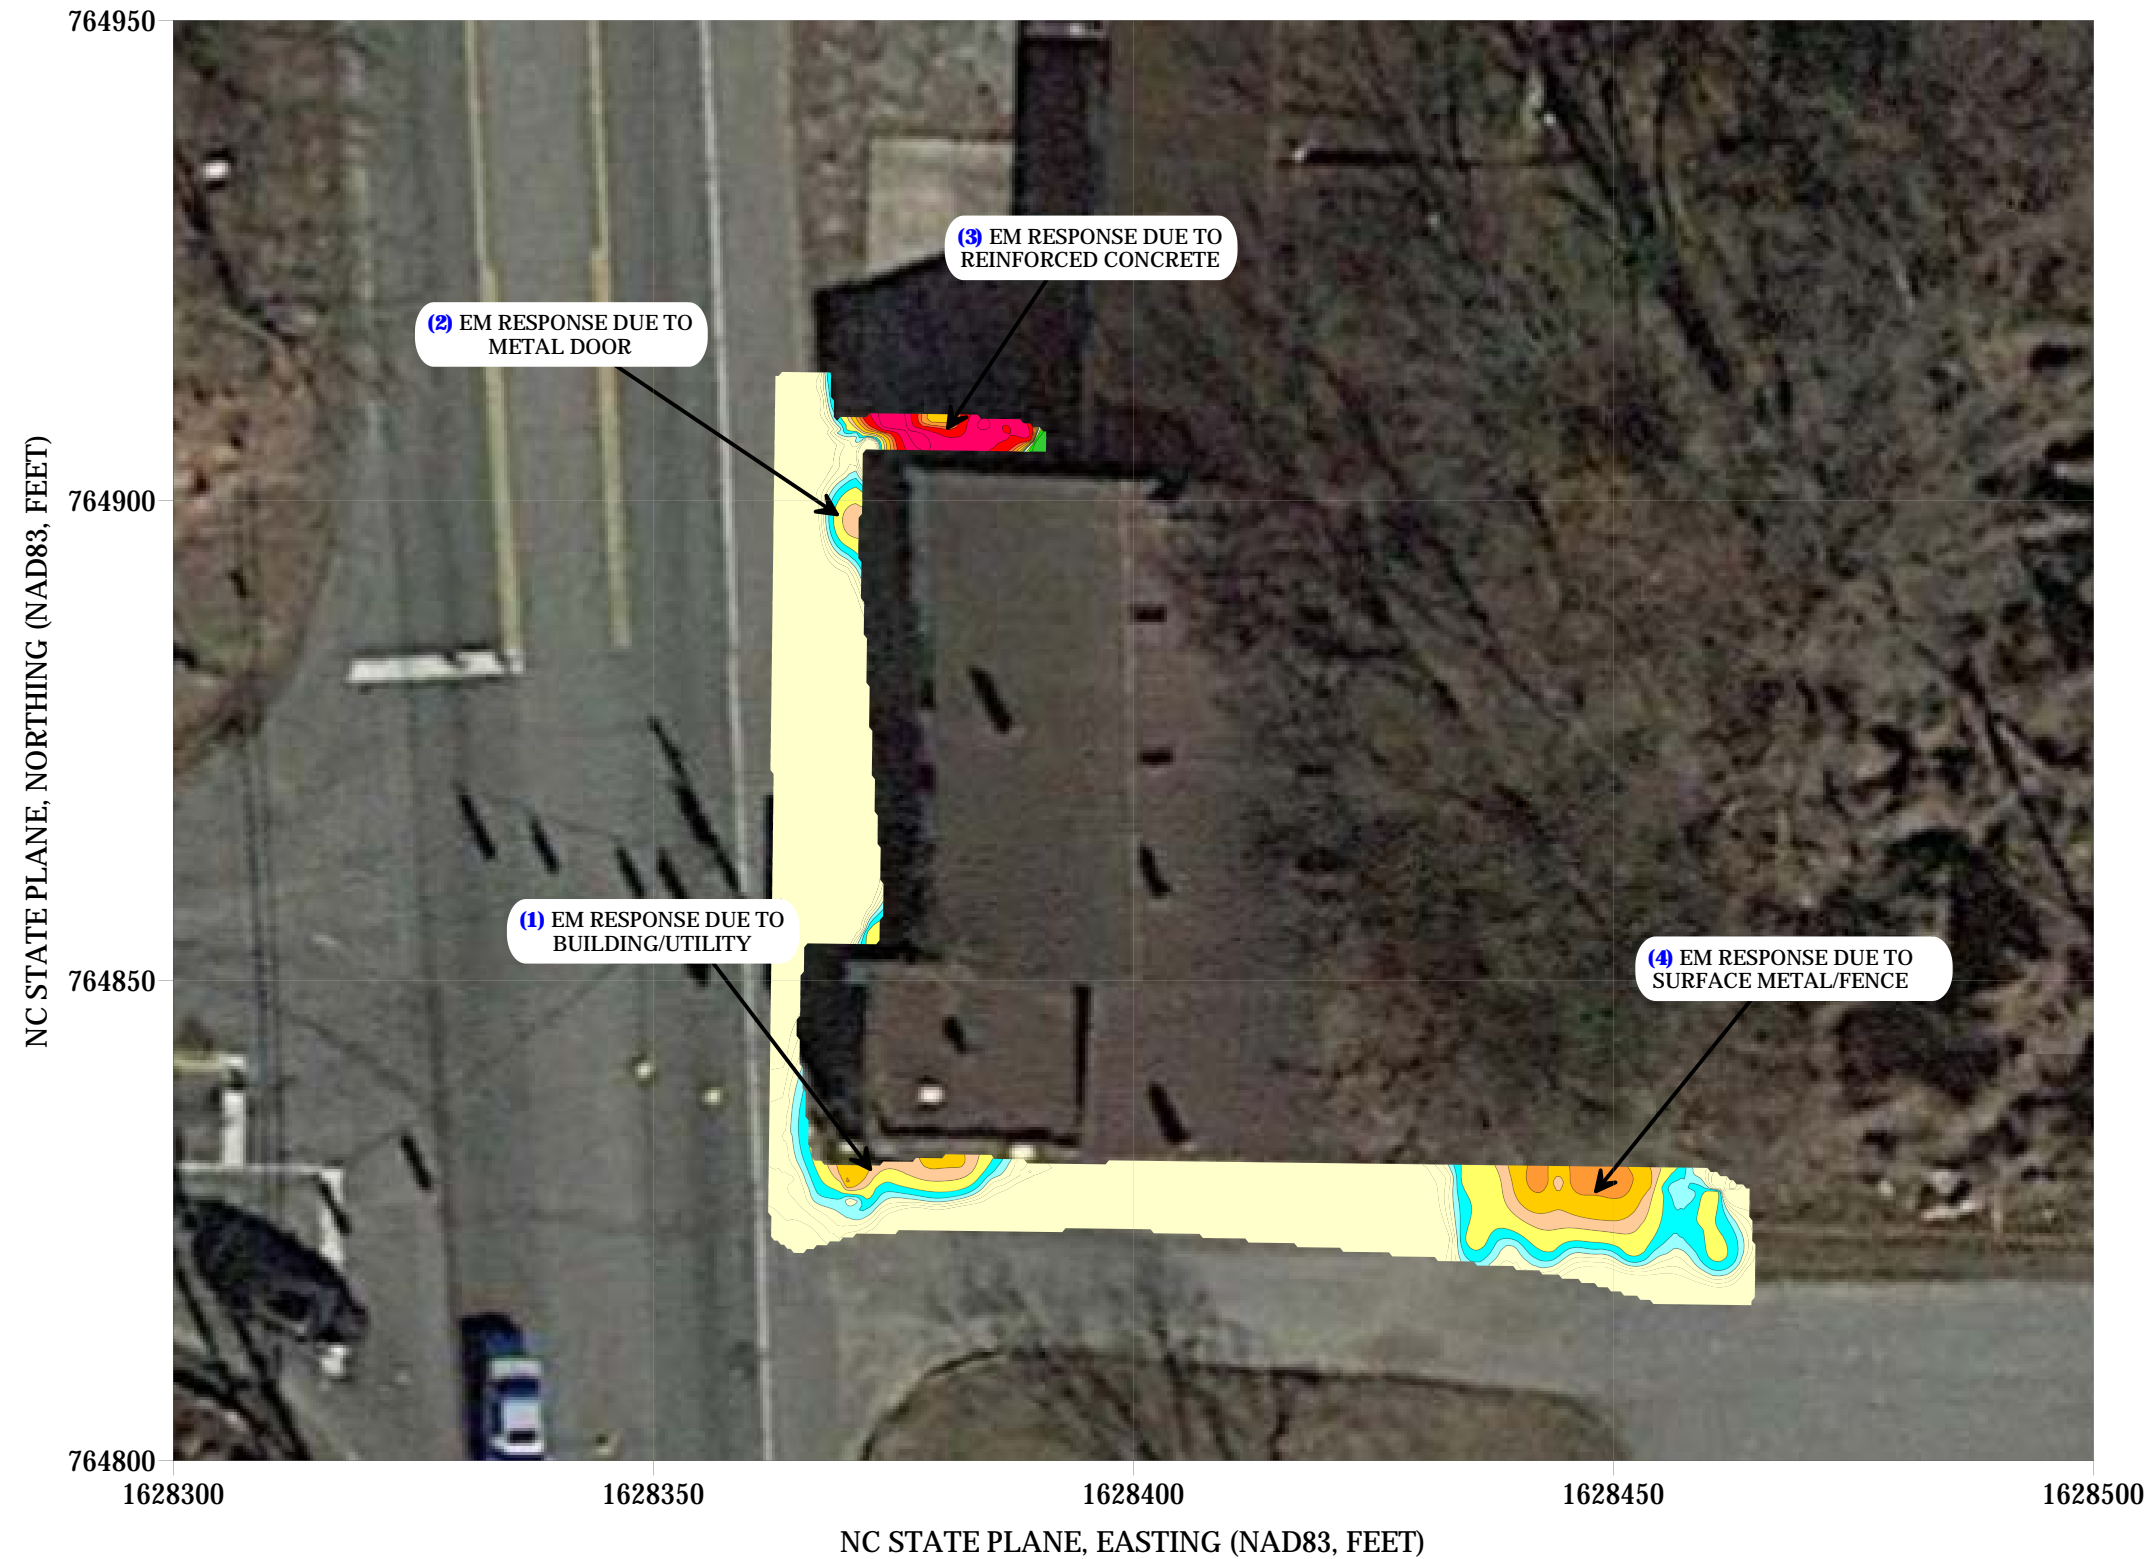
CLIENT
KLEINFELDER
FIGURE 2

A contour plot of the EM61 results obtained across the survey area at the property is presented in **Figure 2**. Each EM anomaly is numbered for reference in the figure. The following table presents the list of EM anomalies and the cause of the metallic response, if known:

Metallic Anomaly #	Cause of Anomaly	Investigated with GPR
1	Building/Utility	✓
2	Metal Door	
3	Reinforced Concrete	✓
4	Surface Metal/Fence	✓

NO EVIDENCE OF METALLIC USTs WAS OBSERVED.

The contour plot shows the differential results of the EM61 instrument in millivolts (mV). The differential results focus on larger metallic objects such as USTs and drums. The EM data were collected on July 16, 2019, using a Geonics EM61-MK2 instrument. Verification GPR data were collected using a GSSI UtilityScan DF instrument with a dual frequency 300/800 MHz antenna on July 17, 2019.

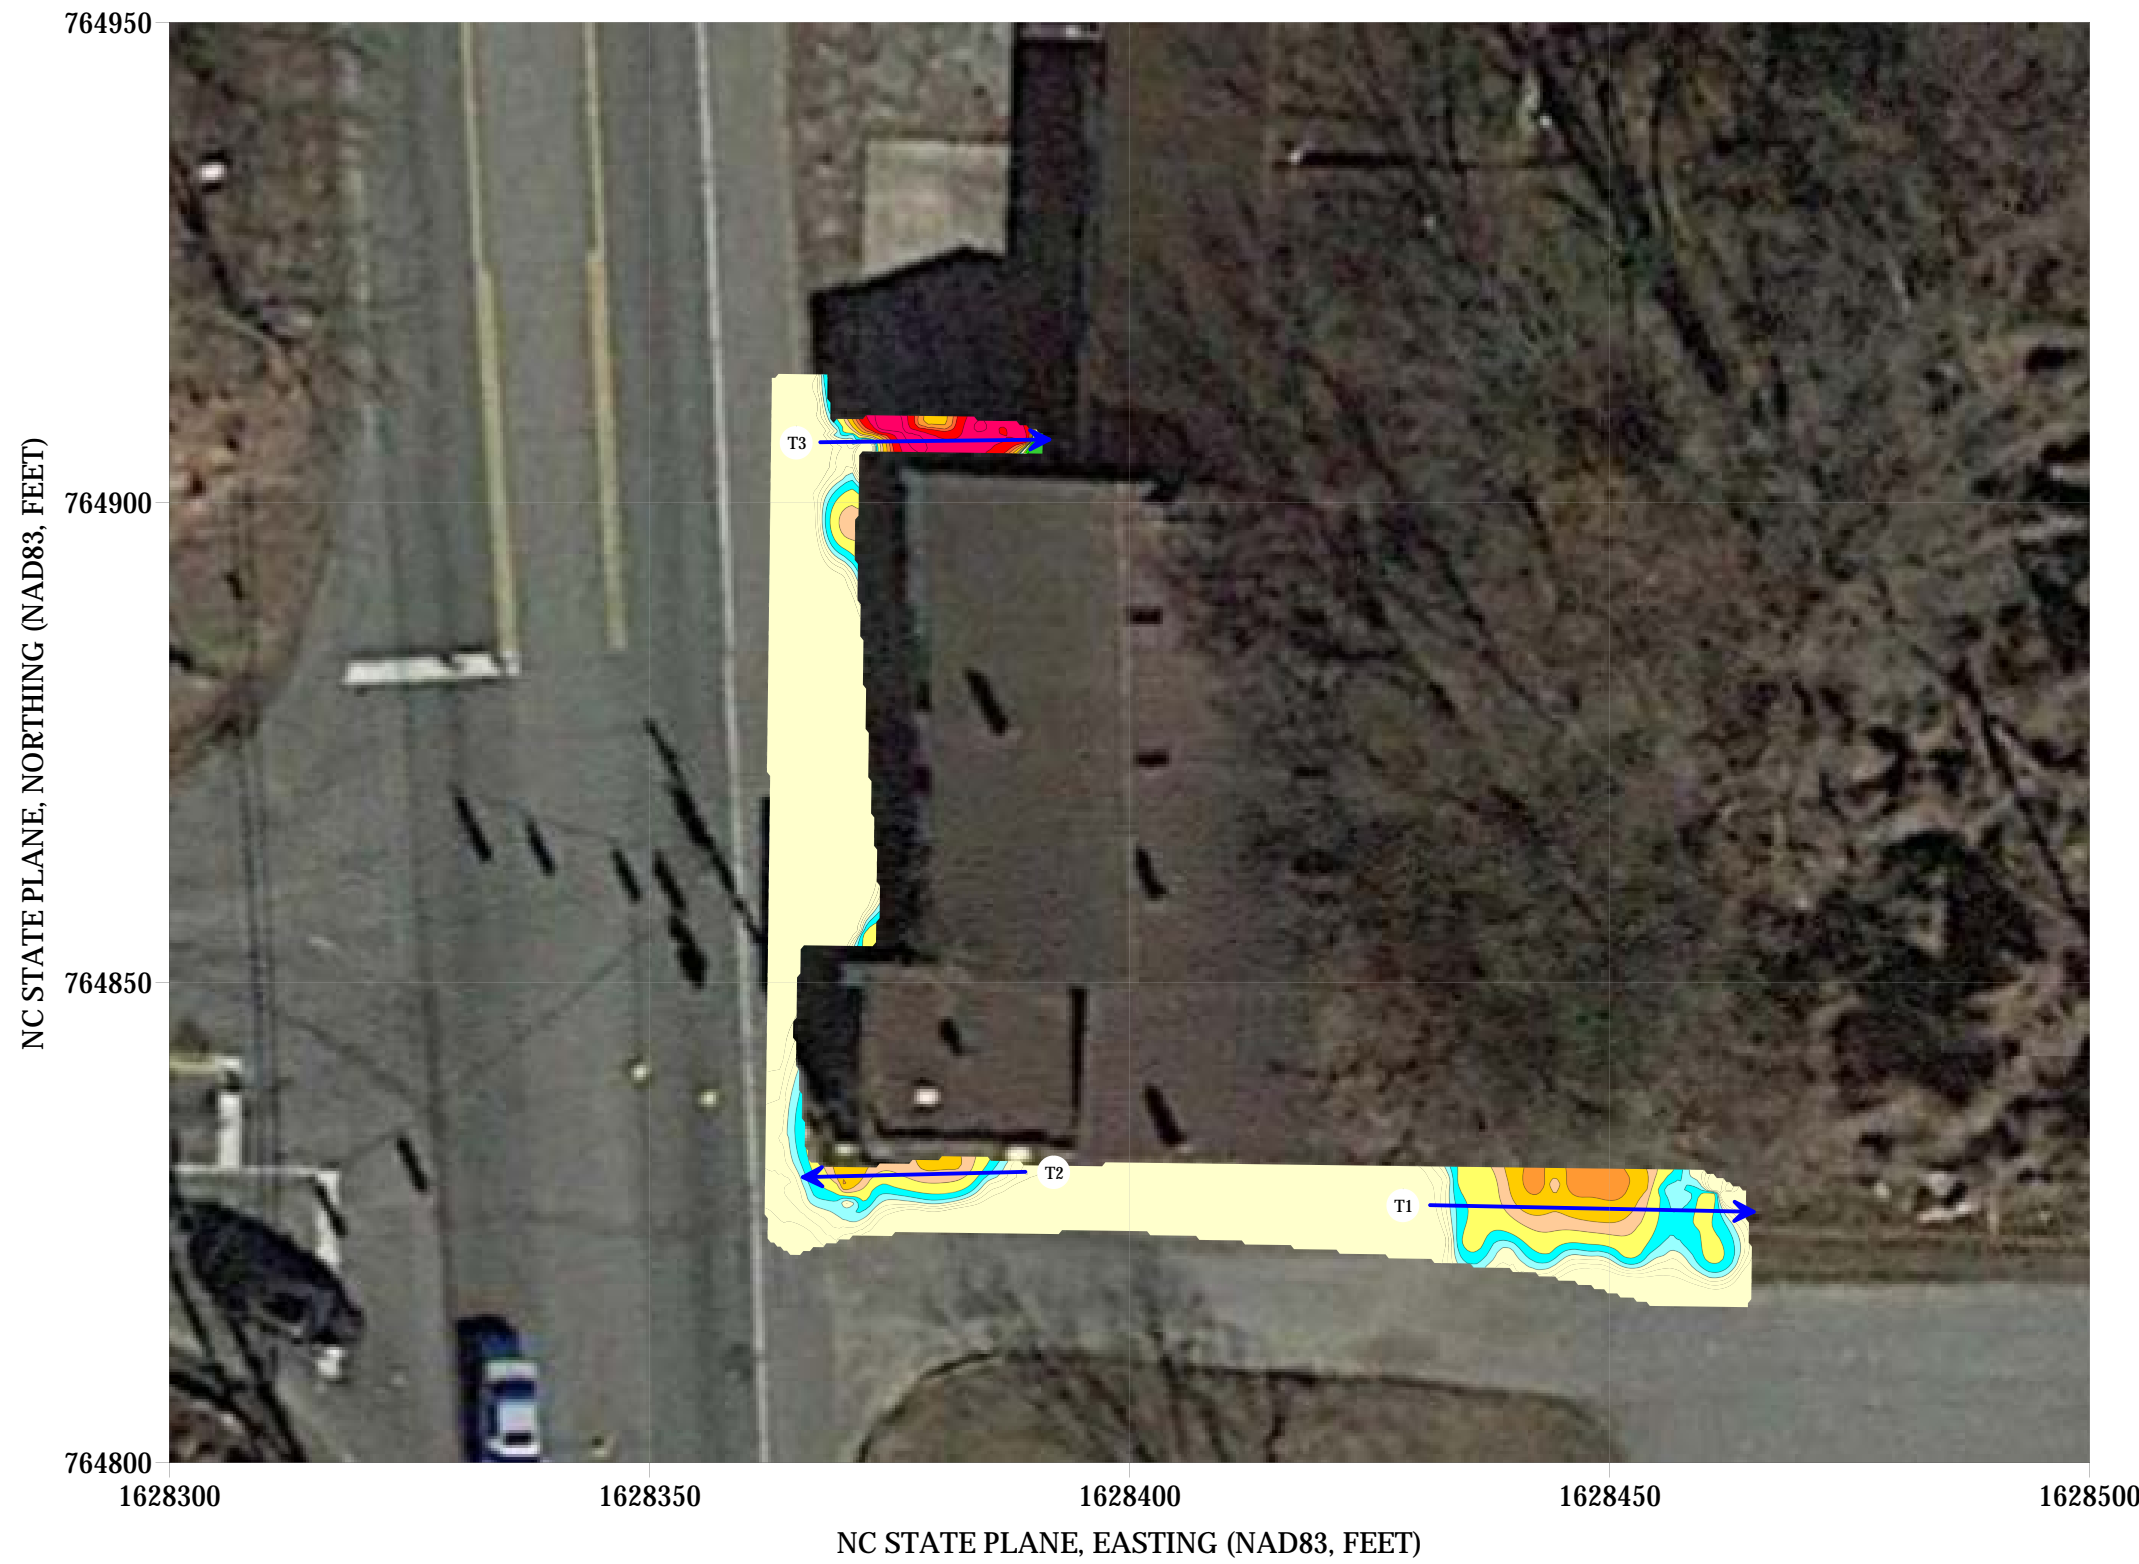
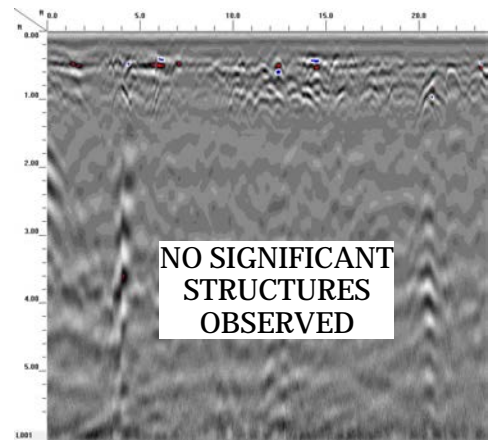
CLIENT
KLEINFELDER
FIGURE 3

Figure 3 presents the locations of the formal GPR transects performed at the property as well as the transect images. A total of three formal GPR transects were performed at the site. GPR Transect 1 was performed across an area associated with interference from surface metal/fence (EM Anomaly 4). No significant structures were observed.

GPR Transect 2 was performed across an area associated with interference from the building/utility (EM Anomaly 1). No evidence of any significant structures was observed, verifying that the EM anomaly was the result of interference from the building.

GPR Transect 3 was performed across an area of suspected reinforced concrete (EM Anomaly 3). This transect confirmed the presence of metal reinforcement in the concrete north of the building. No evidence of any buried structures such as USTs was observed.

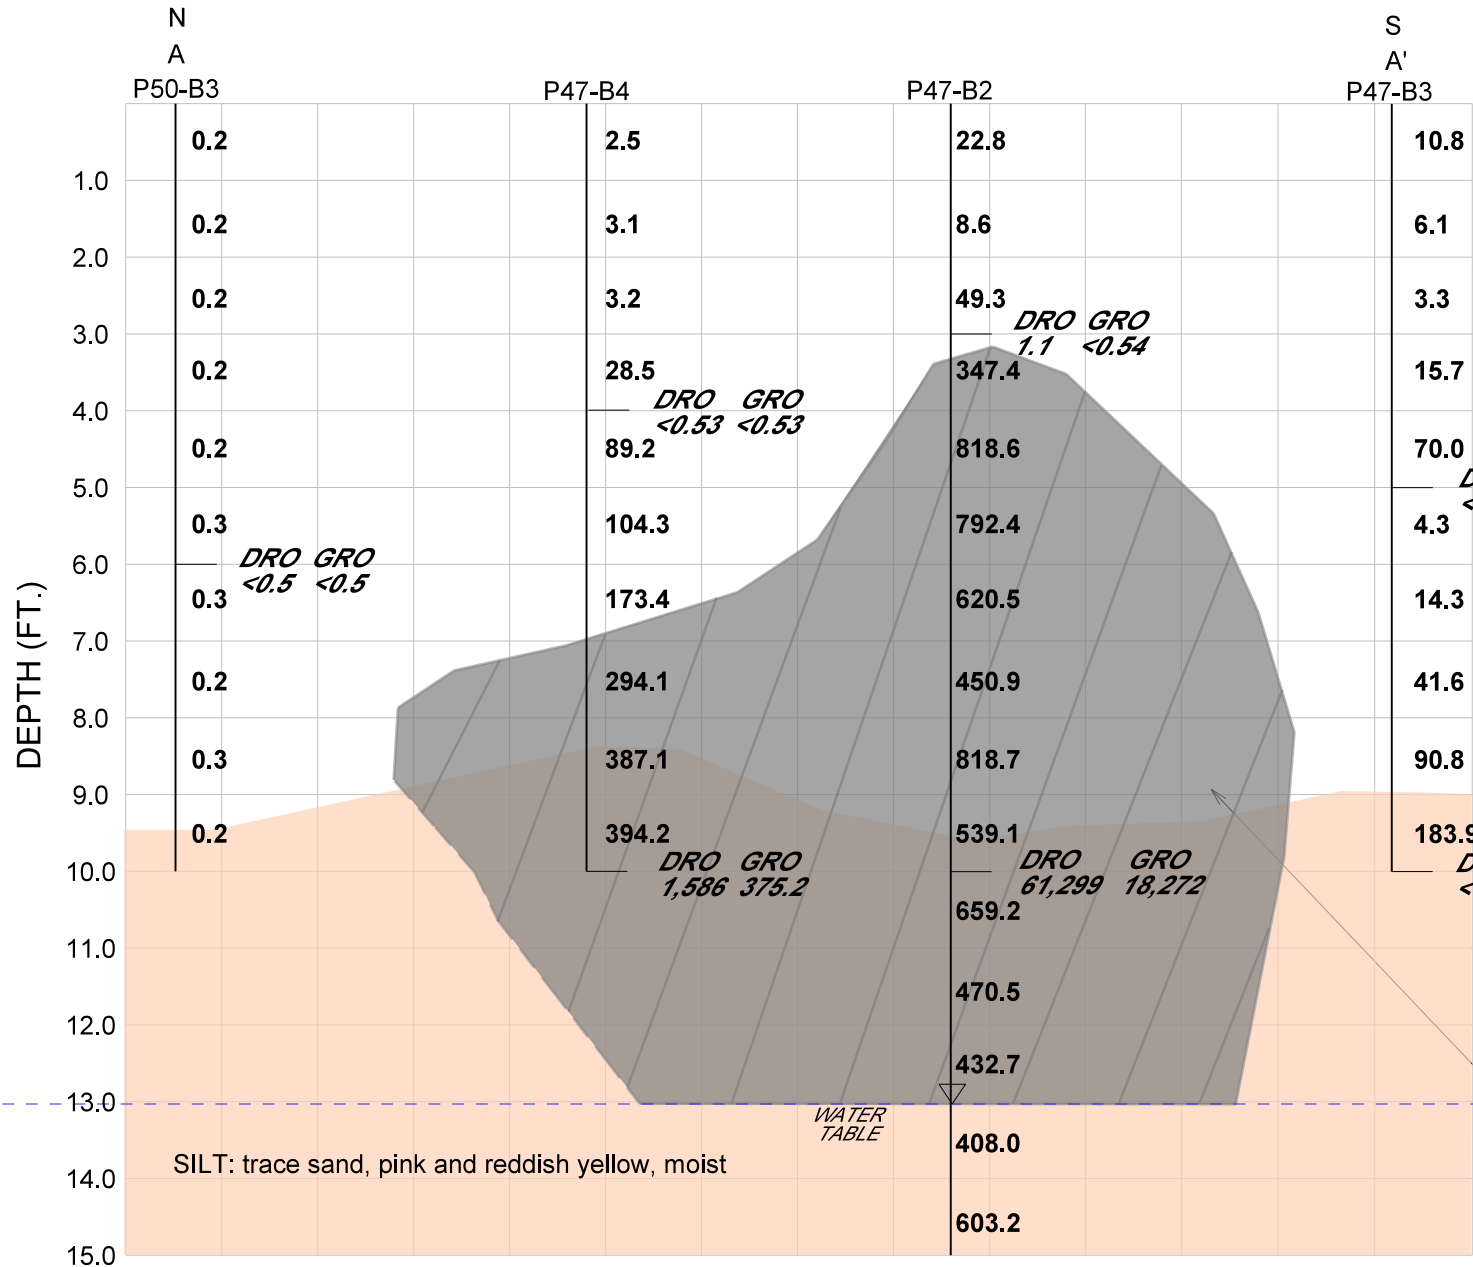
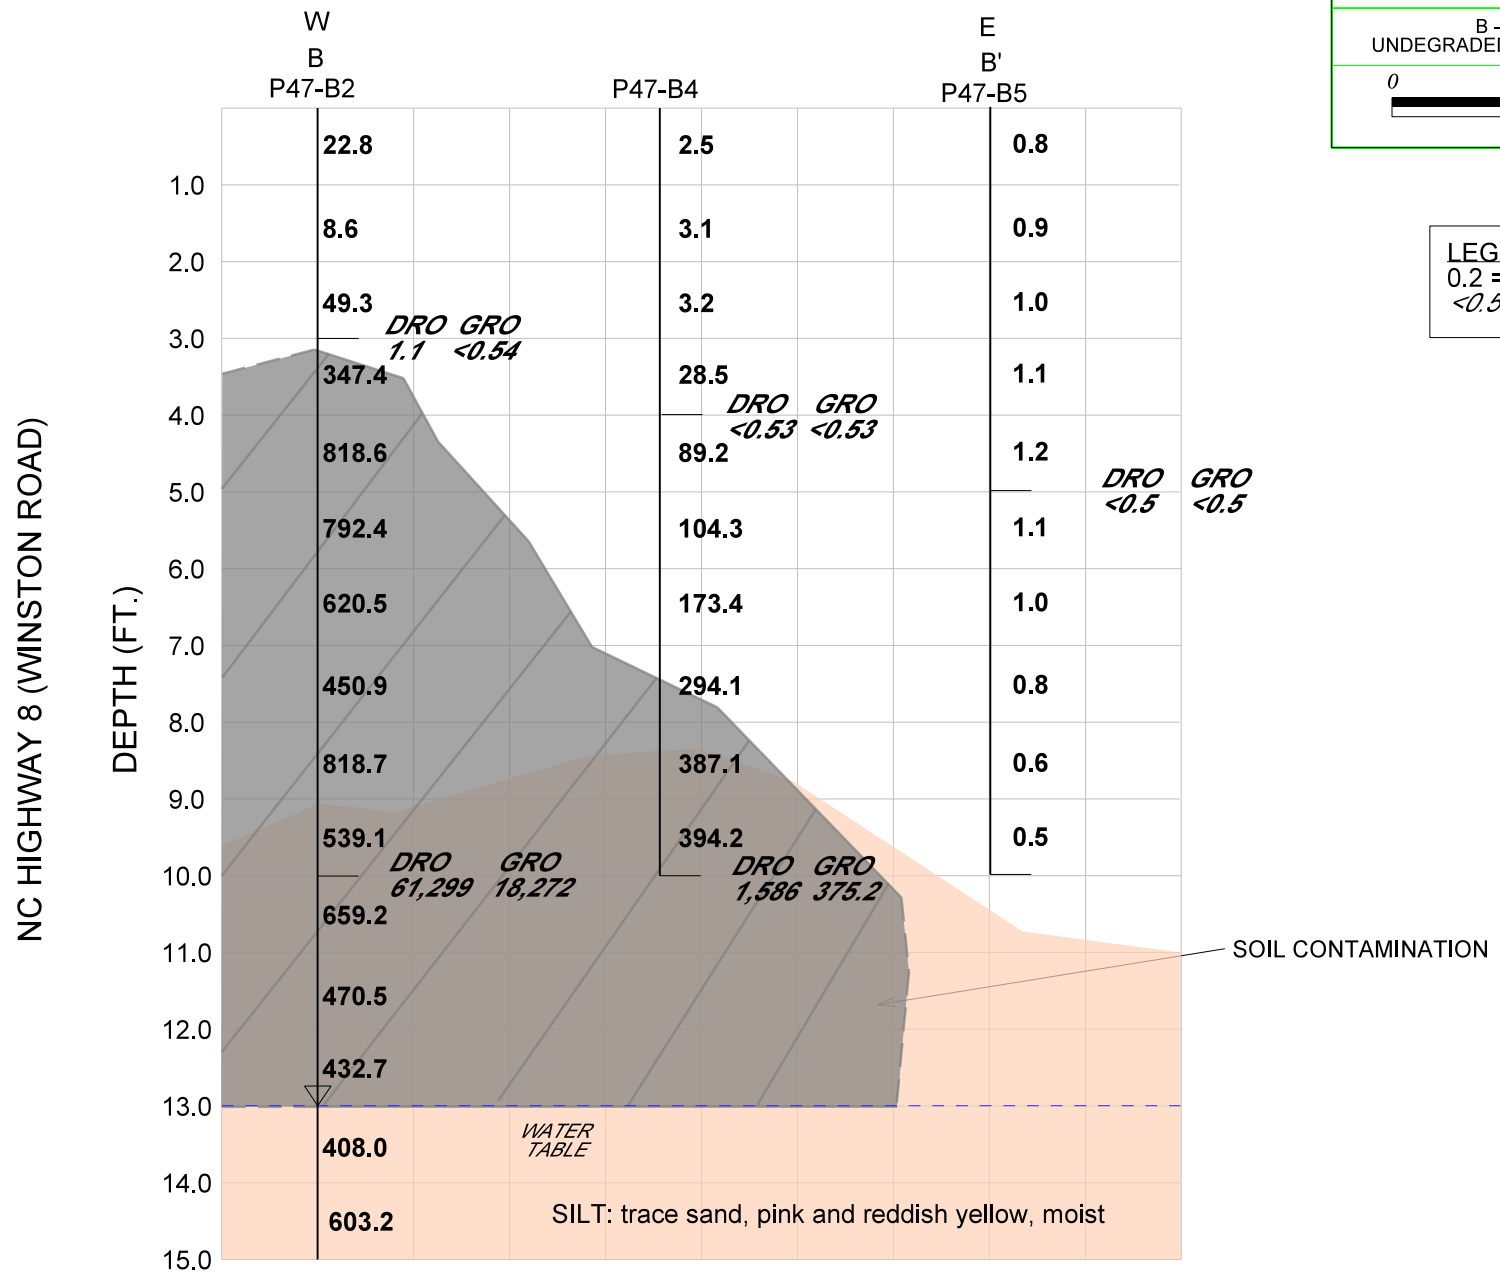
PROJECT REFERENCE NO.	FIGURE NO.
U-5757-P47	6
B - B' CROSS SECTION UNDEGRADED KEROSENE CONTAMINATION

Soils from Parcel 47 generally consisted of a foot of silt, underlain by several feet each of a silty clay, then a clayey silt, then a sandy silt. Groundwater was encountered in soil boring P47-B2, which was advanced to a termination depth of 15 feet bgs. Moist soil (and pink and reddish yellow sandy silt) was encountered at 9 feet bgs in soil borings P47-B2, P47-B3, and P47-B4. Copies of the boring logs are included in Appendix C.

Total: 773.85 tons of undegraded kerosene impacted soil

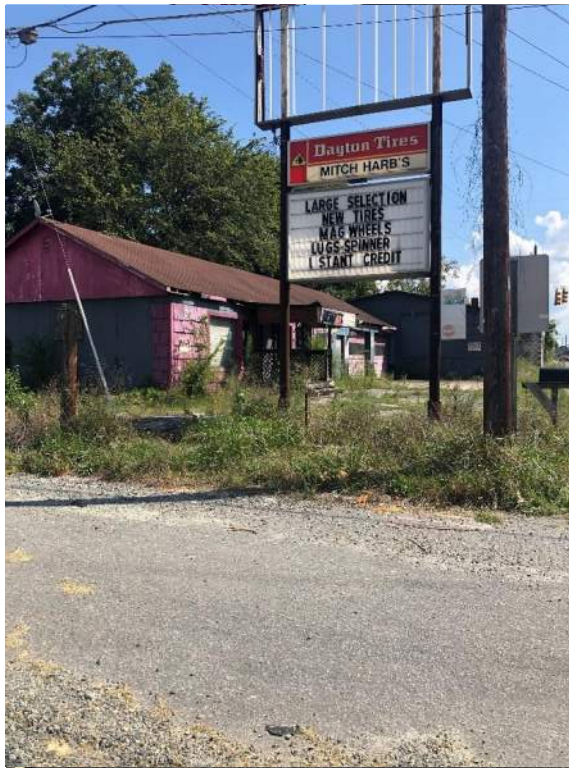
View facing southeast toward the former service station on Parcel 47.

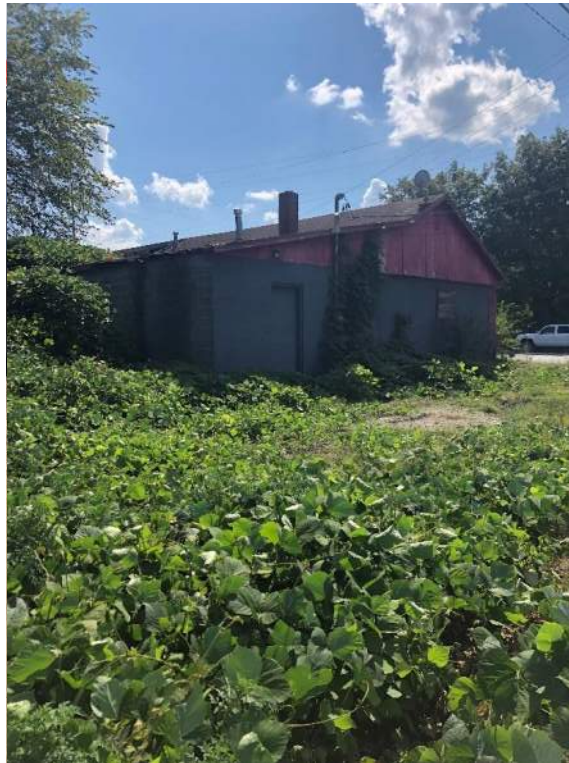
View facing southwest towards former service station on Parcel 47.
