**SUBJECT: Preliminary Site Assessment Report
Parcels 50, 56, 60 – BH & HH Realty, LLC
WBS Element No. 54035.1.1, TIP No. U-5757
NC 8 (Winston Road) from 9th Street to SR 1408 (Biesecker Rd) in
Lexington. Widen to multi lanes
Kleinfelder Project No. 20201105.001A**

**PRELIMINARY SITE ASSESSMENT REPORT
PARCELS 50, 56, 60 – BH & HH REALTY, LLC
PARCEL 11332E0000012
1496 OLD US HIGHWAY 52
LEXINGTON, DAVIDSON COUNTY, NORTH CAROLINA**

**NCDOT WBS ELEMENT 54035.1.1
STATE PROJECT U-5757
NC 8 (WINSTON RD) FROM 9TH STREET TO SR 1408
(BIESECKER RD) IN LEXINGTON. WIDEN TO MULTI LANES**

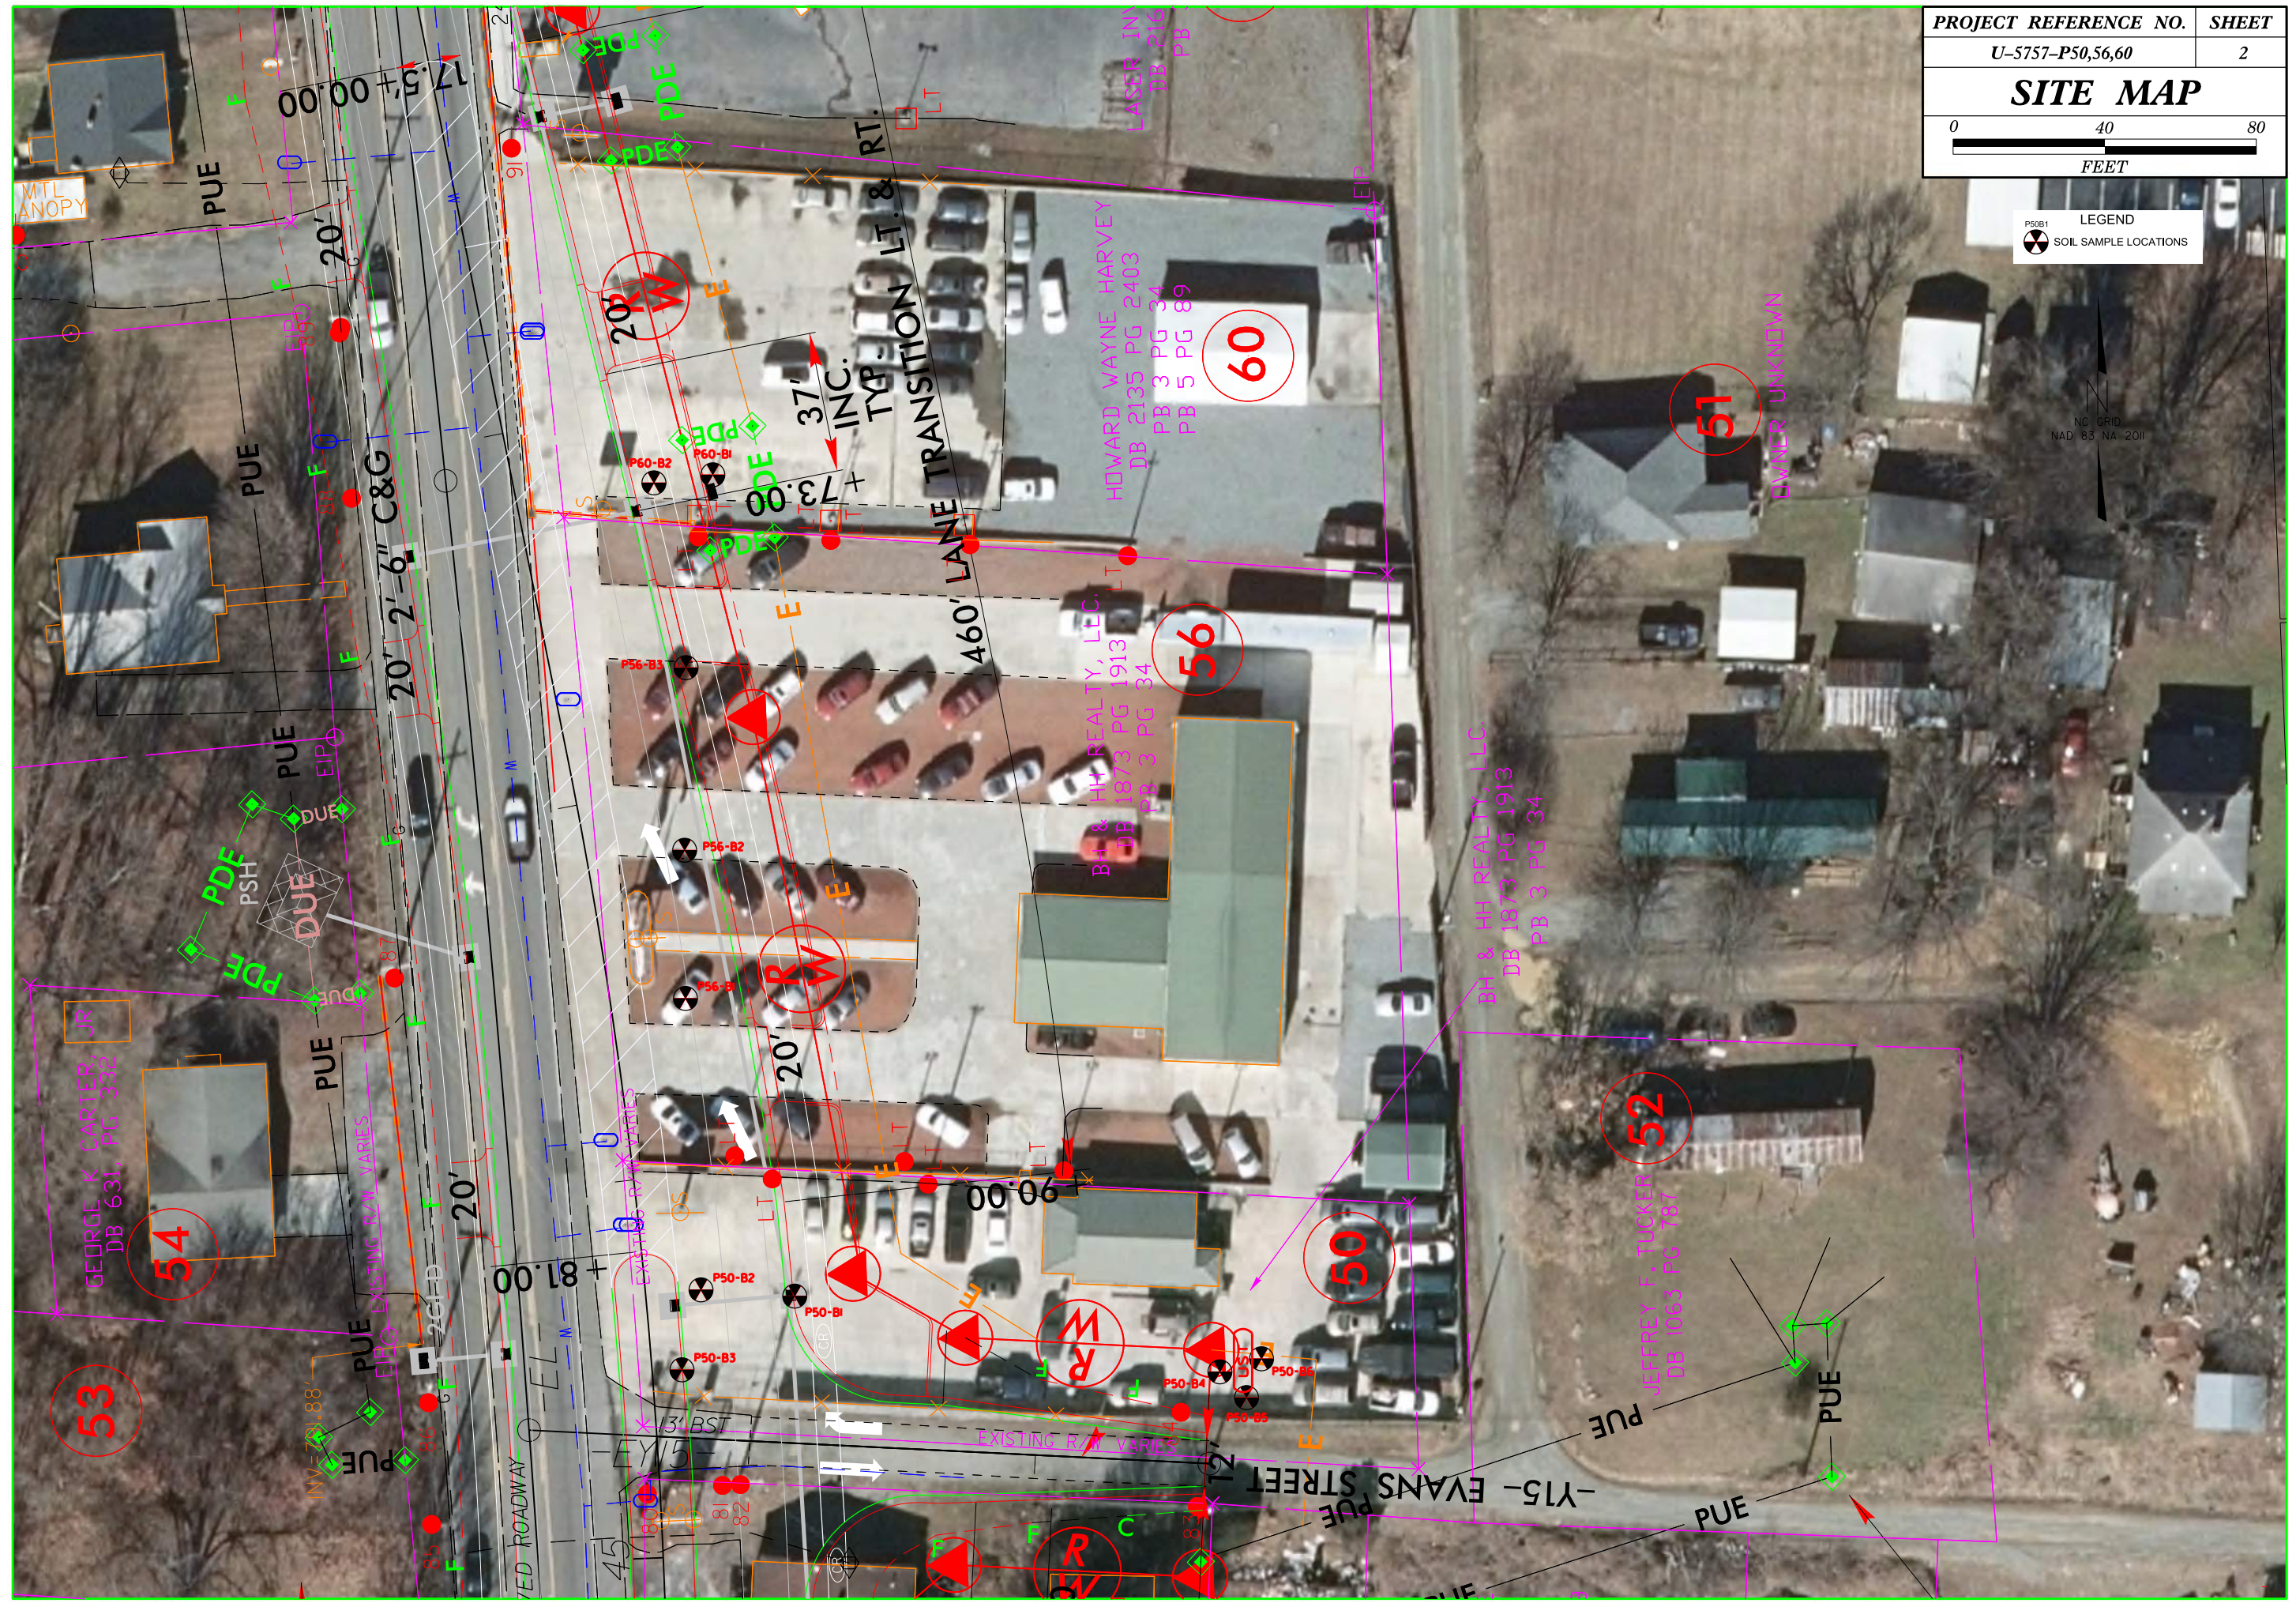
PROJECT REFERENCE NO.	SHEET
U-5757-P50,56,60	2
SITE MAP	
FEET

Evidence of one (1) possible UST within the southern survey area of Parcel 50 was discovered. No evidence of subsurface anomalies indicative of USTs or other buried structures was found on Parcels 56 or 60. The UST was located southeast of the building on Parcel 50, and is approximately 22.5 feet long by 7 feet wide (thus, approximately 6,475 gallons in capacity). The approximate location of the UST is depicted on Figure 2.

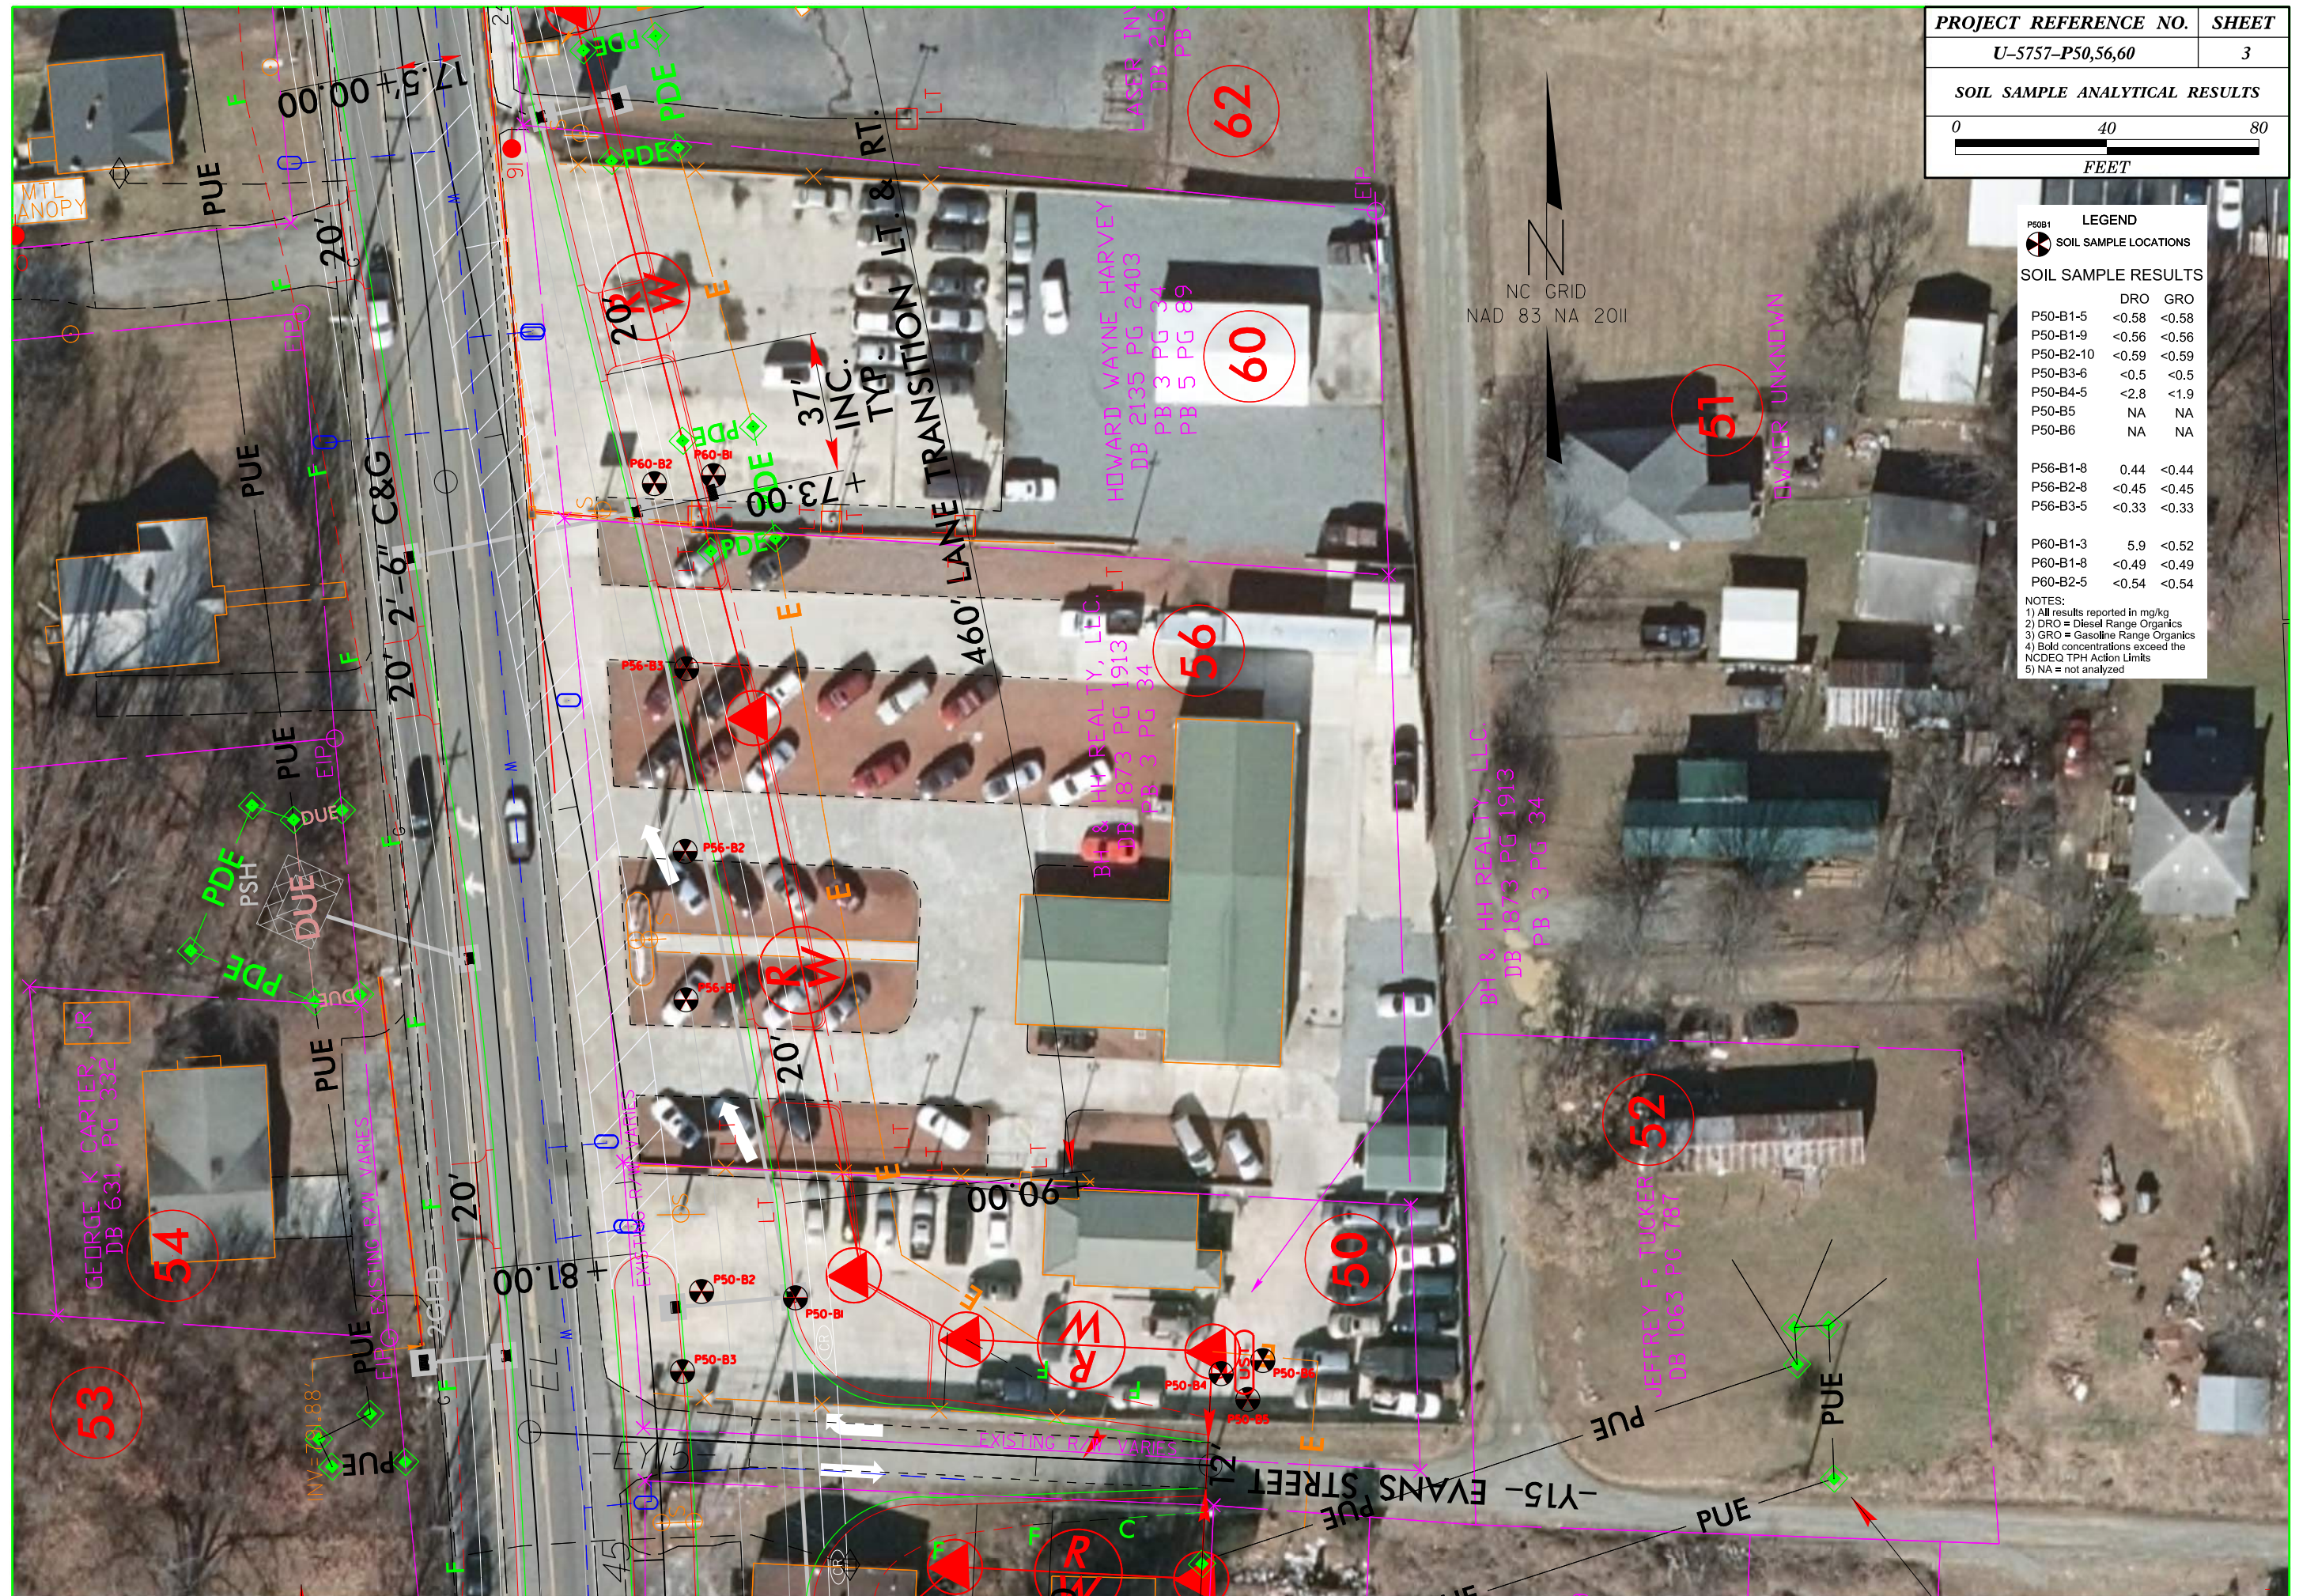
The UVF analysis of soil samples did not indicate the presence of petroleum impact above NCDEQ Action Limits in any of the soil samples analyzed. As such, shallow soil impact does not appear to be present within the existing right-of-way or along the western and southern parcel boundaries. Samples collected within the right-of-way and public utility easement around the probable UST did not indicate that the tank has leaked. A summary of soil sample analytical results is presented in Table 2. The laboratory results associated with each soil boring are presented on Figure 3. The laboratory report and graphs are included in Appendix D.

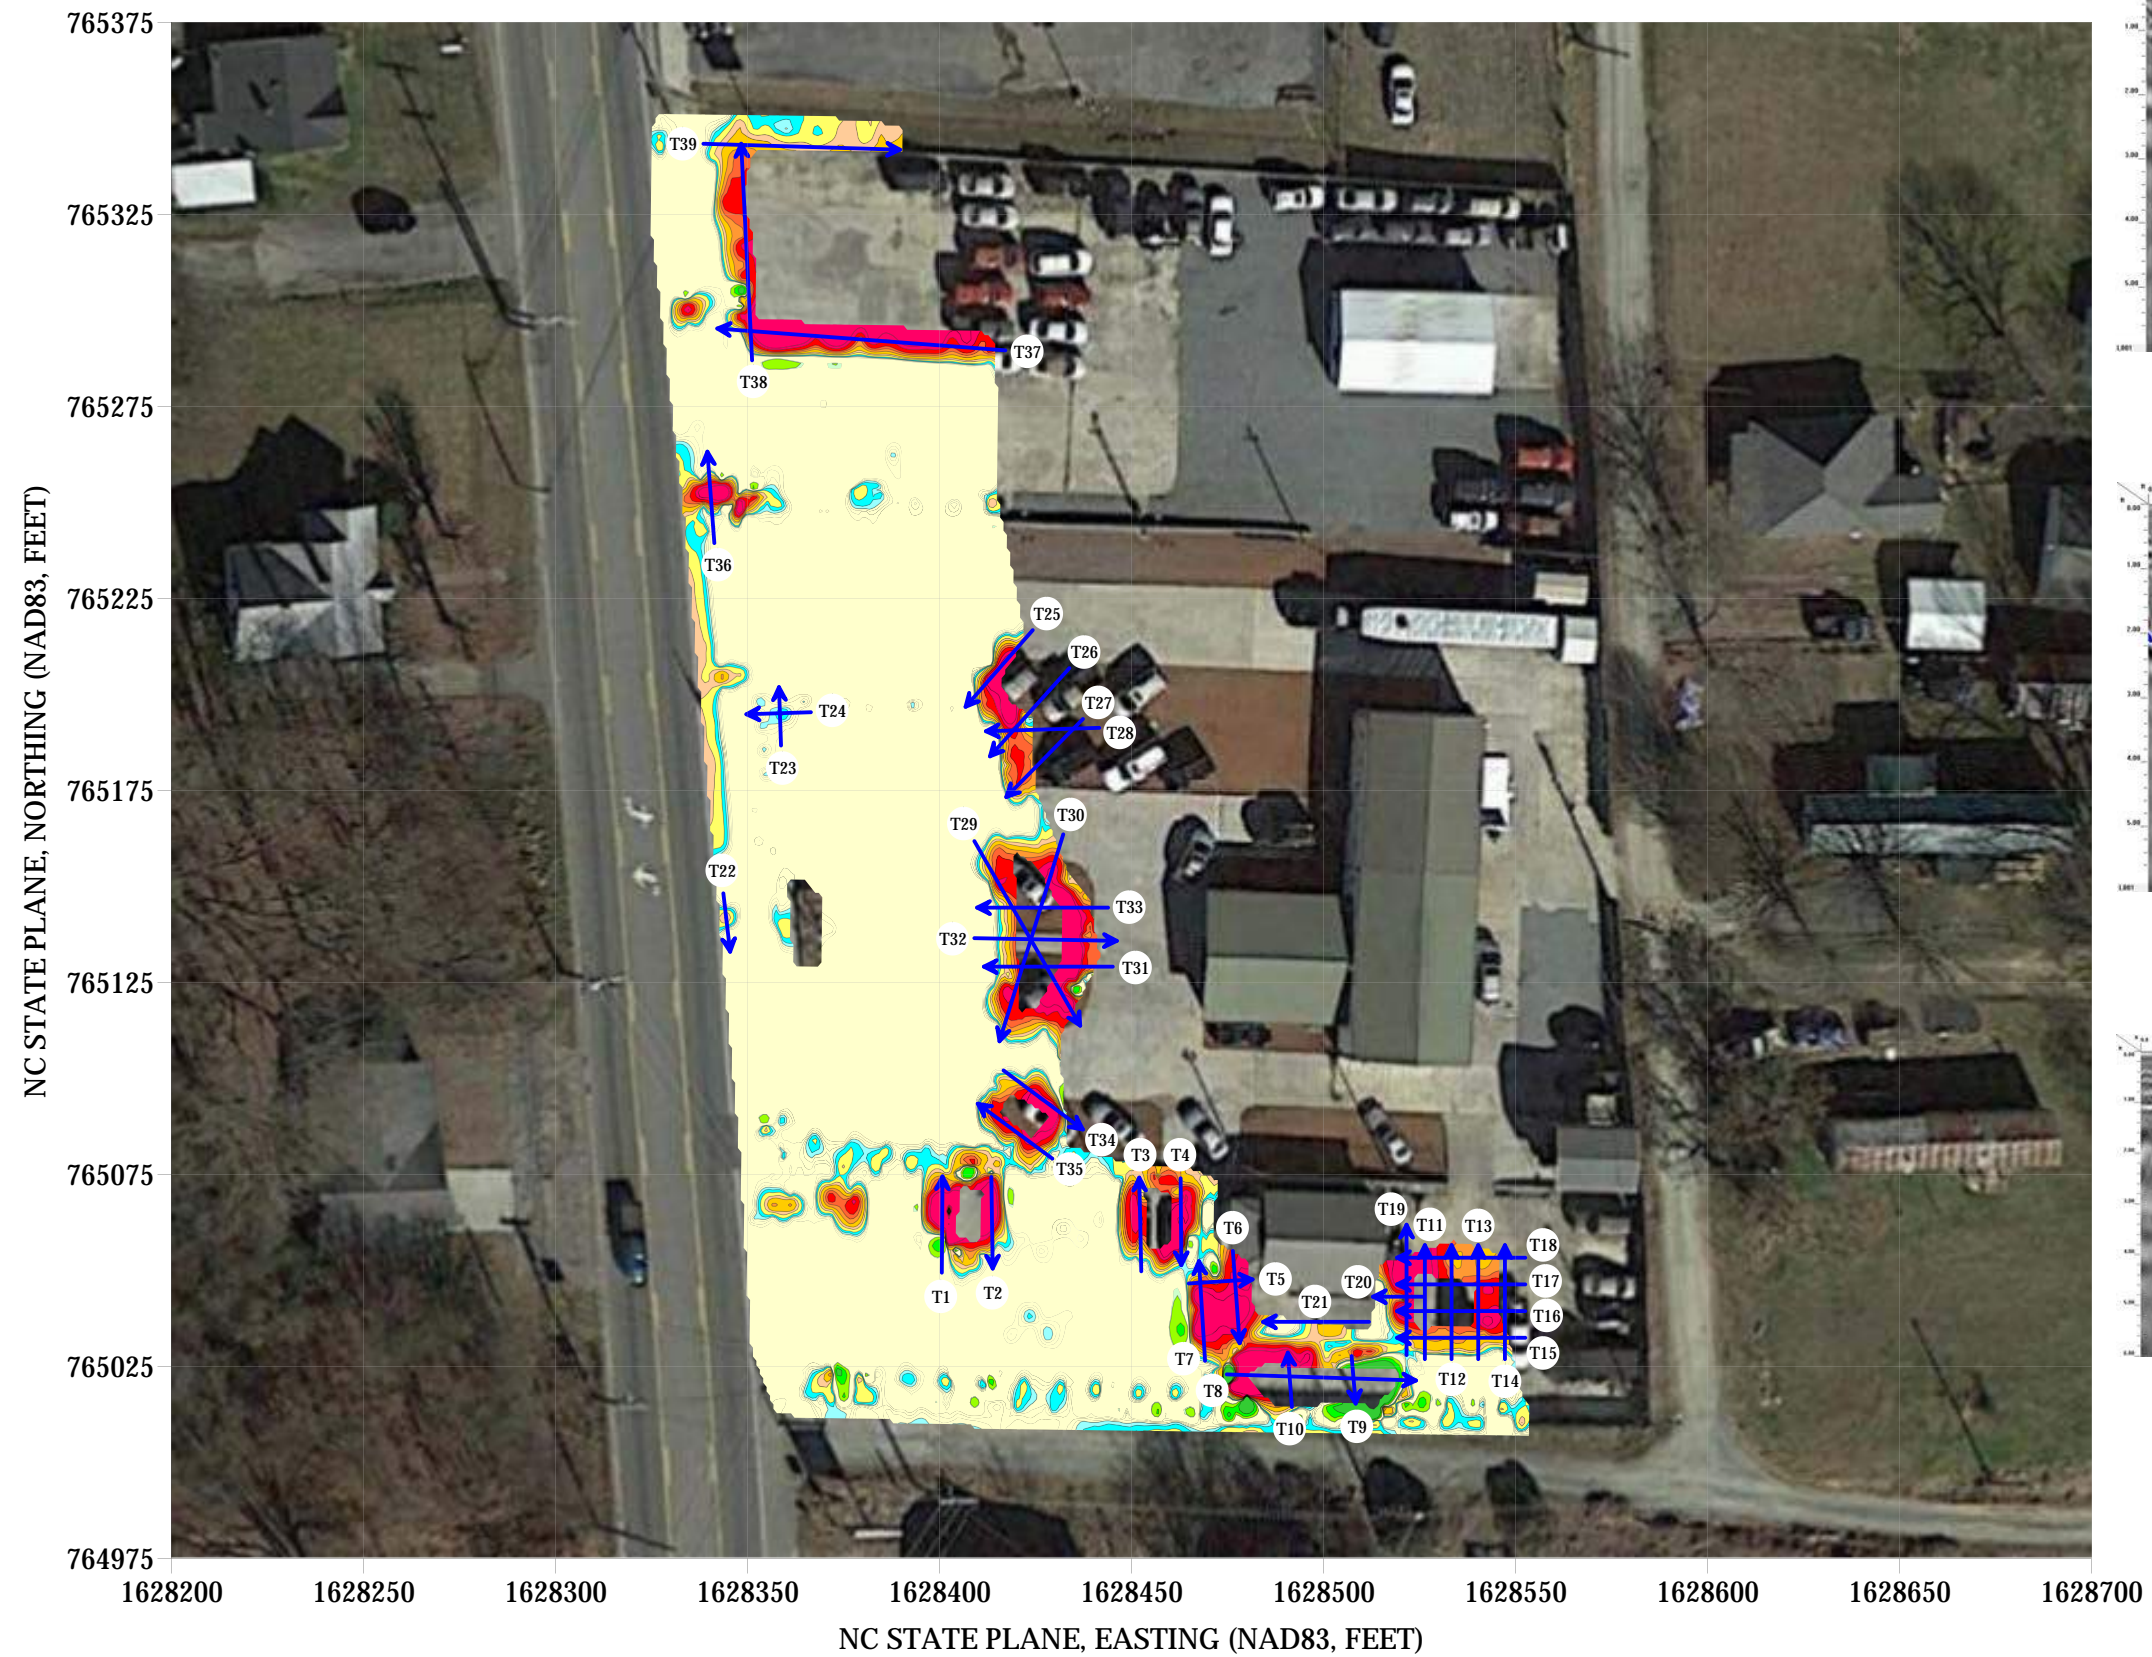
LOCATIONS OF GPR TRANSECTS

GPR Transects 1-2, 3-4, 5-7, 8-10, 21, 25-28, 29-33, and 34-35 were performed across areas of interference caused by the vehicles at the site (EM Anomaly 16). GPR Transects 37-39 were performed across areas of interference caused by vehicles and the fence (EM Anomaly 13). No evidence of buried structures such as USTs was observed.

GPR Transects 22 and 23-24 were performed across areas associated with a suspected utility and suspected buried metallic debris (EM Anomalies 6 and 15). These transects recorded evidence of isolated hyperbolic reflectors that were characteristic of a buried utility and minor reflectors associated with increases in signal penetration relative to the surrounding soil that are typical indicators of buried metallic debris. No evidence of any buried structures such as USTs was observed.

GPR Transect 36 was performed across an anomaly suspected to be a reinforced concrete pipe (EM Anomaly 10). This transect confirmed the presence of reinforcement in the concrete pipe. No evidence of buried structures such as USTs was observed.

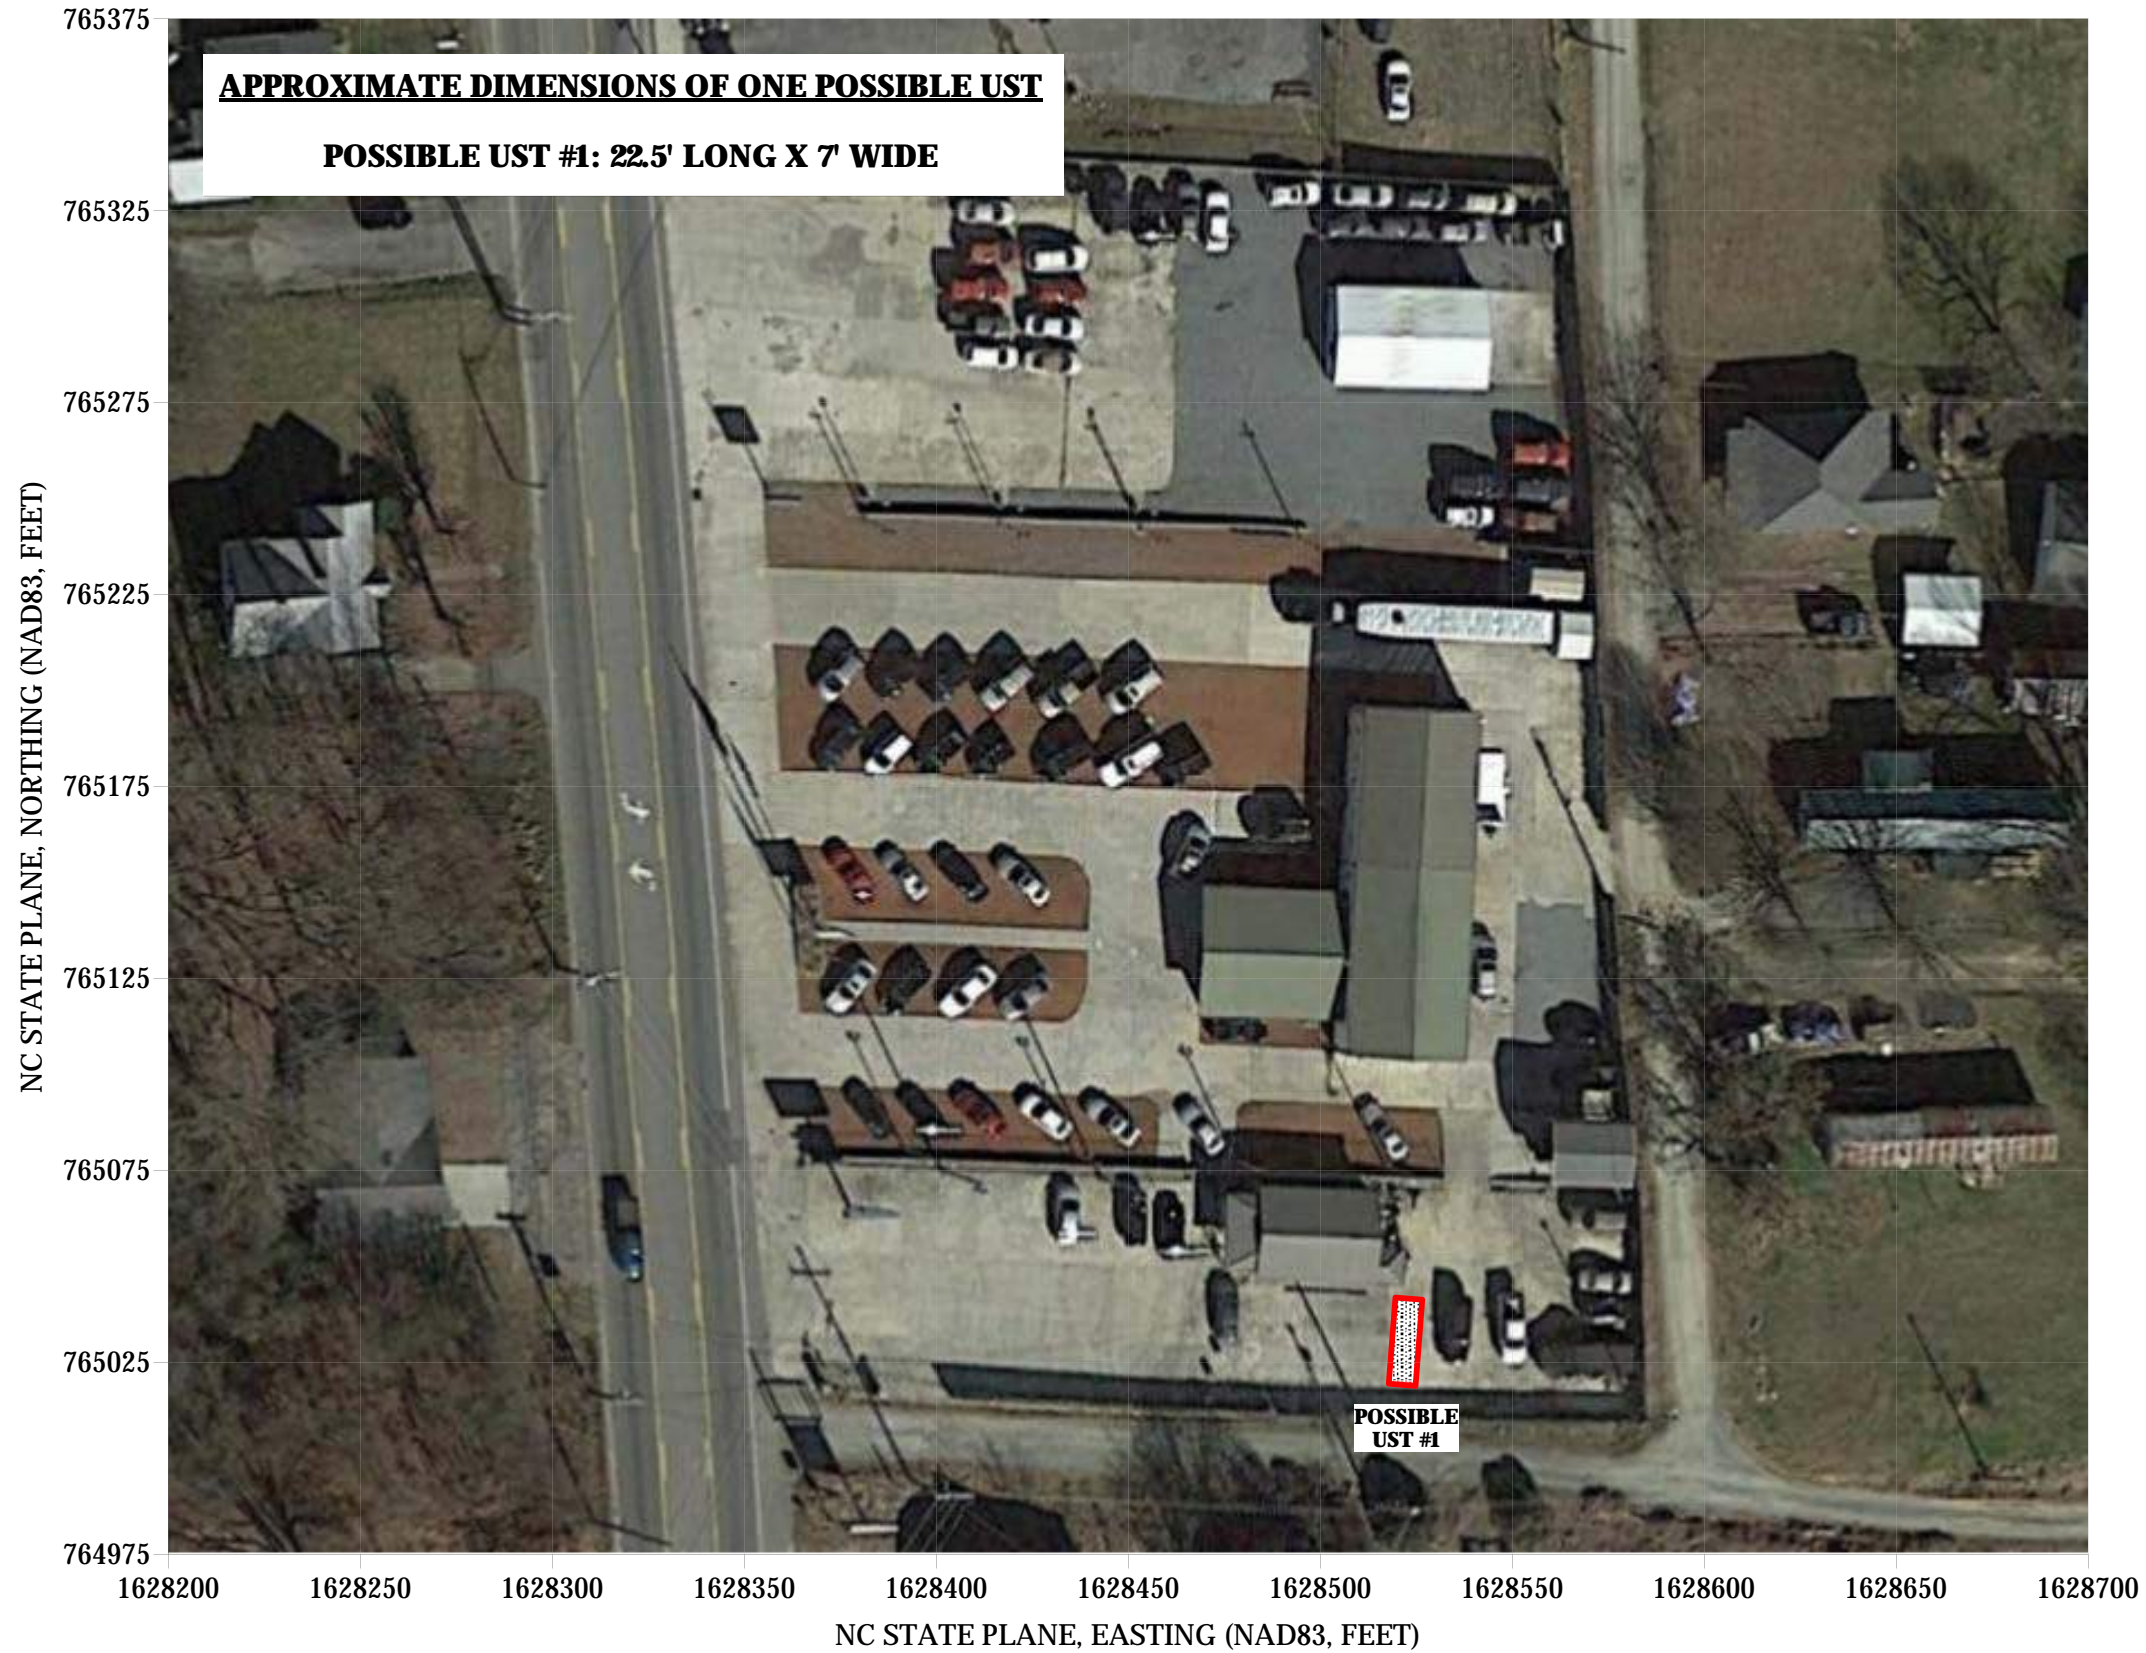
LOCATION OF ONE POSSIBLE UST

Collectively, the geophysical data recorded evidence of one possible UST within the survey area at Parcels 50, 56, & 60. **Figure 5** provides an overlay of the metal detection results and the locations of the possible UST on the NCDOT MicroStation engineering plans for reference.

View of One Possible UST Facing Approximately South
