**North Carolina Department of Transportation  
Preliminary Site Assessment  
State Project: R-2307B  
WBS Element: 37944.1.FR5  
Parcel Number: 4657054168  
Iredell County**

**Parcel 237  
Circle K Store Inc.  
255 NC 150 (West Plaza Drive)  
 Mooresville, North Carolina  
January 28, 2019**

**Wood Environment and Infrastructure Solutions, Inc.  
Project: 188322307**

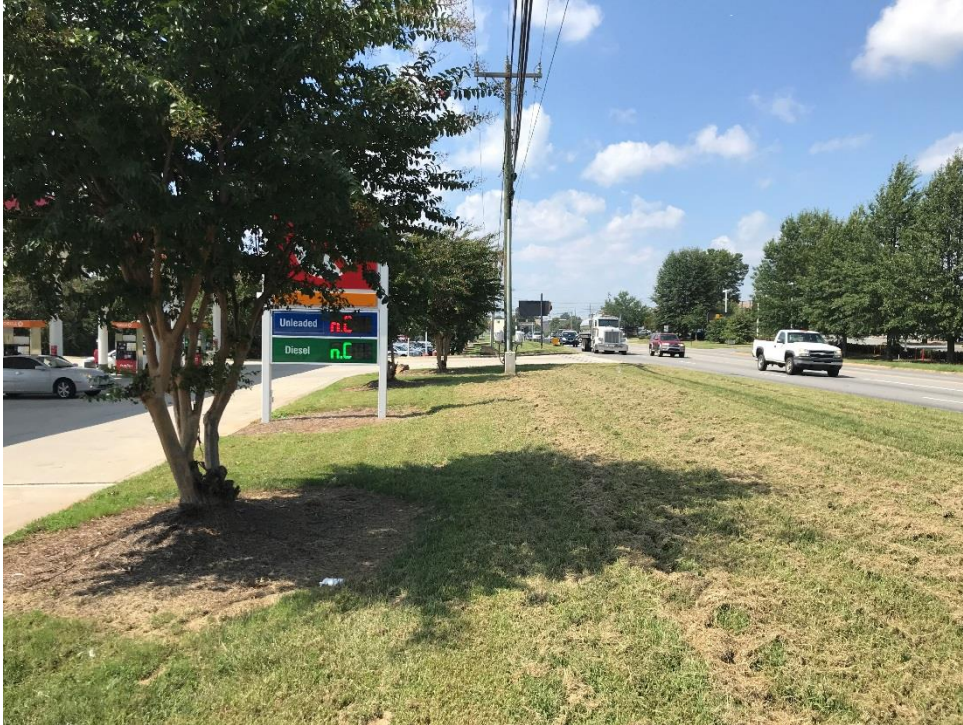
**PHOTO 1:**

View of north side of property, overhead power lines, facing west.

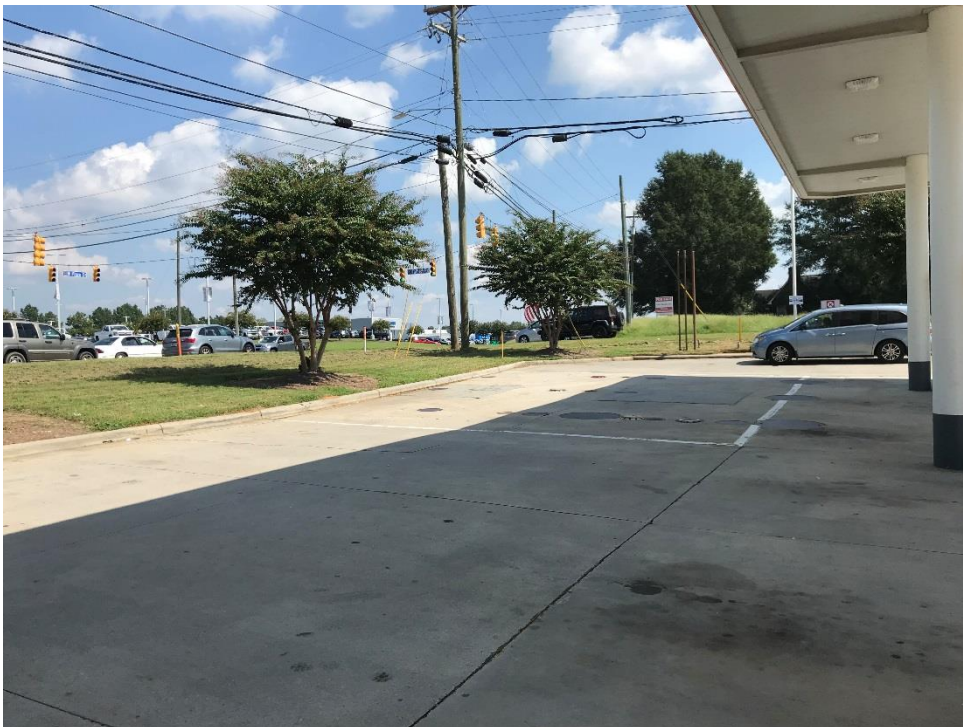
**PHOTO 2:**

View of current active UST basin, USTs are within area of investigation, facing northeast.

Based on these PSA results, Wood does not recommend further assessment or soil sampling in the area of investigation. Before construction of NCDOT's final design, Wood recommends that NCDOT field check that the location of the UST basin and buried fuel lines will not be impacted by construction.

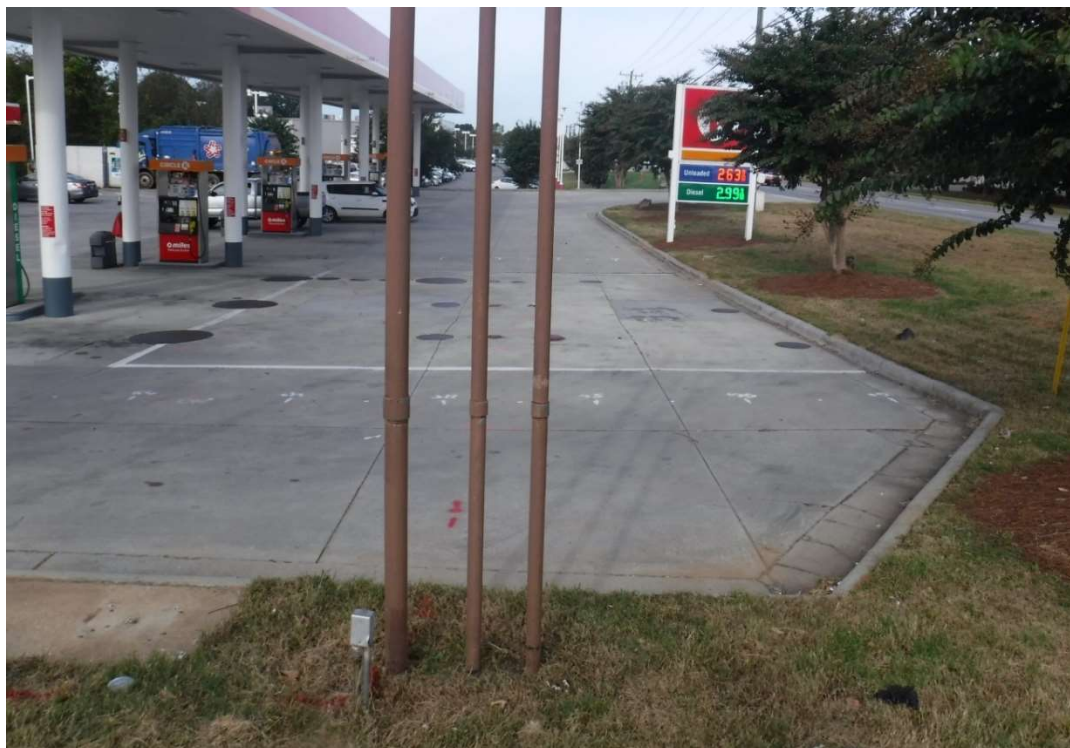
Photo 2: Looking west showing surface metal, obstructions, and known USTs

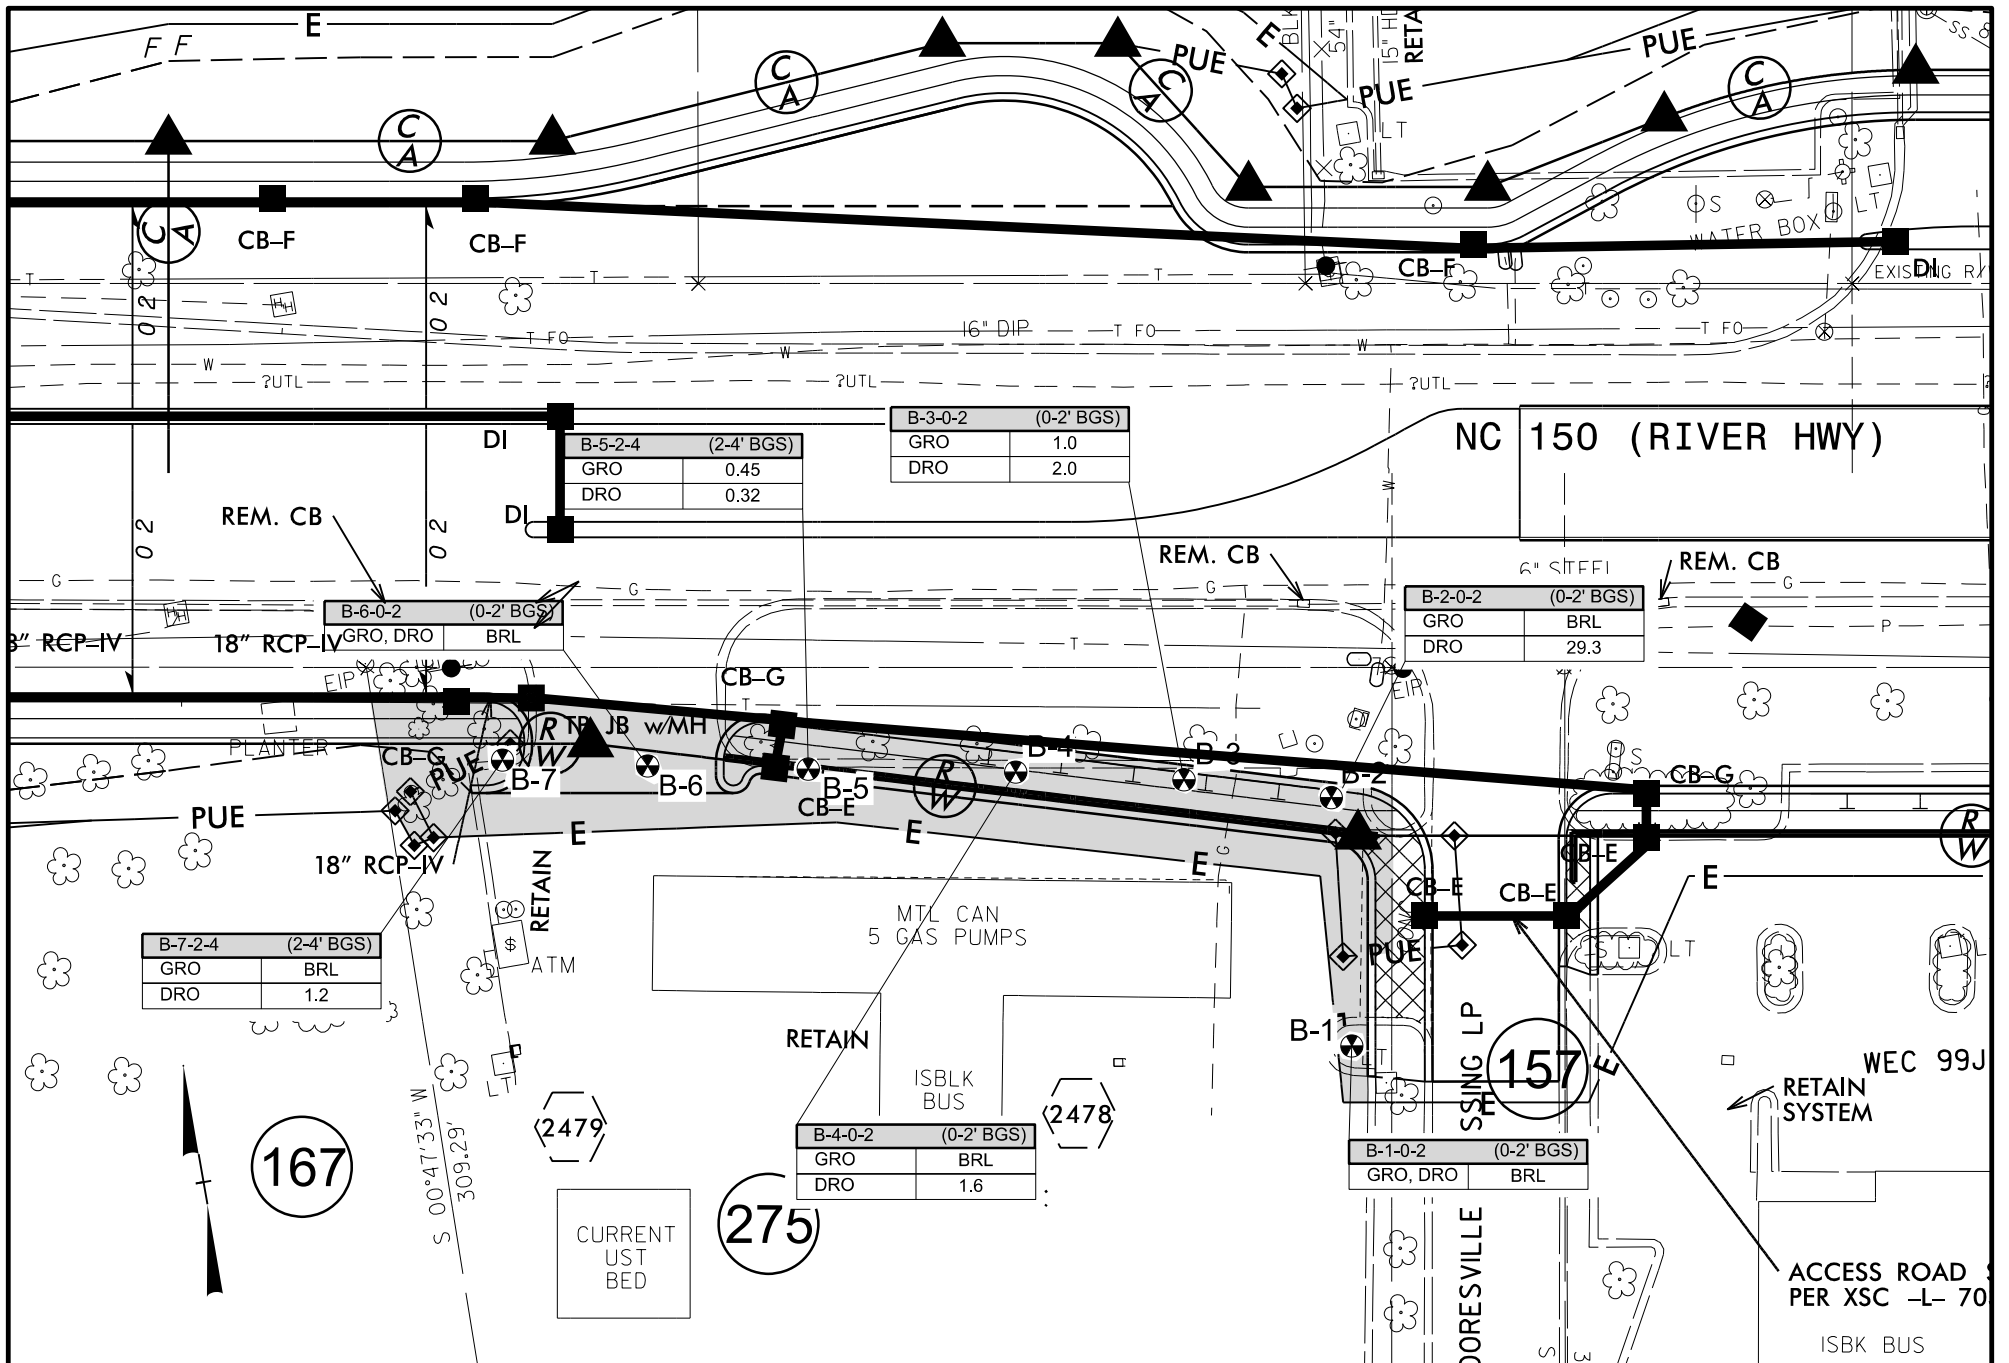
PREPARED BY: LMM	DATE: 1/24/19	CHECKED BY: HPC	DATE: 1/24/19	JOB NUMBER: 186322307	FIGURE: 3
------------------	---------------	-----------------	---------------	-----------------------	-----------

B-3-0-2 (0-2' BGS)	
GRO	1.0
DRO	2.0

B-5-2-4 (2-4' BGS)	
GRO	0.45
DRO	0.32

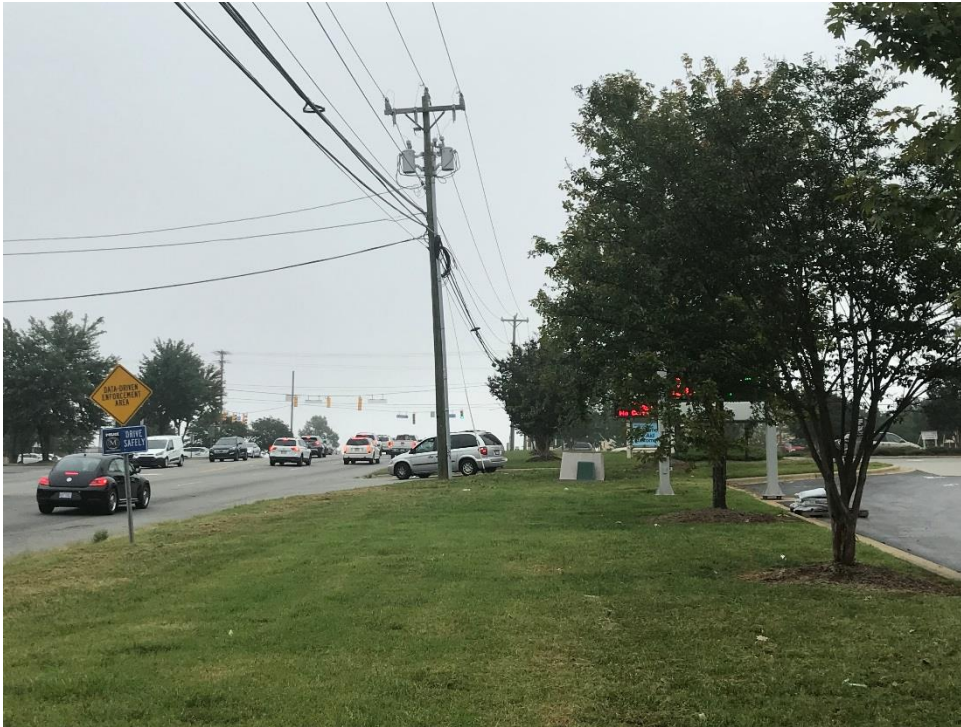
**PHOTO 1:**

View of north side of property, overhead power lines, facing east.

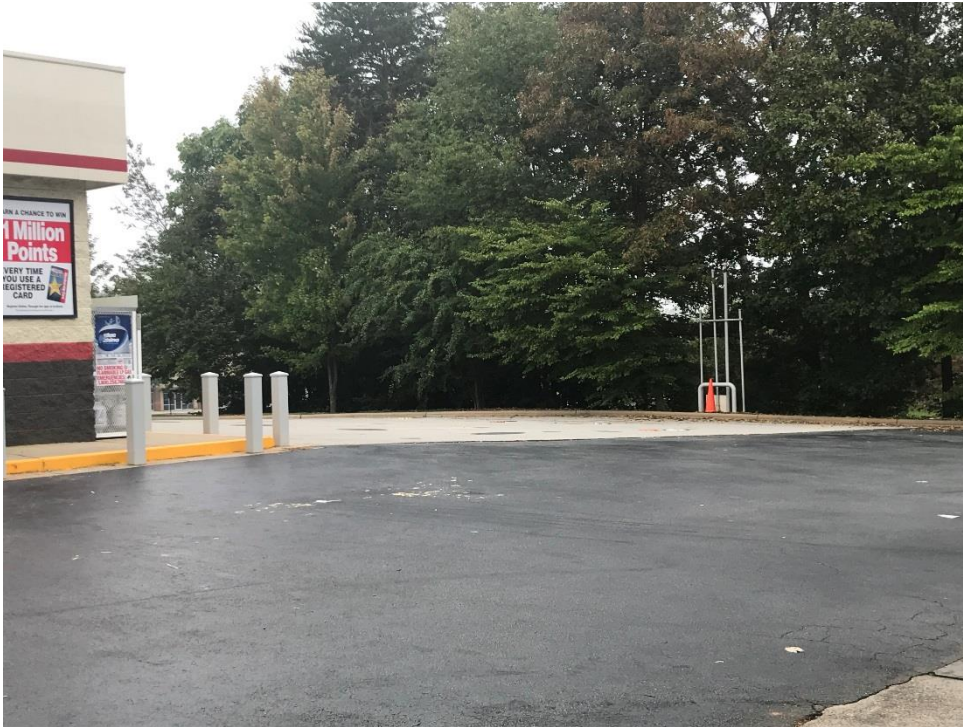
**PHOTO 3:**

View of the current active UST basin, facing southwest.

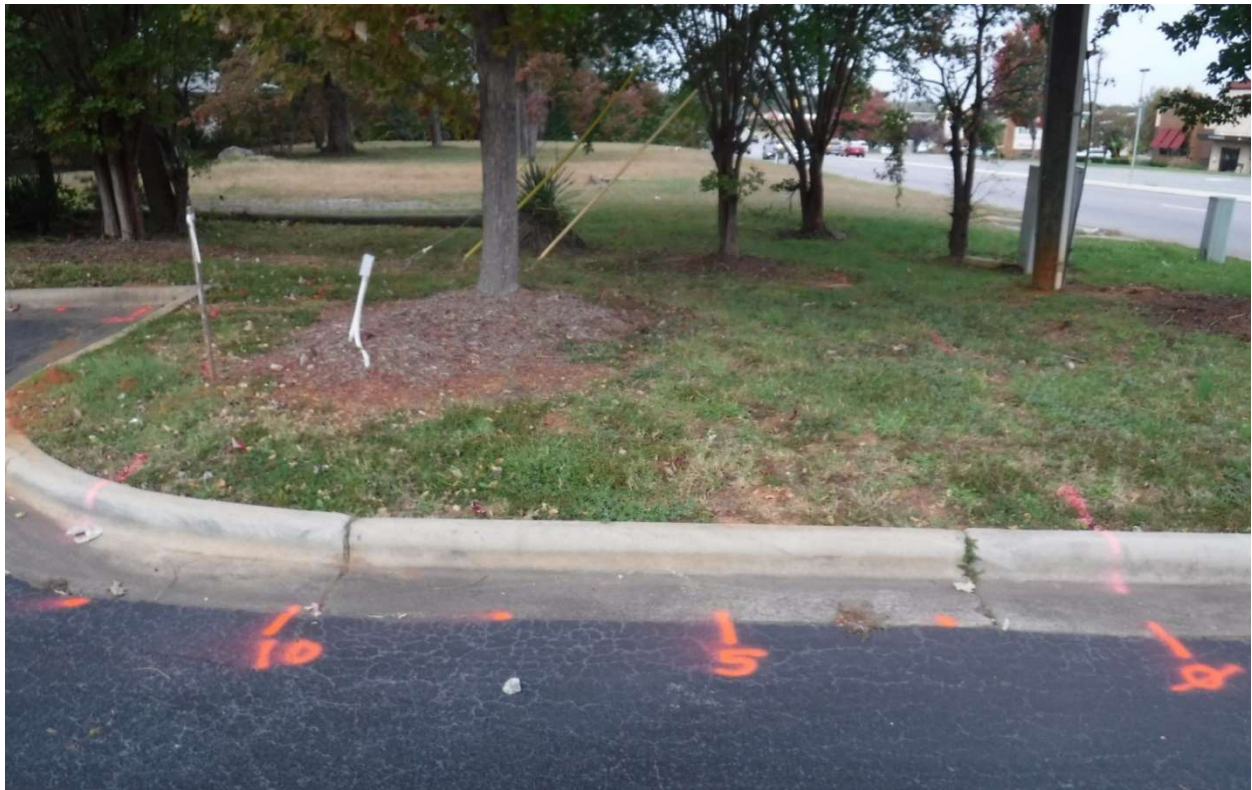
Photo 3: Looking west showing obstructions at west end
