Reference: **Preliminary Site Assessment for the Quality Oil Company Property
2005 New Hope Church Road
Raleigh, Wake County, North Carolina
State Project: P-5715
WBS Element 46927.1.1
DAA Project No. 18110166-010701 Rev 1**

METALLIC UST INVESTIGATION: PARCEL 9 NCDOT PROJECT P-5715

GEOPHYSICAL INVESTIGATION REPORT
Parcel 9 – 2005 New Hope Church Road
Raleigh, Wake County, North Carolina

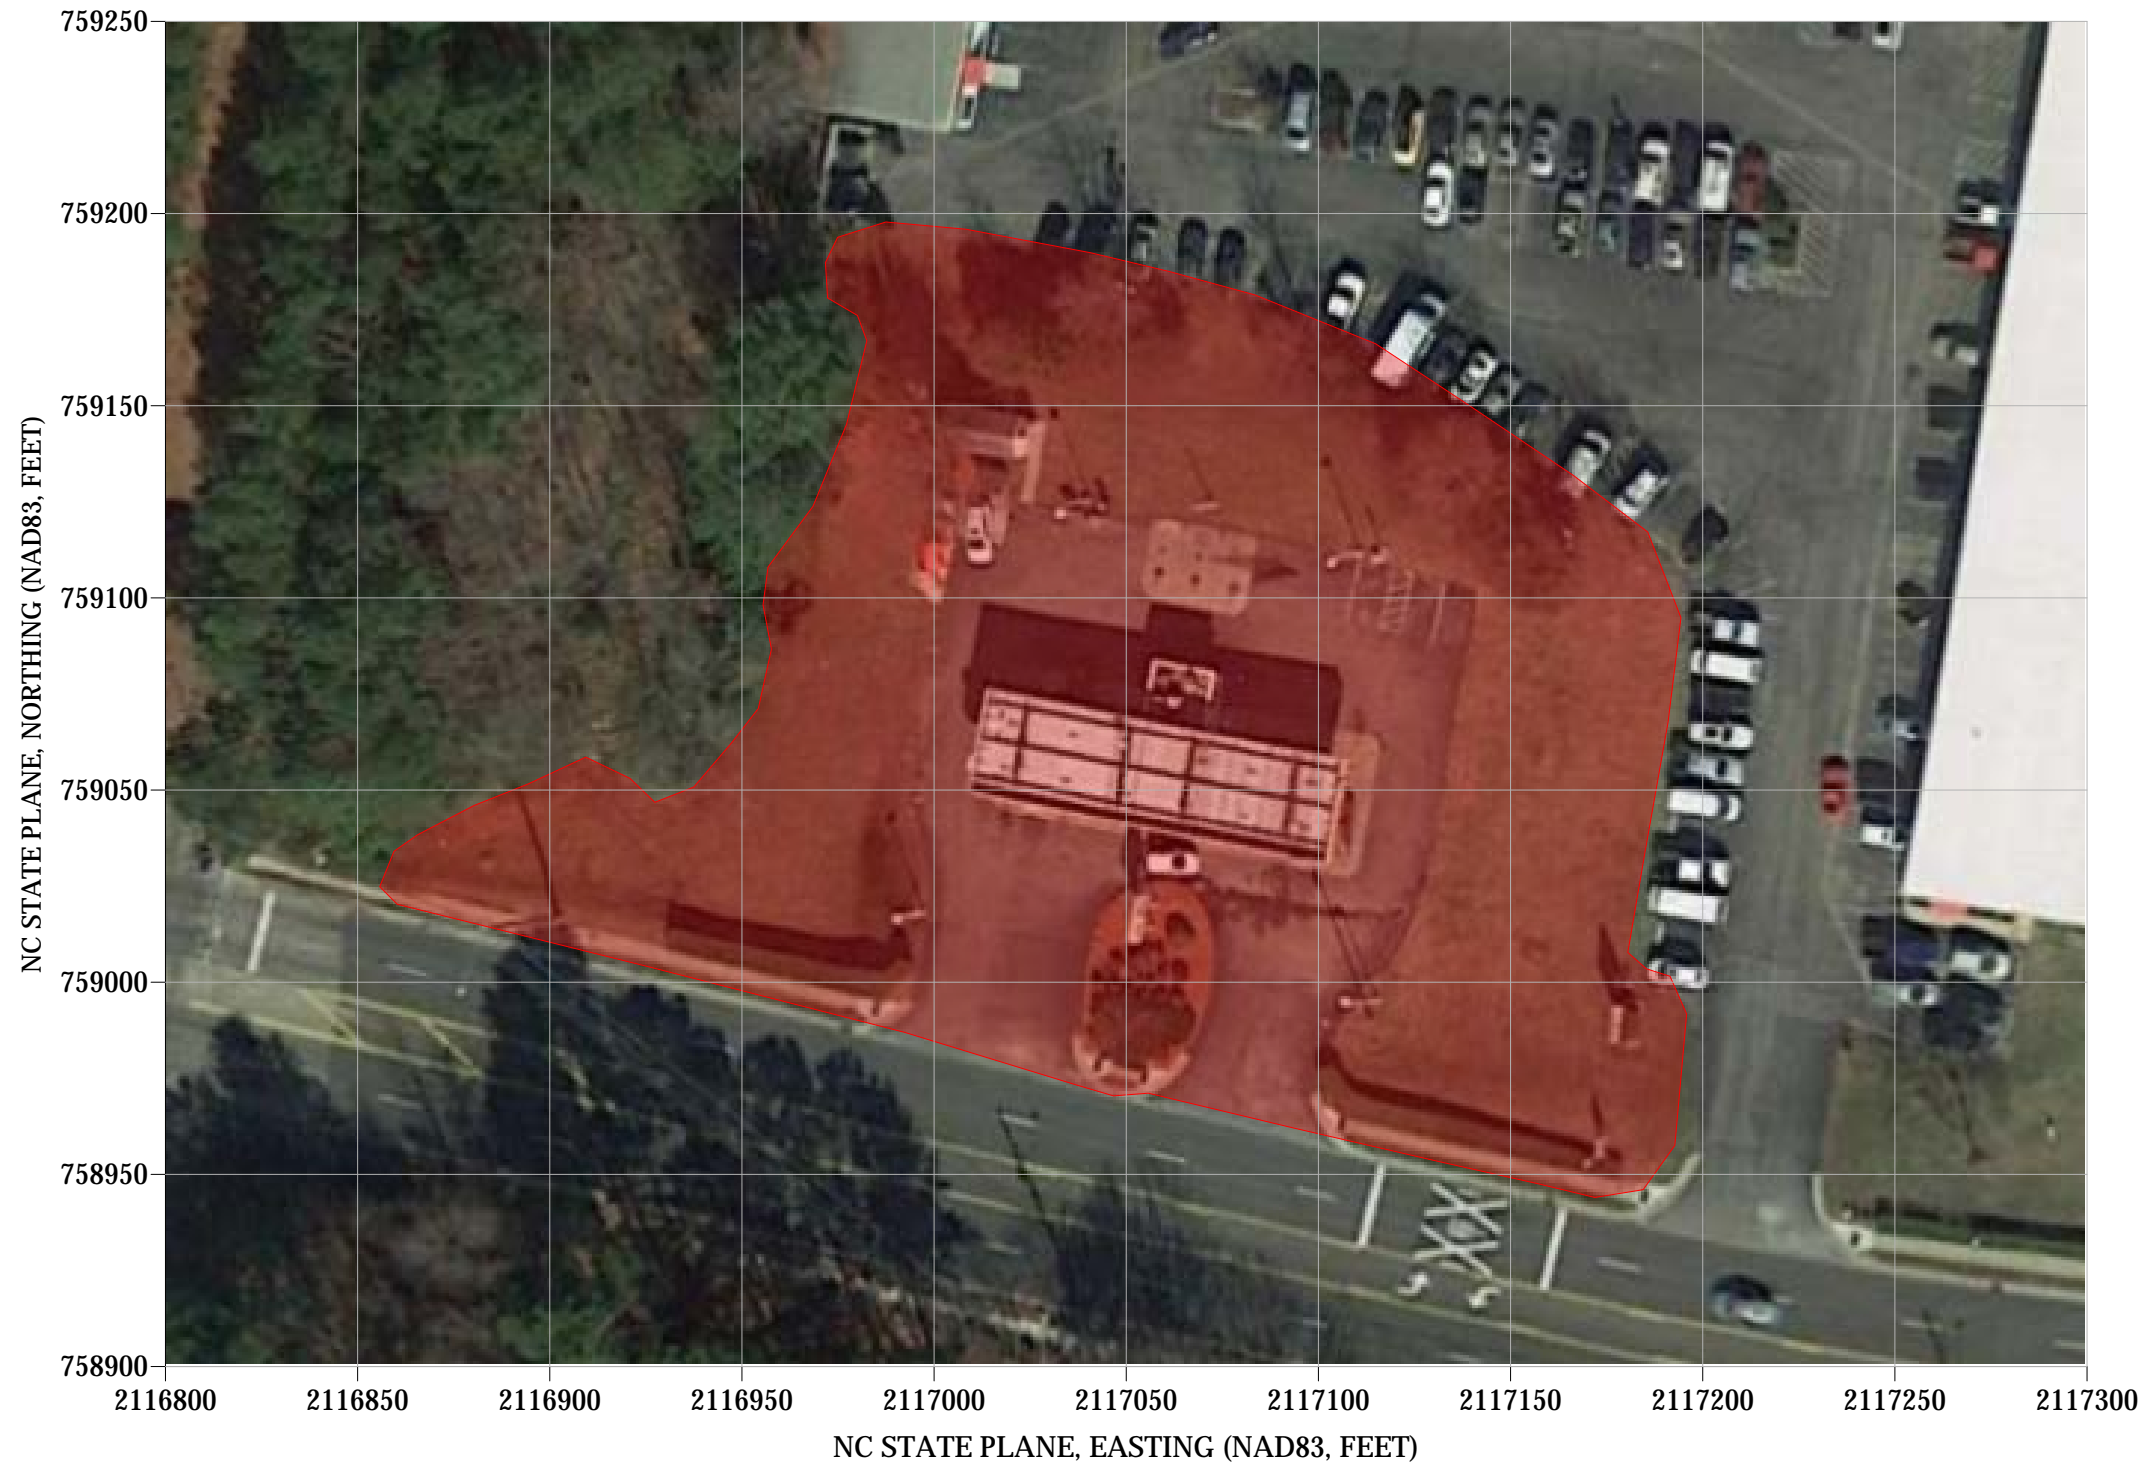
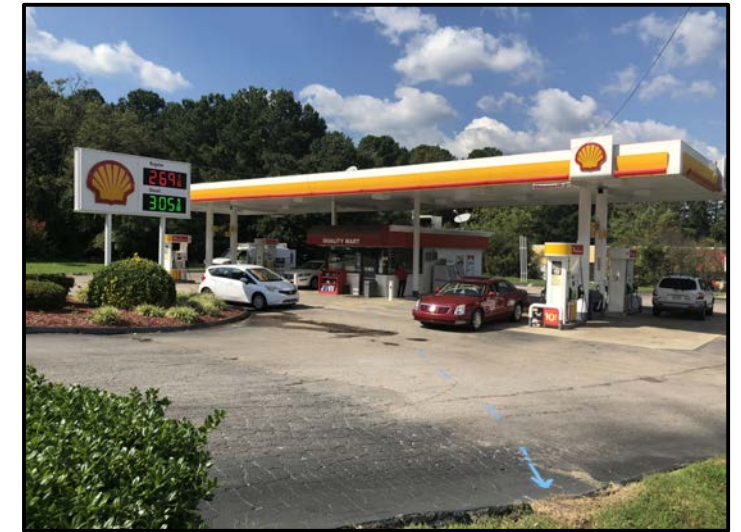
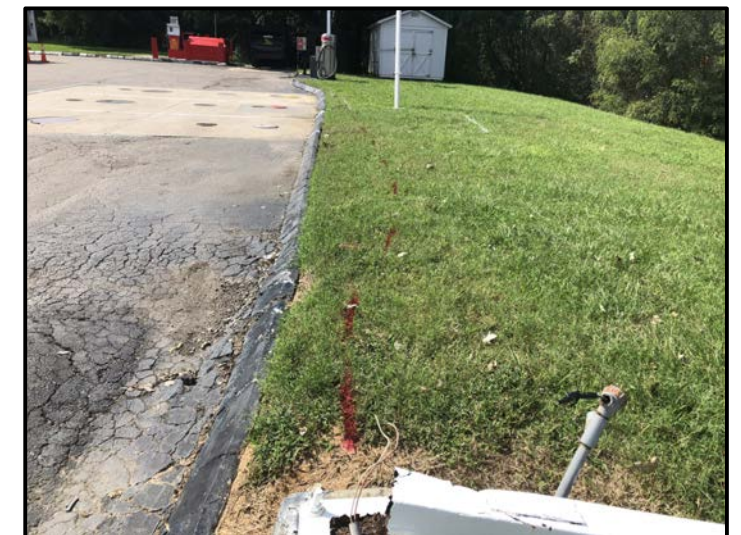
APPROXIMATE BOUNDARIES OF GEOPHYSICAL SURVEY AREA

The site included an active gas station surrounded by concrete, asphalt, and grass surfaces. Three known USTs were located within the survey area on the north side of the service station building. An aerial photograph showing the survey area boundaries and ground-level photographs are shown in **Figure 1**.

View of Survey Area
(Facing Approximately North)

View of Survey Area
(Facing Approximately West)

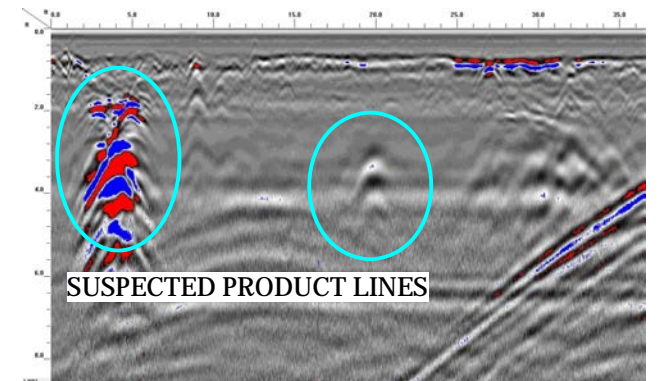
LOCATIONS OF GPR TRANSECTS

Figure 3 presents the locations of the formal GPR transects performed at the property, as well as select transect images. A total of sixteen formal GPR transects were performed at the site. All of the transect images are included in **Appendix A**. GPR Transect 1 was performed across EM Anomaly 7. This transect recorded a hyperbolic reflector consistent with a buried utility.

GPR TRANSECT 2 (T2)

GPR TRANSECT 3 (T3)

GPR TRANSECT 14 (T14)

GPR Transect 2 was performed across the widths of the three known USTs associated with EM Anomaly 2. This transect, as well as additional reconnaissance GPR scans, verified the sizes and orientations of the three known tanks. The western UST (UST #1) was approximately 23 feet long by 9 feet wide. The central UST (UST #2) was approximately 24.5 feet long by 10 feet wide. The eastern UST (UST #3) was approximately 32 feet long by 9 feet wide. **Figure 4** provides the locations and sizes of the three known USTs overlain on an aerial, along with ground-level photographs.

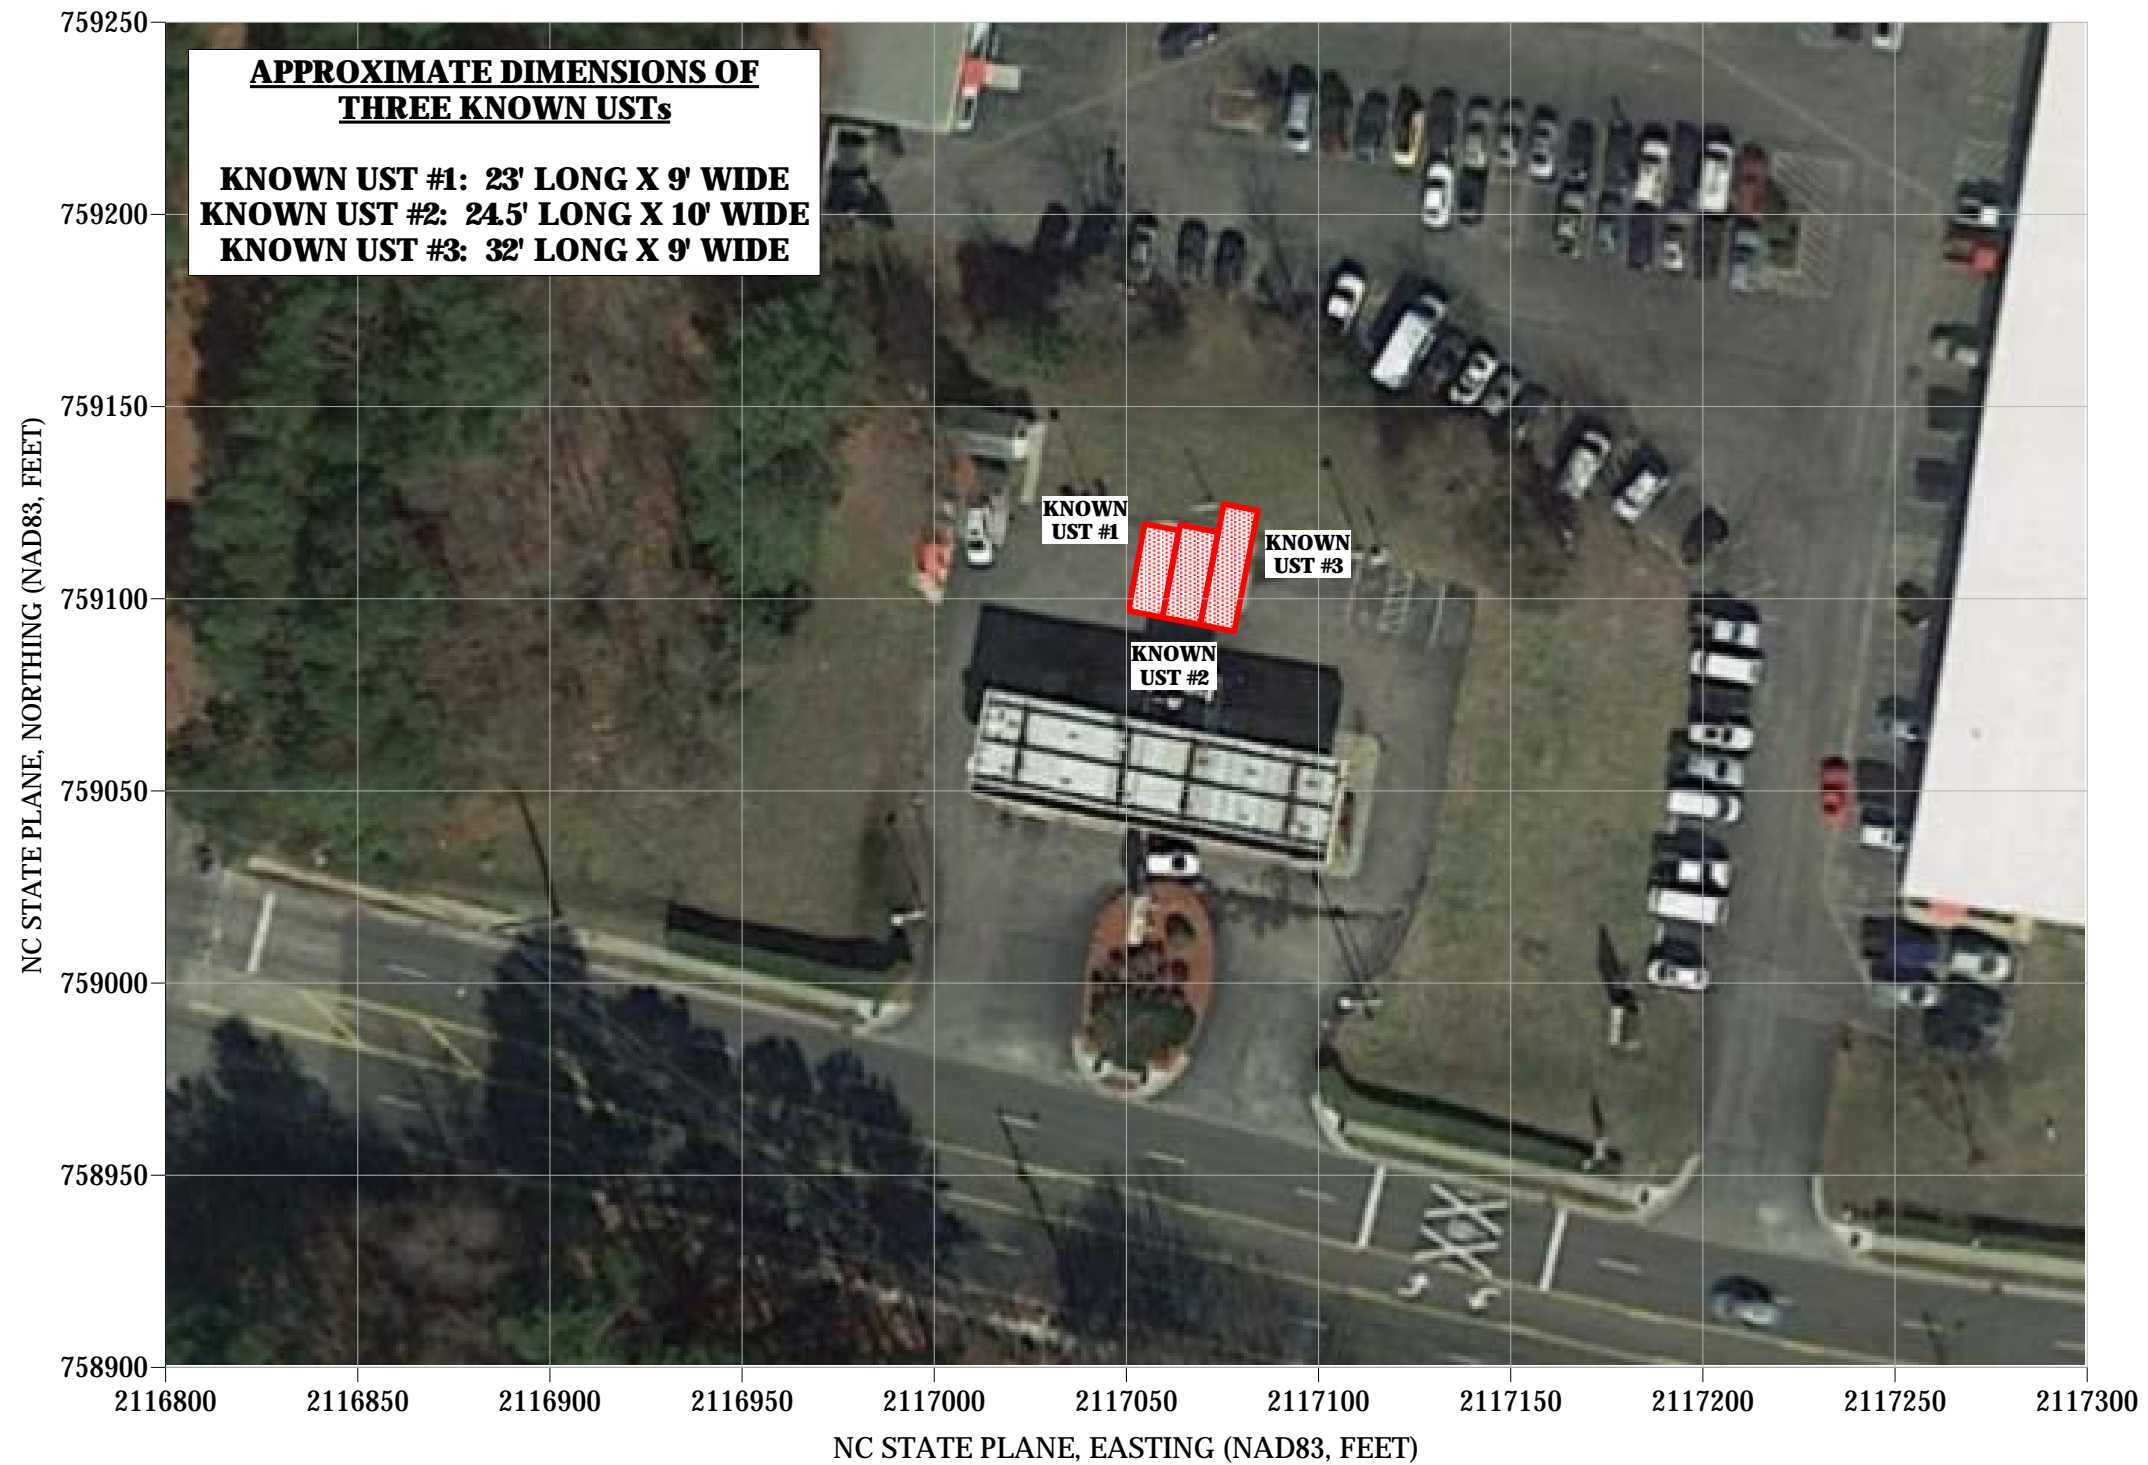
LOCATIONS OF THREE KNOWN USTs

View of Three Known USTs Facing Approximately West

View of Three Known USTs Facing Approximately South

GPR also verified the sizes and orientations of the three known USTs on the north side of the service station building. The western UST (UST #1) was approximately 23 feet long by 9 feet wide. The central UST (UST #2) was approximately 24.5 feet long by 10 feet wide. The eastern UST (UST #3) was approximately 32 feet long by 9 feet wide. Collectively, the geophysical data recorded evidence of three known USTs at Parcel 9.
