**North Carolina Department of Transportation
Phase II Investigation
State Project: R-5709
WBS Element: 50205.1.1
Moore County**

**Parcel 217
John & Kay Bolin Property
10531 NC 211 Hwy
Aberdeen, North Carolina
October 21, 2021**

**Wood Environment & Infrastructure Solutions, Inc.
Project: 20478R5709**

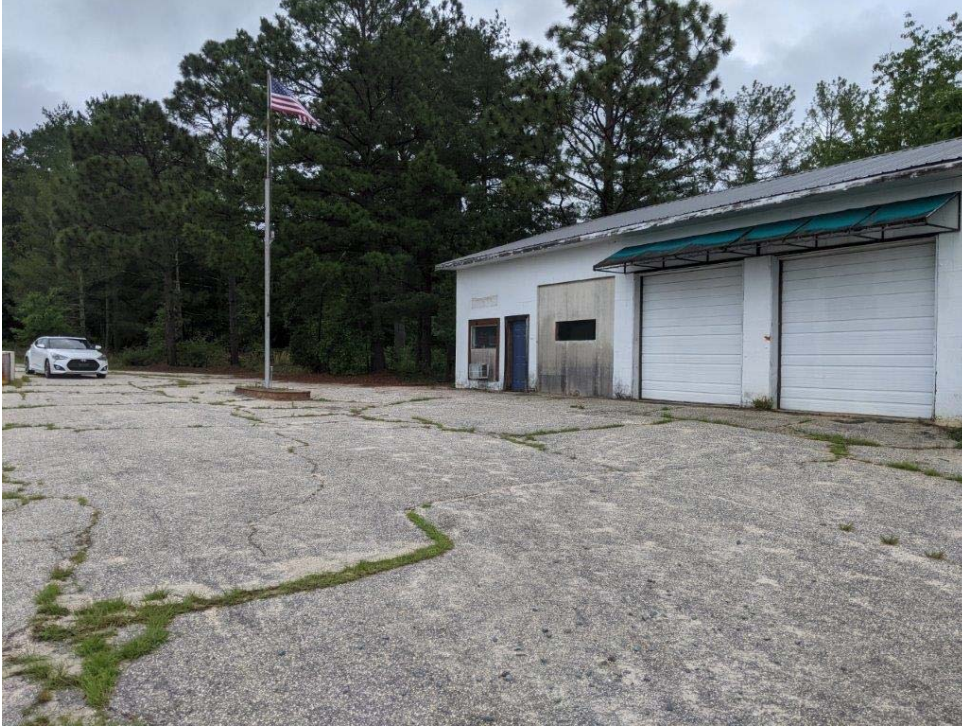
Wood personnel visited the parcel on June 8, 2021 and observed that the Site was occupied with a garage building, a suspected dispenser island located to the southwest of the building, and several old vehicles and trailers. The garage building is suspected to have been formerly operated as a gasoline station. In addition, two suspected UST fill ports were observed along the northwestern exterior of the garage building. A photographic log is included in **Appendix B**.

Photograph 1:
View of building and
suspected dispenser
island at parcel 217,
looking north.

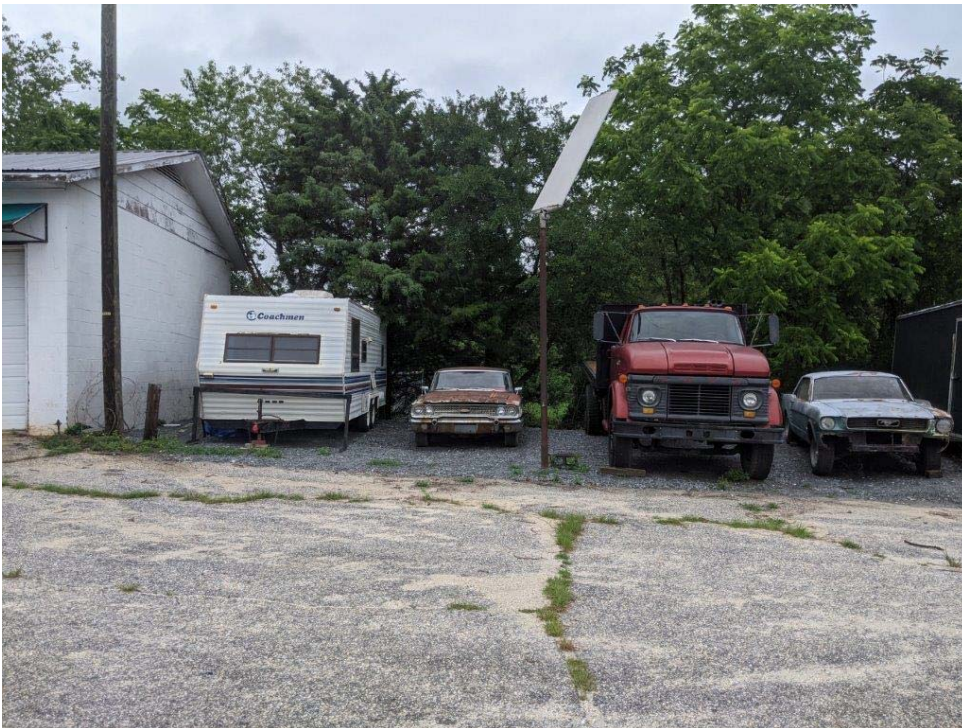
Photograph 2:
Old vehicles located at
parcel 217, facing
northeast.

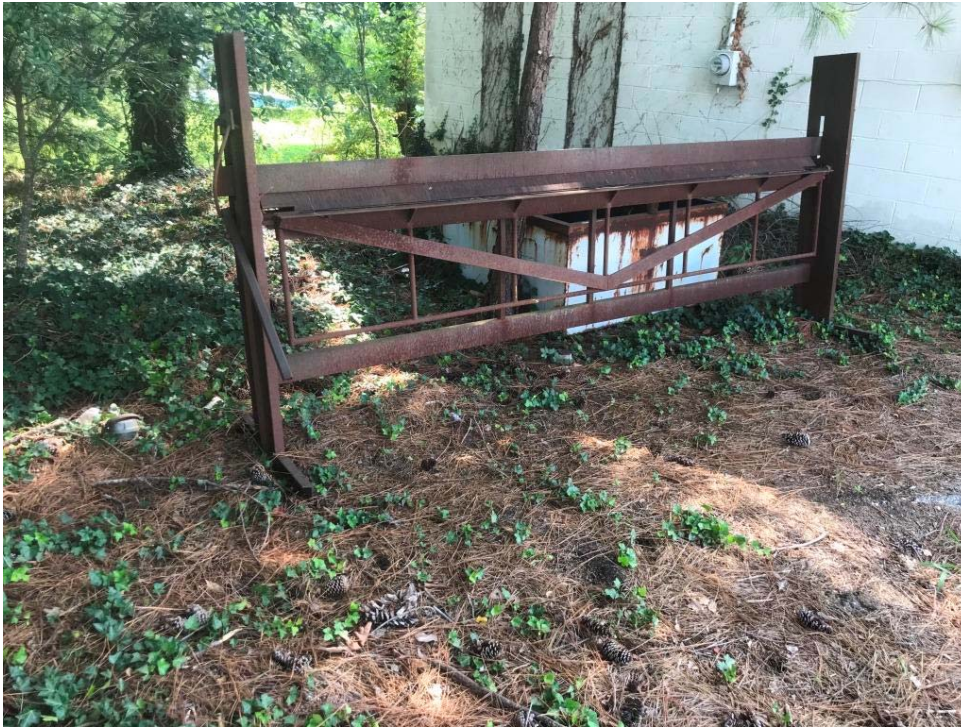
- The geophysical survey identified two probable USTs located along the northwestern exterior of the Site building. Both USTs measured approximately 26 feet long by 7 feet wide and 3 feet to top of tanks.
- Fifteen soil borings were advanced to roughly 10 to 15 feet bgs in the NCDOT ROW investigation area to collect soil samples for on-Site UVF analysis. Thirty-four soil samples were collected for on-Site UVF analysis.
- UVF analysis of the 34 soil samples collected did not identify petroleum-impacted soil.

Photograph 3:
View of area with
probable USTs (brown
pine straw covered
area), facing northeast.

Based on these Phase II Investigation results, Wood recommends the two probable USTs identified during the geophysical survey should be removed in general accordance with the NCDEQ guidelines.

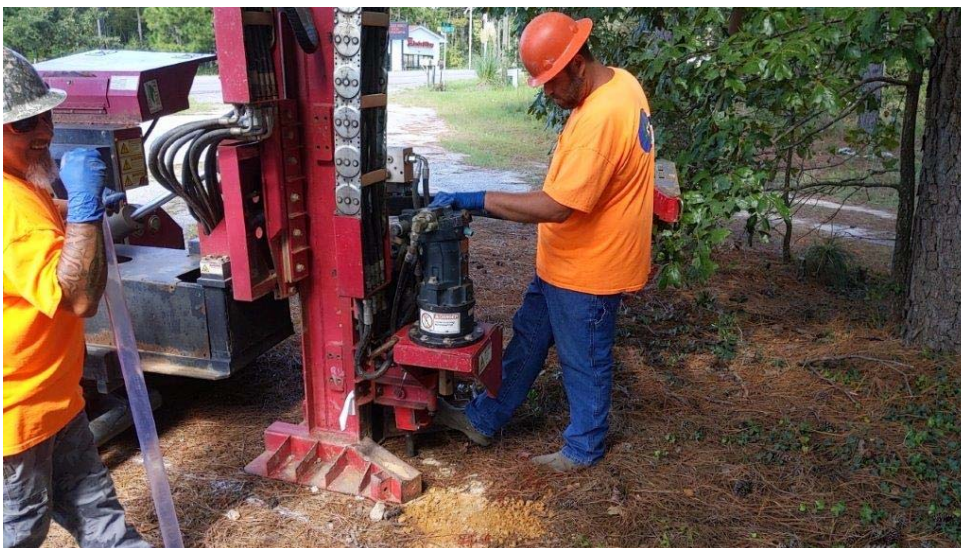
On September 2, 2021, Wood and IET mobilized to the Site to advance 15 shallow soil borings (P217-B1 to P217-B15). The borings were advanced via direct-push technology to approximate depths ranging from 10 to 15 feet bgs. Boring locations targeted potential environmental sources at the Site and future drainage features.

Photograph 4:
View of IET advancing
direct push soil
sampler at parcel 217.

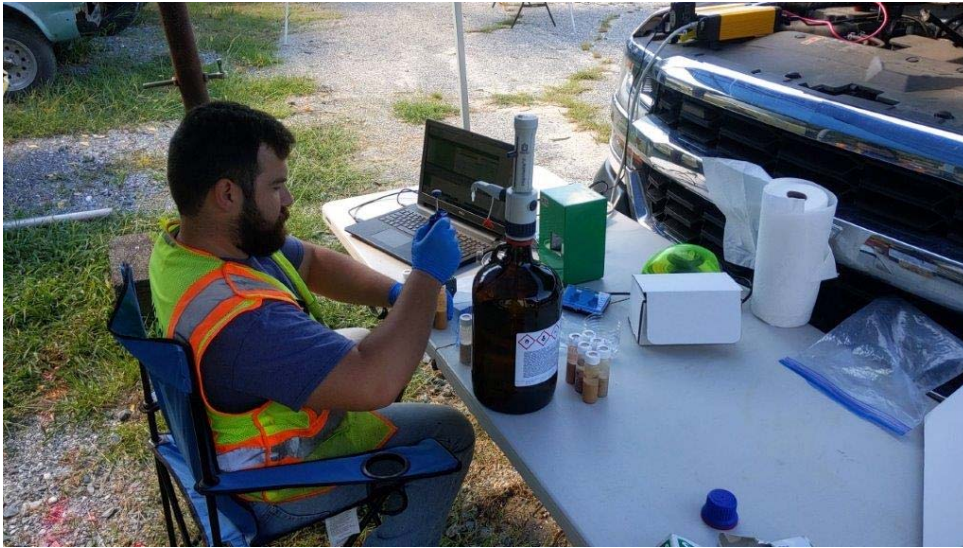
Photograph 5:
View of on-Site UVF
analysis setup.

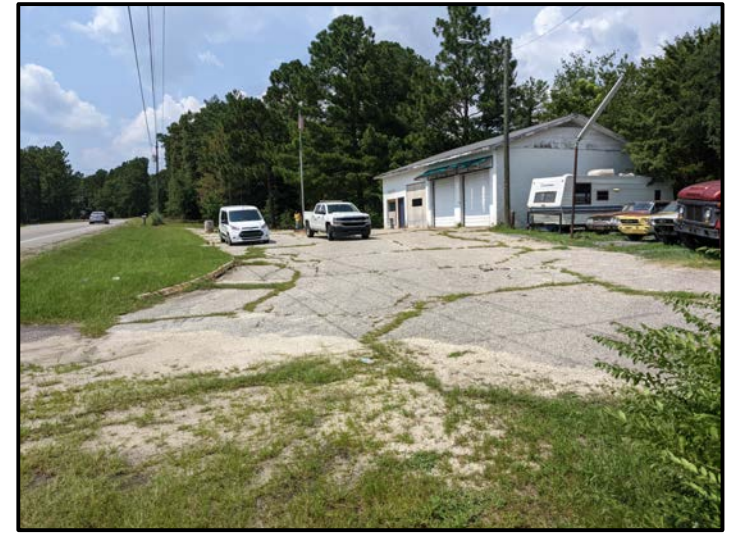
View of Survey Area (Facing Approximately Northwest)

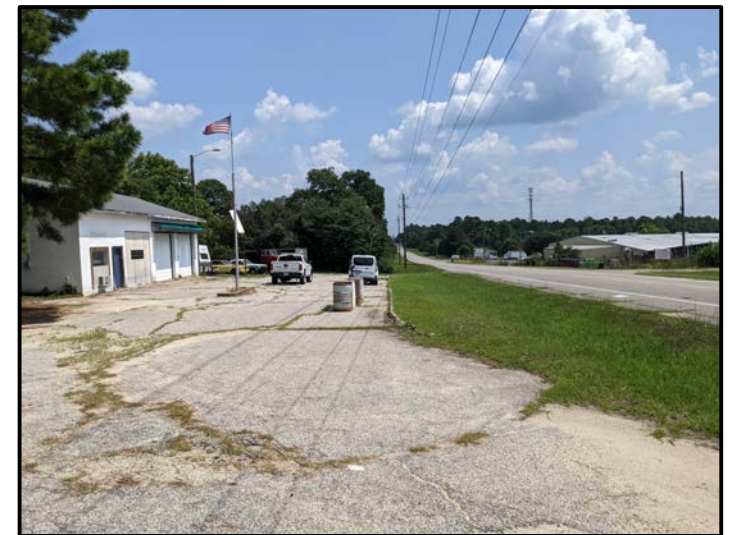
View of Survey Area (Facing Approximately Southeast)

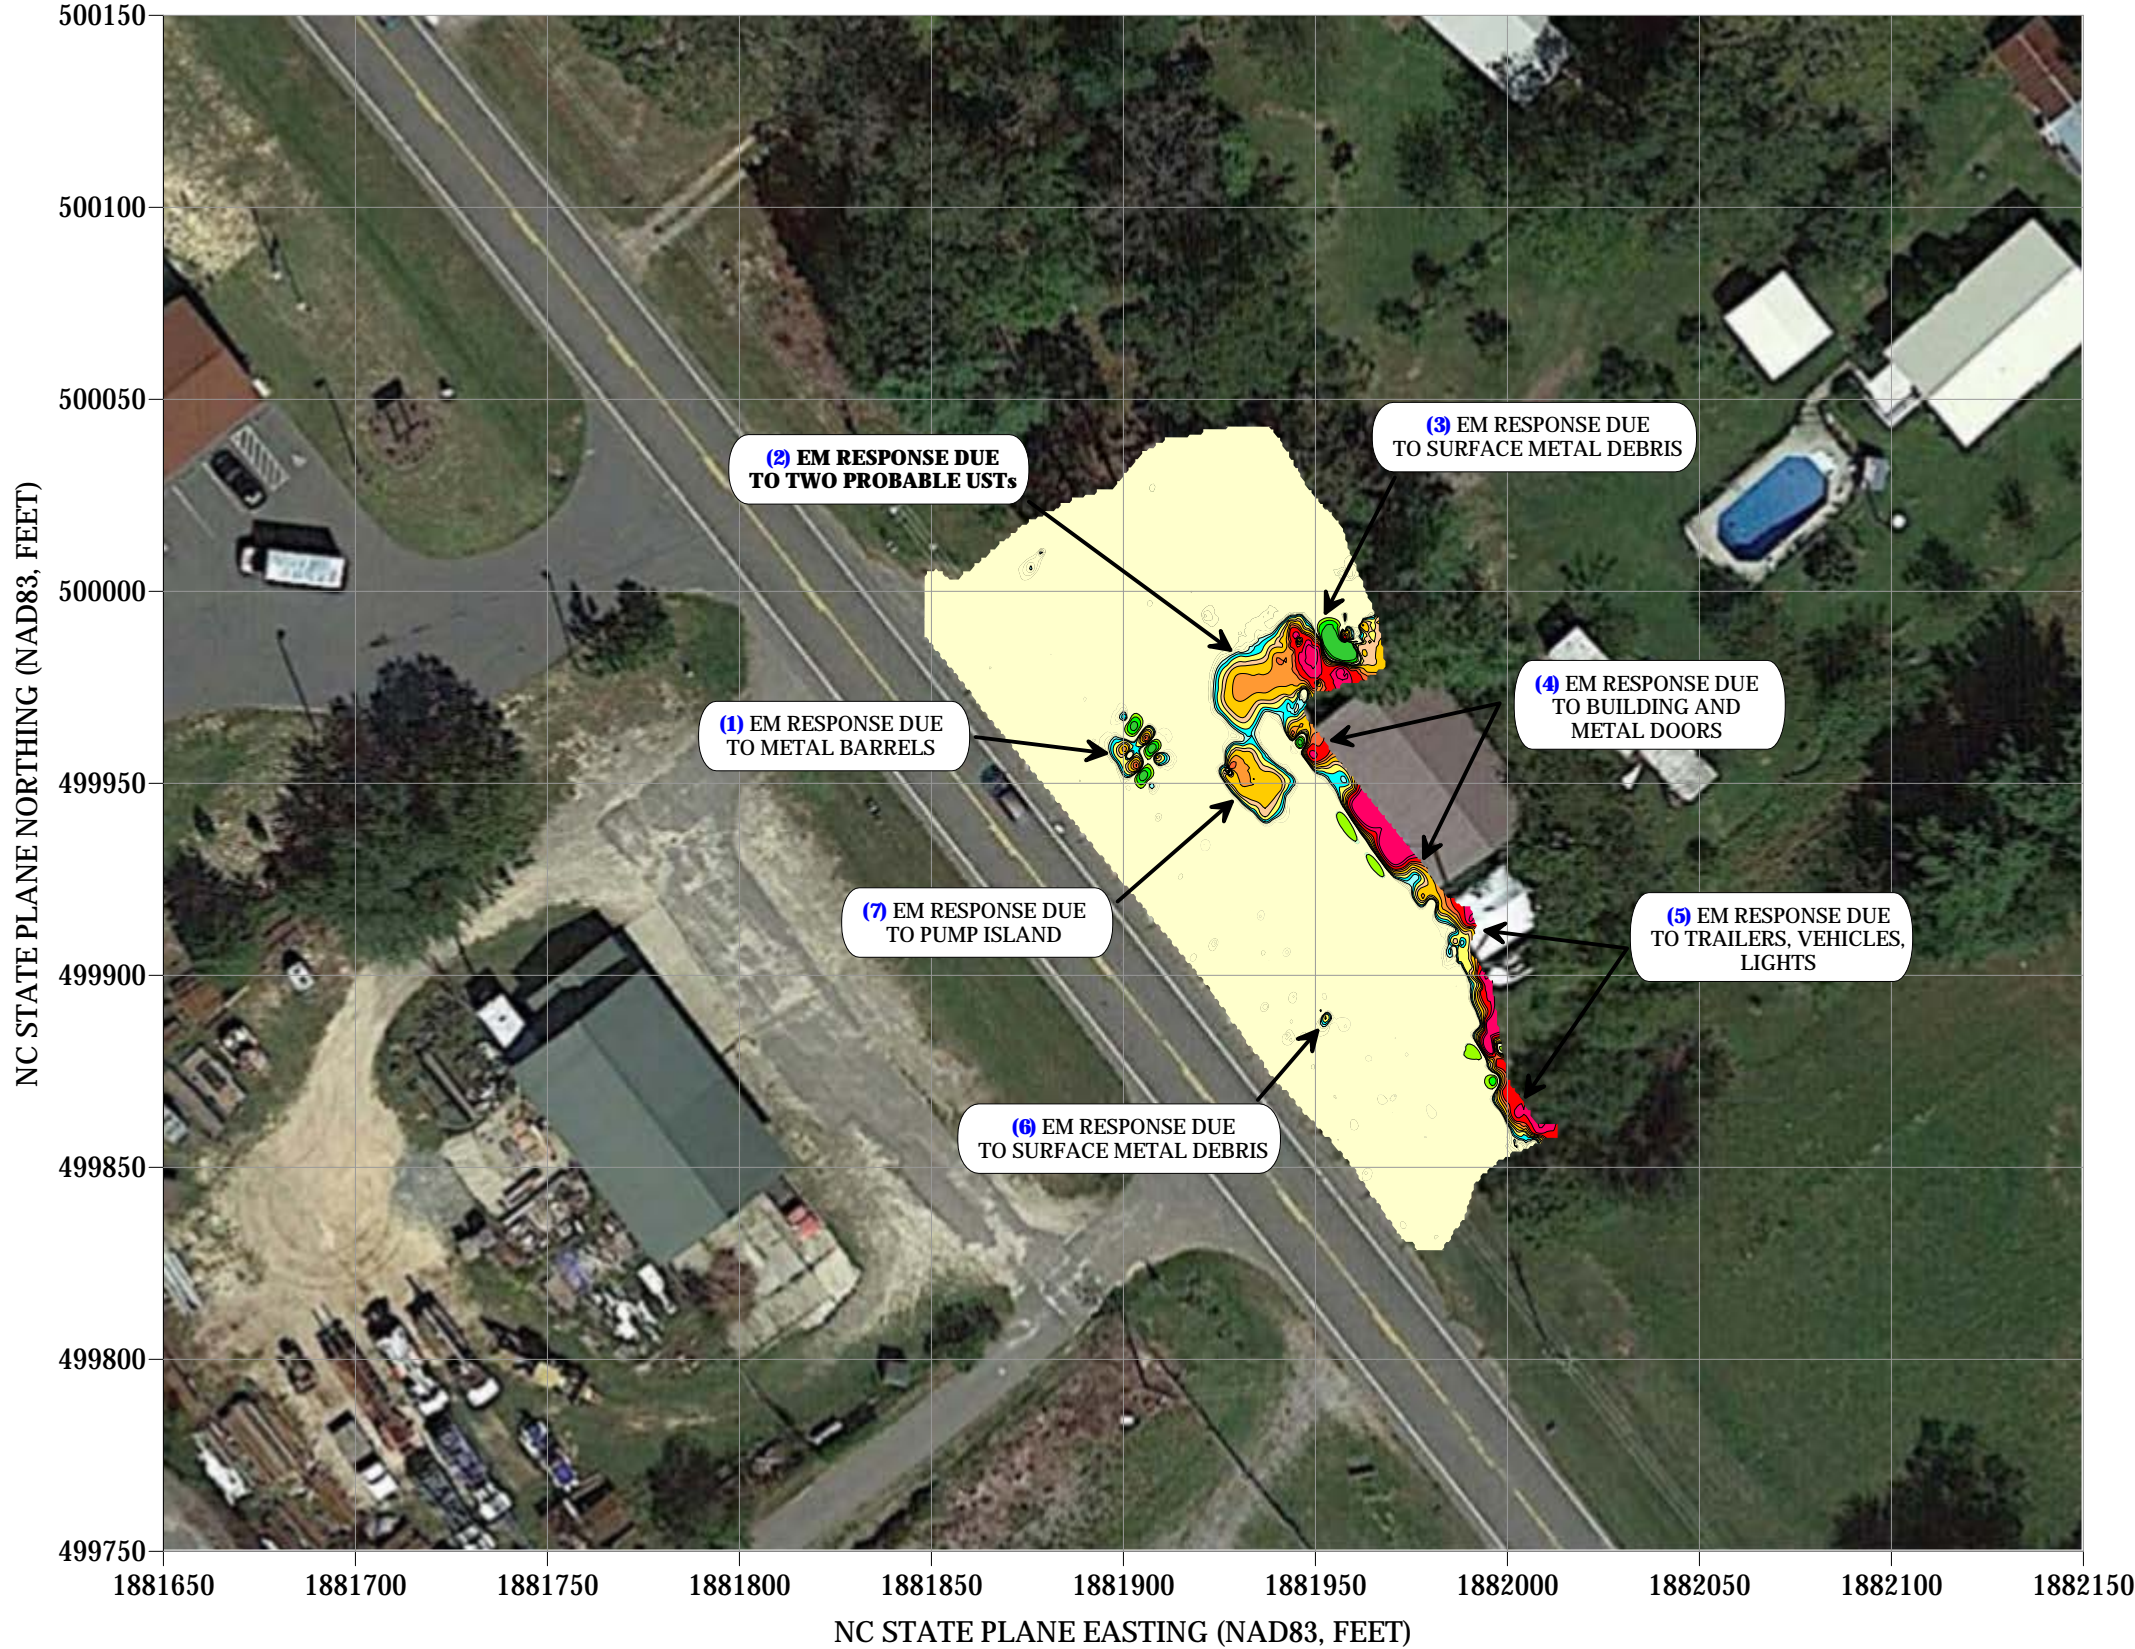
EM61 METAL DETECTION RESULTS

Metallic Anomaly #	Cause of Anomaly	Investigated with GPR
1	Metal Barrels	
2	Two Probable USTs	✓
3	Surface Metal Debris	✓
4	Building and Metal Doors	✓
5	Trailers, Vehicles, Lights	✓
6	Surface Metal Debris	
7	Pump Island	✓

EVIDENCE OF TWO PROBABLE METALLIC USTs WAS OBSERVED.

The contour plot shows the differential results of the EM61 instrument in millivolts (mV). The differential results focus on larger metallic objects such as USTs and drums. The EM data were collected on August 10, 2021, using a Geonics EM61-MK2 instrument. Verification GPR data were collected using a GSSI SIR 4000 instrument with a 350 MHz HS antenna on August 12, 2021.
