**North Carolina Department of Transportation  
Phase II Investigation  
State Project: R-5709  
WBS Element: 50205.1.1  
Moore County**

**Parcel 229  
Donald Earl and Karen & Charles Gillis – Jay’s Food Mart Property  
10827 NC 211 Hwy  
Aberdeen, North Carolina  
October 27, 2021**

**Wood Environment & Infrastructure Solutions, Inc.  
Project: 20478R5709**

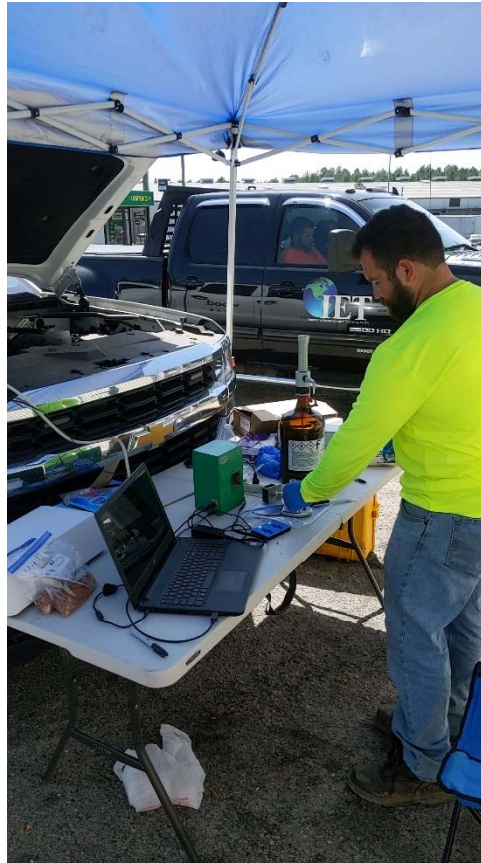
**Photograph 5:**  
View of on-Site UVF  
analysis setup.

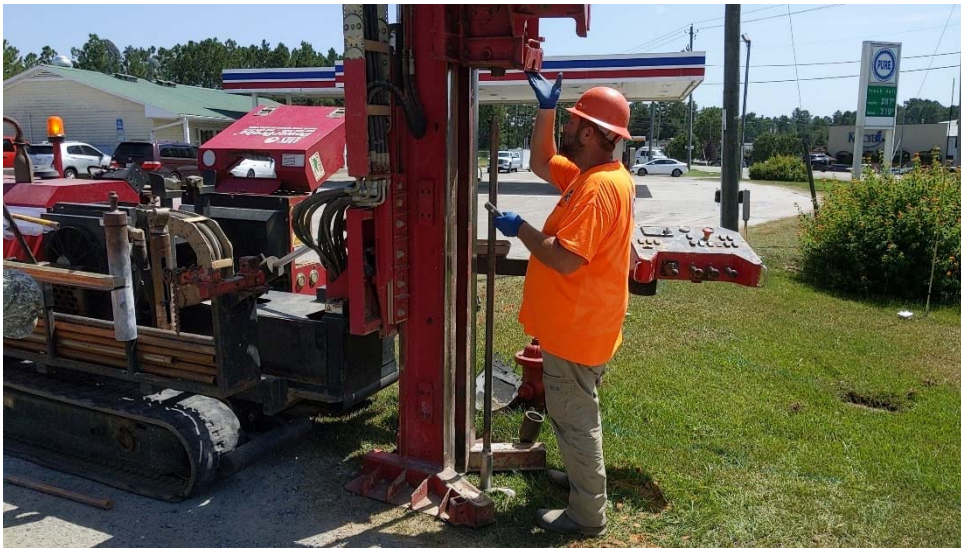
**Photograph 6:**  
View of IET advancing  
direct push soil  
sampler at parcel 229.
