**North Carolina Department of Transportation
Phase II Investigation
State Project: R-5709
WBS Element: 50205.1.1
Hoke County**

**Parcel 431
Herbert L./Jennifer Jones – Just Country Antiques Store Property
5735 NC 211 Highway
Raeford, North Carolina
October 28, 2021**

**Wood Environment & Infrastructure Solutions, Inc.
Project: 20478R5709**

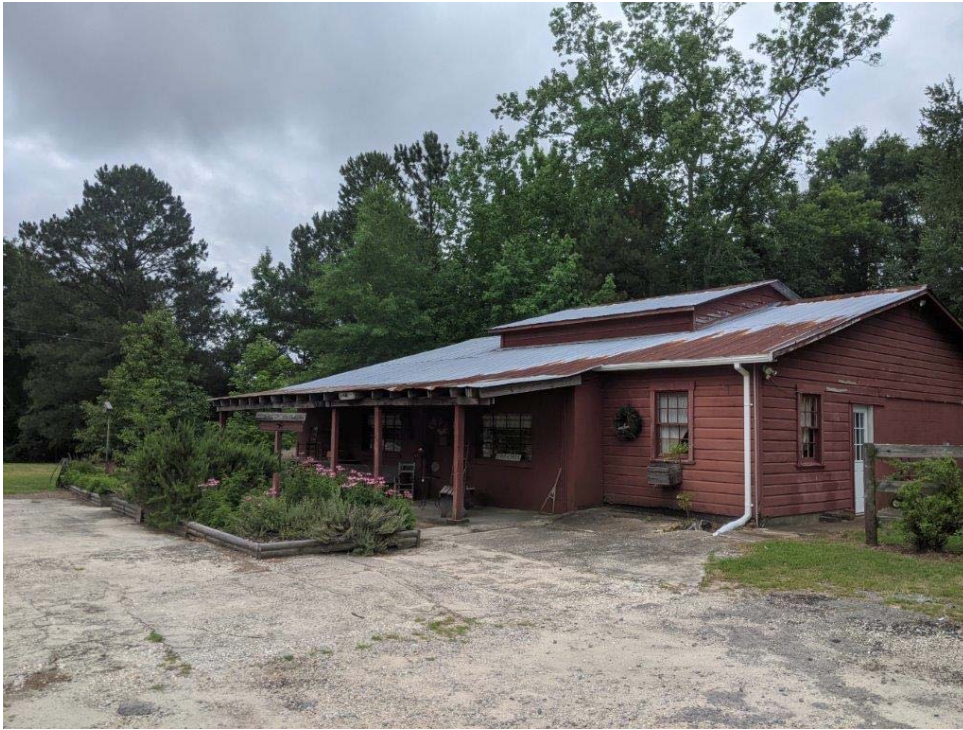
Photograph 1:
View of antique store
and suspected
dispenser island
(beneath flower beds),
facing south.

Based on these Phase II Investigation results, Wood recommends no further soil investigation. Wood notes that the suspected former dispenser island and possible product line located within the investigation area lie within the ROW and thus should be removed, in general accordance with the NCDEQ guidelines.

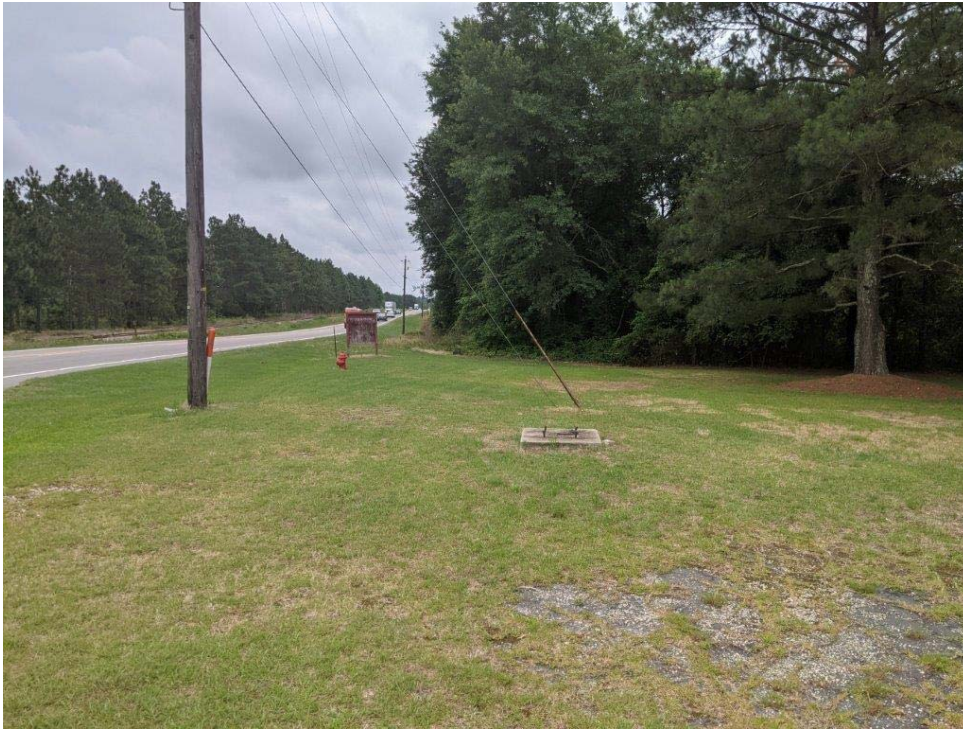
Photograph 3:
View of southern
portion of investigation
area at parcel 431,
facing southeast.

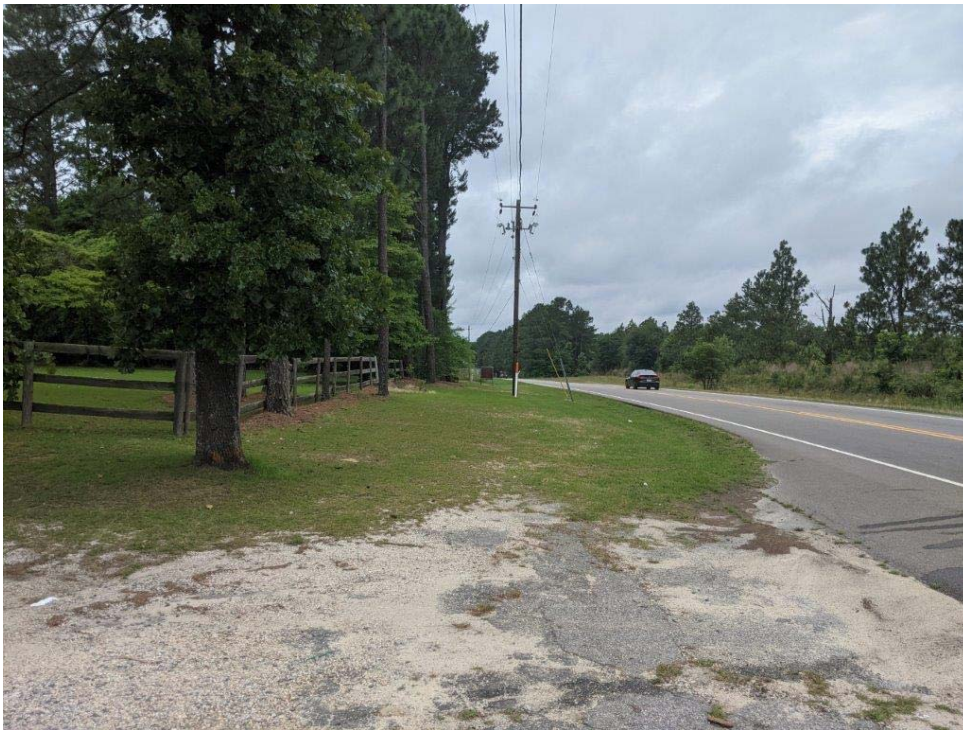
Photograph 4:
View of northern
portion of investigation
area at parcel 431,
facing northwest.

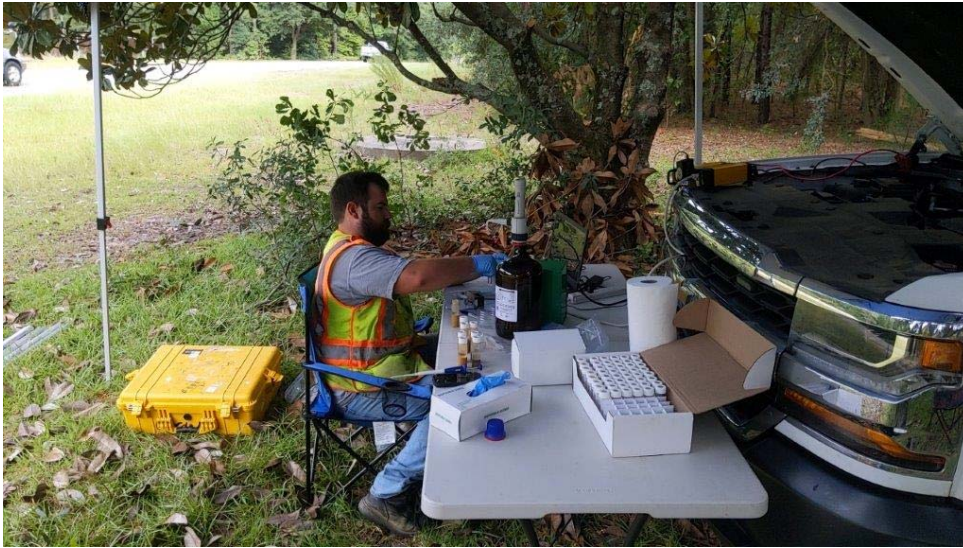
Photograph 5:
View of on-Site UVF
analysis setup.

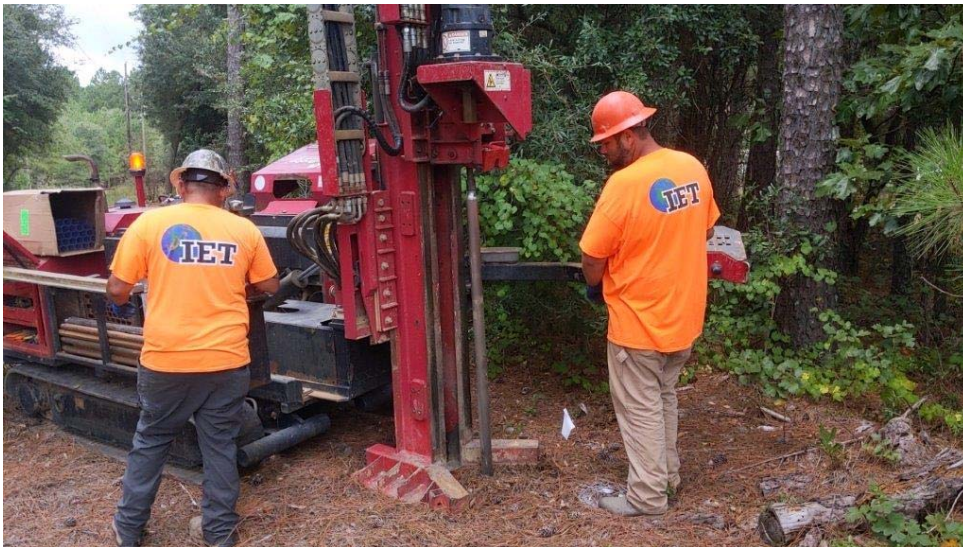
Photograph 6:
View of IET advancing
direct push soil
sampler.

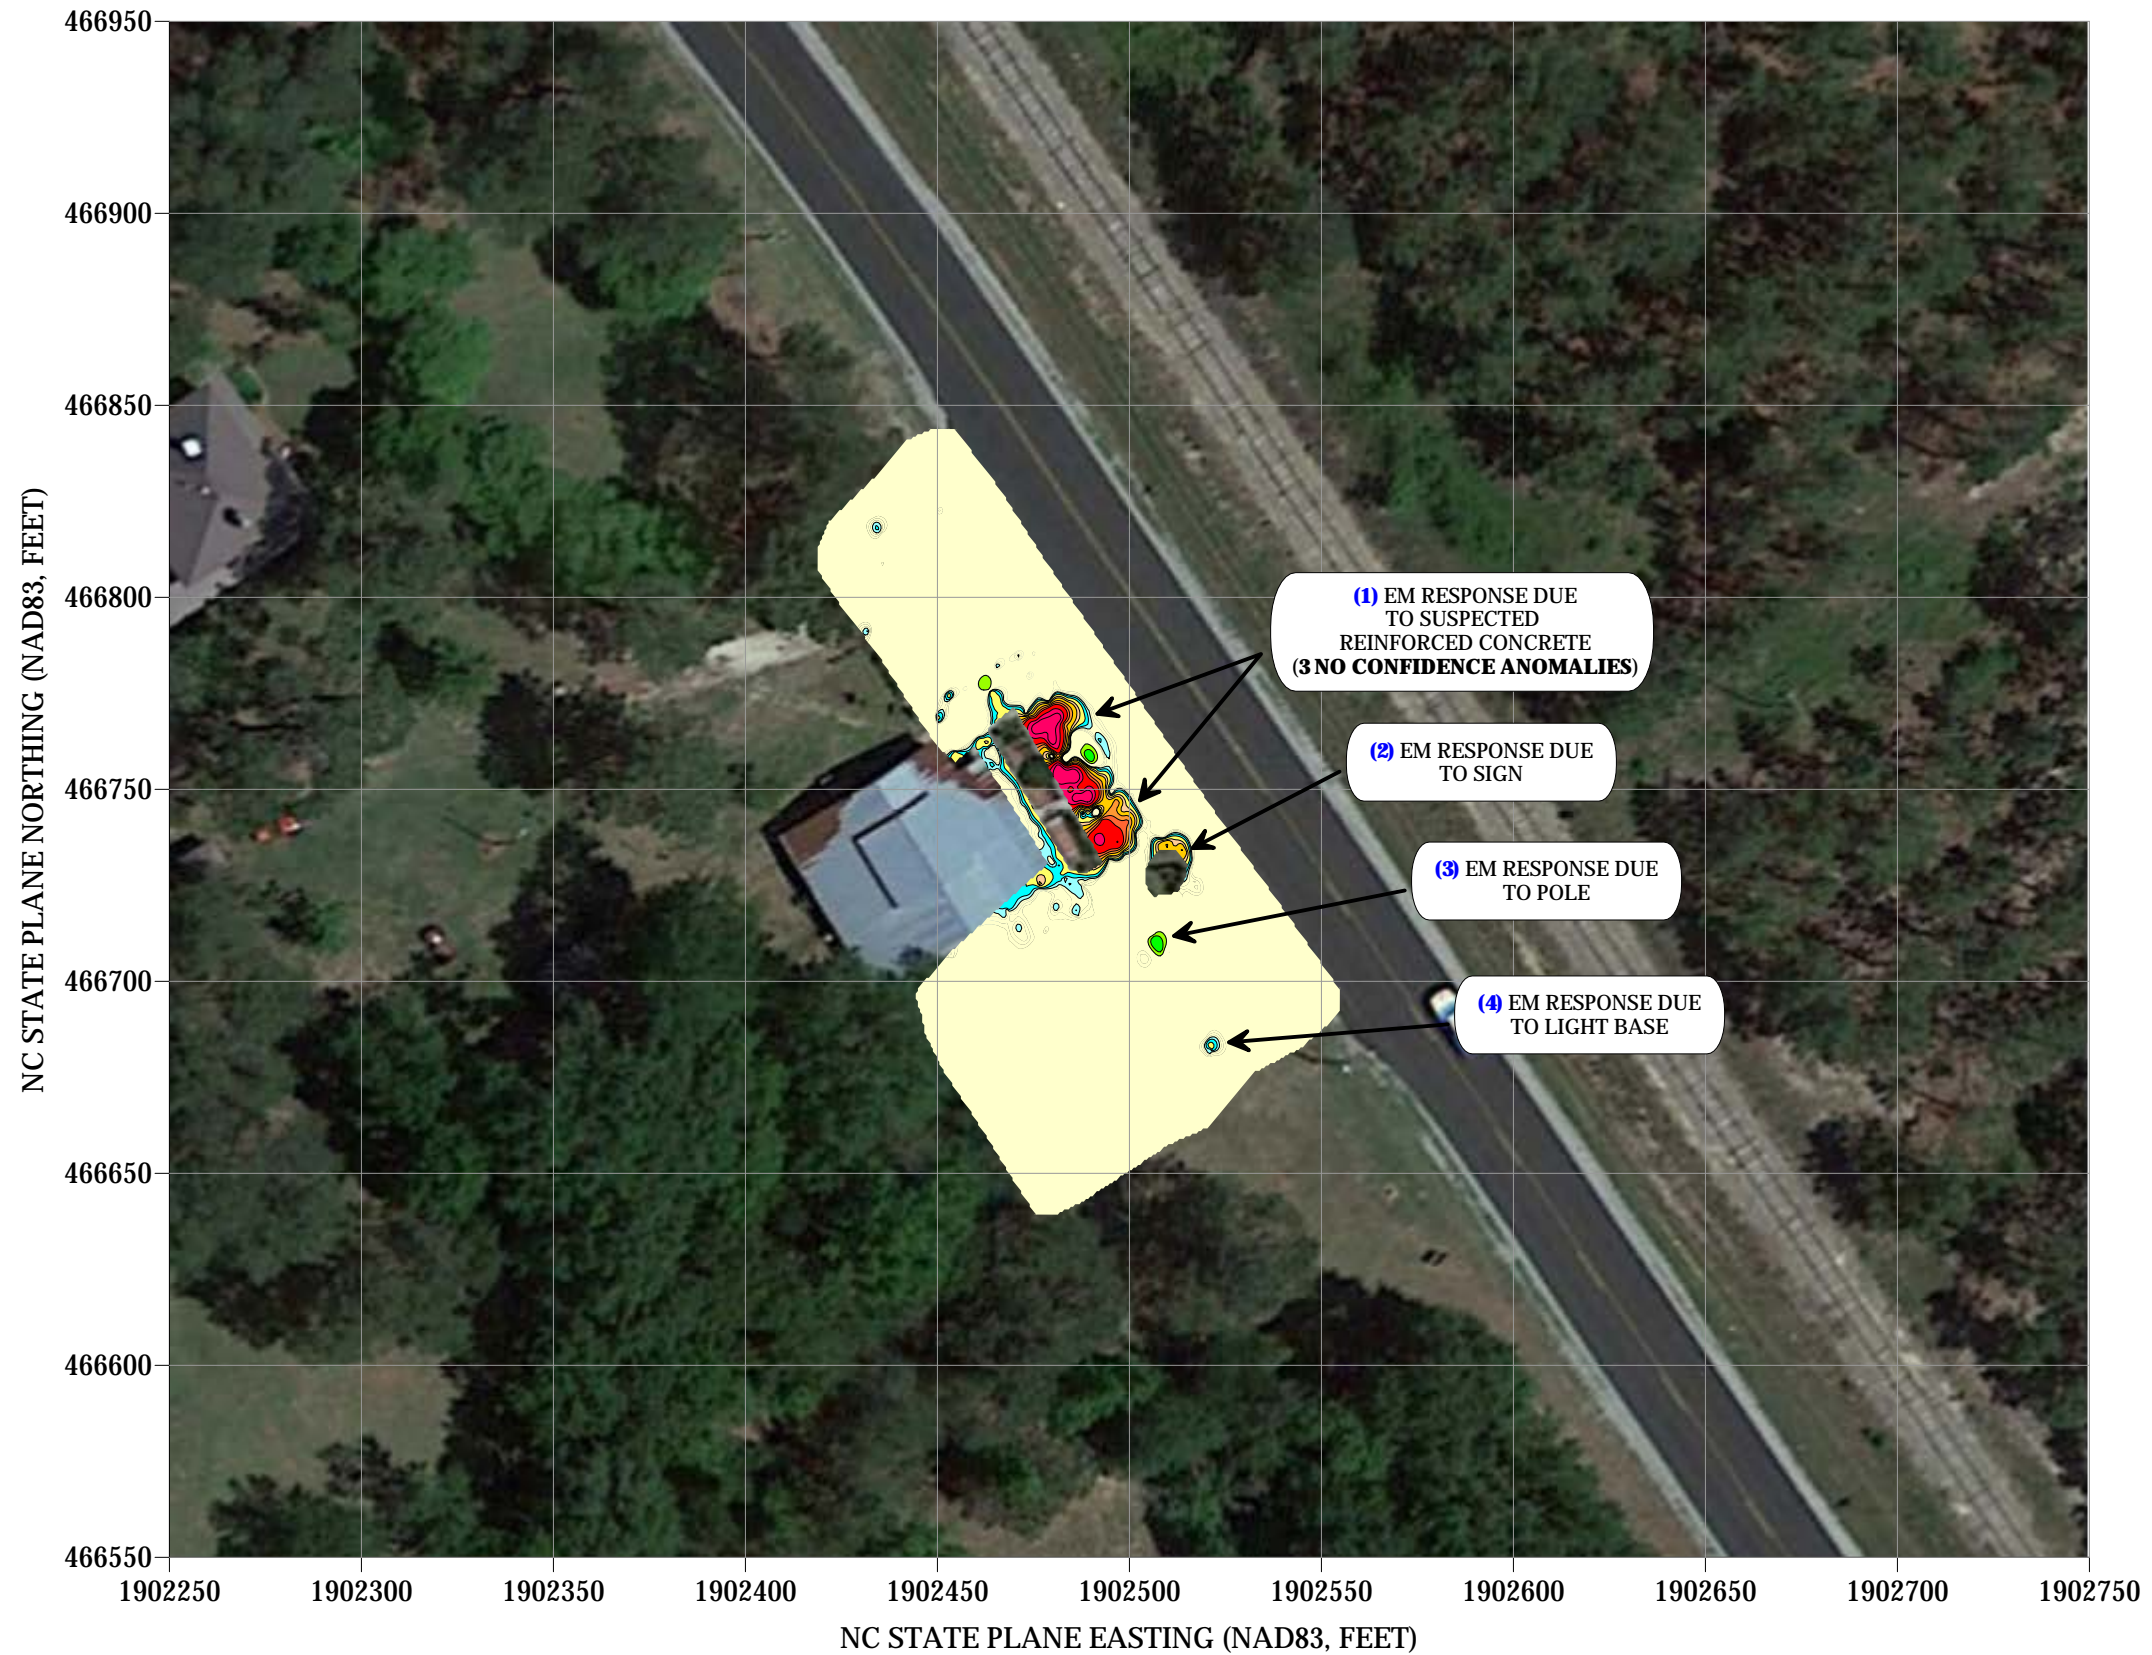
EM61 METAL DETECTION RESULTS

EVIDENCE OF THREE NO CONFIDENCE ANOMALIES WAS OBSERVED.

The contour plot shows the differential results of the EM61 instrument in millivolts (mV). The differential results focus on larger metallic objects such as USTs and drums. The EM data were collected on August 11, 2021, using a Geonics EM61-MK2 instrument. Verification GPR data were collected using a GSSI SIR 4000 instrument with a 350 MHz HS antenna on August 12, 2021.

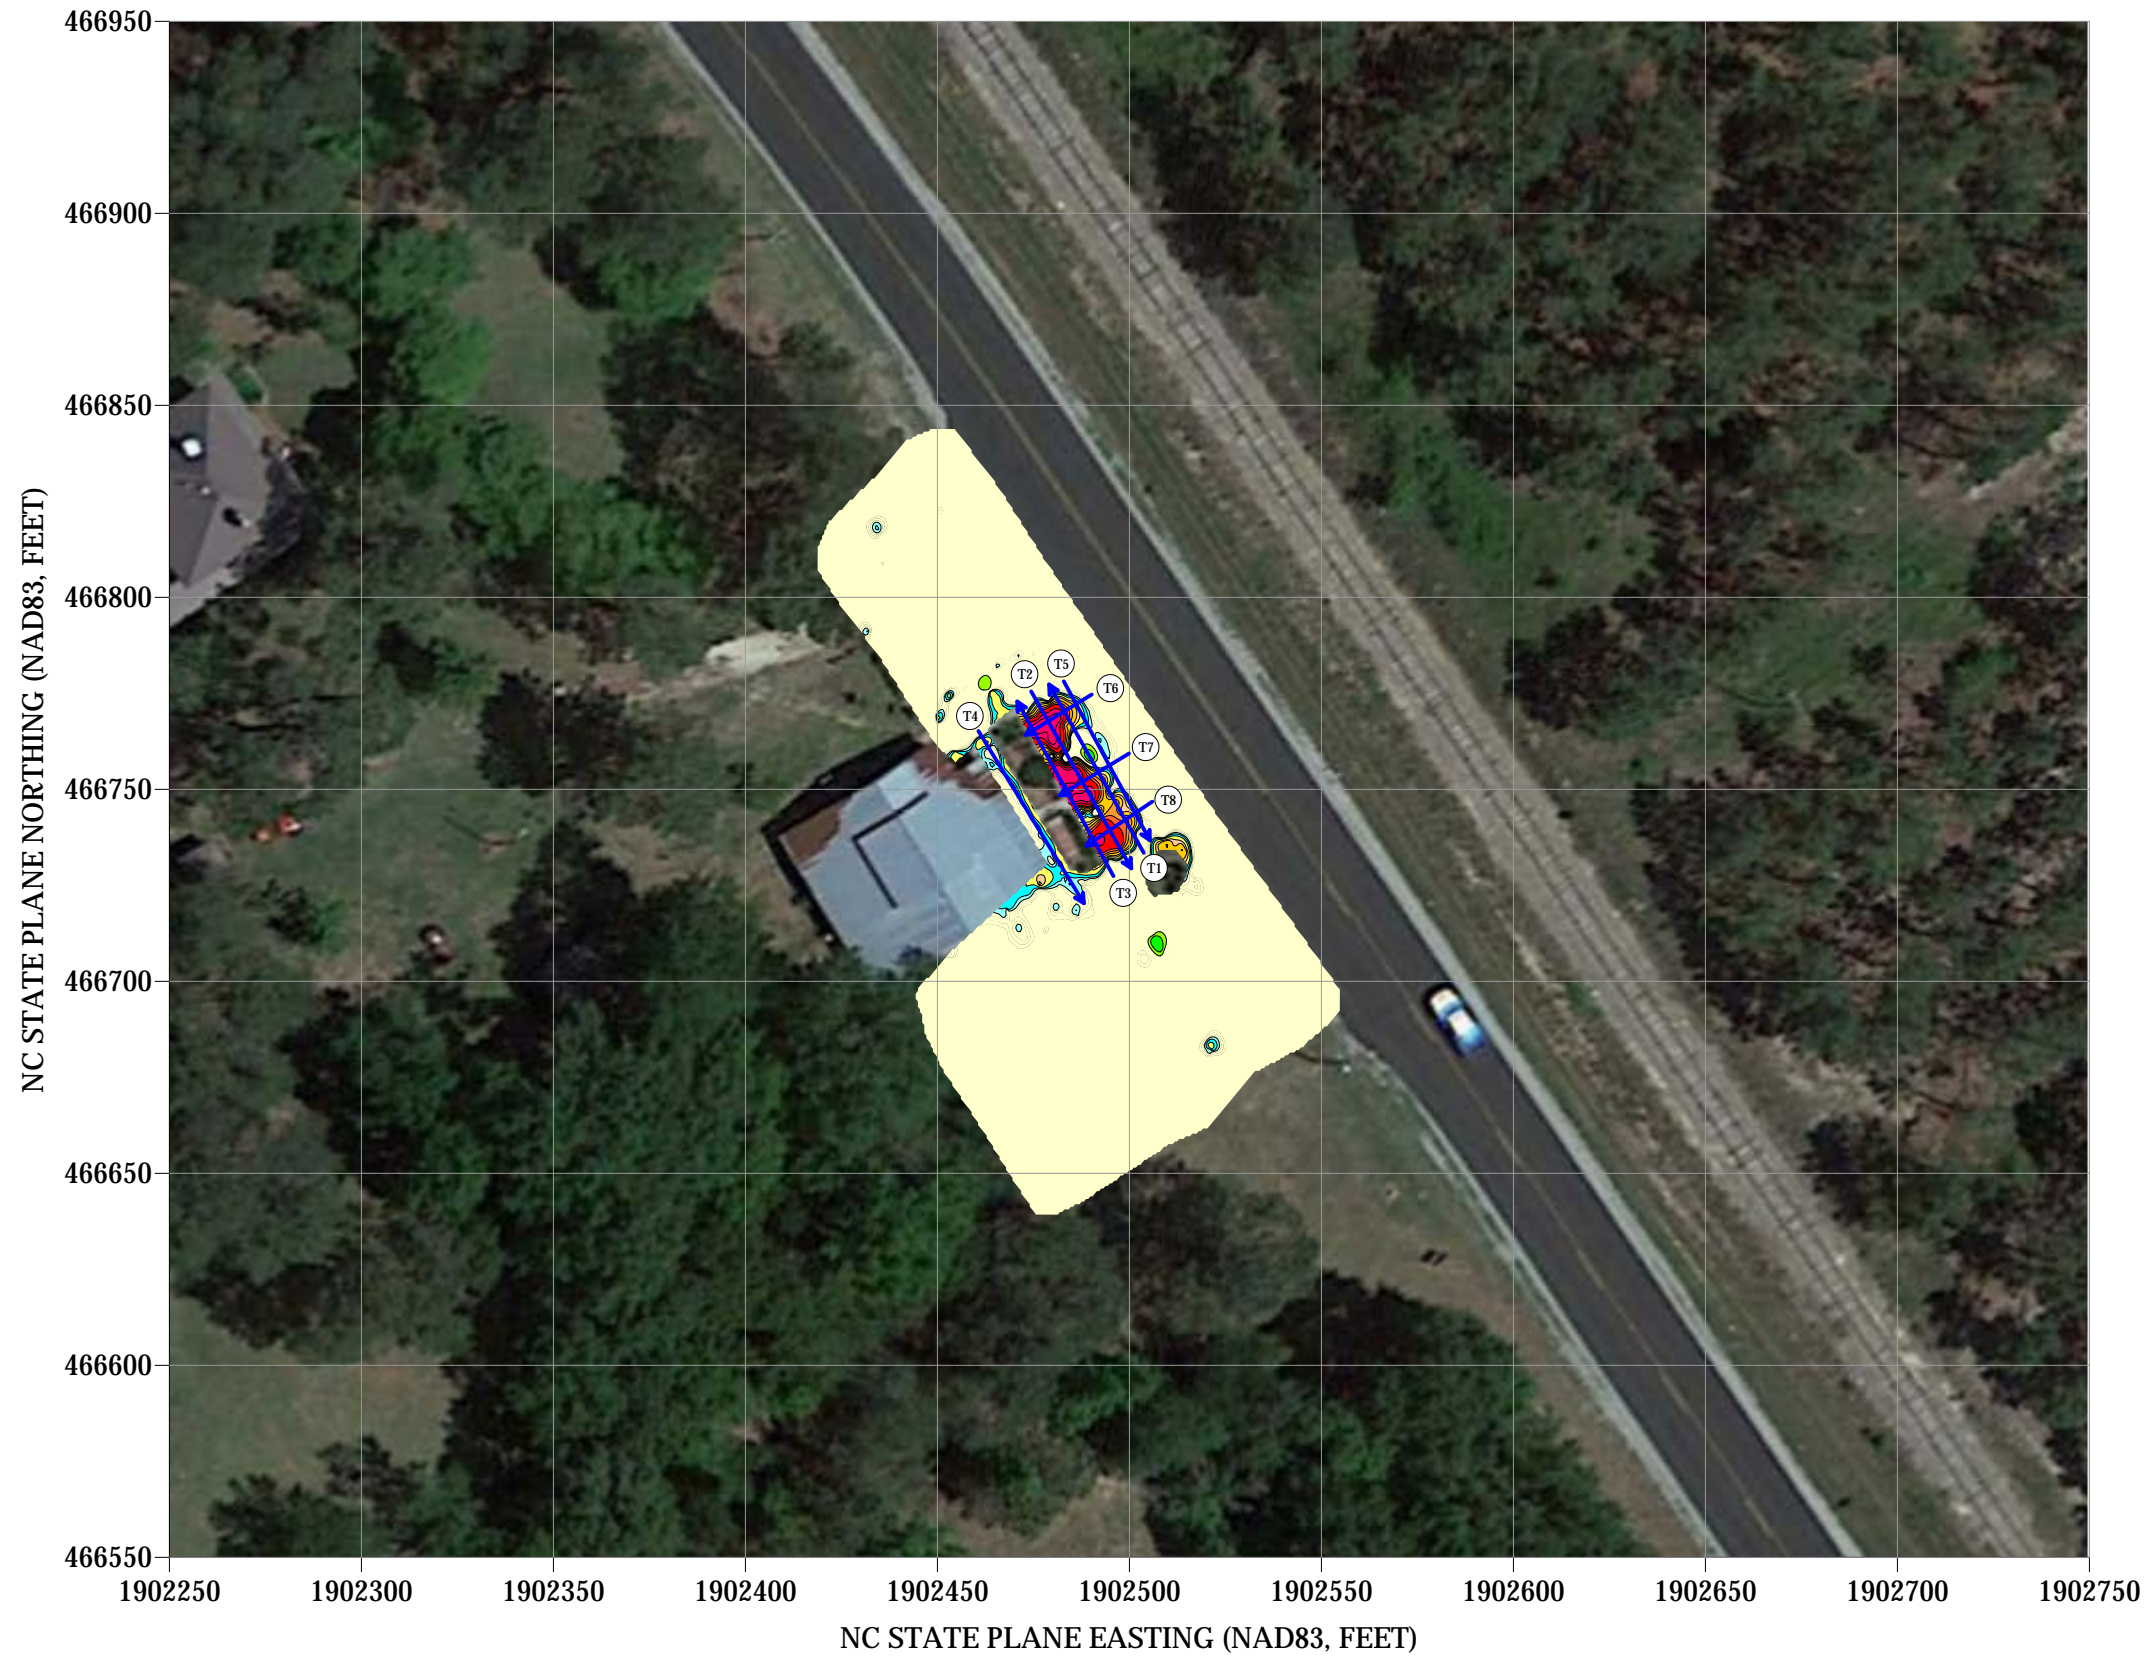
GPR TRANSECT LOCATIONS

GPR Transects 1-8 were performed across EM Anomaly 1. These transects recorded evidence of sections of reinforced concrete and sections of very shallow, high-amplitude lateral reflectors. These reflectors are characteristic of a buried shallow foundation or slab. The intermittent shallow features were divided into three distinct zones. The high-amplitude responses resulted in repeating lateral reflectors with depth, preventing GPR data collection below the suspected shallow slab in some places. For this reason, the three zones have been classified as three no confidence anomalies. From north to south, No Confidence Anomaly #1 covered an area approximately 12 feet long and 13 feet wide, and No Confidence Anomalies #2 and #3 both covered areas approximately 12 feet long and 9.5 feet wide. These features are not characteristic of USTs; however, as mentioned above, the shallow structures prevented deeper penetration by GPR in some areas. **Figure 4**
