**North Carolina Department of Transportation
Phase II Investigation
State Project: R-5709
WBS Element: 50205.1.1
Moore County**

**Parcel 79
Robert L. Schloegl Property
9820 NC 211 Hwy
Aberdeen, North Carolina
October 21, 2021**

**Wood Environment & Infrastructure Solutions, Inc.
Project: 20478R5709**

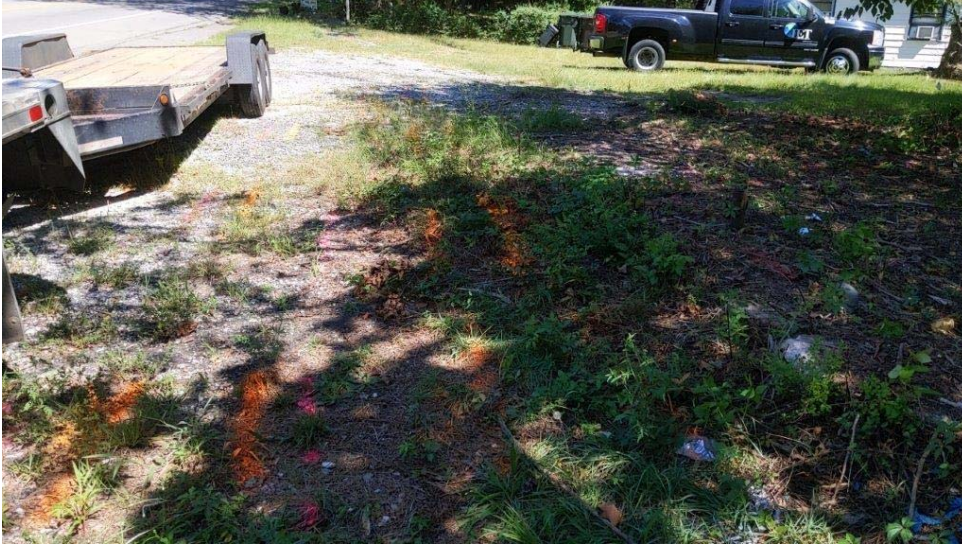
Photograph 5:
View of numerous markings indicating underground utilities located between the suspected dispenser island (right side of photo) and NC 211 Hwy (left side of photo), facing east.

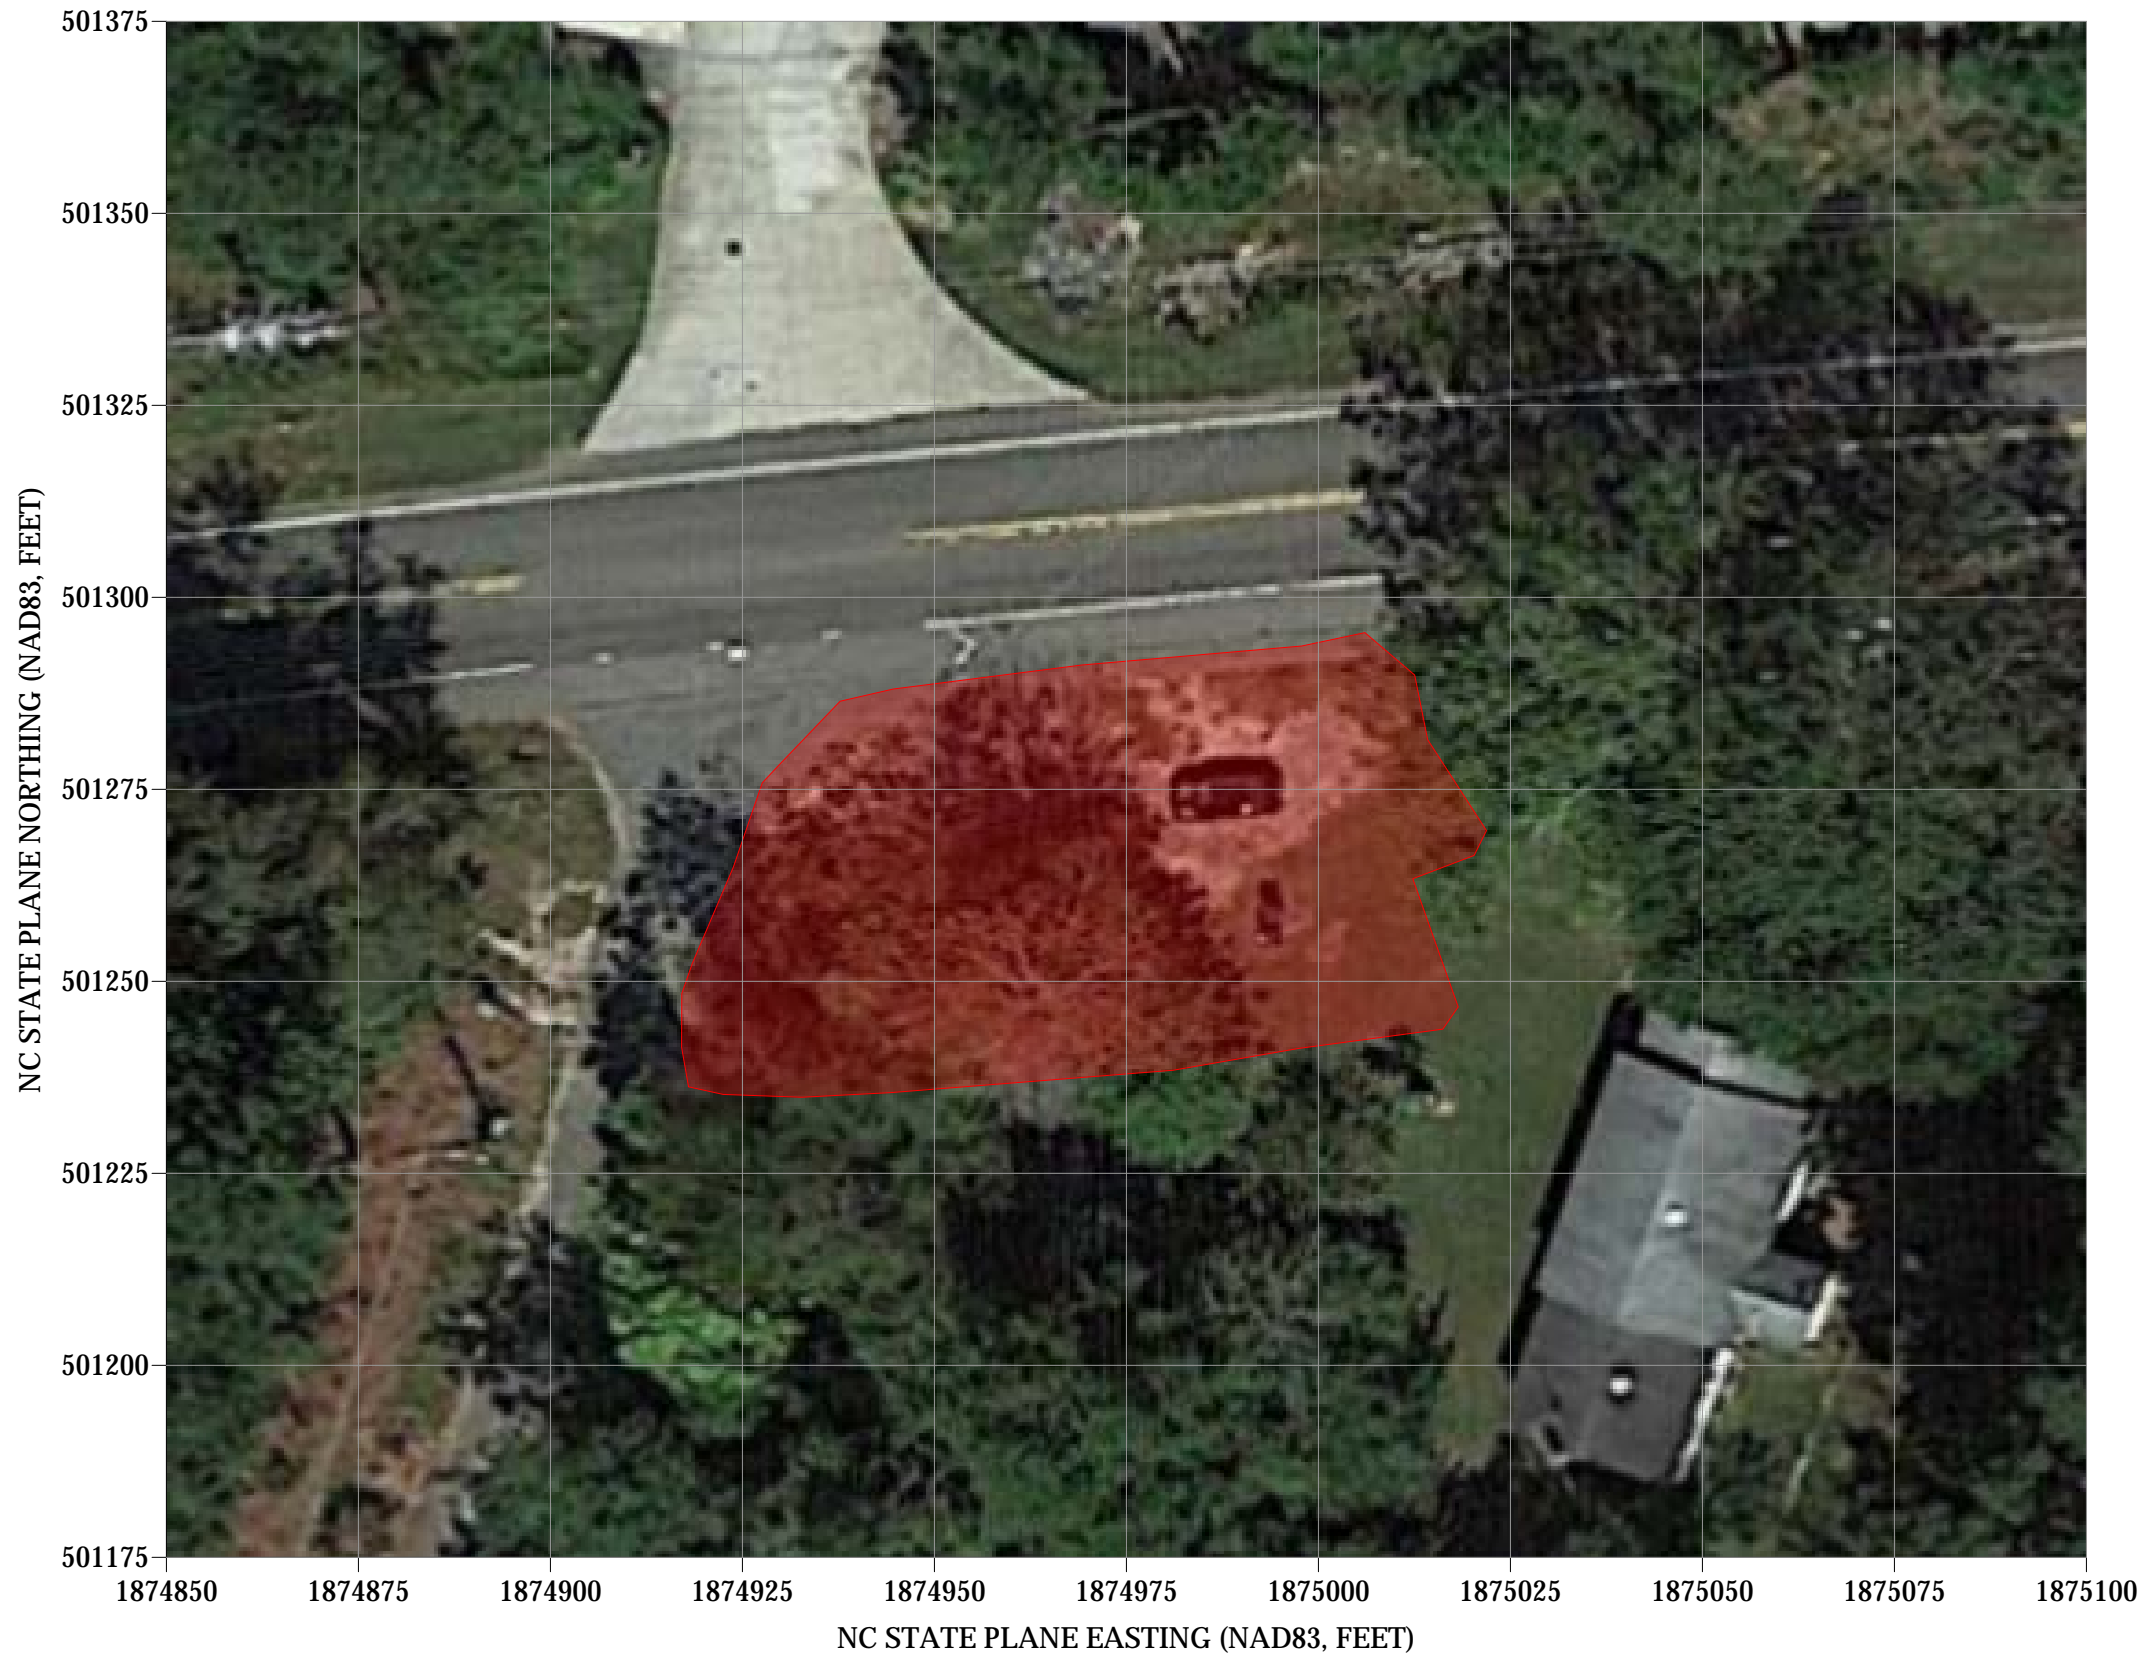
APPROXIMATE BOUNDARIES OF GEOPHYSICAL SURVEY AREA

The site consisted of a vacant lot with a deteriorated structure surrounded by grass, gravel, and dirt surfaces. An aerial photograph showing the survey area boundaries and ground-level photographs are shown in **Figure 1**.

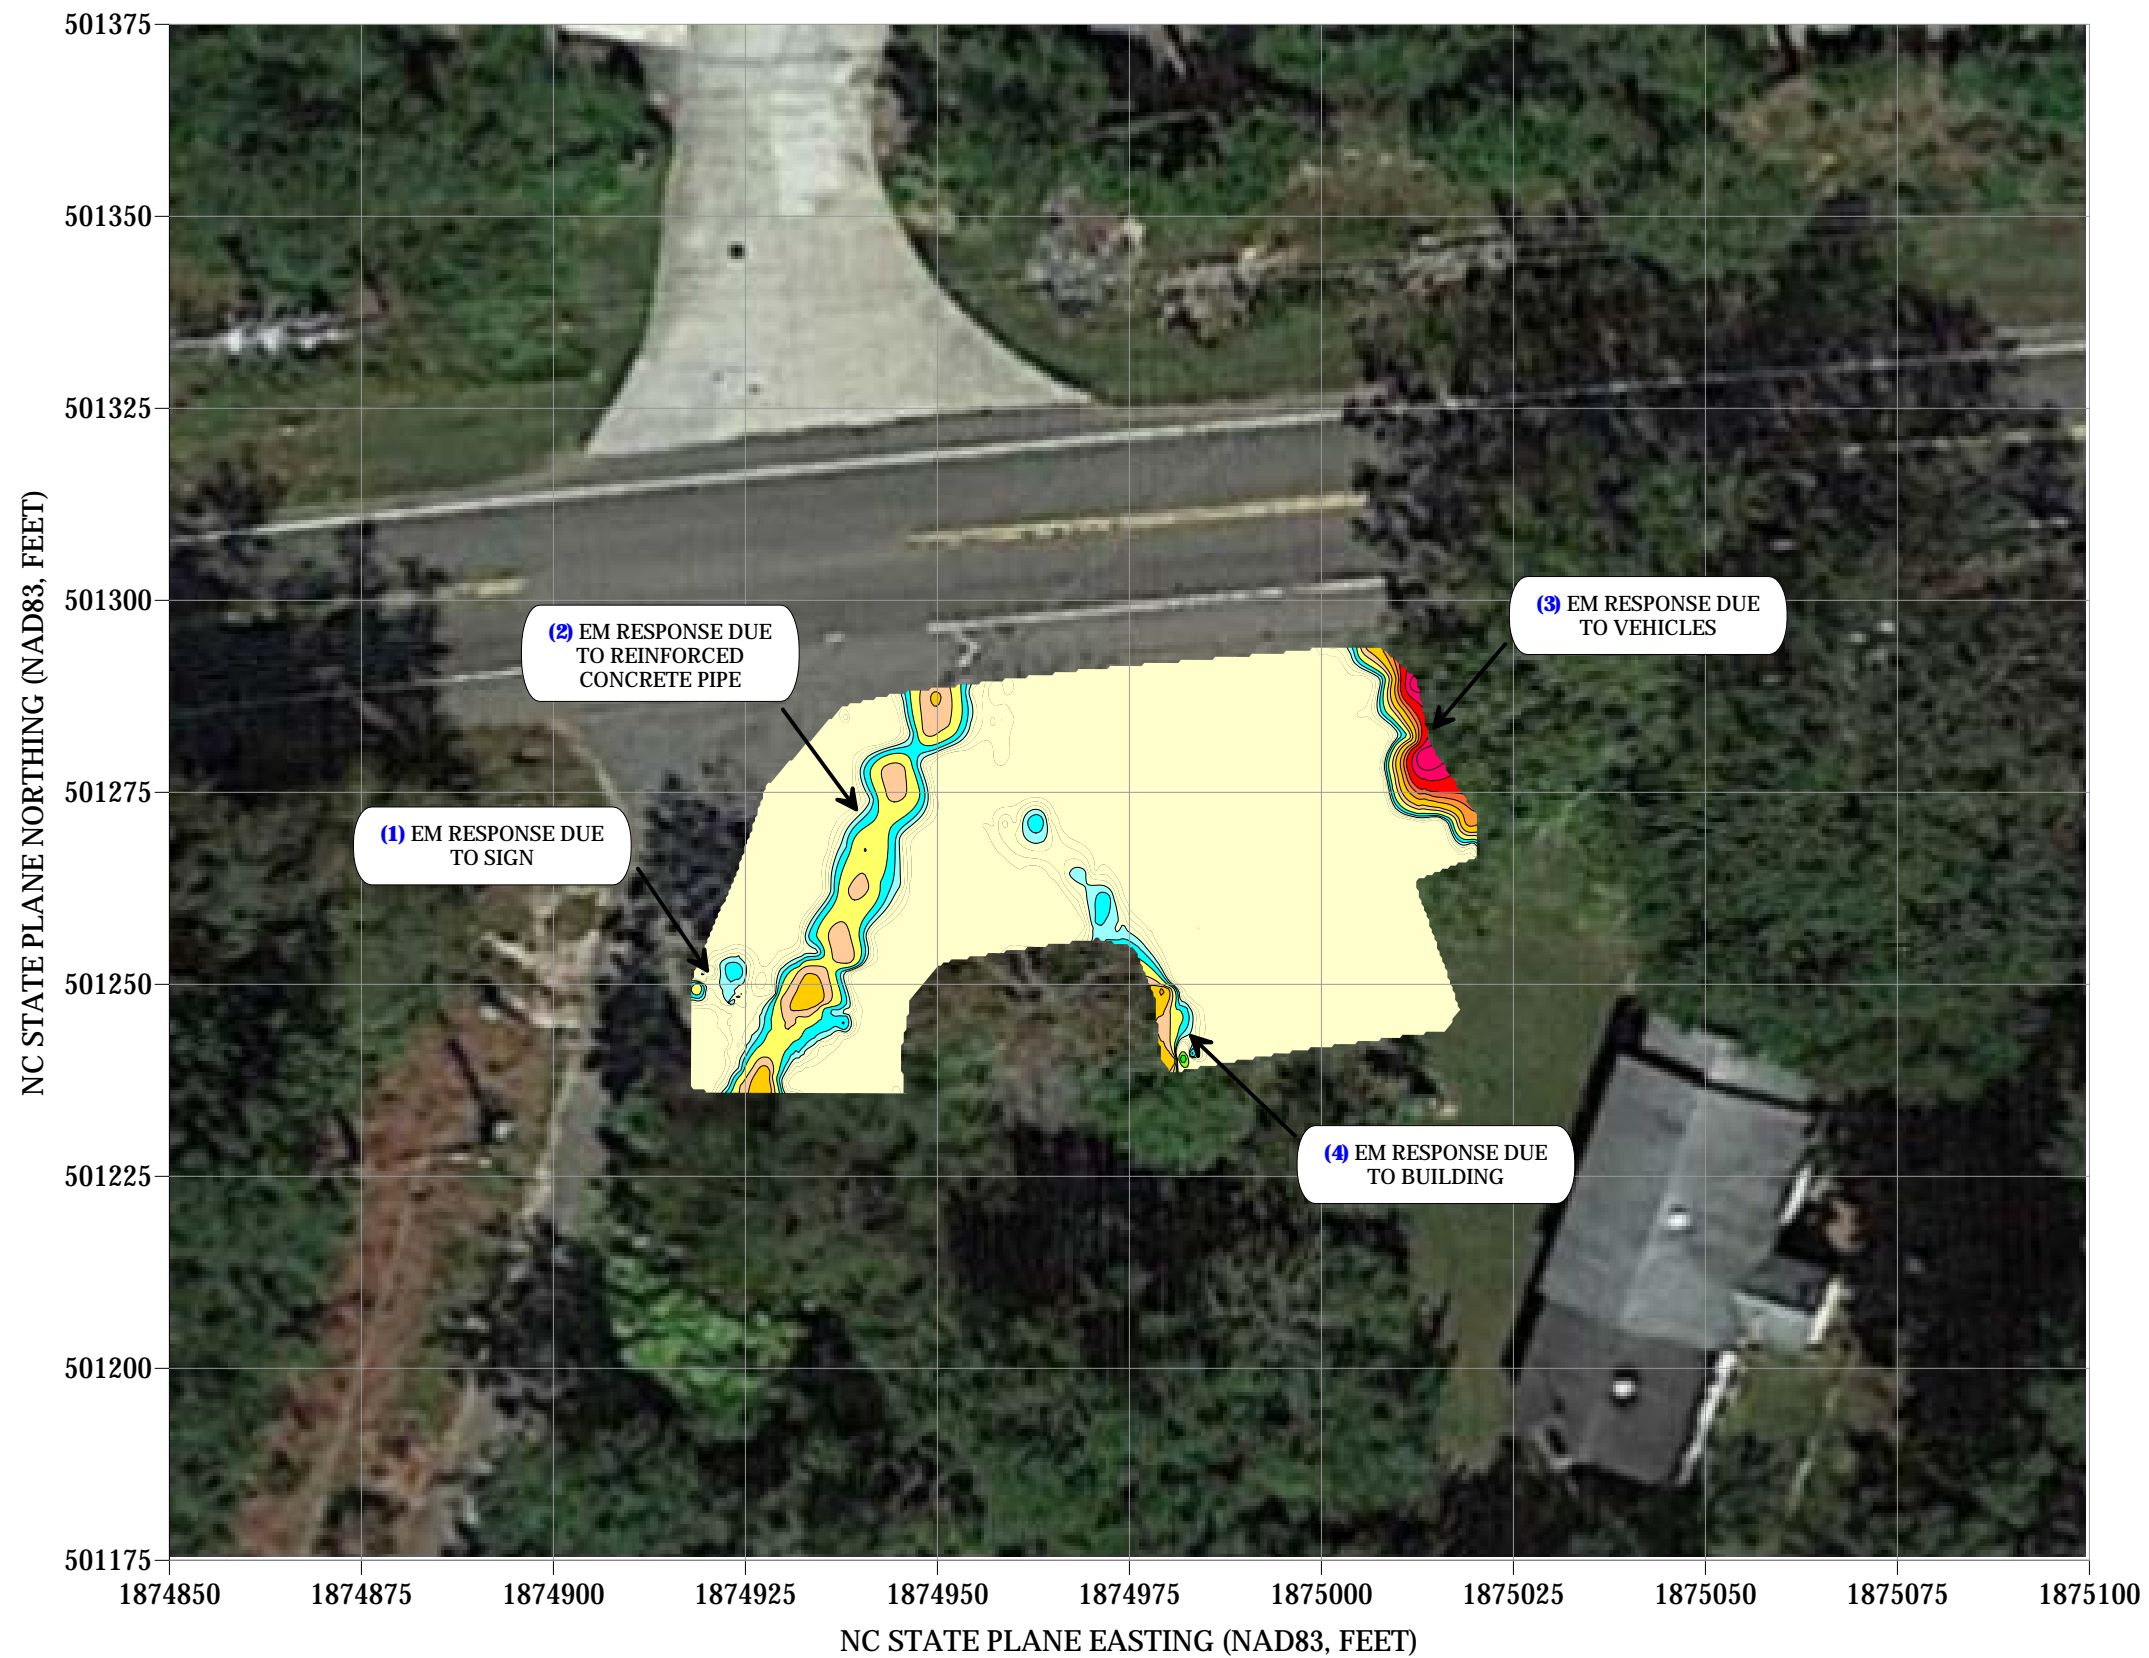
EM61 METAL DETECTION RESULTS

A contour plot of the EM61 results obtained across the survey area at the property is presented in **Figure 2**. Each EM anomaly is numbered for reference in the figure. The

Metallic Anomaly #	Cause of Anomaly	Investigated with GPR
1	Sign	
2	Reinforced Concrete Pipe	
3	Vehicles	✓
4	Building	✓

All of the EM anomalies were directly attributed to visible cultural features at the ground surface, including a sign, a reinforced concrete pipe, vehicles, and the building. GPR was performed around the vehicles and adjacent to the building to confirm that the metallic interference did not obscure any significant structures such as USTs.

NO EVIDENCE OF METALLIC USTs WAS OBSERVED.

The contour plot shows the differential results of the EM61 instrument in millivolts (mV). The differential results focus on larger metallic objects such as USTs and drums. The EM data were collected on August 10, 2021, using a Geonics EM61-MK2 instrument. Verification GPR data were collected using a GSSI SIR 4000 instrument with a 350 MHz HS antenna on August 12, 2021.

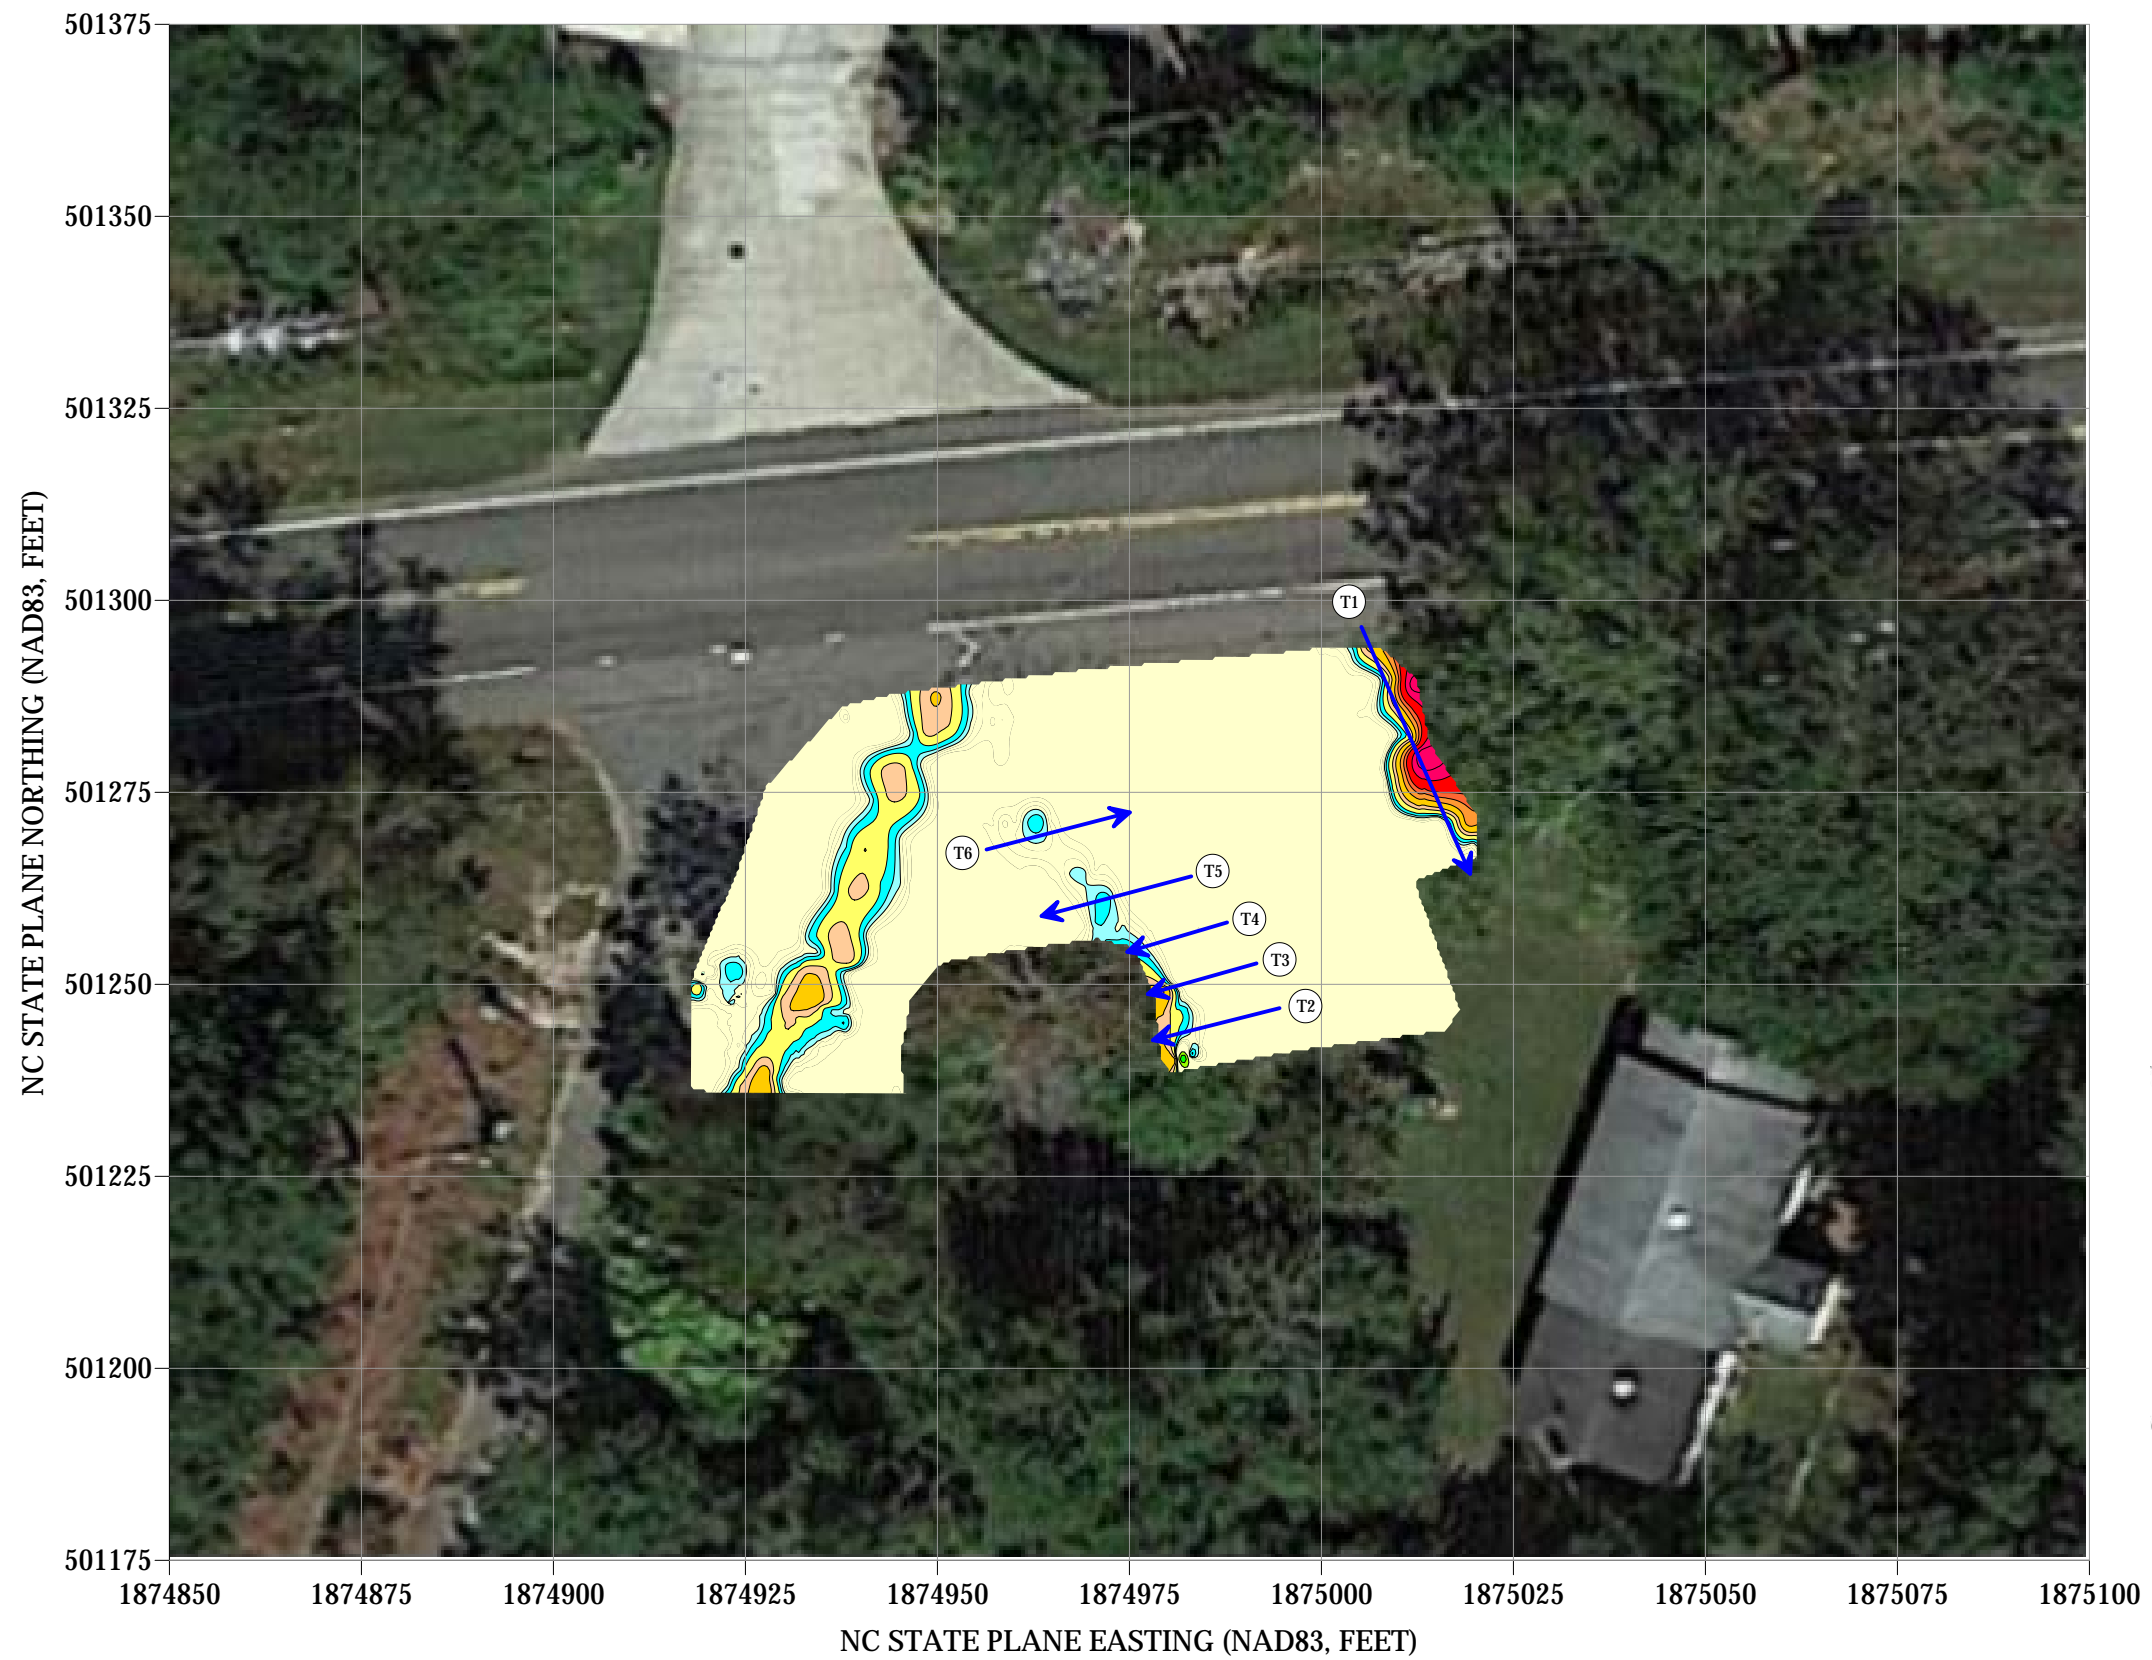
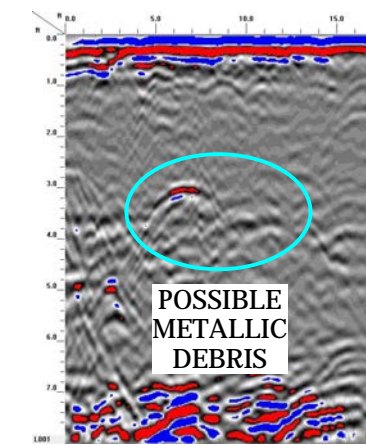
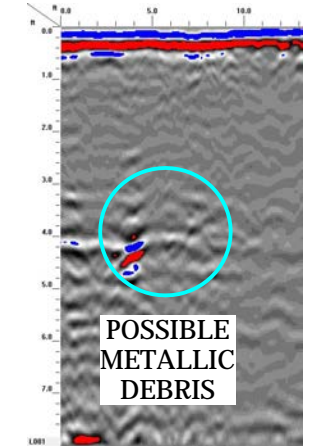
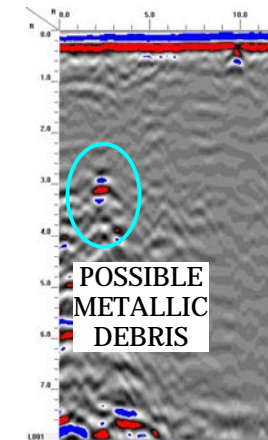
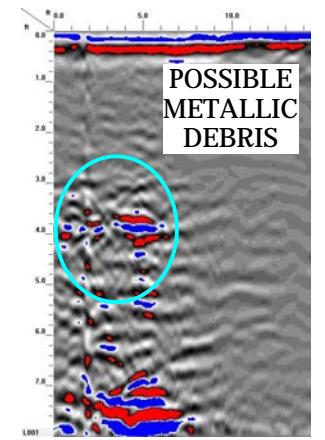
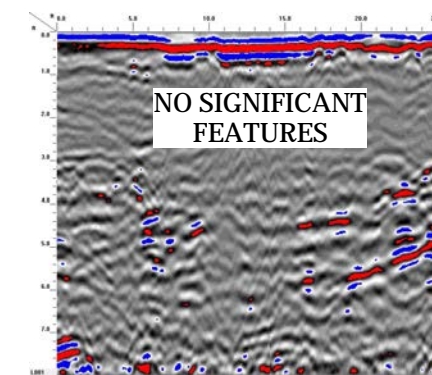
GPR TRANSECT LOCATIONS

Figure 3 presents the locations of the formal GPR transects performed at the property as well as the transect images. A total of six formal GPR transects were performed at the site. GPR Transect 1 was performed adjacent to the vehicles and GPR Transects 2-6 were performed adjacent to the building. Evidence of possible minor buried metallic debris was observed in some of the GPR results. No evidence of significant buried structures such as USTs was observed.
