**North Carolina Department of Transportation
Phase II Investigation
State Project: R-5709
WBS Element: 50205.1.1
Hoke County**

**Parcel 285
Gregory Lowery Property
10575 NC 211 Highway
Aberdeen, North Carolina
October 27, 2021**

**Wood Environment & Infrastructure Solutions, Inc.
Project: 20478R5709**

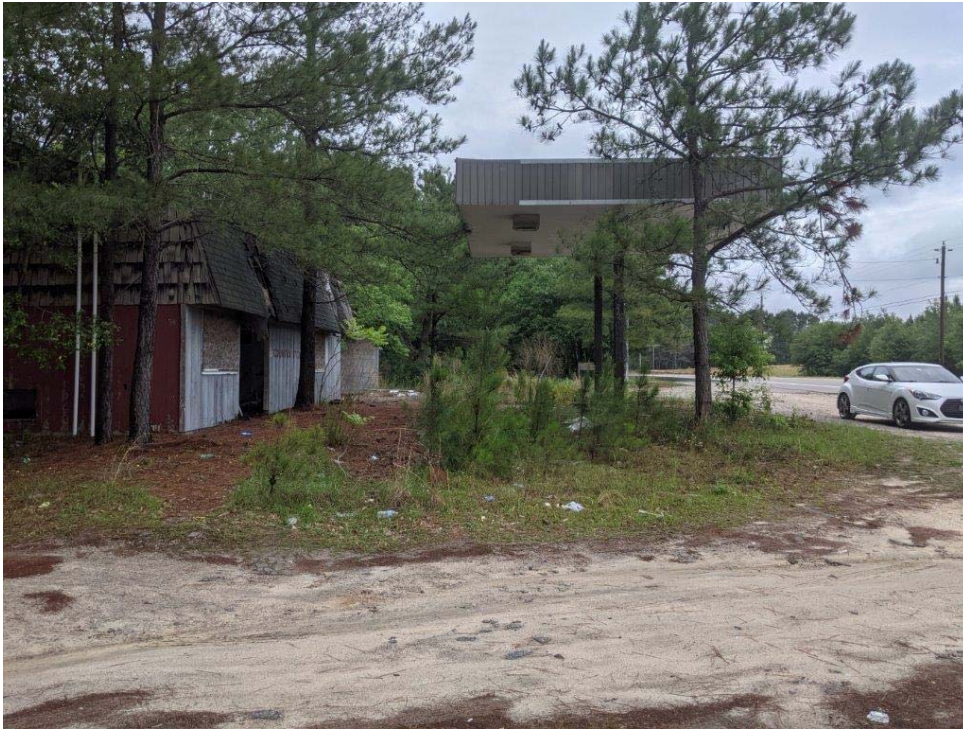
Photograph 1:
Building and canopy at parcel 285, facing northwest. Shrub covered area in center of photo is suspected location of former UST(s).

Based on these Phase II Investigation results, Wood recommends no further soil investigation. Wood notes that the former dispenser islands and probable buried fuel piping located within the investigation area lie within the ROW and thus should be removed, in general accordance with the NCDEQ guidelines.

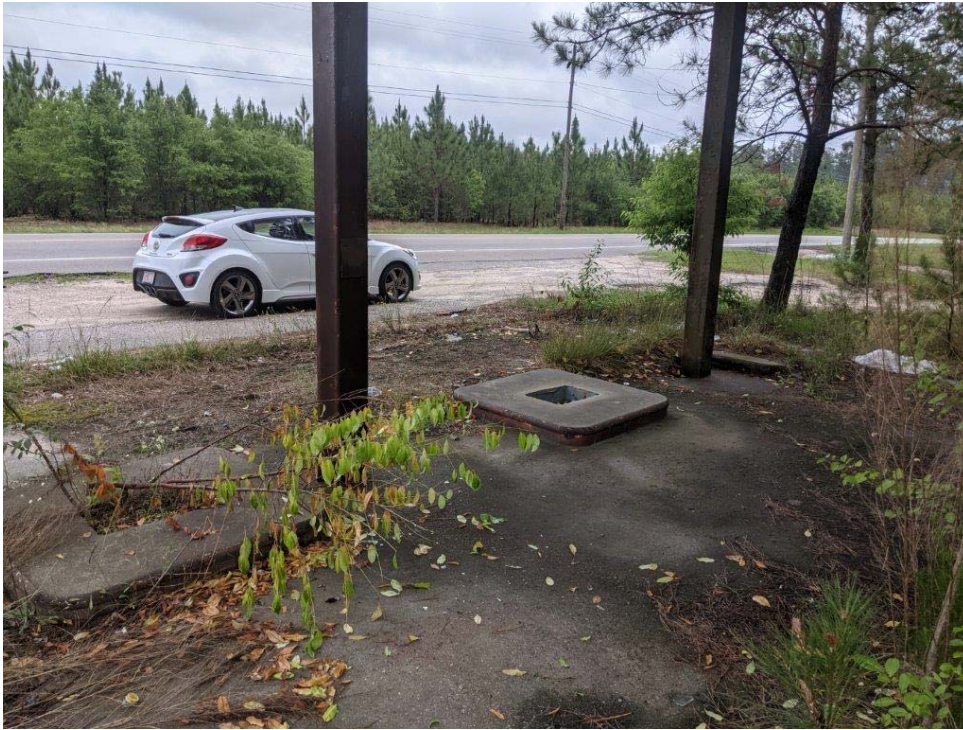
Photograph 3:
Suspected dispenser
islands at parcel 285,
facing southeast.

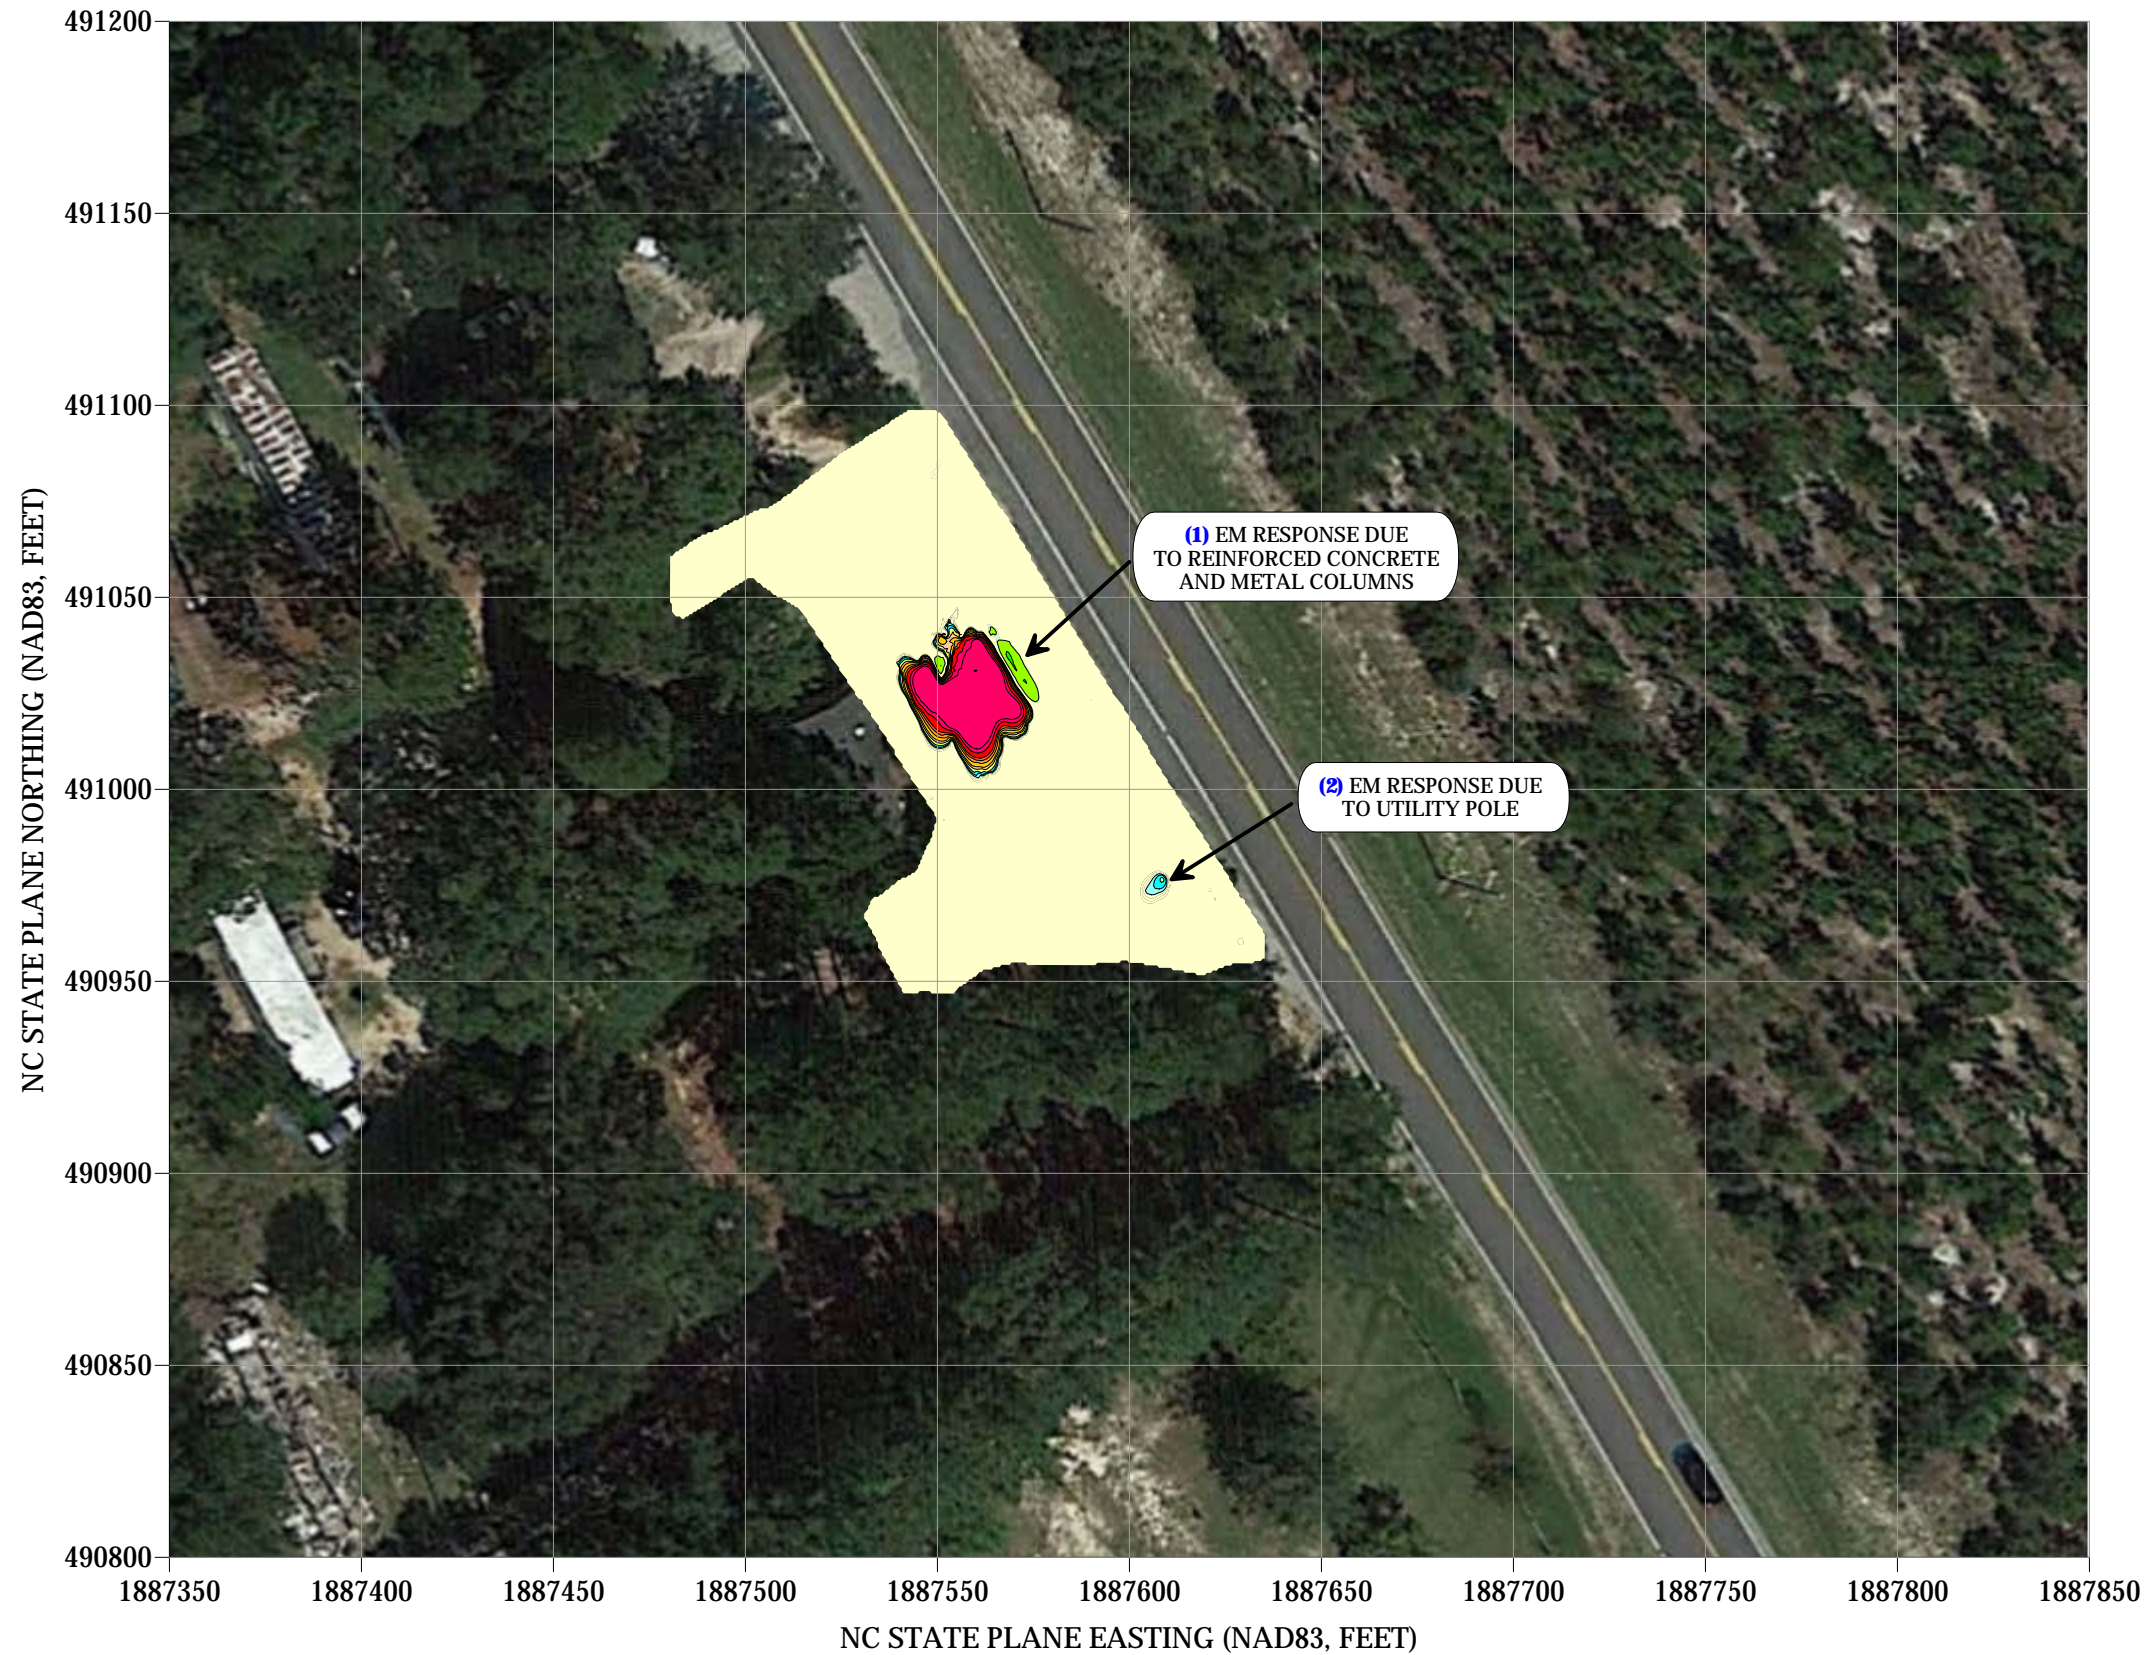
EM61 METAL DETECTION RESULTS

NO EVIDENCE OF METALLIC USTs WAS OBSERVED.

The contour plot shows the differential results of the EM61 instrument in millivolts (mV). The differential results focus on larger metallic objects such as USTs and drums. The EM data were collected on August 10, 2021, using a Geonics EM61-MK2 instrument. Verification GPR data were collected using a GSSI SIR 4000 instrument with a 350 MHz HS antenna on August 11, 2021.

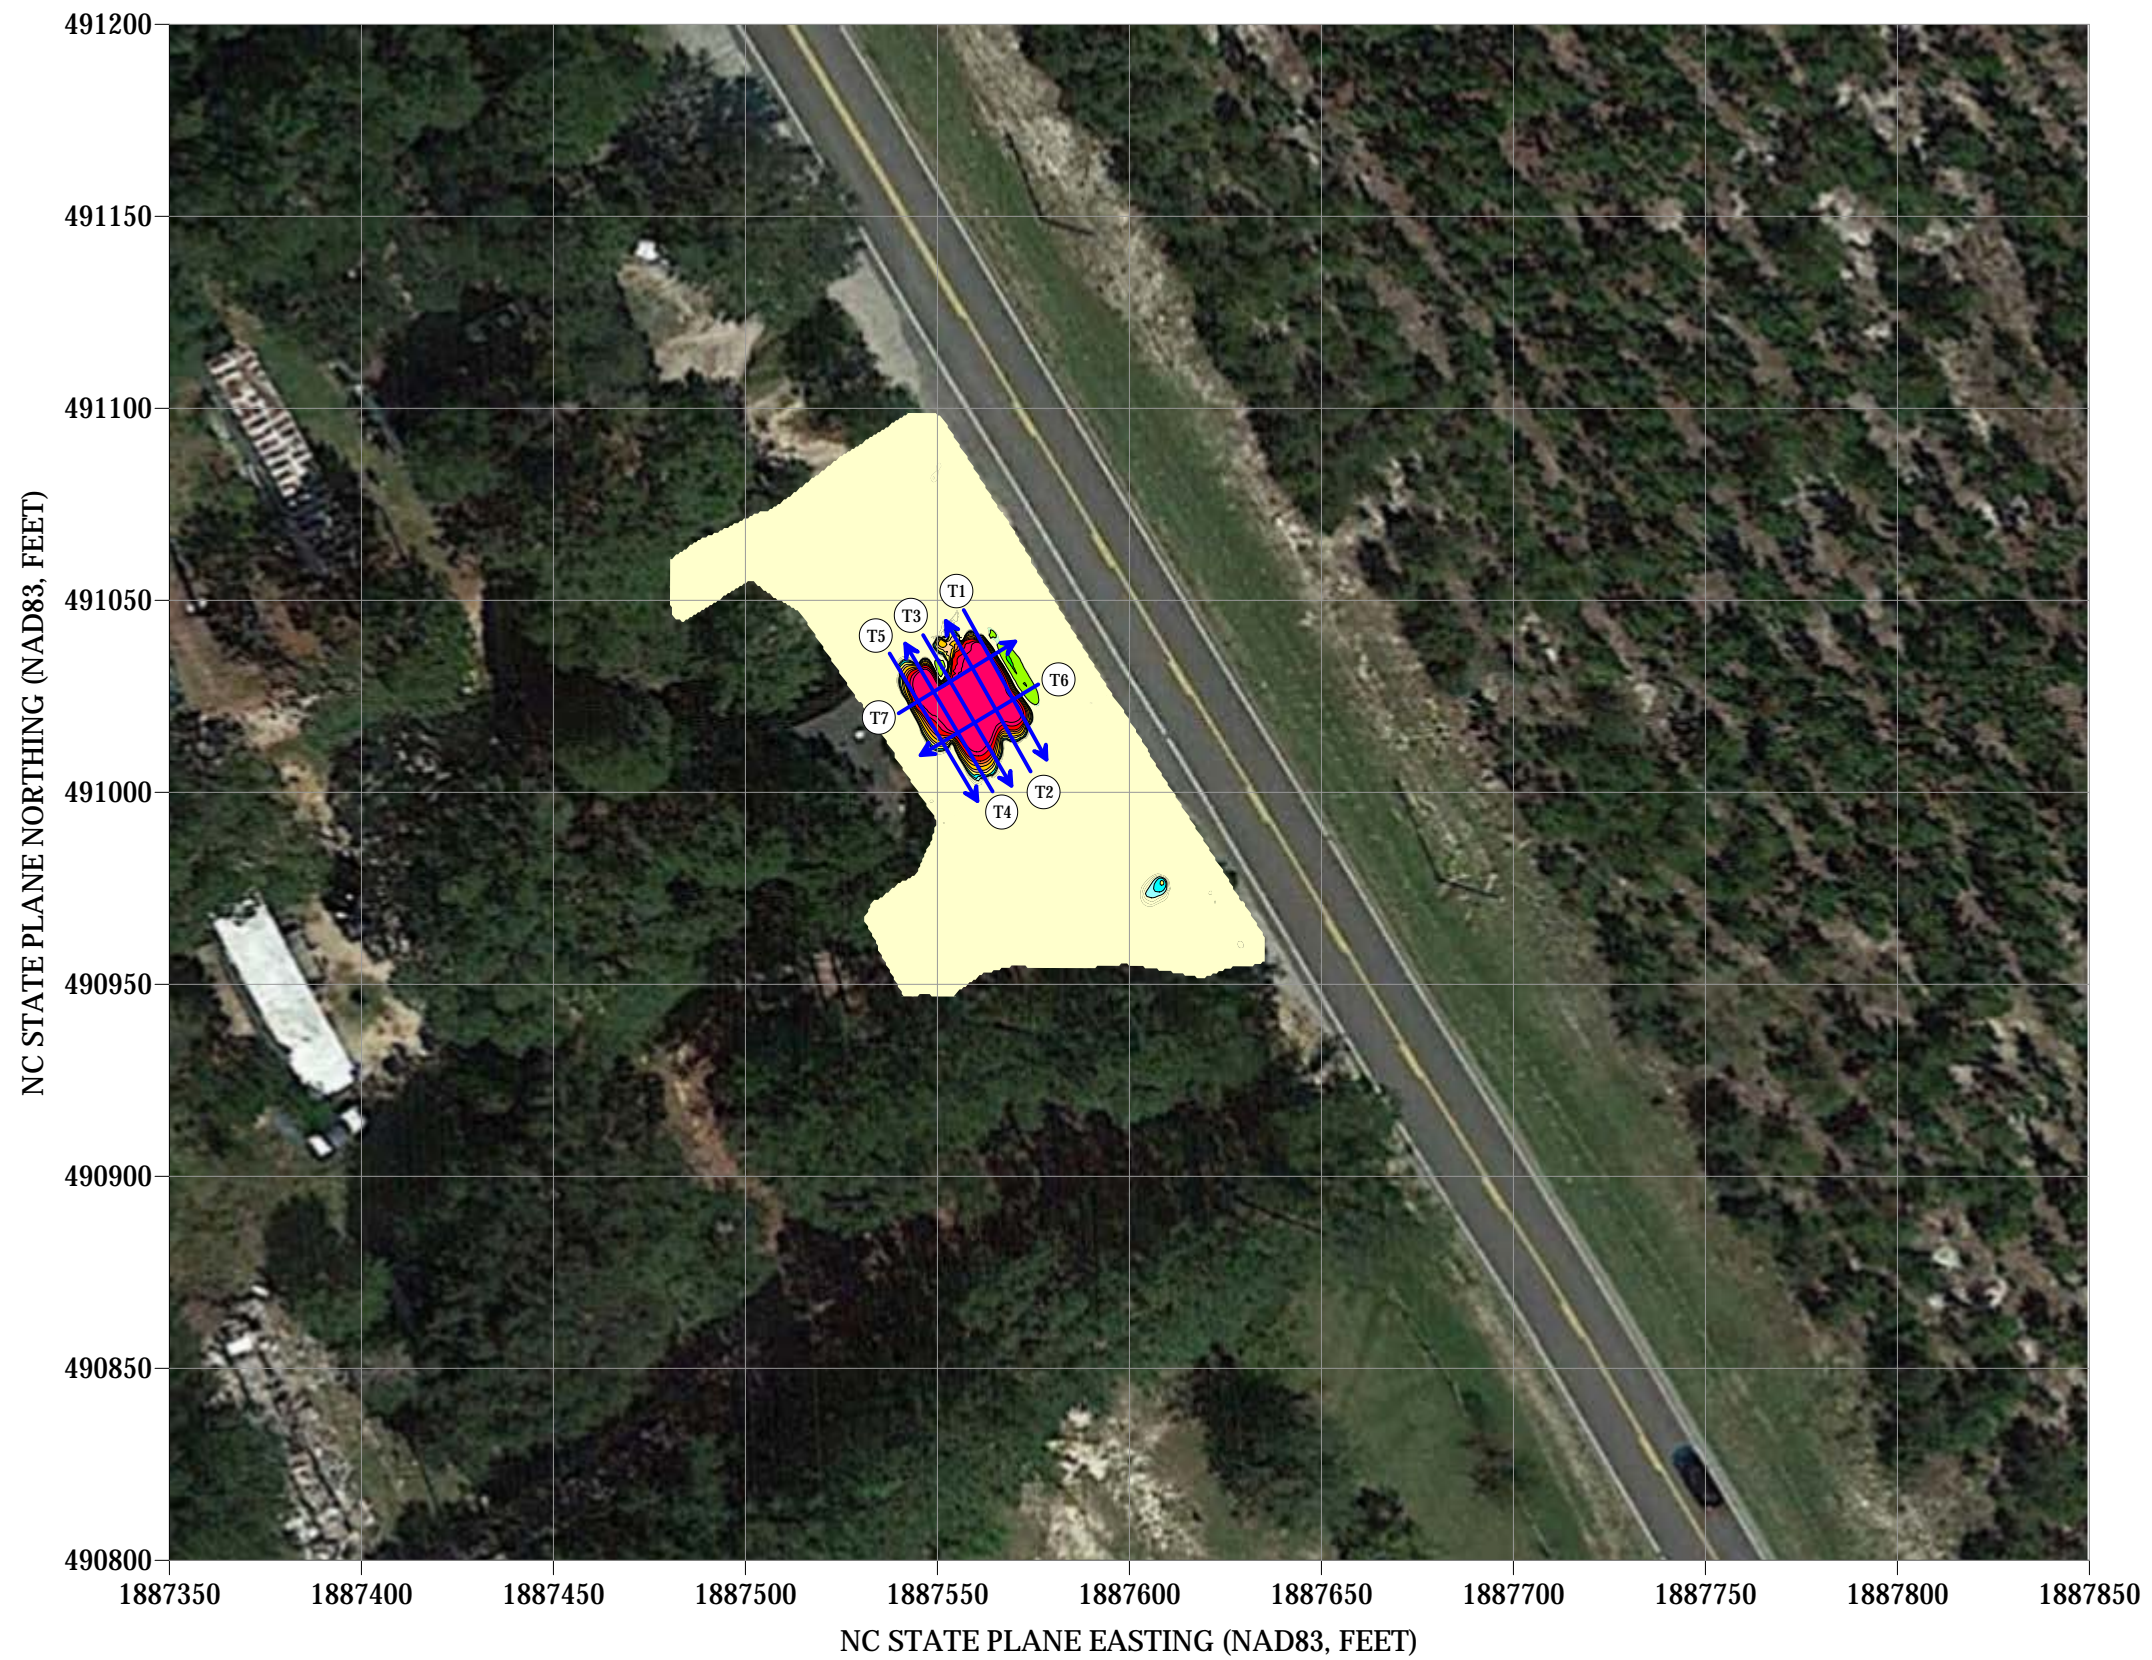
GPR TRANSECT LOCATIONS

Figure 3 presents the locations of the formal GPR transects performed at the property as well as select transect images. All of the transect images are included in **Appendix A**. A total of seven formal GPR transects were performed at the site. GPR Transects 1-7 were performed across the reinforced concrete and around the metal columns beneath the canopy. GPR confirmed the presence of reinforcement and showed evidence of buried utilities beneath the canopy. No evidence of any significant structures such as USTs was observed.

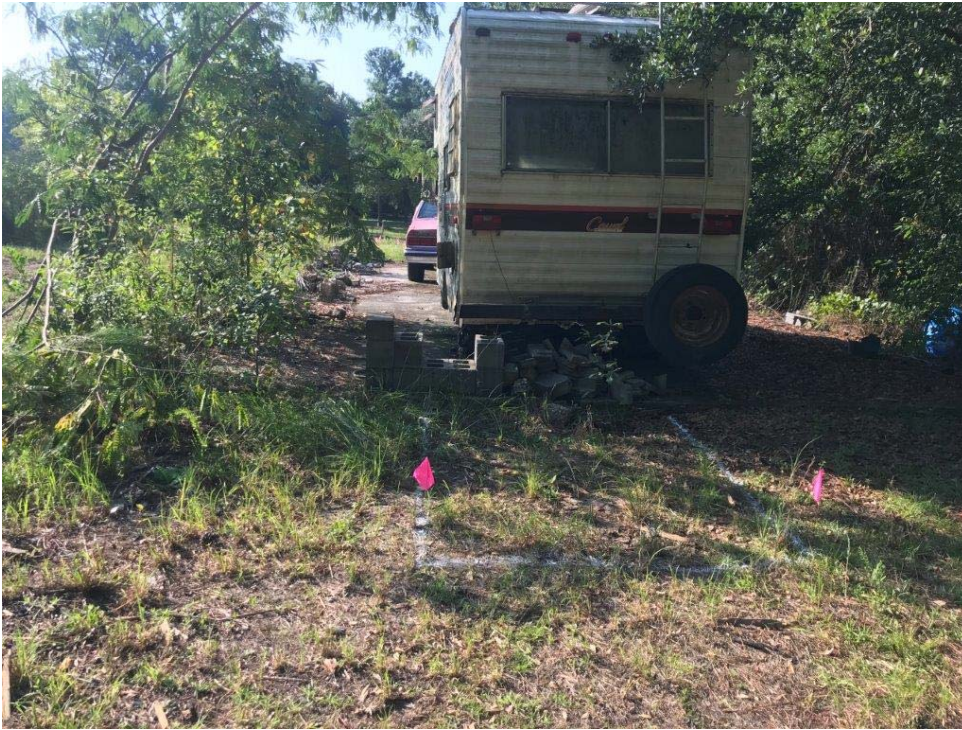
Additionally, Wood personnel used a stainless-steel hand auger and a shovel to confirm the depths of the two possible USTs. Two holes were dug above possible UST #1 and three holes were dug above possible UST #2. The tops of possible USTs #1 and #2 were measured at approximately 1.5 feet and 2 feet bgs, respectively. It was noted that the tops of each possible UST were flatter in shape than would be expected for a buried tank and may indicate objects other than tanks at these locations; however, further excavation is needed to determine the full nature of the buried objects.

Photograph 3:
Area of possible UST
#1, facing southeast.

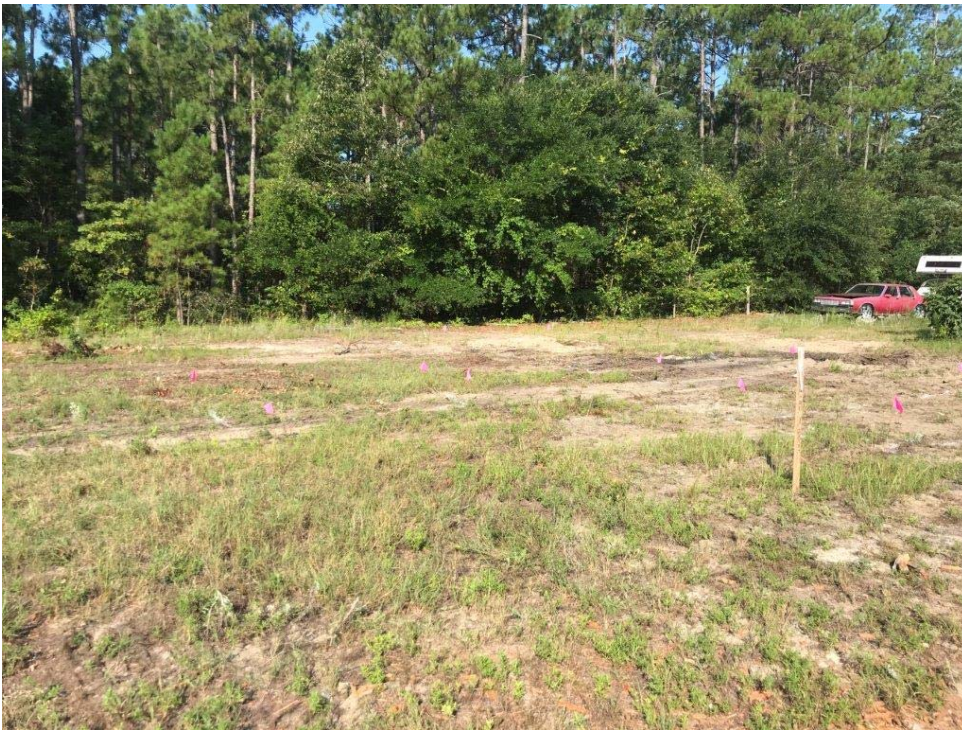
Photograph 4:
Area of possible UST
#2 and no confidence
anomalies, facing west.

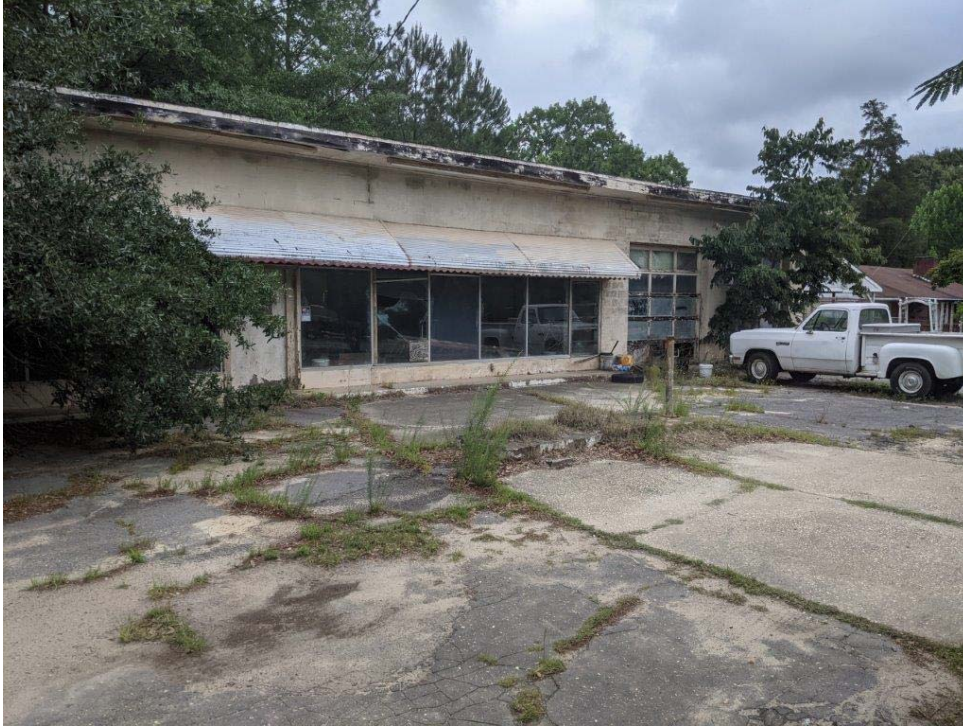
Photograph 1:
Dilapidated building
and suspected
dispenser island at
parcel 368, facing
southeast.

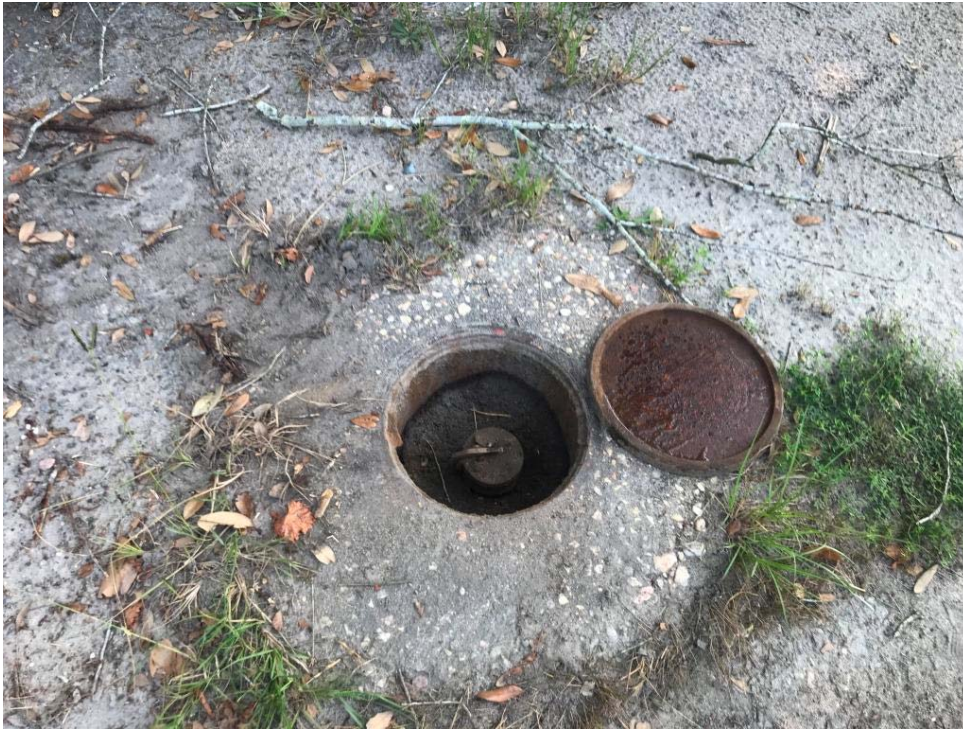
Photograph 3:
Possible UST fill port
located near the
western building
corner at parcel 368.

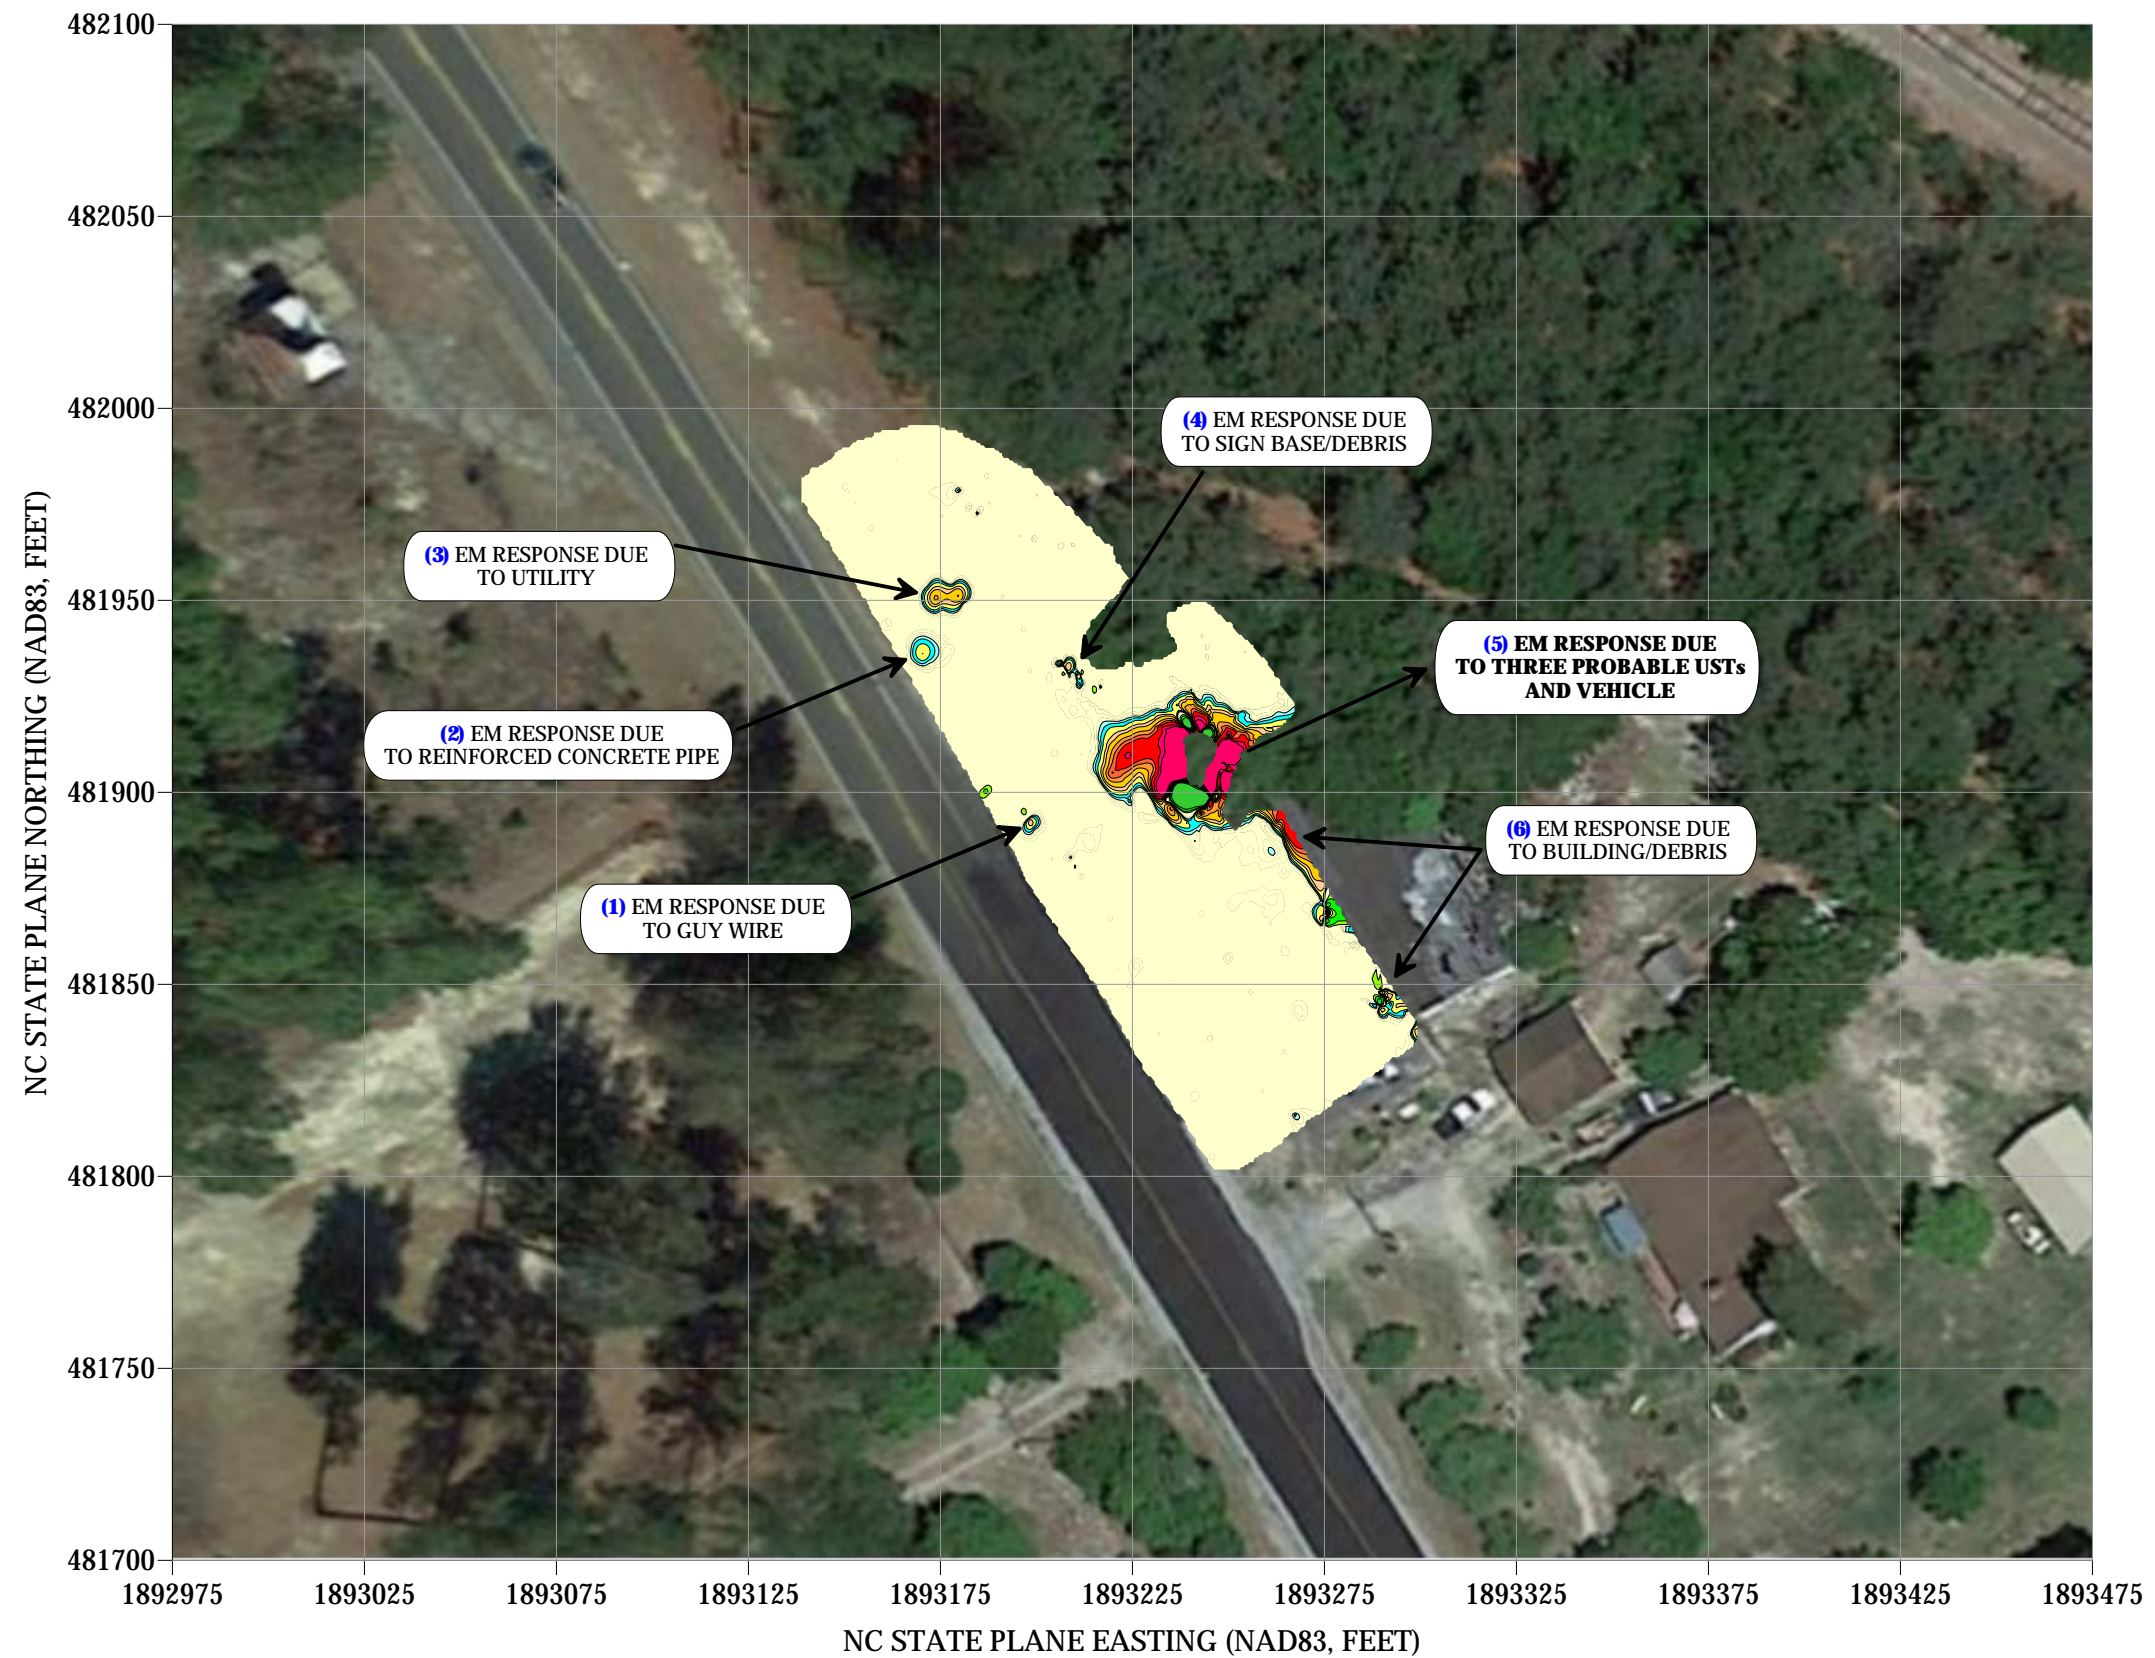
EM61 METAL DETECTION RESULTS

EVIDENCE OF THREE PROBABLE METALLIC USTs WAS OBSERVED.

The contour plot shows the differential results of the EM61 instrument in millivolts (mV). The differential results focus on larger metallic objects such as USTs and drums. The EM data were collected on August 11, 2021, using a Geonics EM61-MK2 instrument. Verification GPR data were collected using a GSSI SIR 4000 instrument with a 350 MHz HS antenna on August 12, 2021.

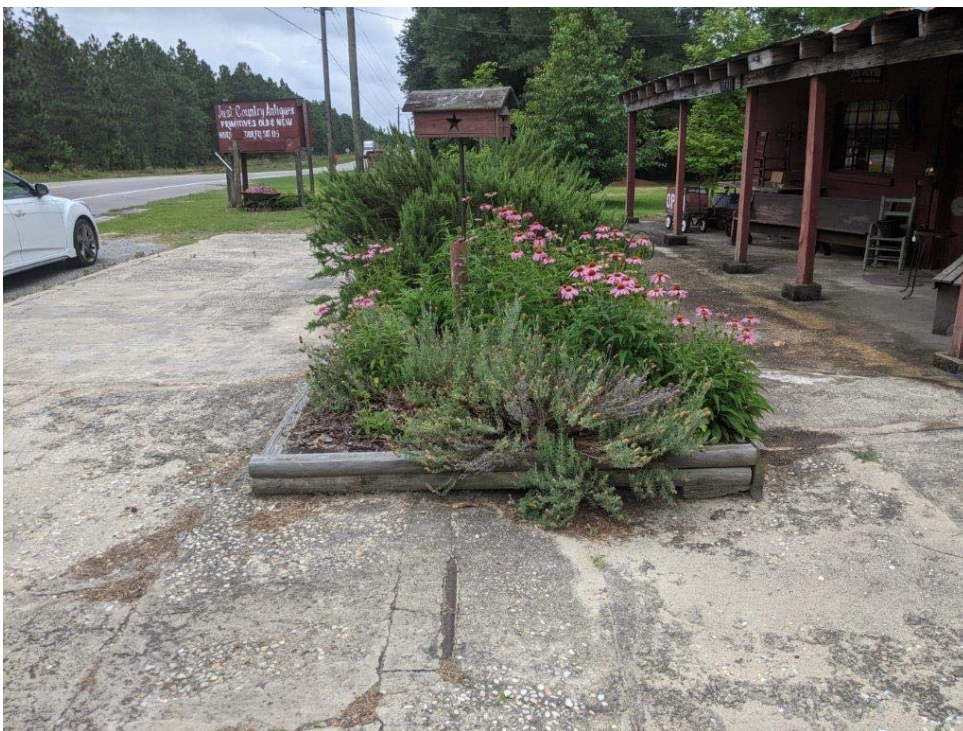
Photograph 2:
View of suspected
dispenser island
(beneath flower beds)
and possible product
line (bottom of photo),
facing southeast.

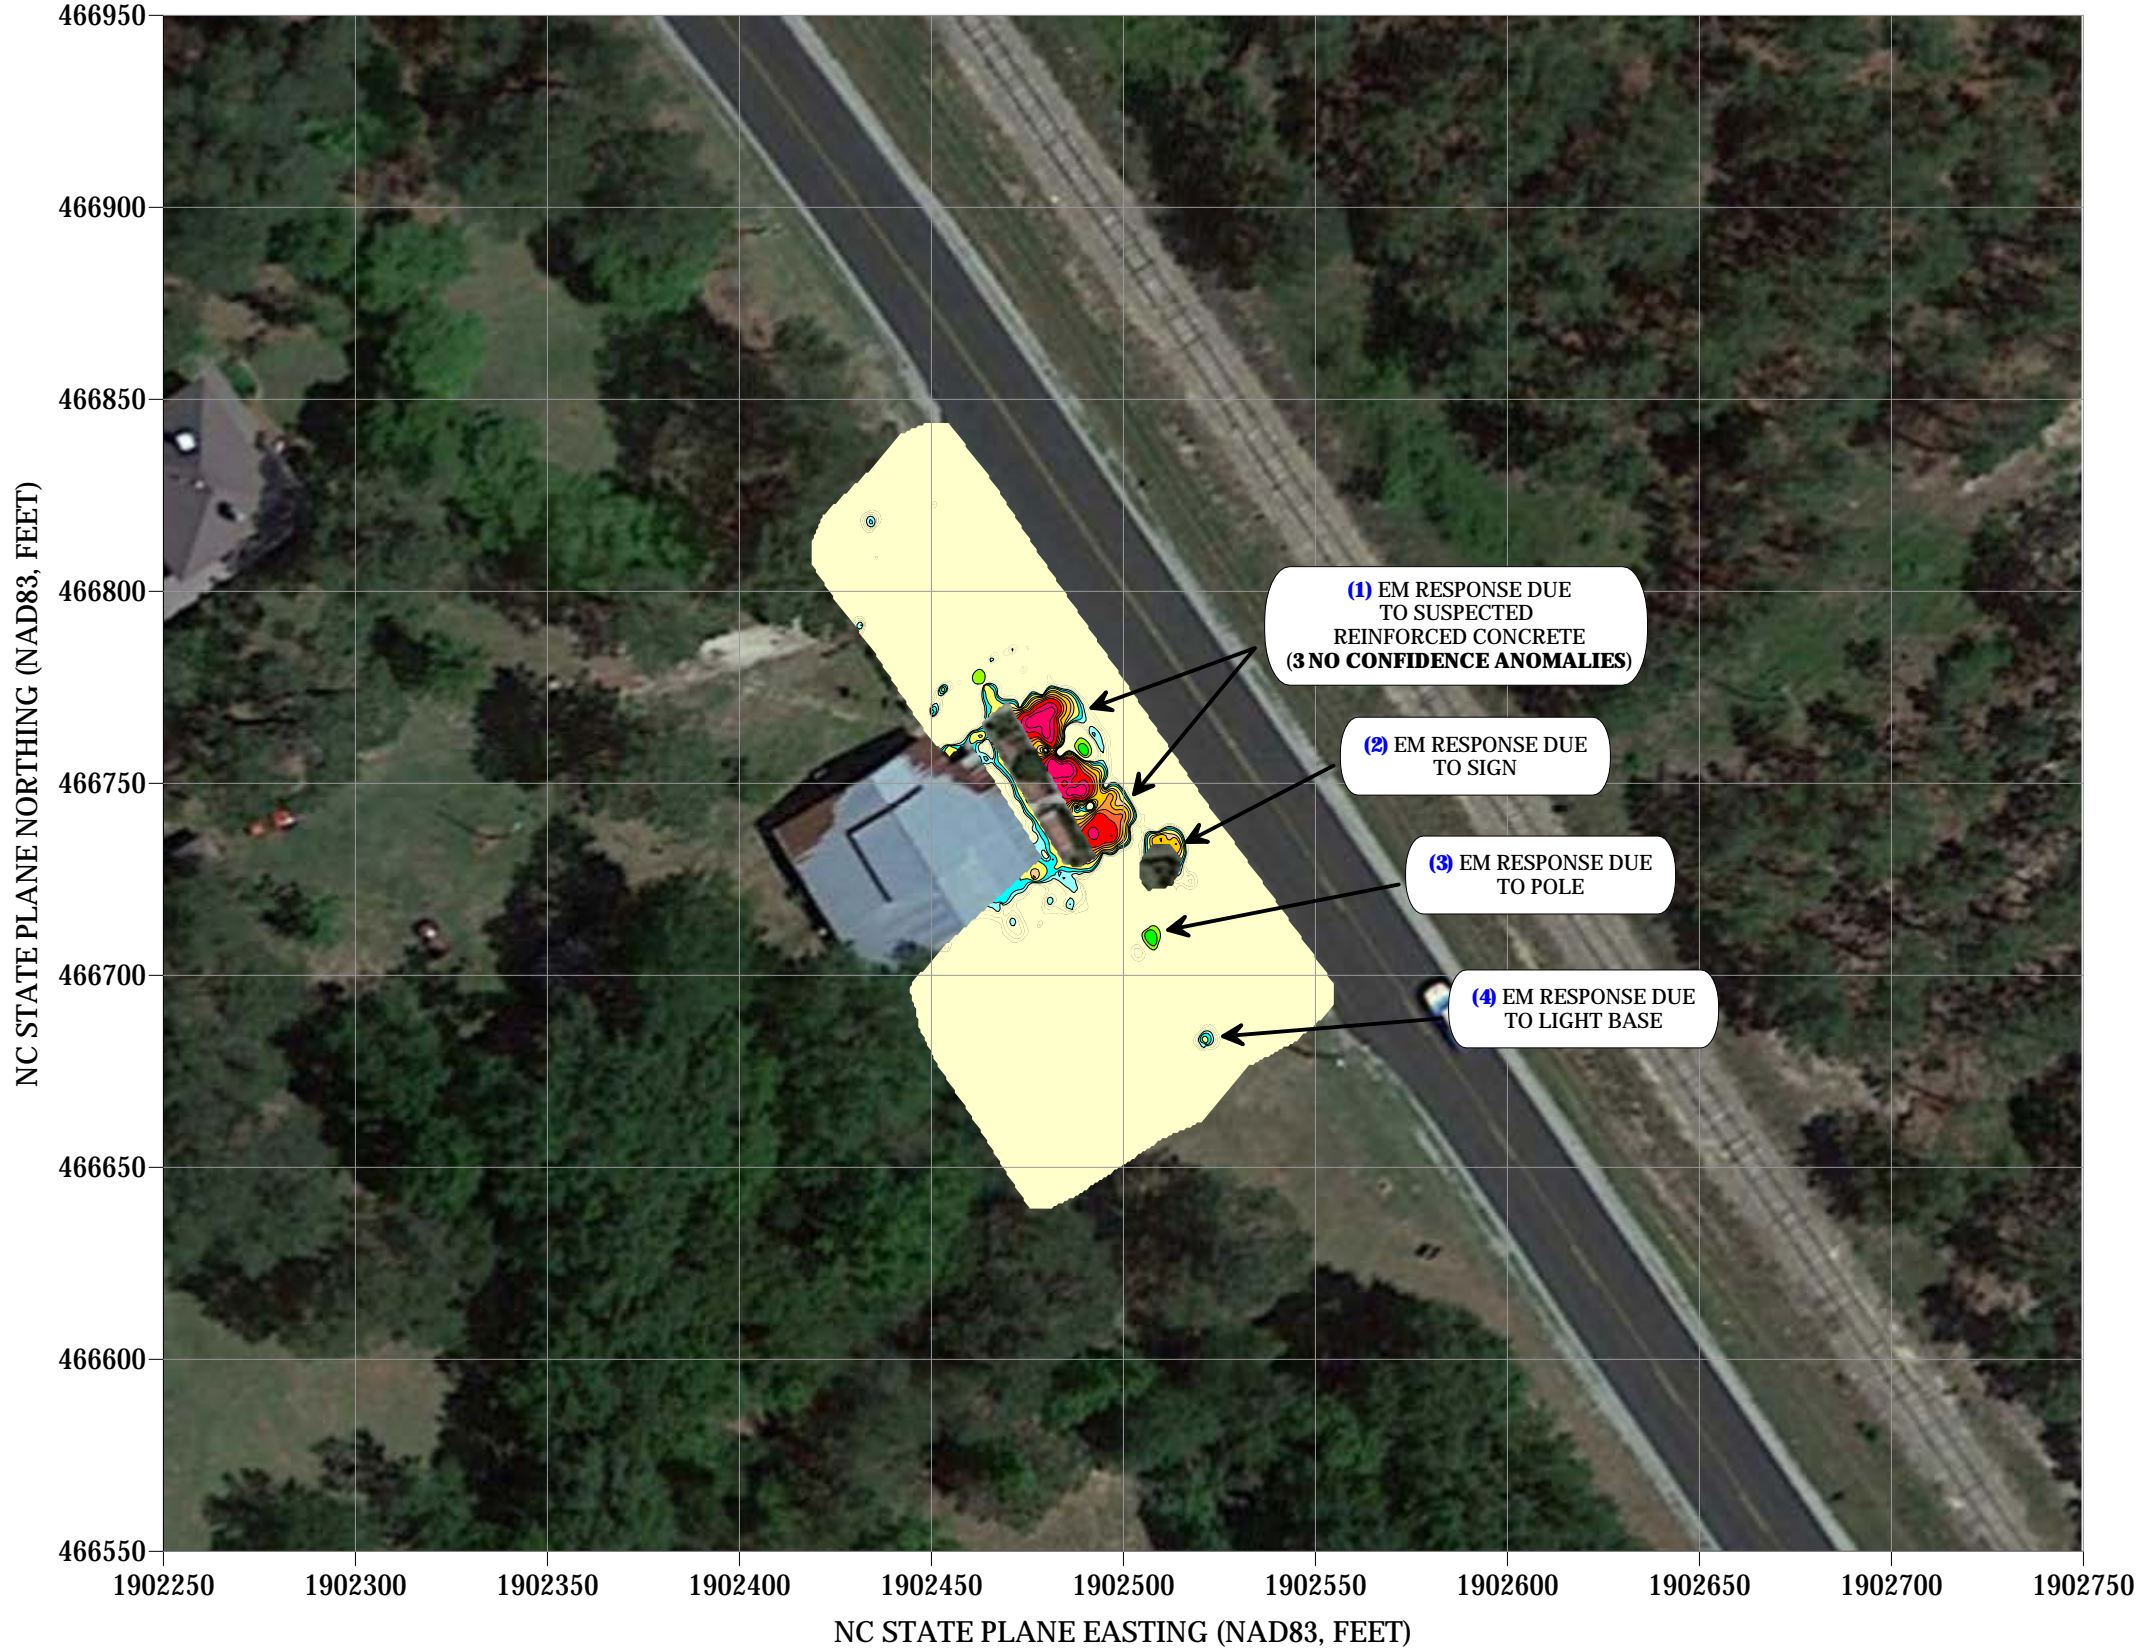
EM61 METAL DETECTION RESULTS

EVIDENCE OF THREE NO CONFIDENCE ANOMALIES WAS OBSERVED.

The contour plot shows the differential results of the EM61 instrument in millivolts (mV). The differential results focus on larger metallic objects such as USTs and drums. The EM data were collected on August 11, 2021, using a Geonics EM61-MK2 instrument. Verification GPR data were collected using a GSSI SIR 4000 instrument with a 350 MHz HS antenna on August 12, 2021.
