**North Carolina Department of Transportation
Phase II Investigation
State Project: R-5709
WBS Element: 50205.1.1
Moore County**

**Parcel 79
Robert L. Schloegl Property
9820 NC 211 Hwy
Aberdeen, North Carolina
October 21, 2021**

**Wood Environment & Infrastructure Solutions, Inc.
Project: 20478R5709**

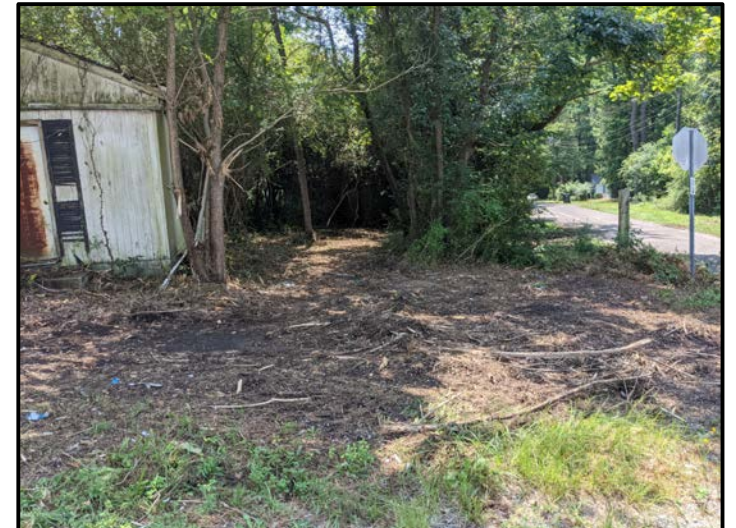
FIGURE 1

The site consisted of a vacant lot with a deteriorated structure surrounded by grass, gravel, and dirt surfaces. An aerial photograph showing the survey area boundaries and ground-level photographs are shown in **Figure 1**.

APPROXIMATE BOUNDARIES OF GEOPHYSICAL SURVEY AREA

View of Survey Area (Facing Approximately South)

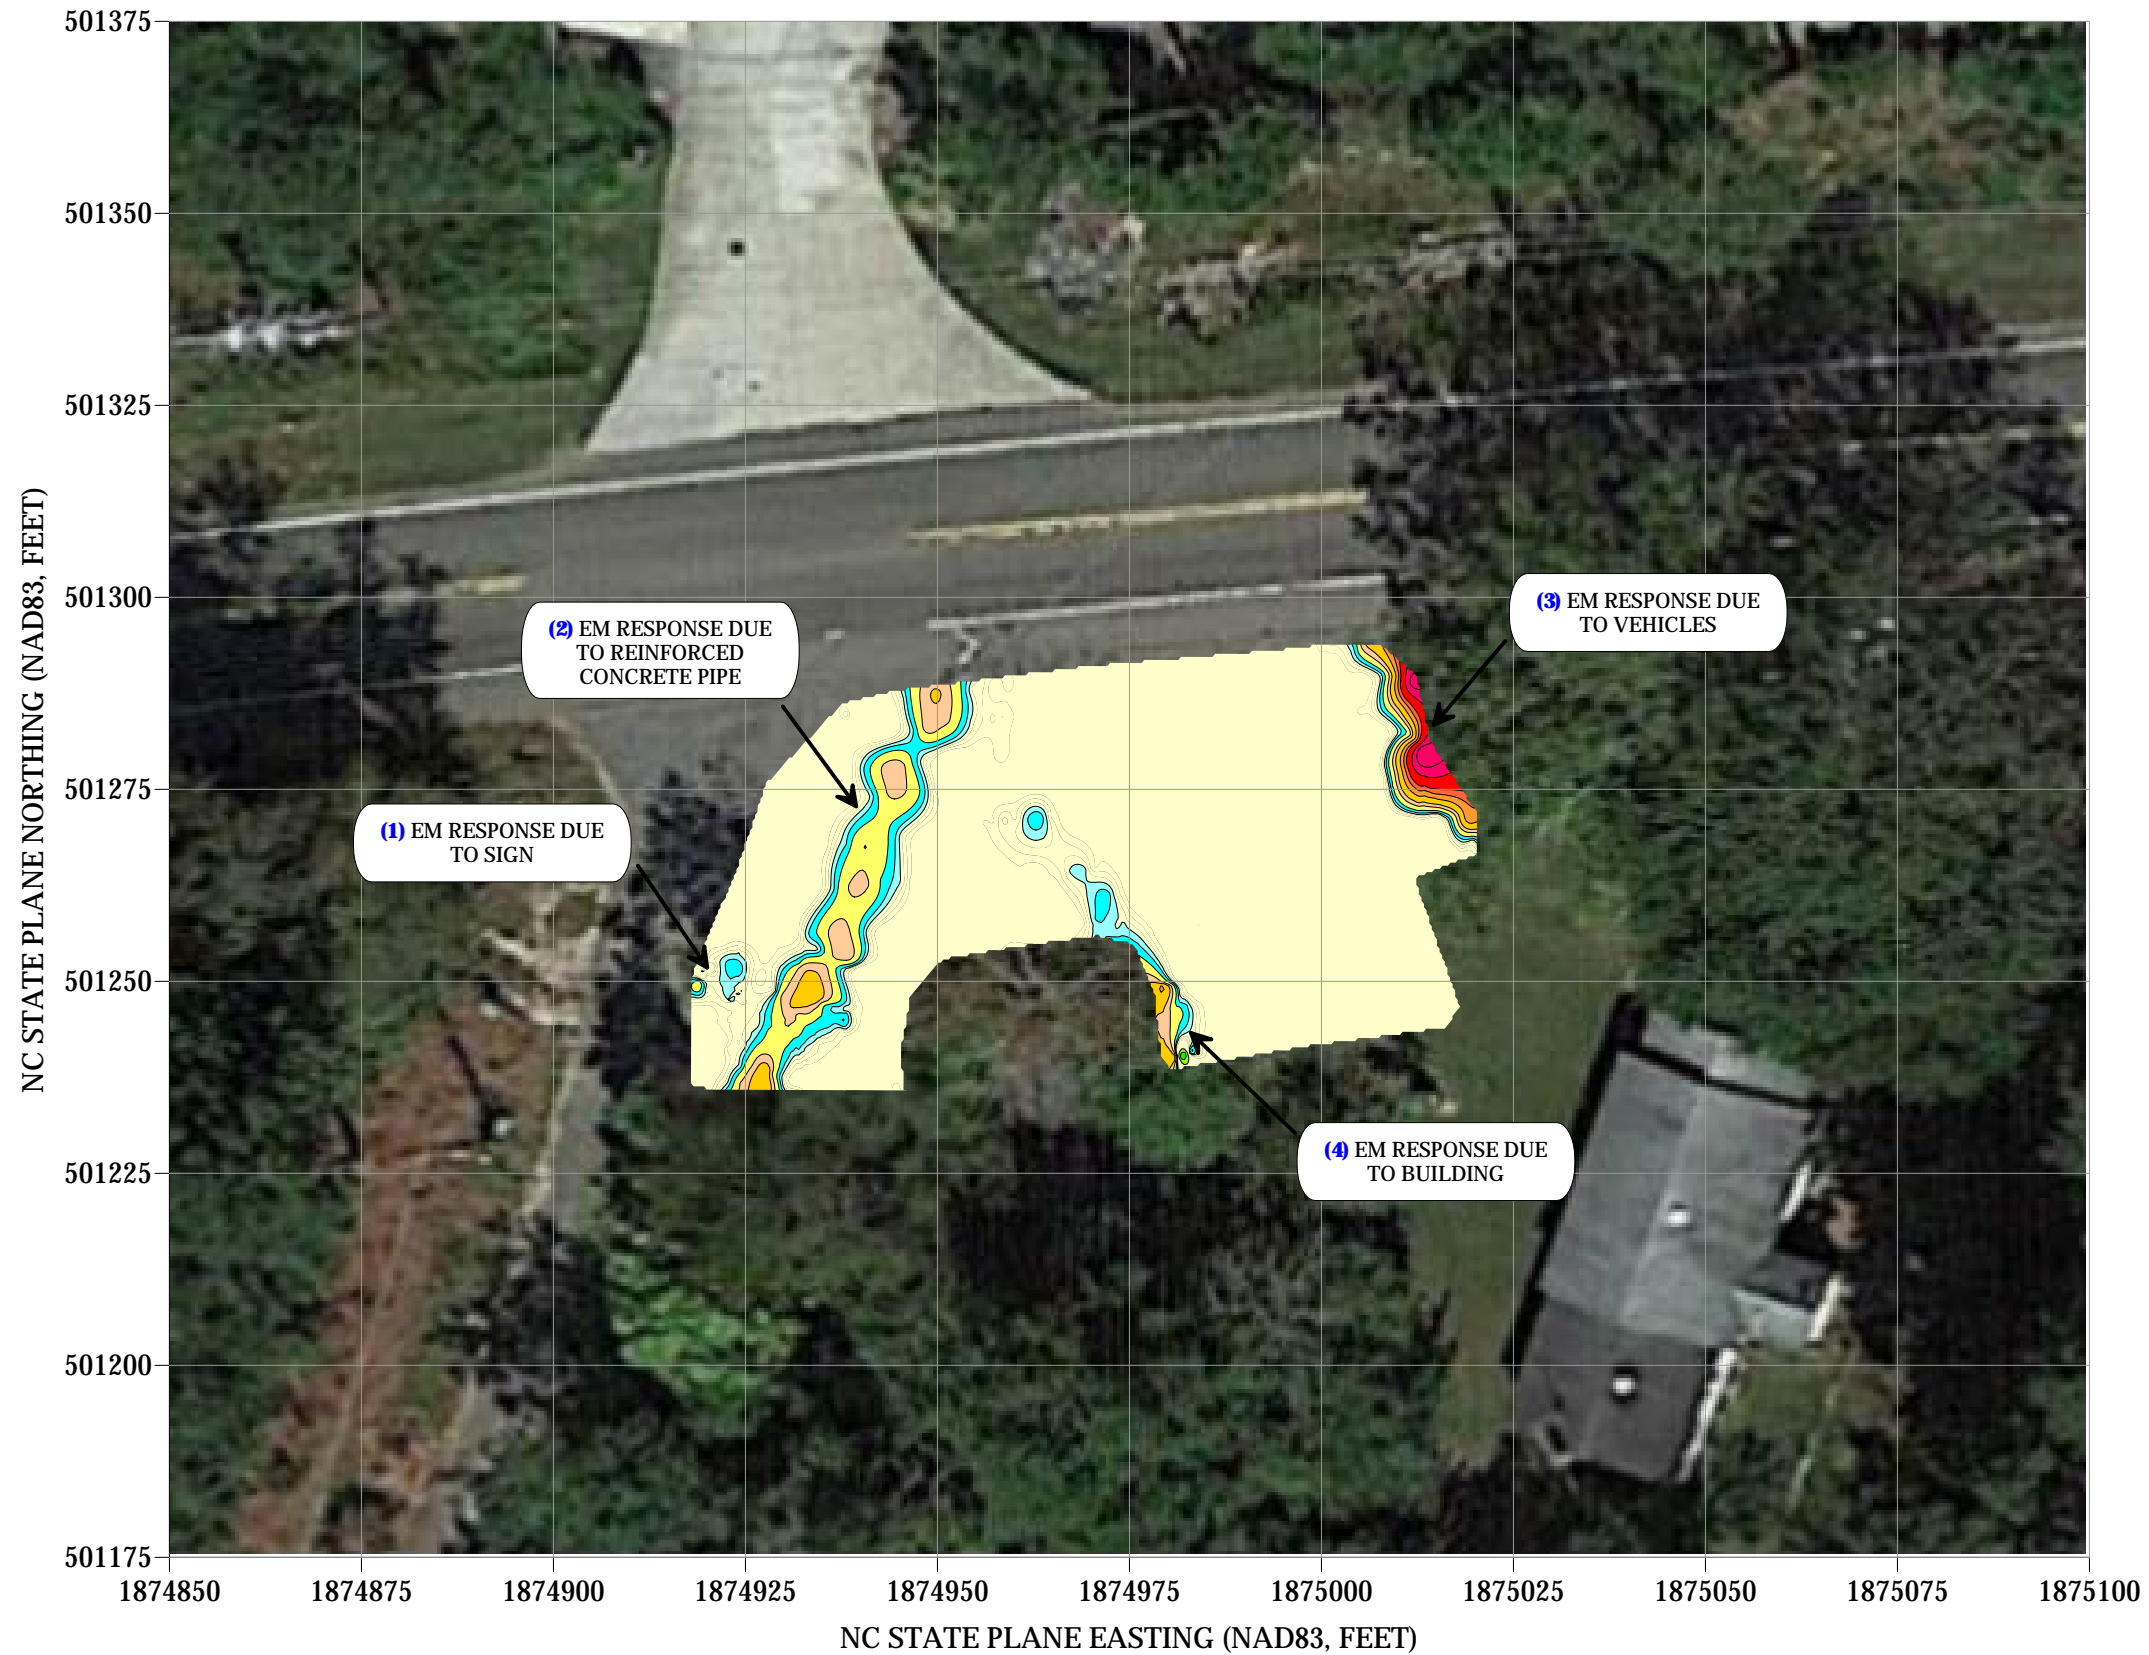
EM61 METAL DETECTION RESULTS

NO EVIDENCE OF METALLIC USTs WAS OBSERVED.

The contour plot shows the differential results of the EM61 instrument in millivolts (mV). The differential results focus on larger metallic objects such as USTs and drums. The EM data were collected on August 10, 2021, using a Geonics EM61-MK2 instrument. Verification GPR data were collected using a GSSI SIR 4000 instrument with a 350 MHz HS antenna on August 12, 2021.

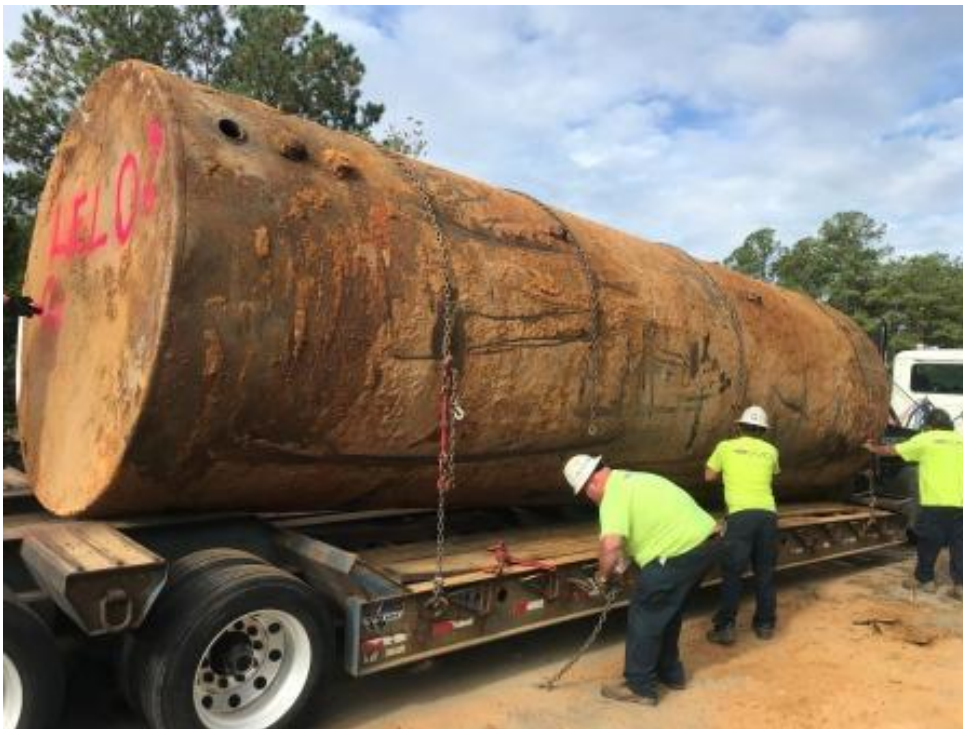
Photograph 6:
EVO loading UST#1 on trailer. UST was in good condition, no holes or pitting.

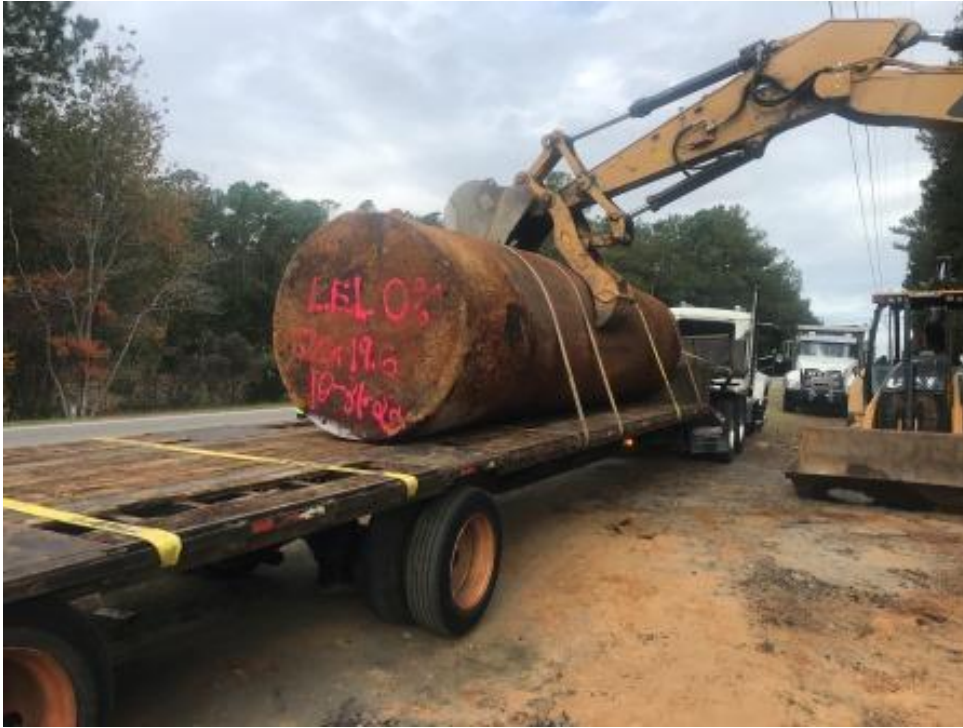
Photograph 7:
EVO loading UST#2 on trailer. UST was in good condition, no holes or pitting.

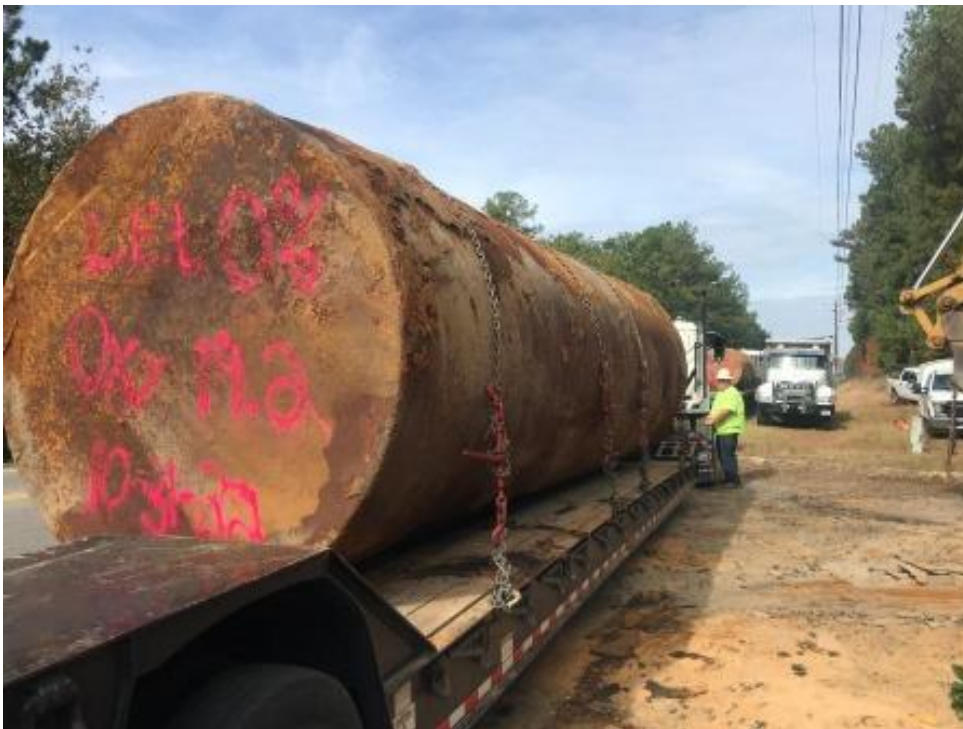
Photograph 8:
Evo loading UST#3 on to trailer. UST in good condition, no pitting or holes.

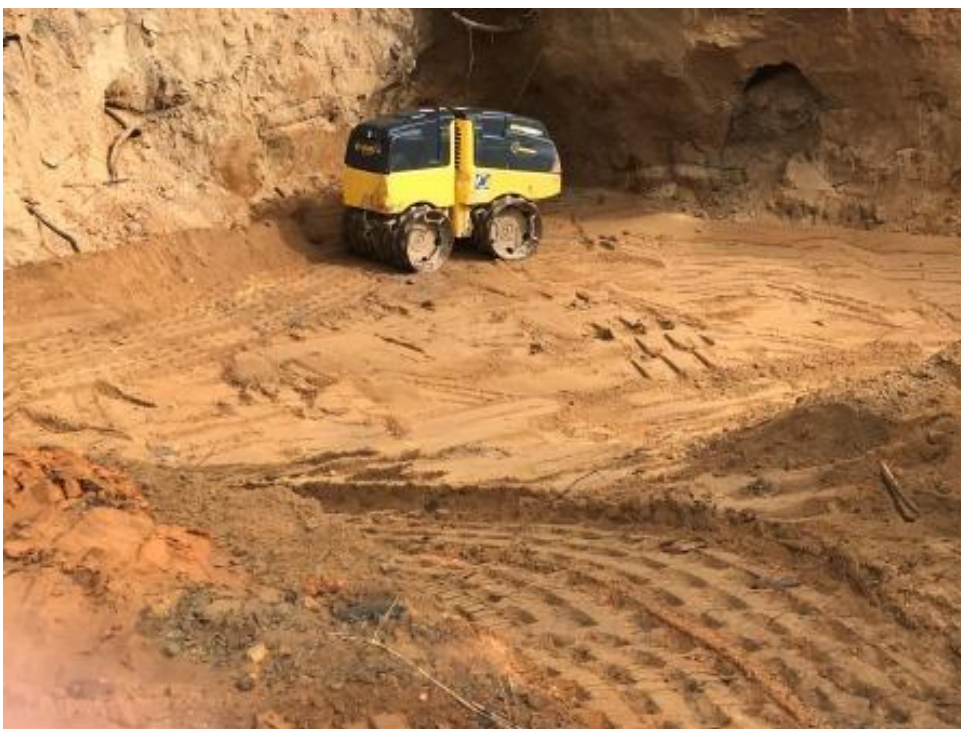
Photograph 9:
EVO compacting
excavation with remote
compactor.

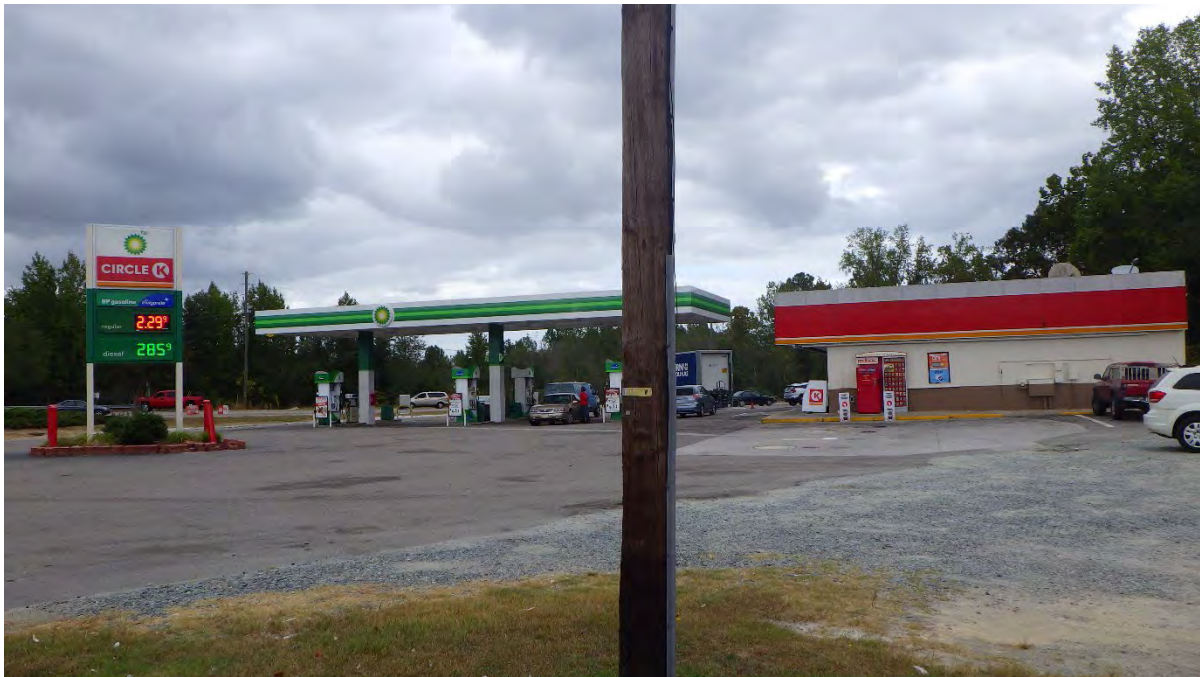
This is an active gas station with four USTs permitted in use at the site. Monitoring wells and remediation wells were observed on site and one groundwater incident is recorded in NCDEQ's UST incident database.

UST permit

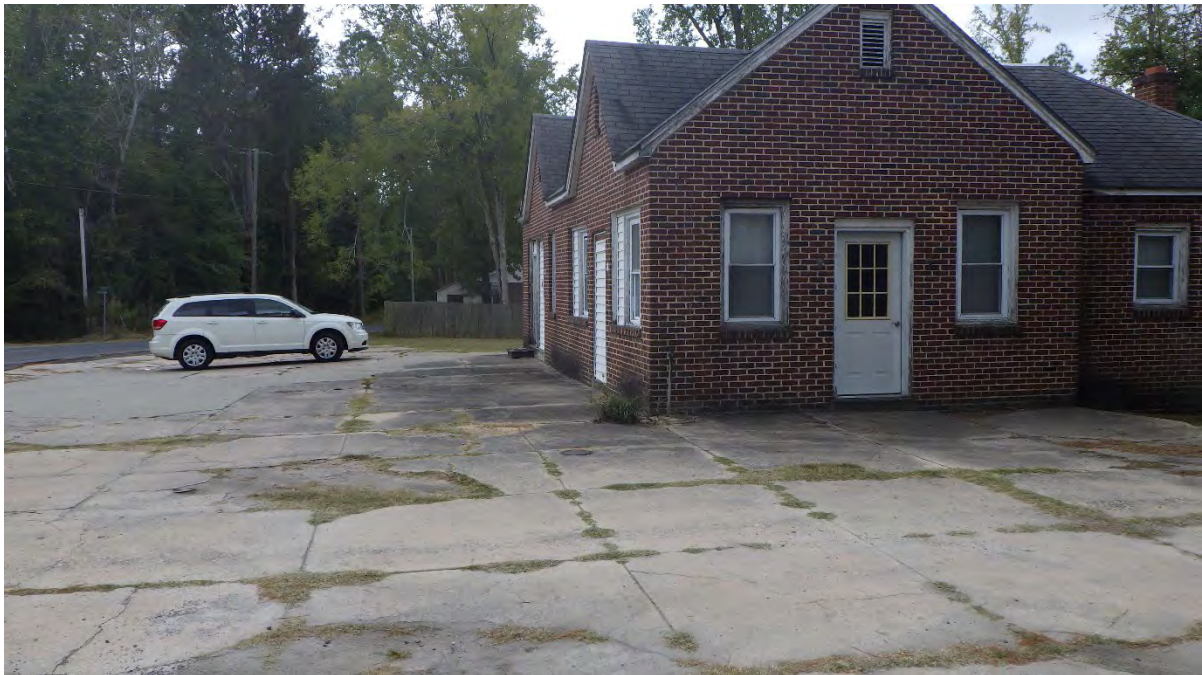
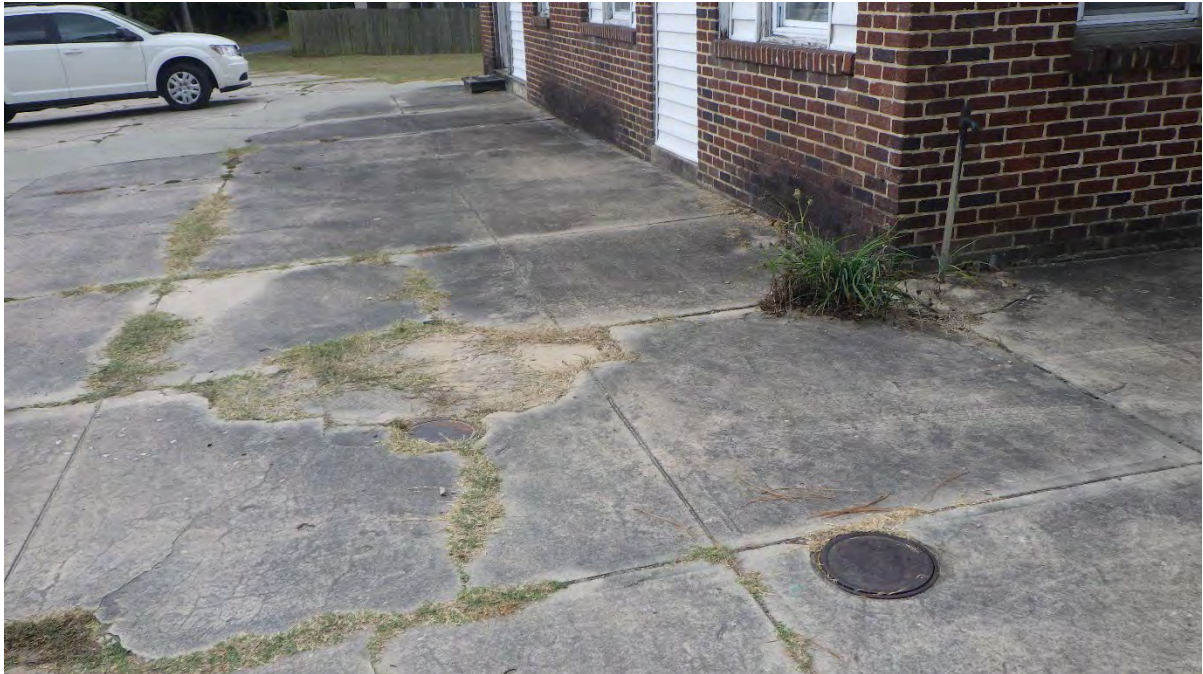
This is a former gas station with at least 2 small USTs observed on site. The store building was probably built in 1930s and is in fair condition. No monitoring wells were observed on site and no incident record can be located in NCDEQ's database.

UST fill port with cover

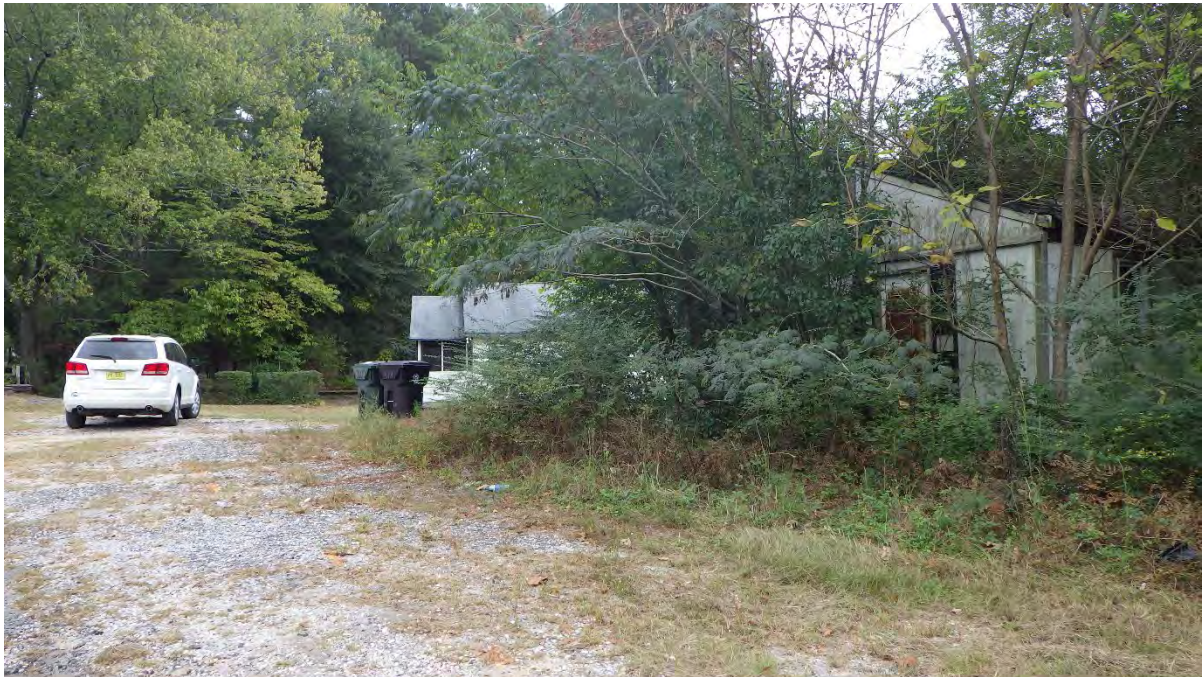
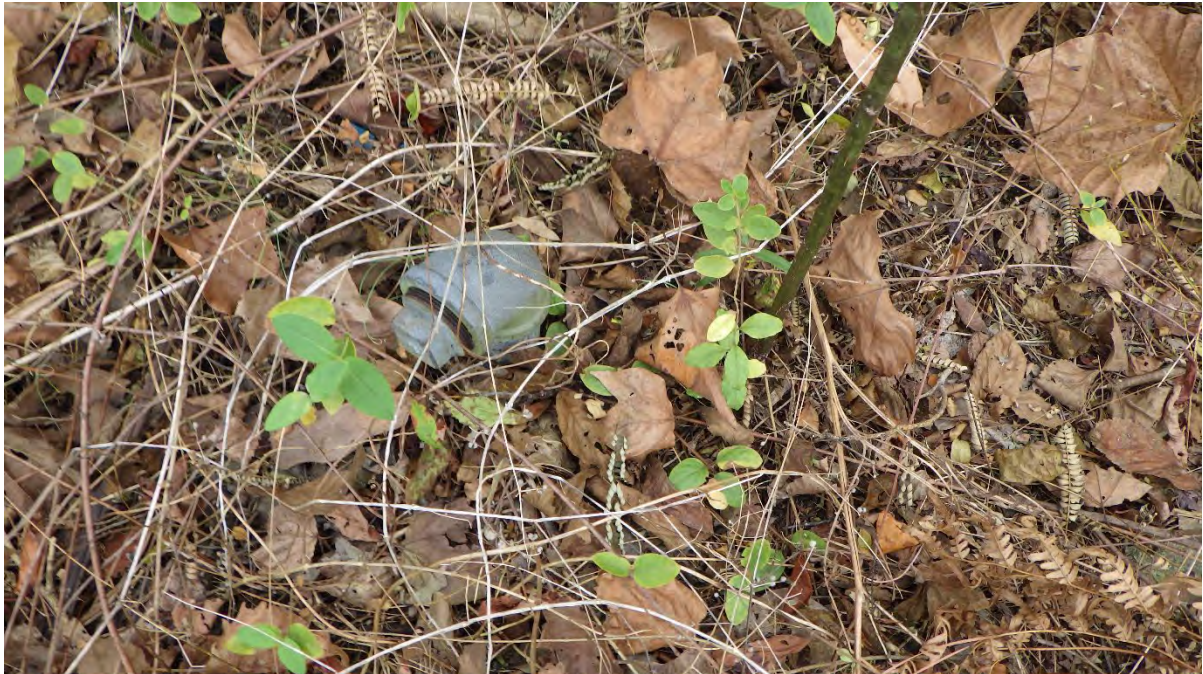
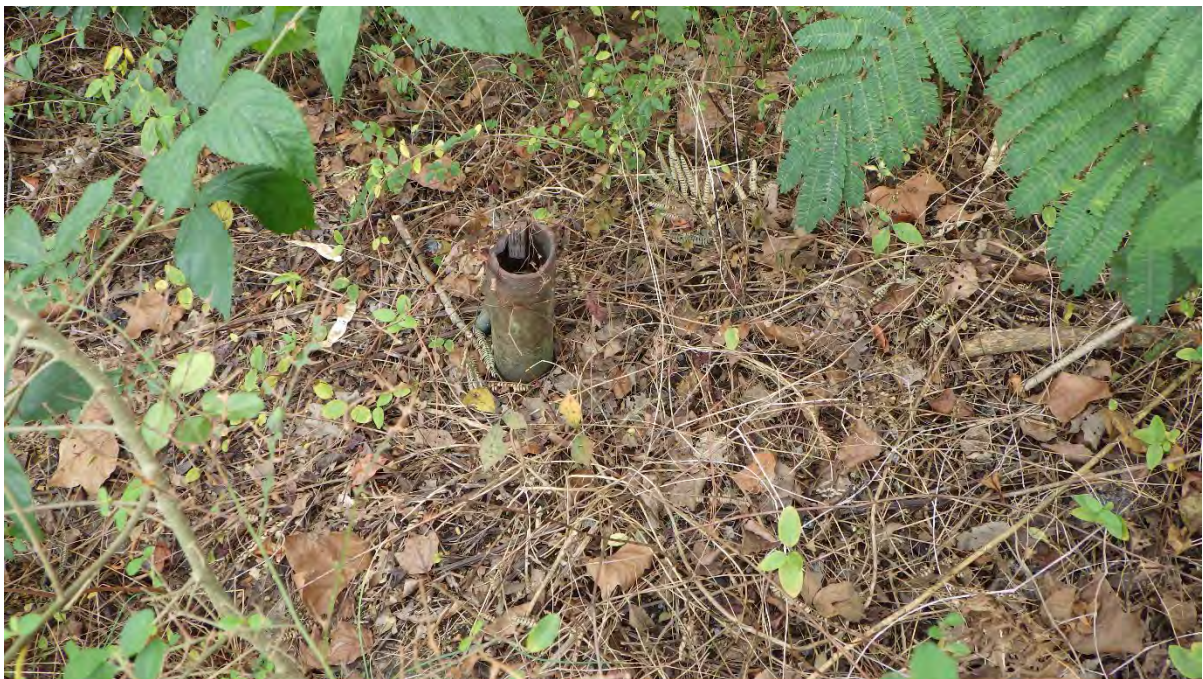
This is an old former gas station with former dispenser island remains on site (under the trees in front of the building). The store building was in poor condition and probably built in 1930s or earlier. Two small USTs probably still remain underneath the island and no monitoring wells were observed on site. No incident record can be located in NCDEQ's database.

UST features in the dispenser island area

UST features in the dispenser island area-product line

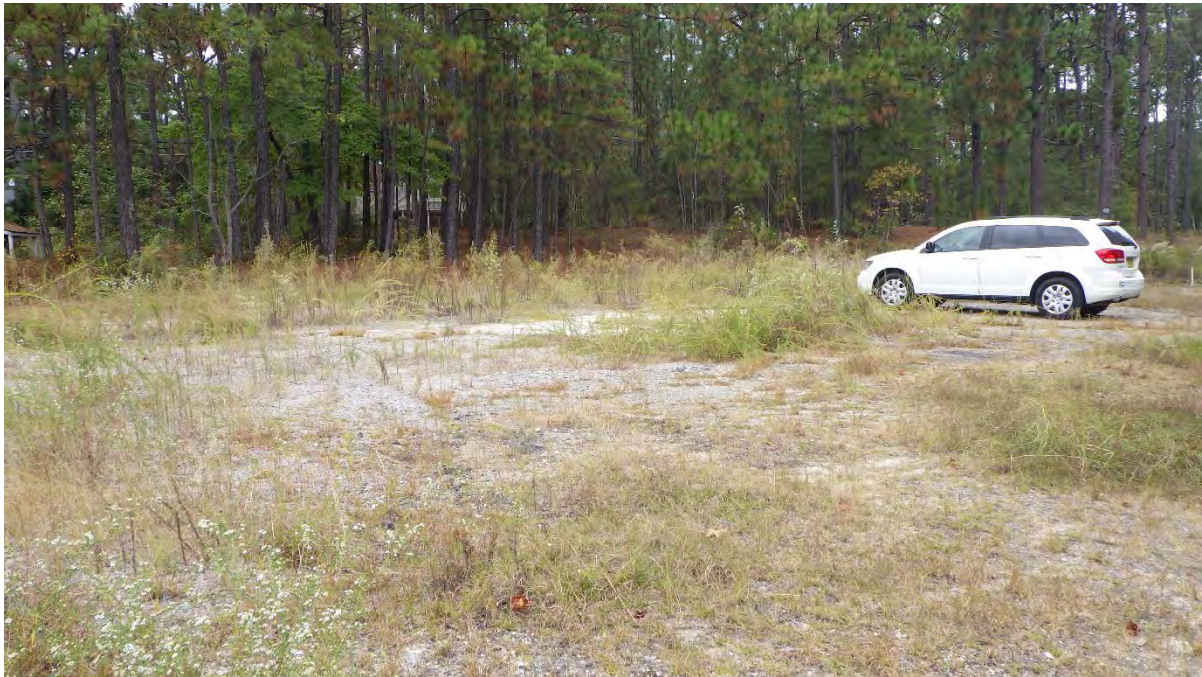
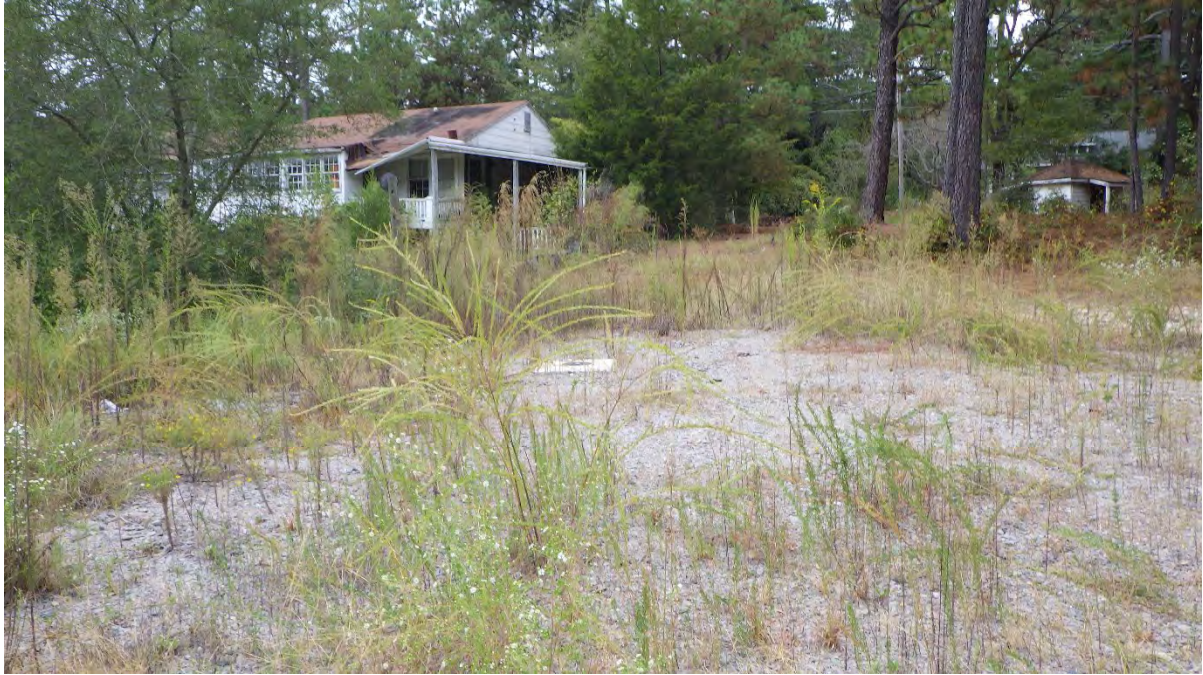
This is a vacant lot with building foundation remained on site. It was a possible former gas station with USTs removed. One monitoring well observed on site and no incident record can be located in NCDEQ's database.

UST removal area.

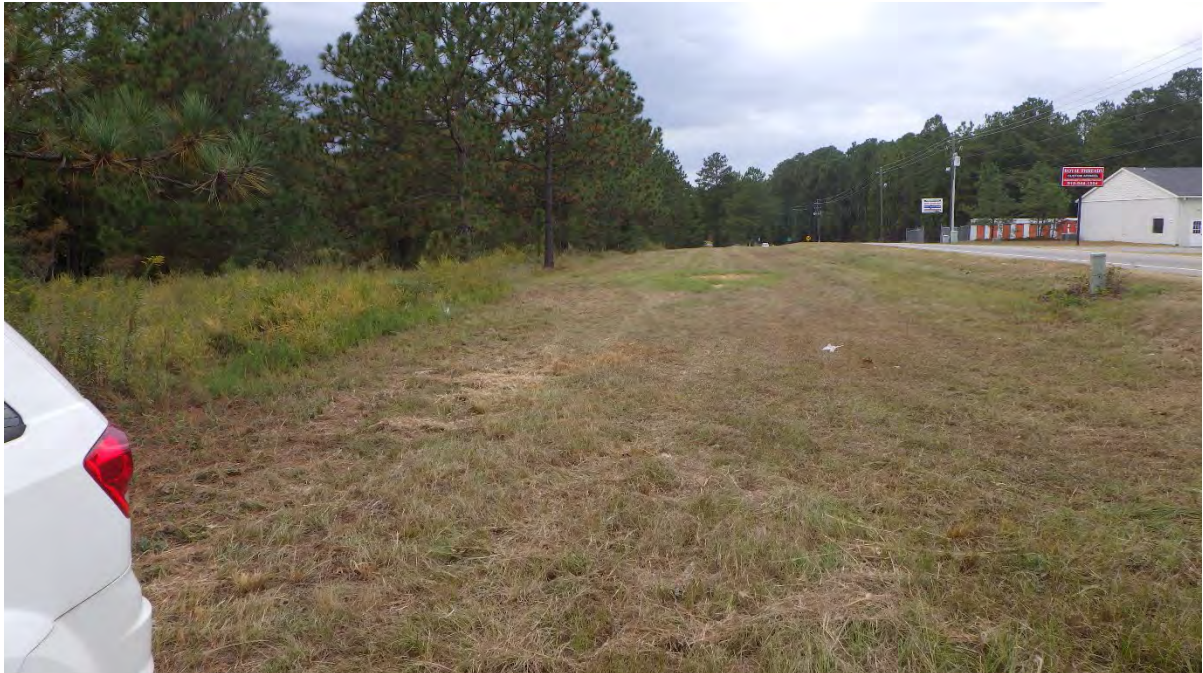
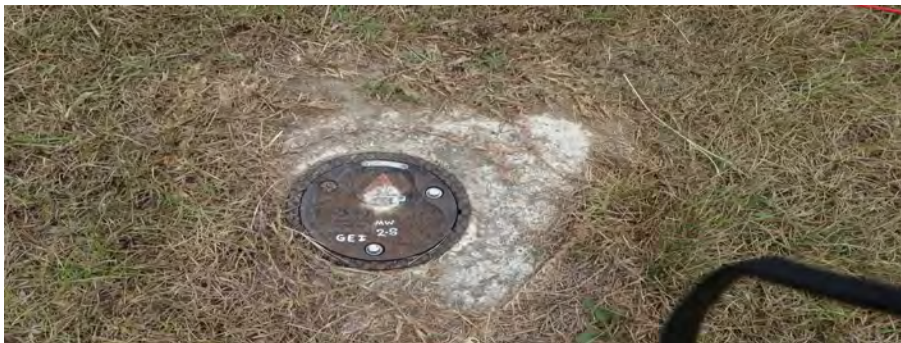
This is a vacant lot owned by a railroad company. There was a KAISER CHEMICAL building removed from the site years ago. Soils contaminated with pesticides were identified by EPA and soil excavation were completed in 1996 and 1997. One monitoring well was observed on site, and no USTs observed on site.

Monitoring well

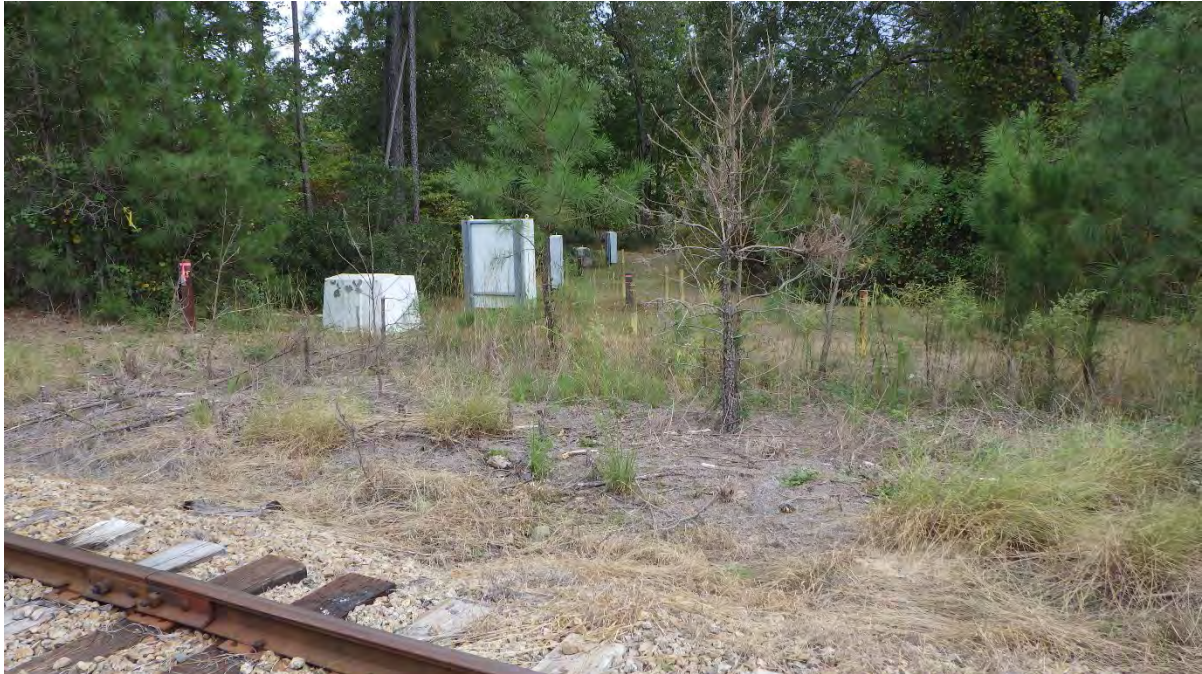
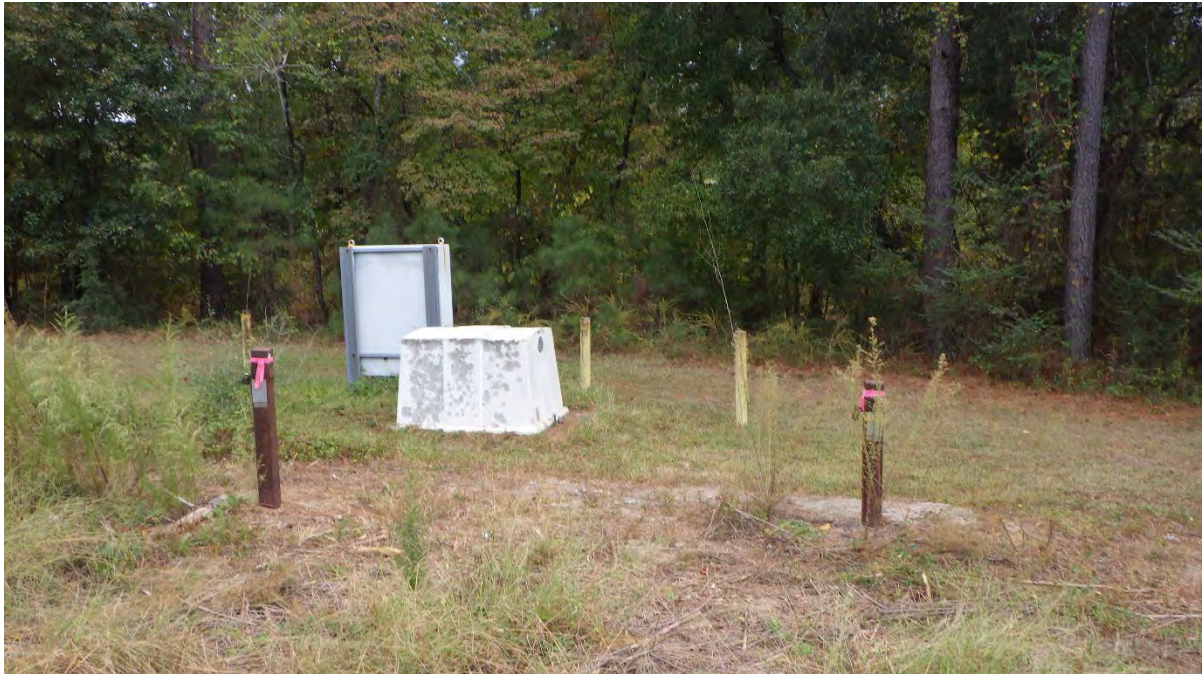
This is a large track of wooded vacant lot. The contamination on this site is directly related to site 5 (GEIGY CHEMICAL) activities. Superfund soil removal (see site 5 figures) and groundwater clean-up action have occurred at this site. Multiple groundwater monitoring wells and remediation systems were observed over the site.

Remediation/monitoring wells

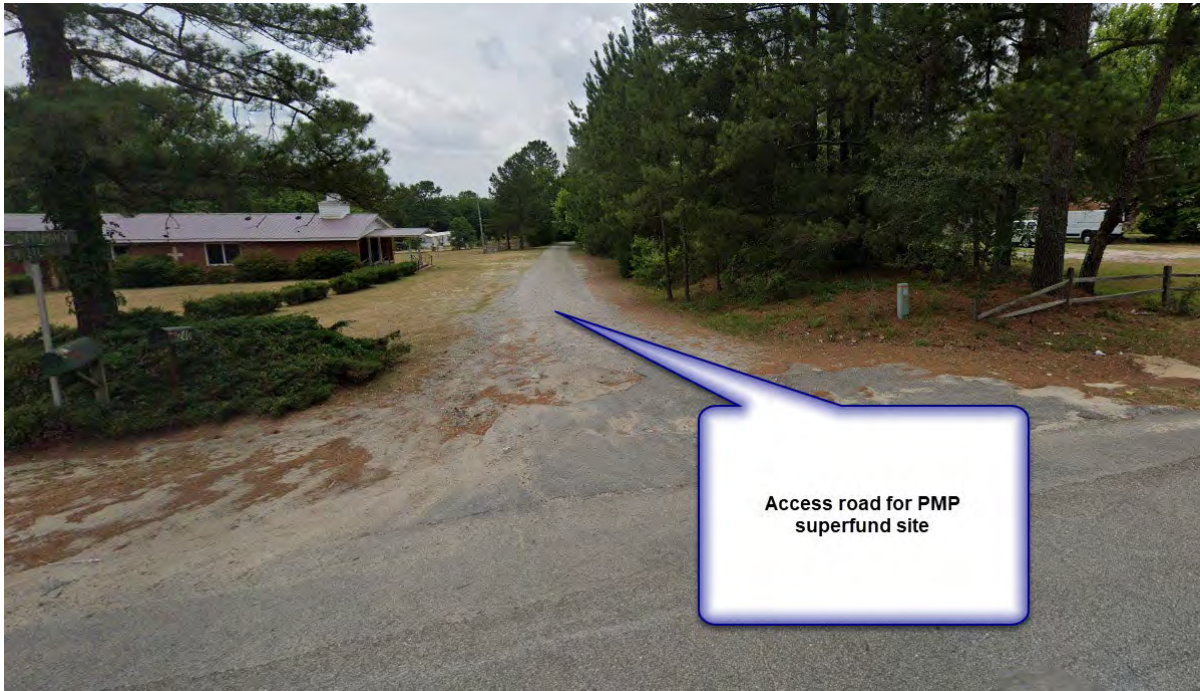
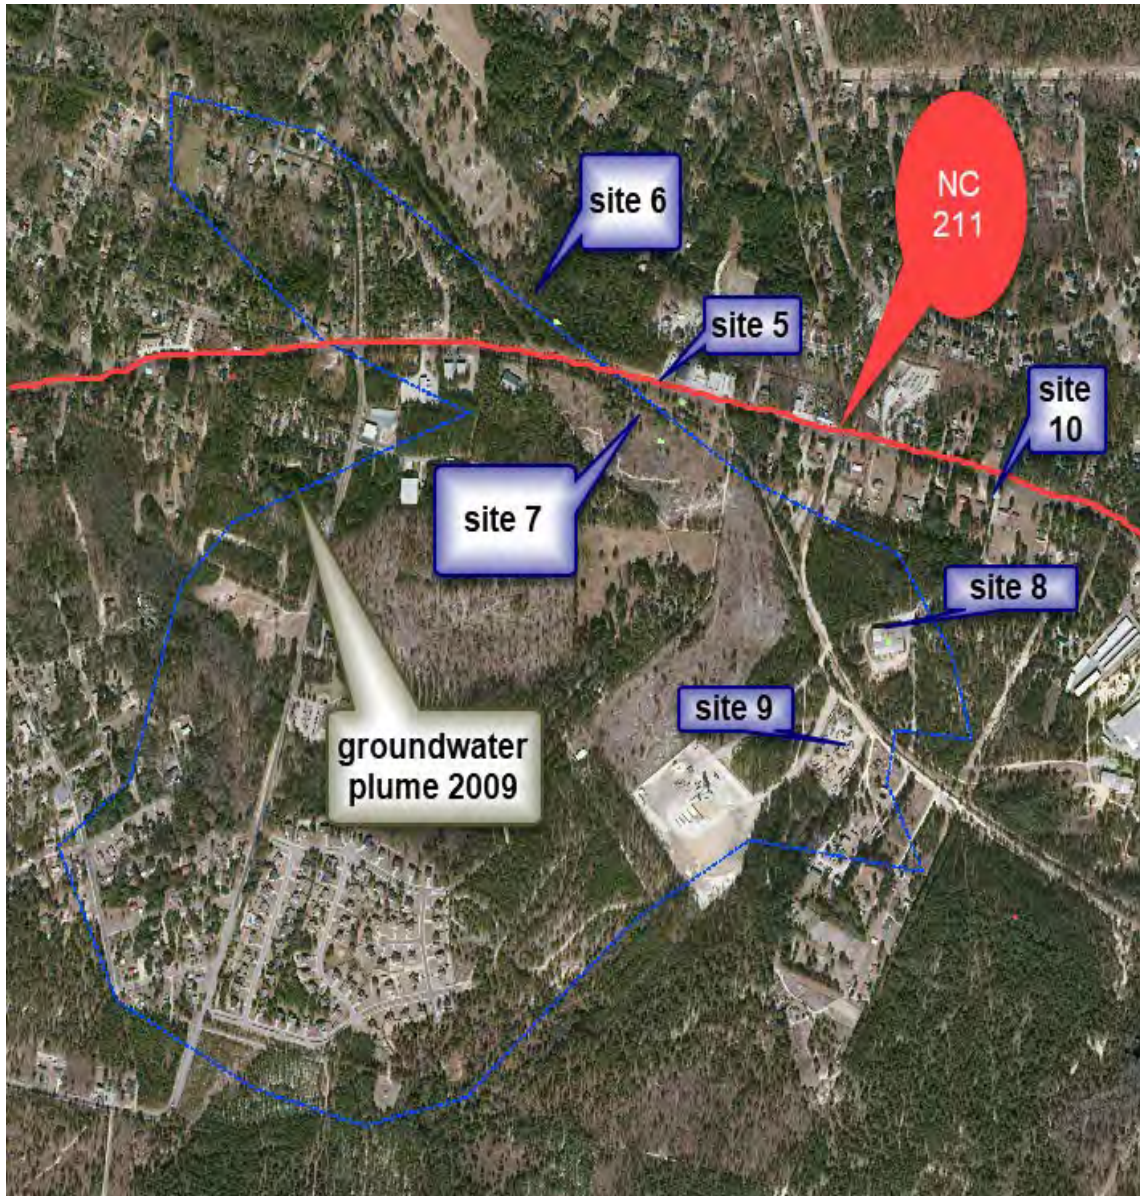
This is the access road to a large track of land with the former Powder Metals Products (PMP) superfund site (Site 9) and the project design is likely to impact this area. Soil and water contamination related to the former PMP site (site 8) were identified in 2000 with solvents release but not to extend to this location (Site 10). Groundwater contamination were investigated by EPA related to the incident, however, there has been no active remediation of the groundwater on the former PMP site. No monitoring wells were documented or observed in the area. This access road is situated adjoint NC 211 and to be in a topographical and hydrogeological up gradient location to the groundwater contaminated area at this property and other sites (5,7,8 and 9) in the area.

Location of this site (site 10) and other superfund associated sites. Blue line is approximate groundwater plume (2009).

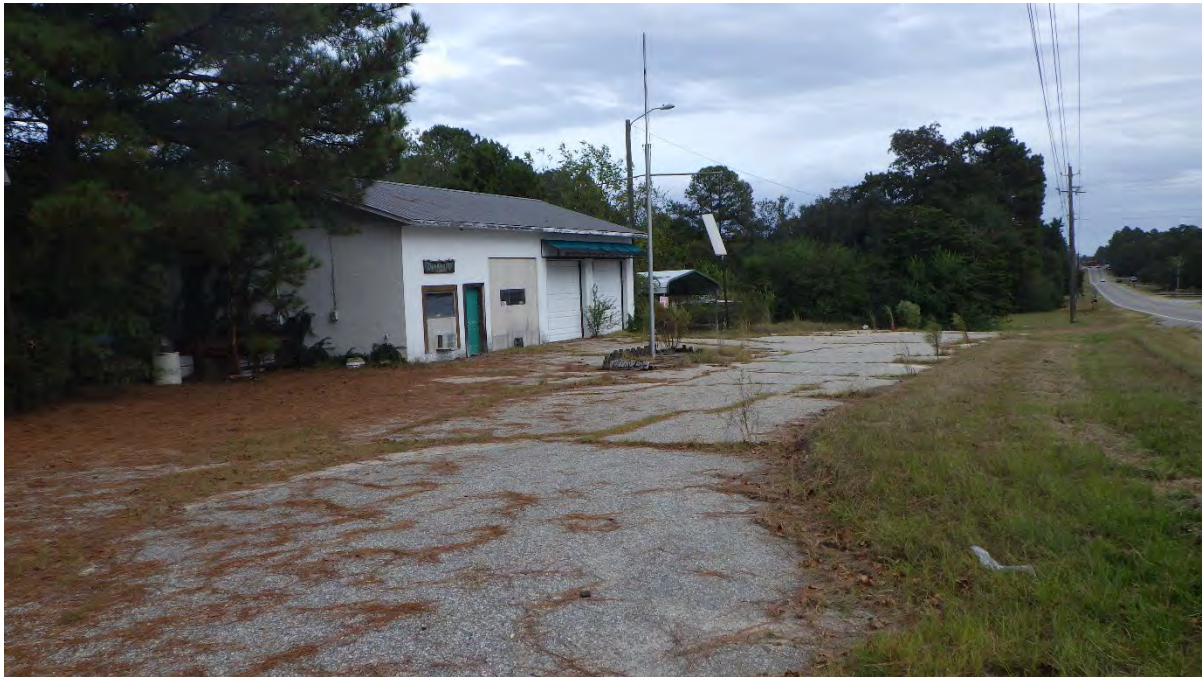
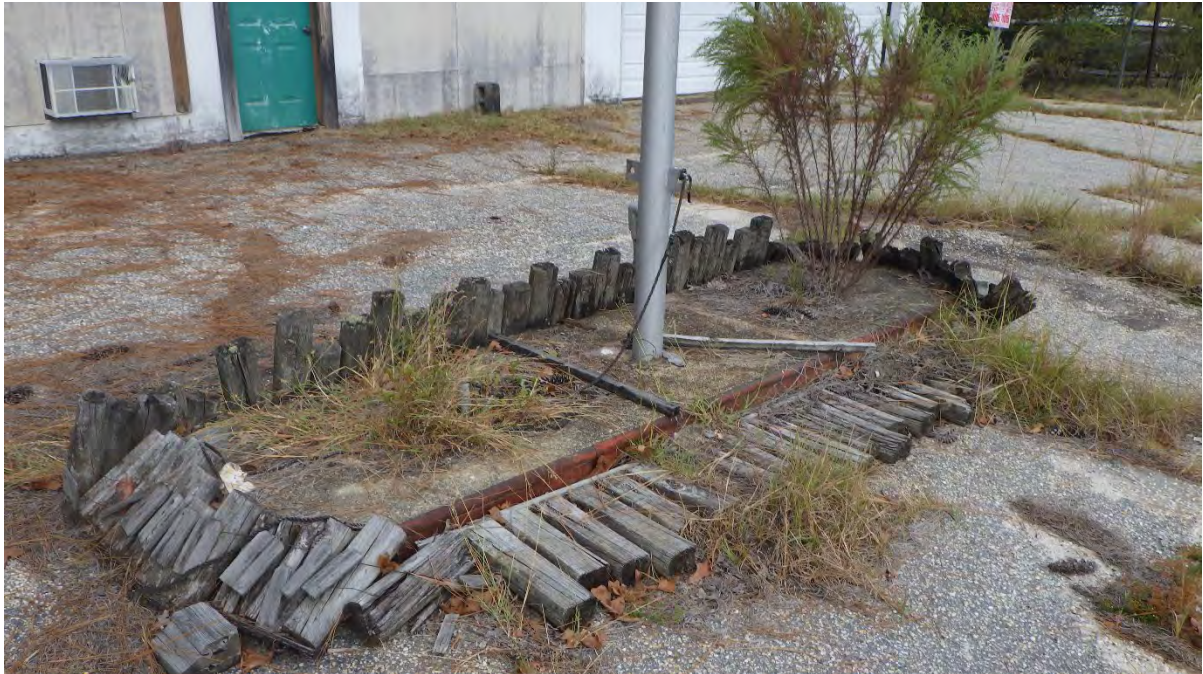
This is a vacant garage building and a possible former gas station with dispenser island remains on site. No monitoring wells or USTs were observed on site. No incident record can be located in NCDEQ's database.

Possible former disperser island

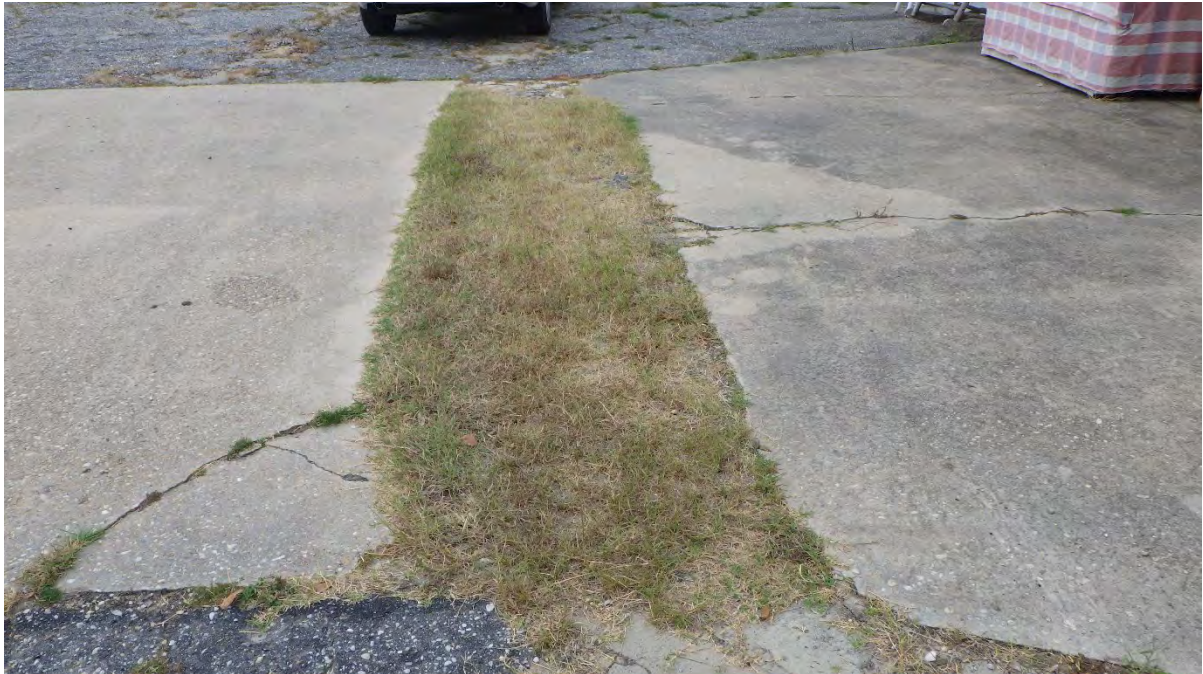
This is a fabric retail store and a possible former gas station with possible dispenser islands (removed). No monitoring wells or USTs were observed on site. No incident record can be located in NCDEQ's database.

Possible former disperser island location.

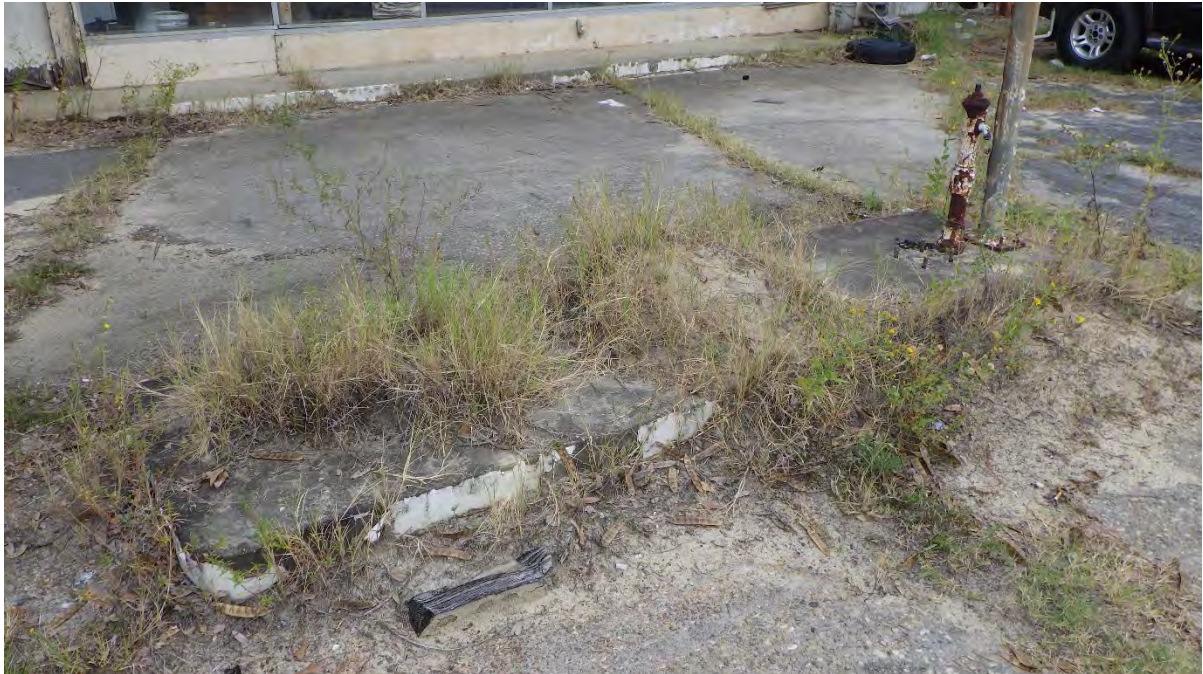
This is an abandoned retail store and a possible former gas station with possible dispenser island remains. No monitoring wells or USTs were observed on site. No incident record can be located in NCDEQ's database.

Possible UST disperser island.
