**North Carolina Department of Transportation
Phase II Investigation
State Project: R-5709
WBS Element: 50205.1.1
Moore County**

**Parcel 79
Robert L. Schloegl Property
9820 NC 211 Hwy
Aberdeen, North Carolina
October 21, 2021**

**Wood Environment & Infrastructure Solutions, Inc.
Project: 20478R5709**

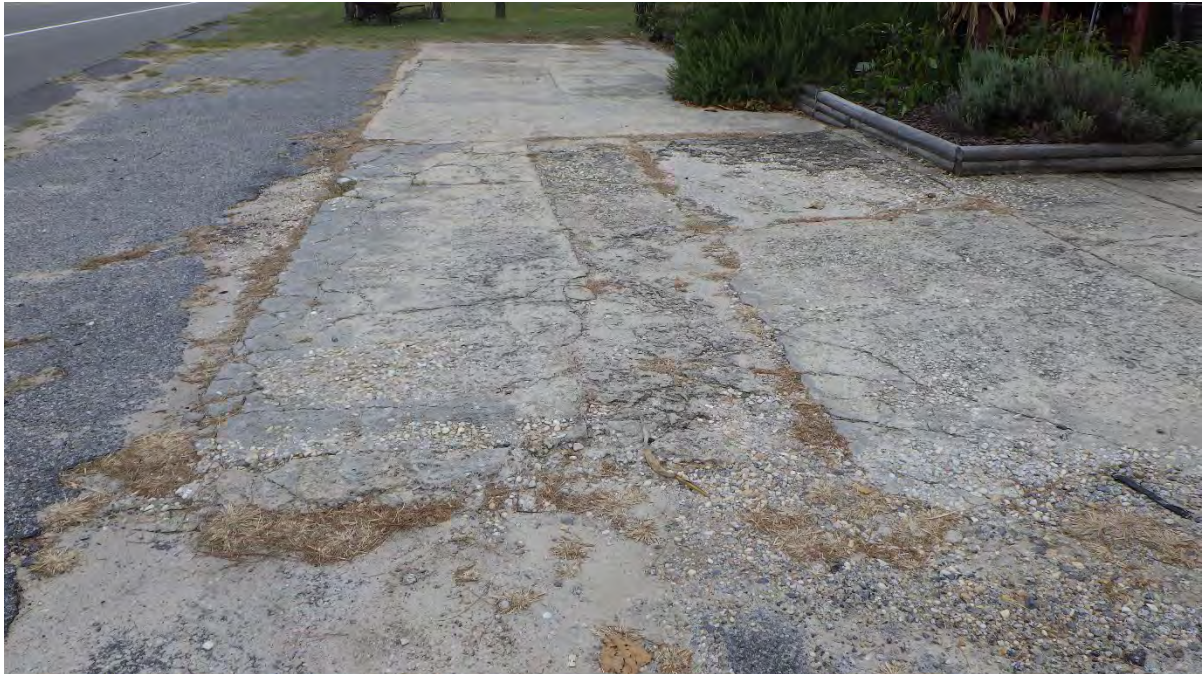
This is a vacant Bed and Breakfast and possible former gas station with UST features remaining on site. No monitoring wells or USTs were observed on site. No incident record can be located in NCDEQ's database.

Possible former disperser island location
