PROJECT SPECIAL PROVISIONS GEOENVIRONMENTAL

CONTAMINATED SOIL (7/19/2022)

PHASE II INVESTIGATION

NCDOT TIP Number: U-5536 NCDOT WBS Number: 44108.1.2 D.D. Stimson Jr. Property: Parcel # 31 6373 Shallowford Road Lewisville, Forsyth County, North Carolina

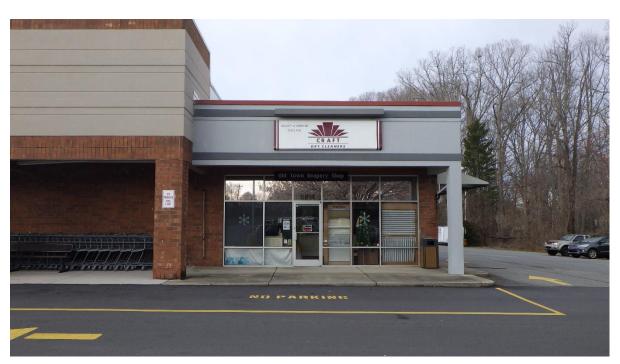
Anticipated Impacts: Low

The site currently operates as a Dry Cleaning drop off location in Oaks Shopping Center. No actual dry cleaning takes place at this location. No documented incidents are associated with the business. Formerly operated as the Old Town Drapery Shop. There is an incident (#14139) associated with the overall parcel however no evidence of MWs were observed while on site.

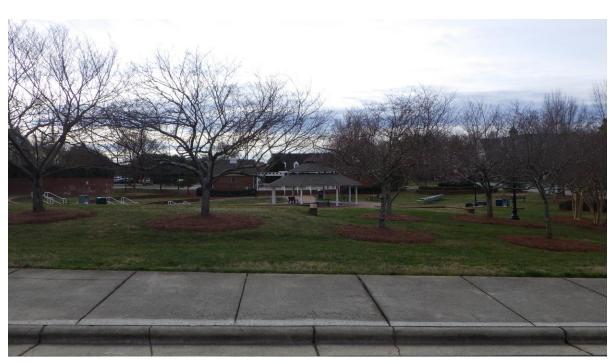
Anticipated Impacts: Low

This site is currently a Town Park hosting special community events from concerts and movie viewings to 4th of July celebrations and Halloween Festivals. The construction of the park was assisted by the NCDENR Parks and Recreation Trust Fund. The incident associated with this property was closed out in October 1997.

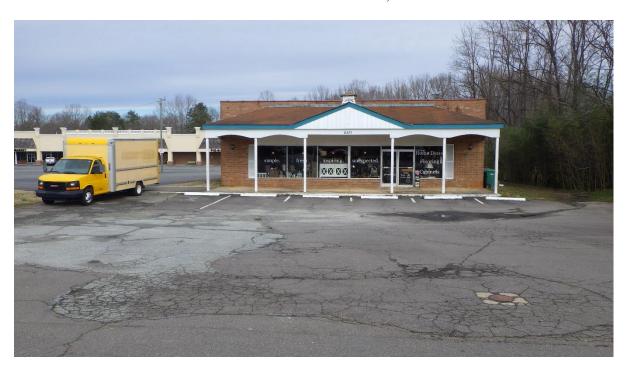
Anticipated Impacts: Low

Today, this former gas station houses an interior decorating business. Incident 13096 is associated with the parcel, the regulatory database says the incident was closed out January 15, 1999. In the parking lot, four (4) monitoring wells, with 12" manhole covers were observed.

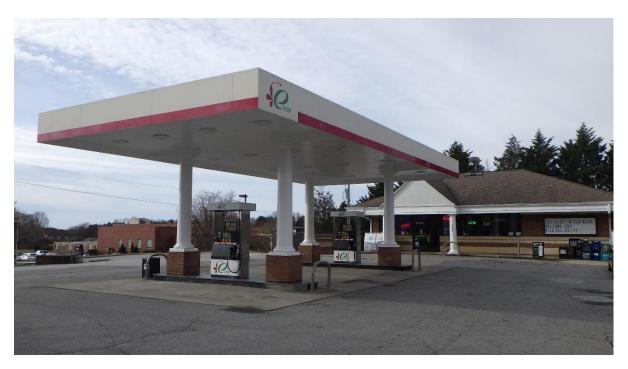
Anticipated Impacts: Low

The site is an active gas station with two (2) underground storage tanks. The parcel does have an associated incident number, 11308 that was closed out in May 1995. No monitoring wells were observed during the site visit.

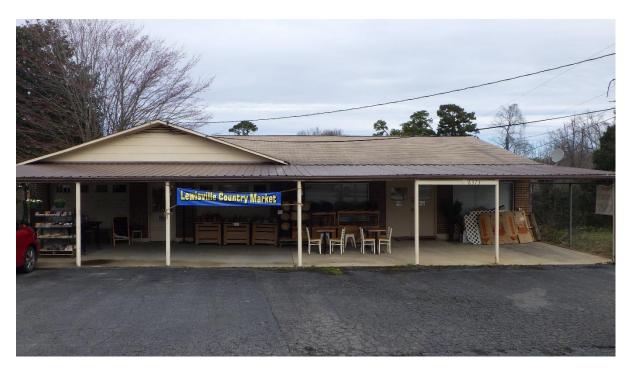
Anticipated Impacts: Low

This parcel has an old country market selling fresh produce, baked goods, etc. From the architecture, it may have at one time been a gas station. Behind the market, the owner operates what appears to be a motorcycle repair shop, DSR Custom Cycles. No monitoring wells were observed while visiting the site.

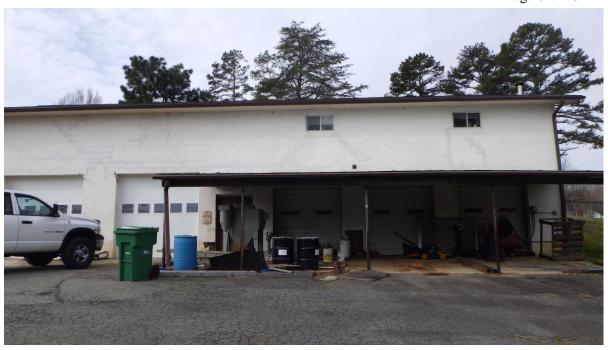
The exterior of what is believed to be DSR Custom Cycles, there were no readily observable signs posted. It is anticipated that this building will fall within the construction limits of the project.

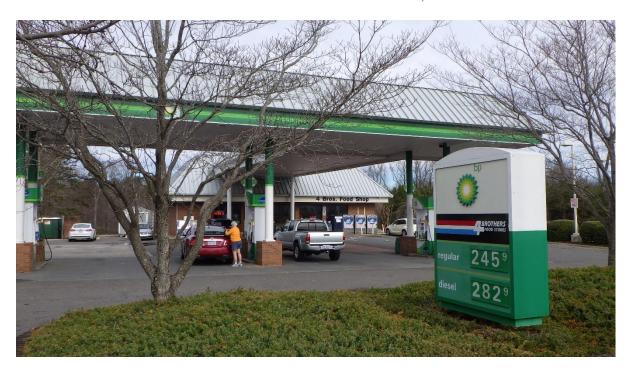
Anticipated Impacts: Low

An active gas station is at this location, with three (3) registered underground storage tanks. Incident 19245 is associated with this parcel, back when the gas station operated as Friendly Food Mart #3. Four (4) monitoring wells were observed while conducting the site visit.

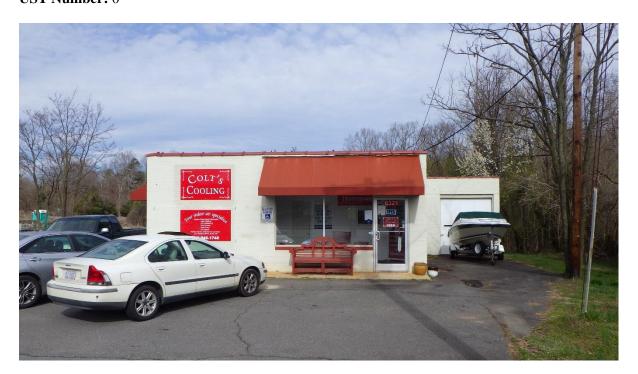
Anticipated Impacts: Low

Currently a heating and cooling business operates out of this building. From the architecture, circle drive and drive-up window, the building may have once operated as a dry-cleaning facility. No monitoring wells were observed during the site visit.

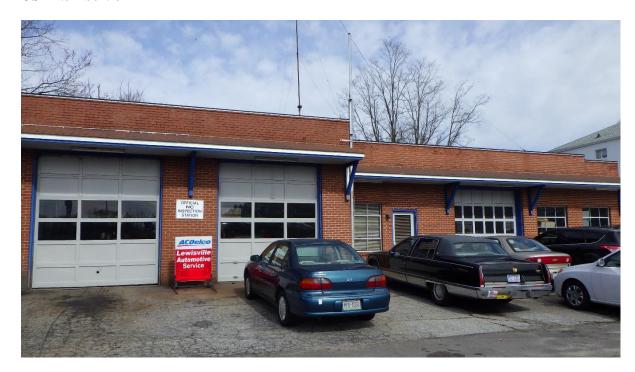
Anticipated Impacts: Low

Lewisville Automotive Services has been operating at this location for over five (5) decades. There is currently at least one (1) in ground lift and signs of surficial spills. There are no underground storage tanks registered at this property, nor any documented incidents.

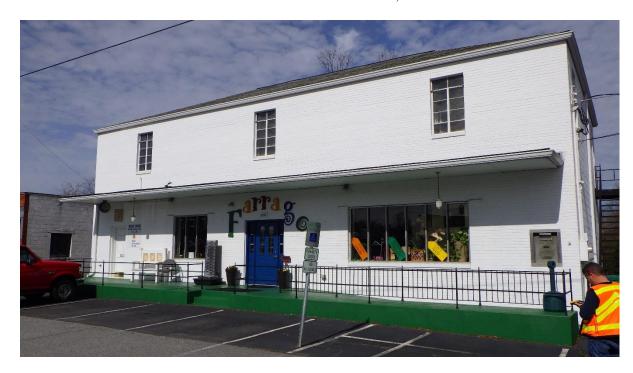
Anticipated Impacts: Low

The building on site has operated as an old hardware store, a bank, and an antique shop. The Lewisville Volunteer Fire Department was located on the same Parcel as the Masonic Lodge. Today where the Fire Station once stood is a parking lot. Incident 14432 is associated with the parcel and several monitoring wells were observed. Today it houses the local masonic lodge and a hair salon named FARRAGO.

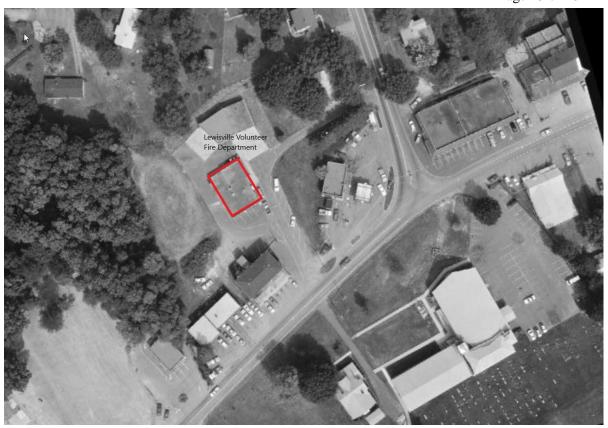
This historical aerial image from 1986 shows the location of the Lewisville Volunteer Fire Department.

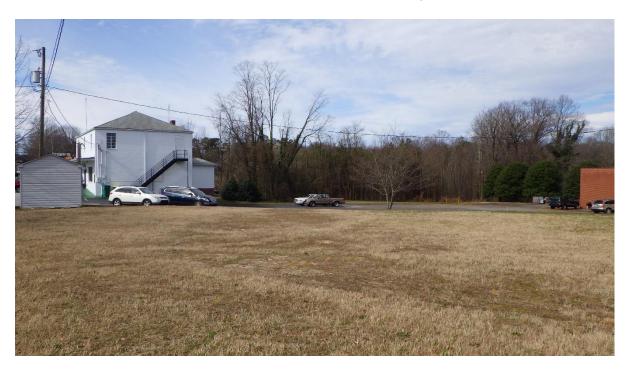
Anticipated Impacts: Low

This former gas station is currently a vacant lot with a remediation system that is no longer operating. Incident 30127 is associated with the parcel and according to the regulatory database has not been officially closed out. Several monitoring wells were located while on site.

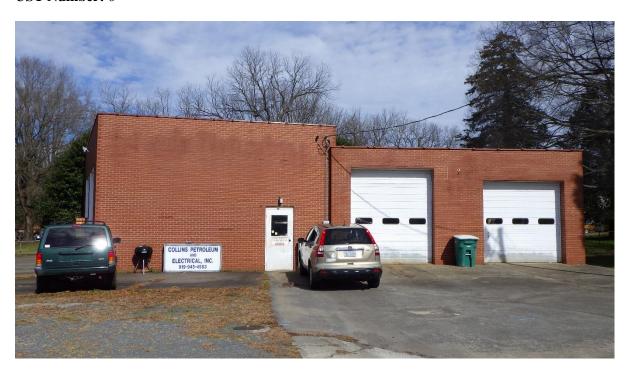
Anticipated Impacts: Low

This business has scrapped fuel dispensers outside of the building, and monitoring wells on the property possibly associated with the Lewisville Volunteer Fire Department Incident. No registered tanks were identified in the regulatory database, nor are any documented incidents associated with the address or owners.

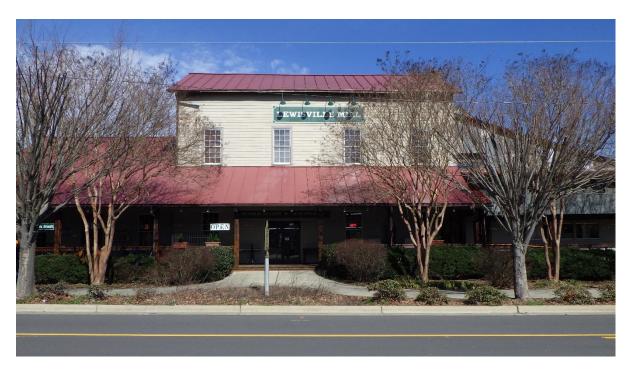
Anticipated Impacts: Low

The former mill operated from approximately 1910 to 1984, grinding grains into flour, cornmeal, and feed for livestock. Currently Lewisville Hardware among other businesses occupy the building. There are no documented incidents associated with the parcel and no monitoring wells were identified while on site.

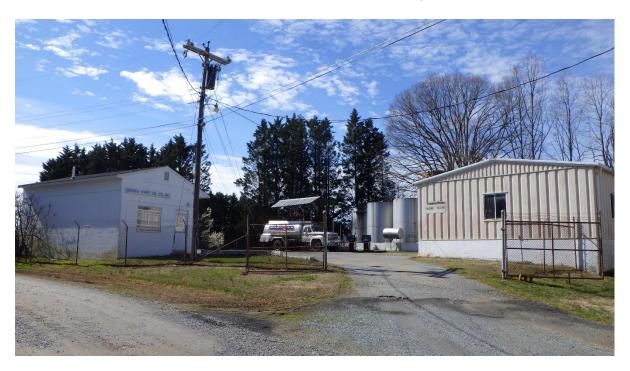
Anticipated Impacts: Low

Denver White Oil Company operates a distribution center from this location. Several large capacity above ground tanks were observed as well as dispensers on the yard and documentation of underground tanks on site. The existing study area clips the parcel, but the proposed construction limits are not anticipated to impact the site.

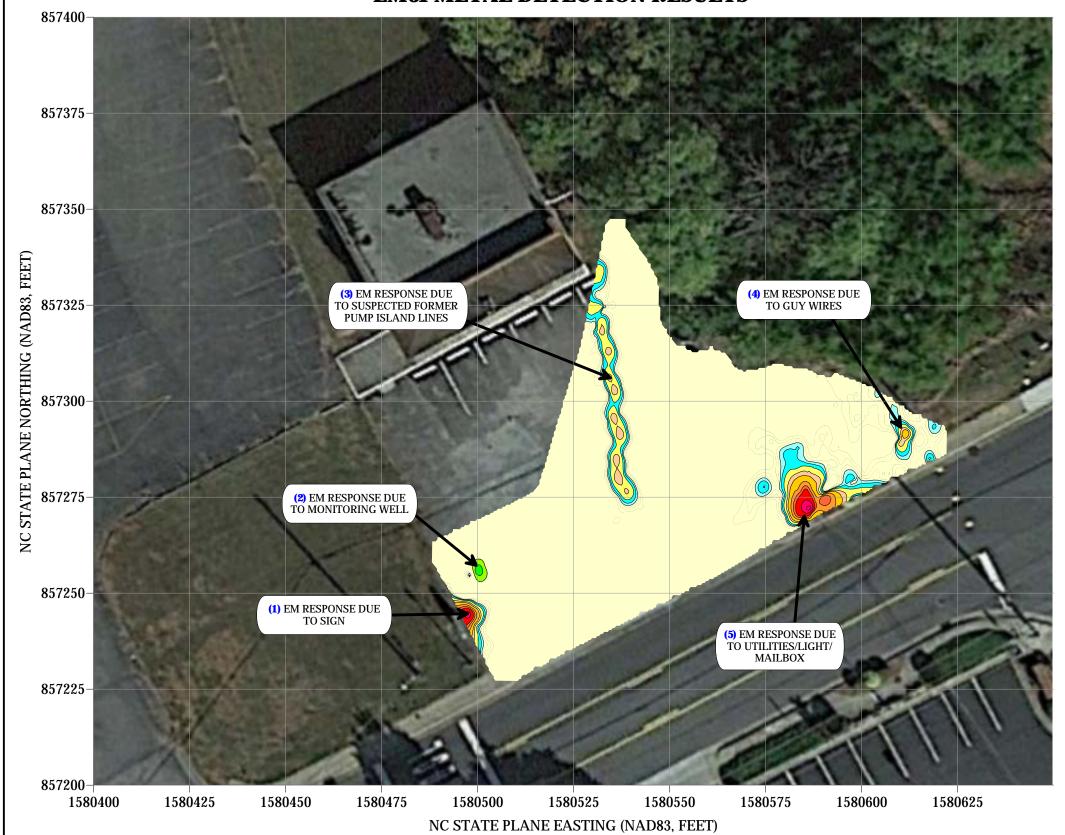
EM61 METAL DETECTION RESULTS

NO EVIDENCE OF METALLIC USTs WAS OBSERVED.

The contour plot shows the differential results of the EM61 instrument in millivolts (mV). The differential results focus on larger metallic objects such as USTs and drums. The EM data were collected on May 10, 2022, using a Geonics EM61-MK2 instrument. Verification GPR data were collected using a GSSI SIR 4000 instrument with a 350 MHz HS antenna on May 11, 2022.

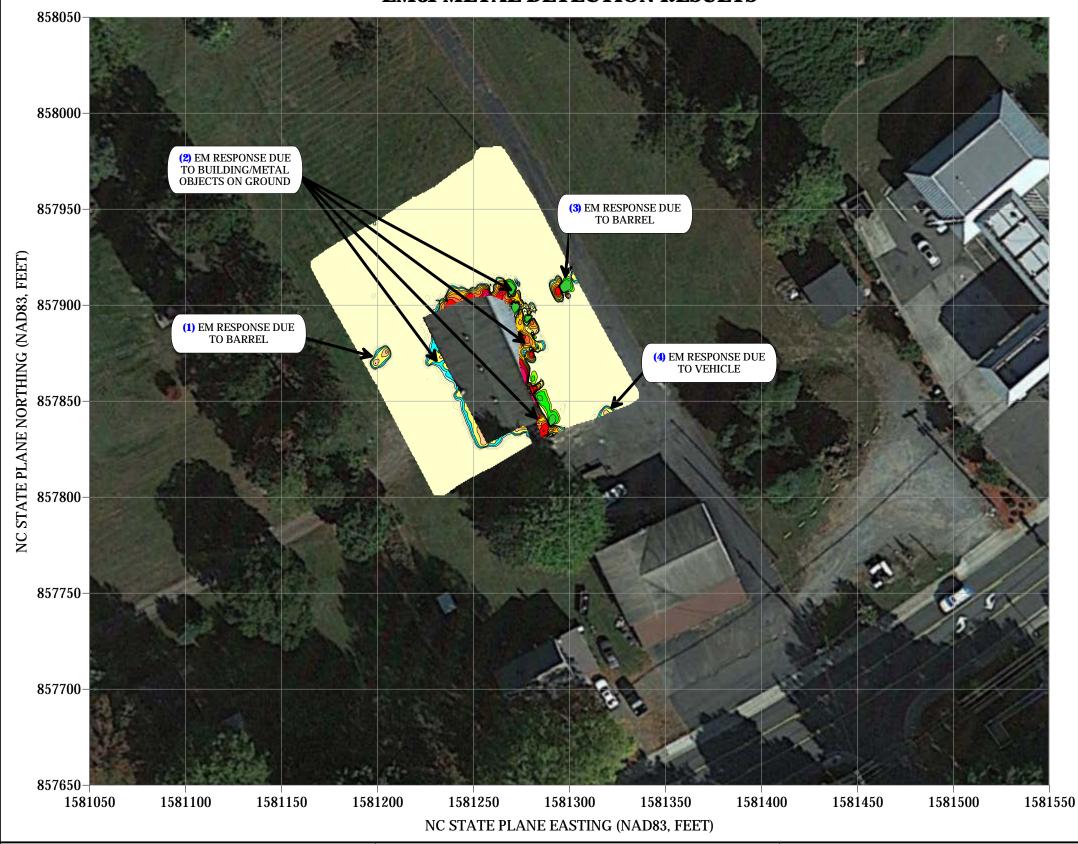
EM61 METAL DETECTION RESULTS

EVIDENCE OF ONE NO CONFIDENCE ANOMALY WAS OBSERVED.

The contour plot shows the differential results of the EM61 instrument in millivolts (mV). The differential results focus on larger metallic objects such as USTs and drums. The EM data were collected on May 10, 2022, using a Geonics EM61-MK2 instrument. Verification GPR data were collected using a GSSI SIR 4000 instrument with a 350 MHz HS antenna on May 11, 2022.

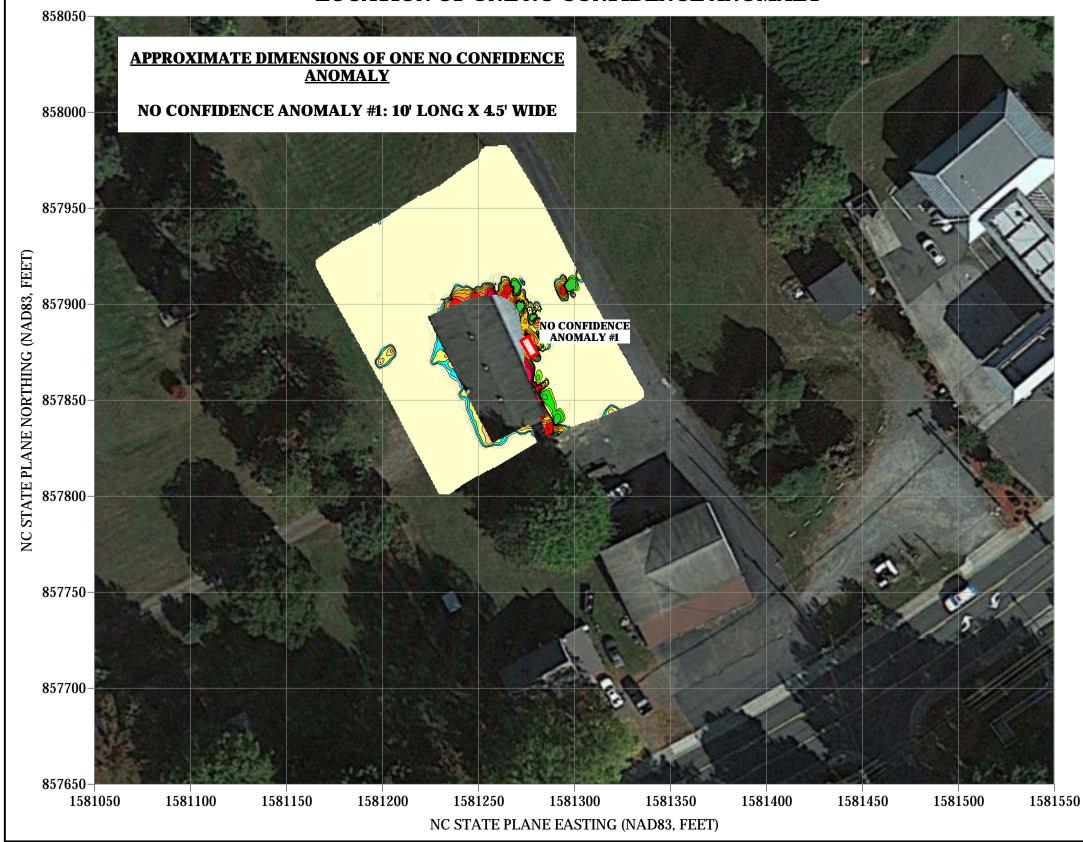
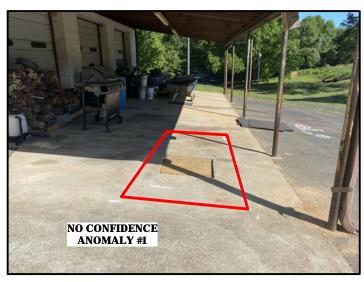
LOCATION OF ONE NO CONFIDENCE ANOMALY

One no confidence anomaly was located underneath the awning on the east side of the building beneath a metal hatch. No Confidence Anomaly #1 is approximately 10 feet long by 4.5 feet wide. This anomaly may be associated with a buried septic tank. Collectively, the geophysical data recorded evidence of one no confidence anomaly at Parcel 31. No evidence of unknown metallic USTs was observed.

View of No Confidence Anomaly (Facing Approximately North)

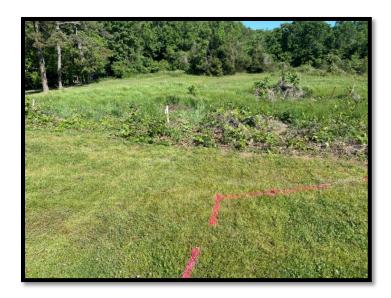
Figure 1 Parcel 34, NC 811 utility mark outs, at SB13, northern view.

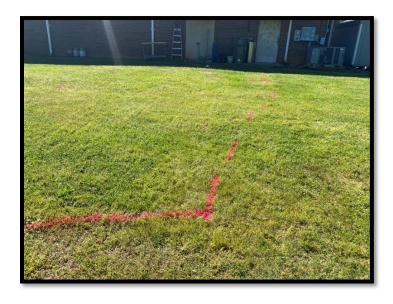
Figure 2 Parcel 34, NC 811 utility mark outs, southern view.

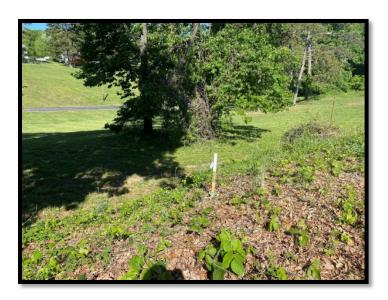
Figure 3 Parcel 34 SB12 northwestern view at rear of main property.

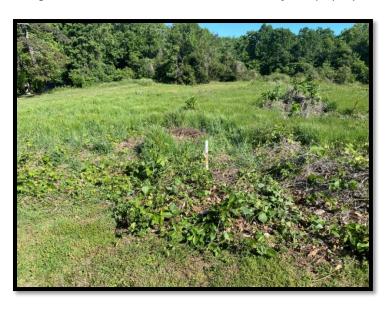
Figure 4 Parcel 34 SB13 northern view at rear of main property.
