RE: Phase II Investigation  
Richard Stimson Property – Parcel # 36  
6321 Shallowford Road, Lewisville, Forsyth County, NC  
NCDOT TIP Number: U-5536  
NCDOT WBS Number: 44108.1.2  
CES Project Number: 7893.0422E

## **PHASE II INVESTIGATION**

**NCDOT TIP Number: U-5536  
NCDOT WBS Number: 44108.1.2  
Richard Stimson Property: Parcel # 36  
6321 Shallowford Road  
Lewisville, Forsyth County, North Carolina**

**NCDOT TIP Number: U-5536**  
**NCDOT WBS Number: 44108.1.2**  
**Michael & Julie Collins Property: Parcel # 37**  
**116 Lewisville-Vienna Road**  
**Lewisville, Forsyth County, North Carolina**

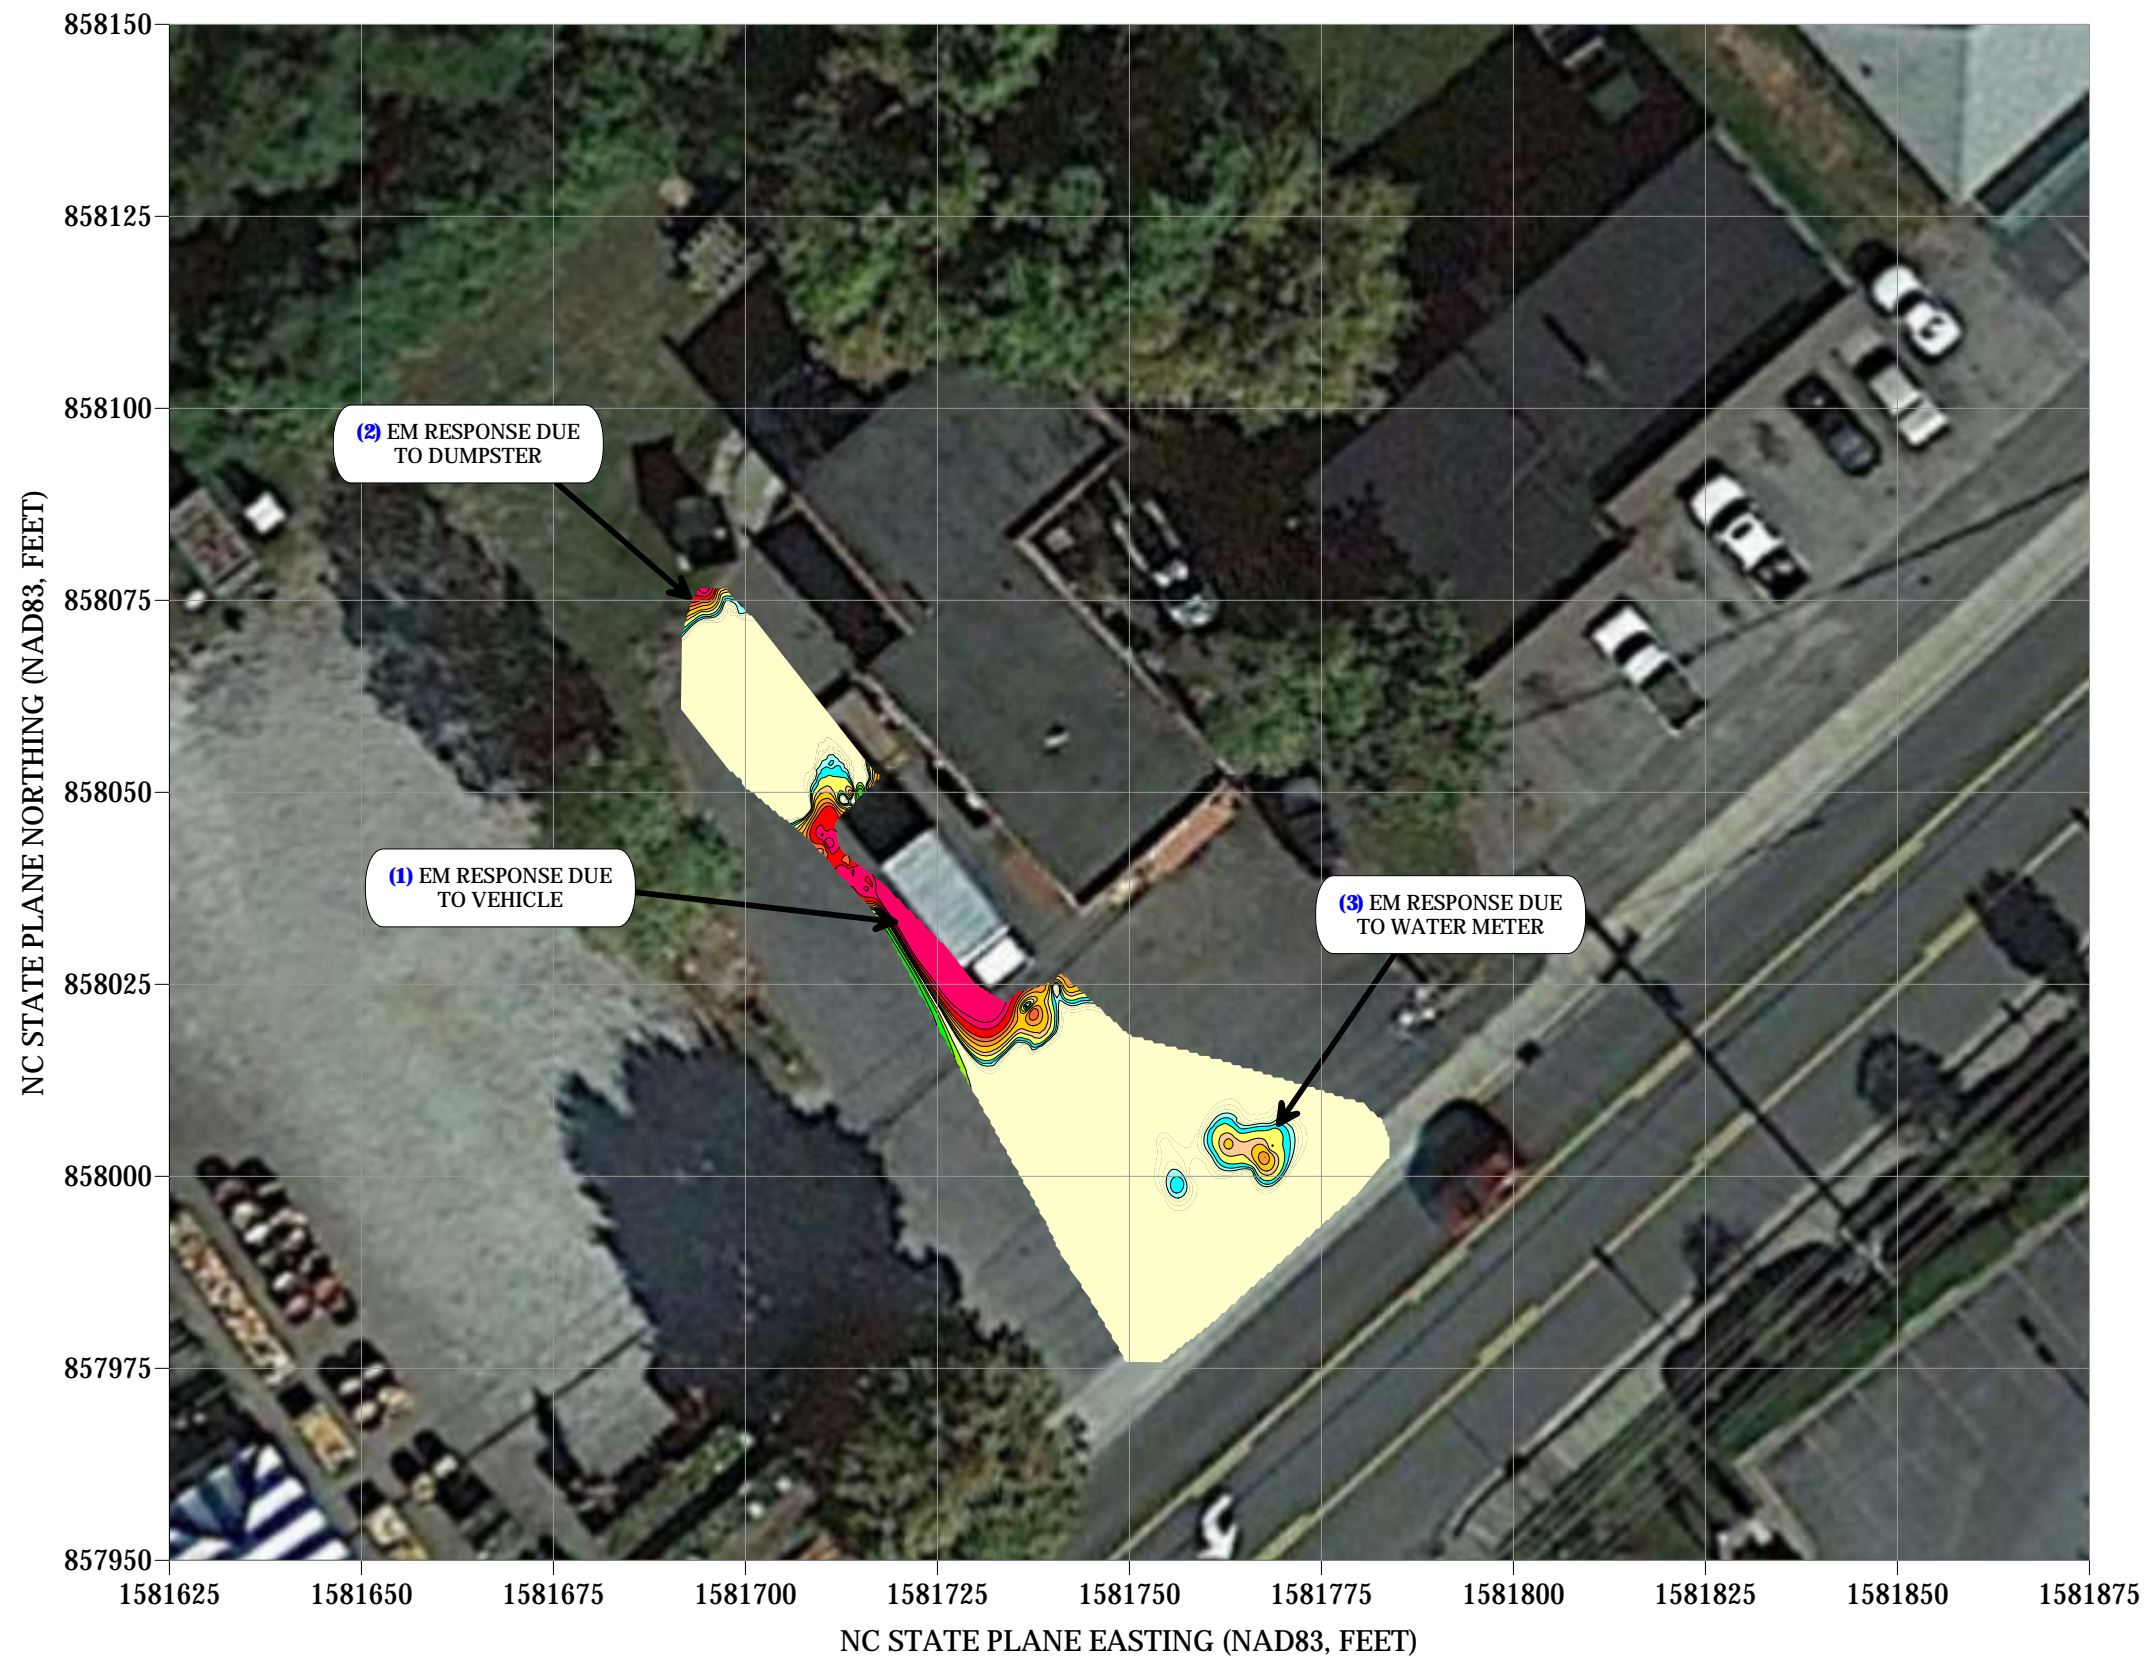
# EM61 METAL DETECTION RESULTS

**NO EVIDENCE OF METALLIC USTs WAS OBSERVED.**

The contour plot shows the differential results of the EM61 instrument in millivolts (mV). The differential results focus on larger metallic objects such as USTs and drums. The EM data were collected on May 10, 2022, using a Geonics EM61-MK2 instrument. Verification GPR data were collected using a GSSI SIR 4000 instrument with a 350 MHz HS antenna on May 11, 2022.

A contour plot of the EM61 results obtained across the survey area at the property is presented in **Figure 2**. Each EM anomaly is numbered for reference in the figure. The following table presents the list of EM anomalies and the cause of the metallic response, if known:

All of the EM anomalies were directly attributed to visible cultural features at the ground surface, including a vehicle, a dumpster, and a water meter. GPR was performed around areas of significant metallic interference caused by the vehicle to confirm that the metallic interference did not obscure any significant structures such as USTs.

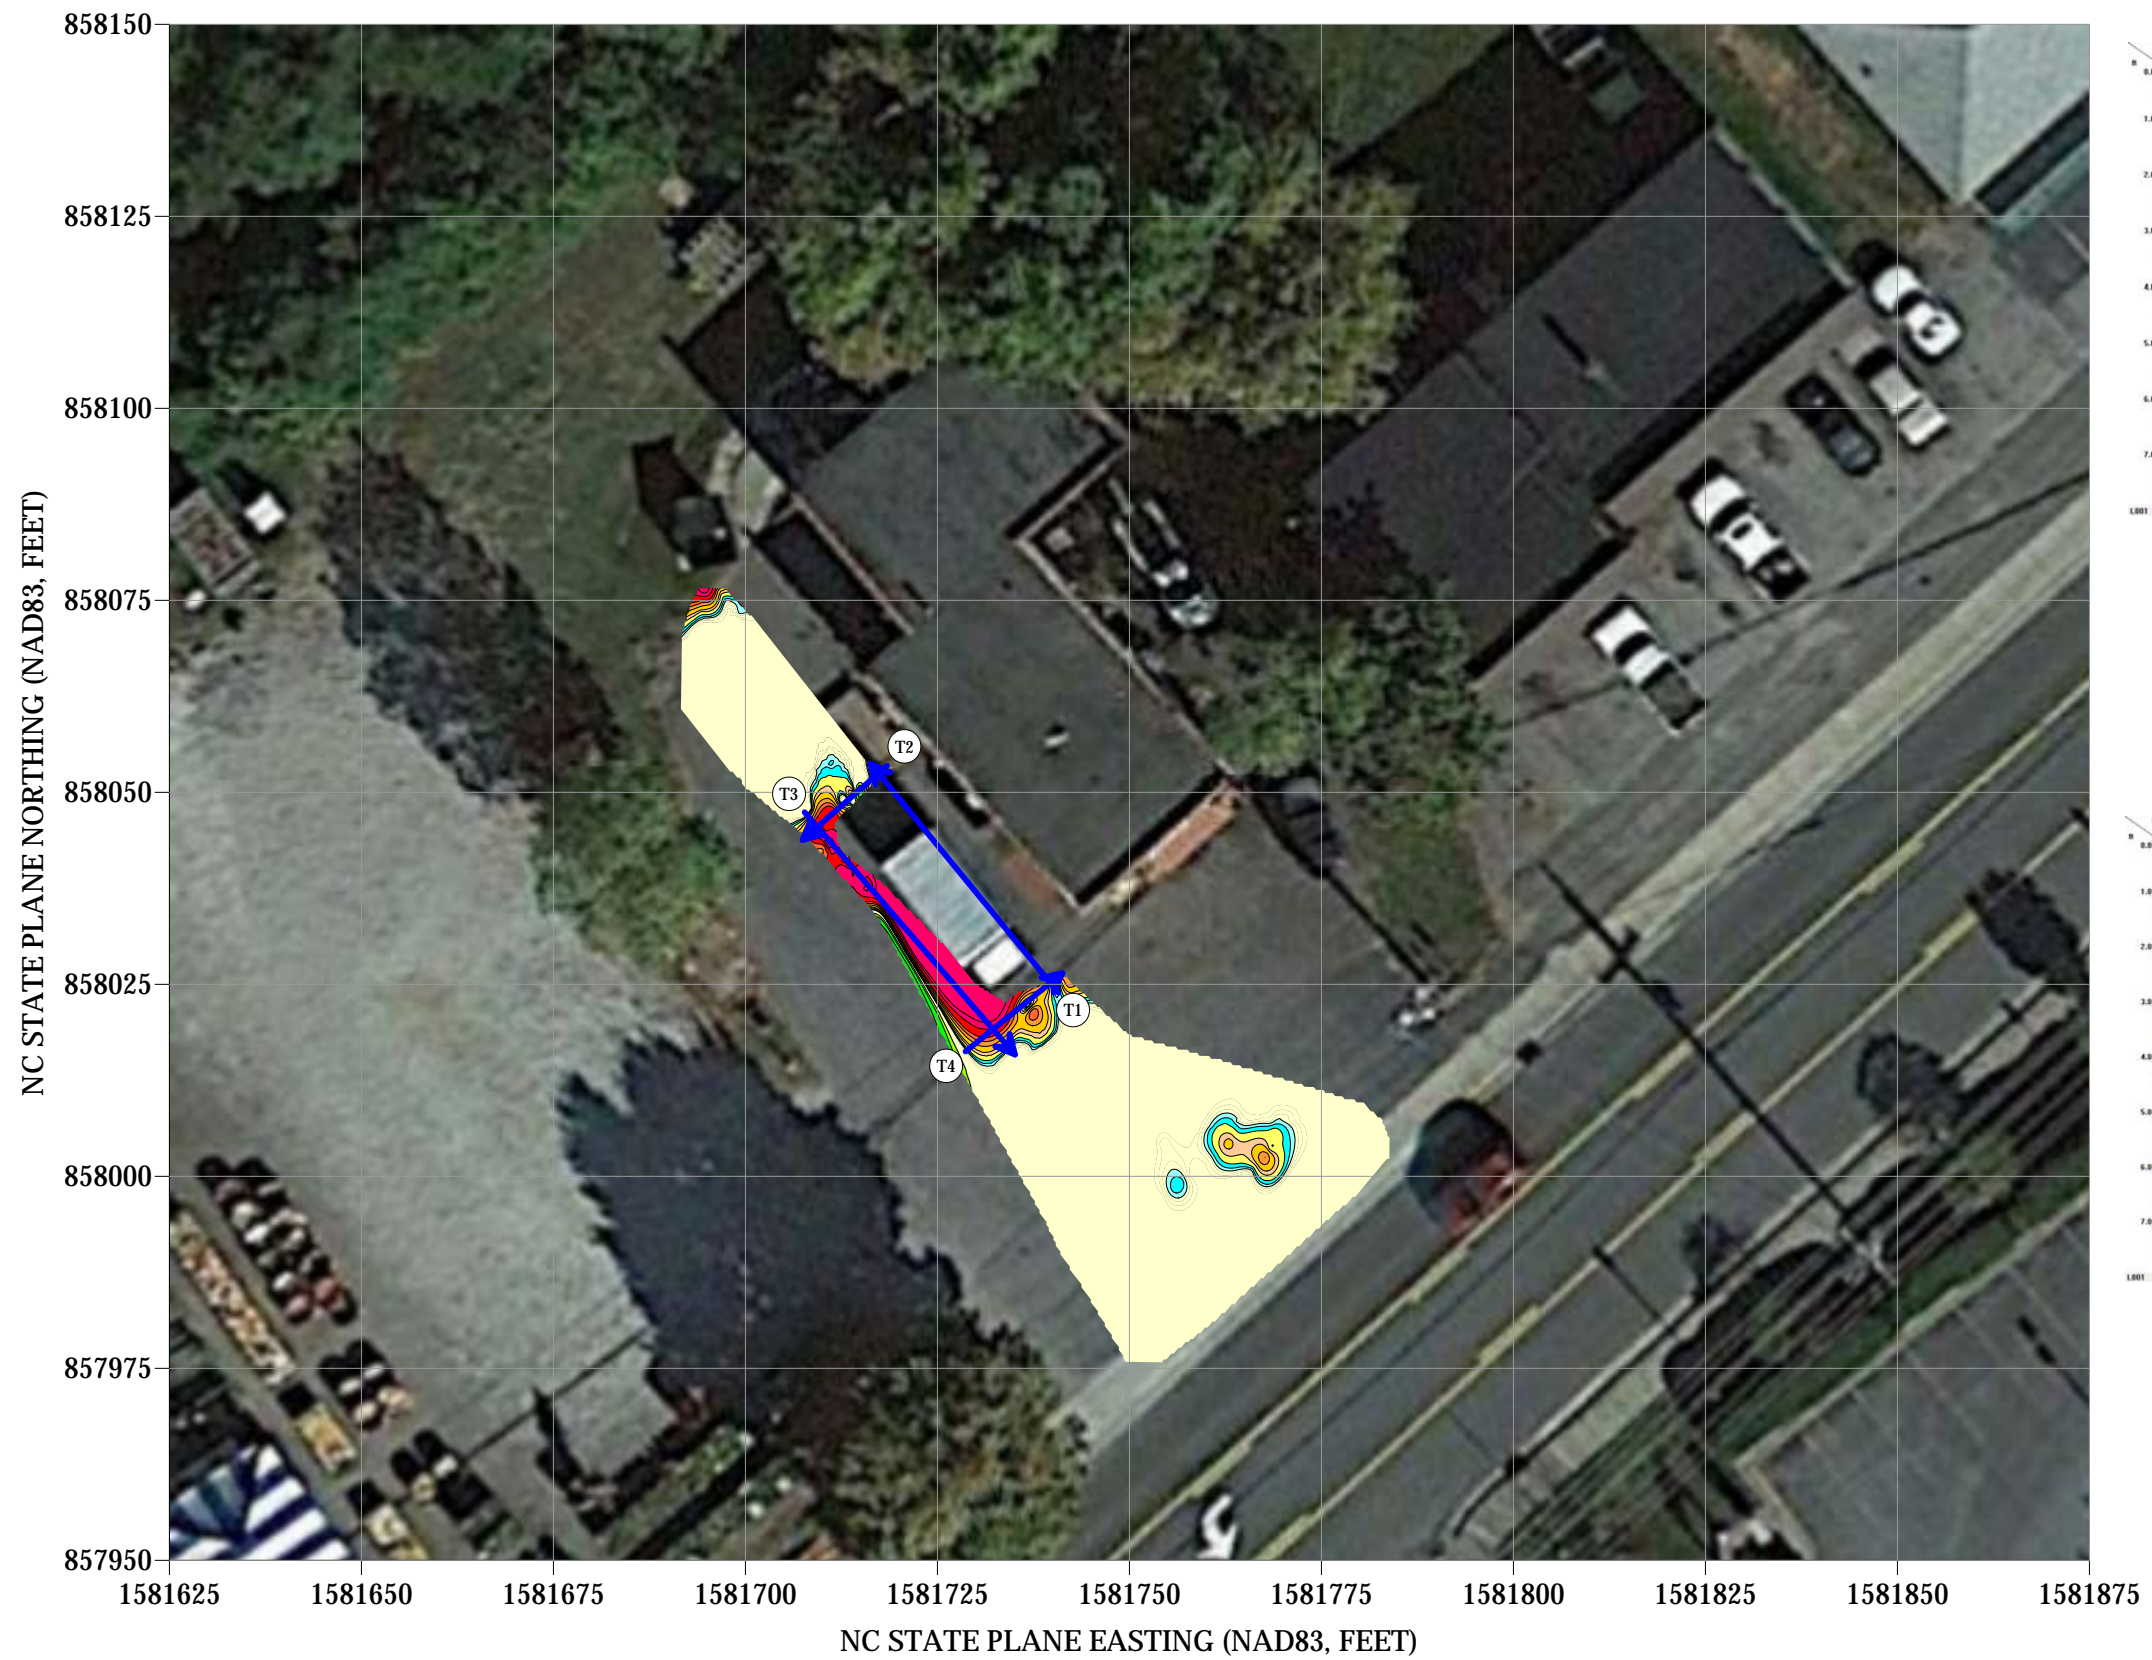
# GPR TRANSECT LOCATIONS

GPR TRANSECT 1 (T1)

GPR Transects 1-4 were performed around the vehicle. These transects showed shallow reflectors consistent with possible buried utilities and/or debris. No evidence of significant structures such as USTs was observed.

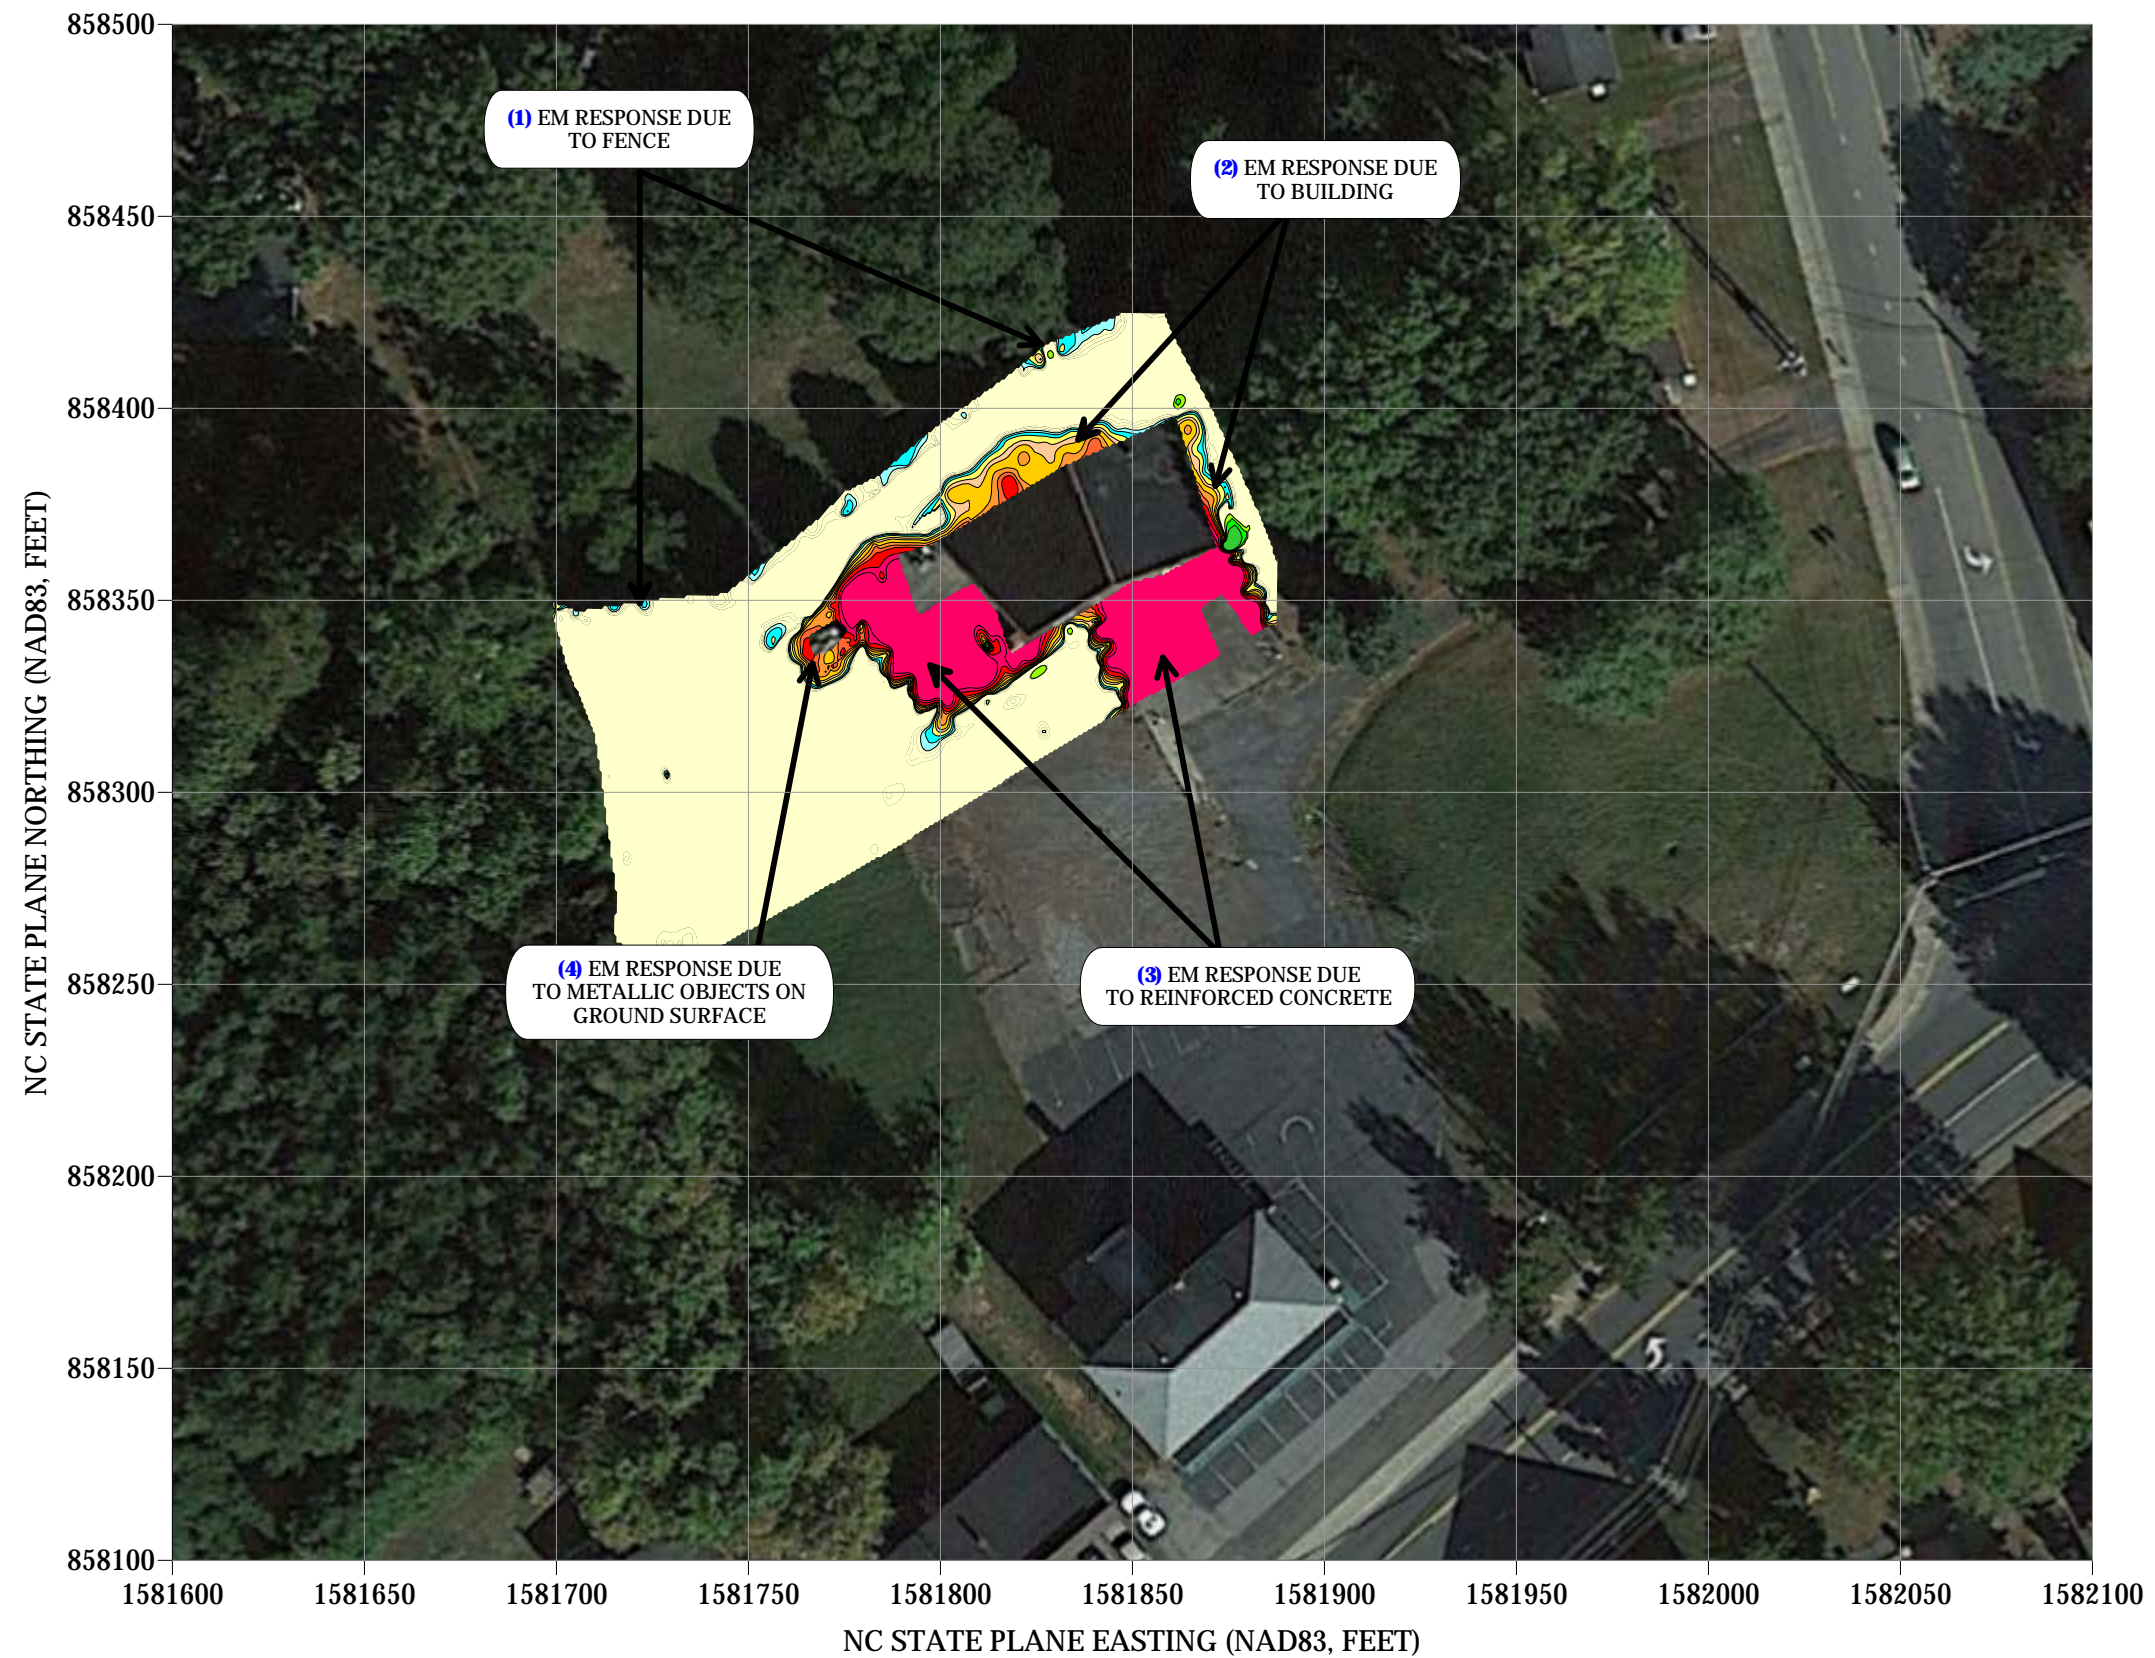
# EM61 METAL DETECTION RESULTS

**NO EVIDENCE OF METALLIC USTs WAS OBSERVED. ONE SEPTIC TANK WAS IDENTIFIED.**

The contour plot shows the differential results of the EM61 instrument in millivolts (mV). The differential results focus on larger metallic objects such as USTs and drums. The EM data were collected on May 10, 2022, using a Geonics EM61-MK2 instrument. Verification GPR data were collected using a GSSI SIR 4000 instrument with a 350 MHz HS antenna on May 11, 2022.

A contour plot of the EM61 results obtained across the survey area at the property is presented in **Figure 2**. Each EM anomaly is numbered for reference in the figure. The following table presents the list of EM anomalies and the cause of the metallic response, if known:

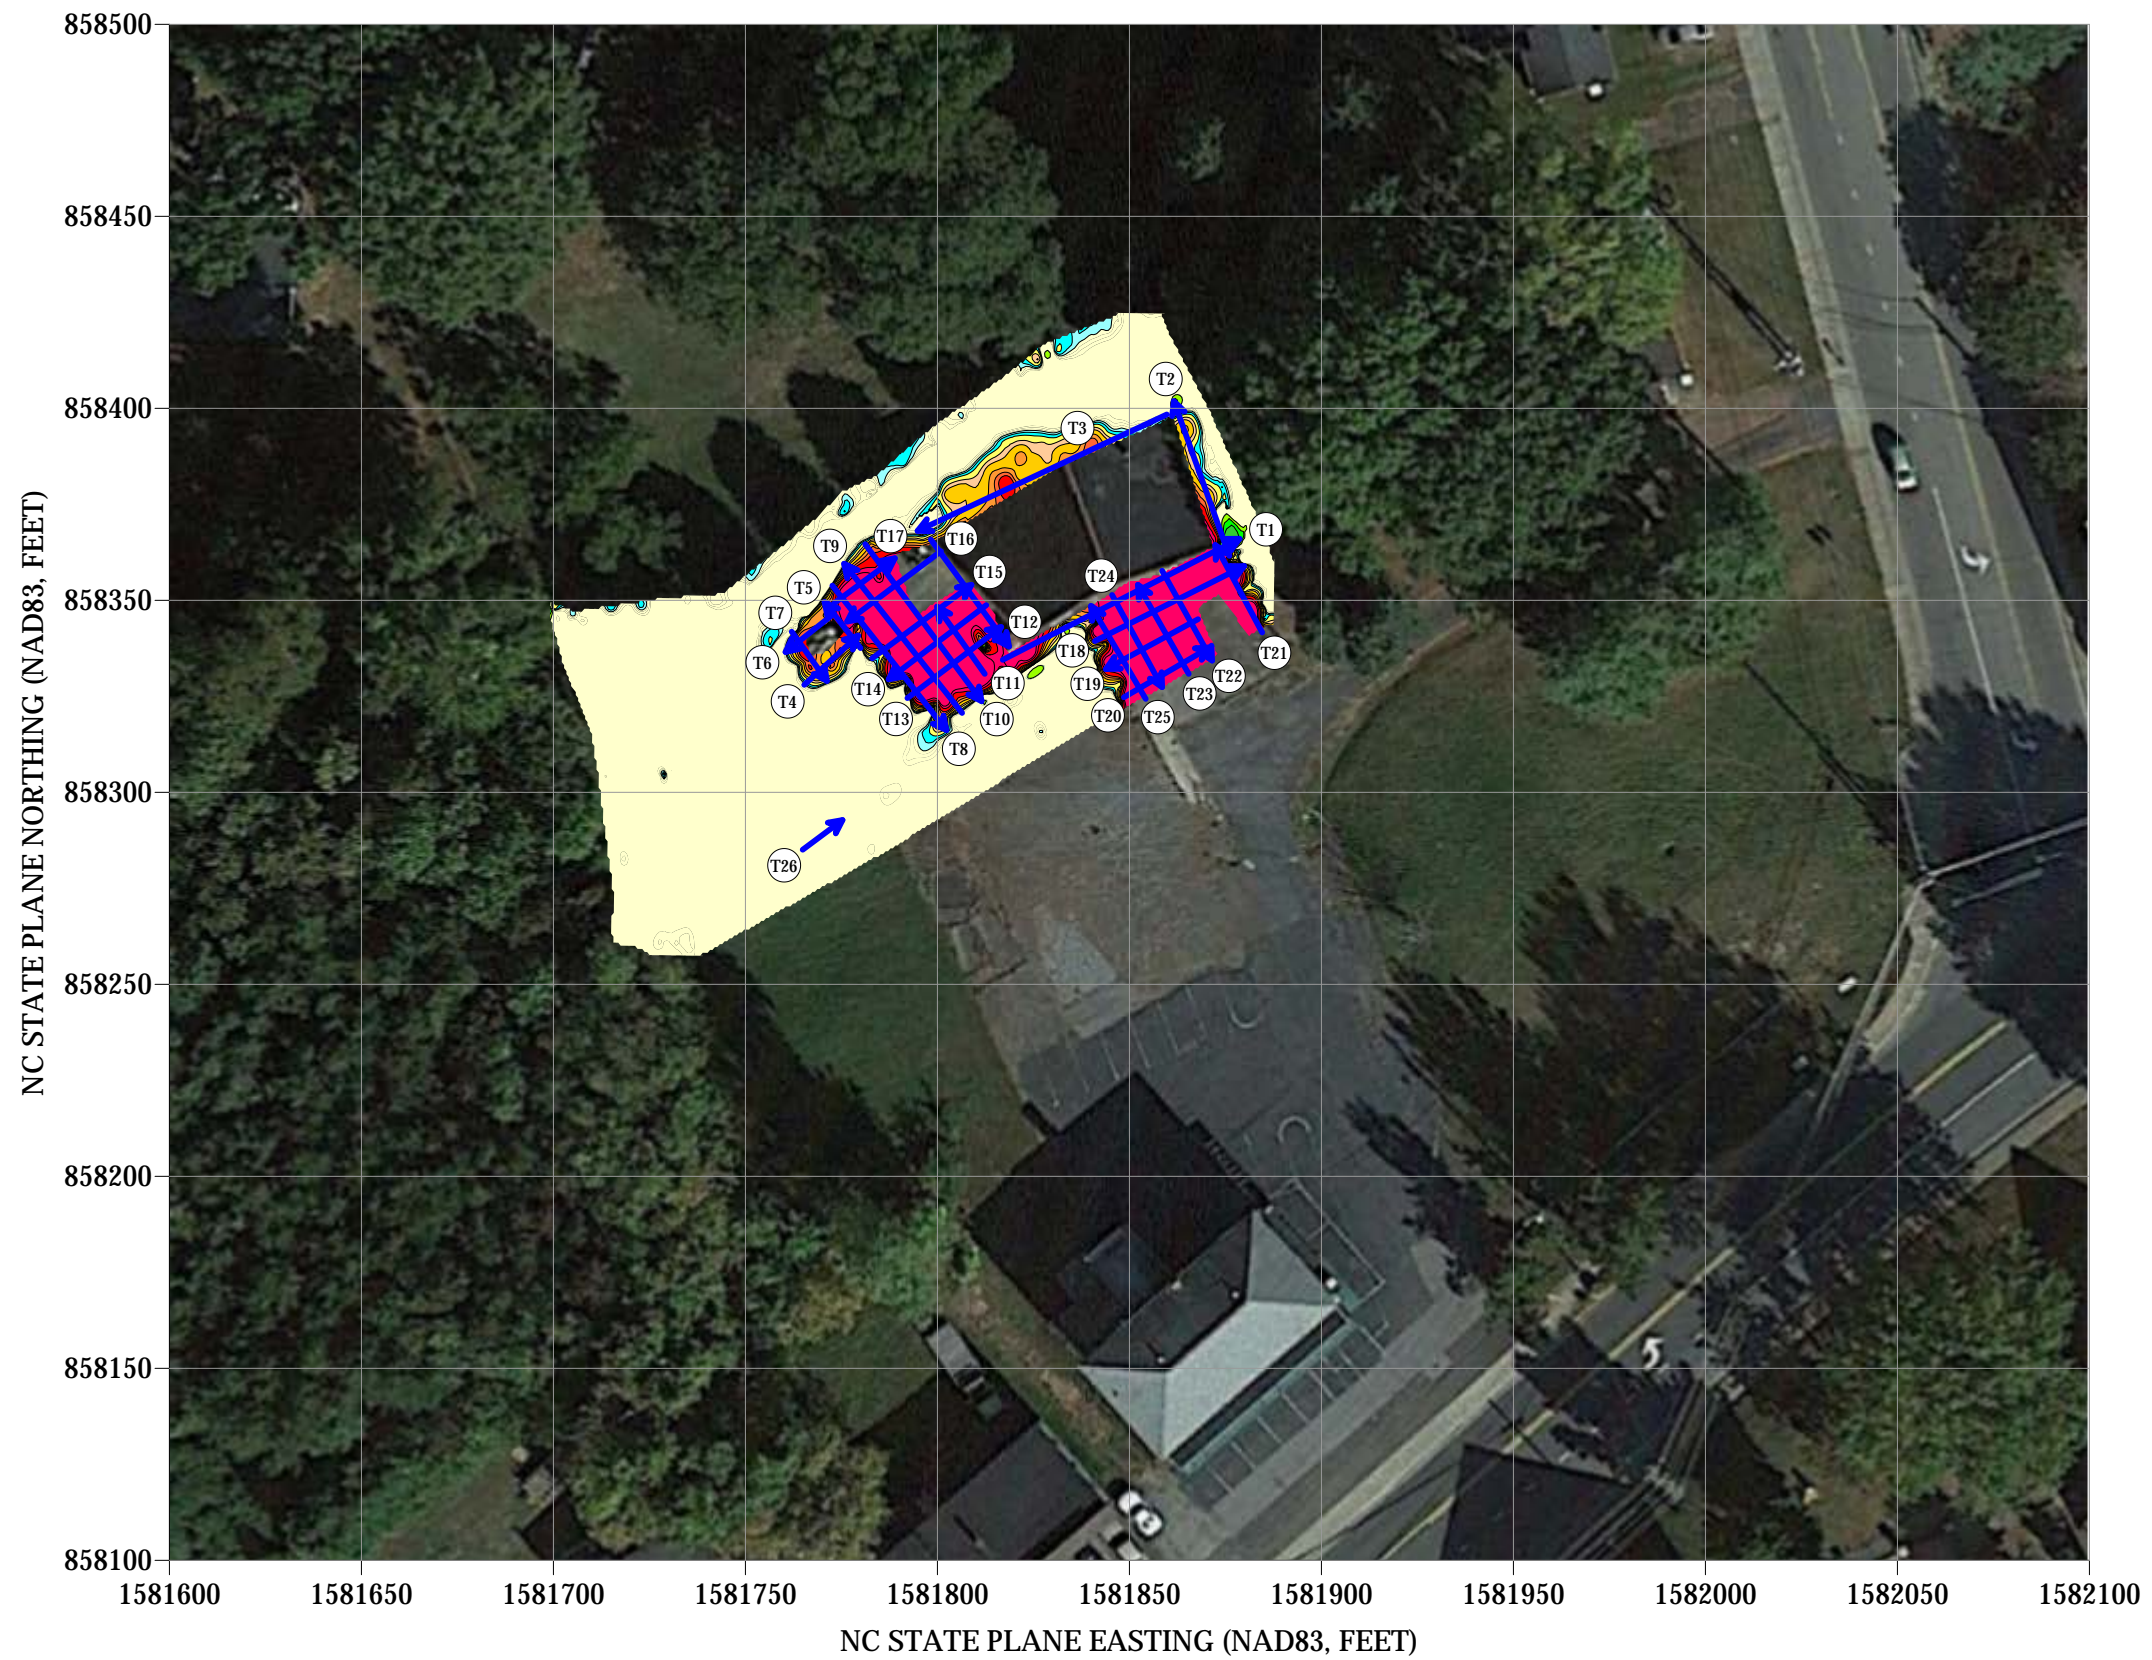
# GPR TRANSECT LOCATIONS

GPR TRANSECT 10 (T10)

GPR Transects 1-25 were performed across areas of metallic interference. These transects showed shallow reflectors consistent with possible buried utilities and/or debris and verified the presence of reinforcement in the concrete slab. No evidence of significant structures such as USTs was observed.

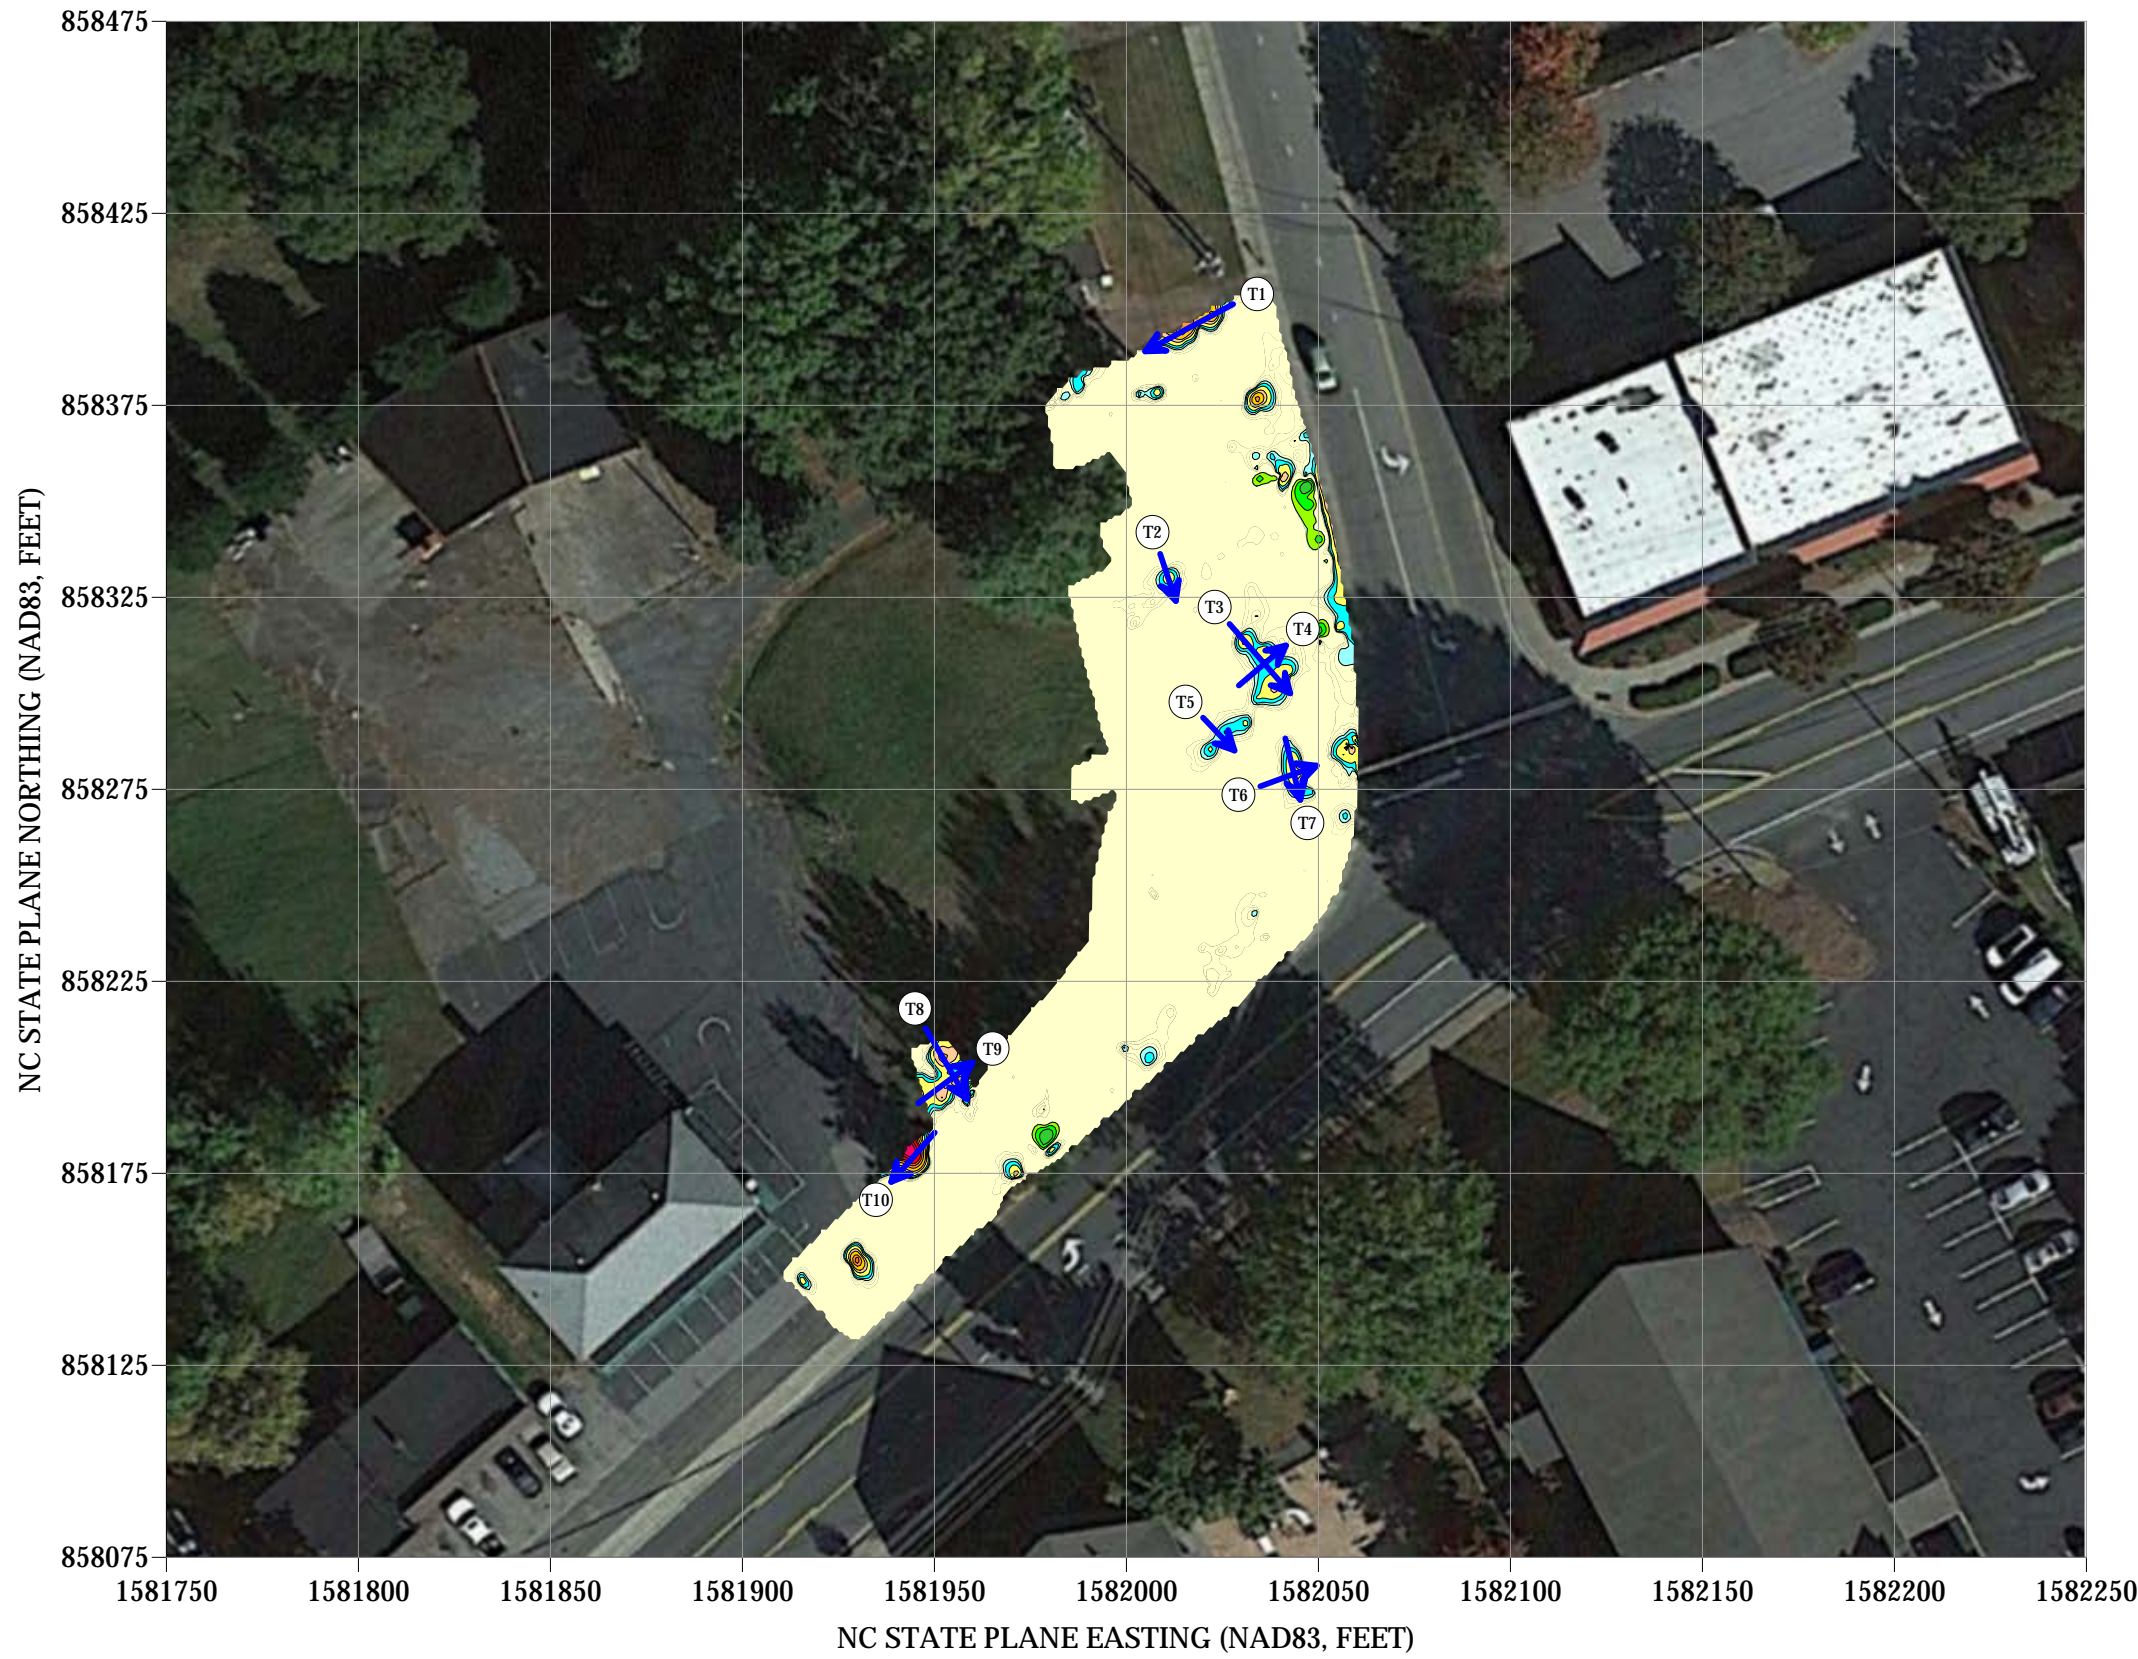
# GPR TRANSECT LOCATIONS

GPR TRANSECT 3 (T3)

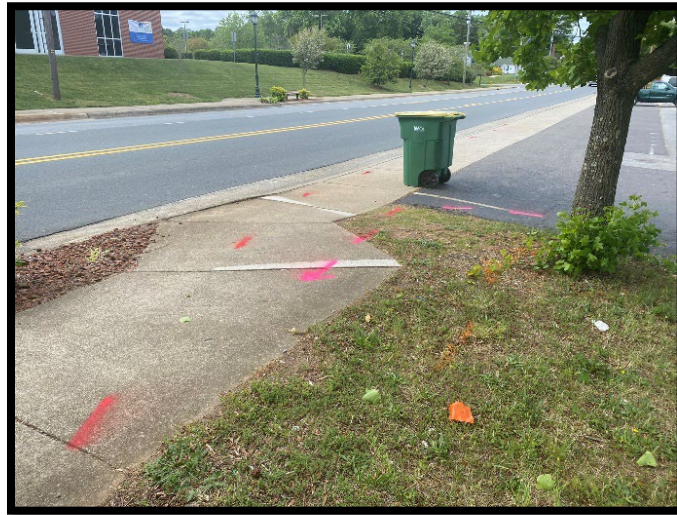
*Figure 1 Parcel 39, NC 811 and Pyramid utility mark outs at southwestern portion of property along Shallowford Road*

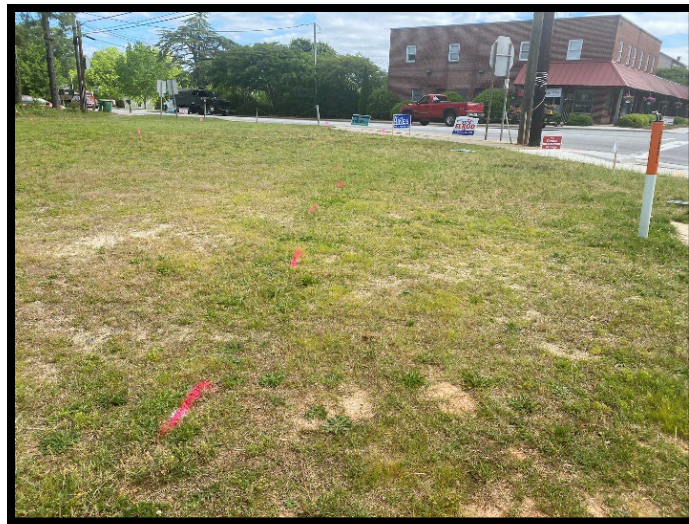
*Figure 2 Parcel 39, NC 811 and Pyramid utility mark outs near fiber optic easement, along Shallowford Road.*
