Reference: Preliminary Site Assessment Edward Schantz Property (Parcel #139) 6006 Raeford Road Fayetteville, Cumberland County, North Carolina State Project: U-4405 WBS Element 39049.1.1 SIES Project No. 2016.0054.NDOT

Solutions-IES, Inc., (SIES) has completed the Preliminary Site Assessment conducted at the abovereferenced property. The work was performed in accordance with the Technical and Cost proposal dated September 26, 2016, and the North Carolina Department of Transportation's (NCDOT's) Notice to Proceed dated September 26, 2016. Activities associated with the assessment consisted of conducting a geophysical investigation, collecting soil samples for analysis, and reviewing applicable North Carolina Department of Environmental Quality (NCDEQ) records. The purpose of this report is to document the field activities, present the laboratory analyses, and provide recommendations regarding the property.

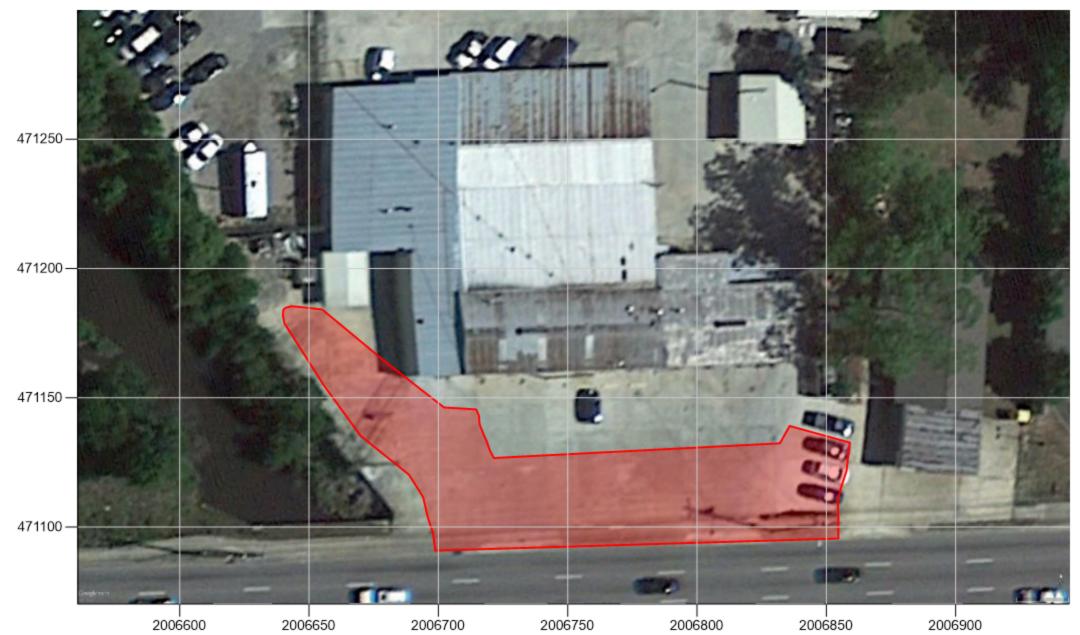
APPROXIMATE BOUNDARIES OF GEOPHYSICAL SURVEY AREA

The site included an automotive repair facility surrounded by concrete parking space. Aerial photographs showing the survey area boundaries and ground-level photographs are shown in **Figure 1**.

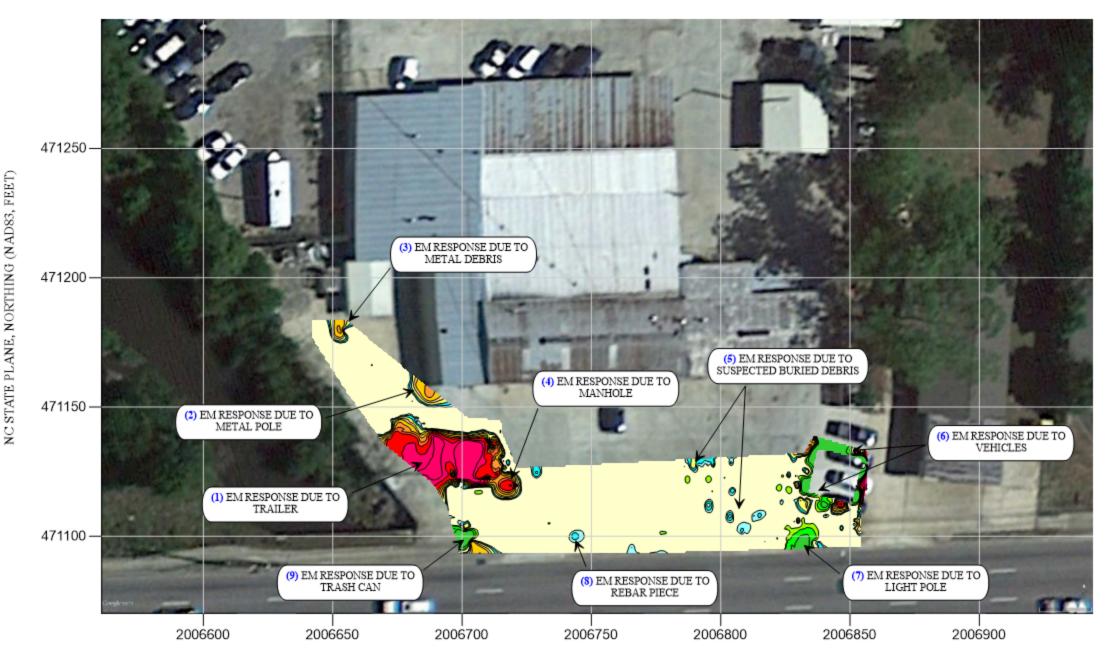
EM61 METAL DETECTION RESULTS

following table presents the list of EM anomalies and the cause of the metallic response, if known:

Metallic Anomaly #	Cause of Anomaly	Investigated with GPR
1	Trailer	
2	Metal Pole	
3	Metal Debris	
4	Manhole	
5	Suspected Metallic Debris	\otimes
6	Vehicles	
7	Light Pole	
8	Rebar Piece	
9	Trash Can

NUMBERS IN BLUE (x) CORRESPOND TO ANOMALY TABLE INCLUDED IN THE REPORT

NO EVIDENCE OF UNKNOWN METALLIC USTs OBSERVED

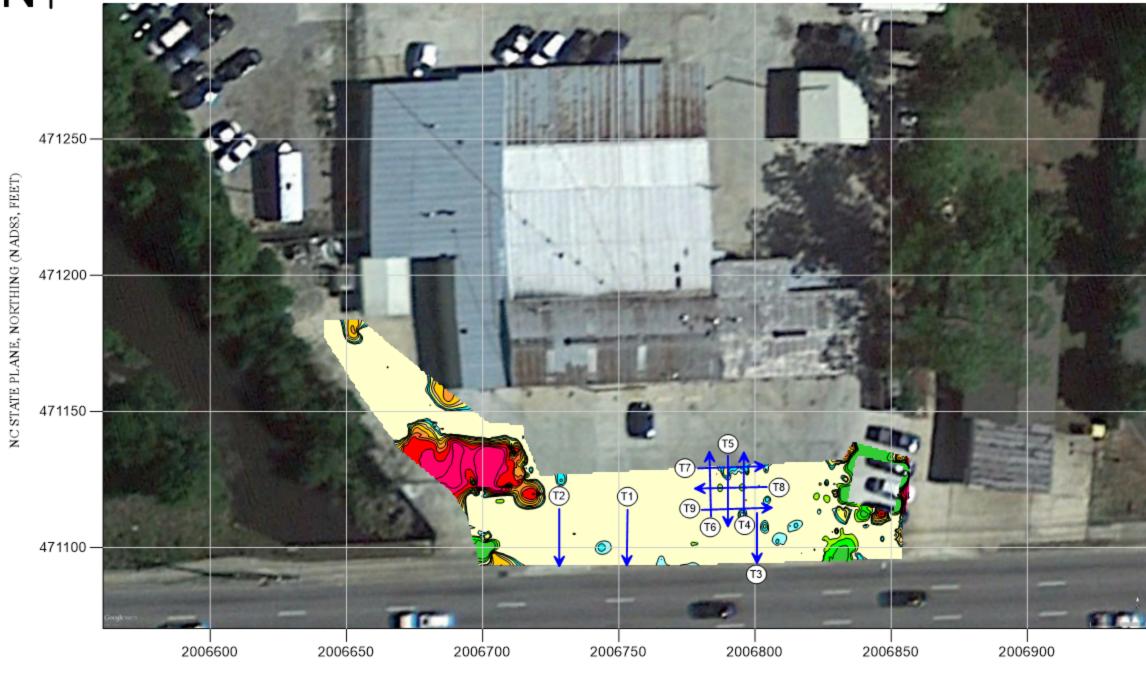
Figure 3 presents the locations of the formal GPR transects performed at the property, as well as select transect images. A total of 9 GPR transects were performed at the site across EM anomalies and other areas of interest. Transects 1-3 were performed across a suspected utility/conduit that was observed during reconnaissance GPR scans. This suspected conduit was not evident on the EM differential results contour map included in this report; however, review of the more sensitive bottom coil EM results did provide evidence of a linear feature extending across the property from west to east that was suggestive of a utility/conduit. These GPR transects recorded an isolated, discreet hyperbolic reflector that is consistent with a utility/conduit.

LOCATIONS OF GPR TRANSECTS

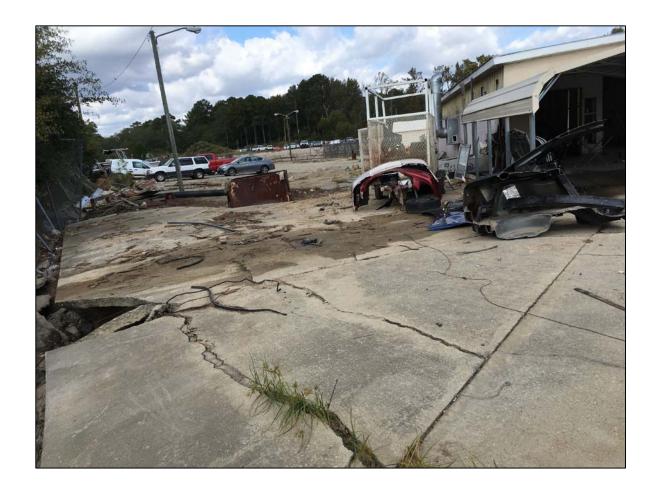
PHOTO 5

INVESTIGATION AREA DAMAGED BY HURRICANE MATTHEW

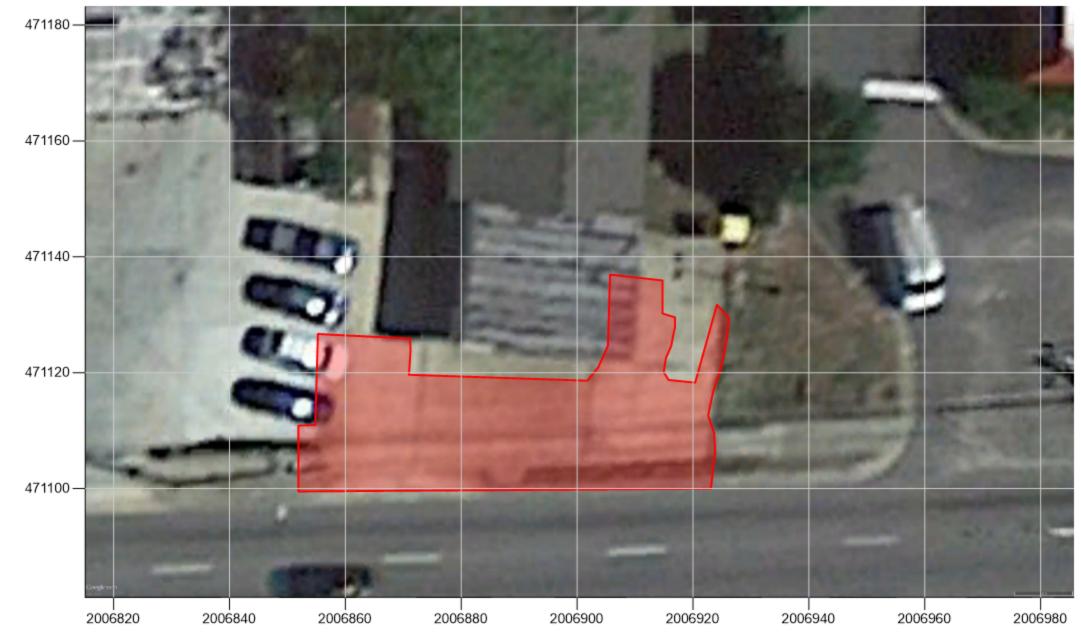
APPROXIMATE BOUNDARIES OF GEOPHYSICAL SURVEY AREA

The site included a commercial building with a canopy surrounded by concrete parking space. Two possible fill ports were observed in the concrete at the east edge of the canopy. Aerial photographs showing the survey area boundaries and a ground-level photograph are shown in **Figure 1**.

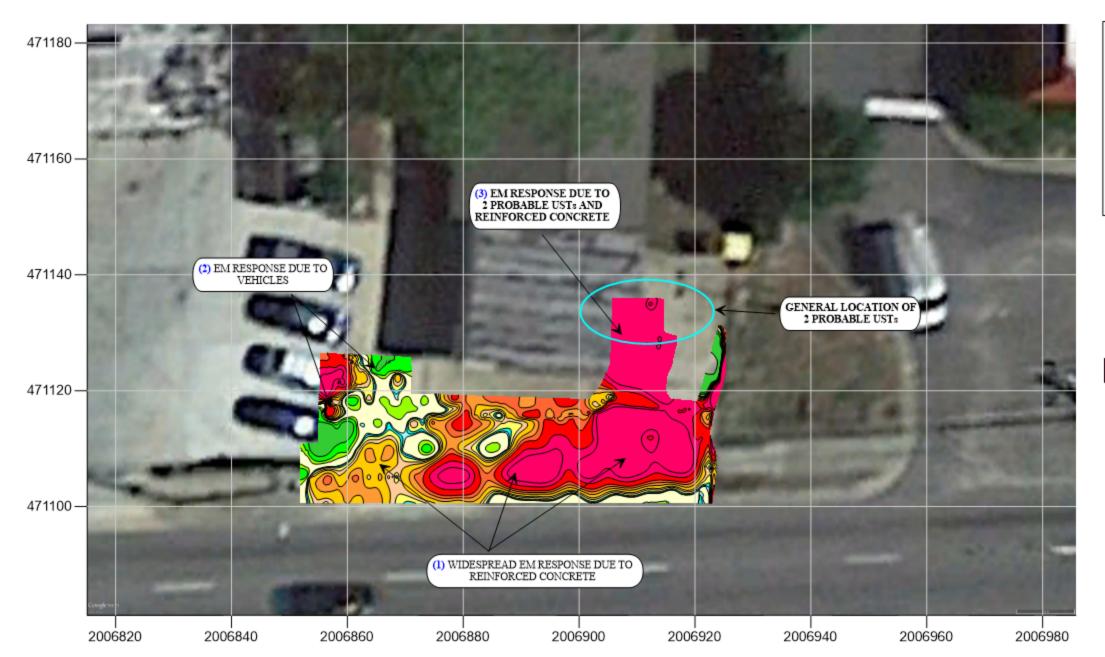
EM61 METAL DETECTION RESULTS

A contour plot of the EM61 results obtained across the survey area at the property is presented in **Figure 2**. Each EM anomaly is numbered for reference in the figure. The following table presents the list of EM anomalies and the cause of the metallic response, if known:

Metallic Anomaly		
#	Cause of Anomaly	Investigated with GPR
1	Widespread Reinforced Concrete	
2	Vehicles	
3	2 Probable USTs and Reinforced Concrete	Ø

Widespread interference was observed across the property due to the presence of metal reinforcement within the majority of the concrete in the survey area. Additionally, EM anomalies were observed on the west side of the survey area (Anomaly 2) that were associated with parked vehicles. Two suspected fill ports were observed on the east side of the canopy at the property, and a high amplitude EM signal was observed at this location. Pyramid performed reconnaissance GPR in this area to investigate for suspected USTs; however, no formal GPR data were saved due to the tenant/property owner preventing further access to the site.

NUMBERS IN BLUE (x) CORRESPOND TO ANOMALY TABLE INCLUDED IN THE REPORT

EVIDENCE OF 2 PROBABLE METALLIC USTs OBSERVED

The contour plot shows the differential results of the EM61 instrument in millivolts (mV). The differential results focus on larger metallic objects such as USTs and drums. The EM61 data were collected on October 13, 2016, using a Geonics EM61 instrument. Initial reconnaissance GPR verified the presence of 2 probable metallic USTs at the location indicated in the figure. Prior to finalizing and saving GPR data, the tenant/owner prevented further access to the property. No GPR data were saved. Approximately 75% of the outlines of the USTs were marked in the field with marking paint.
