UST Closure Report

Former Molgora Property

**6002 Raeford Road
Fayetteville, North Carolina**

February 12, 2019

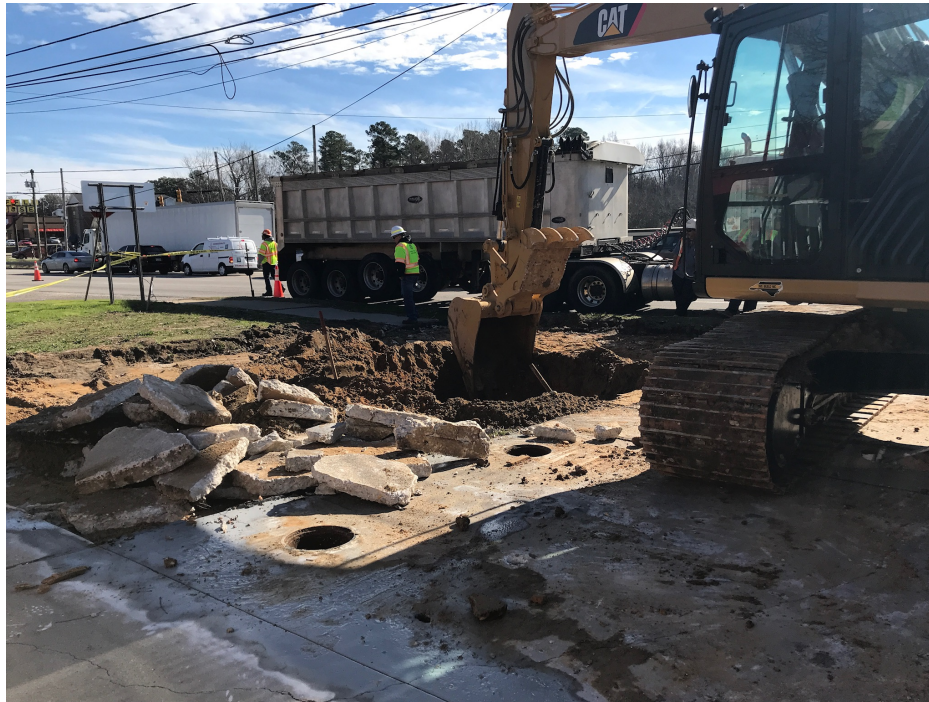
Photo 2: Backhoe excavation of abandoned UST

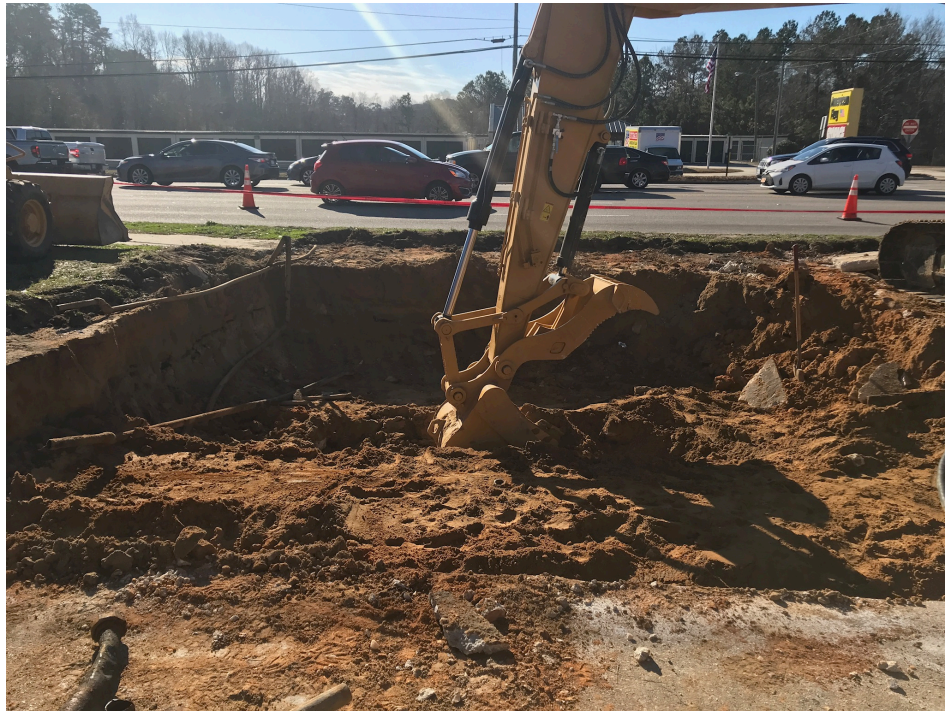
Photo 3: Excavation area prior to tank removal, facing the South.

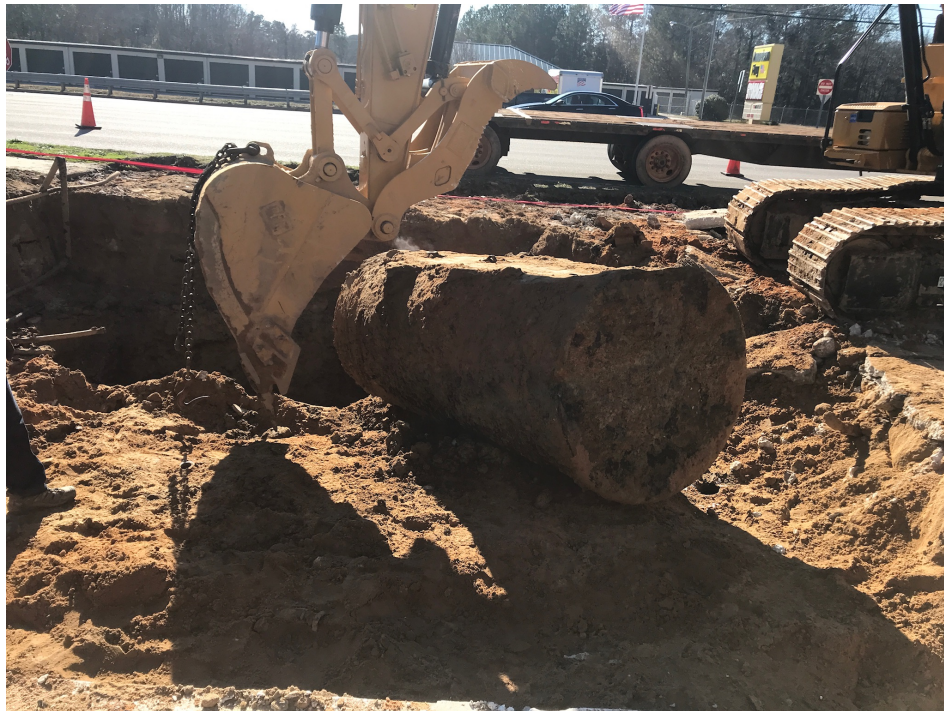
Soils removed prior to removal of USTs were disposed off-site by EVO. Three tanks (UST-1, UST-2, and UST-4) were buried to a depth of about 2.5 feet below ground surface (ft bgs); UST-3 (the kerosene UST) was located at a depth of about 4 ft bgs. During soil excavation, the excavation sidewall and base conditions were observed. Staining and odors were identified in the soil located at the side walls and base of UST-3, but no staining or odors were observed at the other USTs. Additional excavation was completed beneath UST-3 and soils samples were analyzed to a final depth of 10 ft bgs, where soils reached a value below the DRO/GRO action limits.

Photo 4: UST-3 removal, 550-gallon kerosene UST

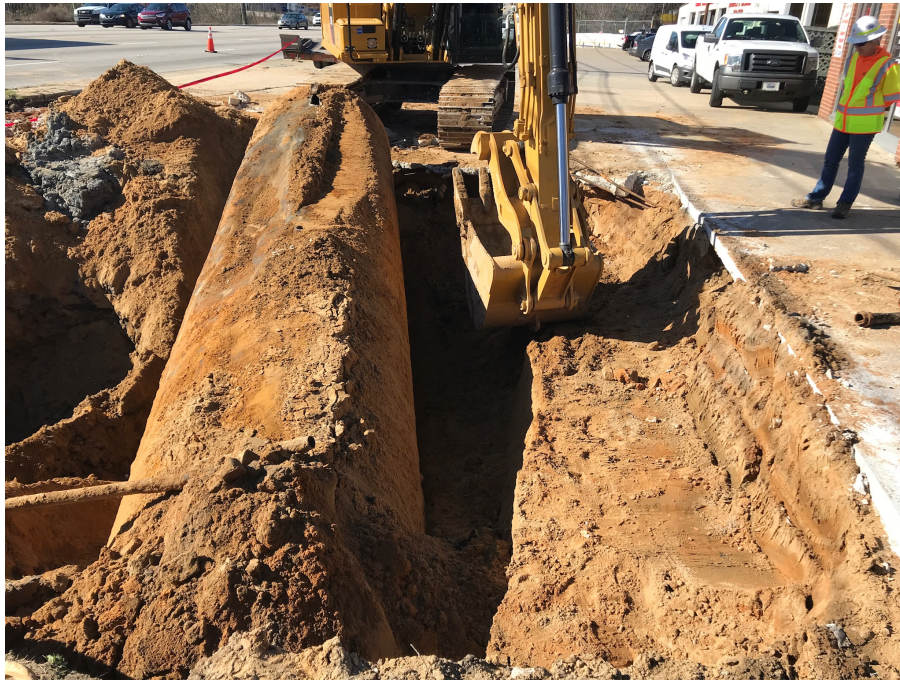
Photo 5: UST-2 removal, 4,000-gallon petroleum UST, facing West

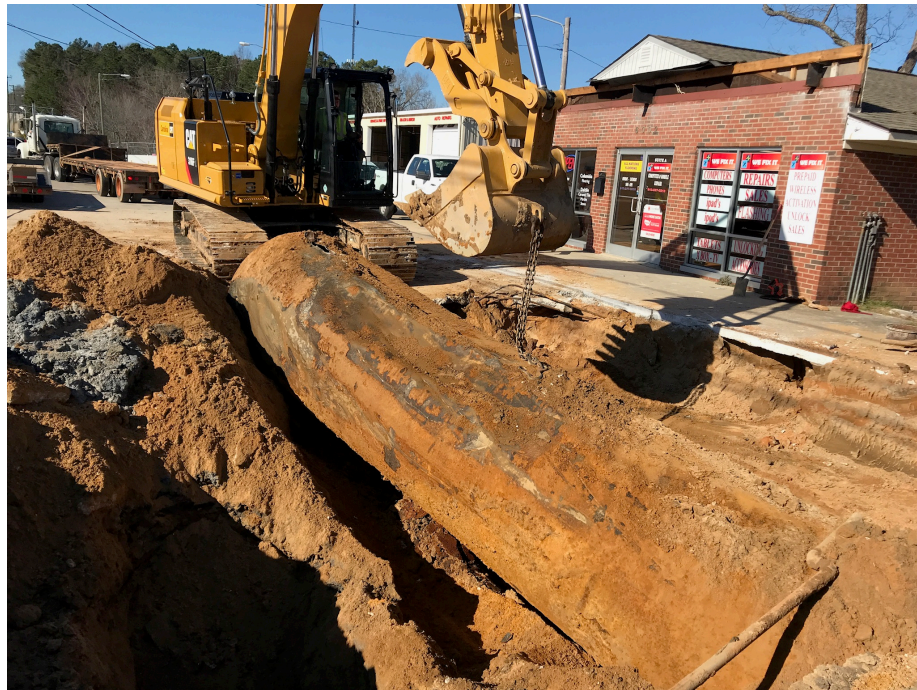
Photo 6: UST-2 removal, 4,000-gallon petroleum UST, facing Northwest

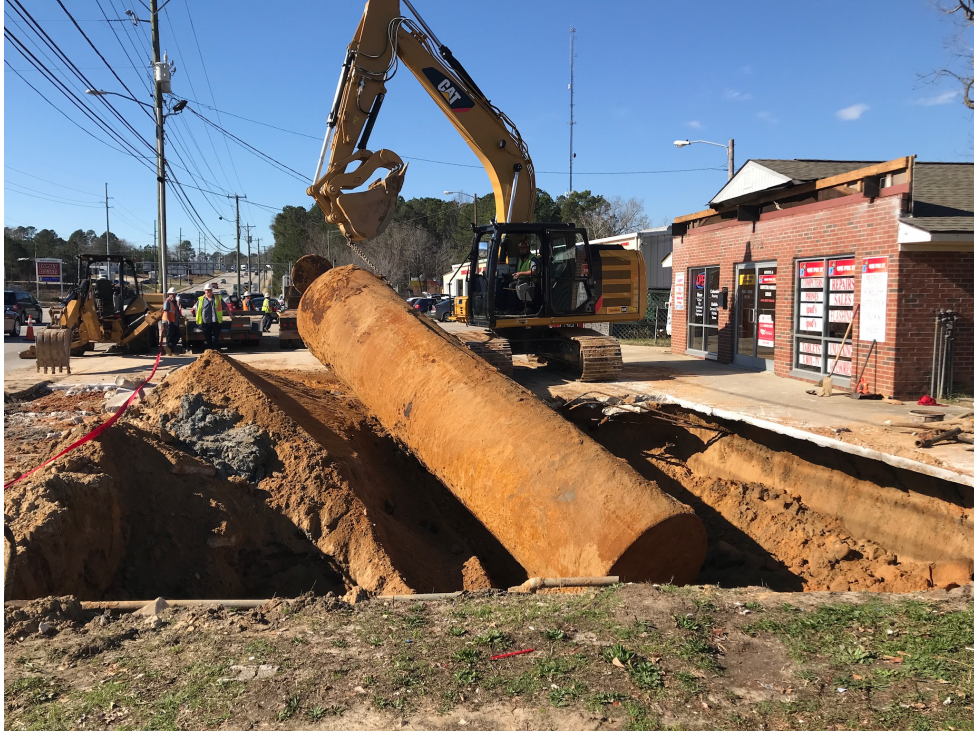
Photo 7: UST-1 removal, 4,000-gallon petroleum UST, facing West

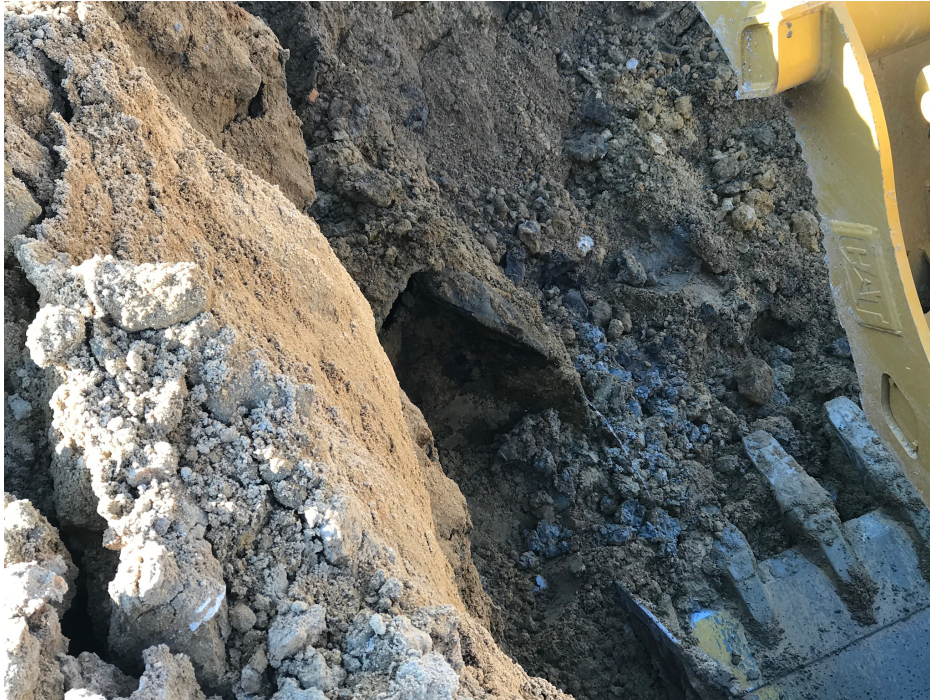
Photo 8: Backhoe excavation of abandoned UST, discovery of UST-4

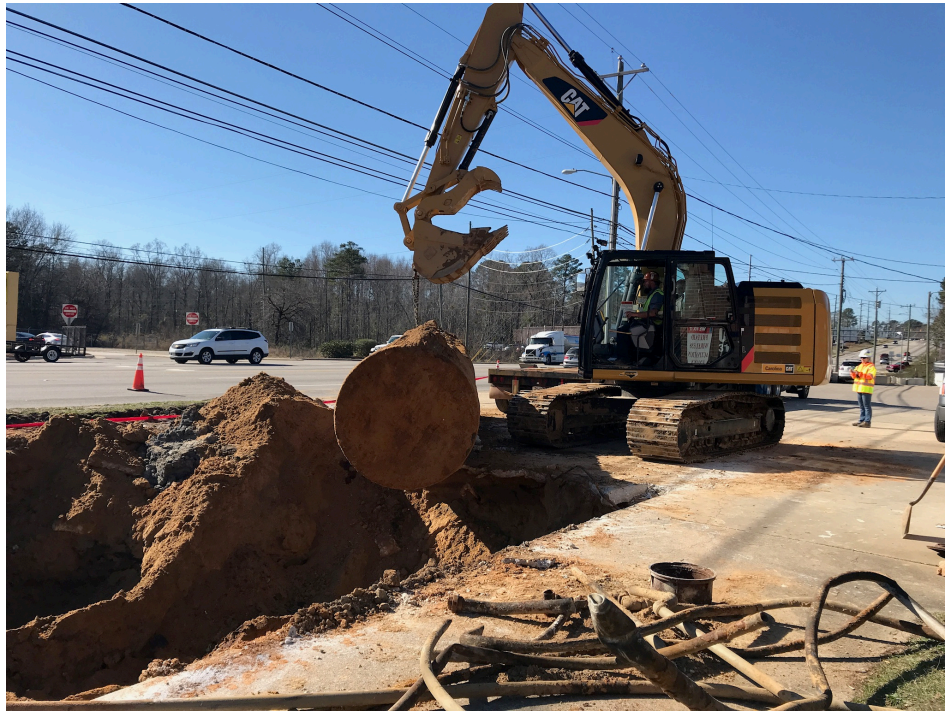
Photo 9: UST-4, 1000-gallon petroleum UST, facing Southwest

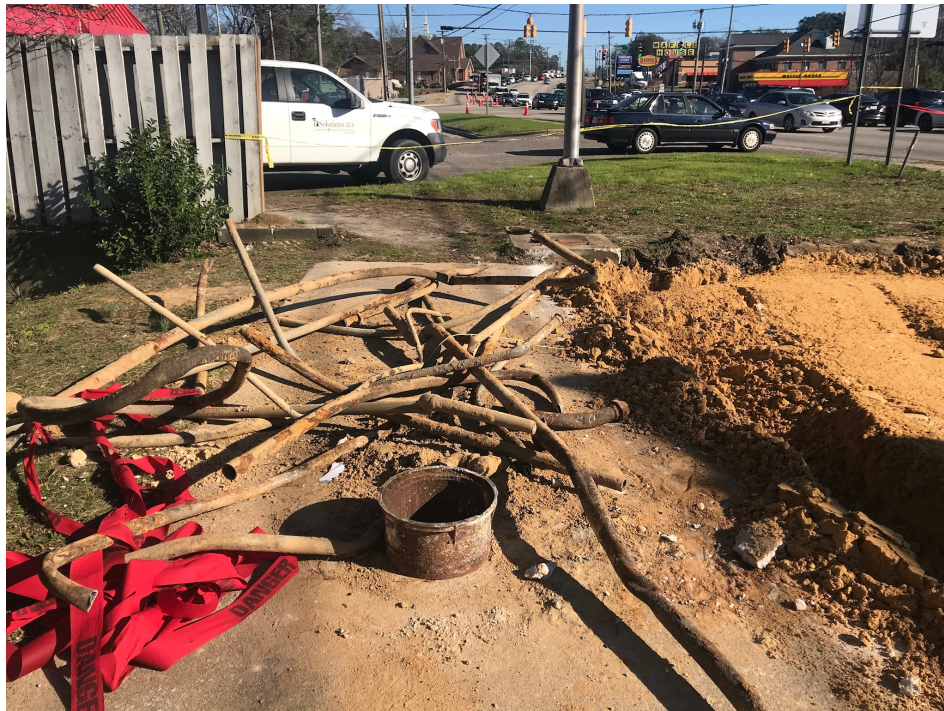
Photo 10: UST connections

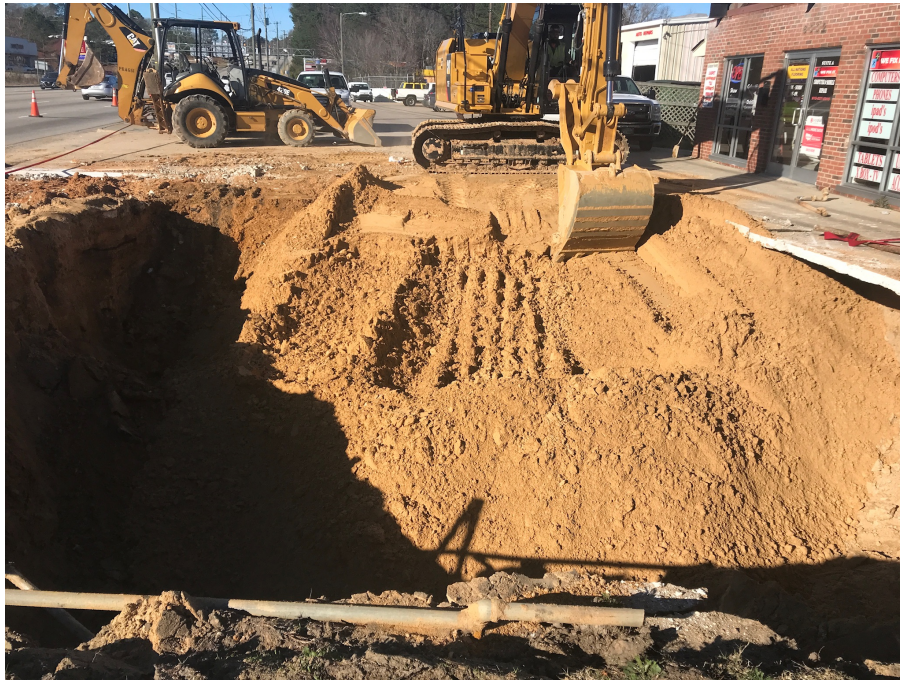
Photo 11: Backfill of excavated area, facing West

About 155 tons of nonhazardous contaminated soil were disposed off-site by EVO. Excavation activities did not encounter groundwater or bedrock. The excavation was backfilled with 154 tons of clean soil and 22 tons of quarry fill on top. Photographs taken during the excavation activities are presented in **Appendix D**.

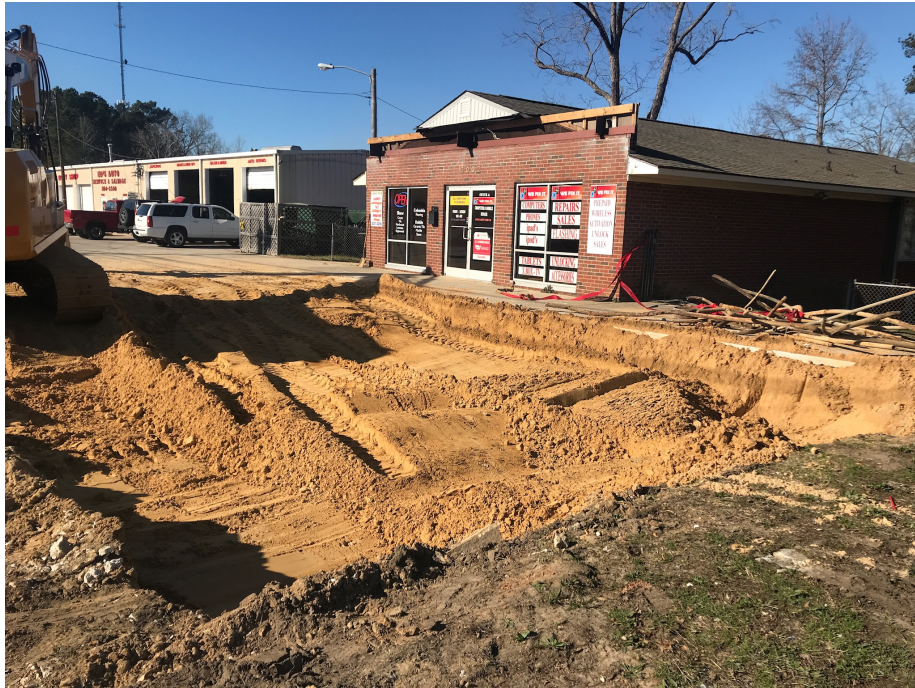
Photo 12: Backfill of excavated area, facing Northwest
