TIP NO: B-5895
WBS: 48088.1.1
COUNTY: Madison
DIVISION: 13
DESCRIPTION: Replace Bridge 67 over French Broad River on US 25/ US 70 in Hot Springs

SUBJECT: **GeoEnvironmental Report for Planning**

Phase II Site Assessment Report
November 30, 2022
WBS Element: 48088.1.1
State Project: B-5895
Madison County

Parcel #: 001
Eugene Glen Hicks, et. al. Property
300 Bridge Street, Hot Springs, NC 28743
PIN #: 8860-63-1420
Facility ID #: N/A
Groundwater Incident #: N/A

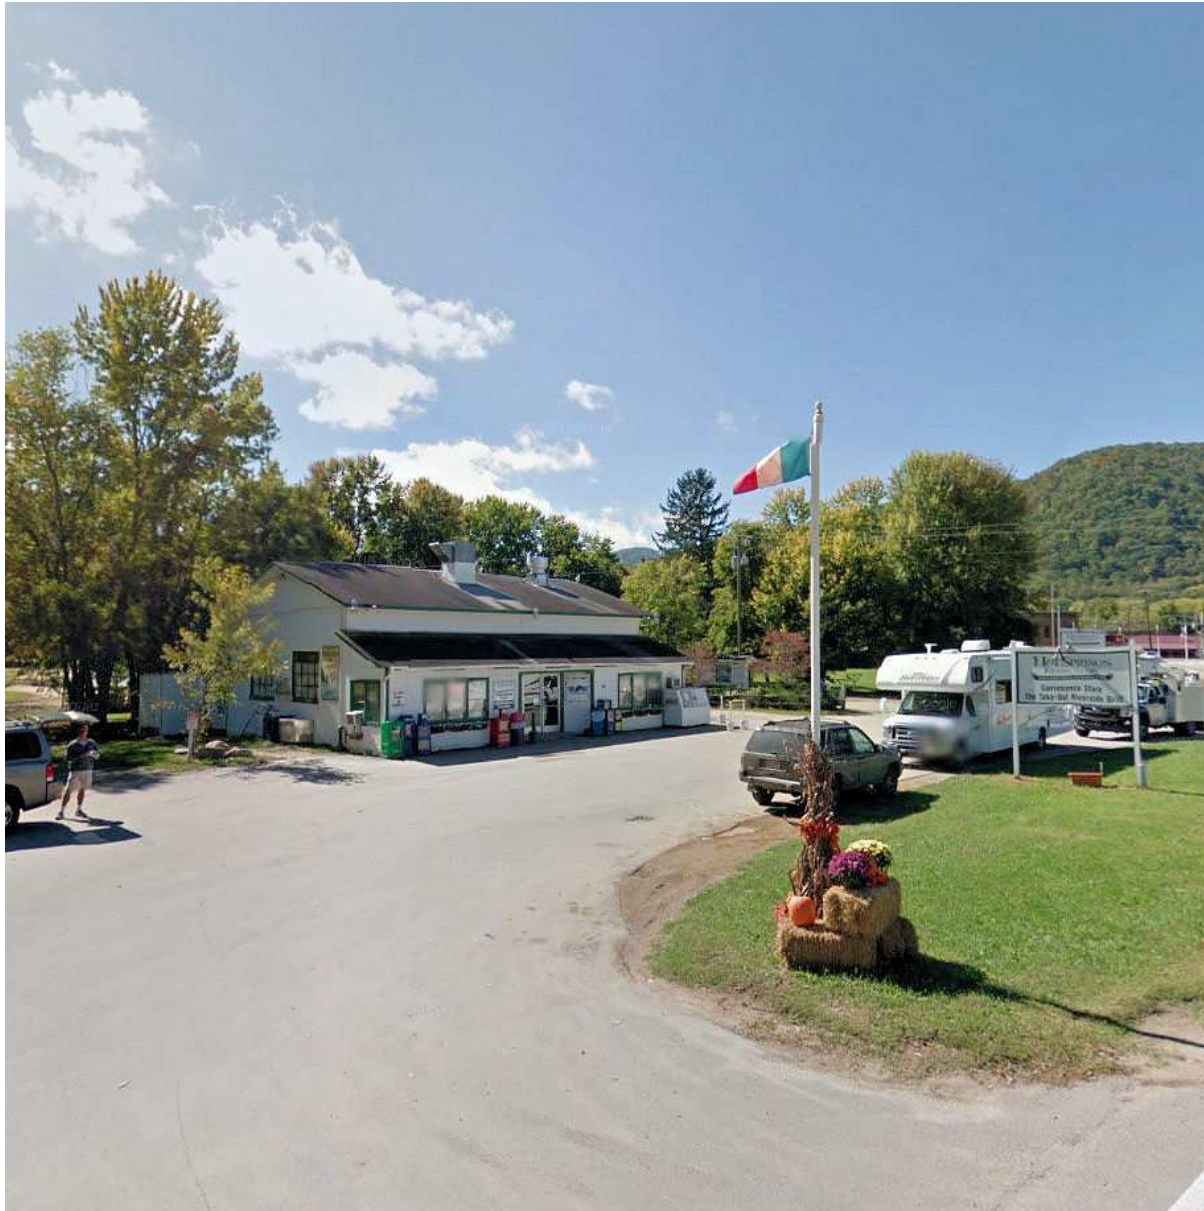
This convenience store is located on the south side of US 25/ US 70 (Bridge Street) and 200 feet west from Bridge 67 in Hot Springs. According to the UST Section Registry five (5) tanks were removed in 2001 from the former Roy Whitson 66. Groundwater Incident AS-2720 was assigned to this site, but closed out the same year. **This site is anticipated to present low geoenvironmental impacts to the project.**

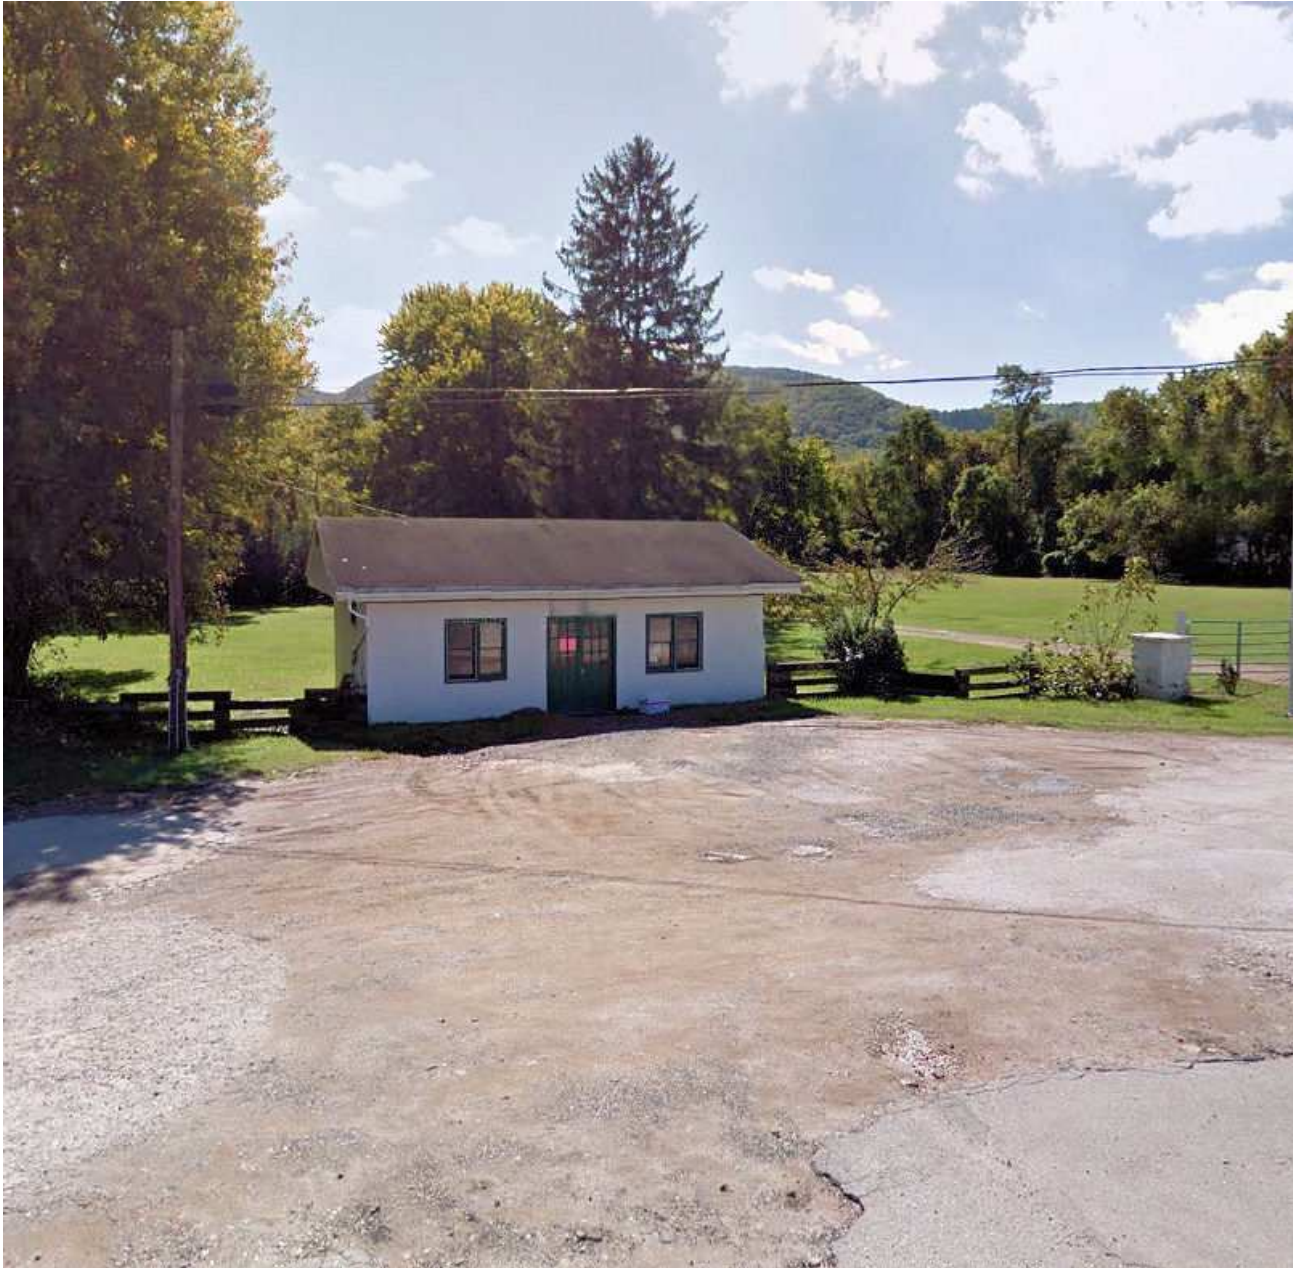
This office is located on the south side of US 25/ US 70 (Bridge Street) and 375 feet west from Bridge 67 in Hot Springs. A gas station may have operated at this location in the past. This property does not appear on the UST Section Registry nor on the Groundwater Incident database. **This site is anticipated to present low geoenvironmental impacts to the project.**

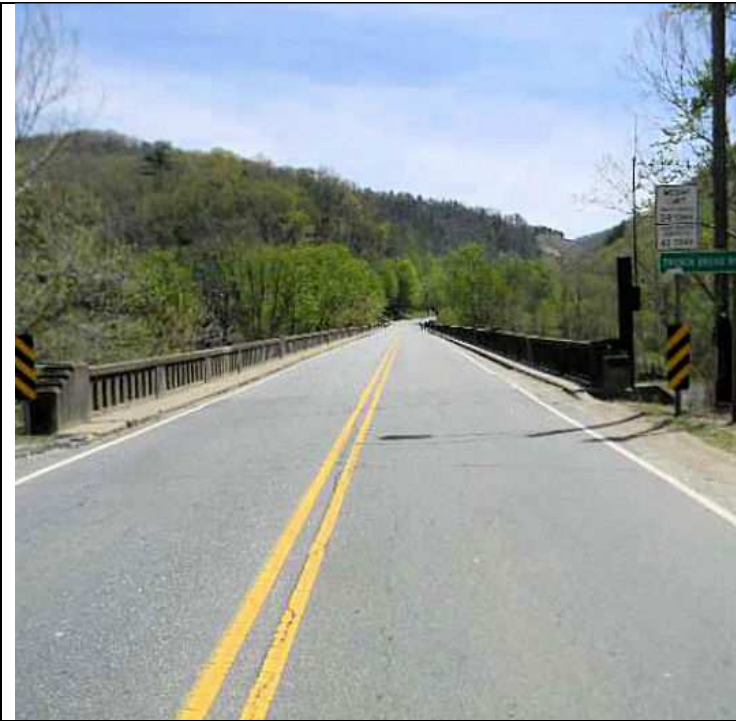
Bridge 67 on US 25/ US 70. View to the east.

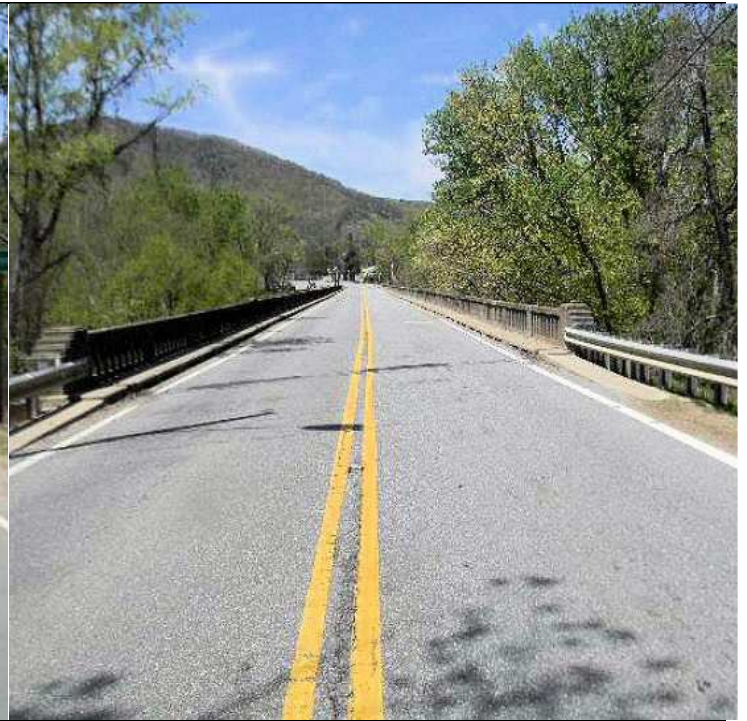
Bridge 67 on US 25/ US 70. View to the west.

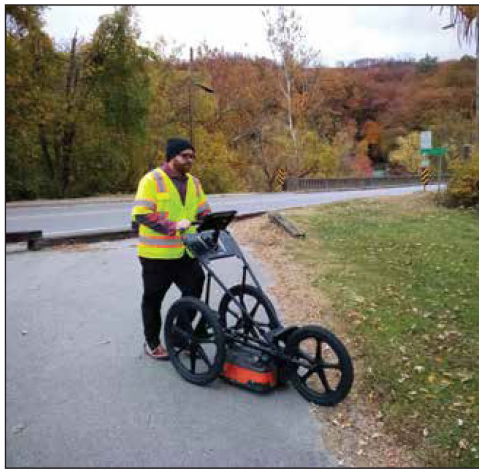
Photo 1. Collecting GPR data in Grid 1 at Parcel #001.

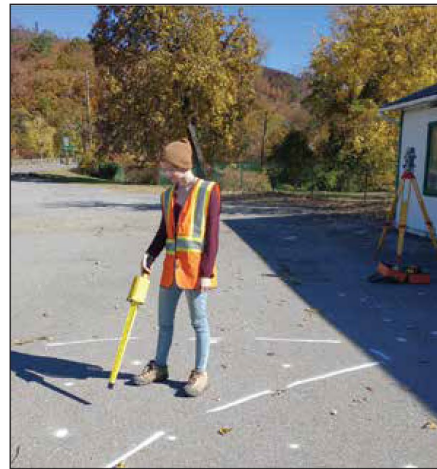
Photo 2. Checking magnetic anomalies with the Schonstedt to mark the perimeter.

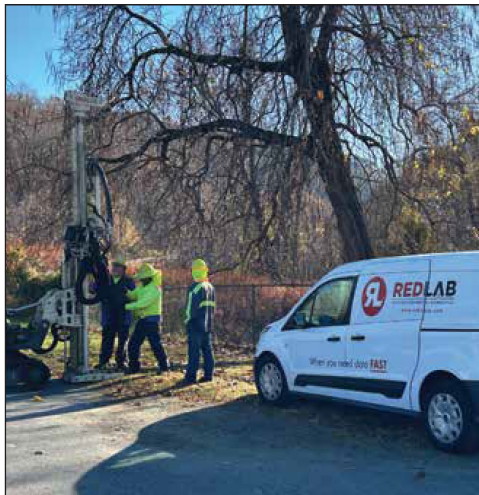
Photo 3. Carolina Soil Investigations drilling boring B-2 & REDLab standing by for samples.

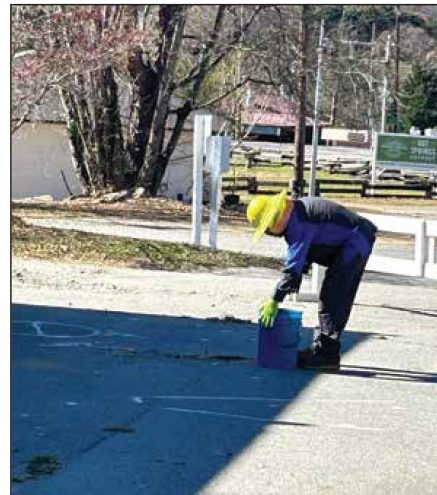
Photo 4. Using asphalt patch to fill in the boring holes at Parcel #001.
