STATE OF NORTH CAROLINA
DEPARTMENT OF TRANSPORTATION

U-5899

New Route from Forum Parkway Connector from SR 3955
(Forum Parkway) To NC 66 (University Parkway) in Rural Hall.
Construct 2-Lane Roadway on New Location

GeoEnvironmental Planning Report

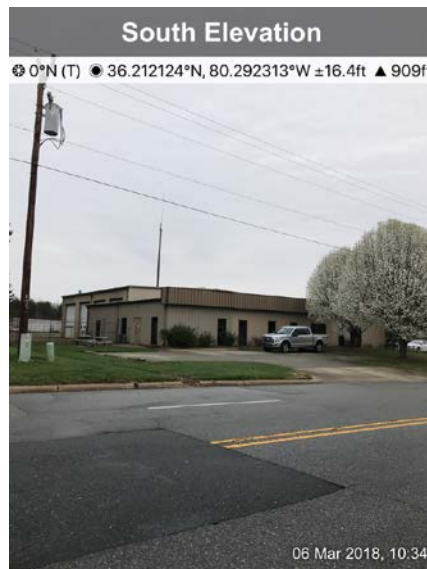
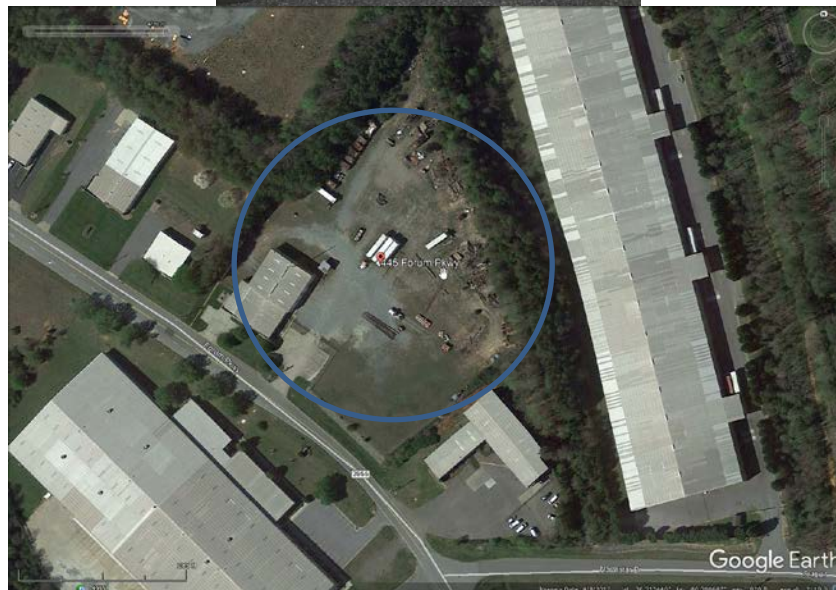
(01) Property Name:

Anticipated Impacts: Low

This parcel is the site of an office, and on the eastern portion of the site, is a construction lay down yard. The site is located NE of Forum Pkwy. There is a risk of hydraulic and fuel leaks associated with stored equipment.

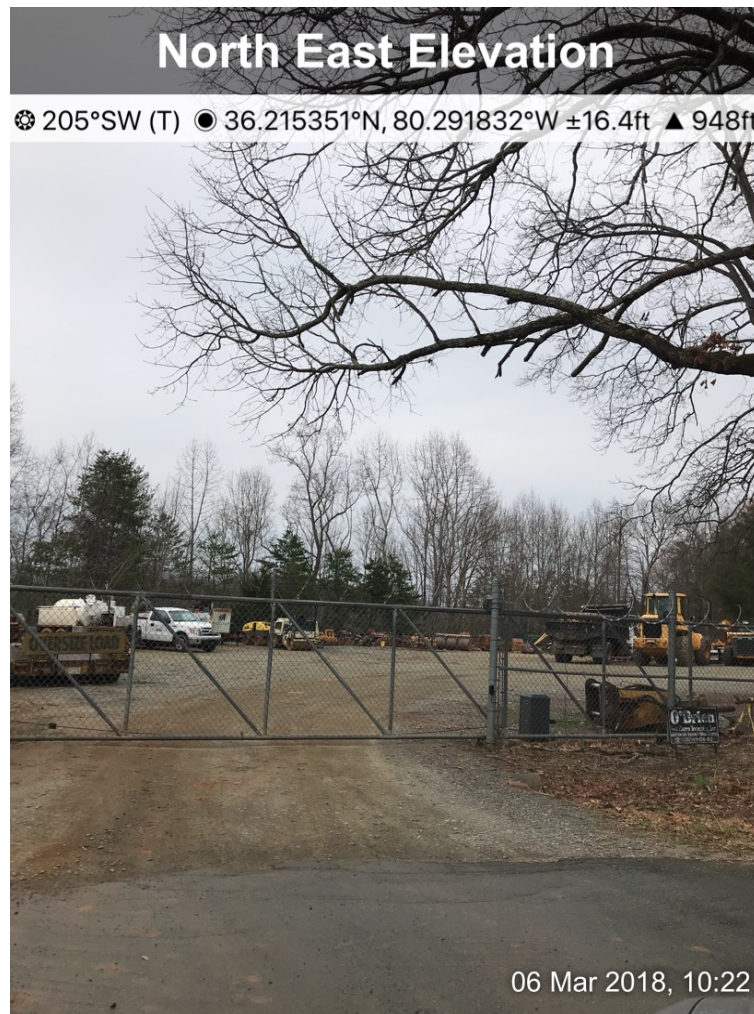
(02) Property Name:

**Anticipated Impacts:** Low

This parcel is the site of a construction yard. It is located North of Angus St. at the eastern end of Angus St. The site use includes long-term parking of diesel/hydraulic construction equipment, since c. 2010. There is a risk of hydraulic and fuel leaks associated with stored equipment.

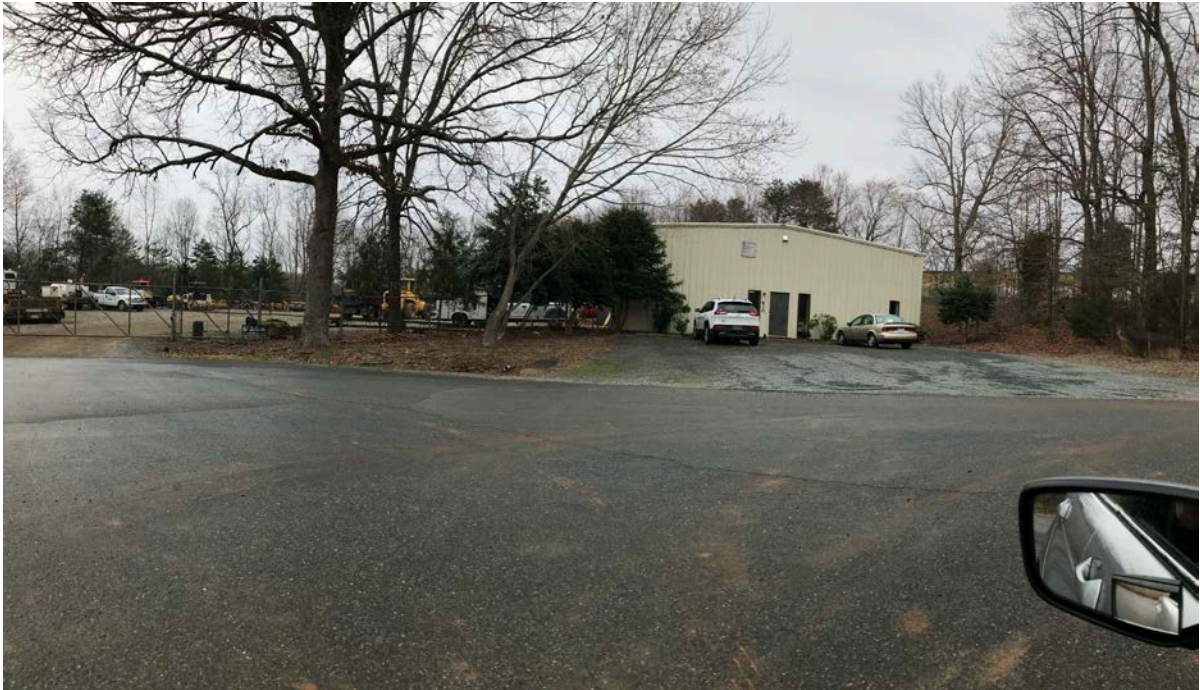
(03) Property Name:

Anticipated Impacts: Low

This construction yard and office building is located South of Angus St. at the eastern end of Angus St. Site use includes long-term parking of trucks and lay down of supplies, since c. 1999. There is a risk of hydraulic and fuel leaks associated with stored equipment.

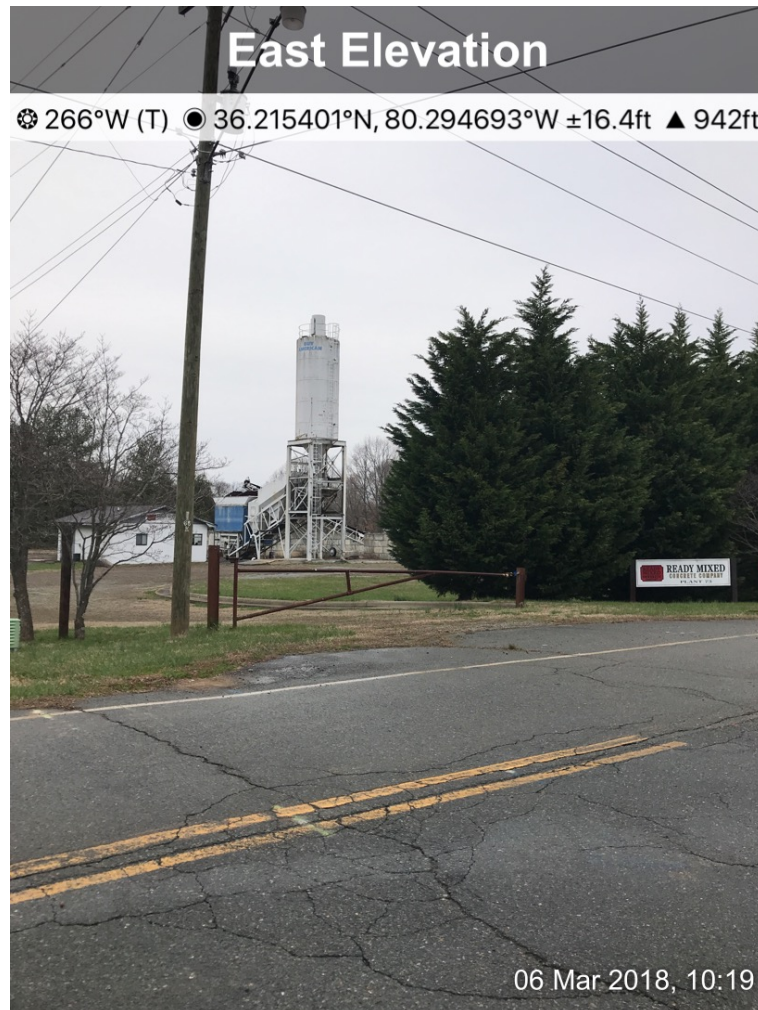
(04) Property Name:

Anticipated Impacts: Low

This ready mixed concrete co. is located along the northern side of Angus St. The site is dilapidated. There is a risk of hydraulic and fuel leaks/spills associated with stored equipment and/or fueling of vehicles are potential concerns on this site.

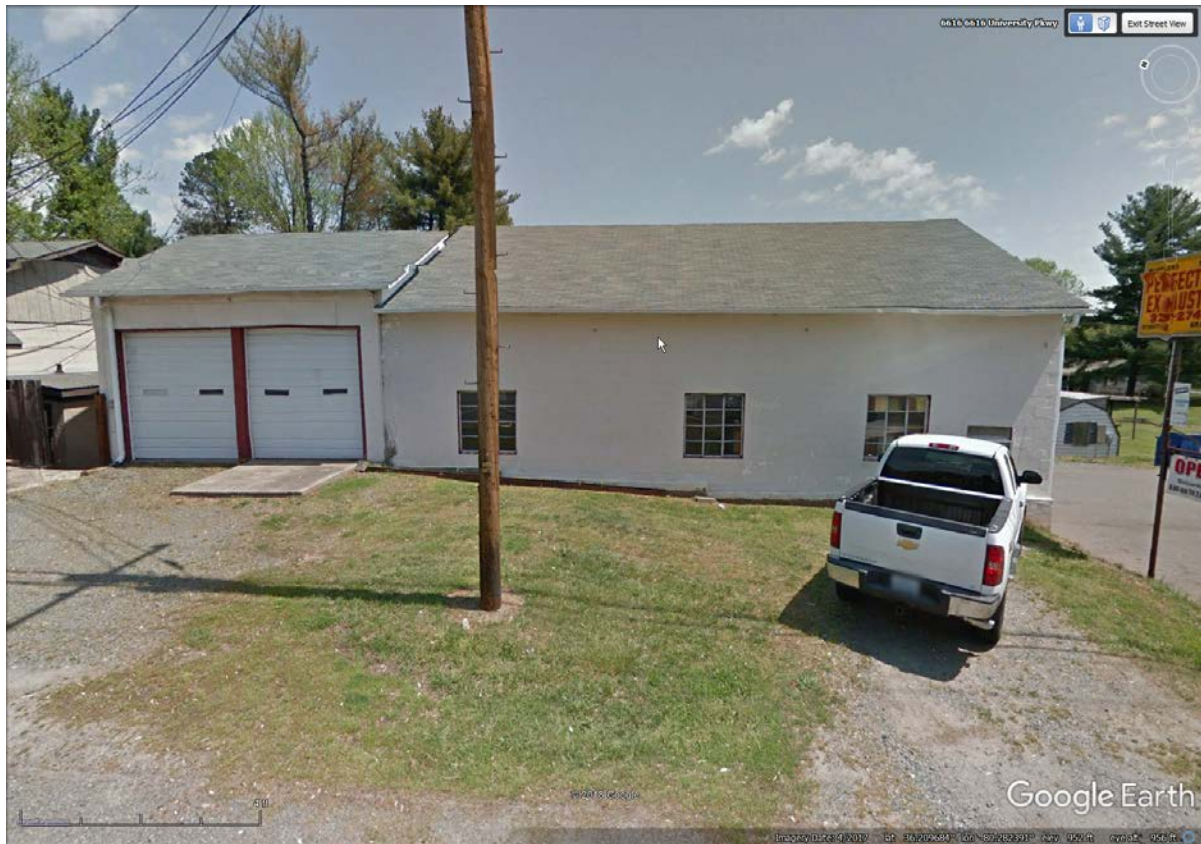
(05) Property Name:
Perfection Exhaust
6615-6617 University Parkway
Rural Hall, NC

Anticipated Impacts: Low

This site has two buildings on the same parcel located along the eastern side of Univ. Pkwy. Perfection Exhaust and Auto Care has two bay doors on the western building side (front). Hydraulic lifts with in-ground components may be present. The potential for USTs, fuel, oil, and solvent spills are a concern on this site

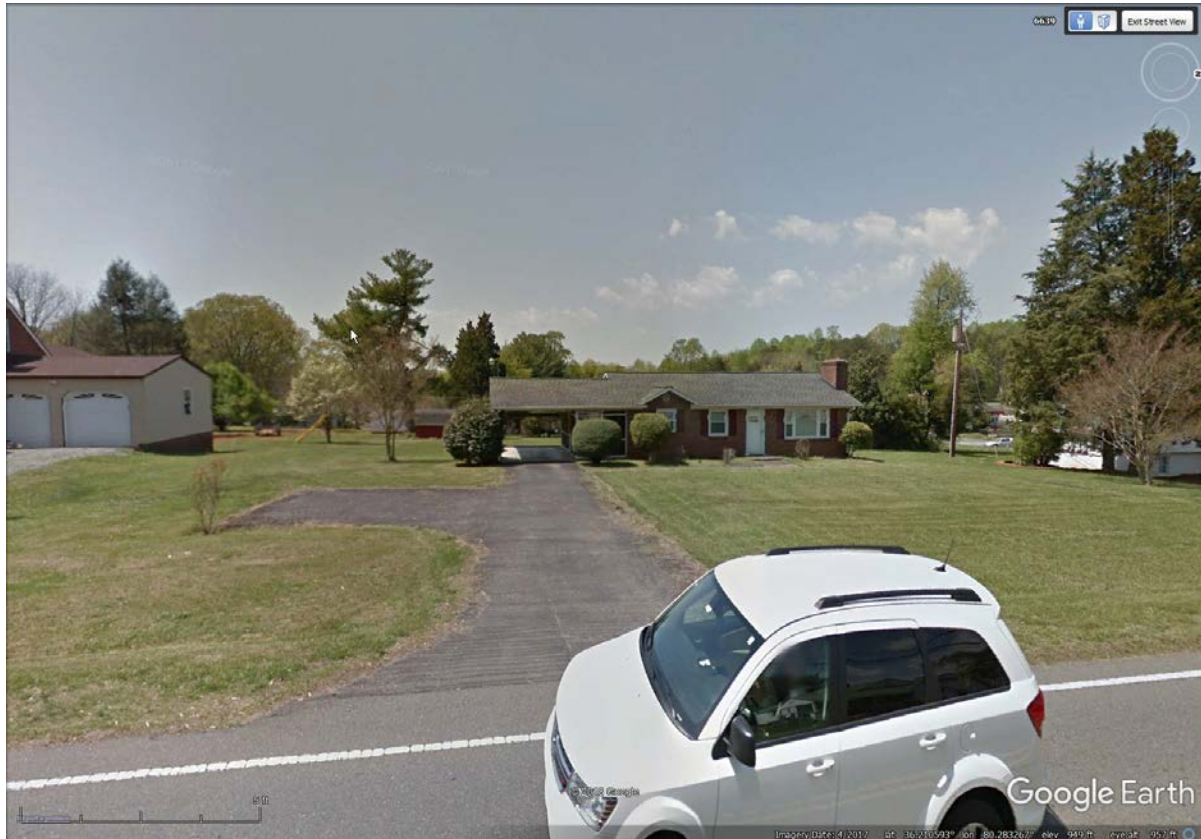
(06) Property Name:

Anticipated Impacts: Low

This parcel is the site of a residence located on the western side of Univ. Pkwy. A residential fuel tank incident occurred April 4, 2017 and was closed December 14, 2017. The potential for USTs, fuel spills are a concern on this site

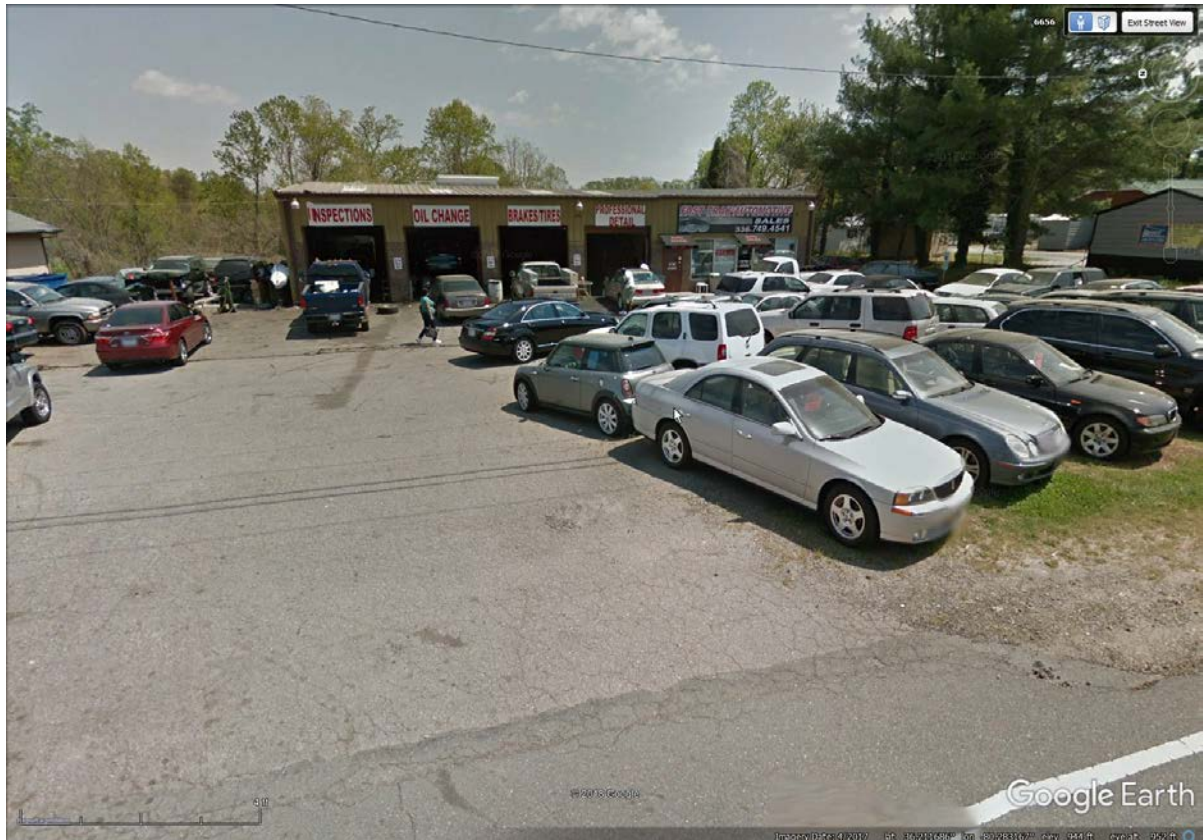
(07) Property Name:
Fast Track Automotive
6651 University Parkway
Rural Hall, NC

Anticipated Impacts: Low

This auto service facility is located on the eastern side of Univ. Pkwy. Modern hydraulic lifts, without in-ground components were observed, which are not a typical geoenvironmental concern, but older hydraulic lifts may also be present that could have in-ground components. The potential for USTs, fuel, oil, and solvent spills are also a concern on this site.

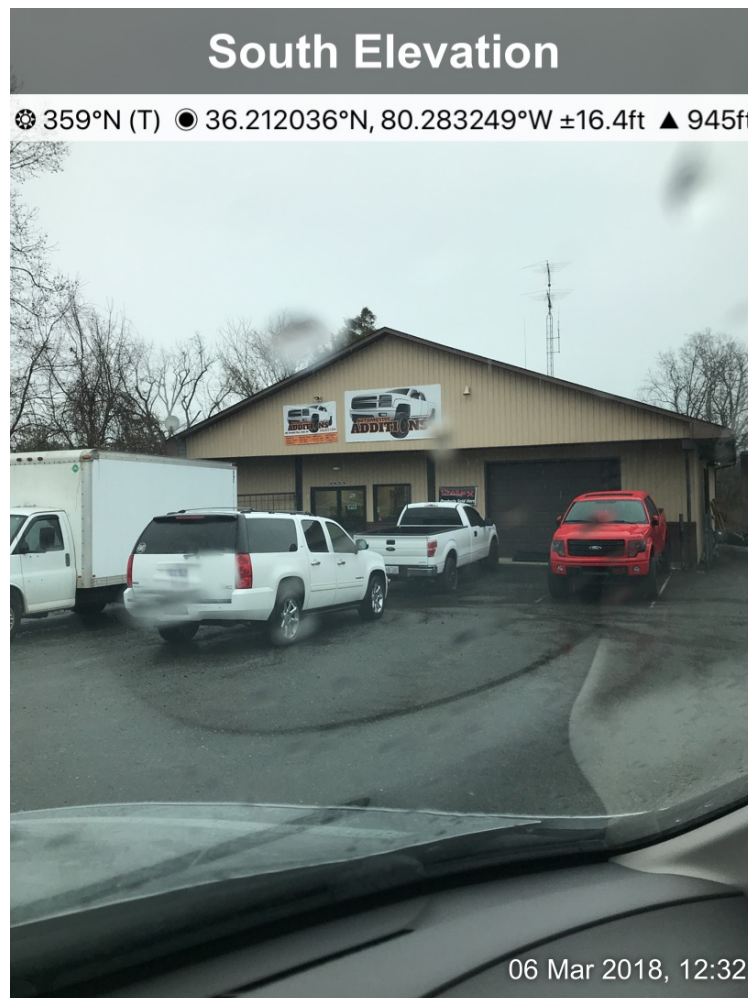
(08) Property Name:
Automotive Additions
6655 University Parkway
Rural Hall, NC

Anticipated Impacts: Low

This parcel is the site of an auto service facility. It is located on the eastern side of Univ. Pkwy. The potential for fuel, oil, and solvent spills are a concern on this site.

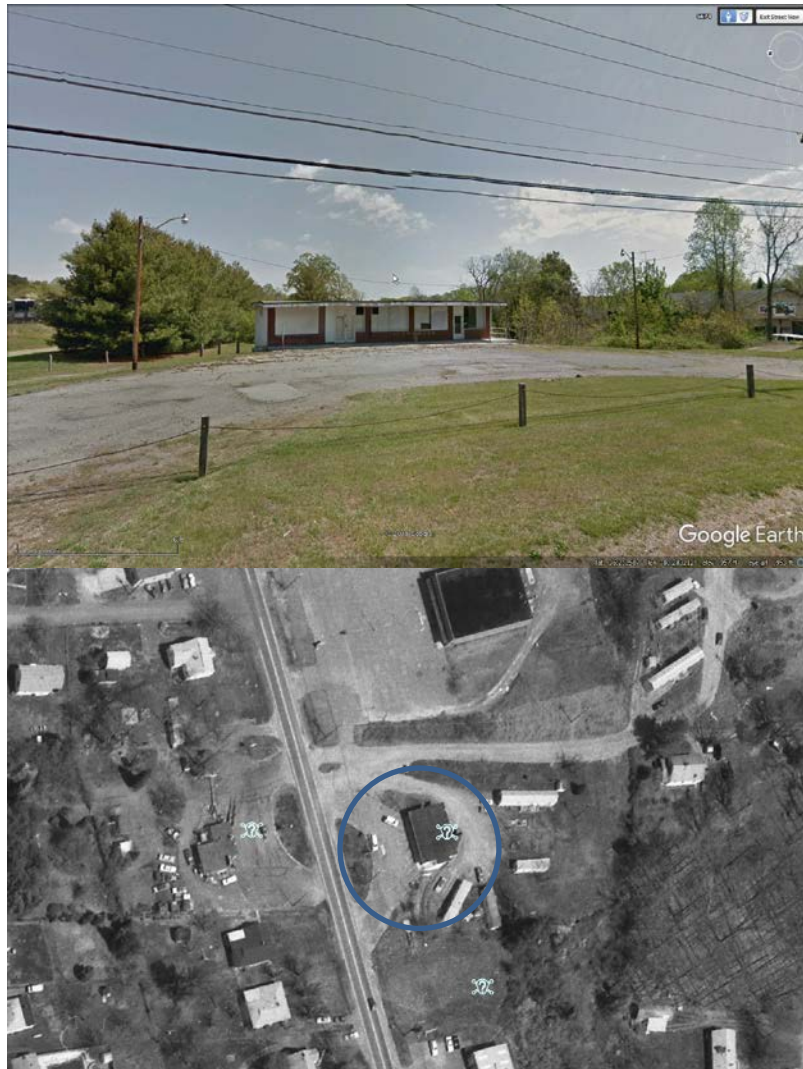
(09) Property Name:

**Anticipated Impacts:** Low

This possible former gas station is located on the eastern side of Univ. Pkwy. White block is on the sides of this building, it has a red brick façade. A heating oil fill port was observed on the northern side of the building (a tank may be in the building). The building appears to be a former gas station per NCDOT Historical Aerial Photography Mission 3118, c. 1993 (blue circle above). A pump island may be evident in the photograph. The potential for USTs, fuel, oil, and solvent spills are a concern on this site

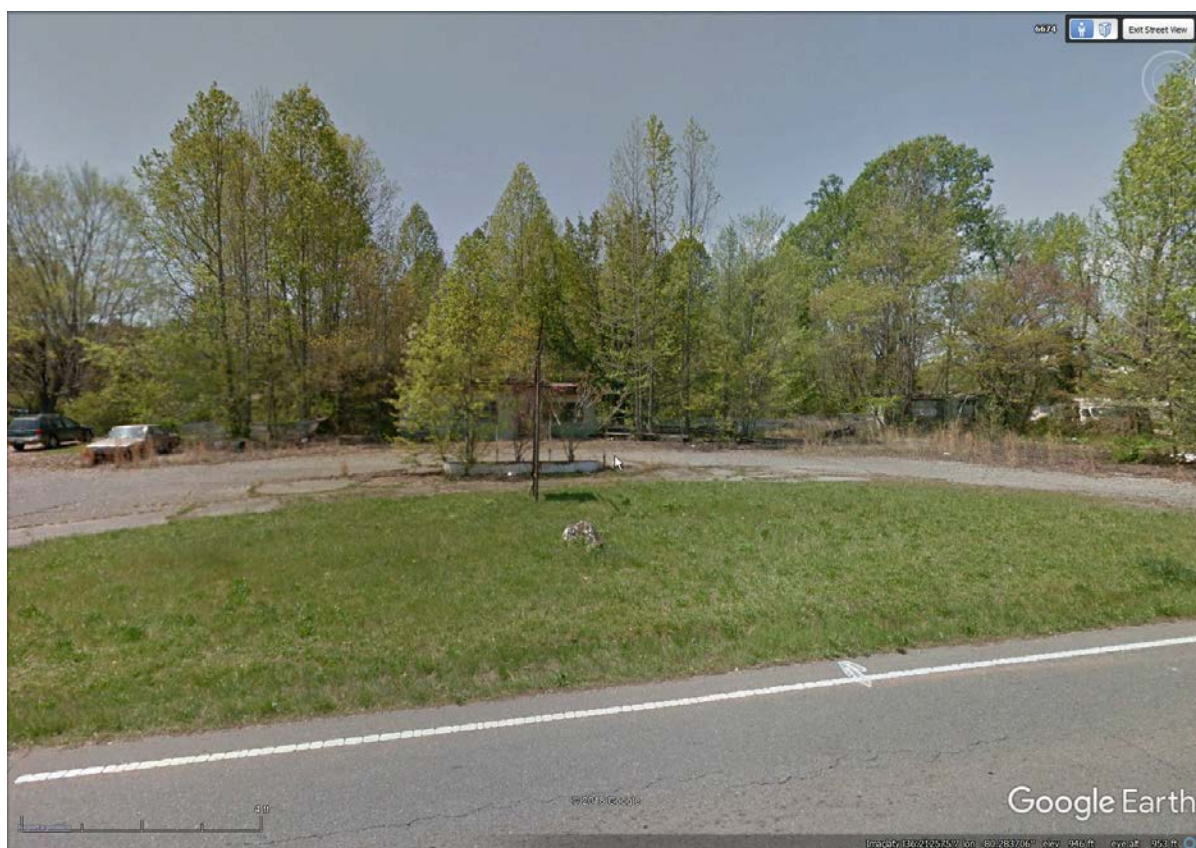
(10) Property Name:

**Anticipated Impacts:** Low

This parcel is the site of a former gas station. It is located on the western side of Univ. Pkwy. A UST incident occurred and was accepted by State Lead 1/11/95. Four USTs were removed, report dated 7/25/1995. Soil was impacted. A No Further Action status was granted 9/30/2005. A pump island remains evident on site (photograph). A second building north of the main building appears to have bay doors, and may have hydraulic lifts with in-ground components. The site was used for car storage, possibly salvage vehicles, c. 2002-2014, per historical aerial photography. The potential for other USTs, fuel, oil, and solvent spills are a concern on this site.

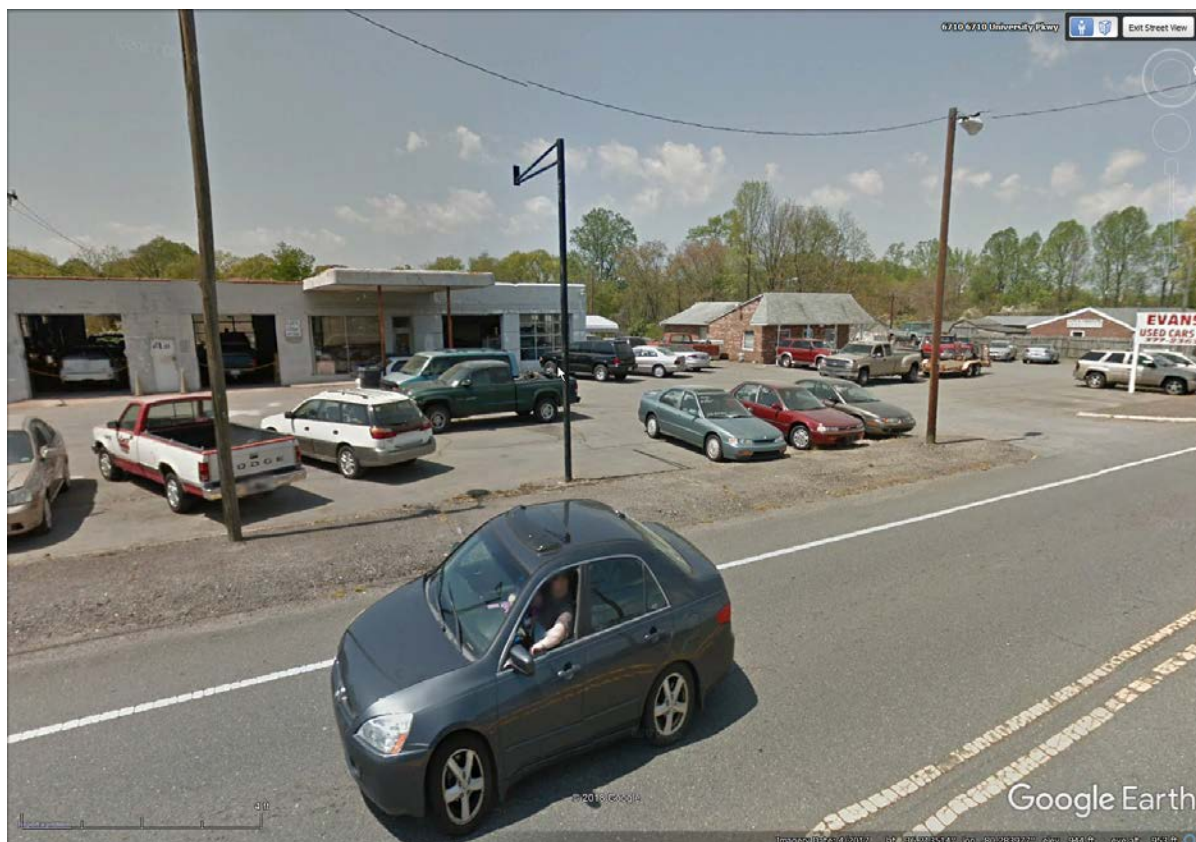
(11) Property Name:

**Anticipated Impacts:** Low

This parcel is the site of two buildings and businesses on the same County parcel: Lee's Garage (left, south) and Evans Used Cars (right, north). This site is located along the western side of Univ. Pkwy. A NCDEQ Incident (with no incident number) is attributed to Evans Used Cars/6710 University Parkway. Lee's garage is an apparent former gas station as a pump island is evident. One of the hydraulic lifts at Lee's Garage was observed to have in-ground components. The potential for USTs, fuel, oil, and solvent spills are a concern.

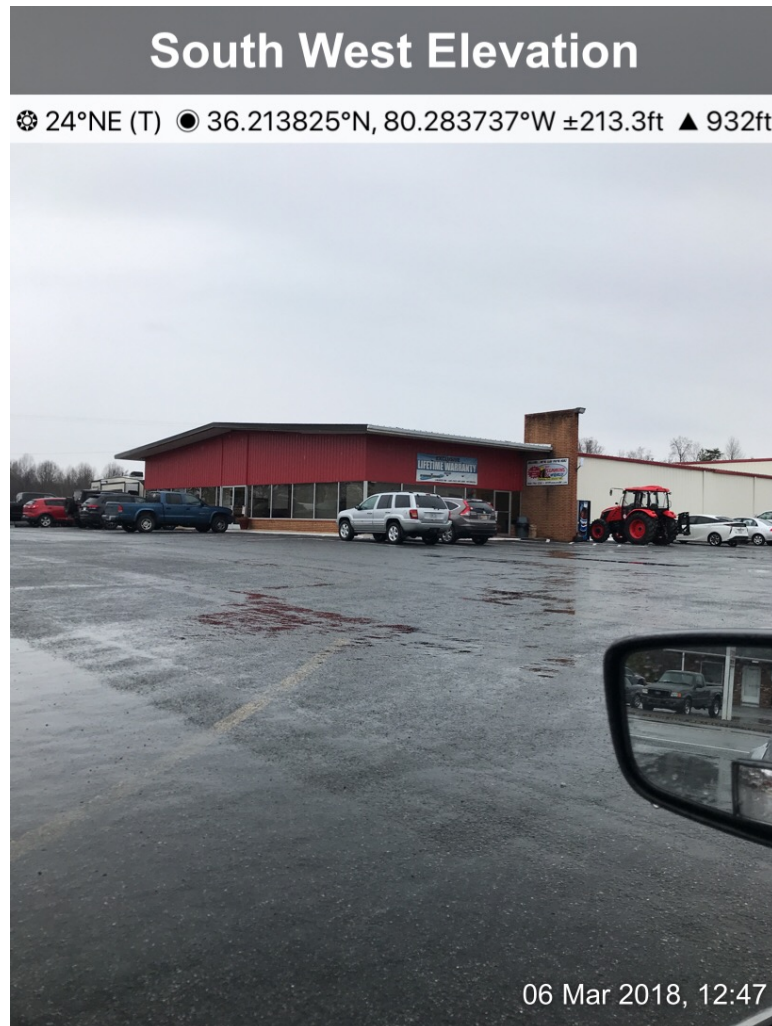
(12) Property Name:

Anticipated Impacts: Low

This parcel is the site of a recreational vehicle facility. It is located on the eastern side of Univ. Pkwy. Five bay doors were observed. The potential for USTs, fuel, oil, and solvent spills are a concern.

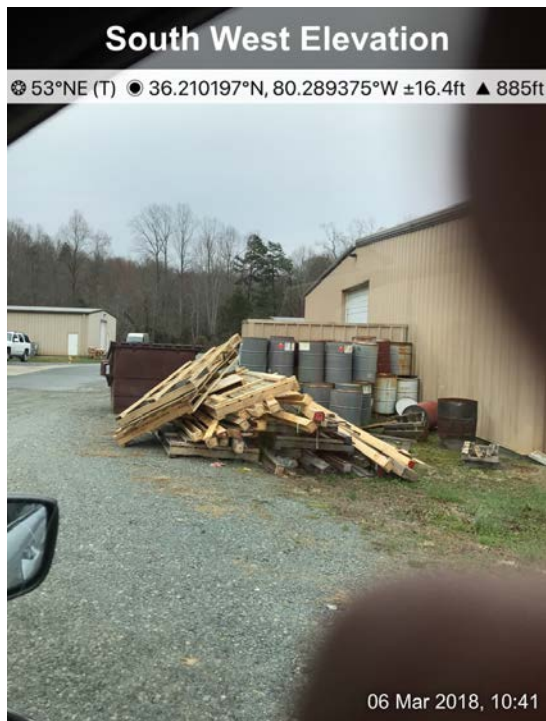
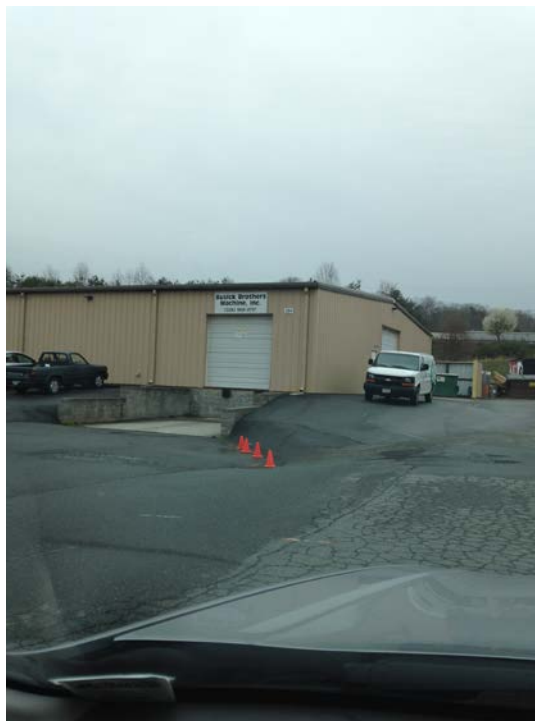
(13) Property Name:

**Anticipated Impacts: Low**

This parcel has multiple buildings with multiple light, mixed use industry vendors in each building. Unit 264 is Busick Brothers Machine shop. The side of this unit has several empty drums stored outside. The drums previously had numerous chemicals within them and have been reportedly repurposed to be filled with waste metal cuttings. The drums reportedly arrive empty, and have not been relabeled, or unlabeled. There is a potential for chemical/solvent spills associated with the drums and/or the machine shop.

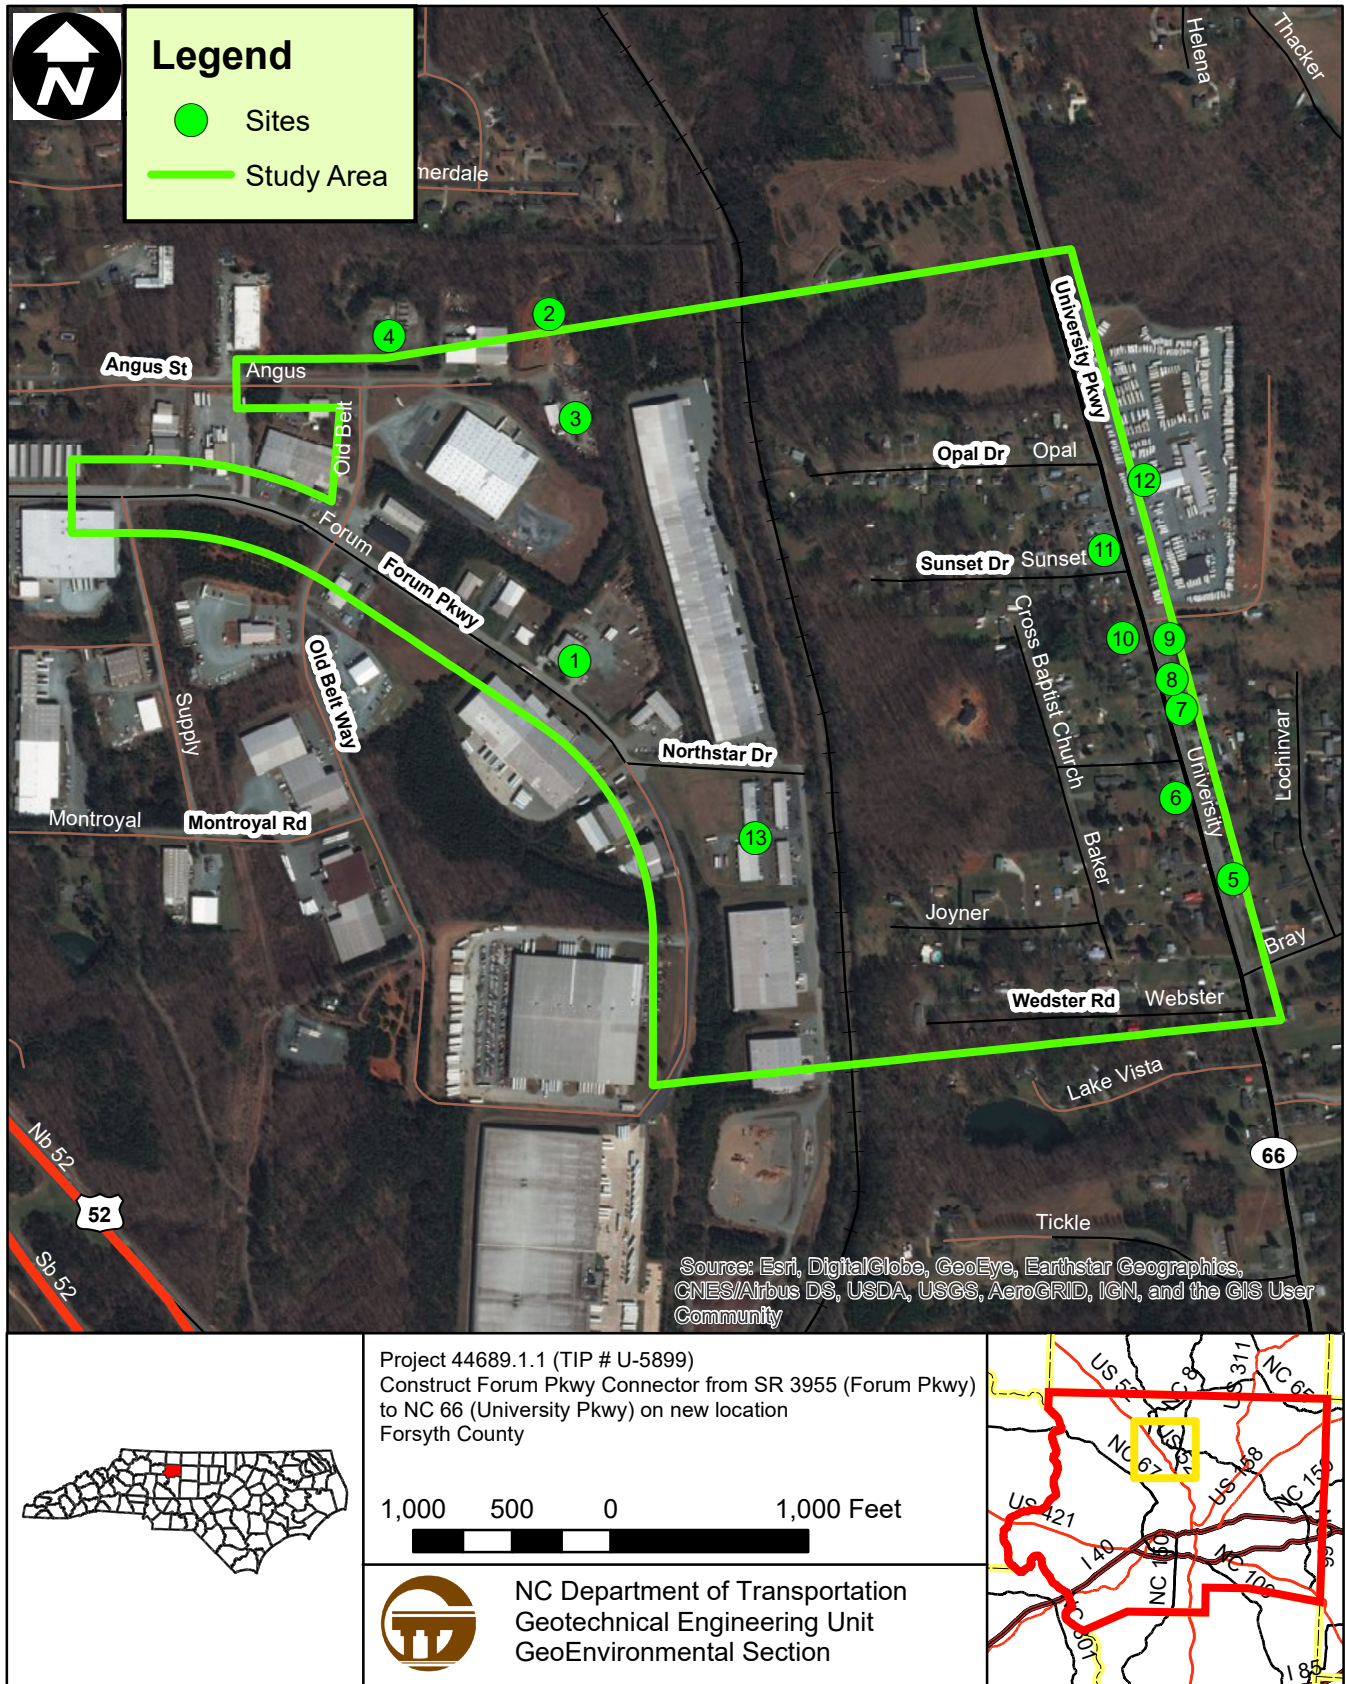
Appendix A Location of GeoEnvironmental Sites of Concern

Thirteen (13) sites of concern were identified within the proposed study area. We anticipate low monetary and scheduling impacts resulting from these sites. See the following table and figure for details.
