TIP NO: R-5863 WBS: 47140.1.1 COUNTY: Clay DIVISION 14

DESCRIPTION: US 64 Business from US Highway 64 to Main Street

SUBJECT: GeoEnvironmental Report for Planning

Preliminary Site Assessment Report R-5863 – Parcel 032, Dora Belcher 47 Hickory Street Hayesville, Clay County, NC 28904 FIGURE

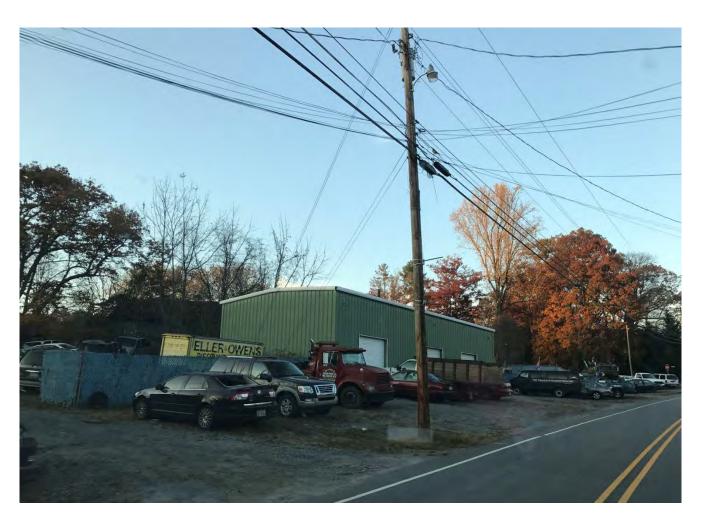
Wood Automotive 1160 US 64 Business Hayesville, NC 28904 **Property Owner:**

This automotive repair facility and wrecker service is located on the eastern side of US 64 Business. This parcel does not appear on the UST Section Registry nor are any incidents associated with this location. There is no evidence of USTs or UST removals. **This site is anticipated to present low geoenvironmental impacts to the project.**

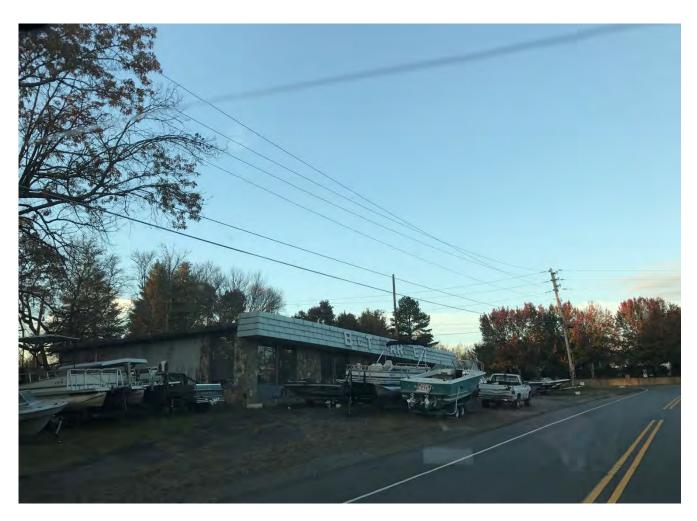
This marine repair and sales facility is located on the eastern side of US 64 Business. This parcel does not appear on the UST Section Registry nor are any incidents associated with this location. There is no evidence of USTs or UST removals. This site is anticipated to present low geoenvironmental impacts to the project.

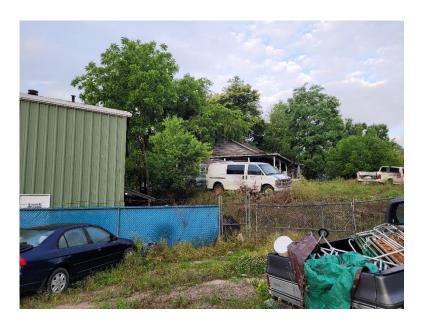
View facing west from the UST basin area in the northern portion of the Project Study Area towards a residential home in the remaining western portion of the parcel beyond the Project Study Area.

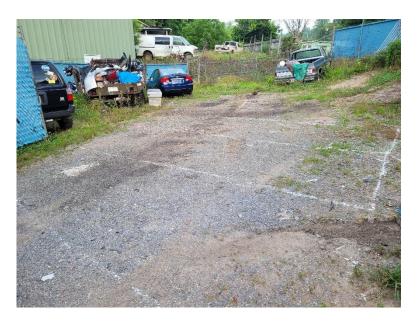
UST basin area in the northern portion of the site with apparent surface staining. Soil Borings 1-4 advanced around all sides of the UST basin area.

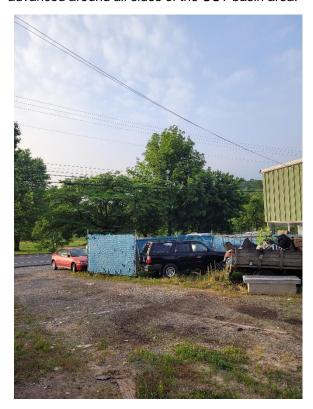
Surface staining apparent west of the UST basin and location of Soil Boring 5. A wrecker/towing vehicle was formerly parked where the staining was apparent.

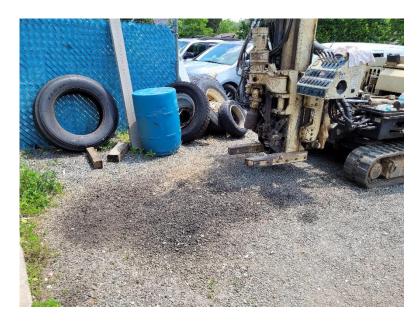
Apparent surface staining in front of the northern bay door. Location of Soil Boring 6.

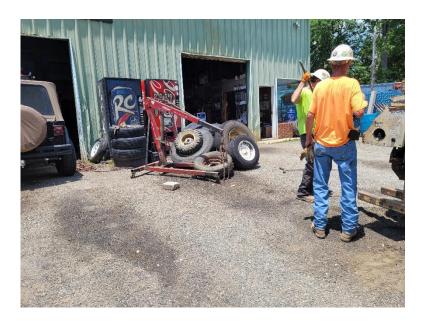
Representative view of apparent surface staining in front of the central and northern bay doors. Staining areas (right to left) are location of Soil Borings 7-9, respectively.

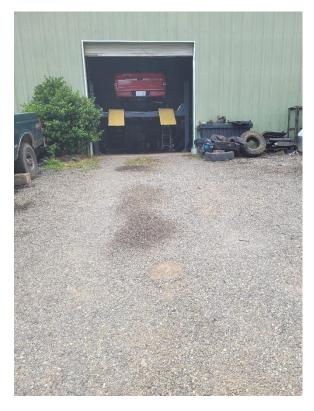
Apparent surface staining in front of the southern bay door. Staining closest to the bay door was outside of the right-of-way. Location of Soil Boring 10.

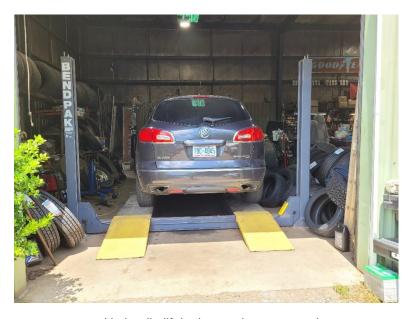
Hydraulic lift in the southern garage bay.

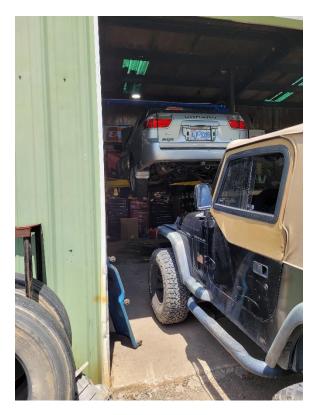
Hydraulic lift in the central garage bay.

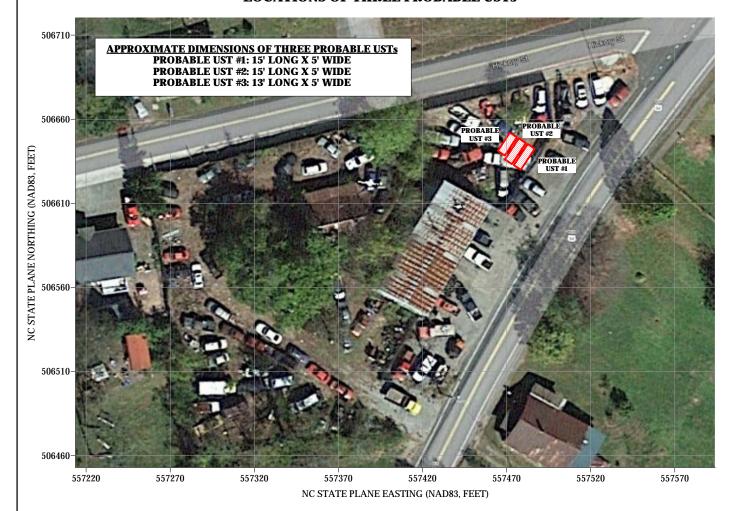
LOCATIONS OF THREE PROBABLE USTs

View of Three Probable USTs (Facing Approximately West)

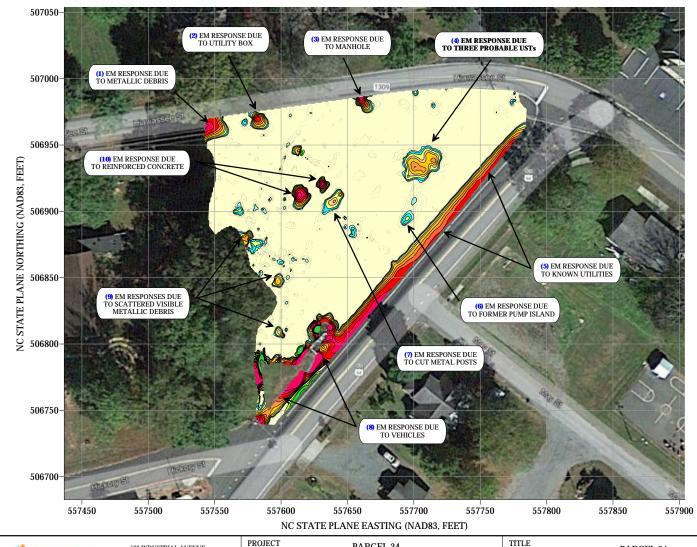
EM61 METAL DETECTION RESULTS

EVIDENCE OF THREE PROBABLE METALLIC USTs WAS OBSERVED.

The contour plot shows the differential results of the EM61 instrument in millivolts (mV). The differential results focus on larger metallic objects such as USTs and drums. The EM data were collected on May 19, 2022, using a Geonics EM61-MK2 instrument. Verification GPR data were collected using a GSSI SIR 4000 instrument with a 350 MHz HS antenna on May 19, 2022.

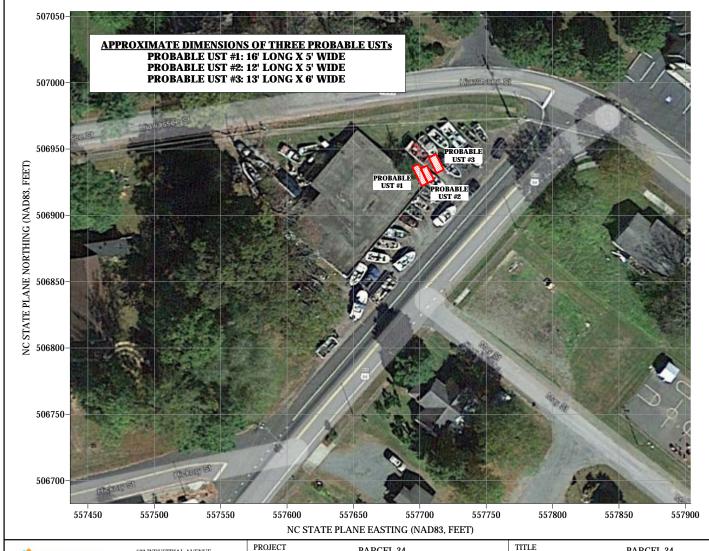
LOCATIONS OF THREE PROBABLE USTs

View of Three Probable USTs (Facing Approximately North)
