REFERENCE: BR-0098

STRUCTURE  
SUBSURFACE INVESTIGATION

COUNTY ROCKINGHAM  
PROJECT DESCRIPTION BRIDGE 780183 ON SR 1767  
(MAYFIELD ROAD) OVER US 29 BYPASS

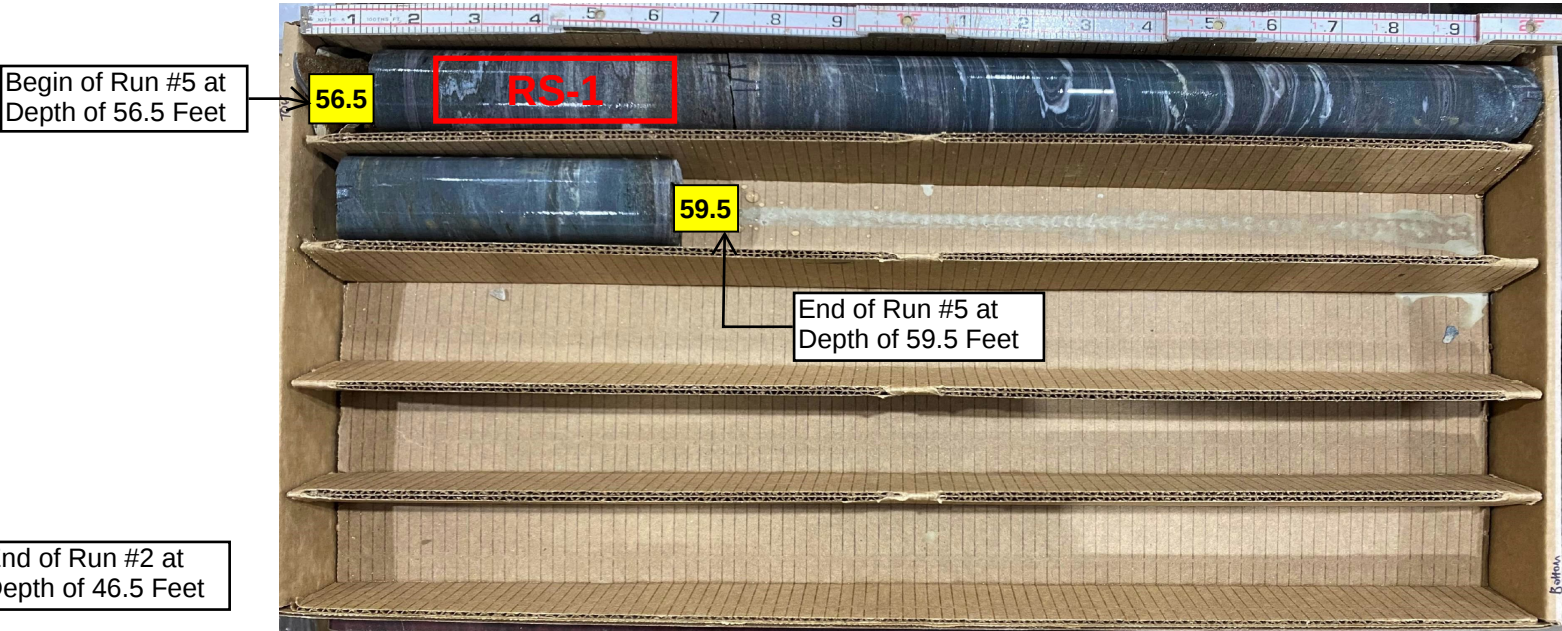
BOX 3: 56.5 - 59.5

| | 612.1 | 56.5 | 3.0 | 1:21/1.0<br>1:39/1.0<br>1:43/1.0 | (2.7)<br>90% | (2.6)<br>87% | RS-1 | (2.7)<br>90% | (2.6)<br>87% | | 612.1 | Gray, Slightly Weathered, Moderately Hard, Moderately Closely to Closely Fractured, Mylonitic Gneiss [REC=90%; RQD=87%; GSI=65-70] | 56.5 |

B1-B

| SUMMARY OF ROCK TEST RESULTS | | | | | | | | | | | | |
|---|---|---|---|---|---|---|---|---|---|---|---|---|
| RS-1 | B1-B | 21+12 | 29 FT RT | -L- | 985,426 | 1,840,083 | 56.7'-57.1' | 1.98 | 4.91 | 691.05 | 174.1 | 8,660 |
