Re: Geophysical Survey Report – Parcel 49  
NC DOT State Project No. R-5600  
WBS Element No. 45818.1.FR1  
Sylva, Jackson County, North Carolina  
H&H Job No. ROW-704

# Geophysical Survey Report NC DOT Parcel 49

171 E. Main St.  
Sylva, Jackson County  
North Carolina

H&H Job No. ROW-704  
State Project: R-5600  
WBS Element No. 45818.1.FR1  
November 30, 2022

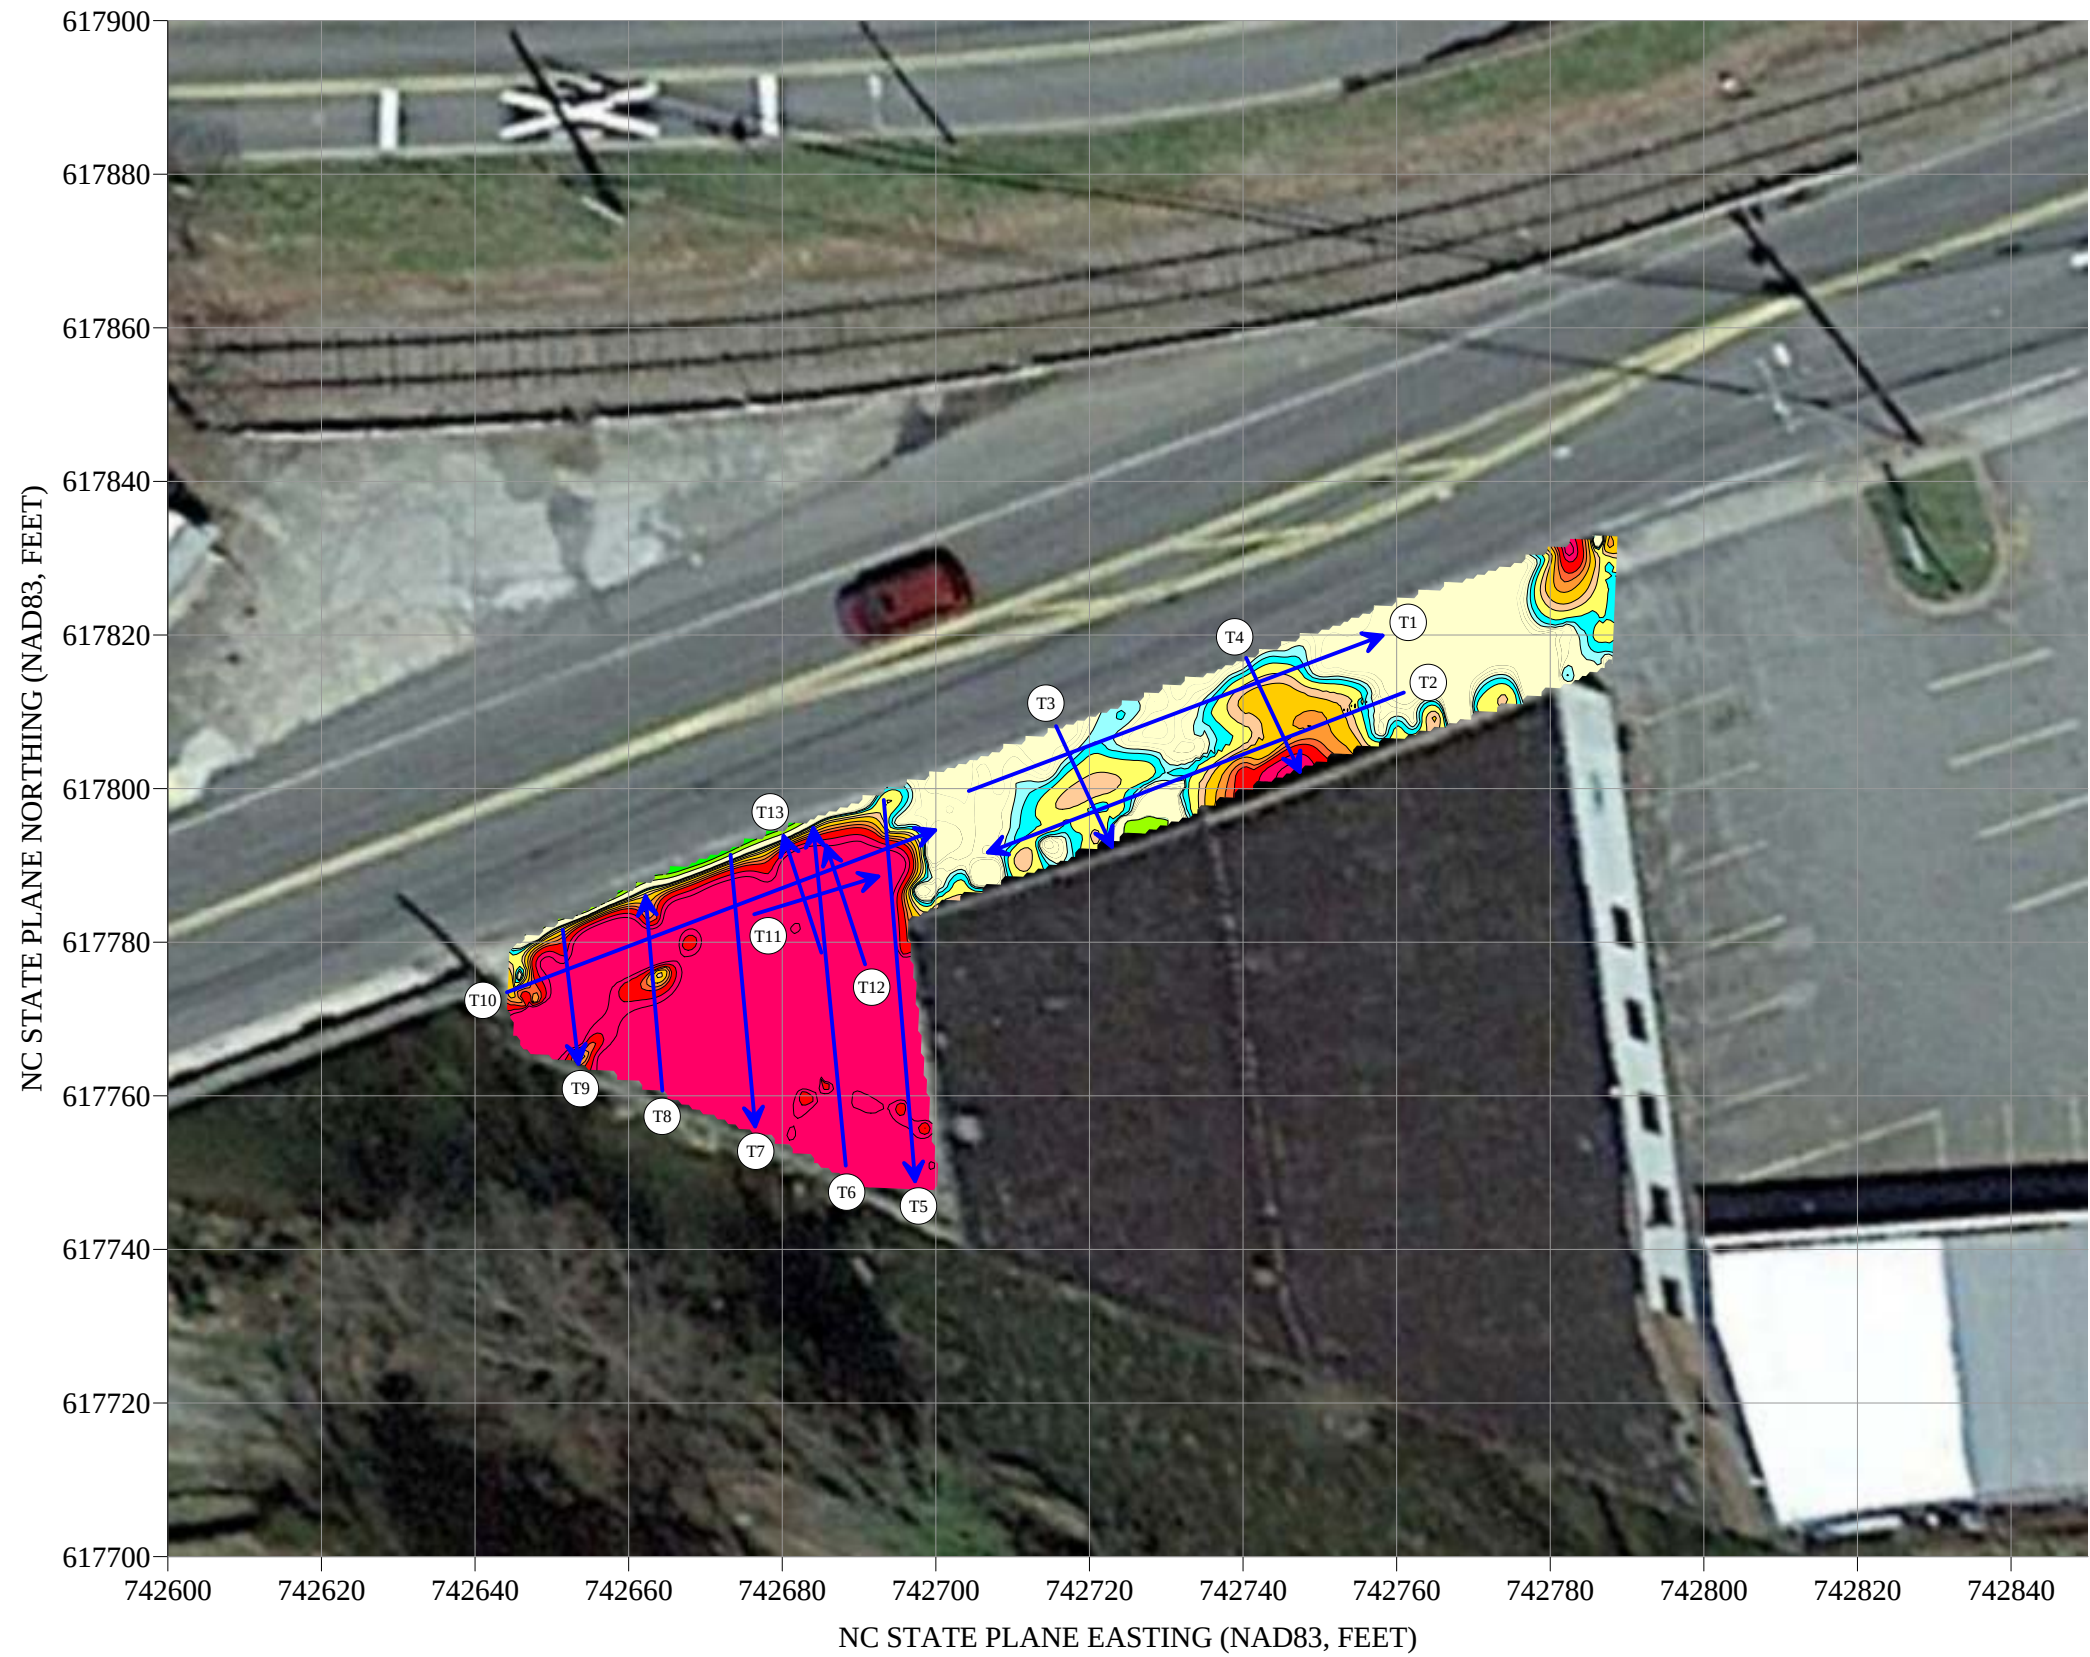
GPR TRANSECT LOCATIONS

GPR Transects 1-4 were performed across EM Anomaly 2. Evidence of utilities and/or buried infrastructure was observed.

GPR Transects 5-13 confirmed the presence of reinforcement within the concrete. Evidence of utilities and/or smaller fragments of buried debris was observed. Additionally, GPR Transect 11 showed two large, high-amplitude hyperbolic reflectors and GPR Transects 12-13 each showed a high-amplitude lateral reflector. These reflectors are typical of USTs. Due to the metallic interference from the reinforced concrete, it is unknown whether these features are metallic and are classified as possible USTs. Possible USTs #1 and #2 are both 10.5 feet long by 4.5 feet wide. **Figure 4** provides the locations and sizes of the two possible USTs, overlain on an aerial, along with ground-level photographs.

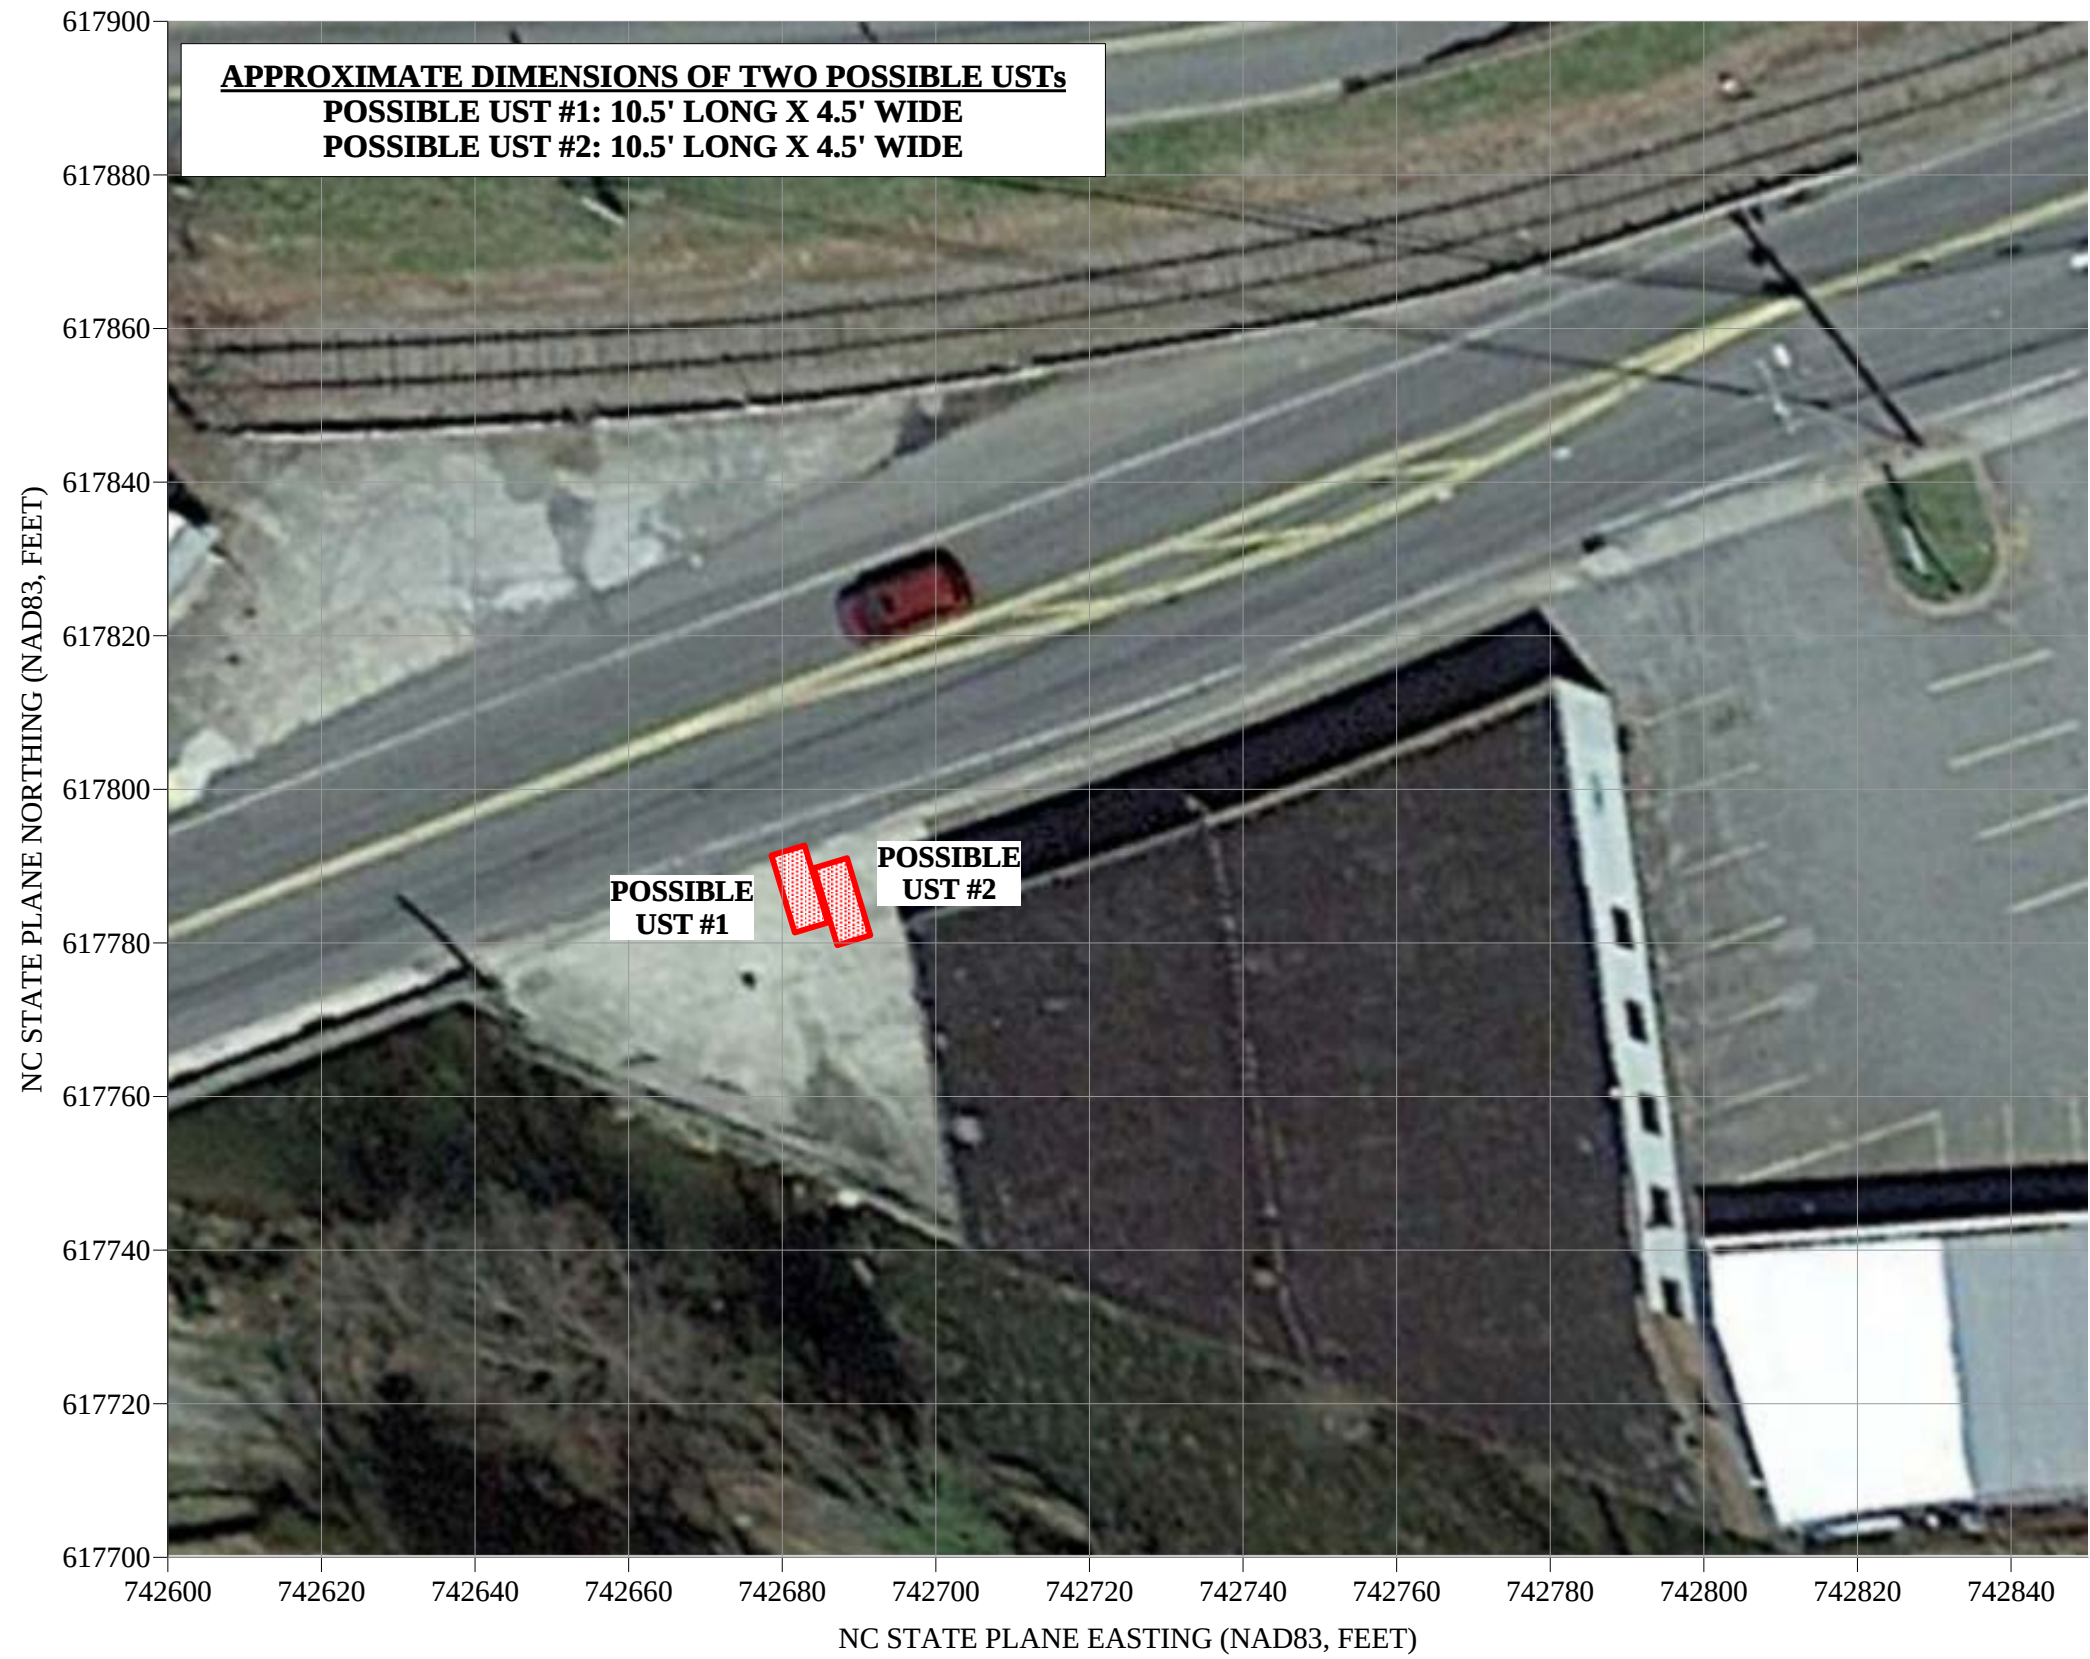
LOCATIONS OF TWO POSSIBLE USTs

View of Two Possible USTs  
(Facing Approximately North)

View of Two Possible USTs  
(Facing Approximately West)

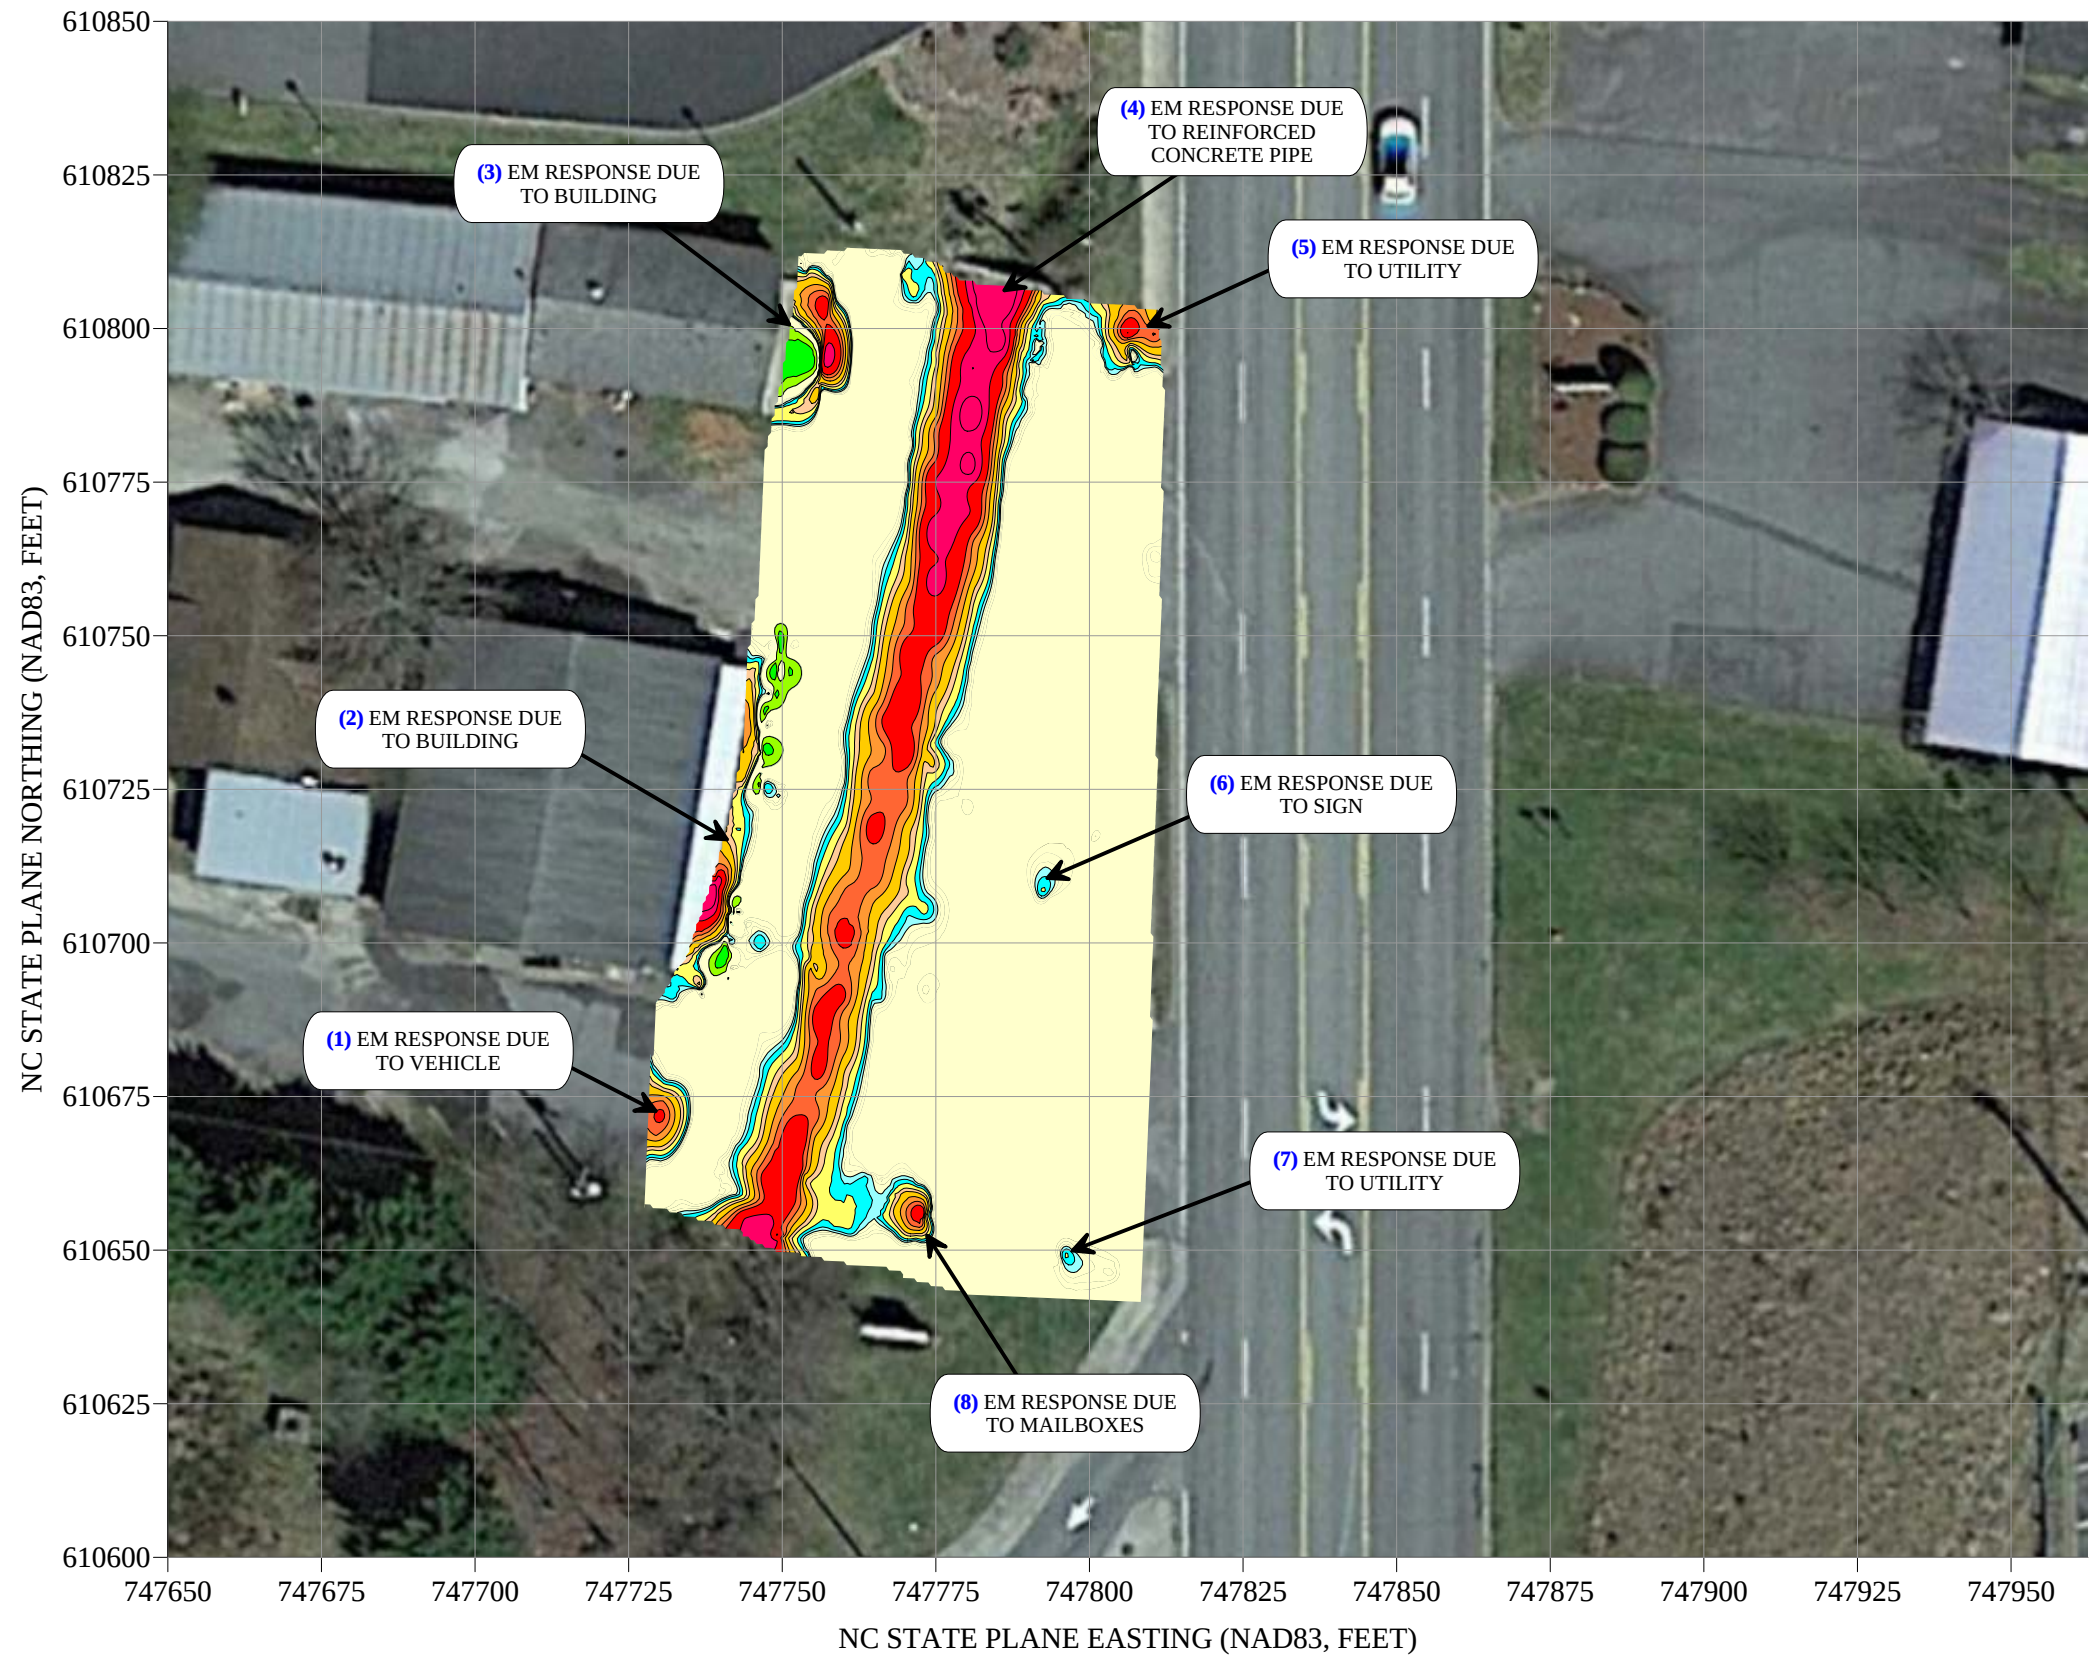
EM61 METAL DETECTION RESULTS

**EVIDENCE OF ONE PROBABLE USTs WAS OBSERVED OUTSIDE OF THE SURVEY AREA. NO EVIDENCE OF METALLIC USTs WAS OBSERVED WITHIN THE SURVEY AREA.**

The contour plot shows the differential results of the EM61 instrument in millivolts (mV). The differential results focus on larger metallic objects such as USTs and drums. The EM data were collected on September 26, 2022, using a Geonics EM61-MK2 instrument. Verification GPR data were collected using a GSSI SIR 4000 instrument with a 350 MHz HS antenna on September 28-29, 2022.

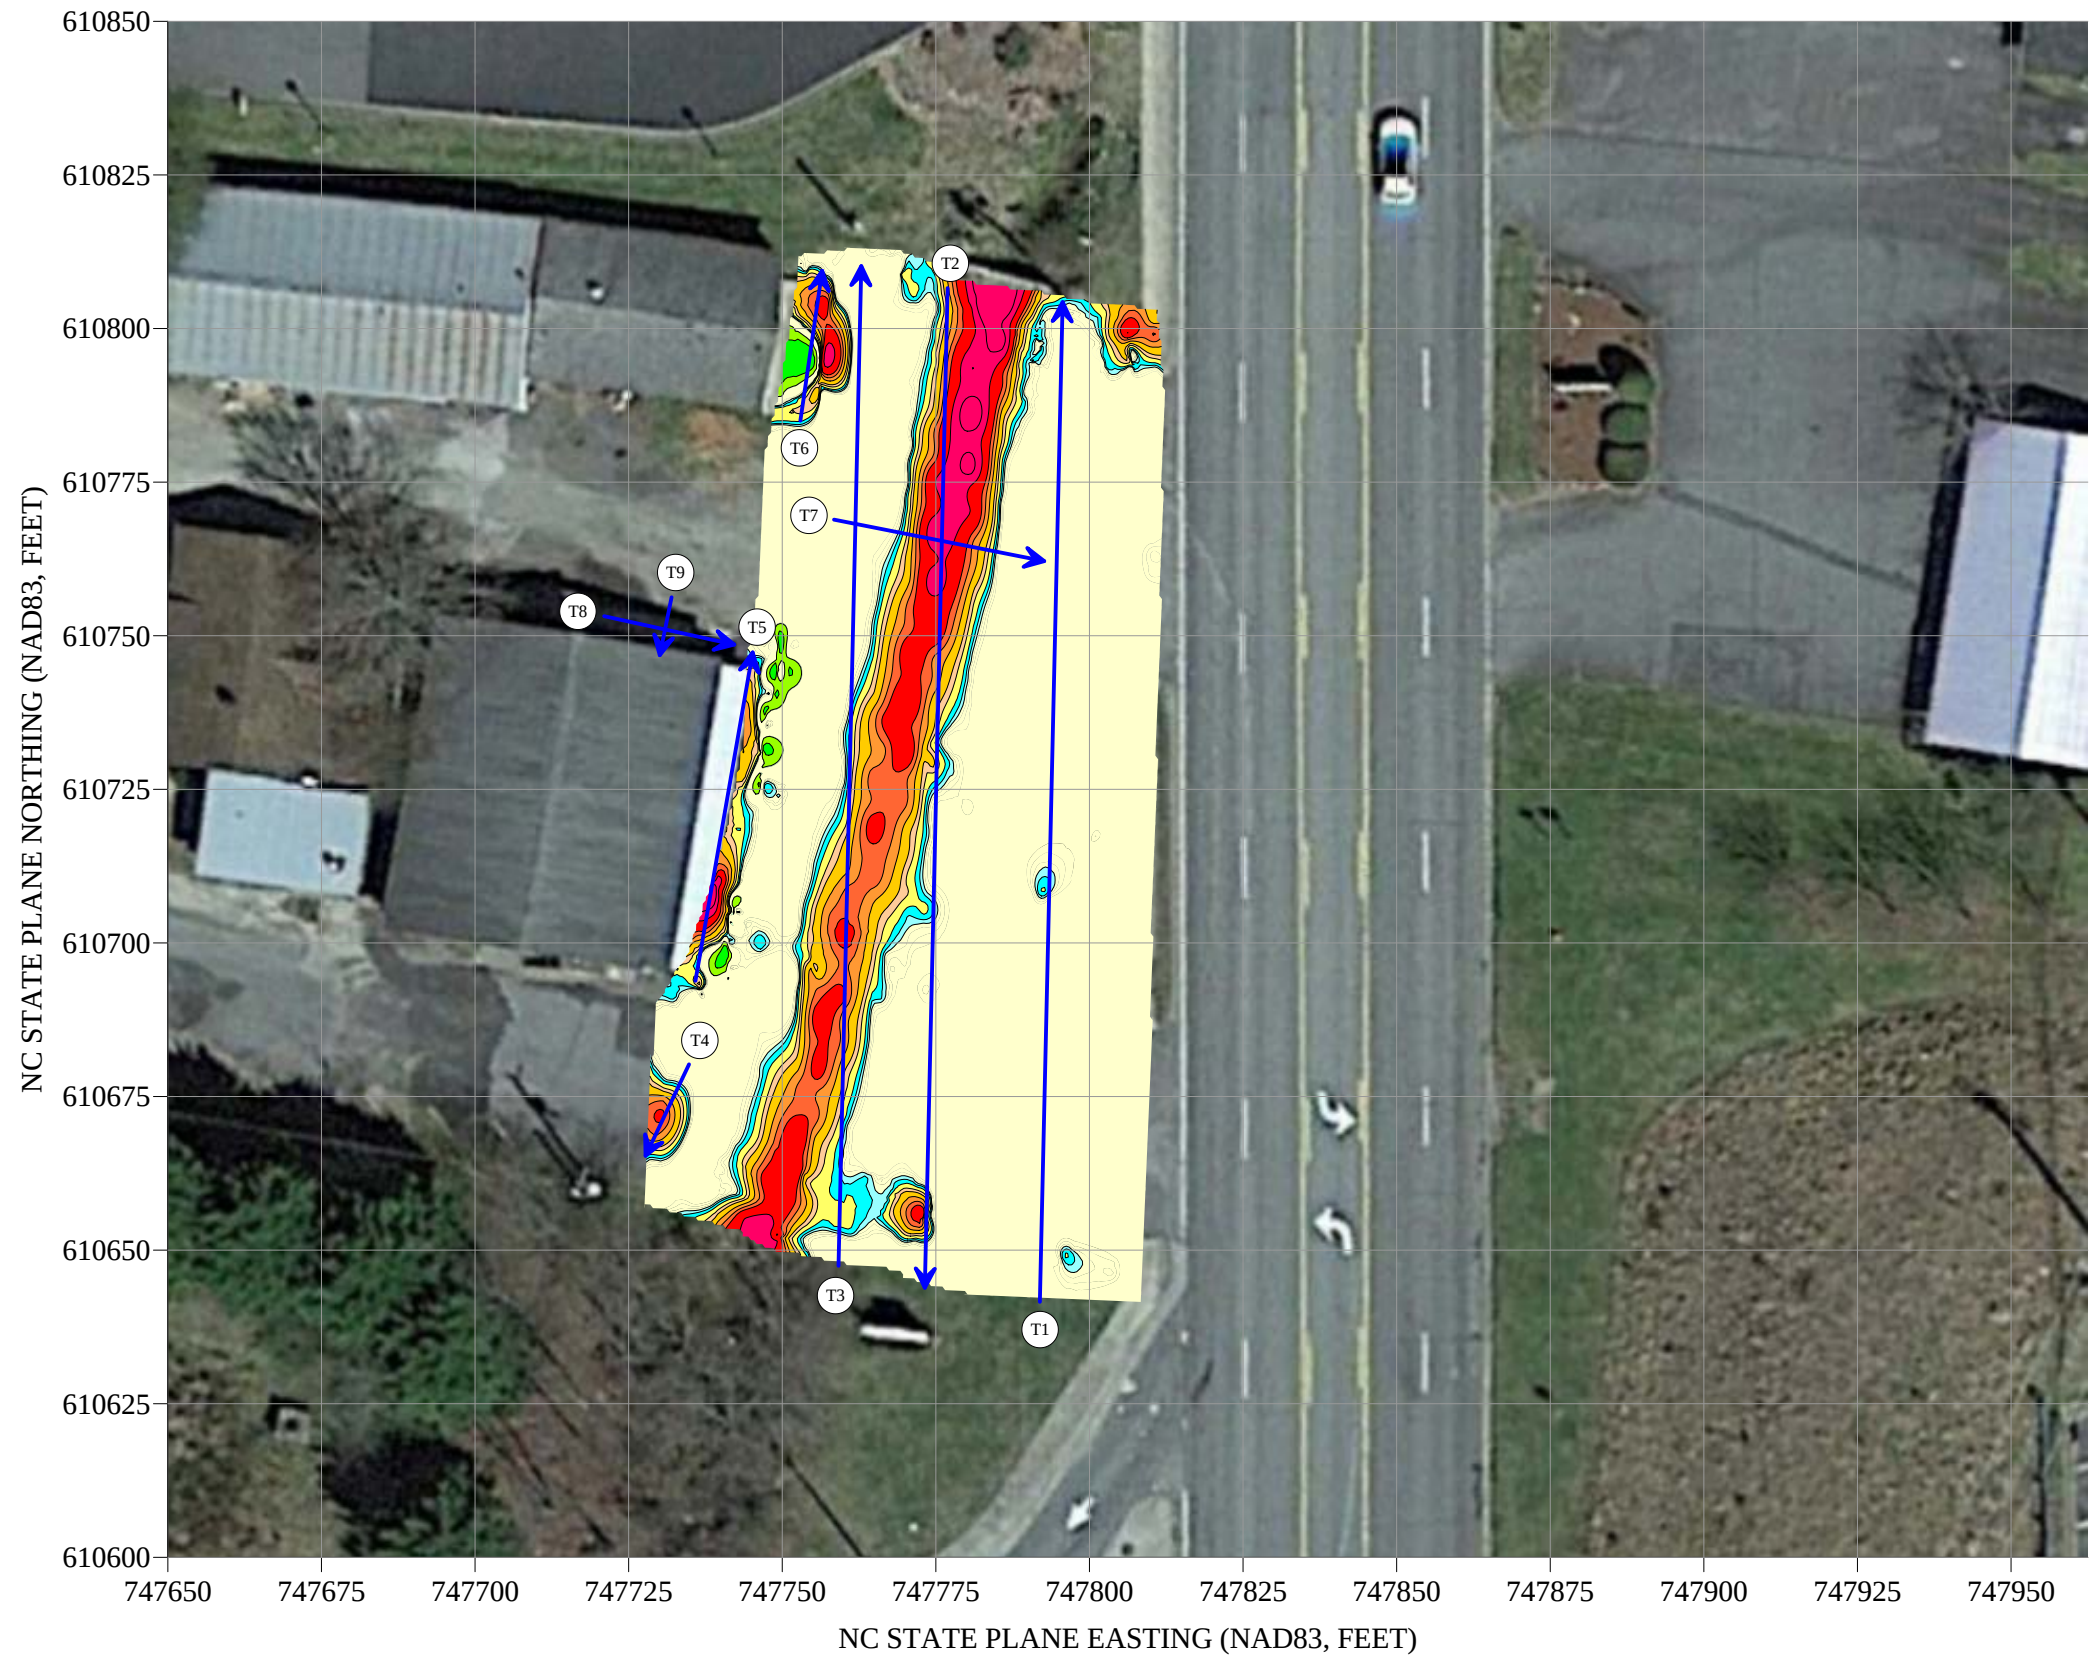
GPR TRANSECT LOCATIONS

GPR Transects 1-3 were performed as general reconnaissance scans at the request of Hart & Hickman. GPR Transects 4-7 were performed across and around areas of significant metallic interference. None of these transects showed evidence of significant structures such as USTs. Evidence of utilities and/or smaller fragments of buried debris was observed.

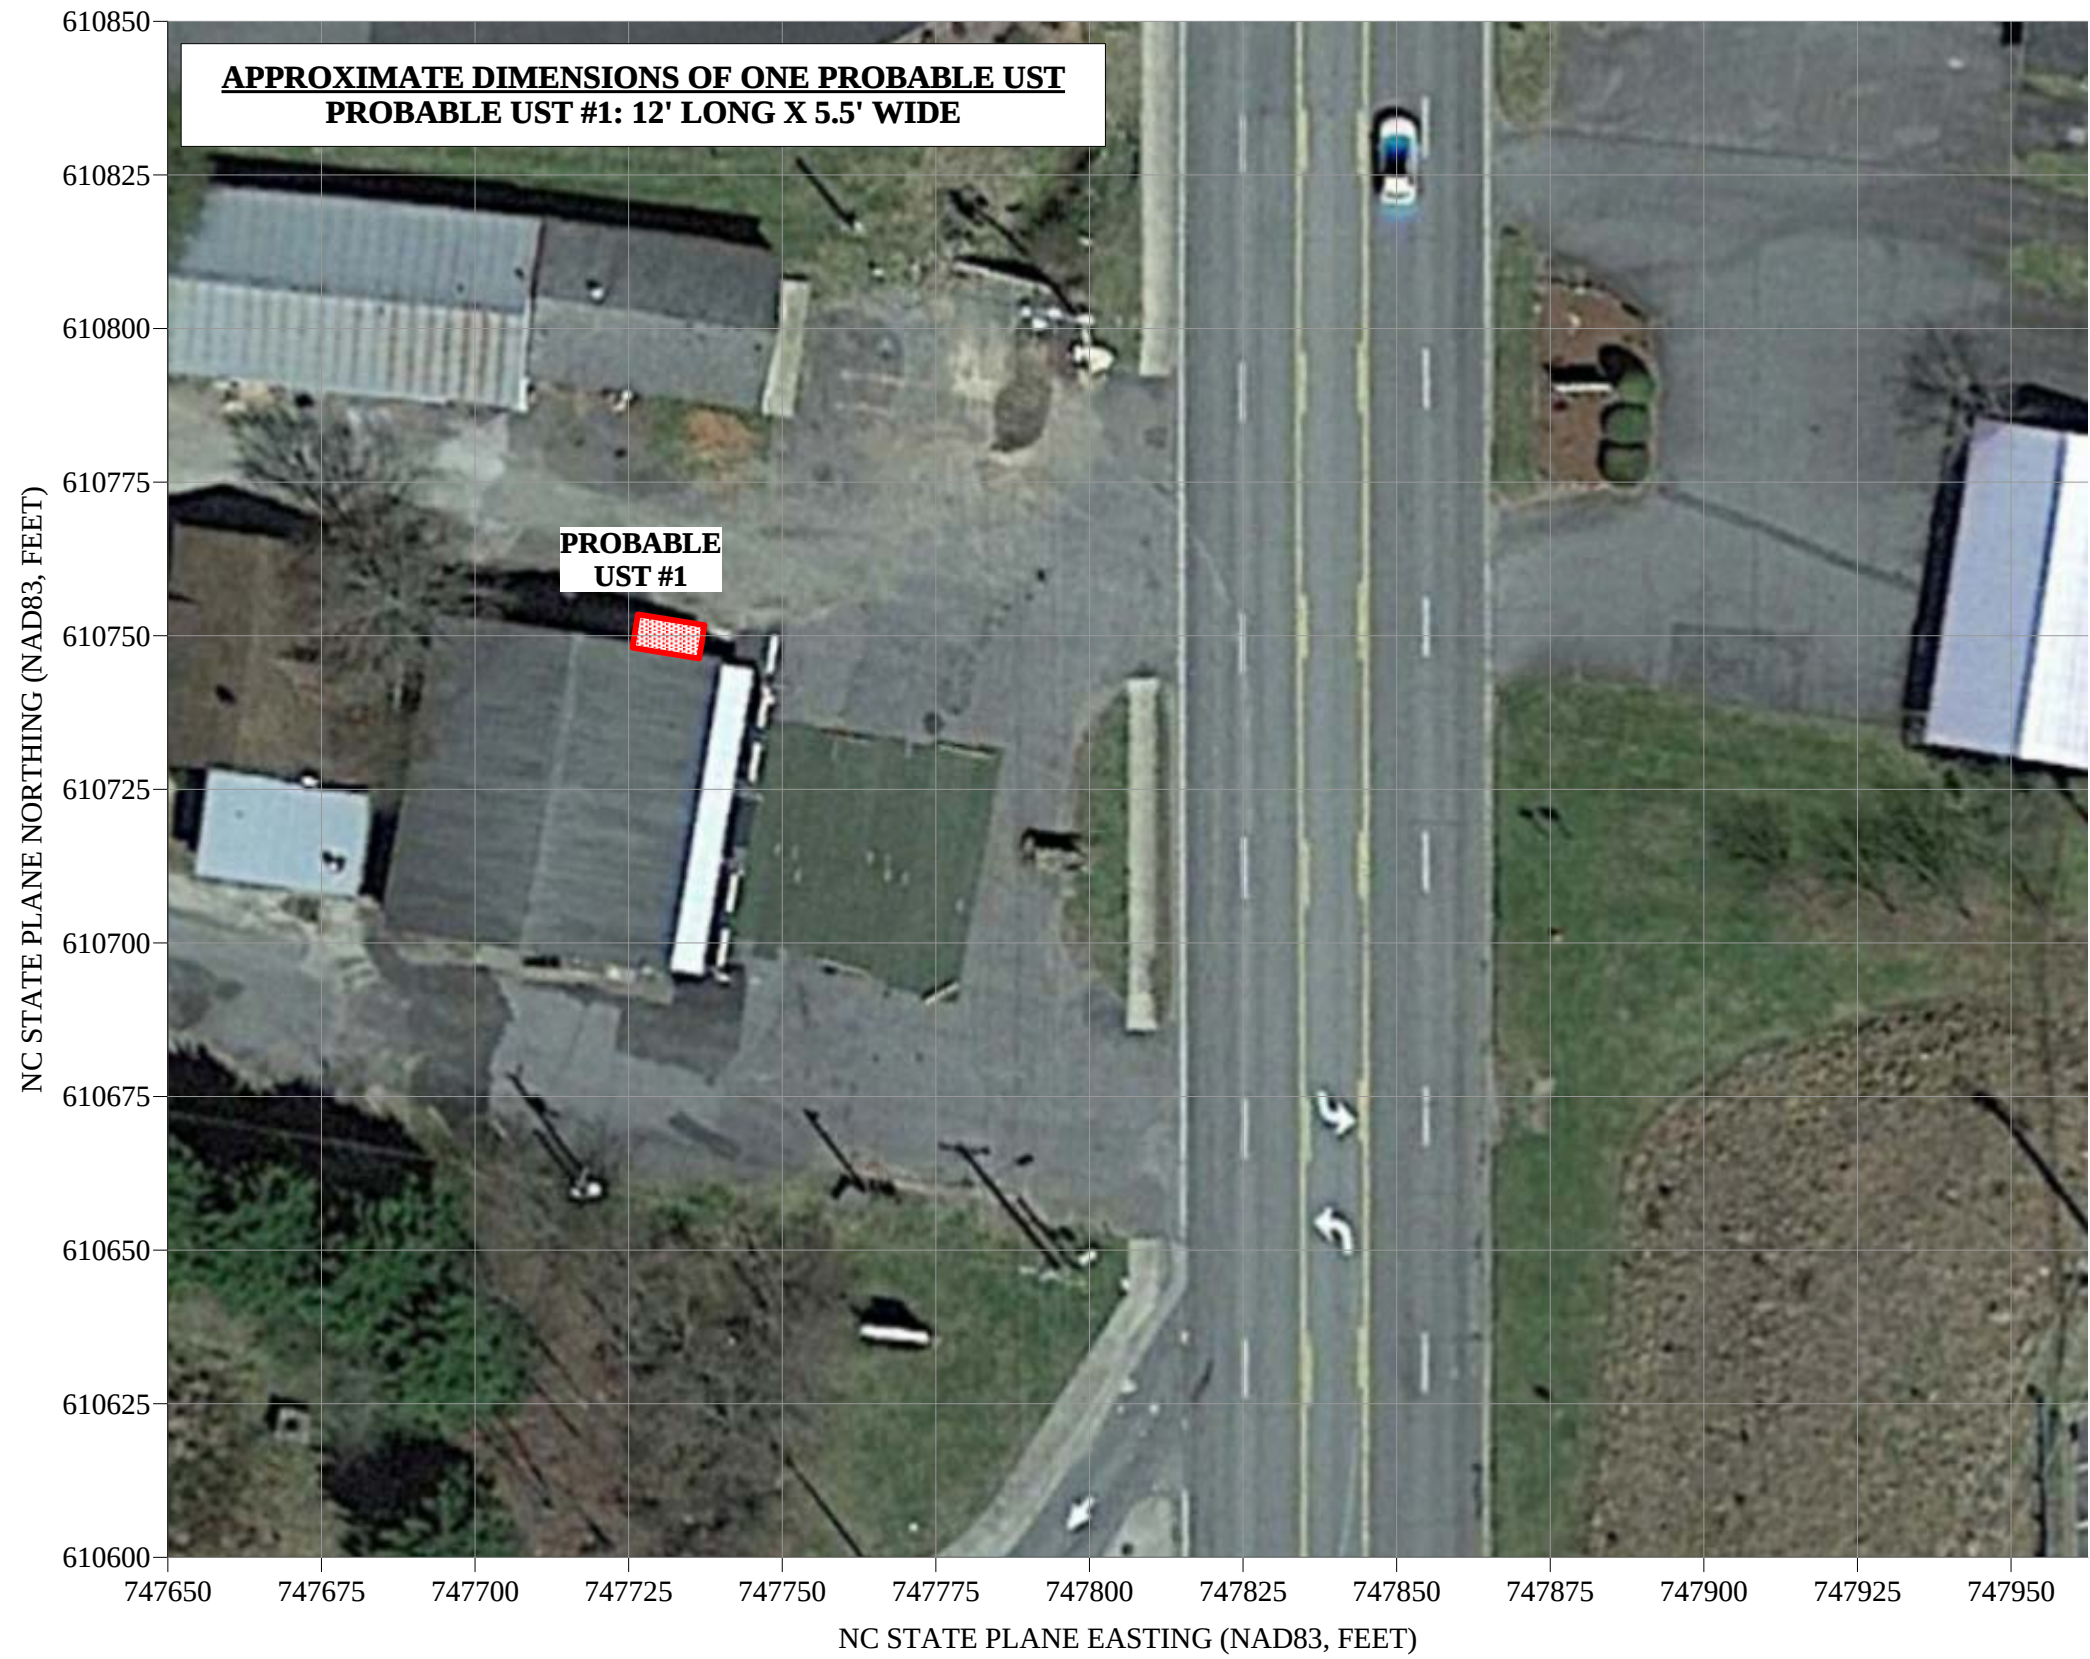
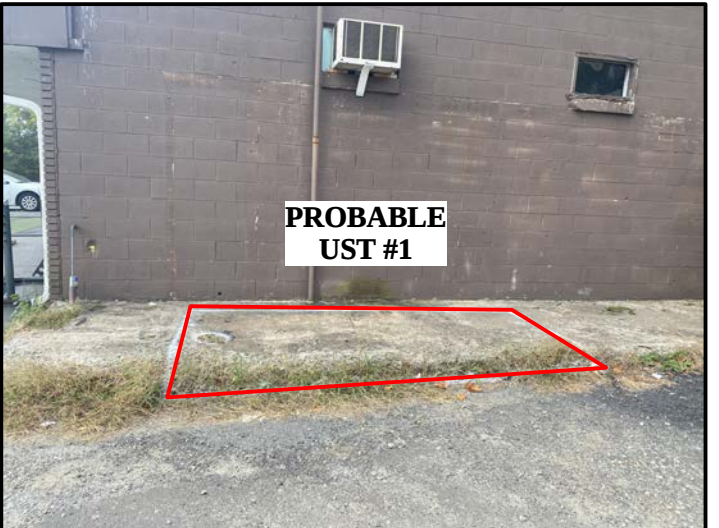
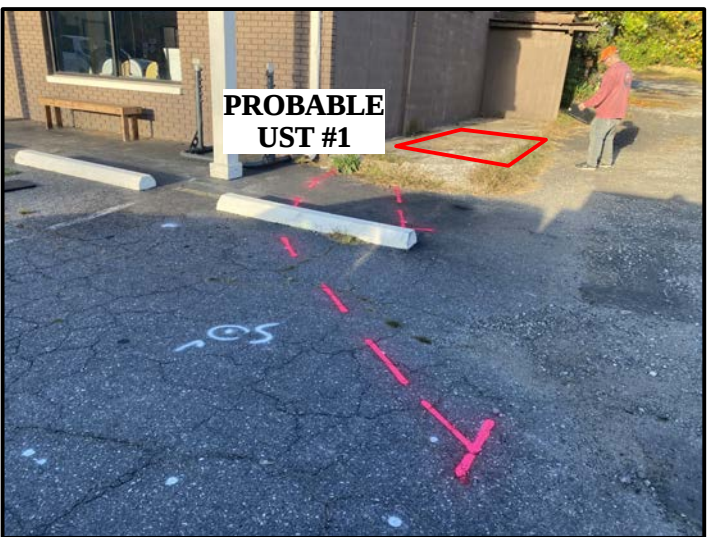
LOCATION OF ONE PROBABLE UST

View of One Probable UST  
(Facing Approximately South)

View of One Probable UST  
(Facing Approximately West)
