Re: Phase II Investigation Report – Parcel 2/2A

NC DOT State Project No. R-5600 WBS Element No. 45818.1.FR1

Sylva, Jackson County, North Carolina

Phase II Investigation NC DOT Parcel 2/2A

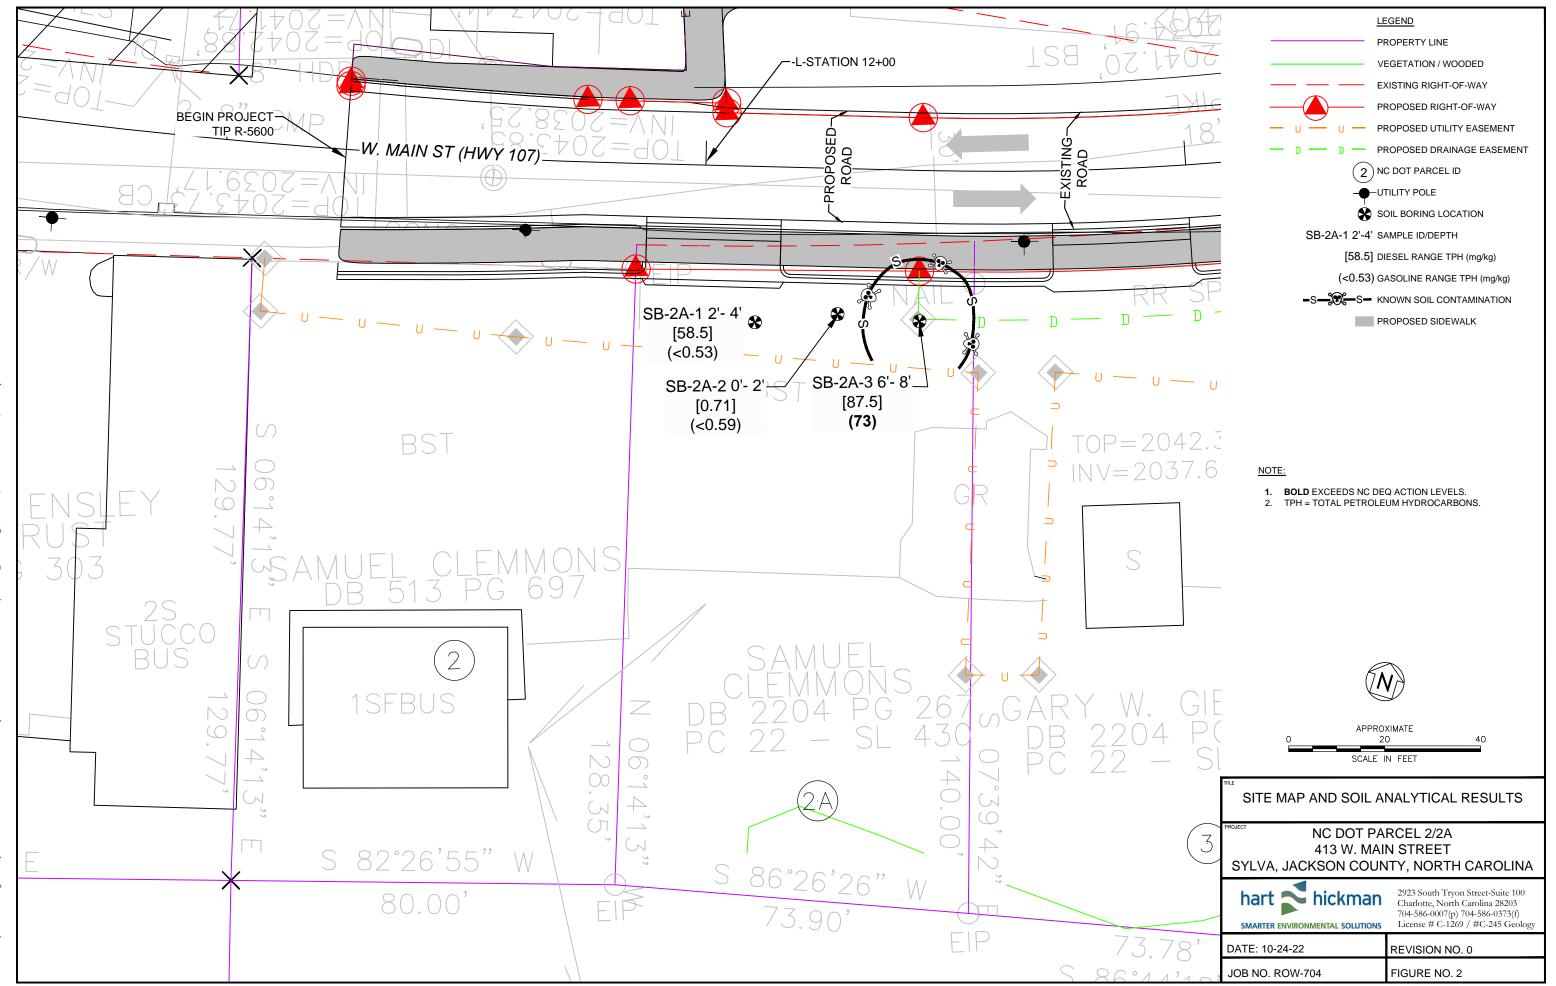
2A-1 through SB-2A-3. Soil samples were collected at various depths between 0 ft to 2 ft and 6 ft to 8 ft bgs. Soil boring logs are included in Appendix C. GPS coordinate data for the soil borings are summarized in Table 1, and the boring locations are shown on Figure 2.

Concentrations of TPH DRO (ranging from 0.71 mg/kg to 87.5 mg/kg) were detected in soil samples collected from borings SB-2A-1 through SB-2A-3. These concentrations are below the NC DEQ Action Level for TPH DRO of 100 mg/kg. TPH GRO was detected in soil sample SB-2A-3 at a concentration of 73 mg/kg, which exceeds the NC DEQ Action Level for TPH GRO of 50 mg/kg. TPH data are depicted on Figure 2.

The estimated depth of impacted soils is based on field screening results up to the approximate water table. However, field screening and lab results did not provide information that fully defines the impacted soil interval or extent. Therefore, impacts may extend beyond the depths and amounts indicated above. The approximate area of impacted soil is shown on Figure 2.

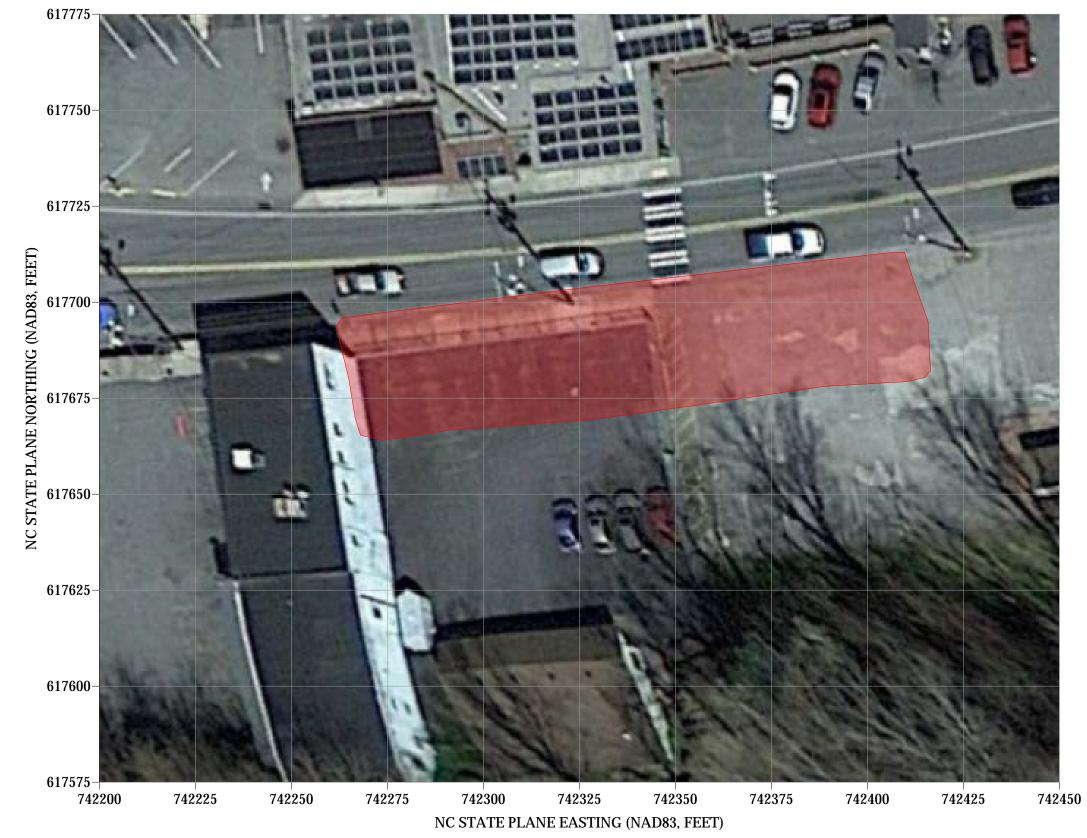
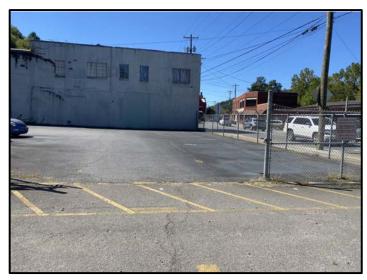
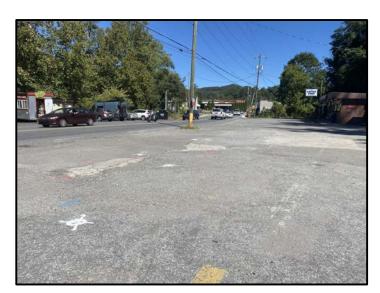
DATE	9/30/2022	CLIENT	HART & HICKMAN
PYRAMID PROJECT #:	2022-260		FIGURE 1

The site consisted of an active vehicle repair shop surrounded by asphalt and concrete surfaces. An aerial photograph, showing the survey area boundaries, and ground-level photographs are shown in **Figure 1**.

APPROXIMATE BOUNDARIES OF GEOPHYSICAL SURVEY AREA

View of Survey Area (Facing Approximately West)

View of Survey Area (Facing Approximately East)

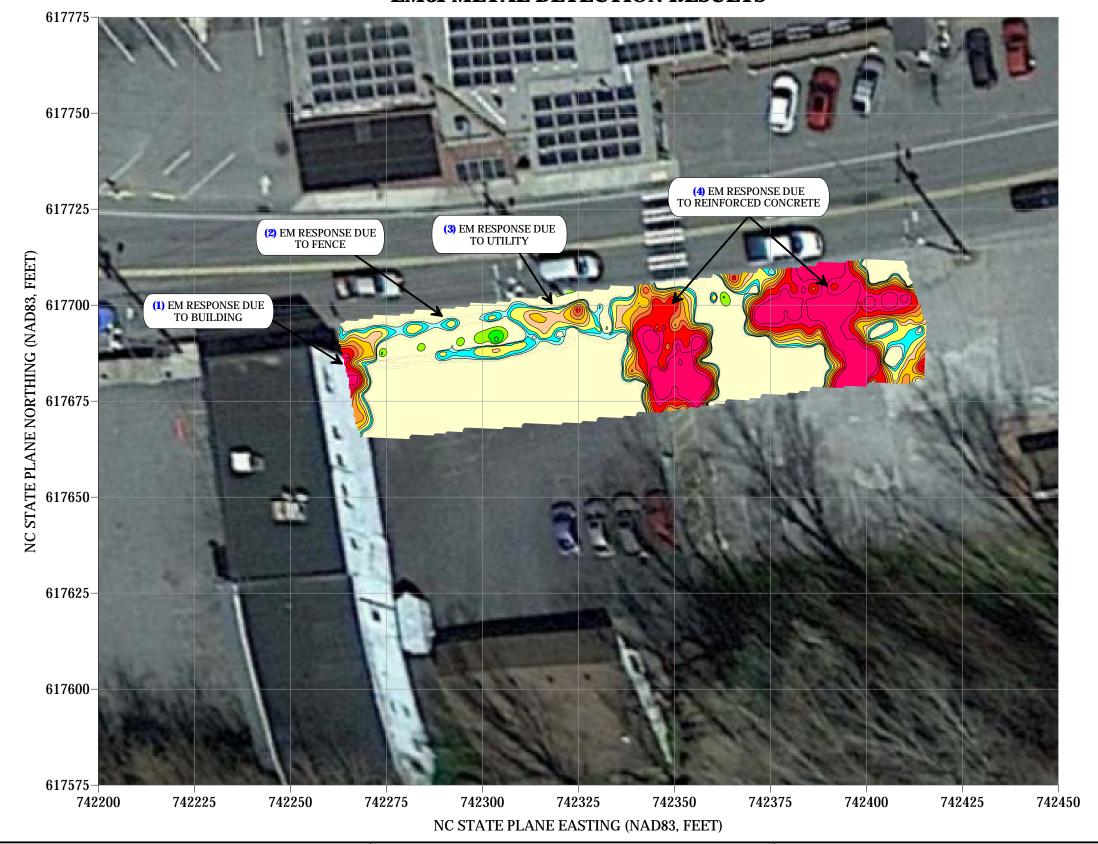
•
DATE	9/30/2022	CLIENT	HART & HICKMAI
PYRAMID PROJECT #:	2022-260		FIGURE 2

EM61 METAL DETECTION RESULTS

NO EVIDENCE OF METALLIC USTs WAS OBSERVED.

The contour plot shows the differential results of the EM61 instrument in millivolts (mV). The differential results focus on larger metallic objects such as USTs and drums. The EM data were collected on September 26, 2022, using a Geonics EM61-MK2 instrument. Verification GPR data were collected using a GSSI SIR 4000 instrument with a 350 MHz HS antenna on September 27, 2022.

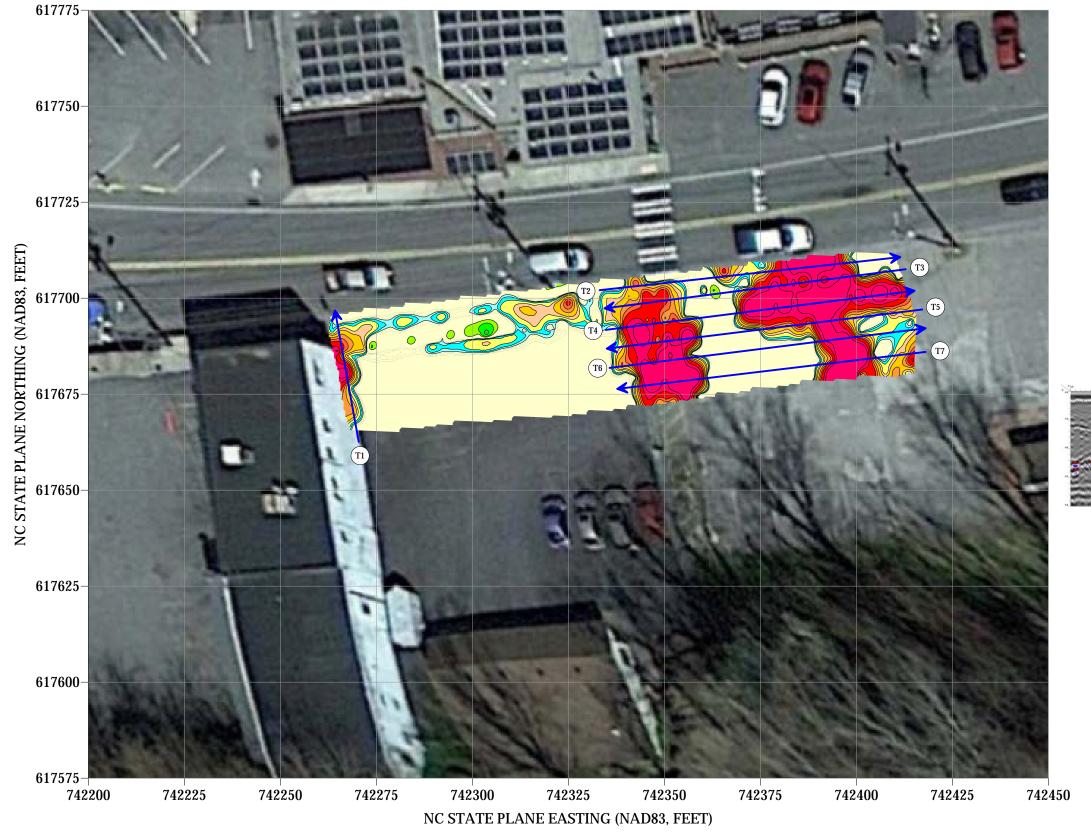
HART & HICKMAN 9/30/2022 PYRAMID PROJECT #: FIGURE 3 2022-260

GPR Transects 1-7 were performed across and around areas of significant metallic interference. GPR Transects 2-7 confirmed the presence of reinforcement within the concrete. None of these transects showed evidence of significant structures such as USTs. Evidence of utilities and/or smaller fragments of buried debris was also observed.

GPR TRANSECT LOCATIONS

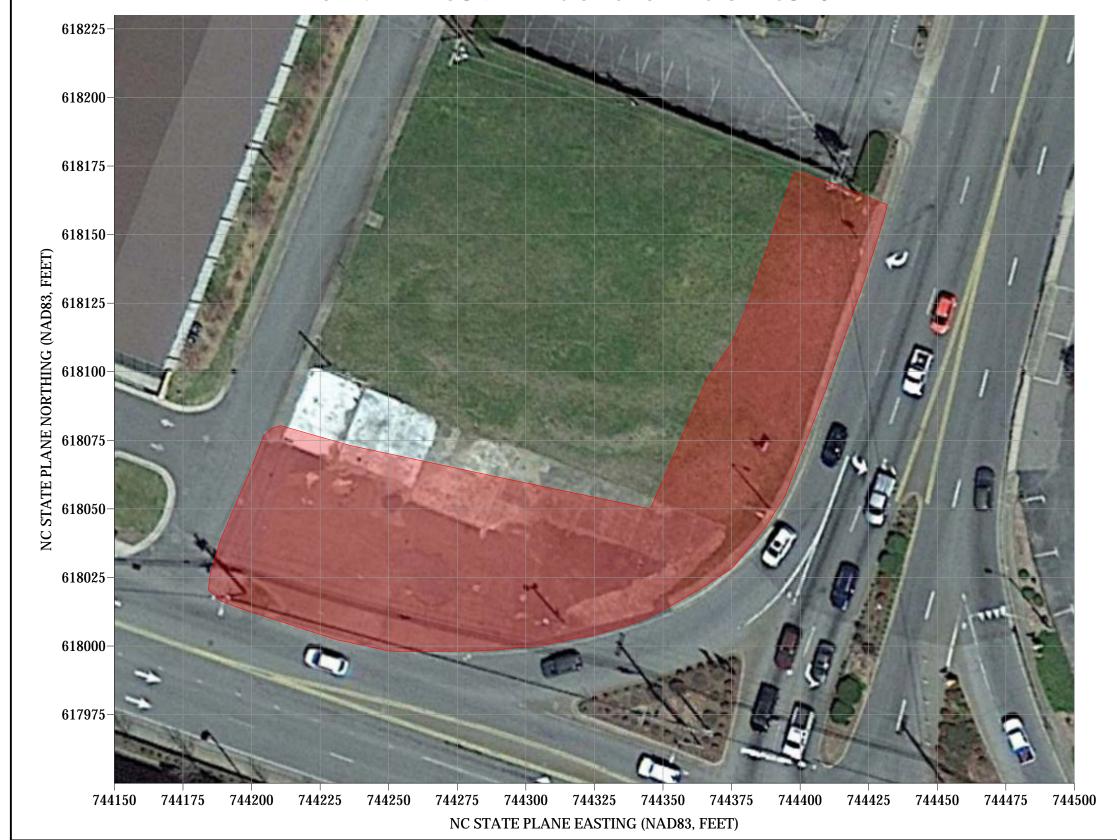
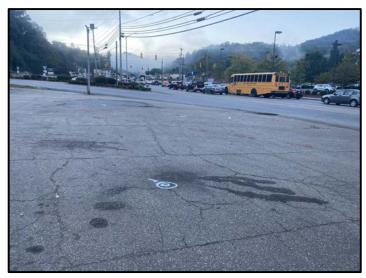
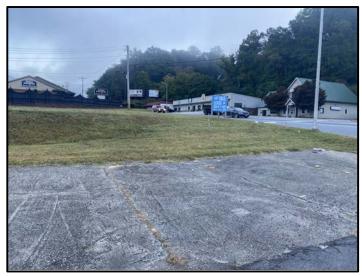
The site consisted of a former building foundation surrounded by asphalt and grass surfaces. An aerial photograph, showing the survey area boundaries, and ground-level photographs are shown in **Figure 1**.

APPROXIMATE BOUNDARIES OF GEOPHYSICAL SURVEY AREA

View of Survey Area (Facing Approximately East)

View of Survey Area (Facing Approximately North)

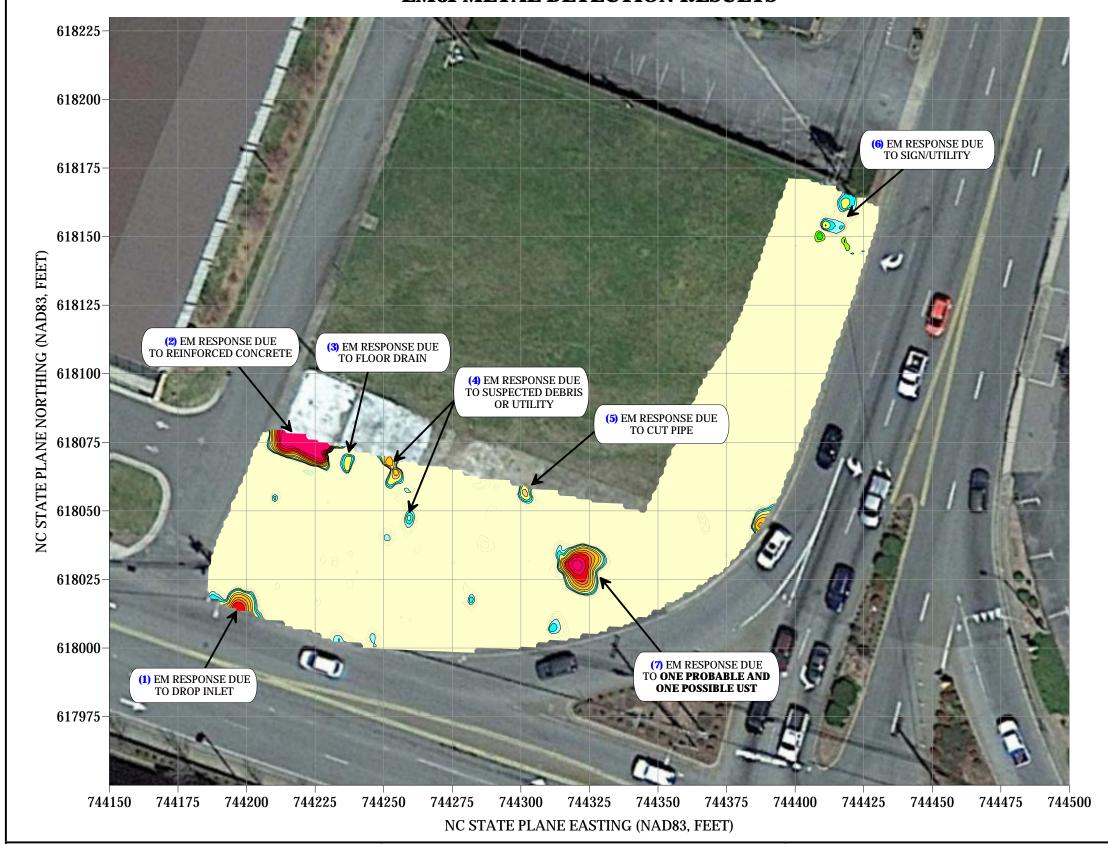
EM61 METAL DETECTION RESULTS

EVIDENCE OF ONE PROBABLE AND ONE POSSIBLE UST WAS OBSERVED.

The contour plot shows the differential results of the EM61 instrument in millivolts (mV). The differential results focus on larger metallic objects such as USTs and drums. The EM data were collected on September 26, 2022, using a Geonics EM61-MK2 instrument. Verification GPR data were collected using a GSSI SIR 4000 instrument with a 350 MHz HS antenna on September 28, 2022.

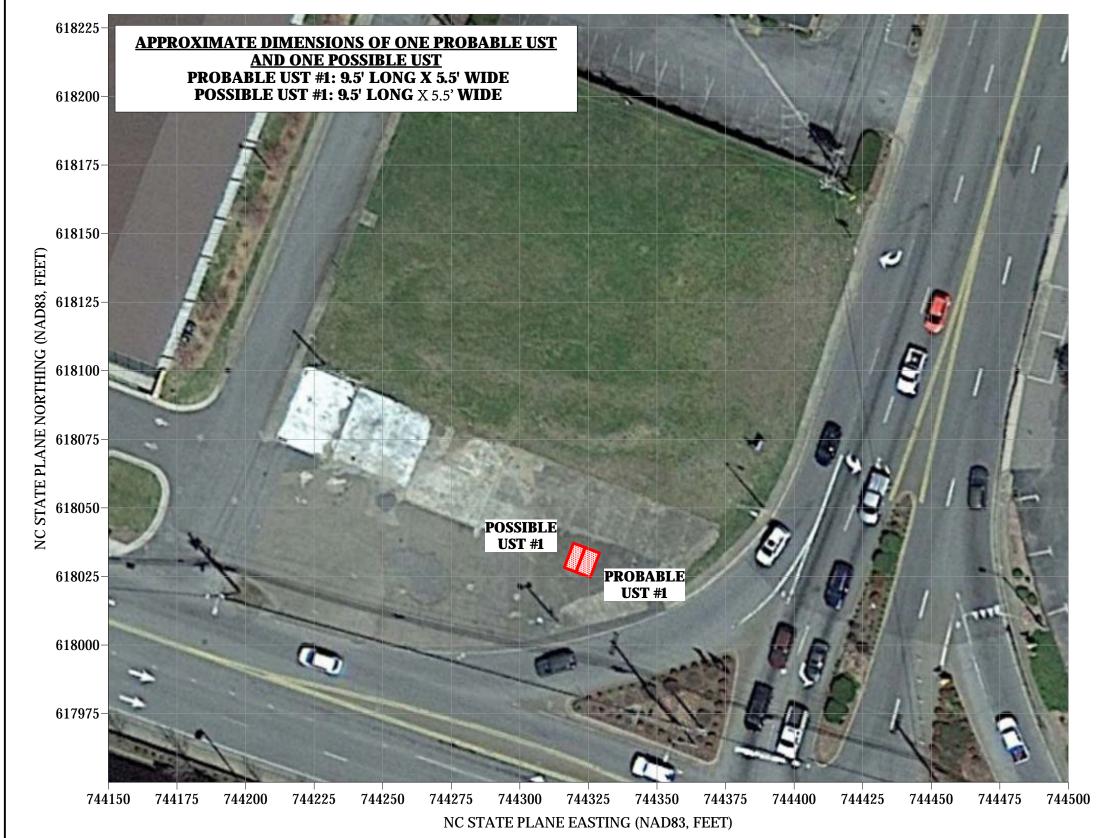
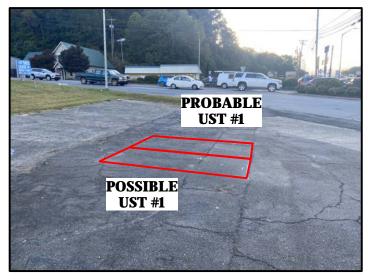
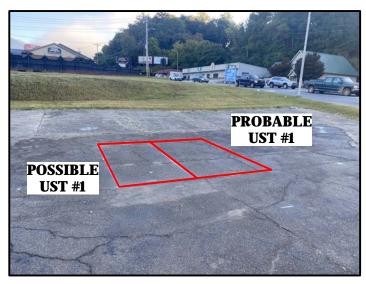
One probable and one possible UST were observed in the southeastern portion of the parcel. Probable UST #1 is approximately 9.5 feet long by 5.5 feet wide. Possible UST #1 is approximately 9.5 feet long by 5.5 feet wide. Collectively, the geophysical data recorded evidence of one probable and one possible UST at Parcel 24.

LOCATIONS OF ONE PROBABLE UST AND ONE POSSIBLE UST

View of One Probable and One Possible UST (Facing Approximately East)

View of One Probable and One Possible UST (Facing Approximately Northeast)

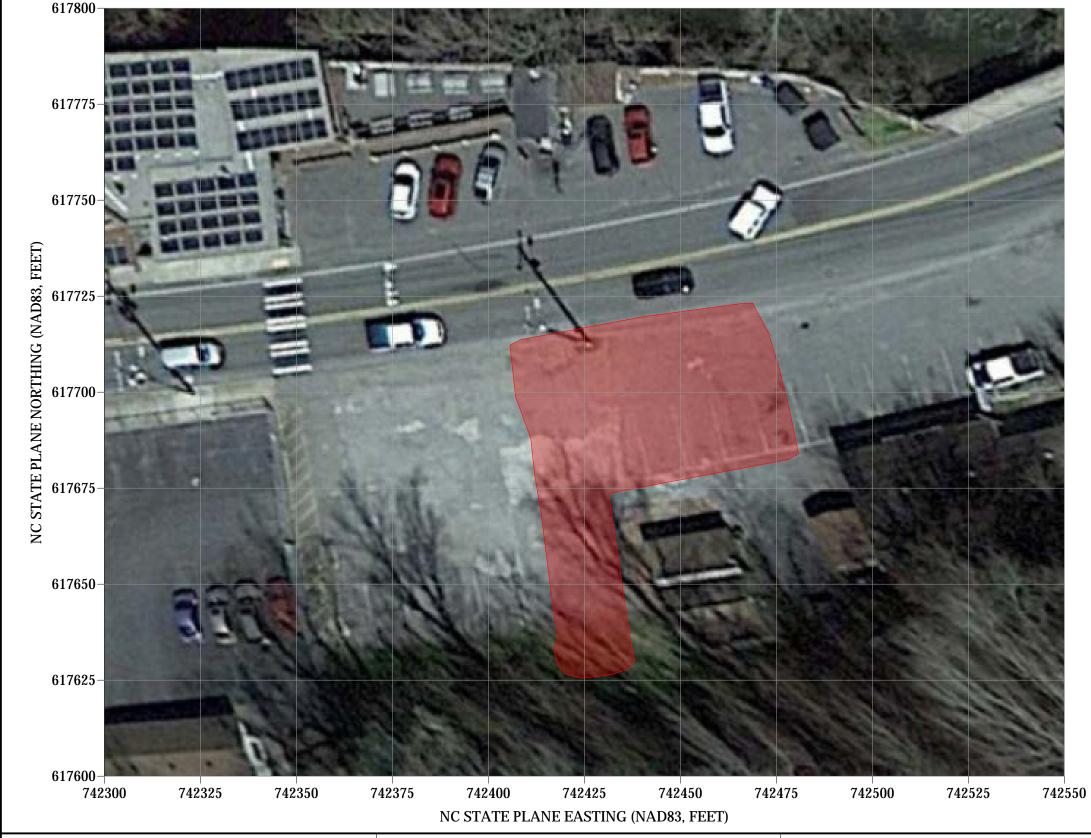
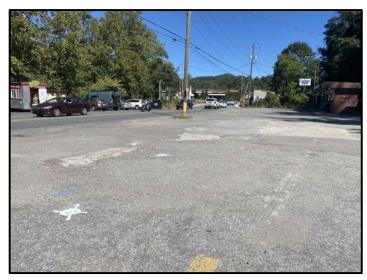
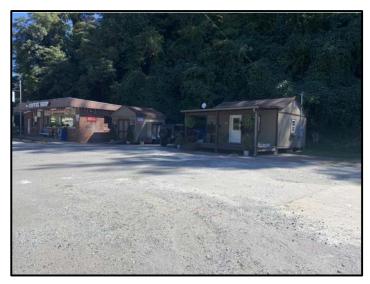
APPROXIMATE BOUNDARIES OF GEOPHYSICAL SURVEY AREA

View of Survey Area (Facing Approximately East)

View of Survey Area (Facing Approximately Southeast)

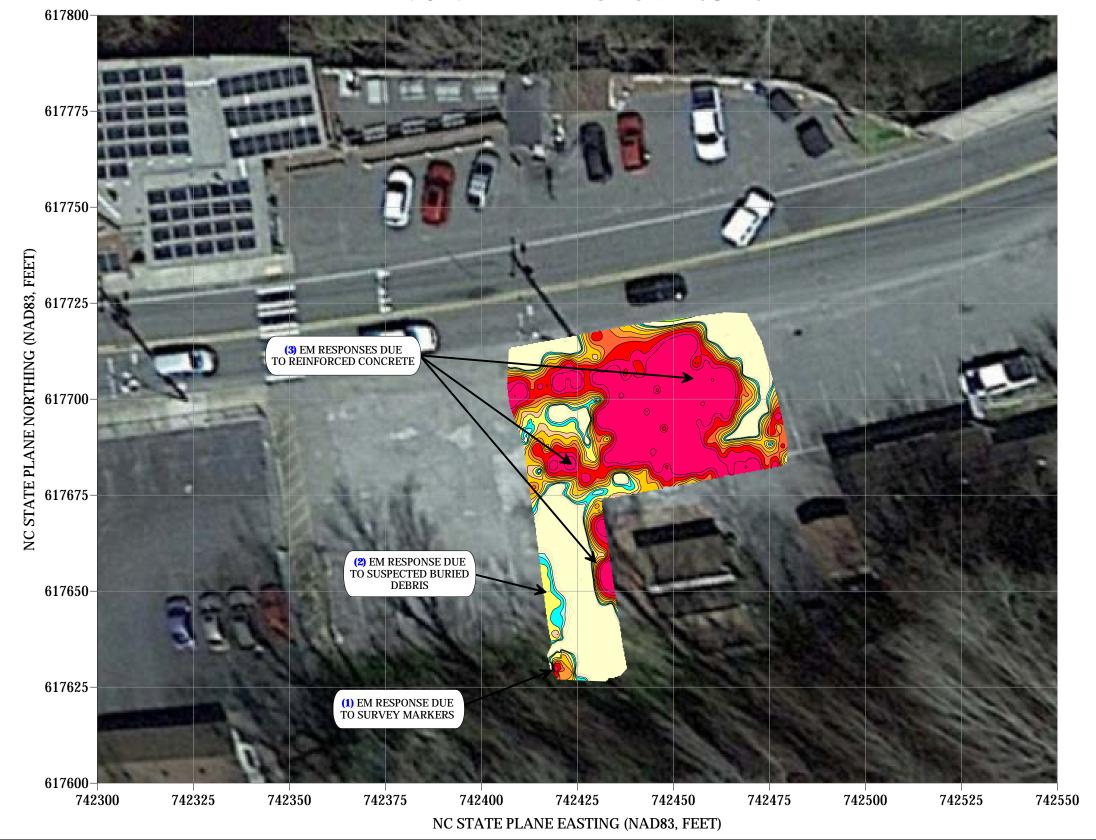
DATE	9/30/2022	CLIENT	HART & HICKMAI
PYRAMID PROJECT #:	2022-260		FIGURE 2

EM61 METAL DETECTION RESULTS

NO EVIDENCE OF METALLIC USTs WAS OBSERVED.

The contour plot shows the differential results of the EM61 instrument in millivolts (mV). The differential results focus on larger metallic objects such as USTs and drums. The EM data were collected on September 26, 2022, using a Geonics EM61-MK2 instrument. Verification GPR data were collected using a GSSI SIR 4000 instrument with a 350 MHz HS antenna on September 27, 2022.
