Re: Phase II Investigation Report – Parcel 4

NC DOT State Project No. R-5600 WBS Element No. 45818.1.FR1

## Phase II Investigation NC DOT Parcel 4

## 385 W. Main St. Sylva, Jackson County North Carolina

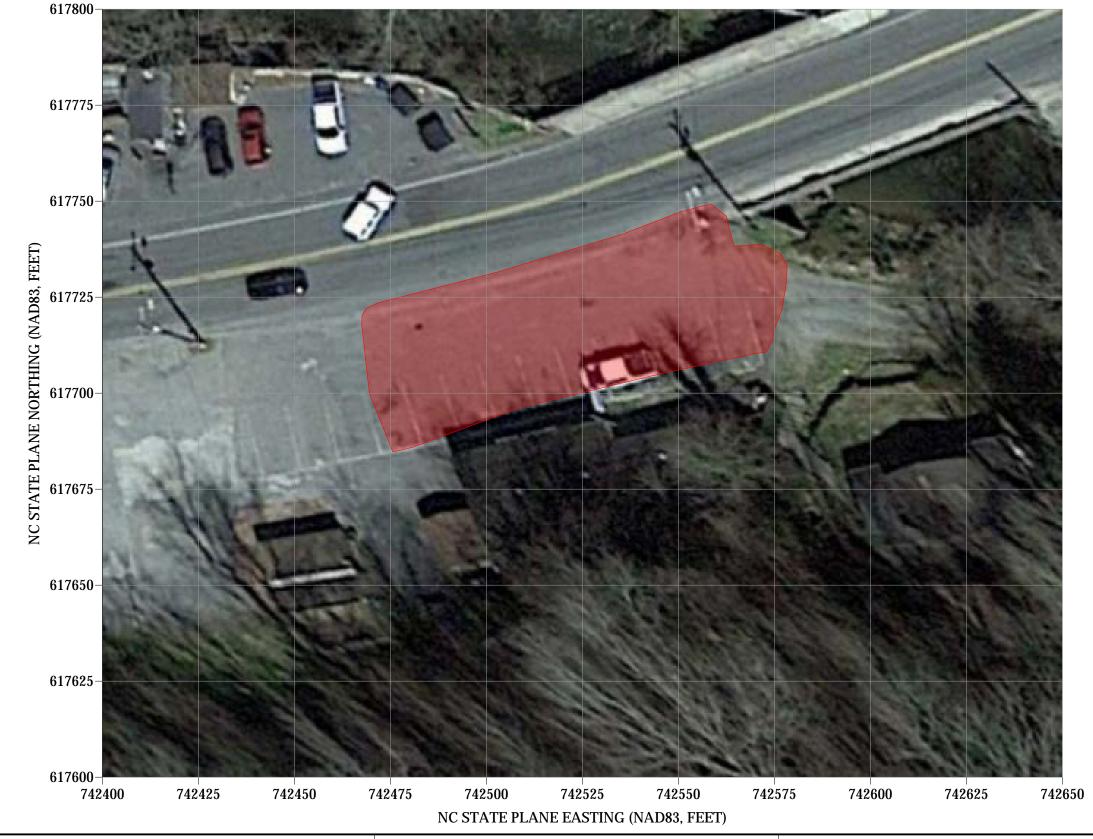
#### APPROXIMATE BOUNDARIES OF GEOPHYSICAL SURVEY AREA

View of Survey Area (Facing Approximately Southeast)

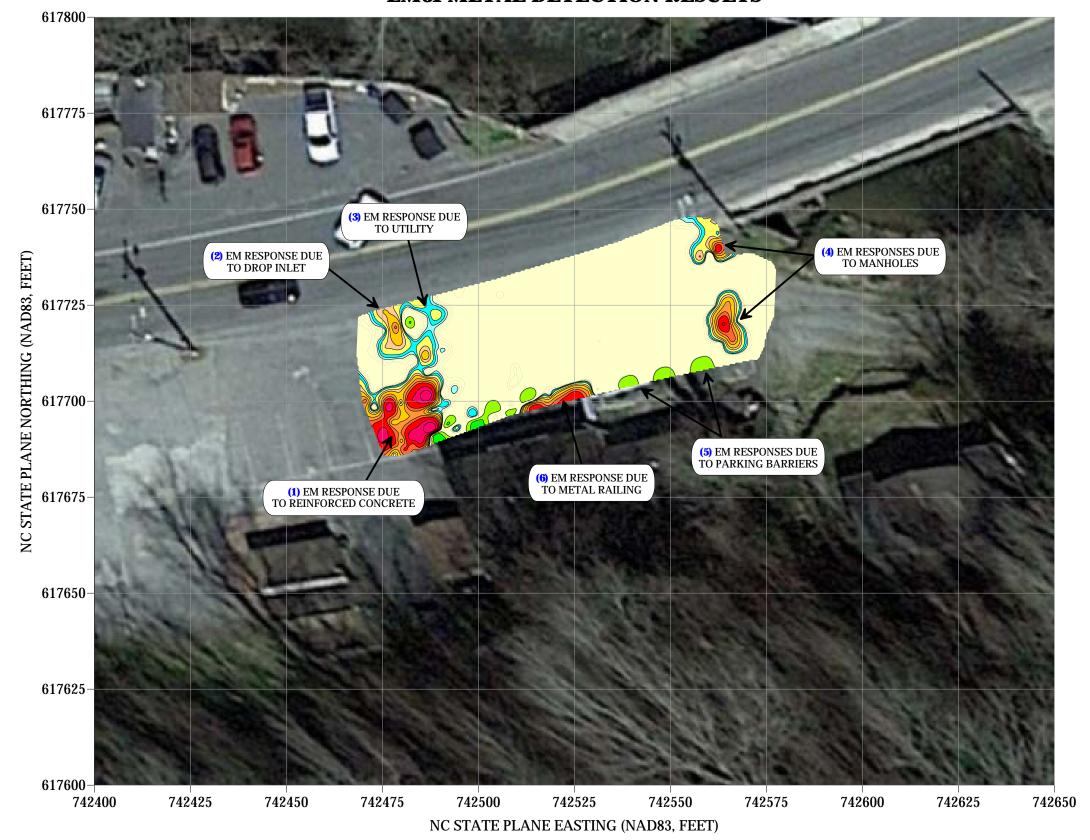
#### **EM61 METAL DETECTION RESULTS**

## NO EVIDENCE OF METALLIC USTs WAS OBSERVED.

The contour plot shows the differential results of the EM61 instrument in millivolts (mV). The differential results focus on larger metallic objects such as USTs and drums. The EM data were collected on September 26, 2022, using a Geonics EM61-MK2 instrument. Verification GPR data were collected using a GSSI SIR 4000 instrument with a 350 MHz HS antenna on September 27, 2022.

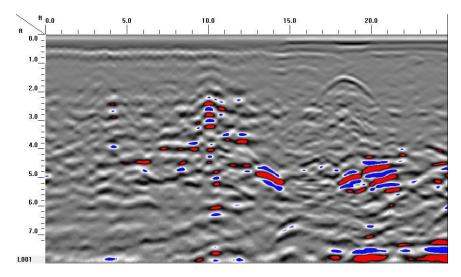
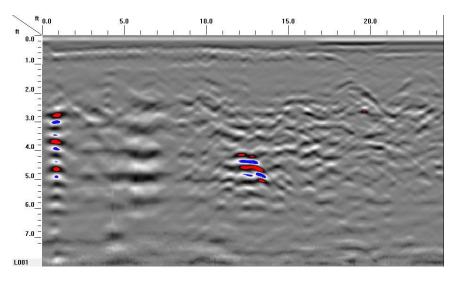
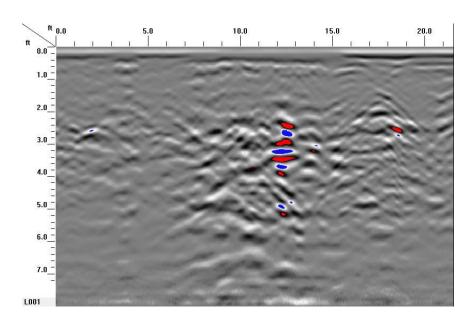
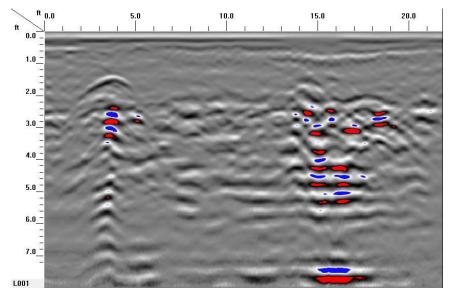
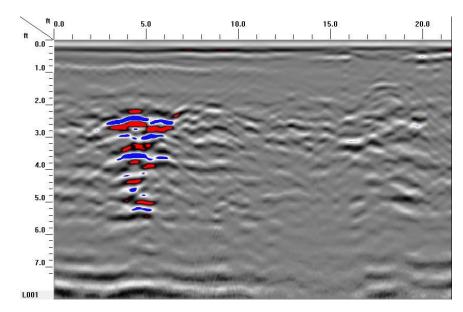
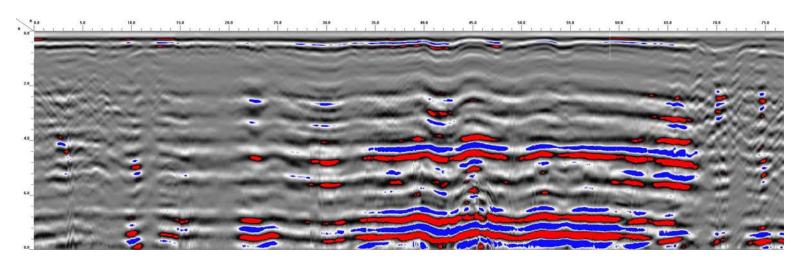
GPR Transects 1-6 confirmed the presence of reinforcement within the concrete. GPR Transects 7-8 were performed as general reconnaissance scans at the request of Hart & Hickman. None of these transects showed evidence of significant structures such as USTs. Evidence of utilities and/or smaller fragments of buried debris was also observed.

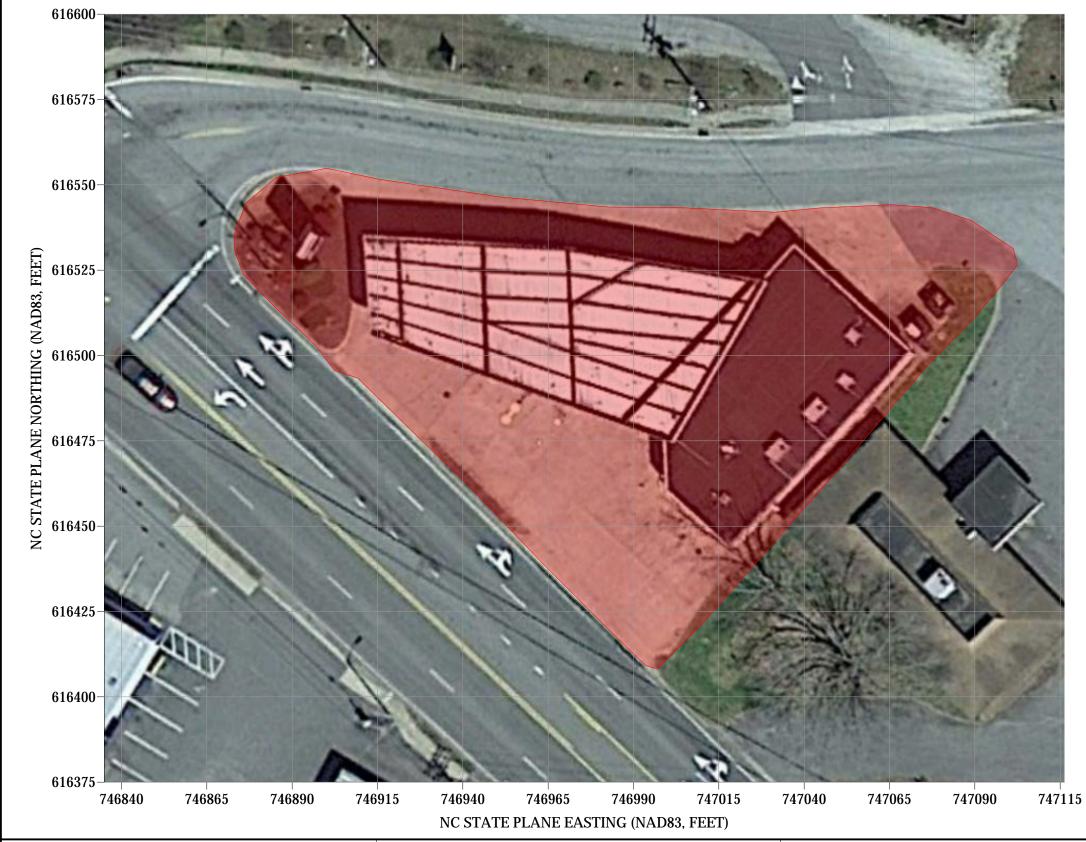
# APPROXIMATE BOUNDARIES OF GEOPHYSICAL SURVEY AREA

View of Survey Area (Facing Approximately Northwest)

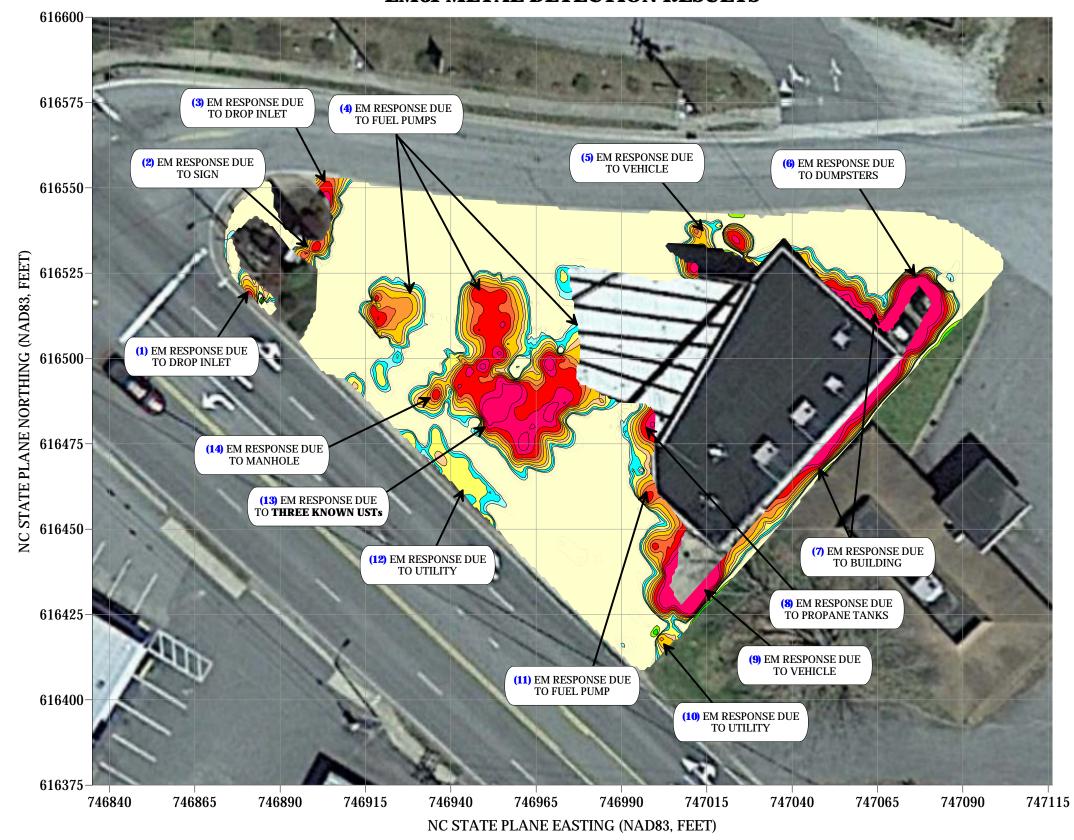
# **EM61 METAL DETECTION RESULTS**

# THREE KNOWN USTS WERE IDENTIFIED AT THE SITE. NO EVIDENCE OF UNKNOWN USTS WAS OBSERVED.

The contour plot shows the differential results of the EM61 instrument in millivolts (mV). The differential results focus on larger metallic objects such as USTs and drums. The EM data were collected on September 26, 2022, using a Geonics EM61-MK2 instrument. Verification GPR data were collected using a GSSI SIR 4000 instrument with a 350 MHz HS antenna on September 27, 2022.

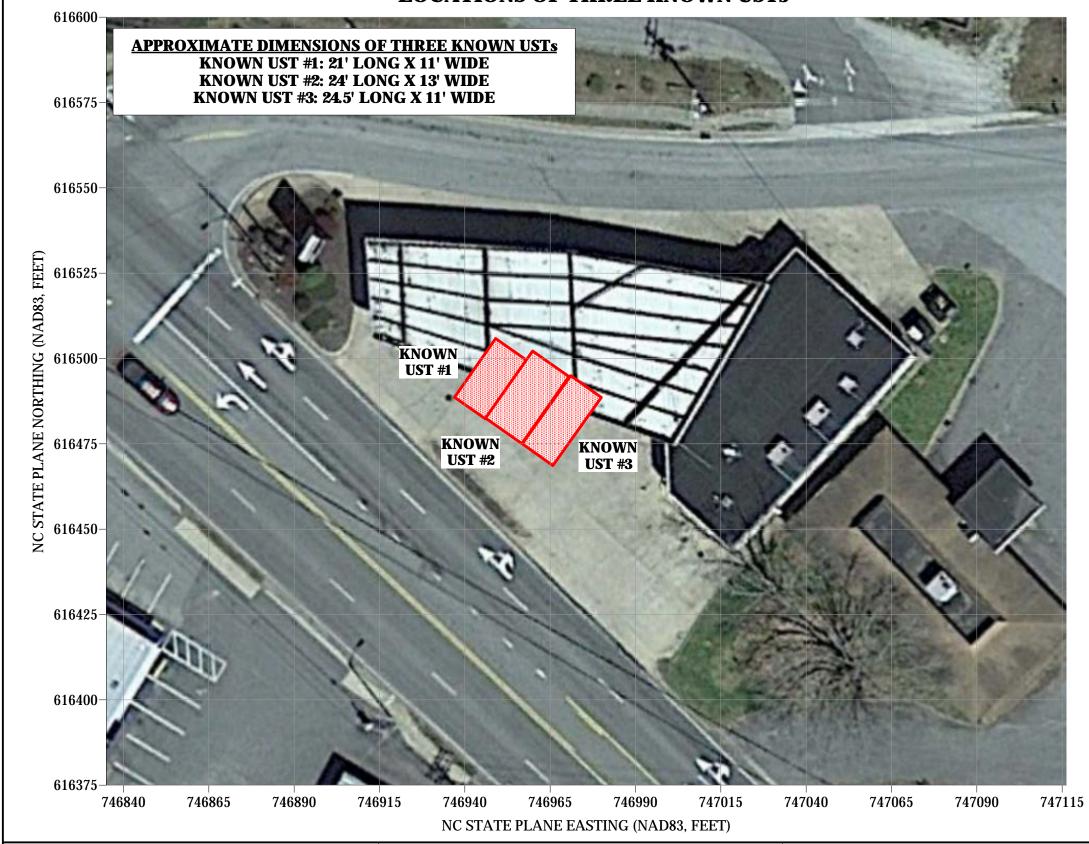
## **LOCATIONS OF THREE KNOWN USTs**

View of Three Known USTs (Facing Approximately Northwest)
