Reference: **Preliminary Site Assessment for the John Kakavitsas Property (Parcel 5)**  
**3620 Oakdale Road**  
**Charlotte, Mecklenburg County, North Carolina**  
**State Project: W-5710X**  
**WBS Element 44856.1.24**  
**DAA Project No. 2101183**

JOHN KAKAVITSAS PROPERTY (PARCEL 5)  
3620 OAKDALE ROAD  
CHARLOTTE, NORTH CAROLINA

## METALLIC UST INVESTIGATION: PARCEL 5 NCDOT PROJECT W-5710X

PROJECT  
PARCEL 12  
CHARLOTTE, NORTH CAROLINA  
NCDOT PROJECT W-5710X

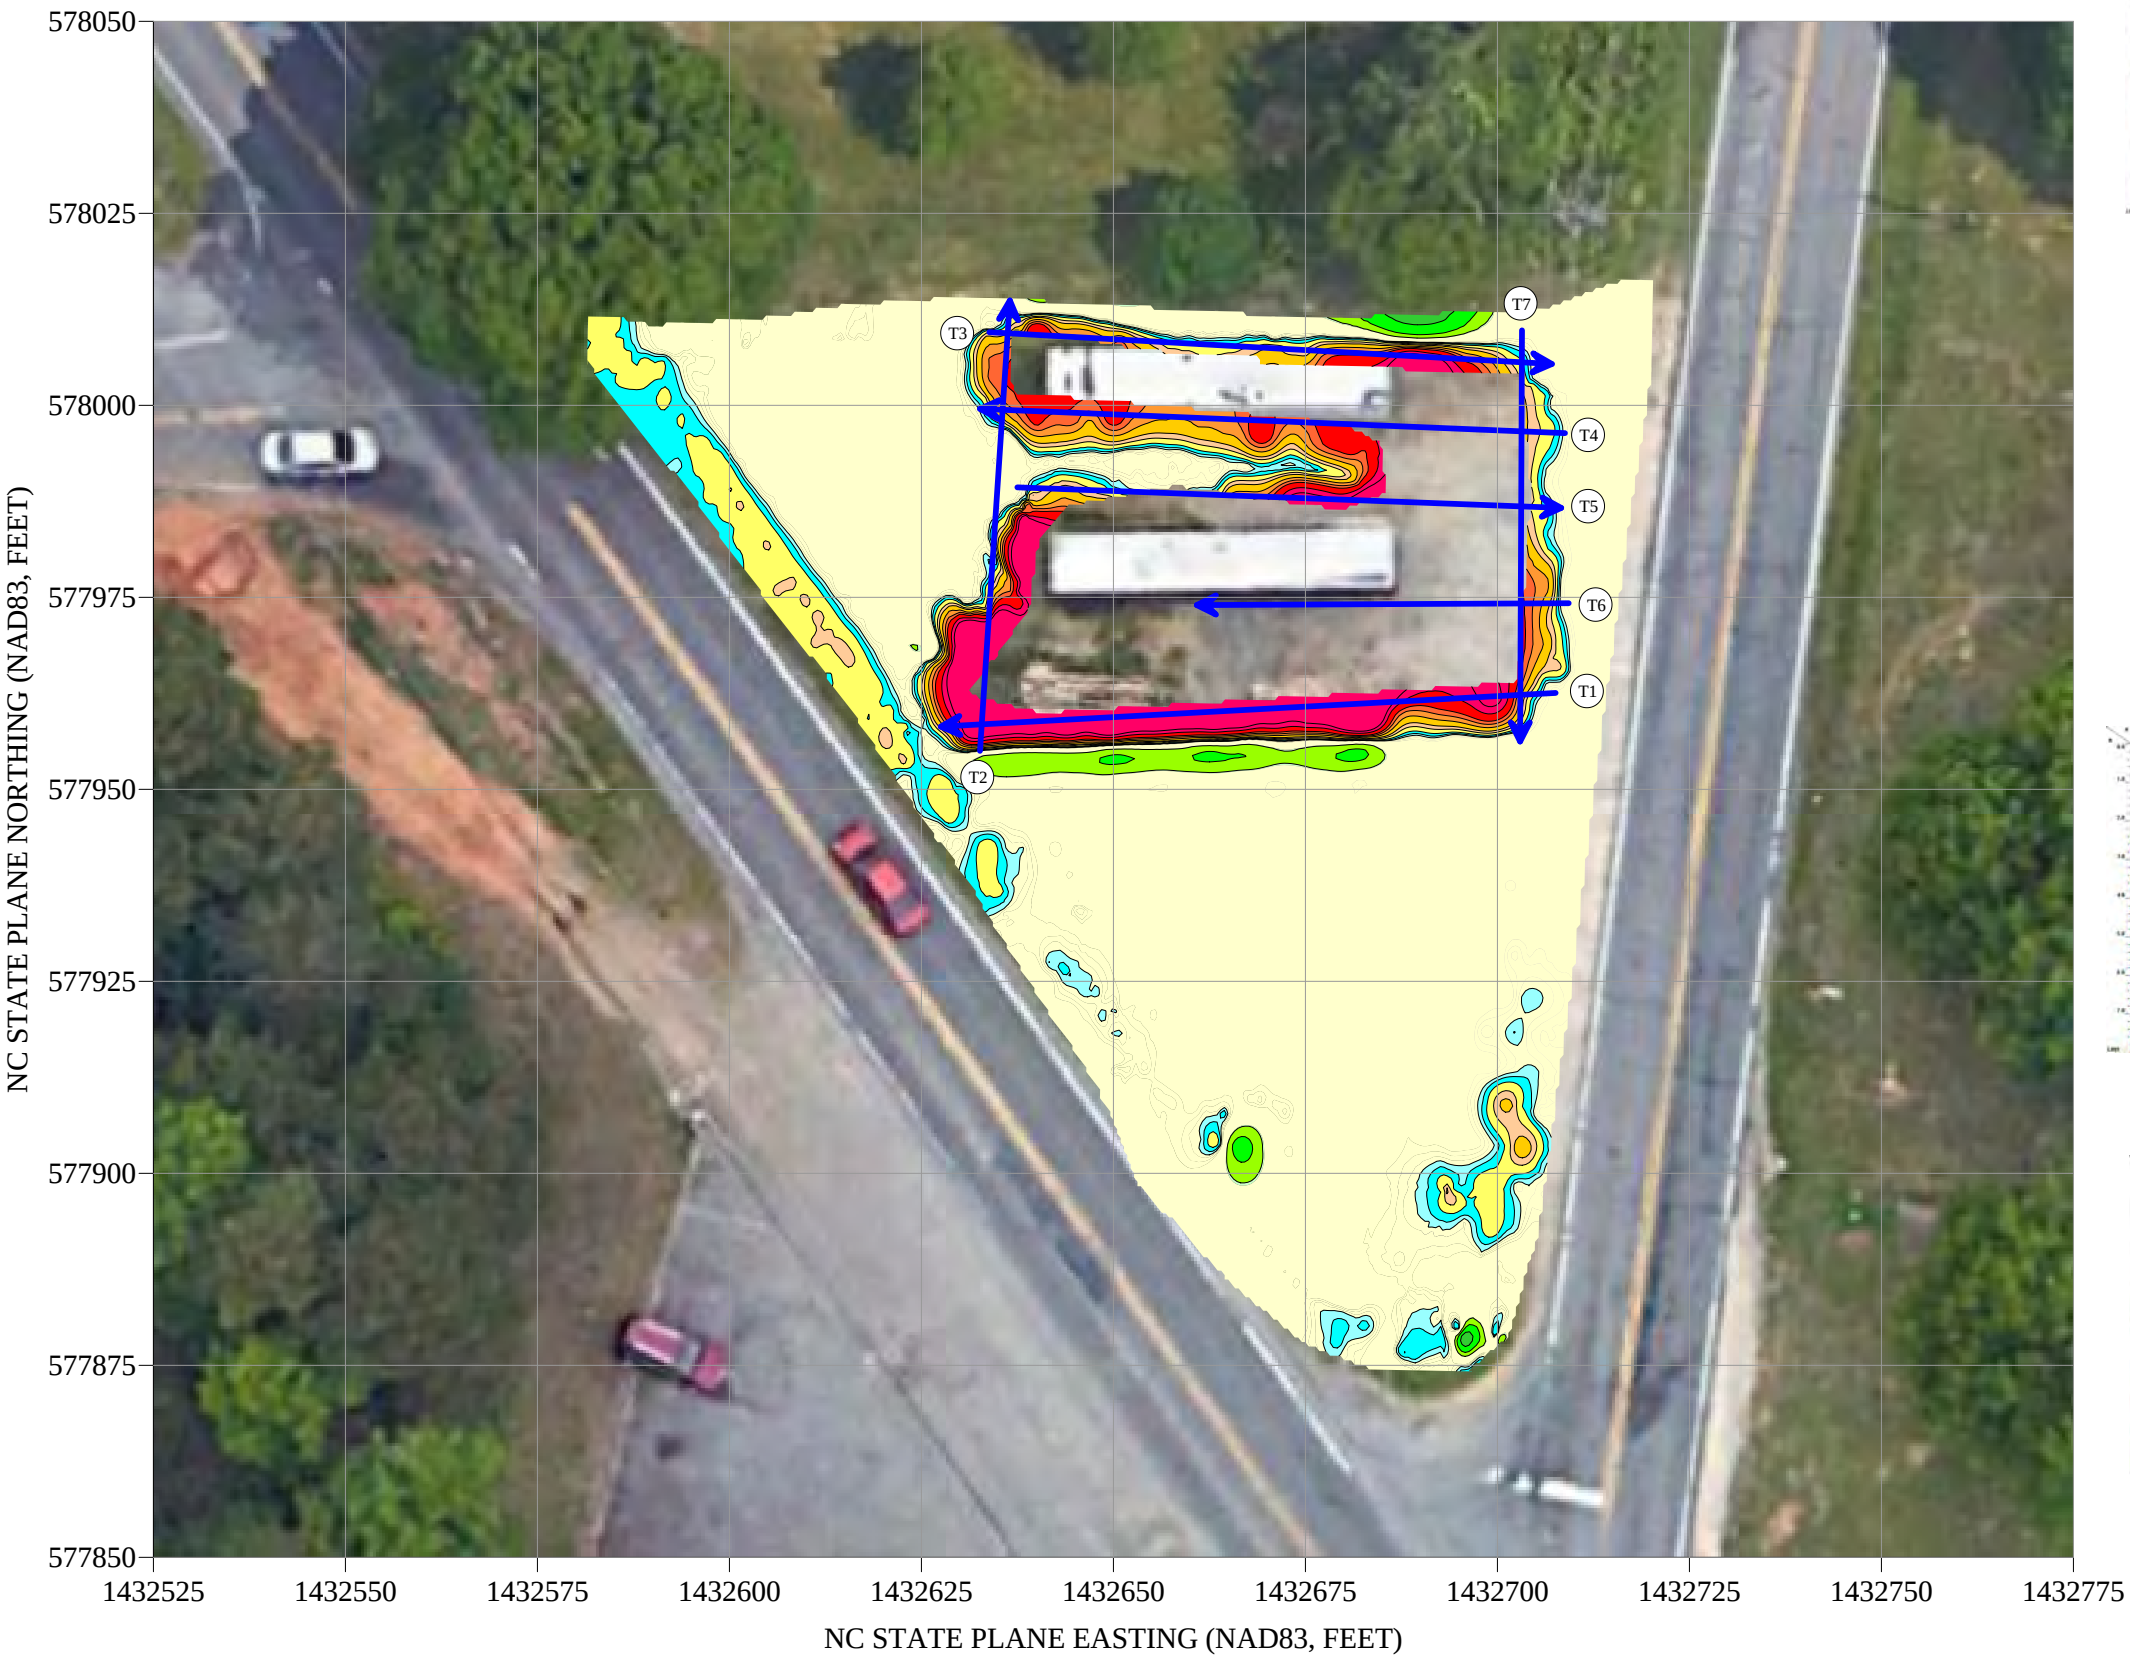
GPR TRANSECT LOCATIONS

GPR Transects 1-7 were performed across the areas of significant metallic interference. No evidence of significant structures such as USTs was observed.

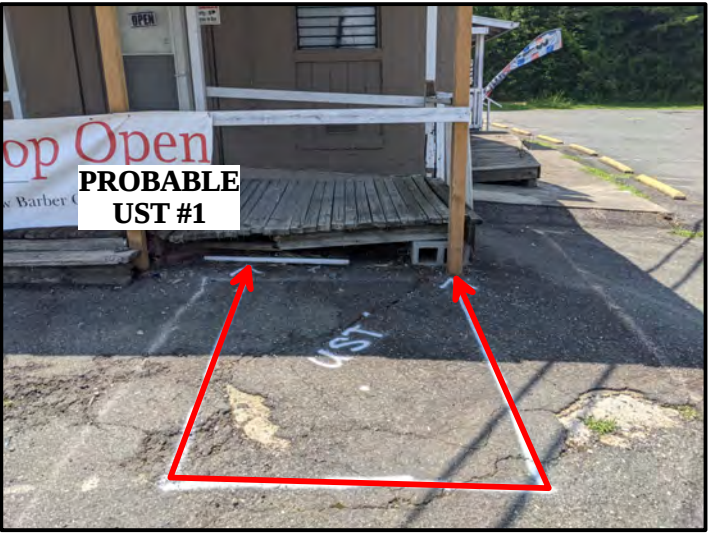
LOCATIONS OF ONE PROBABLE UST AND ONE NO CONFIDENCE ANOMALY

View of One Probable UST  
(Facing Approximately West)

View of One No Confidence Anomaly  
(Facing Approximately West)

DAA conducted a Preliminary Site Assessment to evaluate the NCDOT proposed ROW/easement on the Gregory Moore Property (Parcel #12) located at 3601 Oakdale Road in Charlotte, Mecklenburg County, North Carolina. A geophysical survey indicated the presence of a possible UST within the proposed ROW/easement; however, no visual signs of a UST were noted.
