# STATE OF NORTH CAROLINA DEPARTMENT OF TRANSPORTATION

TIP NO:
 B-5985

DESCRIPTION: Replace Bridge # 770125 over Lumber River on NC 41/NC 72 &

SUBJECT: GeoEnvironmental Planning Report

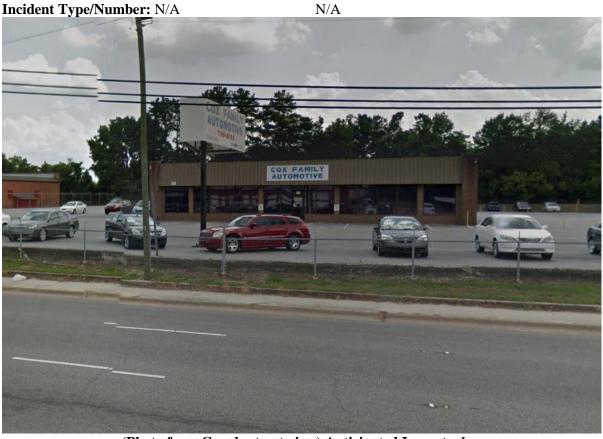
(01) Property Name: Cox Family Automotive

(Photo from Google street view) Anticipated Impacts: Low

This site is a currently a used car dealership. It is located on the south side of W 5th St at the fork of W 5th St and W 2nd St. It is the former location of Lumberton Nissan Inc. The facility is not listed in the UST section registry and there are no known incidents associated with it. There are several service bays located on back potion of the building.

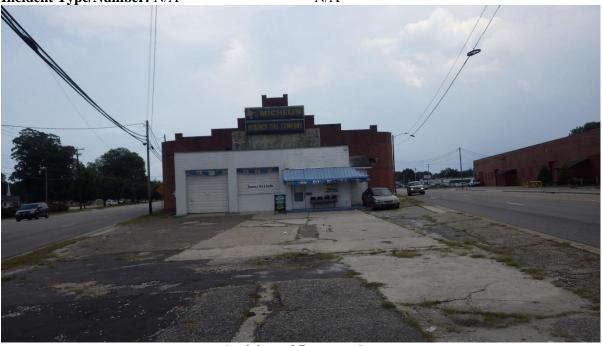
(02) Property Name: Ronnie's Tint & Auto 595 W 5th St

**Anticipated Impacts:** Low

This facility currently operates as an auto detail and body shop. It is located in the fork of W 2<sup>nd</sup> St & W 5th St. The current business (See Site # 3 red brick building) occupies both building on 2 separate parcels. The white brick building is the old gas station where the auto detailing is conducted. There is an outline of an old pump island on the western end of the property and 2 possible UST fill ports. The facility was not identified in the UST registry and there are no known incidents associated with it.

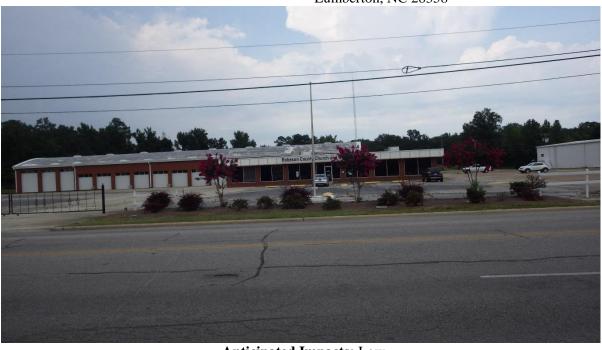
#### (04) Property Name:

**Anticipated Impacts:** Low

This facility currently operates as a church and community center. It is located on the north side of W 5th St at the intersection with W 2nd St. It is the former location of Lumberton Ford Lincoln Mercury. According to the UST section registry one 500 gallon UST was removed in 1988. There are no known incidents associated with this site.

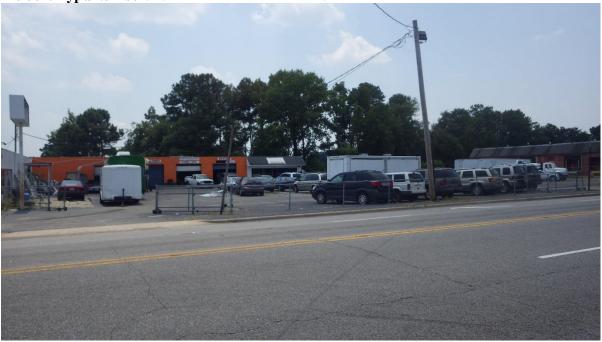
(05) Property Name:

**Anticipated Impacts:** Low

This site operates as an Auto repair and used car dealer. It is located on the south side of W 2nd St approximately 520 feet northwest of NC 41. This business is on two different parcels with different property owners. The western parking lot is on the property owned by the Thompson and the buildings and eastern portion of the parking lot is on the same parcel as the strip mall. The address is not listed in the UST section registry and there are no known incidents associated with it. No Evidence of USTs or monitoring wells were observed during the site investigation.

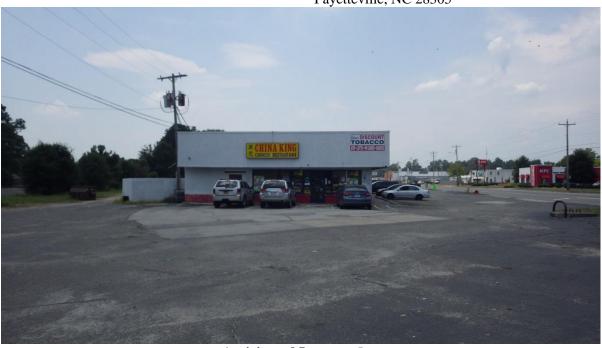
(06) Property Name:

**Anticipated Impacts:** Low

This facility currently operates as a Chinese Restaurant. It is the former location of Short Stop 65. It is located in the southwest quadrant of NC 41 and W 2nd St. According to the UST registry two USTs were removed from the Address 502 W 2nd St in 1999. Incident 21930 is associated with the site and is still active. The former pump island outline was visible during the site investigation and several monitor wells were observed.

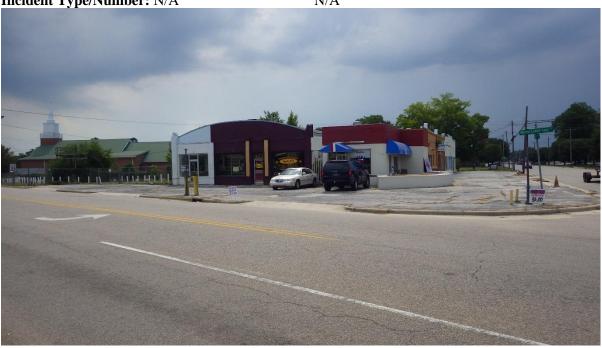
(07) Property Name:

**Anticipated Impacts:** Low

There are several businesses in this strip. It is located on south side of W 5th St in the triangle between W 5th St, MLK Jr. Dr. and Lincoln St. The facility is not listed in the UST section registry and there are no known incidents associated with it. No evidence of USTs or monitoring wells were observed during the site investigation. The design and location of the building suggest it may have operated as an auto repair shop or a convenience store/gas station at one time.

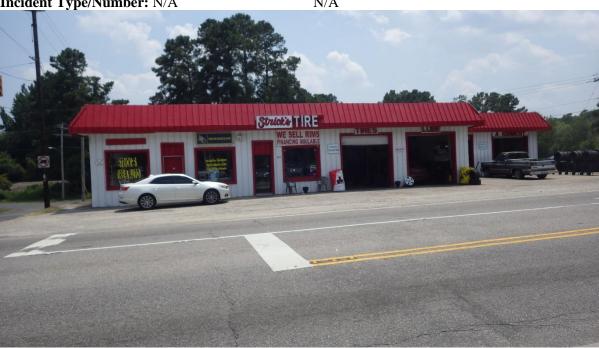
(08) Property Name:

**Anticipated Impacts:** Low

This facility currently operates as an auto repair shop. It is located in the southwest quadrant of W 2nd St and Water St. The facility is not listed in the UST section registry and there are no known incidents associated with it. No evidence of USTs or monitoring wells were observed during the site investigation. One used oil AST was observed in the back of the building.

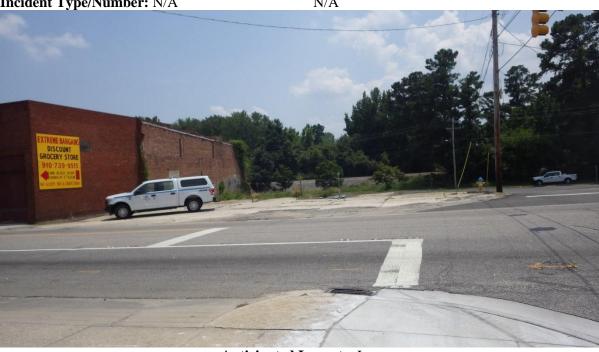
#### (09) Property Name:

**Anticipated Impacts:** Low

This site is currently a vacant lot with a concrete foundation. It is located on the southeast quadrant of W 2<sup>nd</sup> St and Water St. A possible pump island outline was observed during the site investigation. There is no other evidence of USTs and no monitoring wells were observed. The facility is not listed in the UST registry and there are no known incidents associated with it.

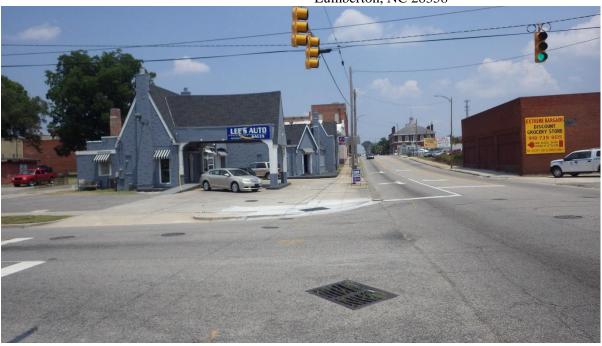
(10) Property Name:

**Anticipated Impacts:** Low

This former gas station currently operates as a used car dealer & auto repair shop. It is located in the northeast quadrant of W 2nd St and Water St. The facility is not listed in the UST section registry. Incident 42003 is associated with this facility and is still active. The incident database indicates that four regulated USTs were abandoned in place in 1988. Notice of regulatory requirements (NORR) sent 8/16. A possible fill port was observed near the Southwest corner of the building. Several monitoring wells were observed and appeared to be active.

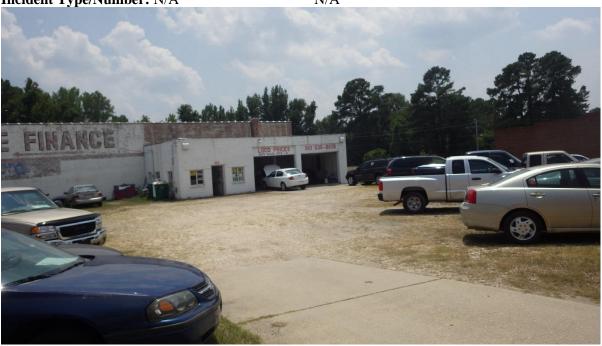
(11) Property Name:

**Anticipated Impacts:** Low

This facility currently operates as a used car dealer and repair shop. It is located on the south side of W 2nd St approximately 180 feet west of Elm St. The facility is not listed in the UST section registry and there are no known incidents associated with it. There is no evidence of USTs and no monitoring wells were observed during the site investigation.

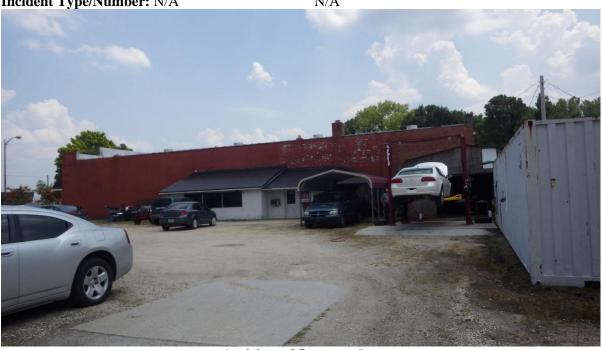
(12) Property Name:

**Anticipated Impacts:** Low

This facility currently operates as a used car dealer and repair shop. It is located on in the southwest quadrant of W 2nd St and Elm St. The facility is not listed in the UST section registry and there are no known incidents associated with it. There is no evidence of USTs and no monitoring wells were observed during the site investigation.

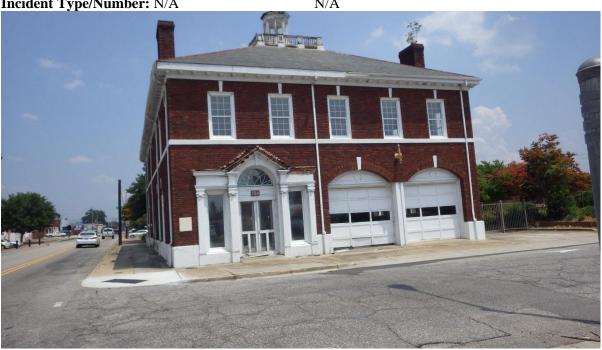
#### (13) Property Name:

**Anticipated Impacts:** Low

This facility is the old Lumberton Fire Station. It is located southwest quadrant of 2nd St and Elm St. The facility is not listed in the UST registry and there are no known incidents associated with it. Two unknown valves or possible fill ports were observed in the side walk near the intersection. No other evidence of USTs and no monitoring wells were observed.

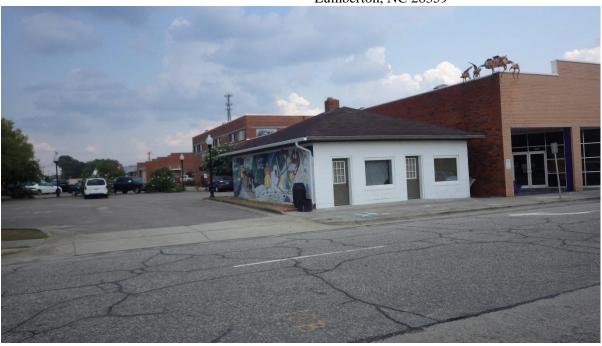
#### (14) Property Name:

#### **Anticipated Impacts:** Low

This parking lot is the former location of Lloyd's Texaco. According to the UST section registry three USTs were removed in 1990, one UST removed in 1998 and three USTs removed in 2004. There are two incidents associated with this facility. Incident 6455 was closed out in 1998, Incident 29131 closed out in 2004 with notice of Residual Petroleum. UST closure not properly followed by City. Over excavation limited due to natural gas line and sidewalk along 2<sup>nd</sup> St. No monitoring wells were observed during site investigation.

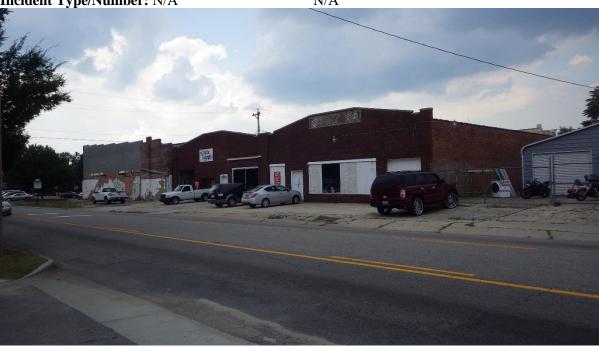
(15) Property Name:

**Anticipated Impacts:** Low

This facility currently operates as a Janitorial wholesale Supply Co. It is located on the north side of E 2nd St approximately 180 feet east of Chestnut St. The facility is not listed in the UST section registry and there are no known incidents associated with it. During the site investigation a possible old pump island outline was observed in front of the building. There is no other evidence of USTs and no monitoring were observed.

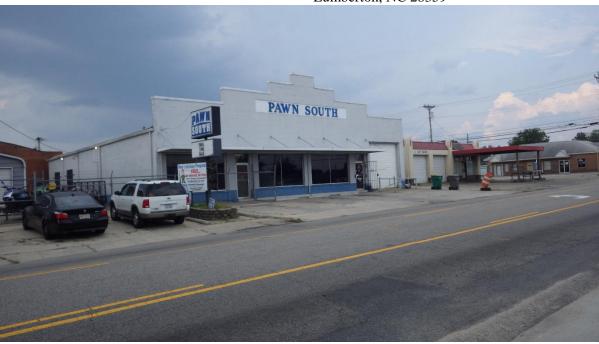
(16) Property Name:

**Anticipated Impacts:** Low

This facility currently operates as a pawn Shop. It is the former location of Mac's of Lumberton Auto Parts. It is located on the north side of E 2nd St approximately 150 feet west of Walnut St. According to the UST section registry three USTs were removed. The closure date in the registry is incorrect. A possible old pump island outline was observed during the site investigation. No other evidence of USTs and no monitoring wells were observed.

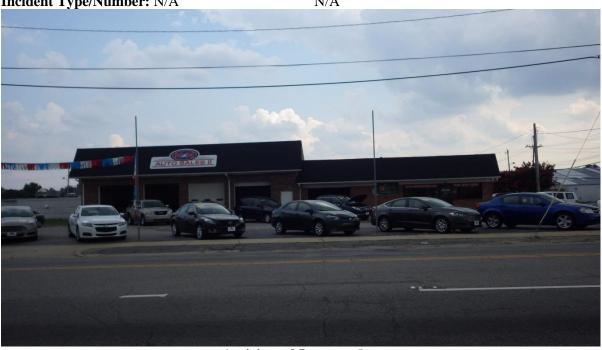
(18) Property Name:

**Anticipated Impacts:** Low

This facility currently operates as a used car dealer and repair shop. It is located in the southeast quadrant of E 2nd St and Walnut St. The facility is not listed on the UST section registry and there are no known incidents associated with it. No USTs or monitoring wells were observed during the site investigation.

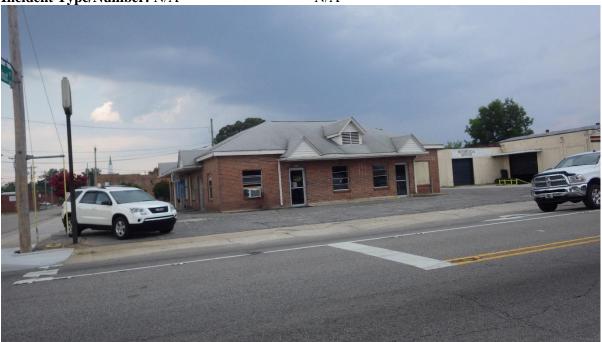
(19) Property Name:

**Anticipated Impacts:** Low

This facility currently operates as the Greyhound/Trailways bus station. It is located in the northeast quadrant of E 2nd St and Walnut St. The facility is not listed in the UST section registry and there are no known incidents associated with it. No USTs or monitoring wells were observed during the site investigation.

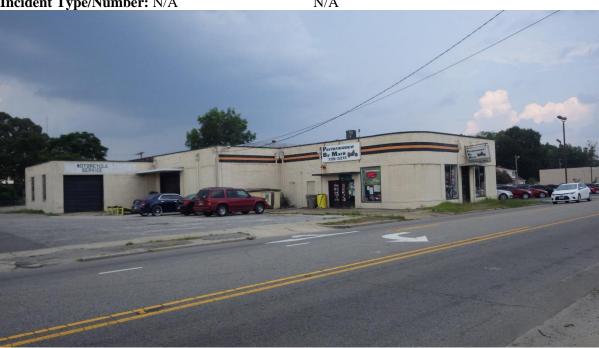
(20) Property Name:

**Anticipated Impacts:** Low

This facility currently operates as a motorcycle accessories and repair shop. It is located on north side of E 2nd St approximately 200 feet east of Walnut St. The facility is not listed in the UST section registry and there are no known incidents associated with it. No evidence of USTs and no monitoring wells were observed during the site investigation.

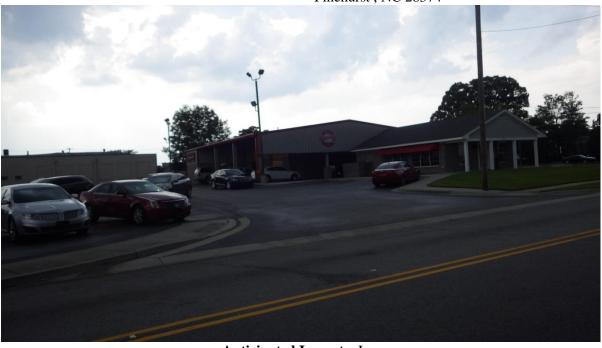
(21) Property Name:

**Anticipated Impacts:** Low

This facility currently operates as a used car dealer and repair shop. It is the former location of Hudson Garage. It is located in the northwest quadrant of E 2nd St and Pine St. According to the UST section registry four USTs were removed in 1988. There are no known incidents associated with it. The property was redeveloped between 2010 and 2013.

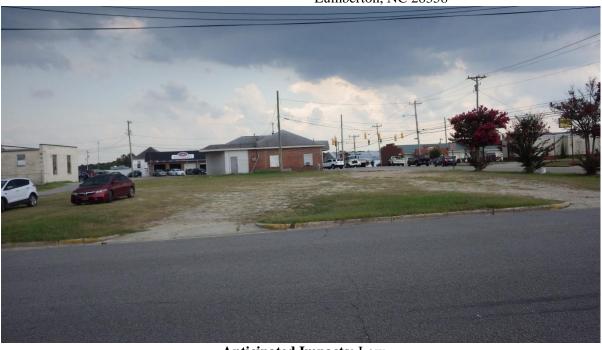
#### (22) Property Name:

**Anticipated Impacts:** Low

This site is a vacant lot. It is located in the southeast quadrant of N Walnut St and E 3rd St. According to the UST section register one UST was removed in 1974. Two Possible UST fill ports were observed on the southern end of the property approximately 118 feet east of N Walnut St and 120 feet south of E 3rd St. No monitoring wells were observed. There are no known incidents associated with this site.

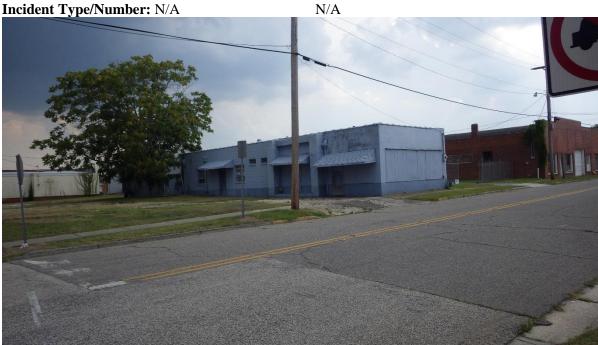
## (23) Property Name:

**Anticipated Impacts:** Low

This facility operated as an upholstery shop. It is located in the southwest quadrant of N Walnut St and E 3rd St. The facility appeared to be vacant at the time of the site investigation. The facility is not listed in the UST section registry and there are no known incidents associated with it.
