PRELIMINARY SITE ASSESSMENT

**SR 1997 (FAYETTEVILLE ROAD) WIDENING
TIP NO. U-5797, WBS NO. 44367.1.1**

**NCDOT PARCEL NO. 11
OWNER: PAIT, JEAN MORRISON
2400 FAYETTEVILLE ROAD
LUMBERTON, ROBESON COUNTY, NORTH CAROLINA**

METALLIC UST INVESTIGATION: PARCEL 11 NCDOT PROJECT U-5797

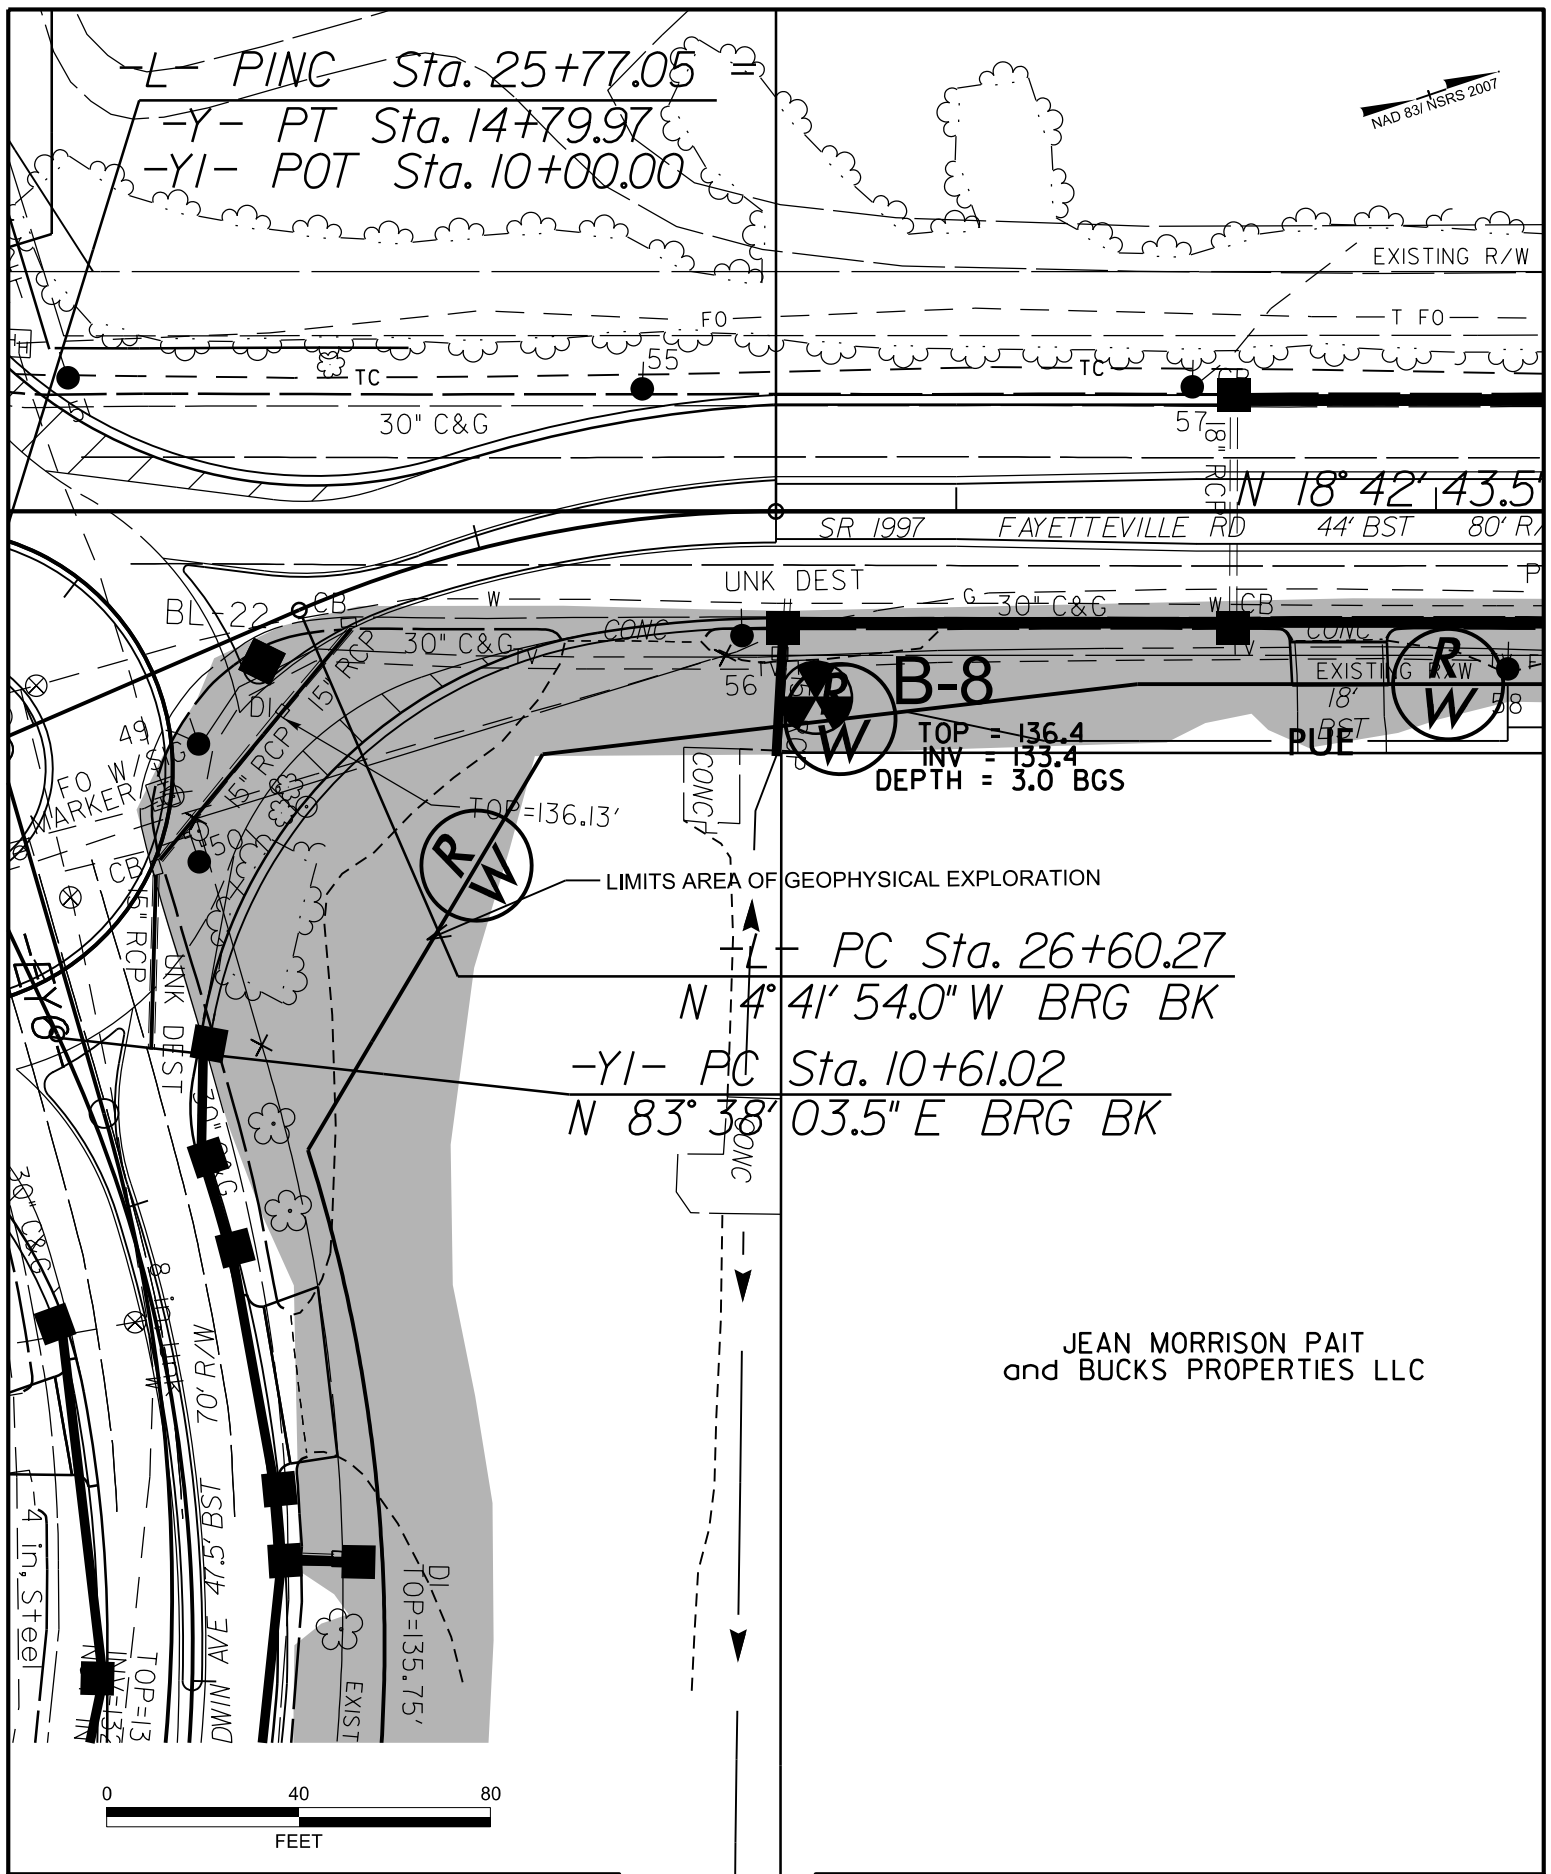
BORING LOCATION PLAN

Falcon and our subcontractor advanced one boring (B-8) to the proposed excavation depth of the drainage features, utilities, or roadway/ditch cut being assessed. Groundwater was not observed. Please see the boring location plan in the attachments for a visual depiction of the sample locations. The coordinates (latitude and longitude) that correspond to the sample locations are shown below in Table No. 1 Boring Coordinates.

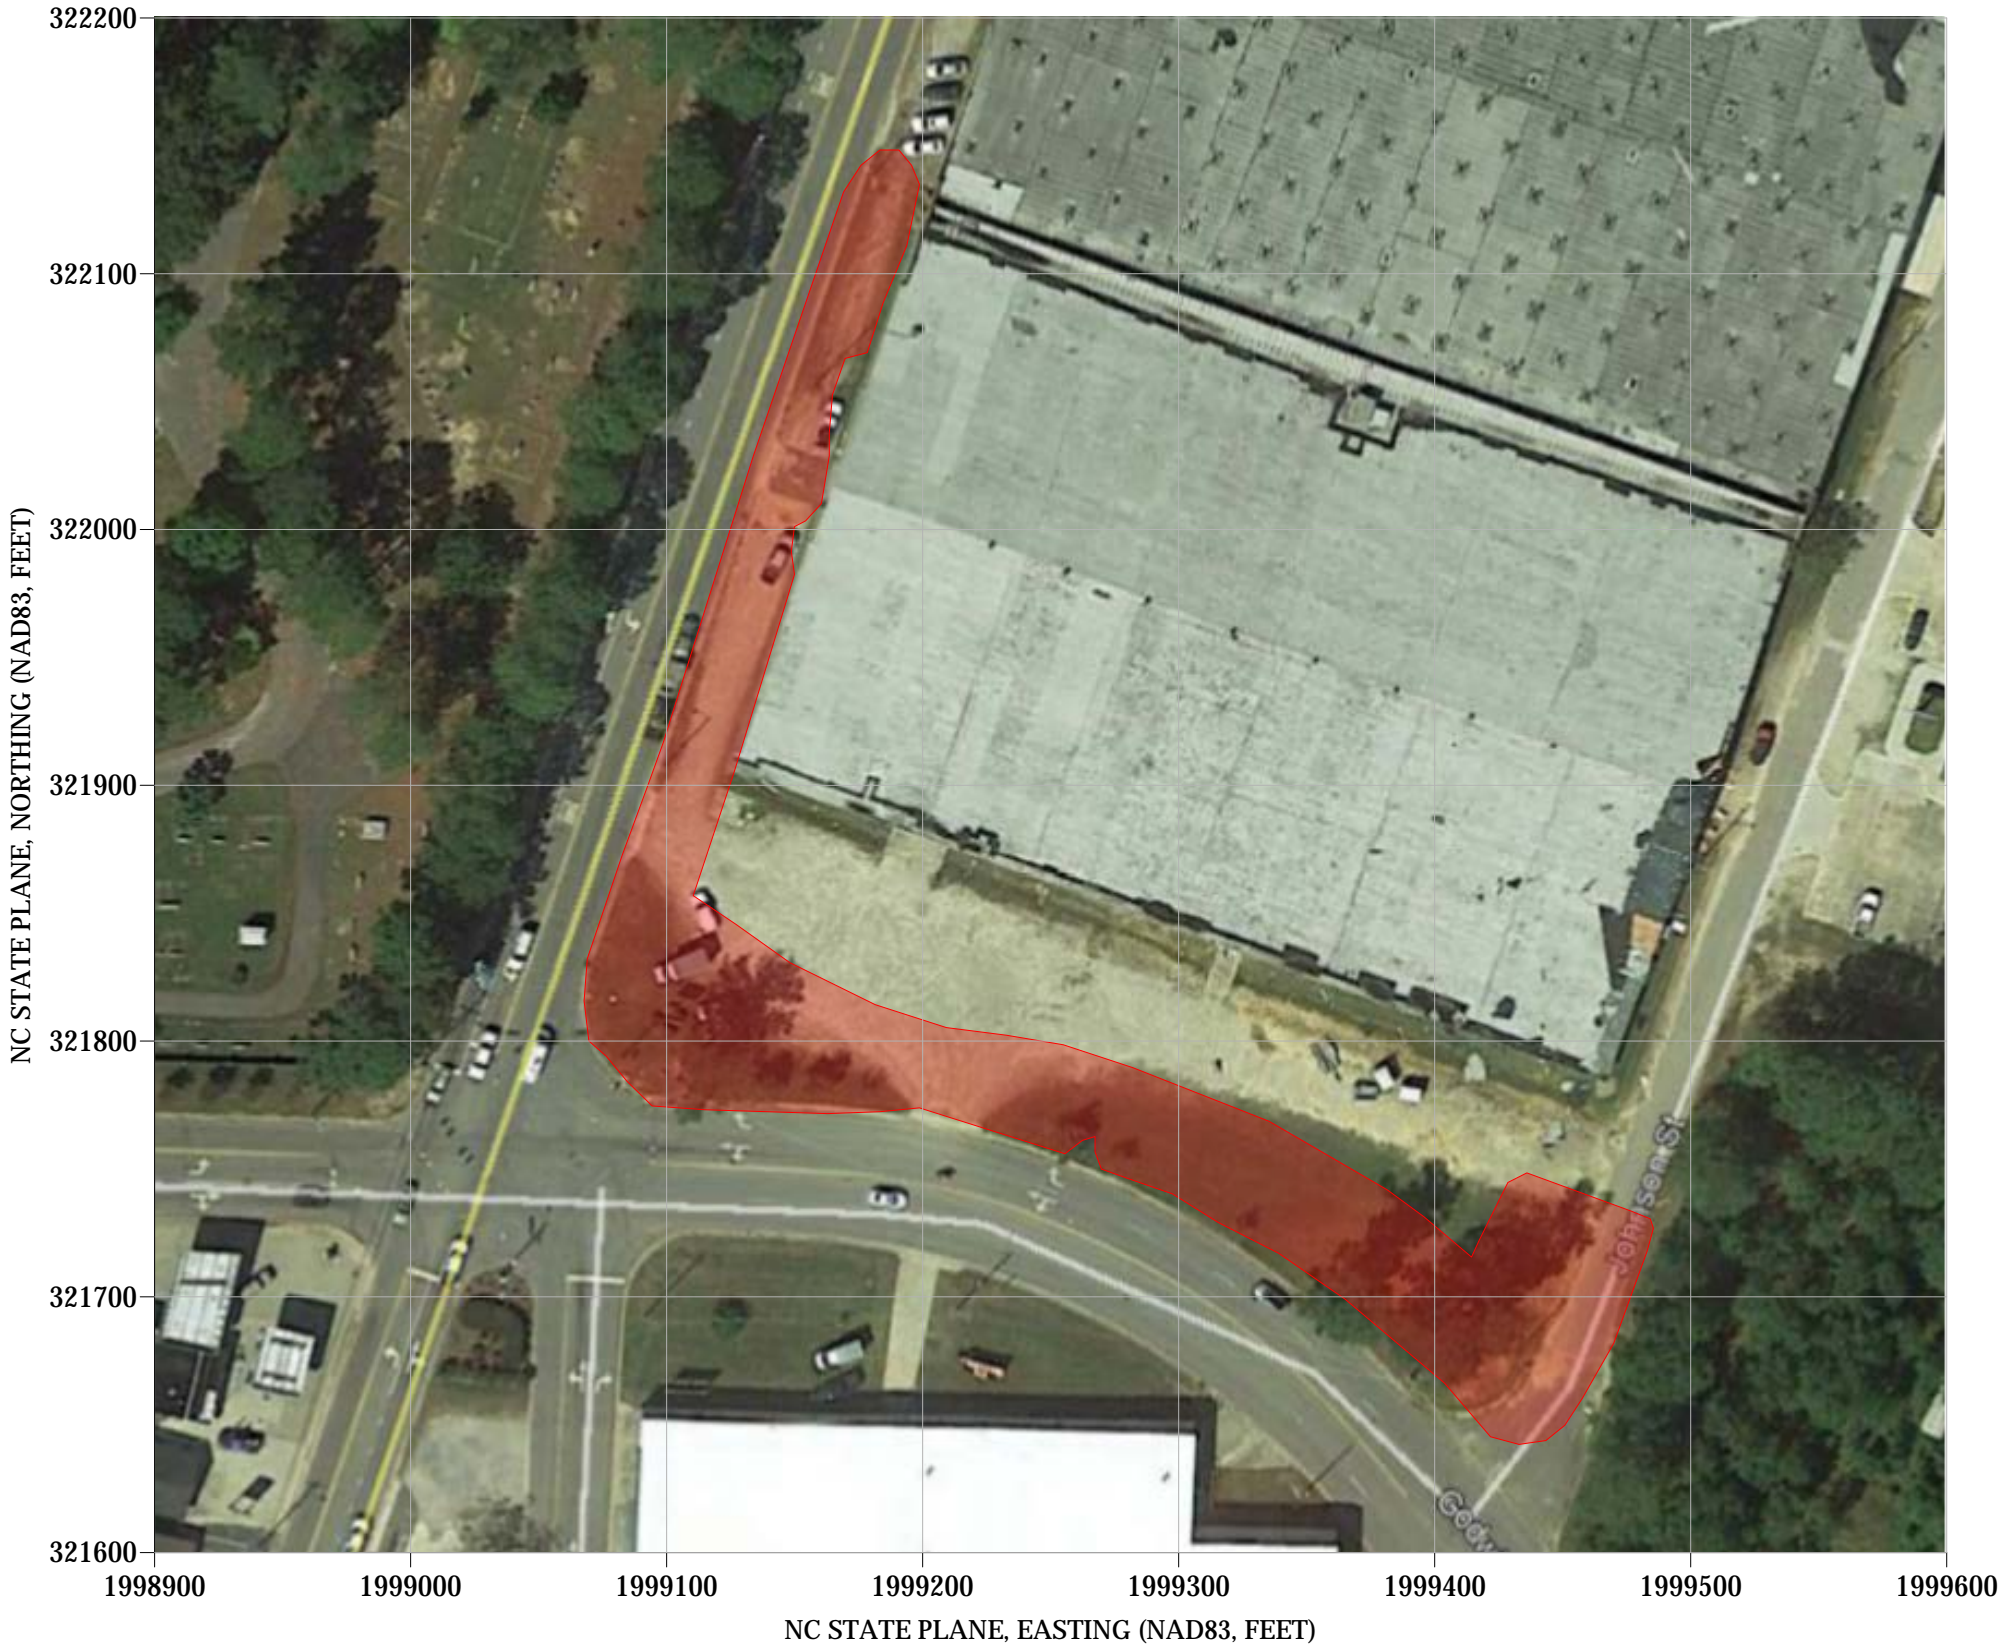
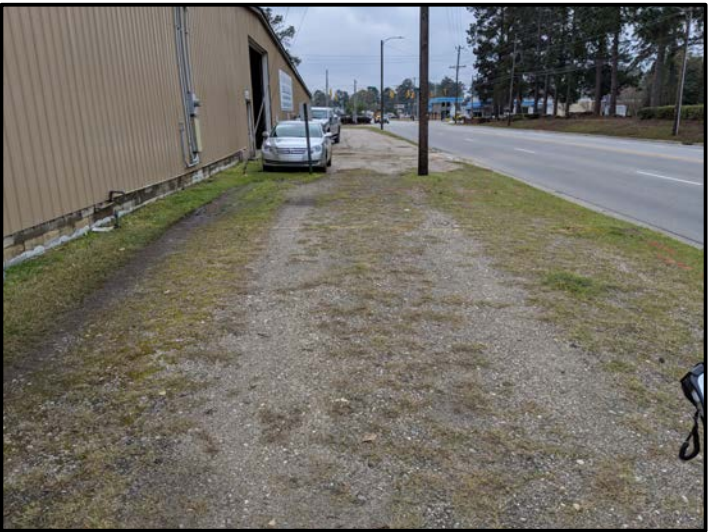
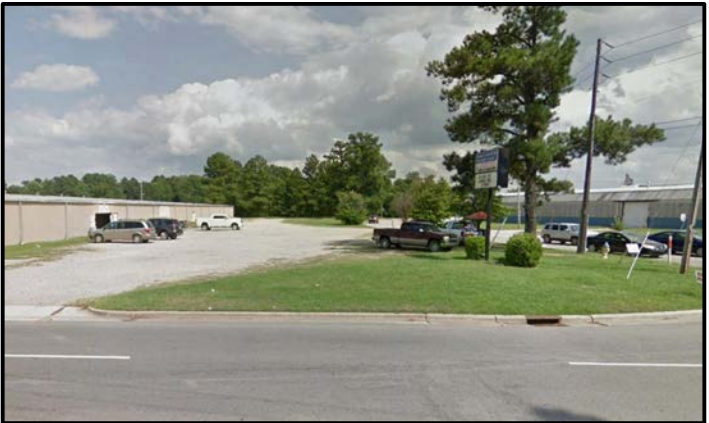
TITLE
PARCEL 11 - GEOPHYSICAL
SURVEY BOUNDARIES AND SITE PHOTOGRAPHS

The site included a commercial building surrounded by gravel, concrete, and grass surfaces. An aerial photograph showing the survey area boundaries and ground-level photographs are shown in **Figure 1**.

View of Survey Area
(Facing Approximately South)

View of Survey Area
(Facing Approximately East)

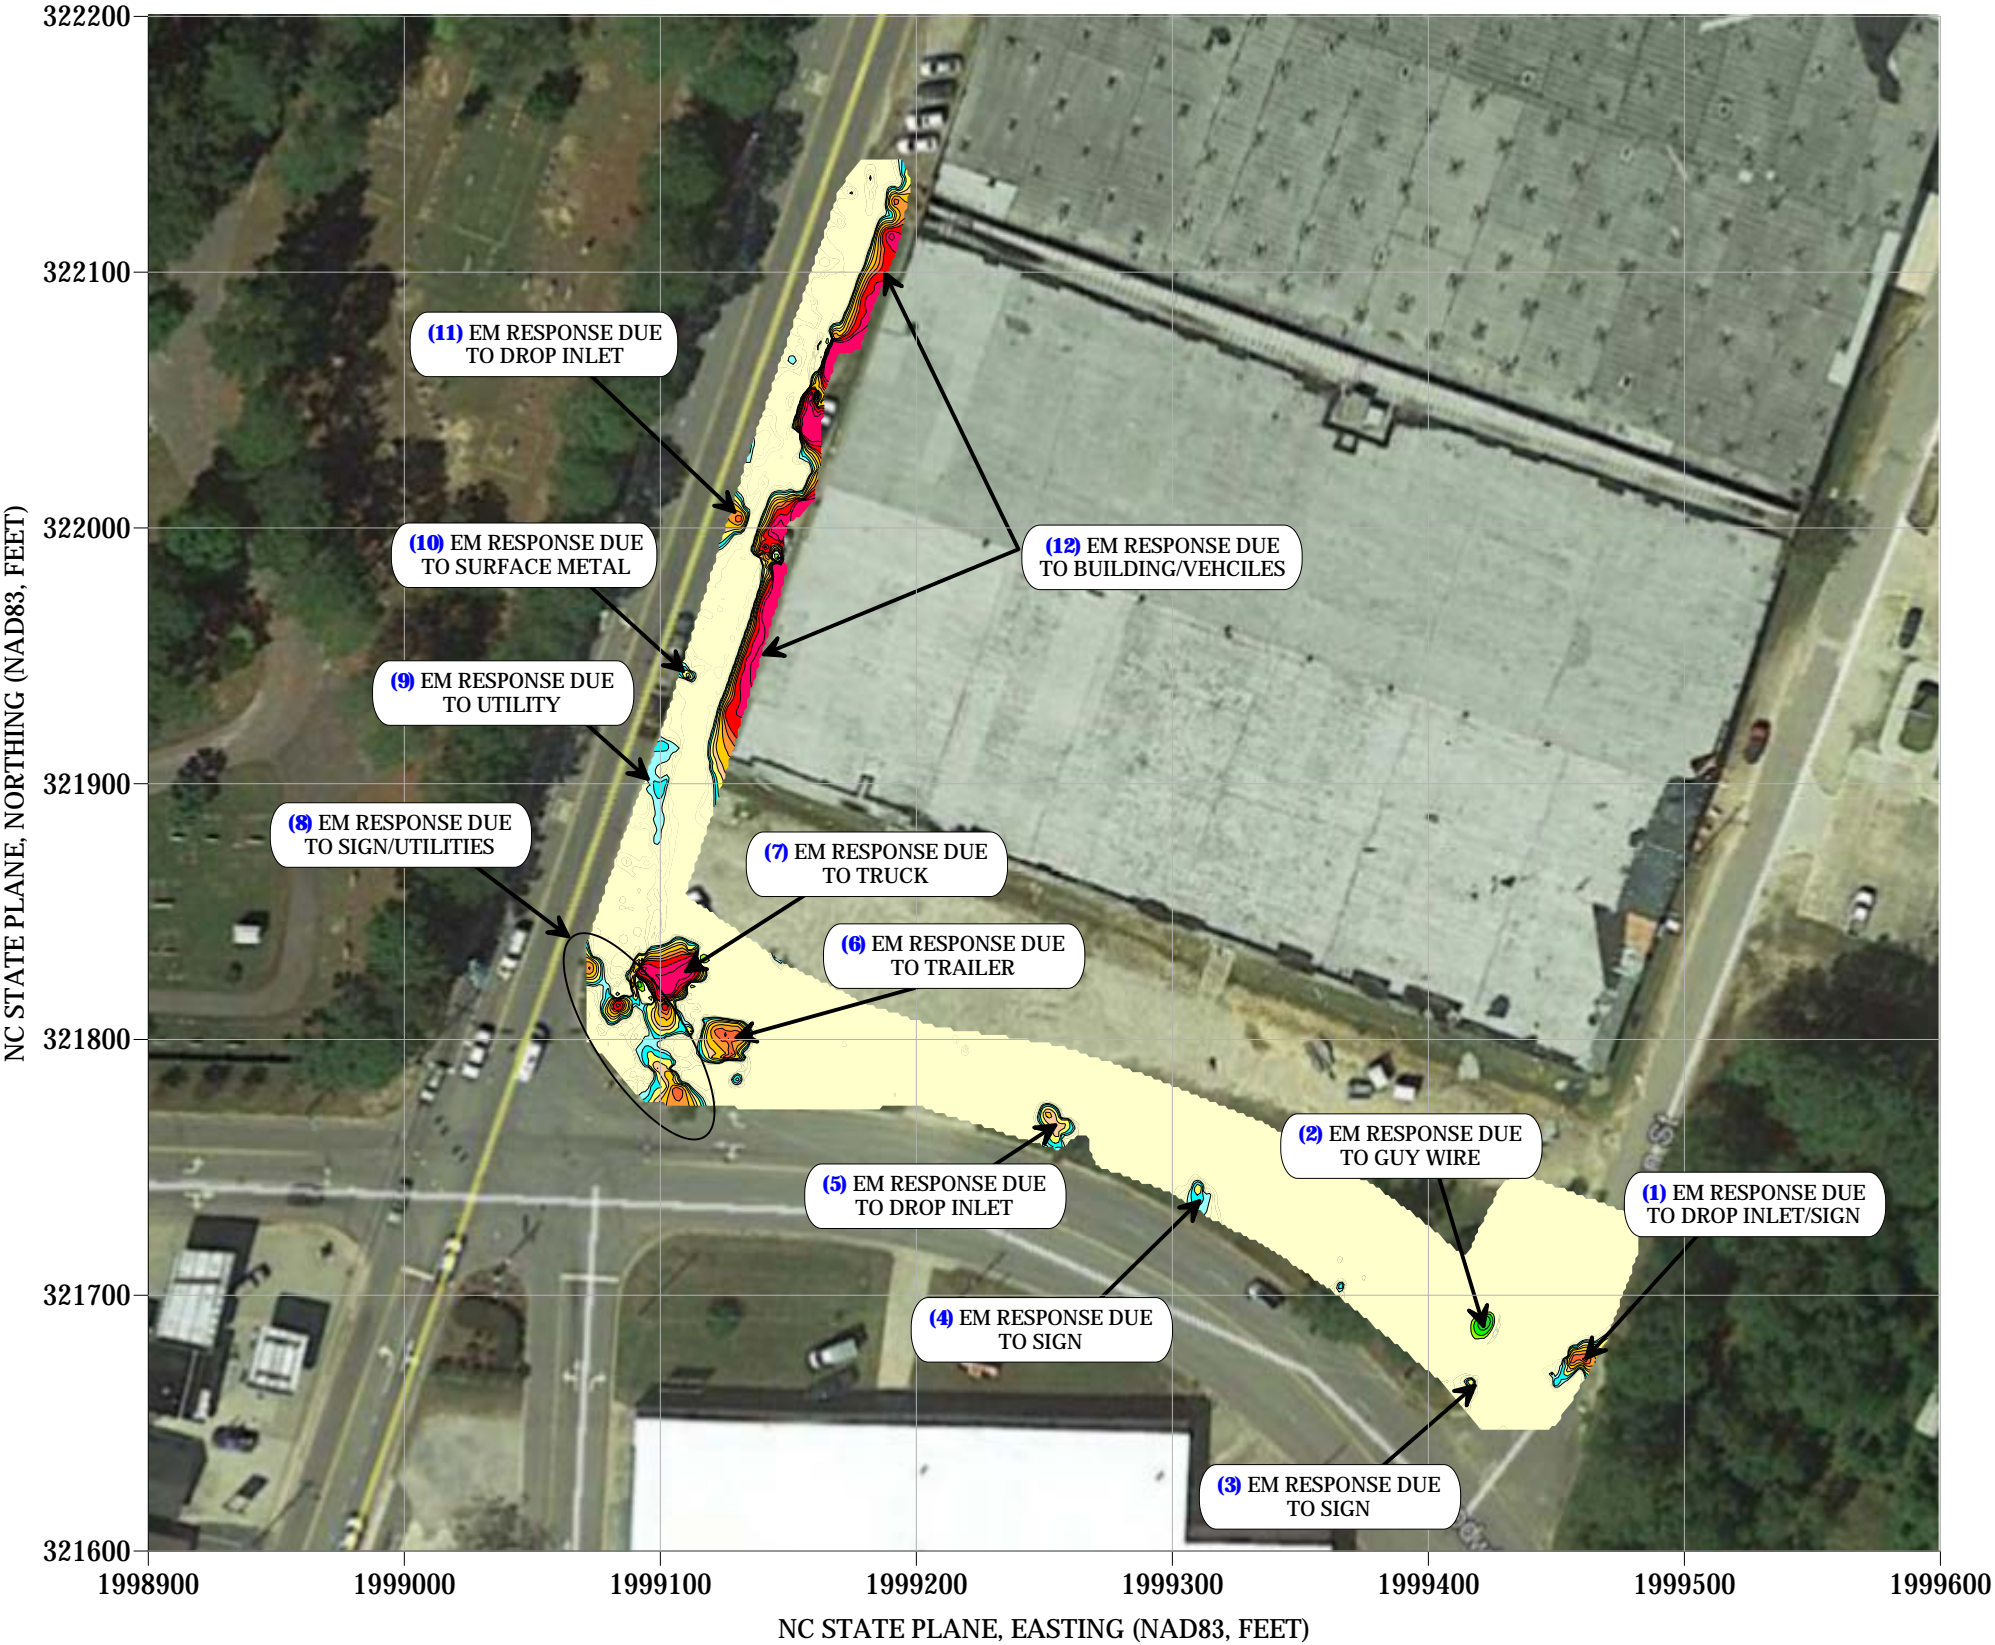
TITLE
PARCEL 11 -
EM61 METAL DETECTION CONTOUR MAP

A contour plot of the EM61 results obtained across the survey area at the property is presented in **Figure 2**. Each EM anomaly is numbered for reference in the figure. The following table presents the list of EM anomalies and the cause of the metallic response, if known:

The majority of the EM anomalies were directly attributed to visible cultural features at the ground surface, including drop inlets, signs, a guy wire, a trailer, a truck, utilities, surface metal, the building, and vehicles. EM Anomalies 6, 7, and 12 were associated with interference from the building, a trailer, and vehicles and were further investigated with GPR to verify that the interference did not obscure buried structures such as USTs.

NO EVIDENCE OF METALLIC
USTs OBSERVED.

The contour plot shows the differential results of the EM61 instrument in millivolts (mV). The differential results focus on larger metallic objects such as USTs and drums. The EM data were collected on March 18, 2019, using a Geonics EM61-MK2 instrument. Verification GPR data were collected using a GSSI UtilityScan DF instrument with a dual frequency 300/800 MHz antenna on March 26, 2019.

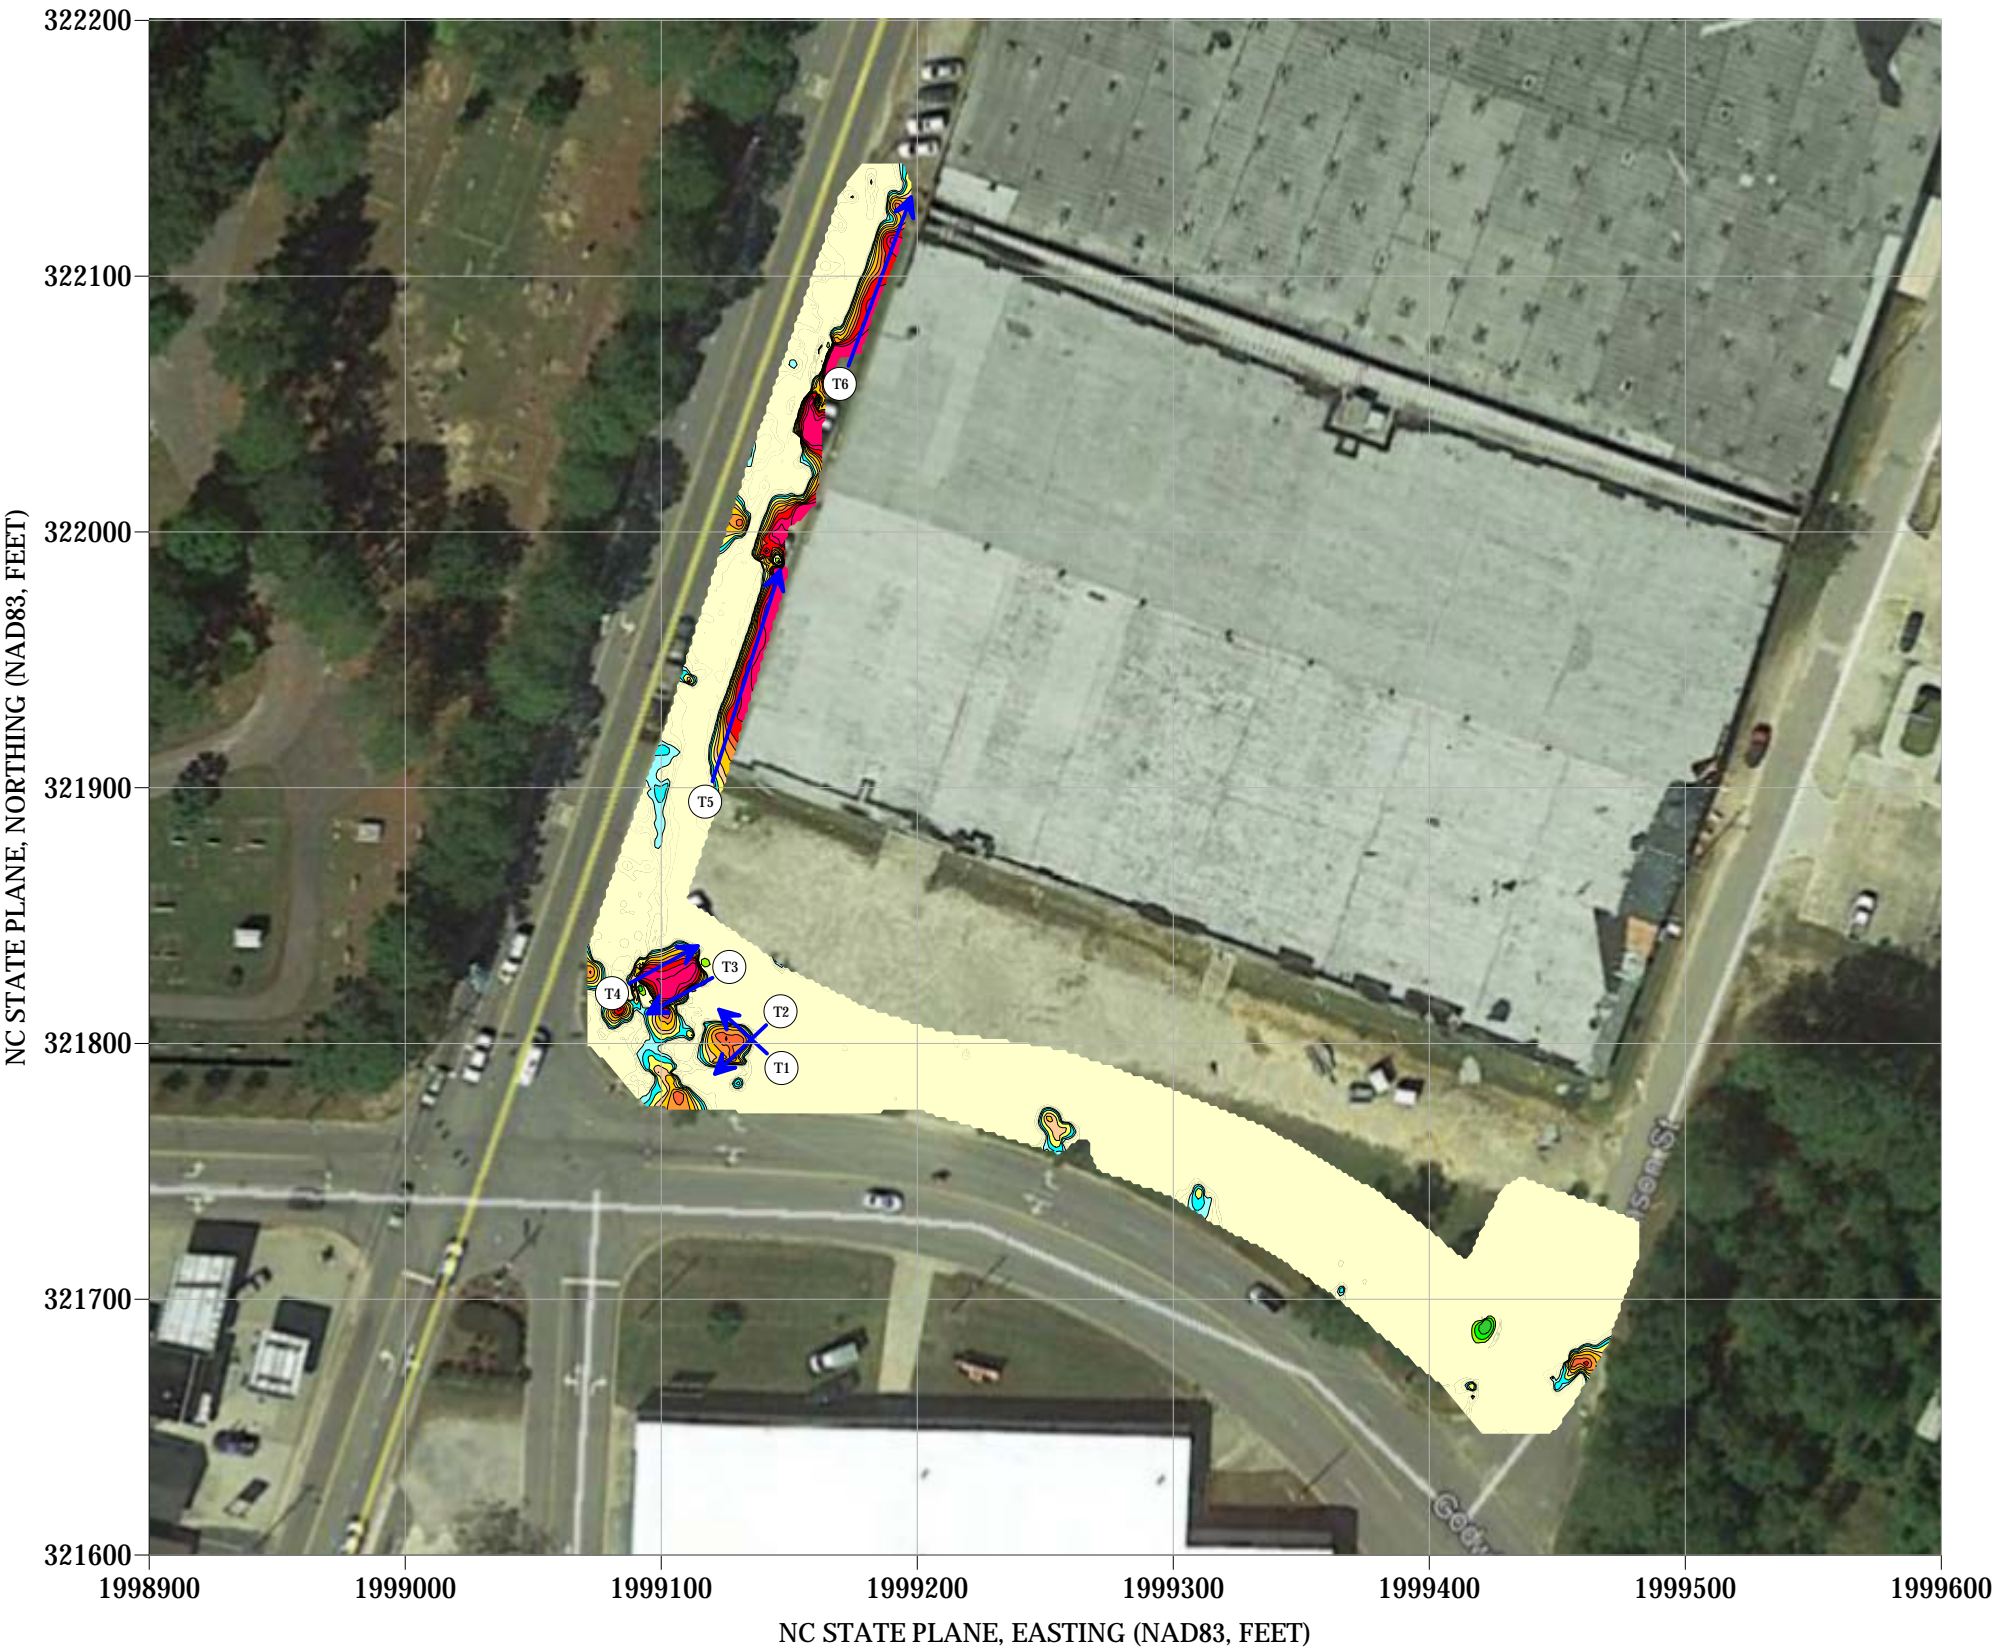
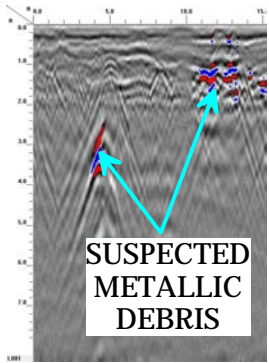
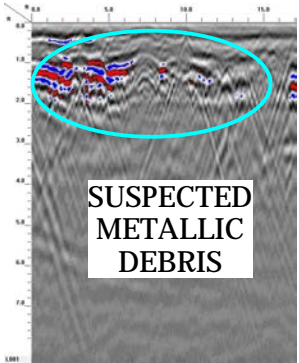
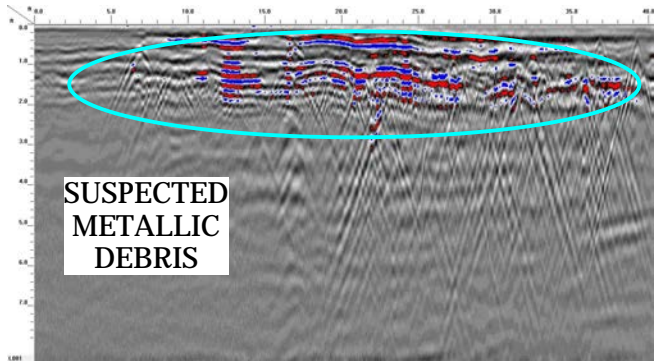
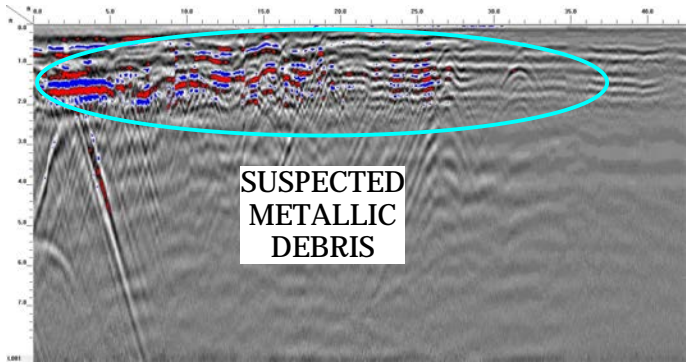
TITLE
PARCEL 11 -
GPR TRANSECT LOCATIONS AND SELECT IMAGES

Figure 3 presents the locations of the formal GPR transects performed at the property as well as select transect images. All of the transect images are included in **Appendix A**. A total of six formal GPR transects were performed at the site. GPR Transects 1-2 were performed across EM Anomaly 6. These transects recorded minor reflectors that were suggestive of possible buried metallic debris. No evidence of any larger structures such as USTs was observed.

GPR Transects 3-4 were performed across EM Anomaly 7. These transects recorded minor reflectors that were suggestive of possible buried metallic debris. No evidence of any larger structures such as USTs was observed.

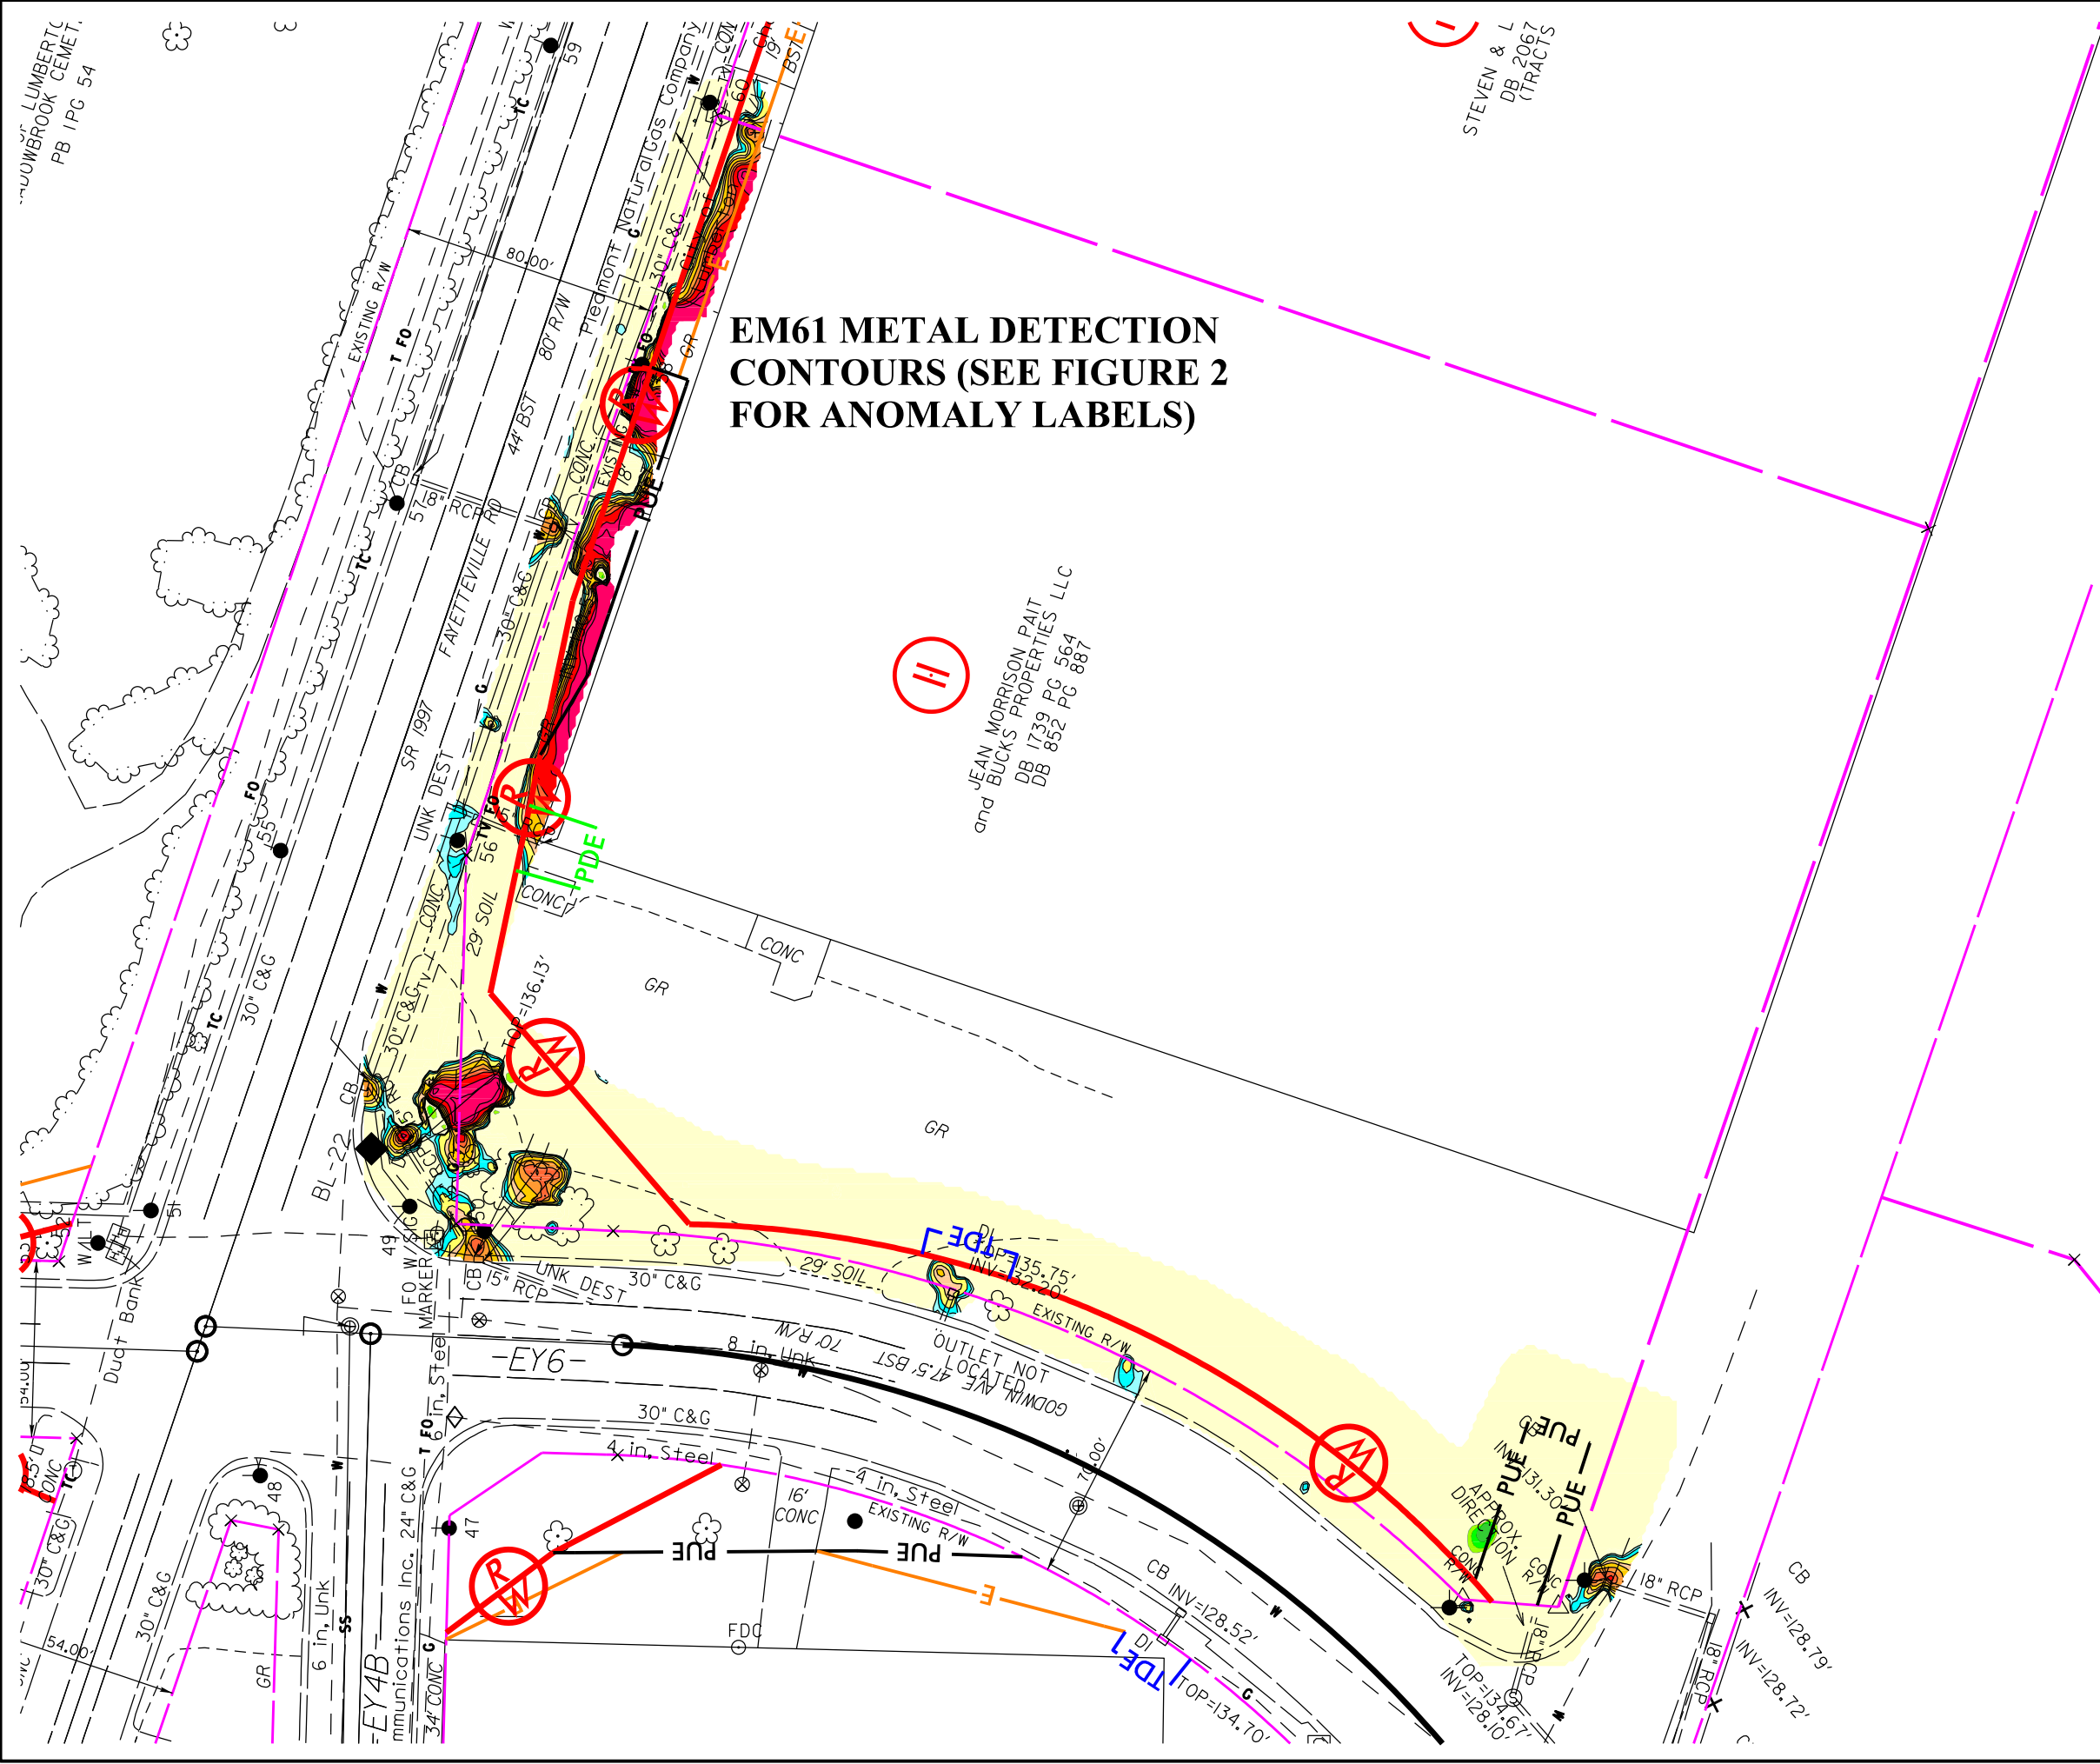
TITLE OVERLAY OF METAL DETECTION RESULTS ON NCDOT ENGINEERING PLANS	
PROJECT PARCEL 011 LUMBERTON, NORTH CAROLINA NCDOT PROJECT U-5797

Collectively, the geophysical data did not record any evidence of unknown metallic USTs within the geophysical survey area at Parcel 11. **Figure 4** provides an overlay of the EM61 metal detection contour map onto the NCDOT MicroStation engineering plans for reference.

**EM61 METAL DETECTION
CONTOURS (SEE FIGURE 2
FOR ANOMALY LABELS)**

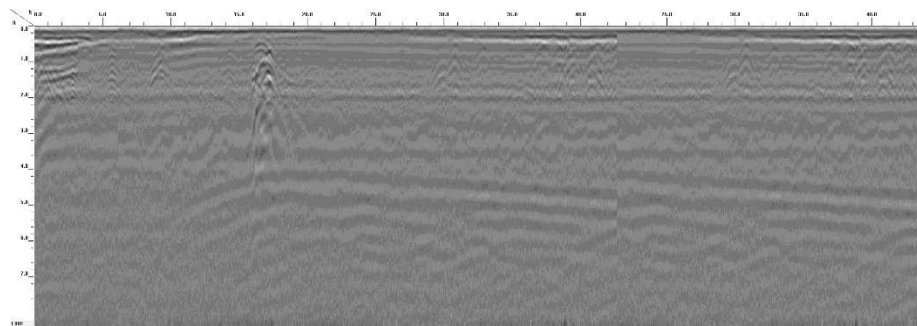
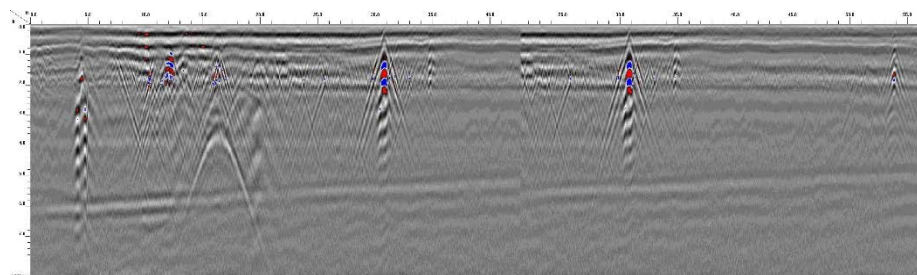
GPR TRANSECT 5

GPR Transects 5-6 were performed along the west side of the building (EM Anomaly 12). These transects recorded no evidence of buried structures, such as USTs.
