PRELIMINARY SITE ASSESSMENT

SR 1997 (FAYETTEVILLE ROAD) WIDENING TIP NO. U-5797, WBS NO. 44367.1.1

NCDOT PARCEL NO. 12

GEOPHYSICAL INVESTIGATION REPORT

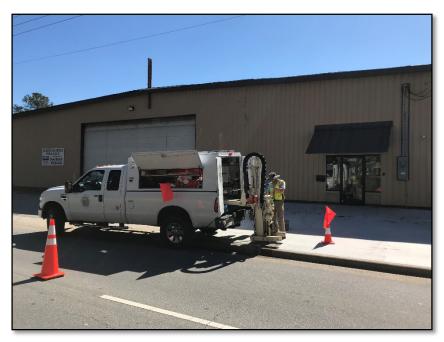
Photograph No. 1: General view of B-9.

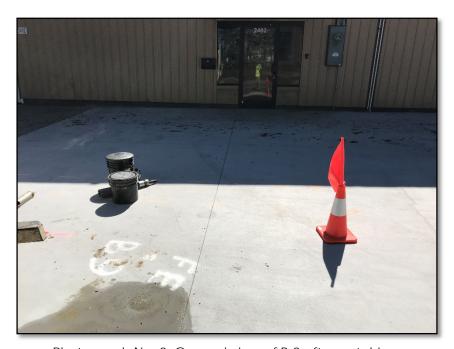
Photograph No. 2: General view of B-9 after patching.

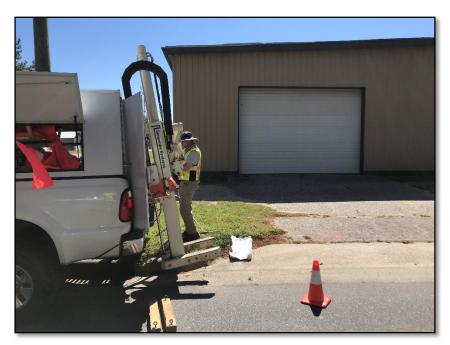
Photograph No. 3: General view of Boring B-10.

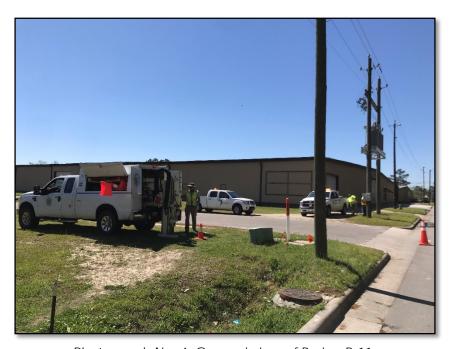
Photograph No. 4: General view of Boring B-11.

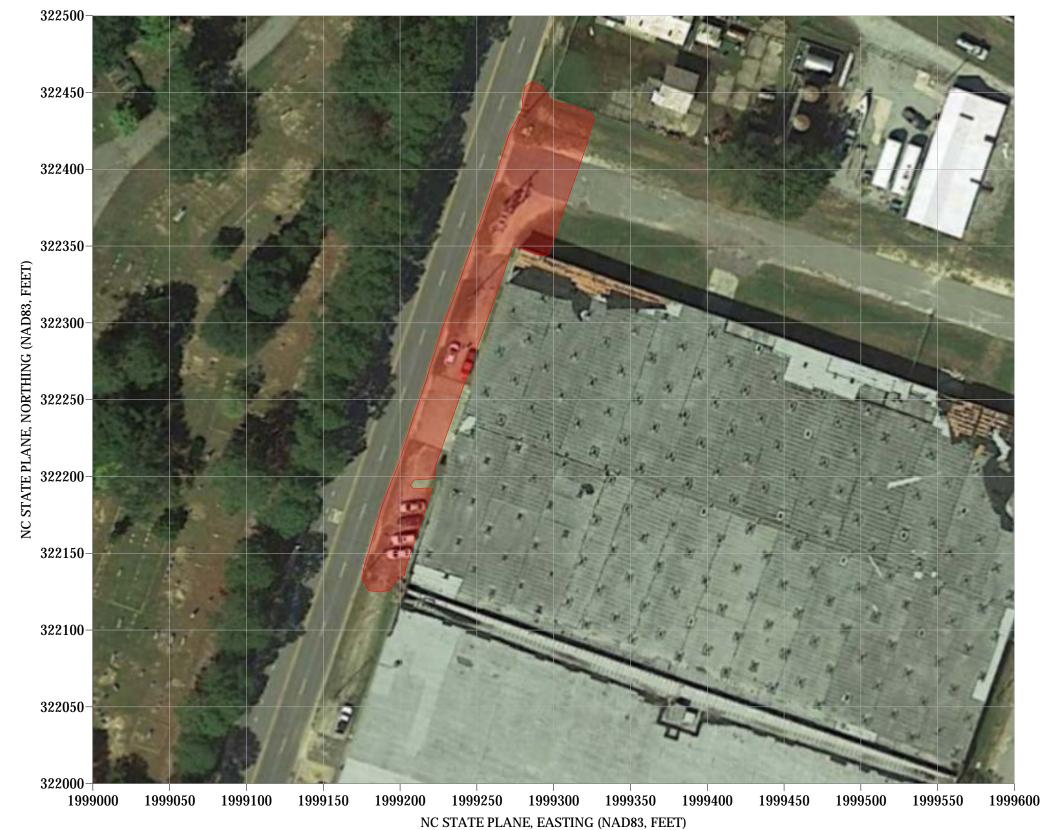
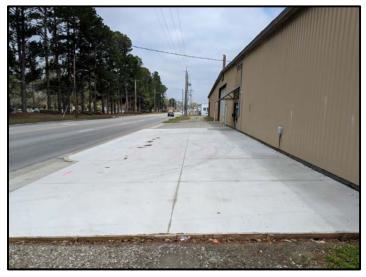
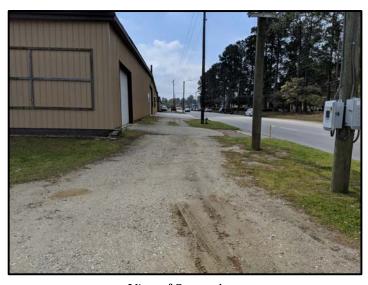
PARCEL 12 - GEOPHYSICAL SURVEY BOUNDARIES AND SITE PHOTOGRAPHS

The site included a commercial building surrounded by gravel, concrete, asphalt, and grass surfaces. An aerial photograph showing the survey area boundaries and ground-level photographs are shown in **Figure 1**.

View of Survey Area (Facing Approximately North)

View of Survey Area (Facing Approximately South)

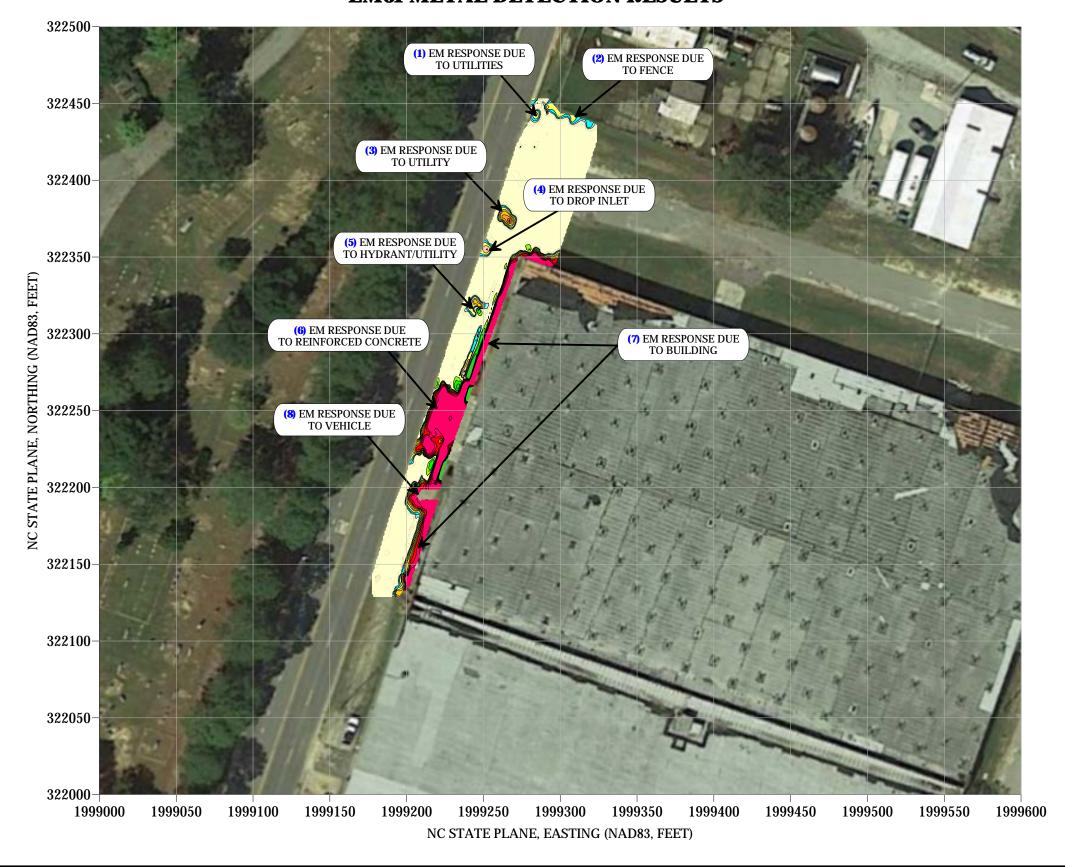
PARCEL 12 -EM61 METAL DETECTION CONTOUR MAP

A contour plot of the EM61 results obtained across the survey area at the property is presented in **Figure 2**. Each EM anomaly is numbered for reference in the figure. The following table presents the list of EM anomalies and the cause of the metallic response, if known:

Metallic Anomaly #	Cause of Anomaly	Investigated with GPR
1	Utilities	
2	Fence	
3	Utility	
4	Drop Inlet	
5	Hydrant/Utility	
6	Reinforced Concrete	Ø
7	Building	Ø
8	Vehicle

The majority of the EM anomalies were directly attributed to visible cultural features at the ground surface, including utilities, a fence, a drop inlet, a hydrant, the building, and a vehicle. EM Anomalies 6 and 7 were associated with interference from the building and suspected reinforced concrete and were further investigated with GPR to verify that the interference did not obscure buried structures such as USTs.

NO EVIDENCE OF METALLIC USTs OBSERVED.

The contour plot shows the differential results of the EM61 instrument in millivolts (mV). The differential results focus on larger metallic objects such as USTs and drums. The EM data were collected on March 18, 2019, using a Geonics EM61-MK2 instrument. Verification GPR data were collected using a GSSI UtilityScan DF instrument with a dual frequency 300/800 MHz antenna on March 26, 2019.

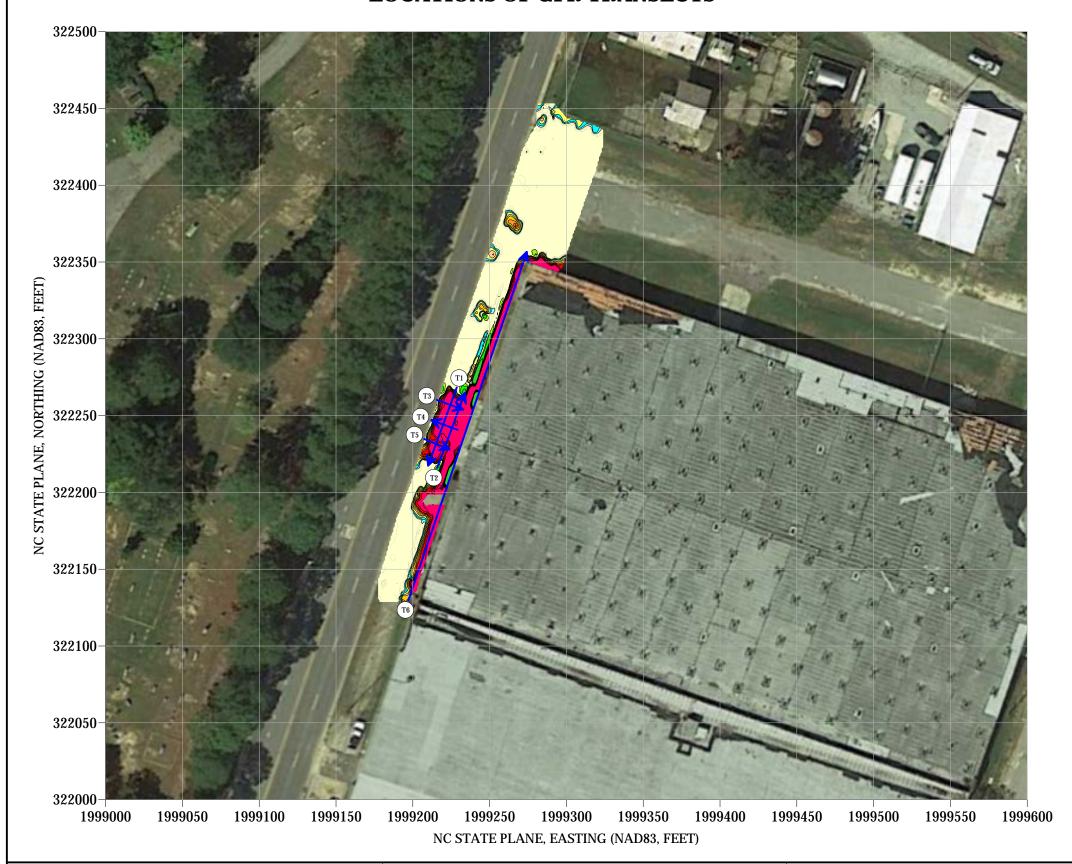
PARCEL 12 -GPR TRANSECT LOCATIONS AND SELECT IMAGES

Figure 3 presents the locations of the formal GPR transects performed at the property as well as select transect images. All of the transect images are included in **Appendix A**. A total of six formal GPR transects were performed at the site. GPR Transects 1-5 were performed in a grid-like fashion across EM Anomaly 6. These transects verified the presence of metal reinforcement in the concrete on the west side of the building. No evidence of any larger structures such as USTs was observed.

GPR Transect 6 was performed across EM Anomaly 7 and showed no evidence of buried structures along the west side of the building.

REINFORCED

CONCRETE

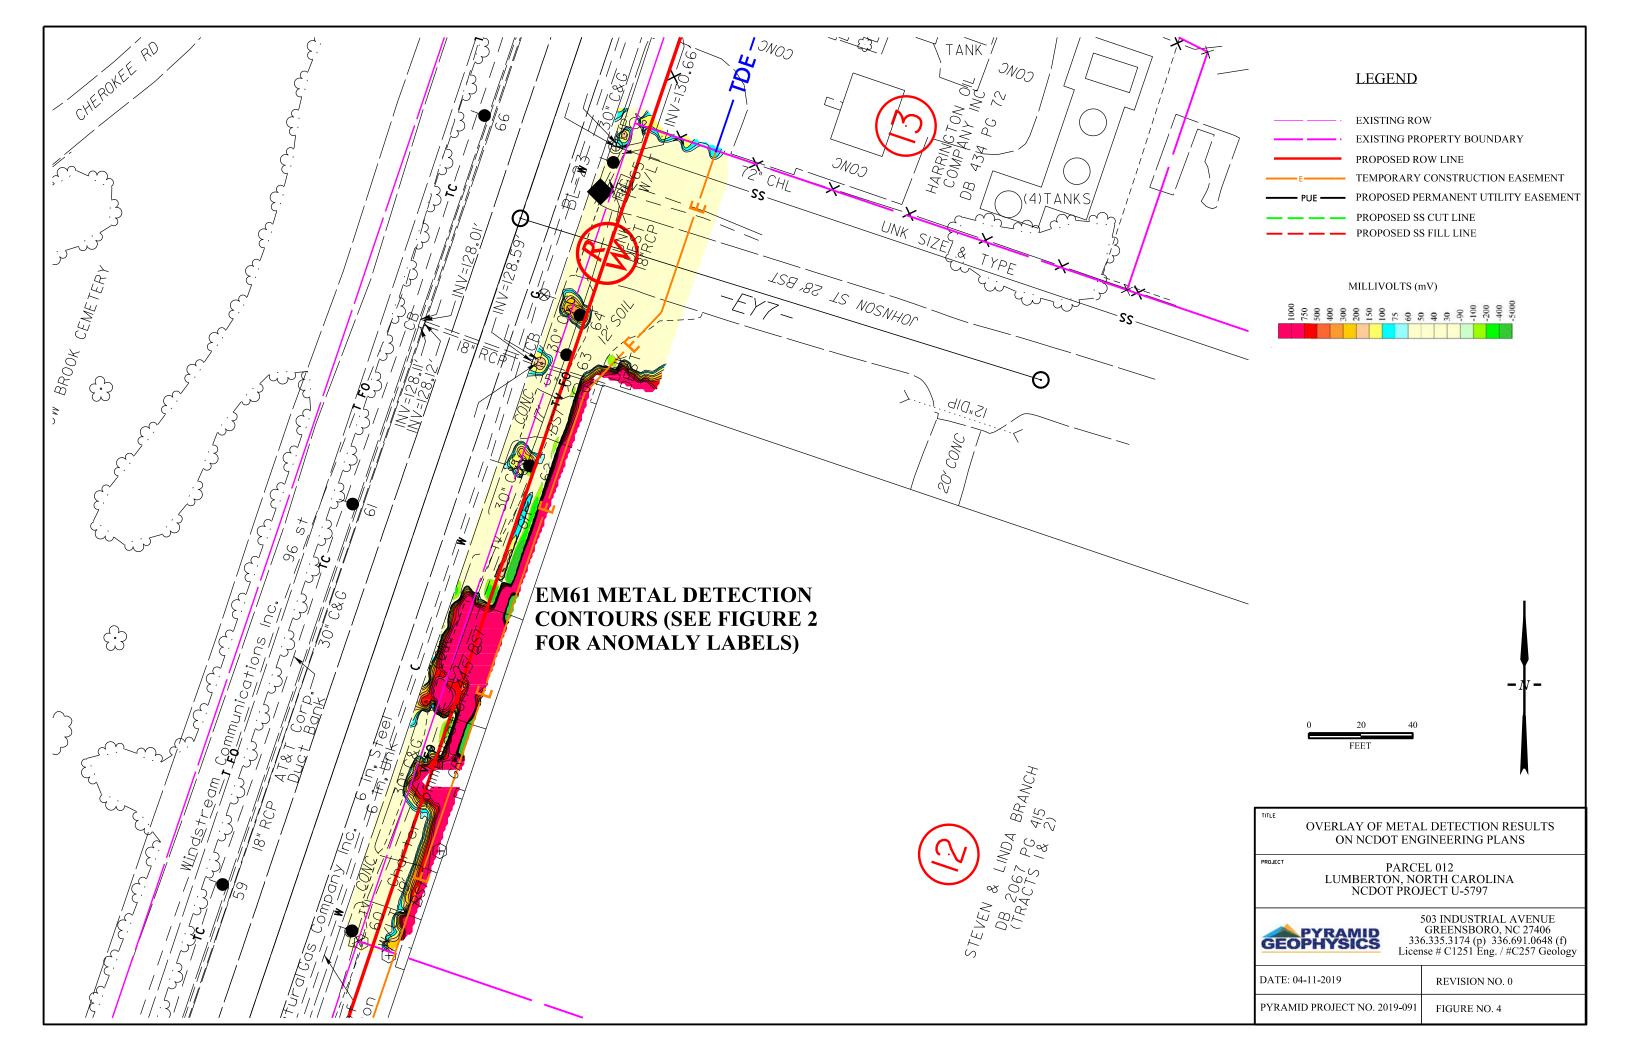
Collectively, the geophysical data <u>did not record any evidence of unknown metallic USTs</u> <u>within the geophysical survey area at Parcel 12</u>. **Figure 4** provides an overlay of the EM61 metal detection contour map onto the NCDOT MicroStation engineering plans for reference.
