PRELIMINARY SITE ASSESSMENT

**SR 1997 (FAYETTEVILLE ROAD) WIDENING
TIP NO. U-5797, WBS NO. 44367.1.1**

**NCDOT PARCEL NO. 13
OWNER: HARRINGTON OIL CO INC
2420 FAYETTEVILLE ROAD
LUMBERTON, ROBESON COUNTY, NORTH CAROLINA**

PROJECT NUMBER: G19011.00
JUNE 9, 2020

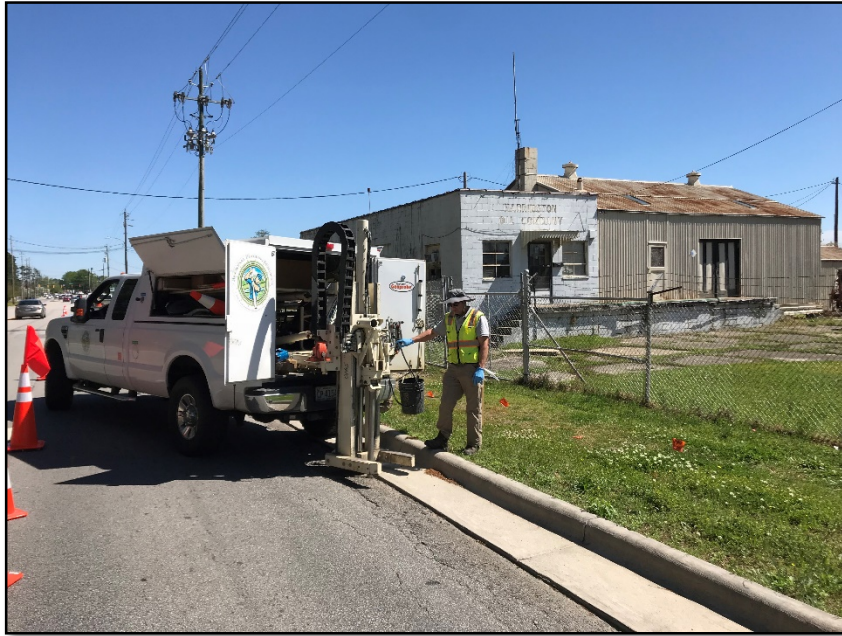
Photograph No. 1: General view of Boring B-12.

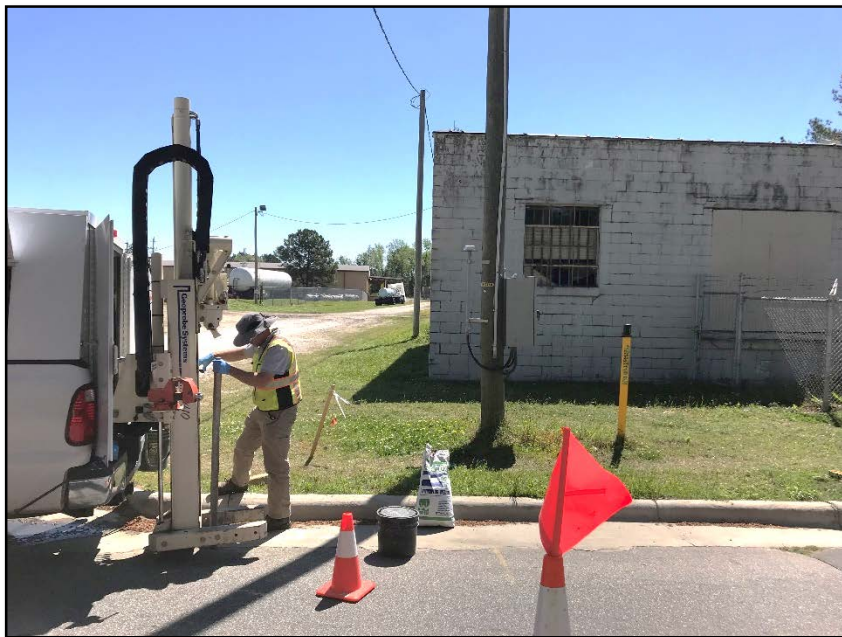
Photograph No. 2: General view of Boring B-13.

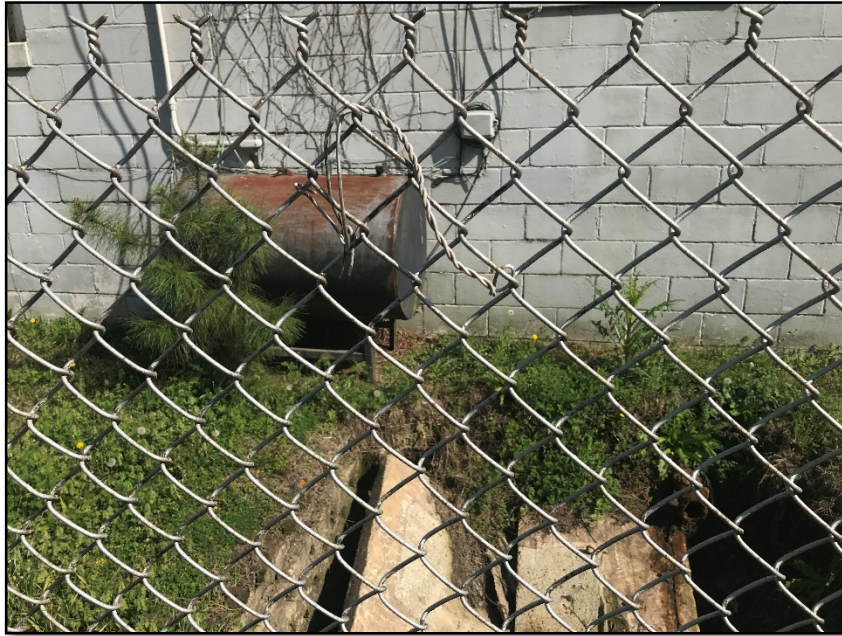
Numerous ASTs (some at least 10,000 gallons in capacity) and several 55-gallon drums were observed on this parcel. One AST adjoins the row in the front of the building. USTs were reported during the Phase I ESA. Monitoring wells, remediation systems, or hydraulic lifts were not observed.

Photograph No. 3: General view of the AST that adjoins the ROW.

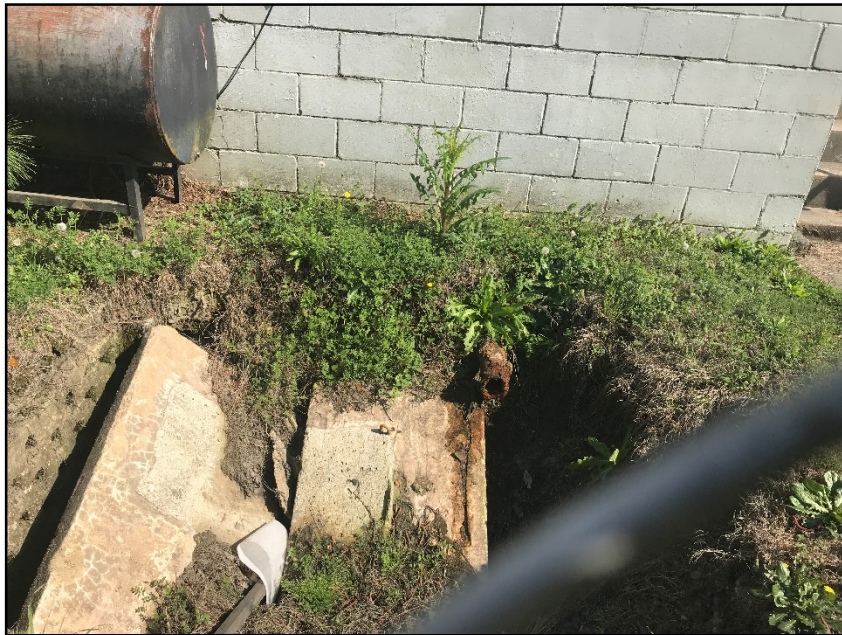
Photograph No. 4: Additional view of the AST that adjoins the ROW.

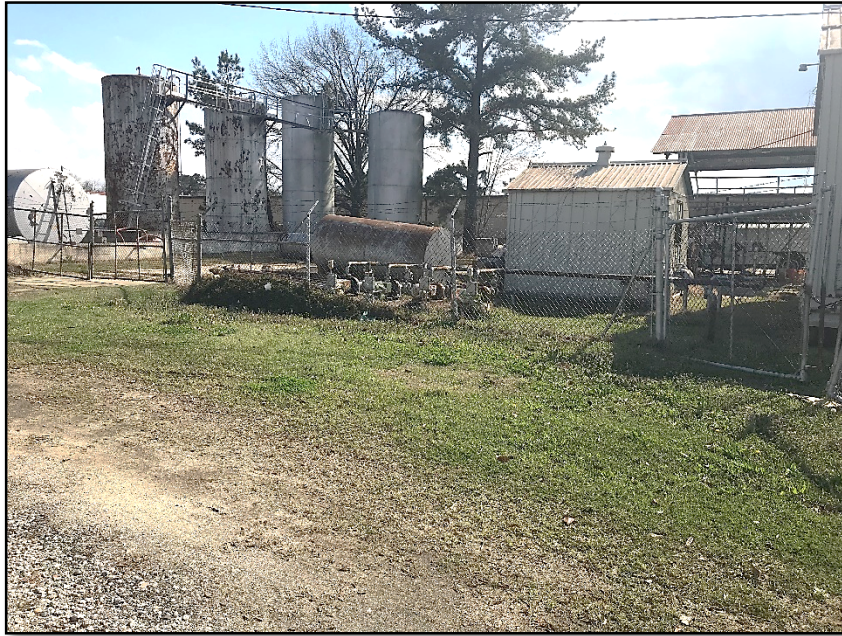
Photograph No. 3: General view of several ASTs behind the building.

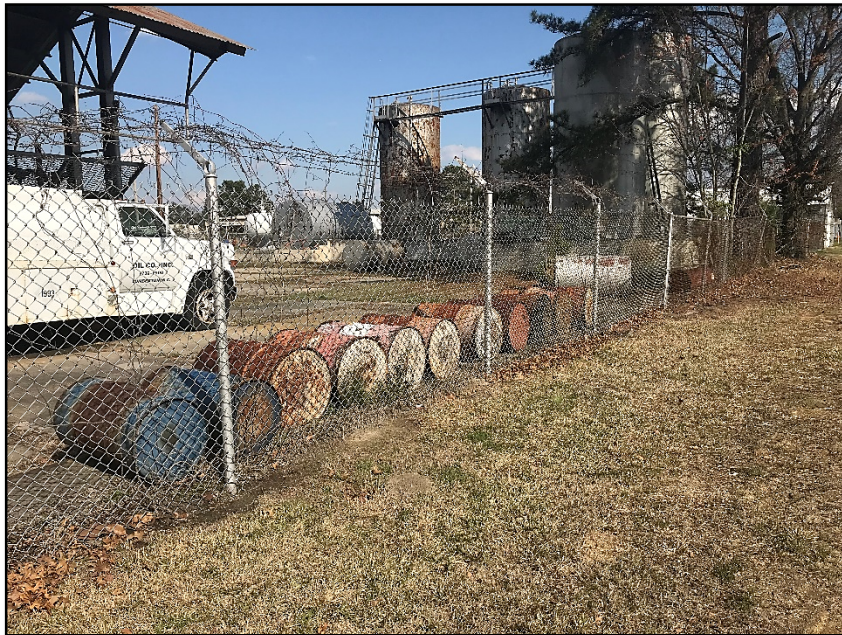
Photograph No. 4: General view of several 55-gallon drums.

Contaminants above the Industrial / Commercial Soil Cleanup Levels were not identified; therefore, additional assessment is not warranted at this time. Falcon recommends if drums, USTs, above ground storage tanks (ASTs), petroleum odors or sheen are observed during any excavation associated with any property involved in the project that all work in the vicinity stop until further assessment takes place. Further assessment can include but is not limited to; sampling the soil and groundwater, excavation, and proper handling and disposal of contaminated soils and groundwater.

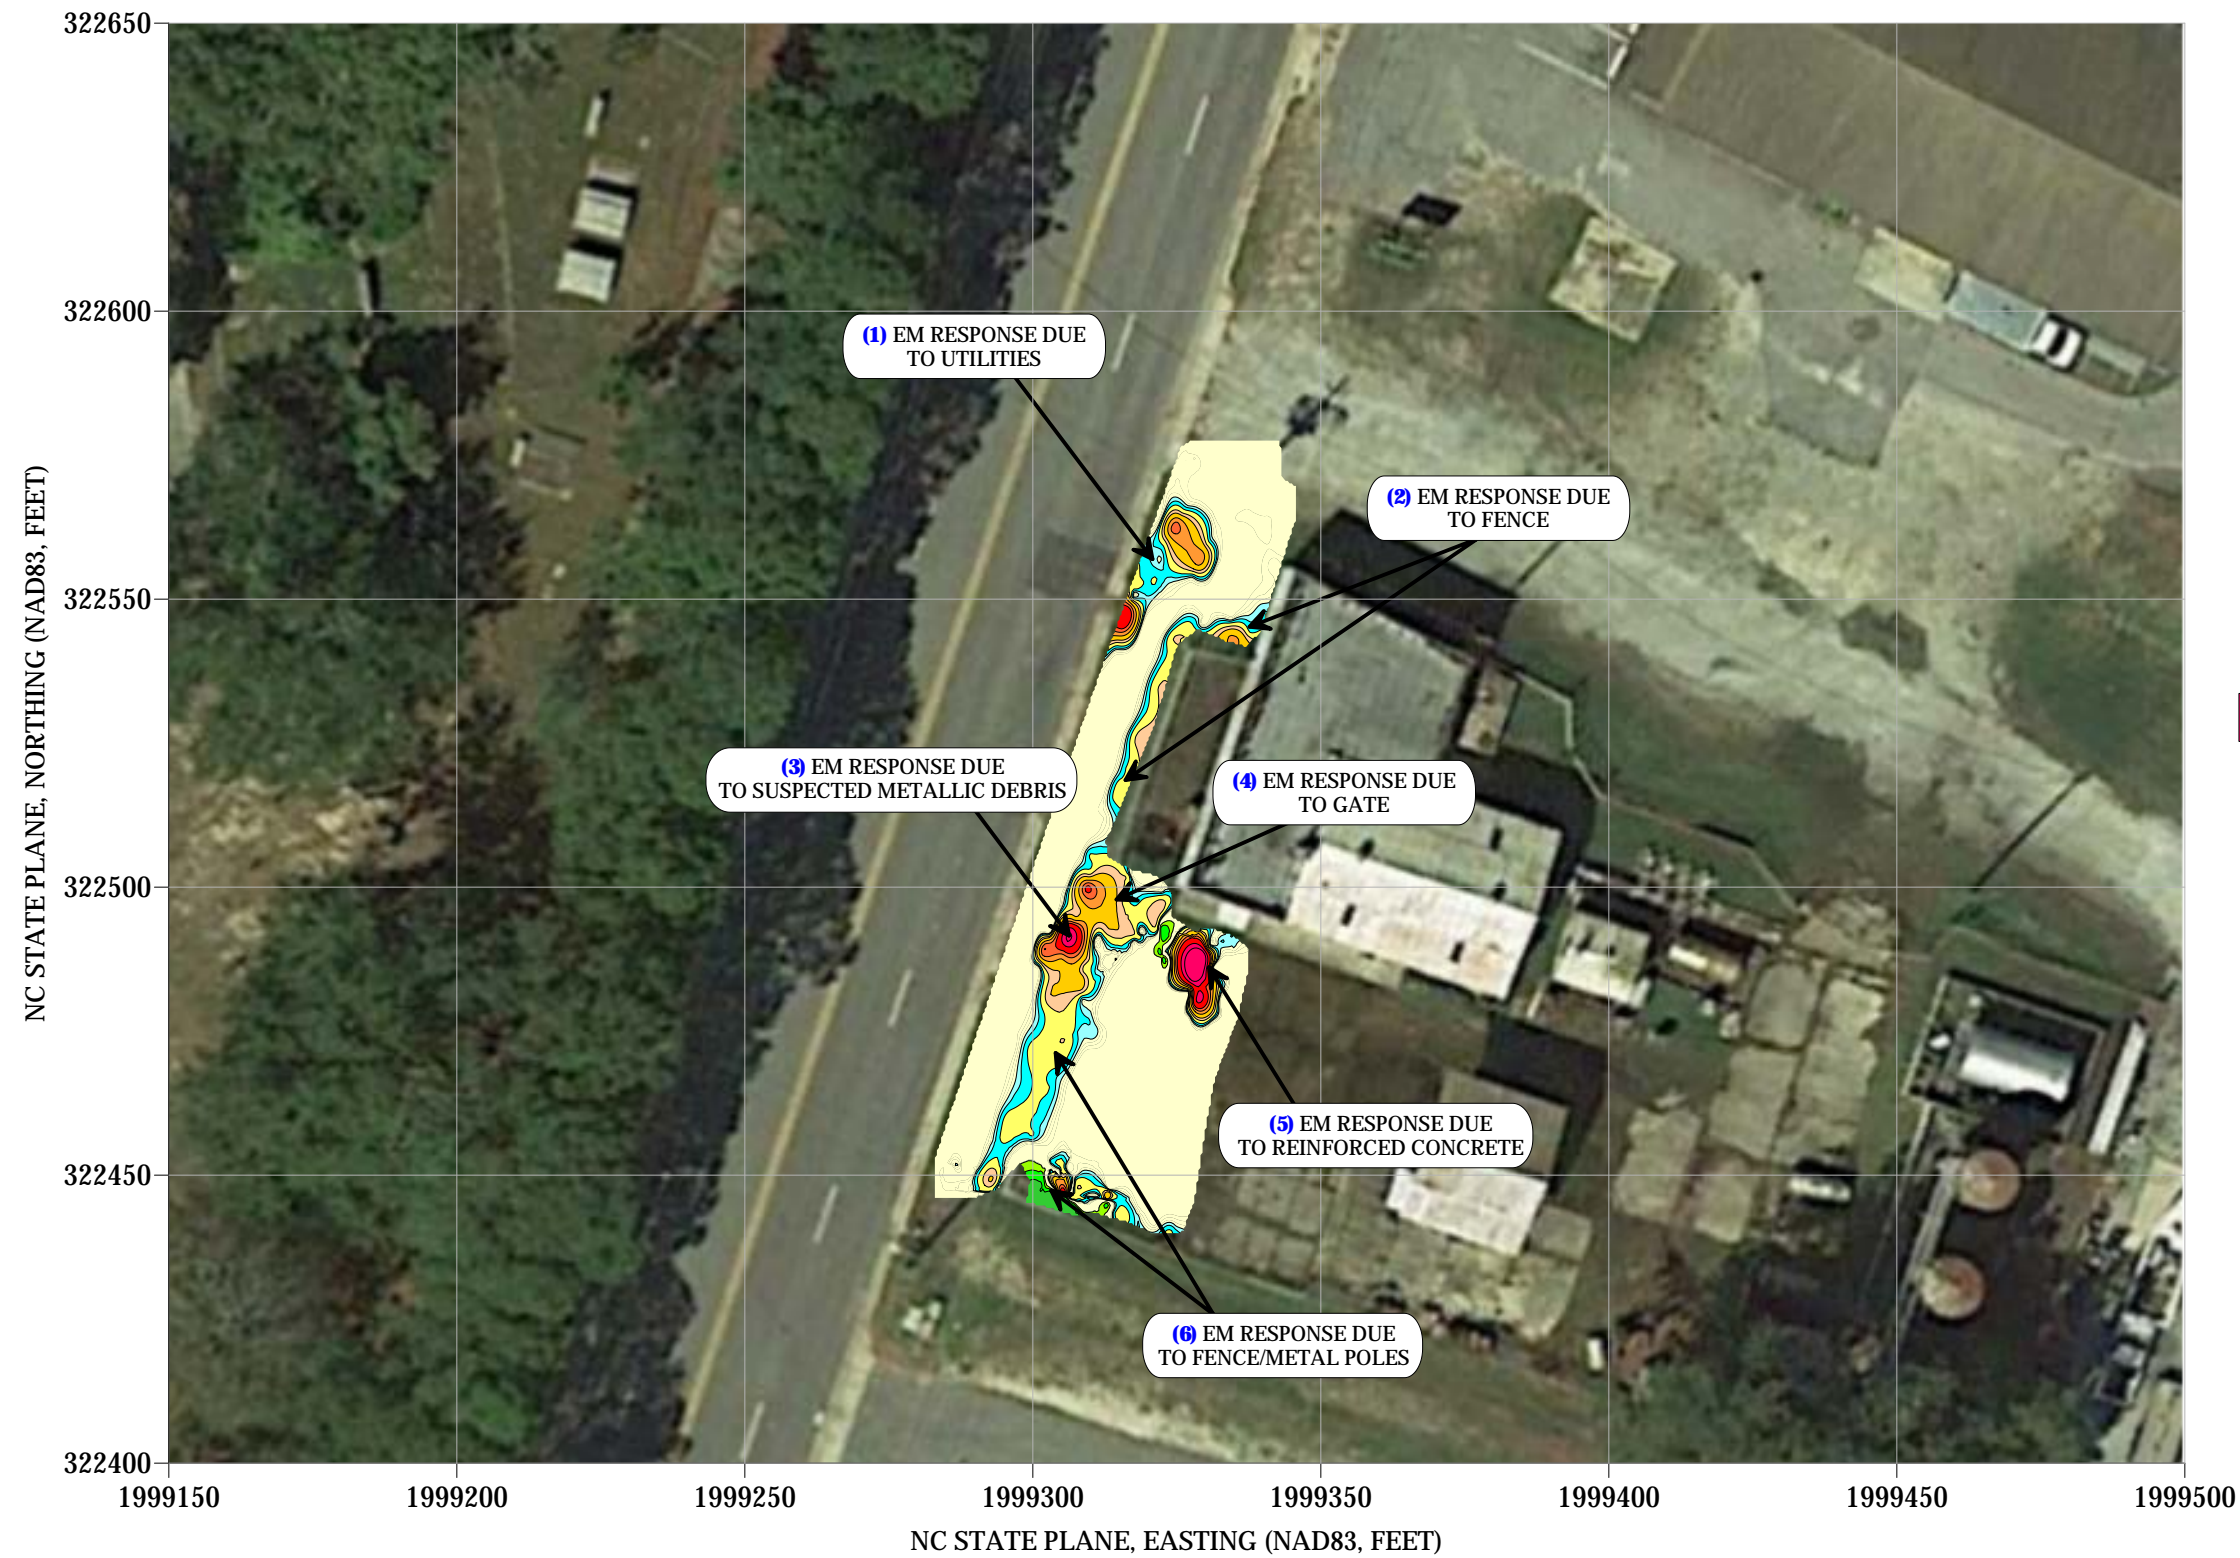
EM61 METAL DETECTION RESULTS

A contour plot of the EM61 results obtained across the survey area at the property is presented in **Figure 2**. Each EM anomaly is numbered for reference in the figure. The following table presents the list of EM anomalies and the cause of the metallic response, if known:

Metallic Anomaly #	Cause of Anomaly	Investigated with GPR
1	Utilities	
2	Fence	
3	Suspected Metallic Debris	✓
4	Gate	
5	Reinforced Concrete	✓
6	Fence/Metal Poles	✓

NO EVIDENCE OF METALLIC USTs OBSERVED.

The contour plot shows the differential results of the EM61 instrument in millivolts (mV). The differential results focus on larger metallic objects such as USTs and drums. The EM data were collected on March 18-21, 2019, using a Geonics EM61-MK2 instrument. Verification GPR data were collected using a GSSI UtilityScan DF instrument with a dual frequency 300/800 MHz antenna on March 27, 2019.

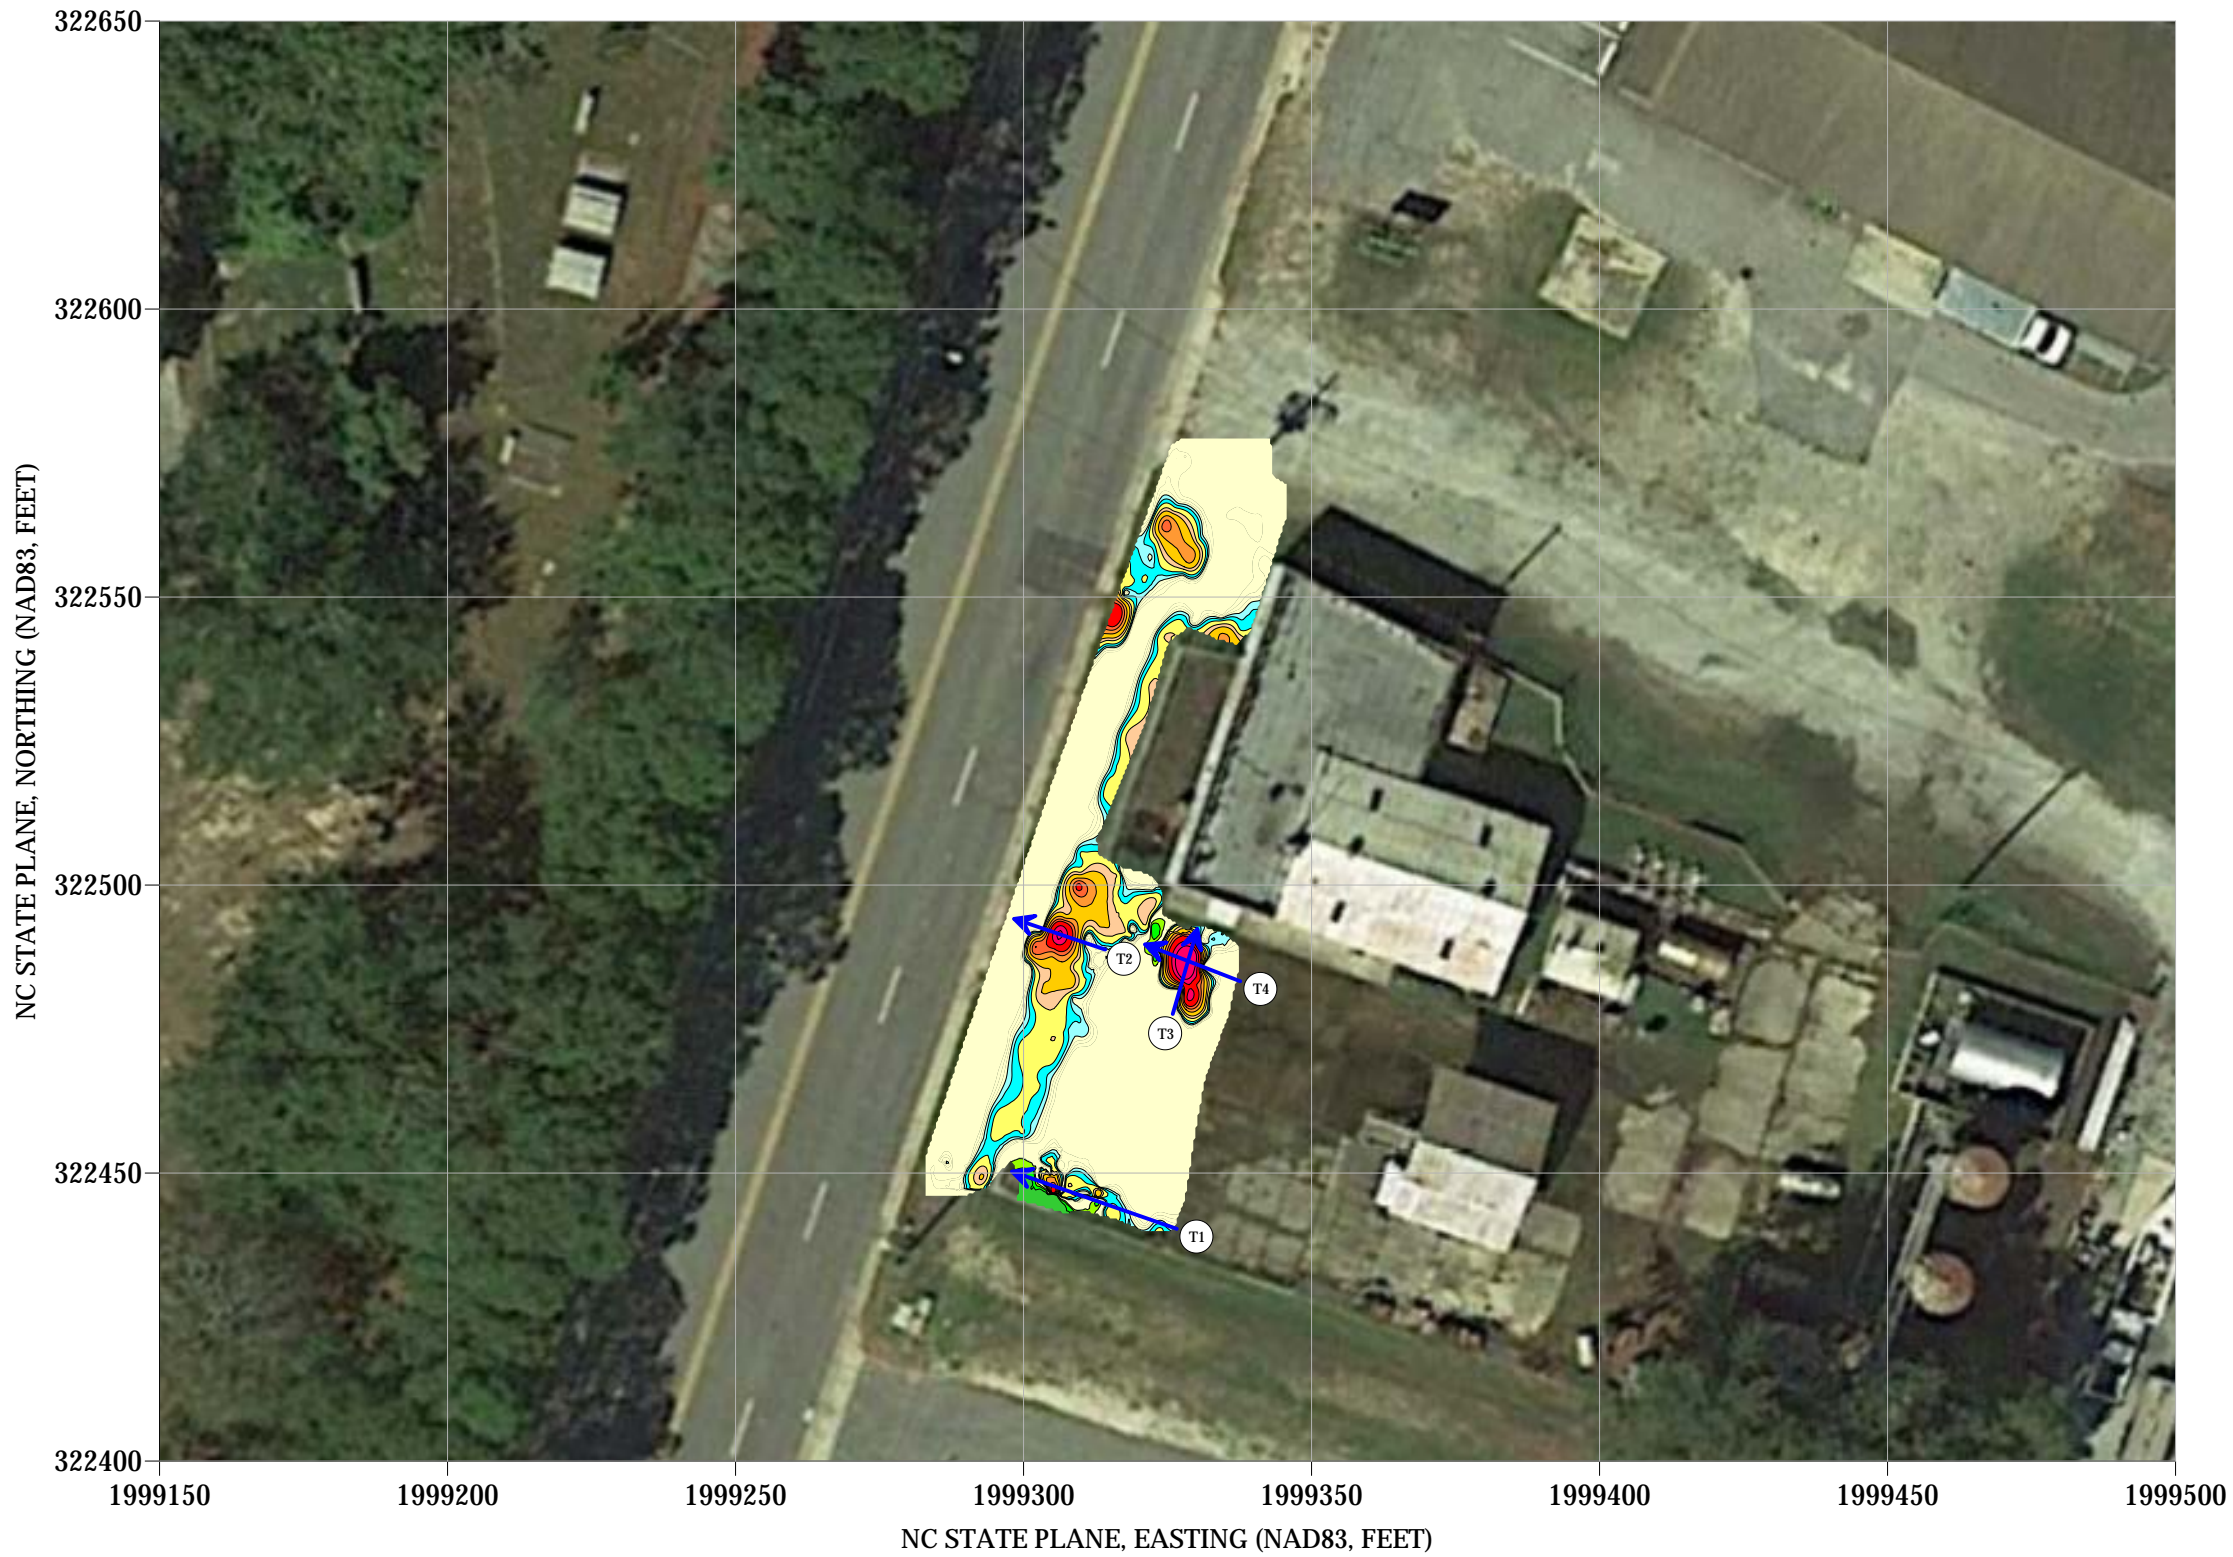
LOCATIONS OF GPR TRANSECTS

Figure 3 presents the locations of the formal GPR transects performed at the property as well as the transect images. A total of four formal GPR transects were performed at the site. GPR Transect 1 was performed across EM Anomaly 6 and recorded minor reflectors that were suggestive of possible buried metallic debris. No evidence of any larger structures such as USTs was observed.

GPR Transect 2 was performed across EM Anomaly 3 and recorded minor reflectors that were suggestive of possible buried metallic debris and verified the presence of metal reinforcement in the concrete. No evidence of any larger structures such as USTs was observed.

GPR Transects 3-4 were performed across EM Anomaly 5 and verified the presence of metal reinforcement in the concrete on the southwest side of the building. No evidence of any larger structures such as USTs was observed.
