PRELIMINARY SITE ASSESSMENT

**SR 1997 (FAYETTEVILLE ROAD) WIDENING
TIP NO. U-5797, WBS NO. 44367.1.1**

**NCDOT PARCEL NO. 15
OWNER: FREEMAN INVESTMENTS INC
2504 FAYETTEVILLE ROAD
LUMBERTON, ROBESON COUNTY, NORTH CAROLINA**

PROJECT NUMBER: G19011.00
JUNE 9, 2020

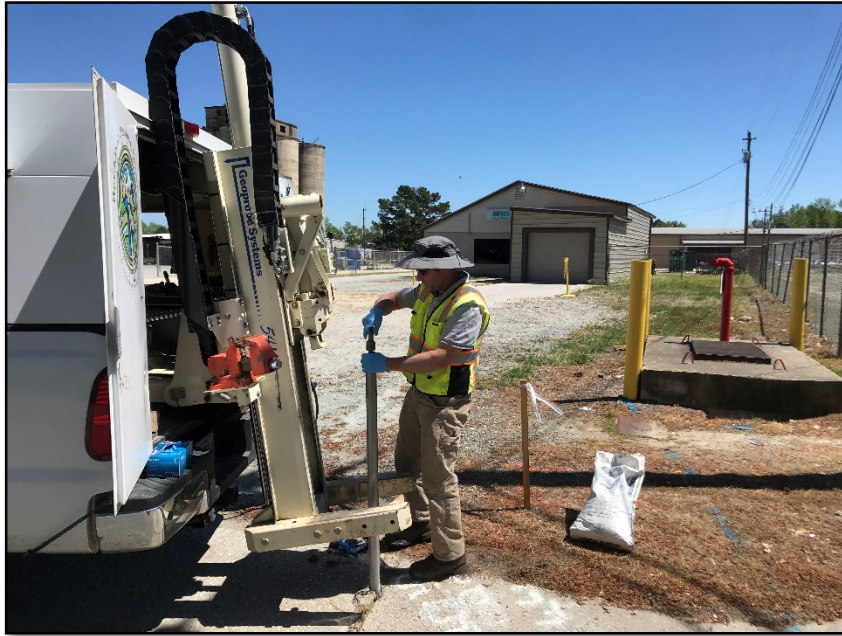
Photograph No. 1: General view of Boring B-15.

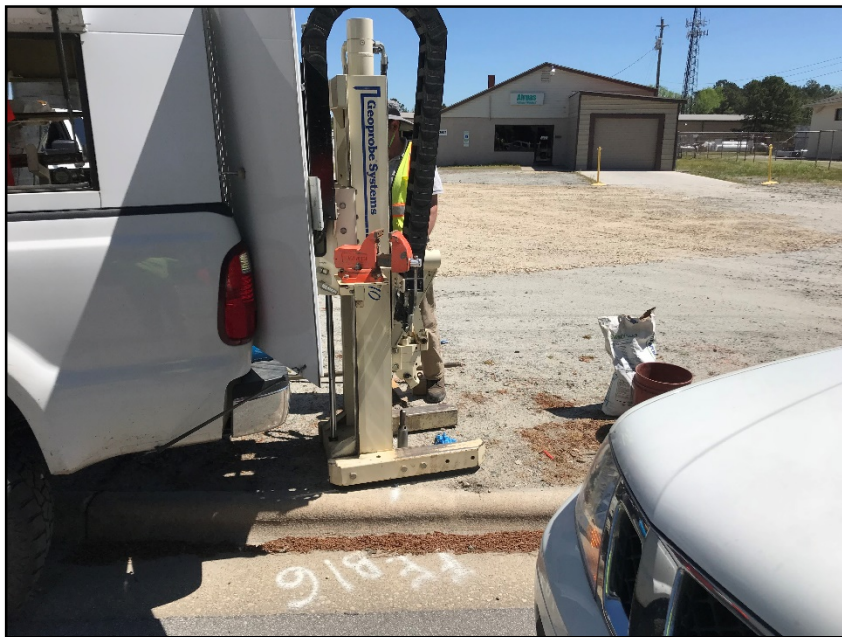
Photograph No. 2: General view of Boring B-16.

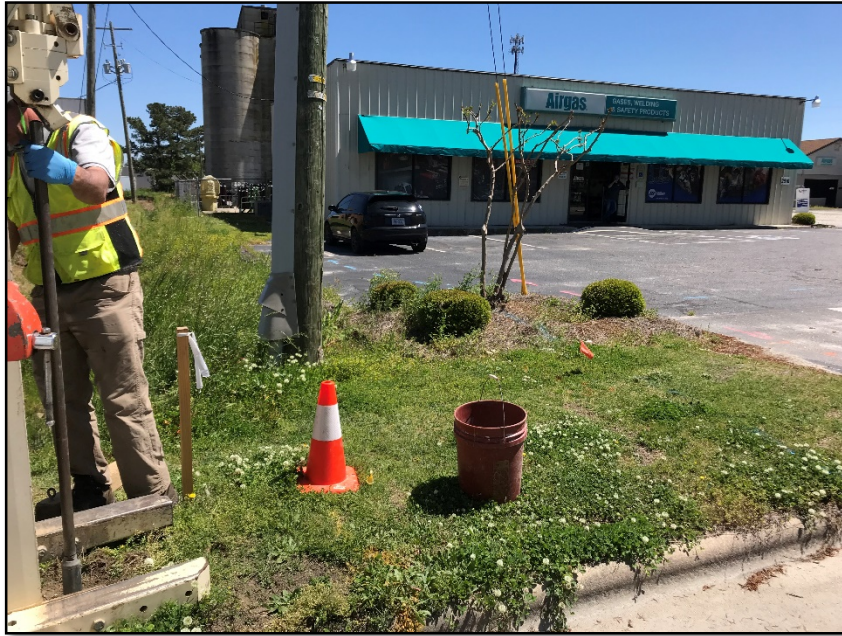
Photograph No. 3: General view of Boring B-17.

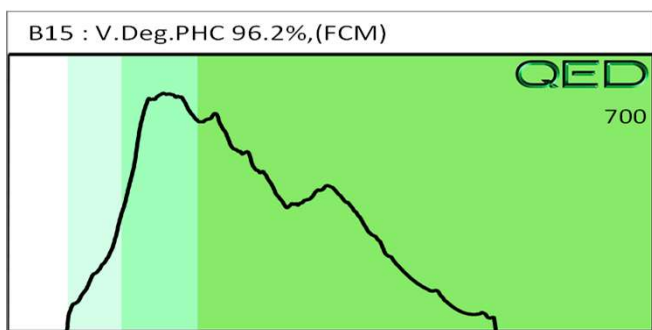
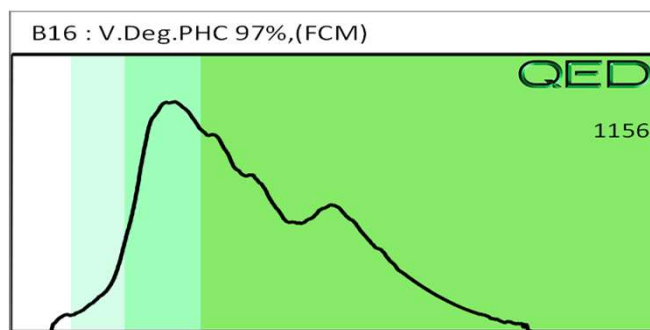
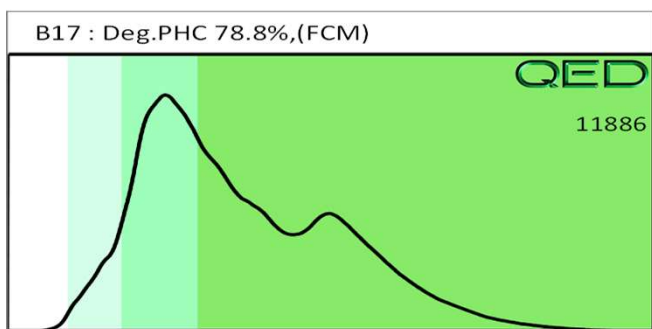
QED Hydrocarbon Fingerprints

Sample ID	BTEX (C6 - C9)	GRO (C5 - C10)	DRO (C10 - C35)	TPH (C5 - C35)	Total Aromatics (C10-C35)	16 EPA PAHs	BaP	Ratios			HC Fingerprint Match
								% light	% mid	% heavy	
B-15	<0.29	<0.29	0.29	0.29	0.15	<0.09	<0.012	0	75.5	24.5	V.Deg.PHC 96.2%,(FCM)
B-16	<0.28	<0.28	0.54	0.54	0.24	<0.09	<0.011	0	76.1	23.9	V.Deg.PHC 97%,(FCM)
B-17	<0.27	<0.27	6.5	6.5	3.1	0.16	<0.011	0	80.5	19.5	Deg.PHC 78.8%,(FCM)

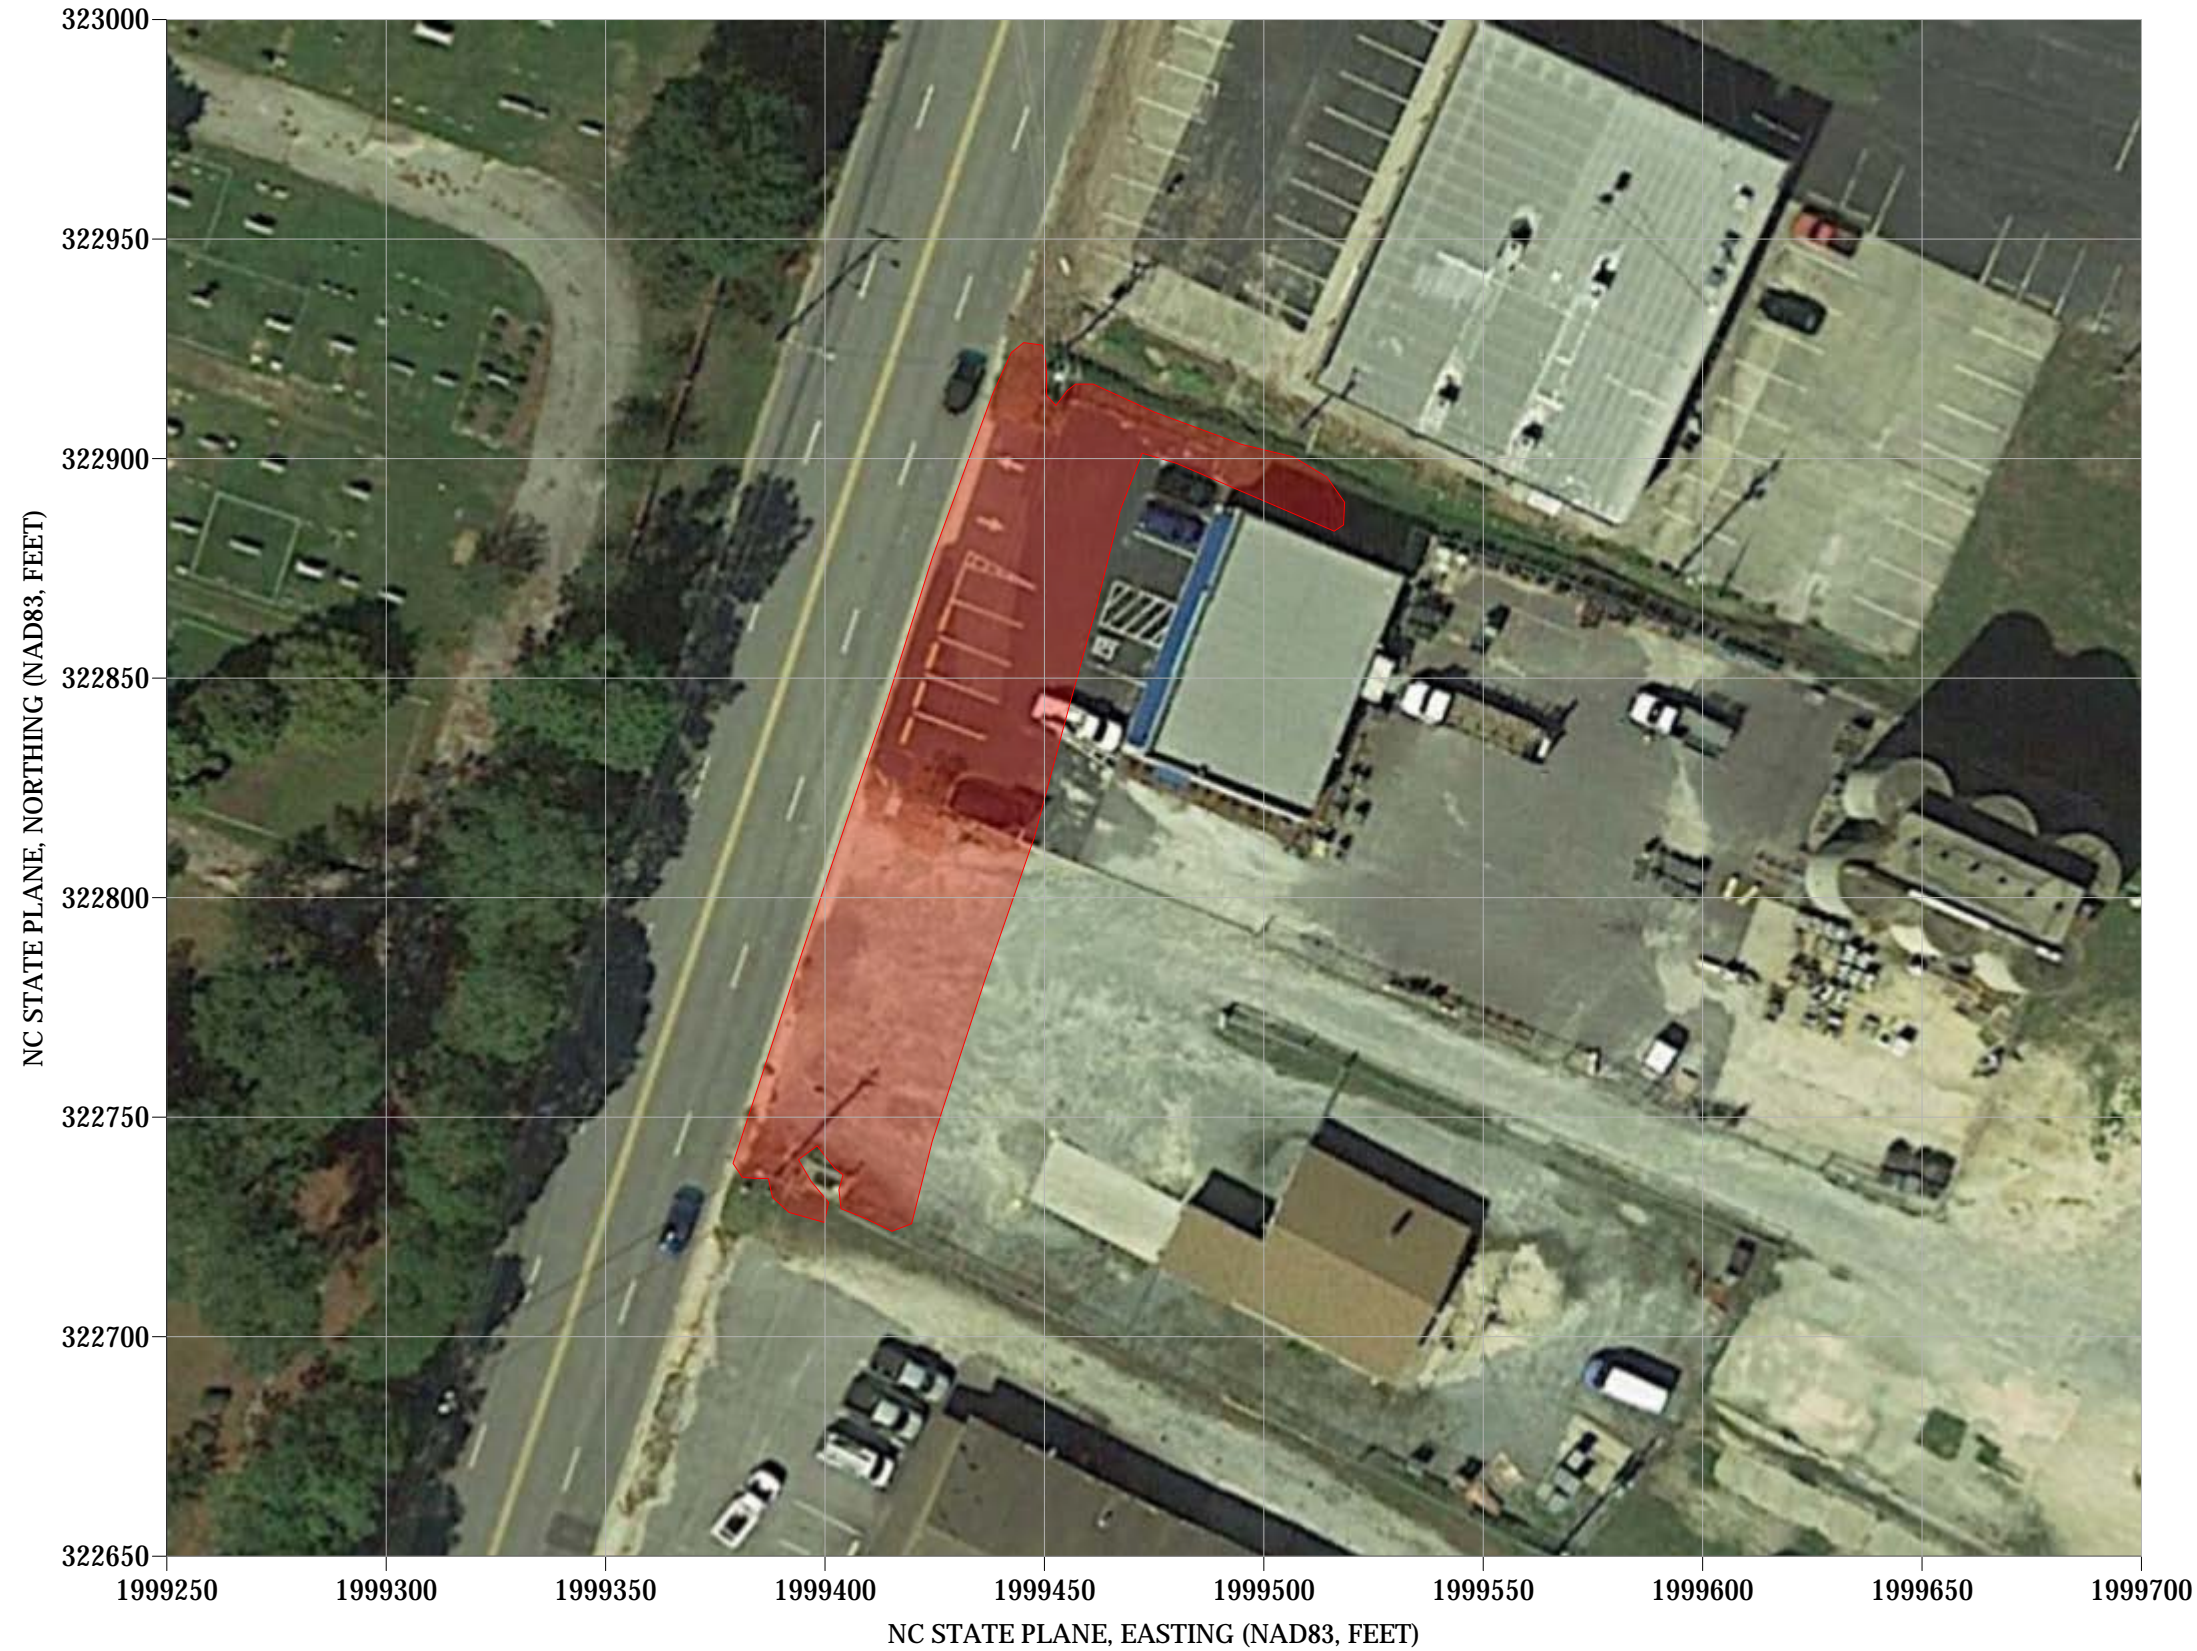
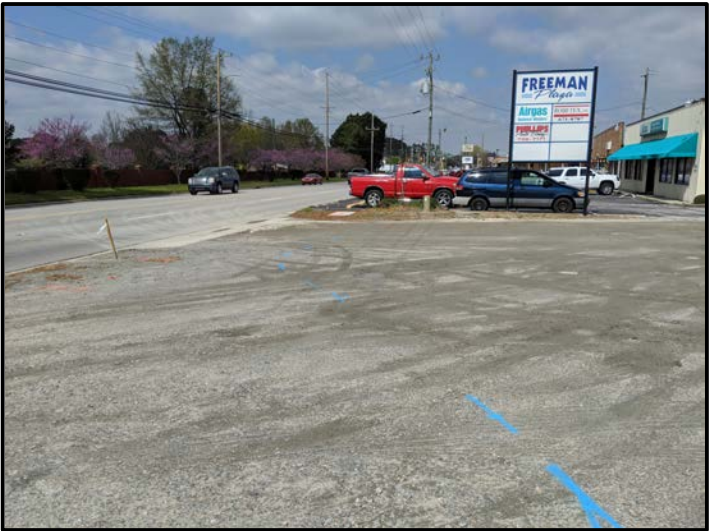
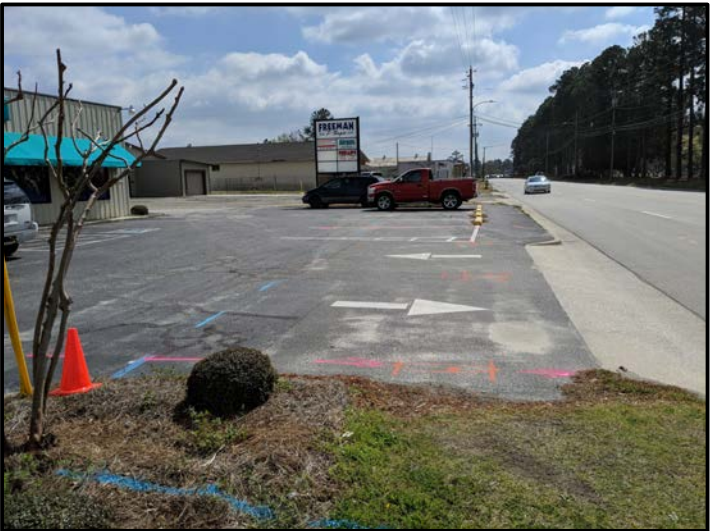
APPROXIMATE BOUNDARIES OF GEOPHYSICAL SURVEY AREA

The site included a commercial building surrounded by gravel, asphalt, and grass surfaces. An aerial photograph showing the survey area boundaries and ground-level photographs are shown in **Figure 1**.

View of Survey Area
(Facing Approximately North)

View of Survey Area
(Facing Approximately South)

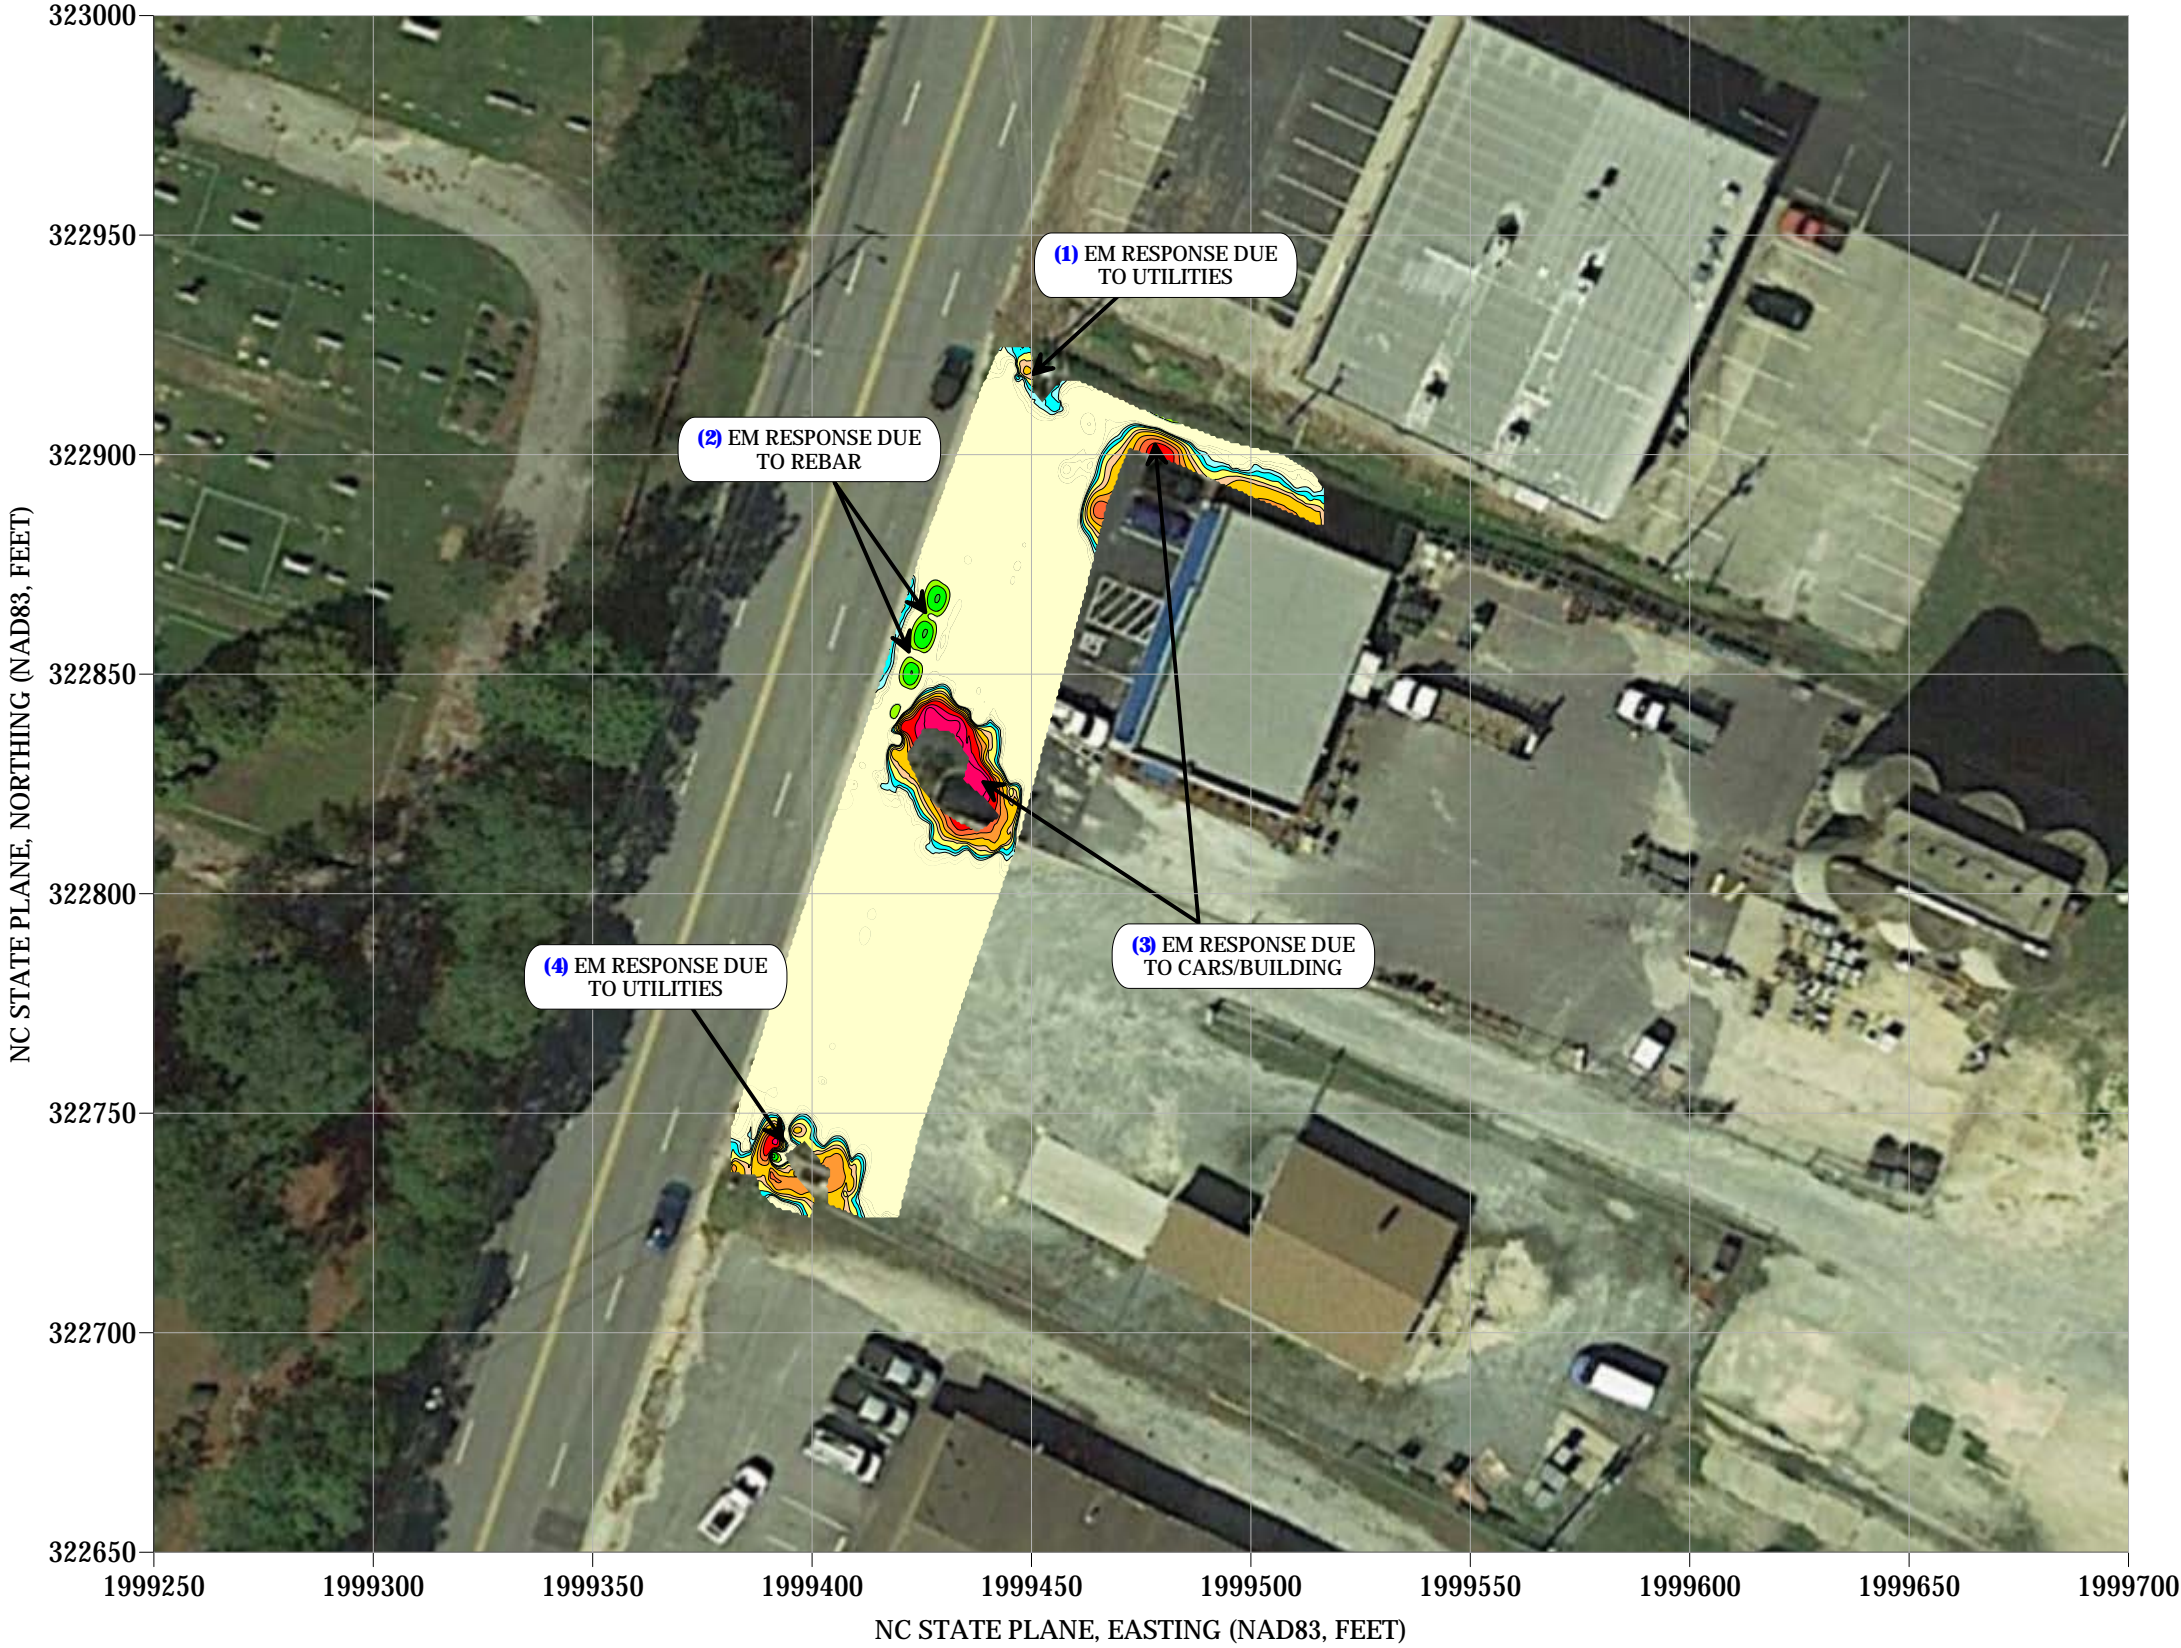
TITLE
PARCEL 15 -
EM61 METAL DETECTION CONTOUR MAP

A contour plot of the EM61 results obtained across the survey area at the property is presented in **Figure 2**. Each EM anomaly is numbered for reference in the figure. The following table presents the list of EM anomalies and the cause of the metallic response, if known:

Metallic Anomaly #	Cause of Anomaly	Investigated with GPR
1	Utilities	
2	Rebar	
3	Cars/Building	✓
4	Utilities

The majority of the EM anomalies were directly attributed to visible cultural features at the ground surface, including utilities, rebar, cars, and the building. EM Anomaly 3 was associated with interference from the building and cars and was further investigated with GPR to verify that the interference did not obscure buried structures such as USTs.

NO EVIDENCE OF METALLIC
USTs OBSERVED.

The contour plot shows the differential results of the EM61 instrument in millivolts (mV). The differential results focus on larger metallic objects such as USTs and drums. The EM data were collected on March 18, 2019, using a Geonics EM61-MK2 instrument. Verification GPR data were collected using a GSSI UtilityScan DF instrument with a dual frequency 300/800 MHz antenna on March 26, 2019.

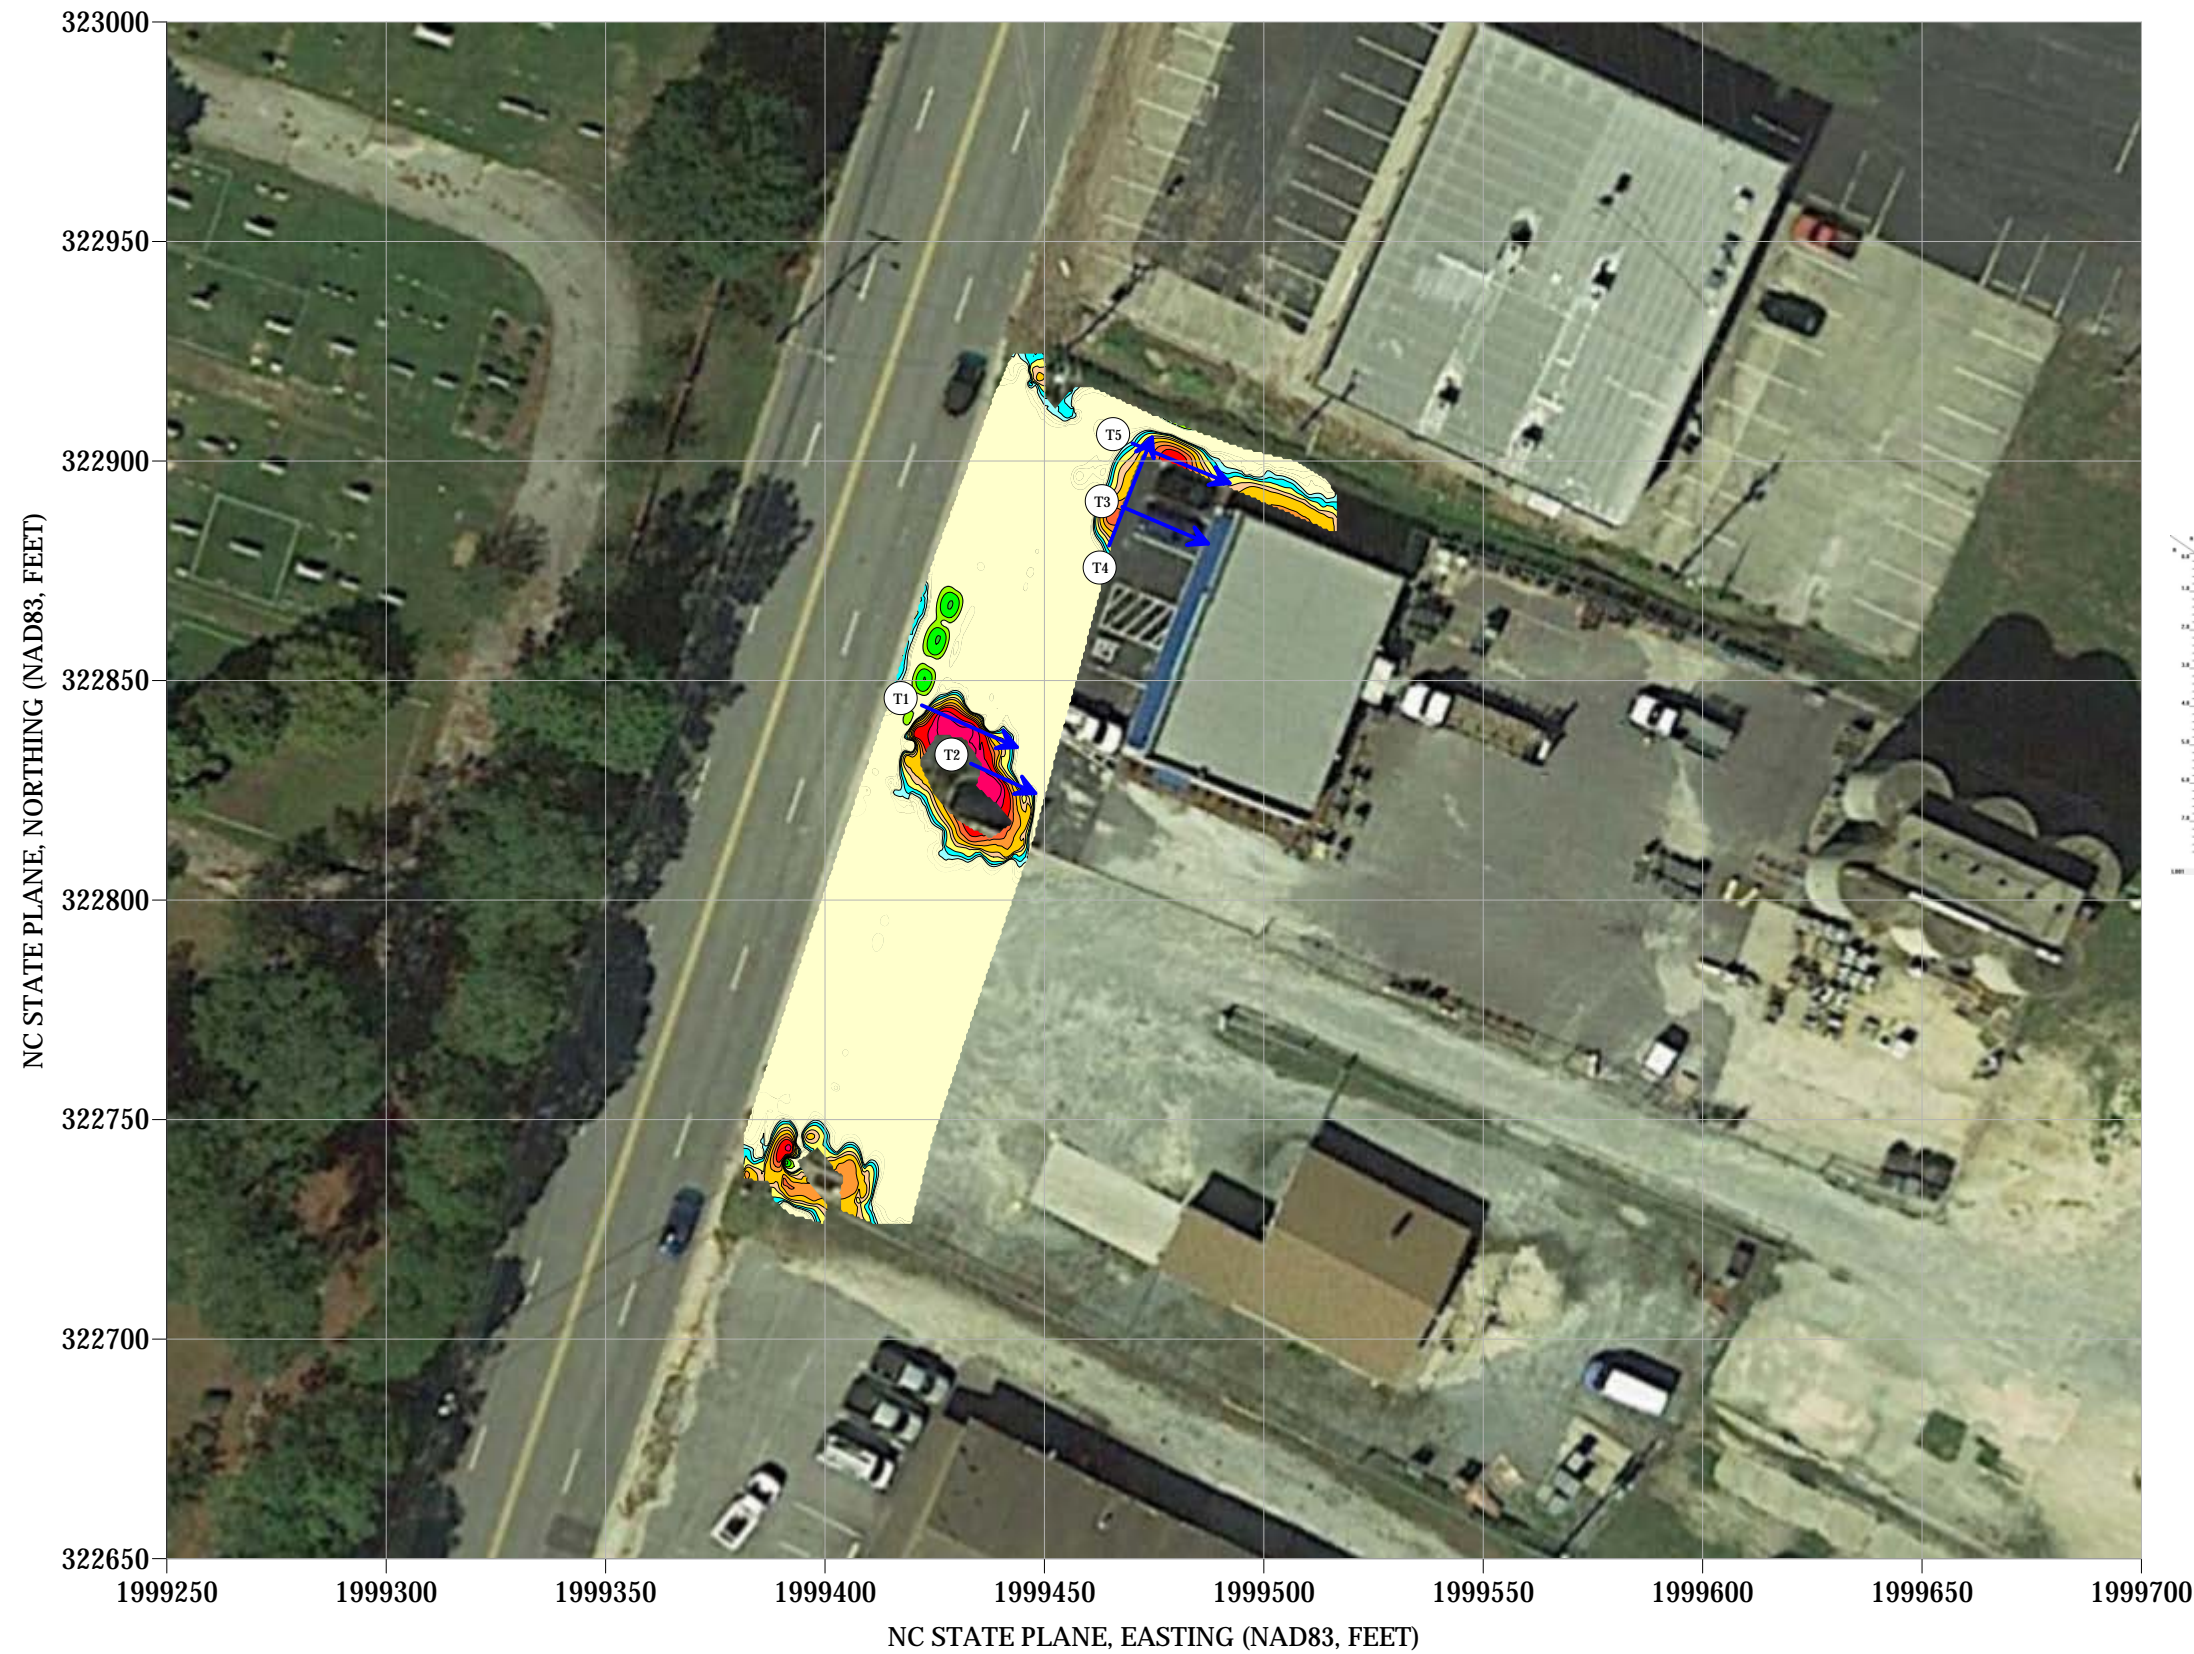
TITLE
PARCEL 15 -
GPR TRANSECT LOCATIONS AND IMAGES

Figure 3 presents the locations of the formal GPR transects performed at the property as well as the transect images. A total of five formal GPR transects were performed at the site. GPR Transects 1-2 were performed across EM Anomaly 3, where cars were parked. These transects recorded no evidence of buried structures, such as USTs.

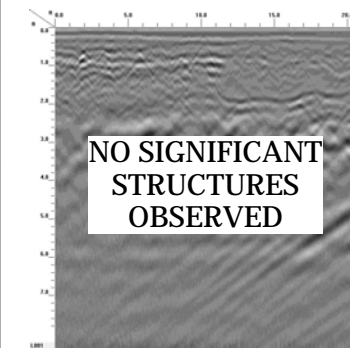
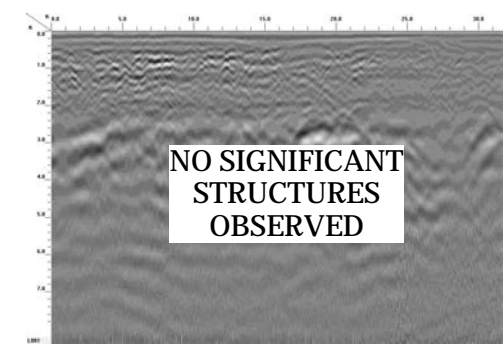
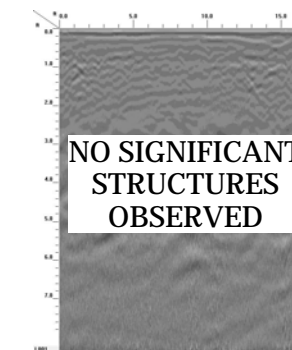
GPR Transects 3-5 were performed across EM Anomaly 3, along the northwest corner of the building. These transects recorded no evidence of buried structures, such as USTs.

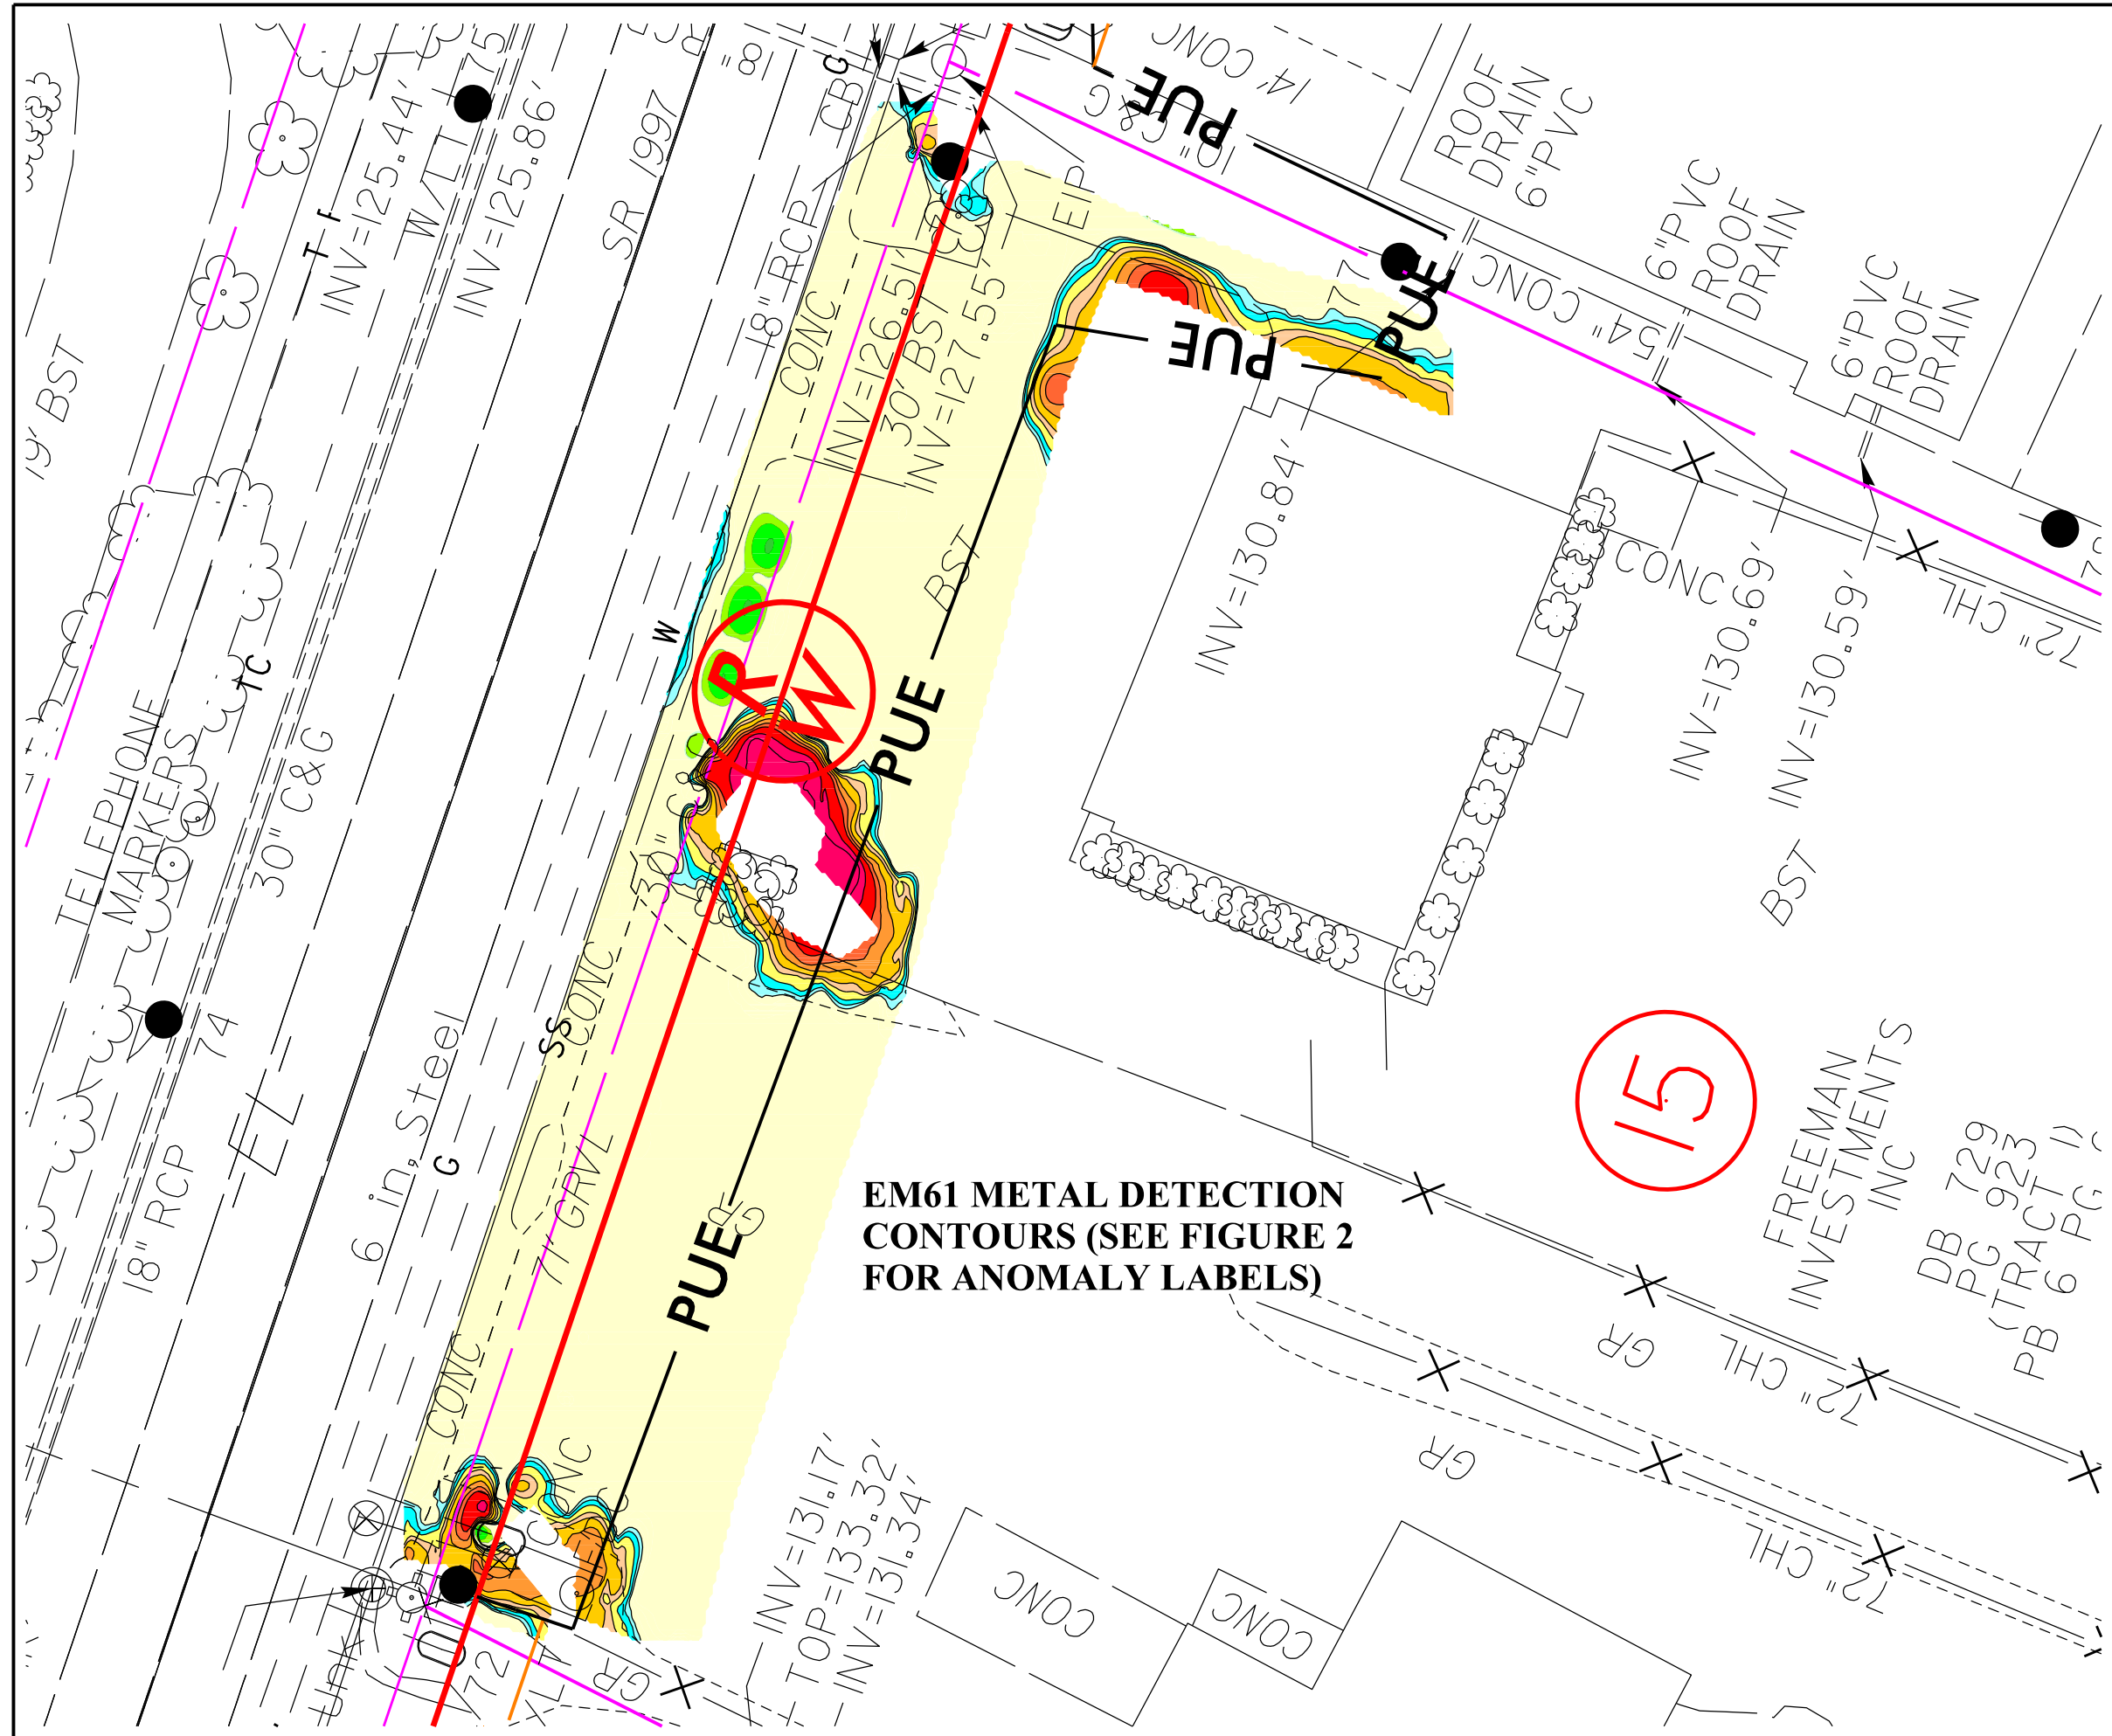
TITLE OVERLAY OF METAL DETECTION RESULTS ON NCDOT ENGINEERING PLANS	
PROJECT PARCEL 015 LUMBERTON, NORTH CAROLINA NCDOT PROJECT U-5797

Collectively, the geophysical data did not record any evidence of unknown metallic USTs within the geophysical survey area at Parcel 15. **Figure 4** provides an overlay of the EM61 metal detection contour map onto the NCDOT MicroStation engineering plans for reference.

**EM61 METAL DETECTION
CONTOURS (SEE FIGURE 2
FOR ANOMALY LABELS)**
