PRELIMINARY SITE ASSESSMENT

**SR 1997 (FAYETTEVILLE ROAD) WIDENING
TIP NO. U-5797, WBS NO. 44367.1.1**

NCDOT PARCEL NO. 26

PROJECT NUMBER: G19011.00
JUNE 9, 2020

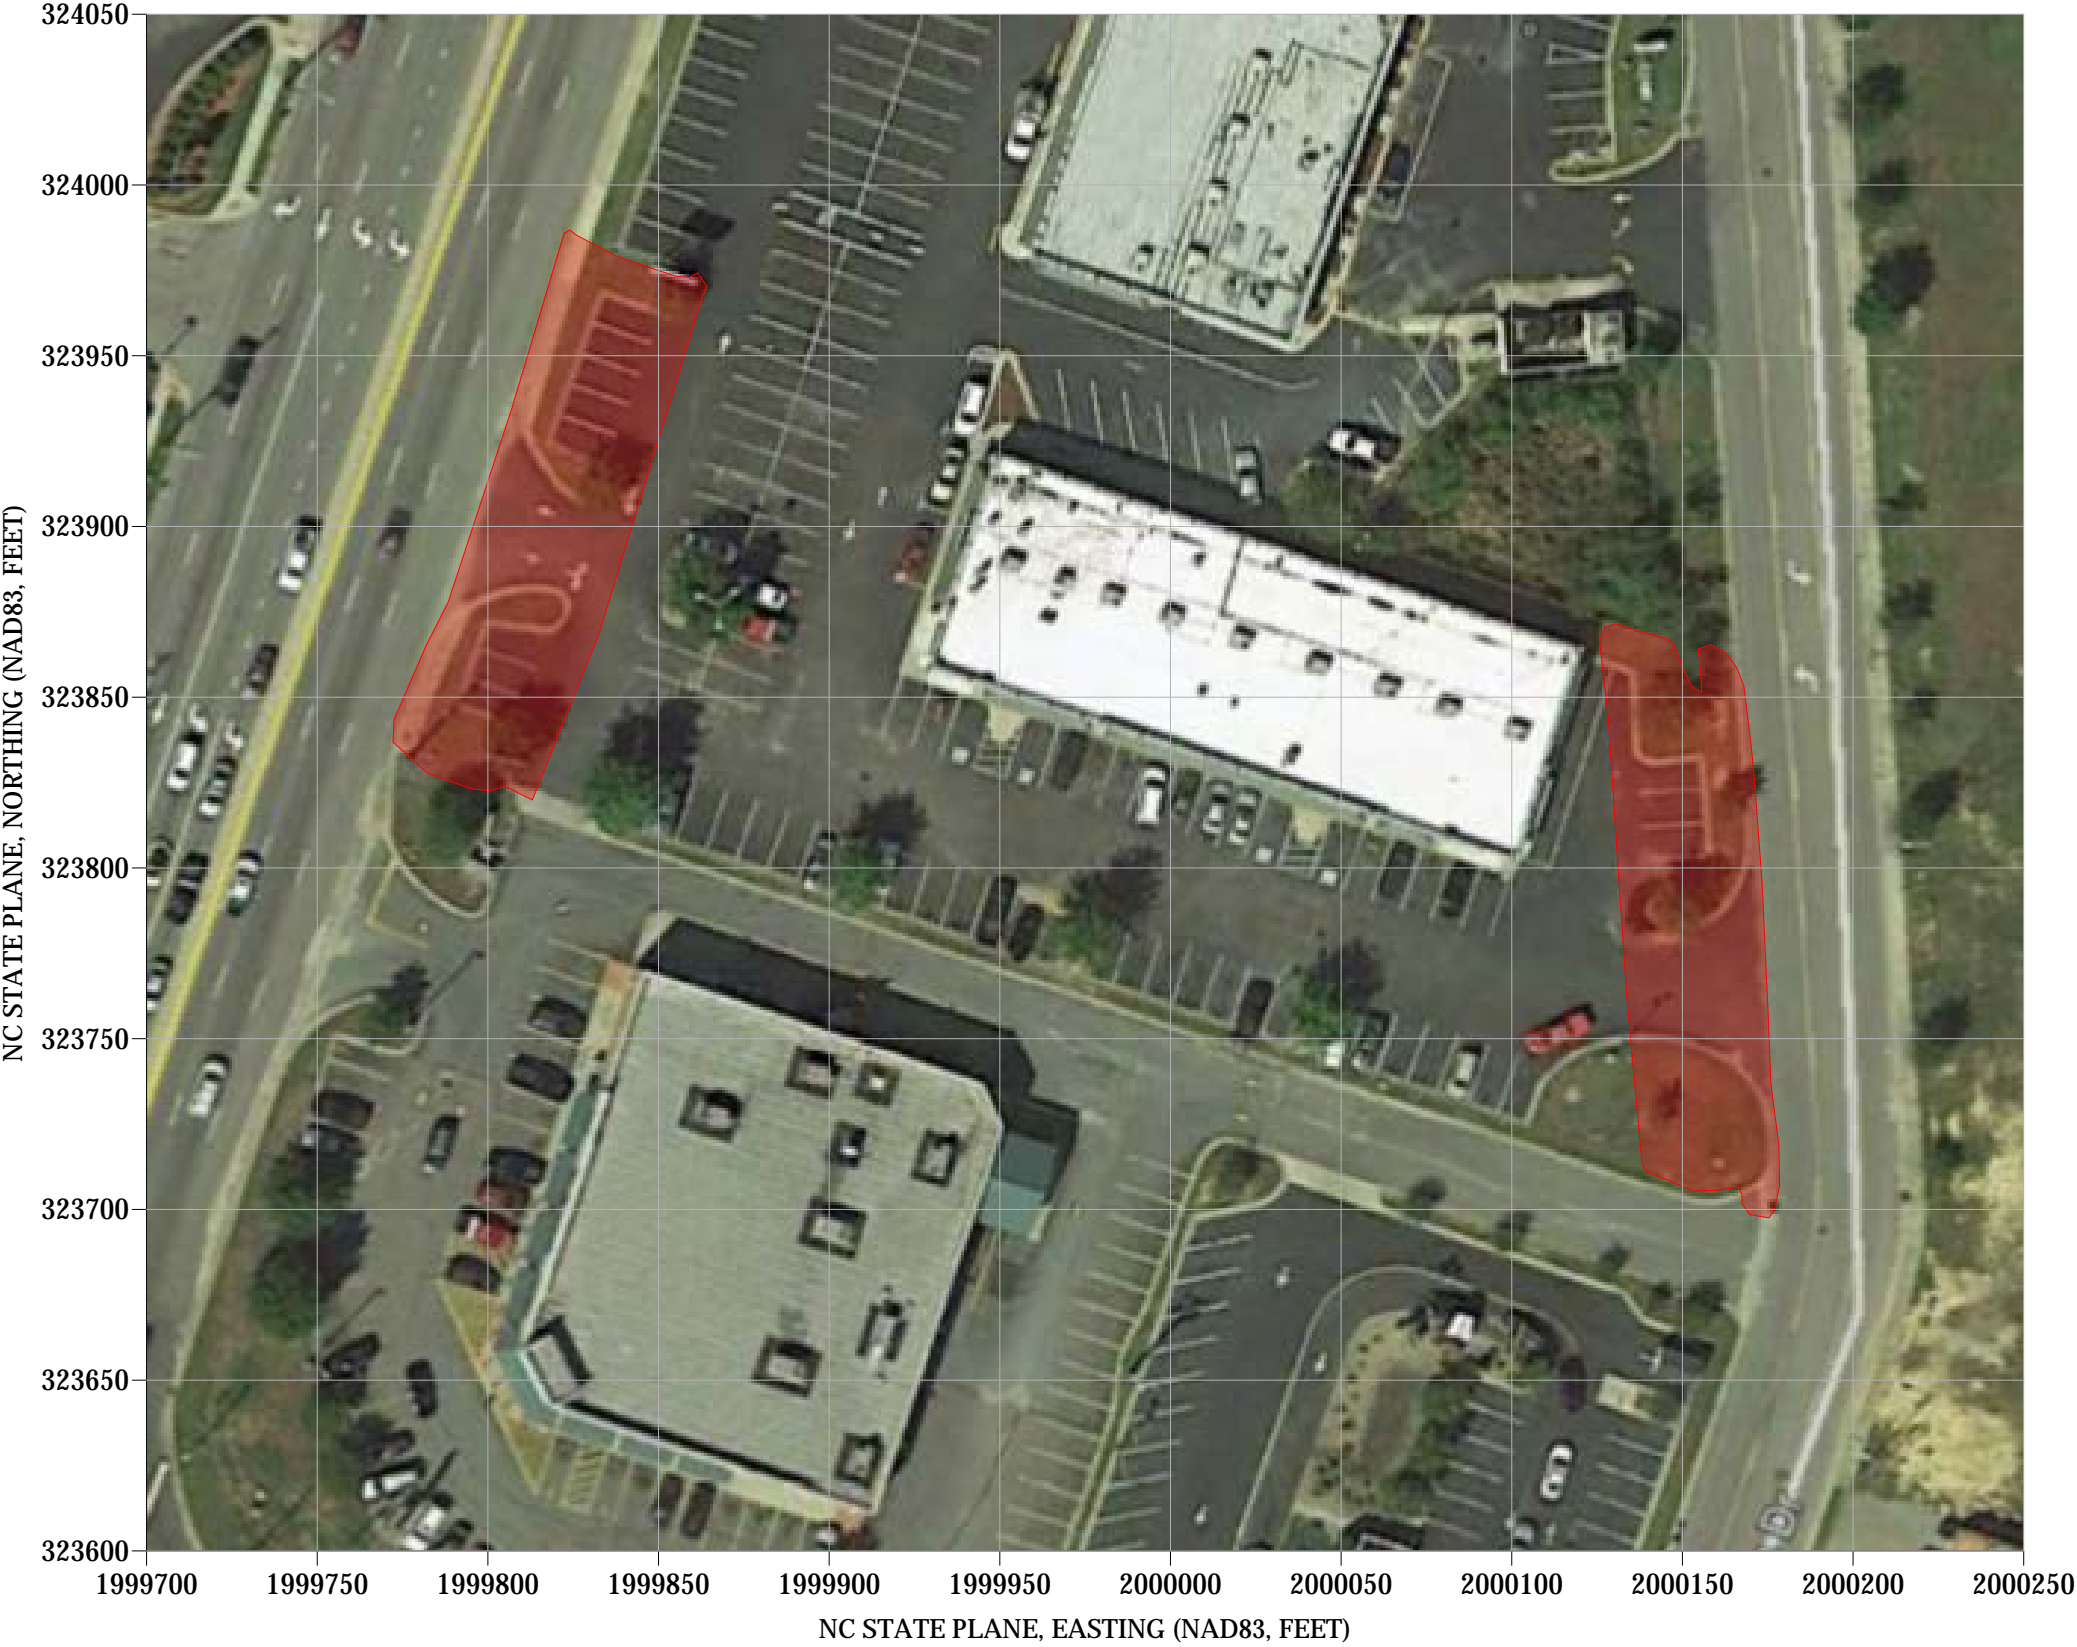
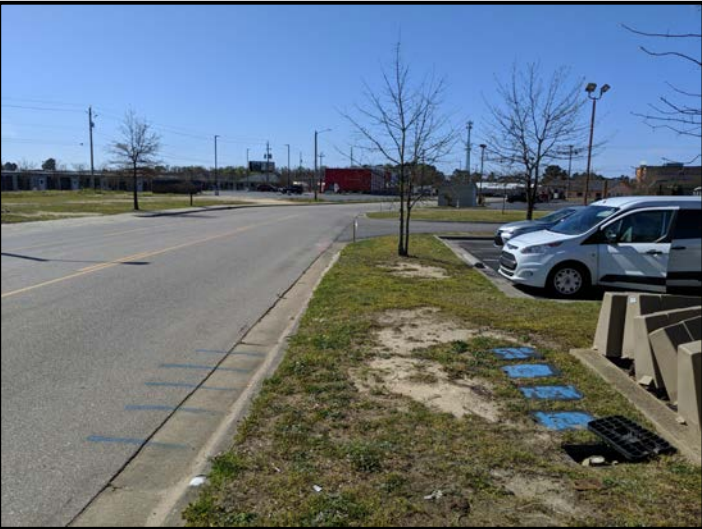
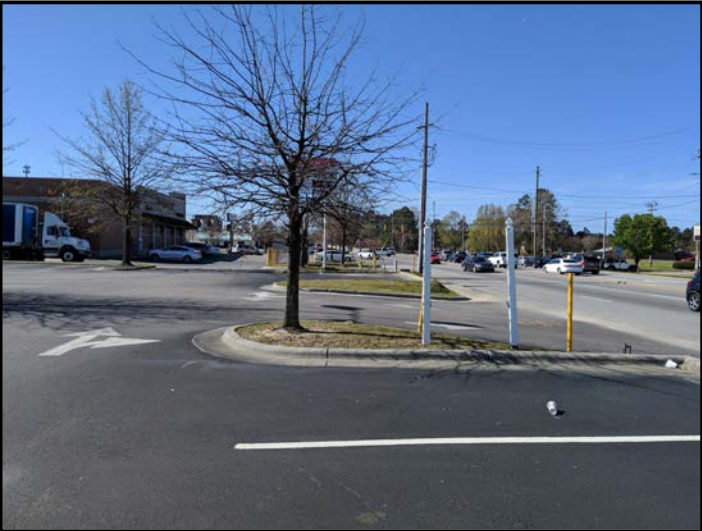
CLIENT
FALCON ENGINEERS
FIGURE 1

APPROXIMATE BOUNDARIES OF GEOPHYSICAL SURVEY AREA

View of Survey Area
(Facing Approximately South)

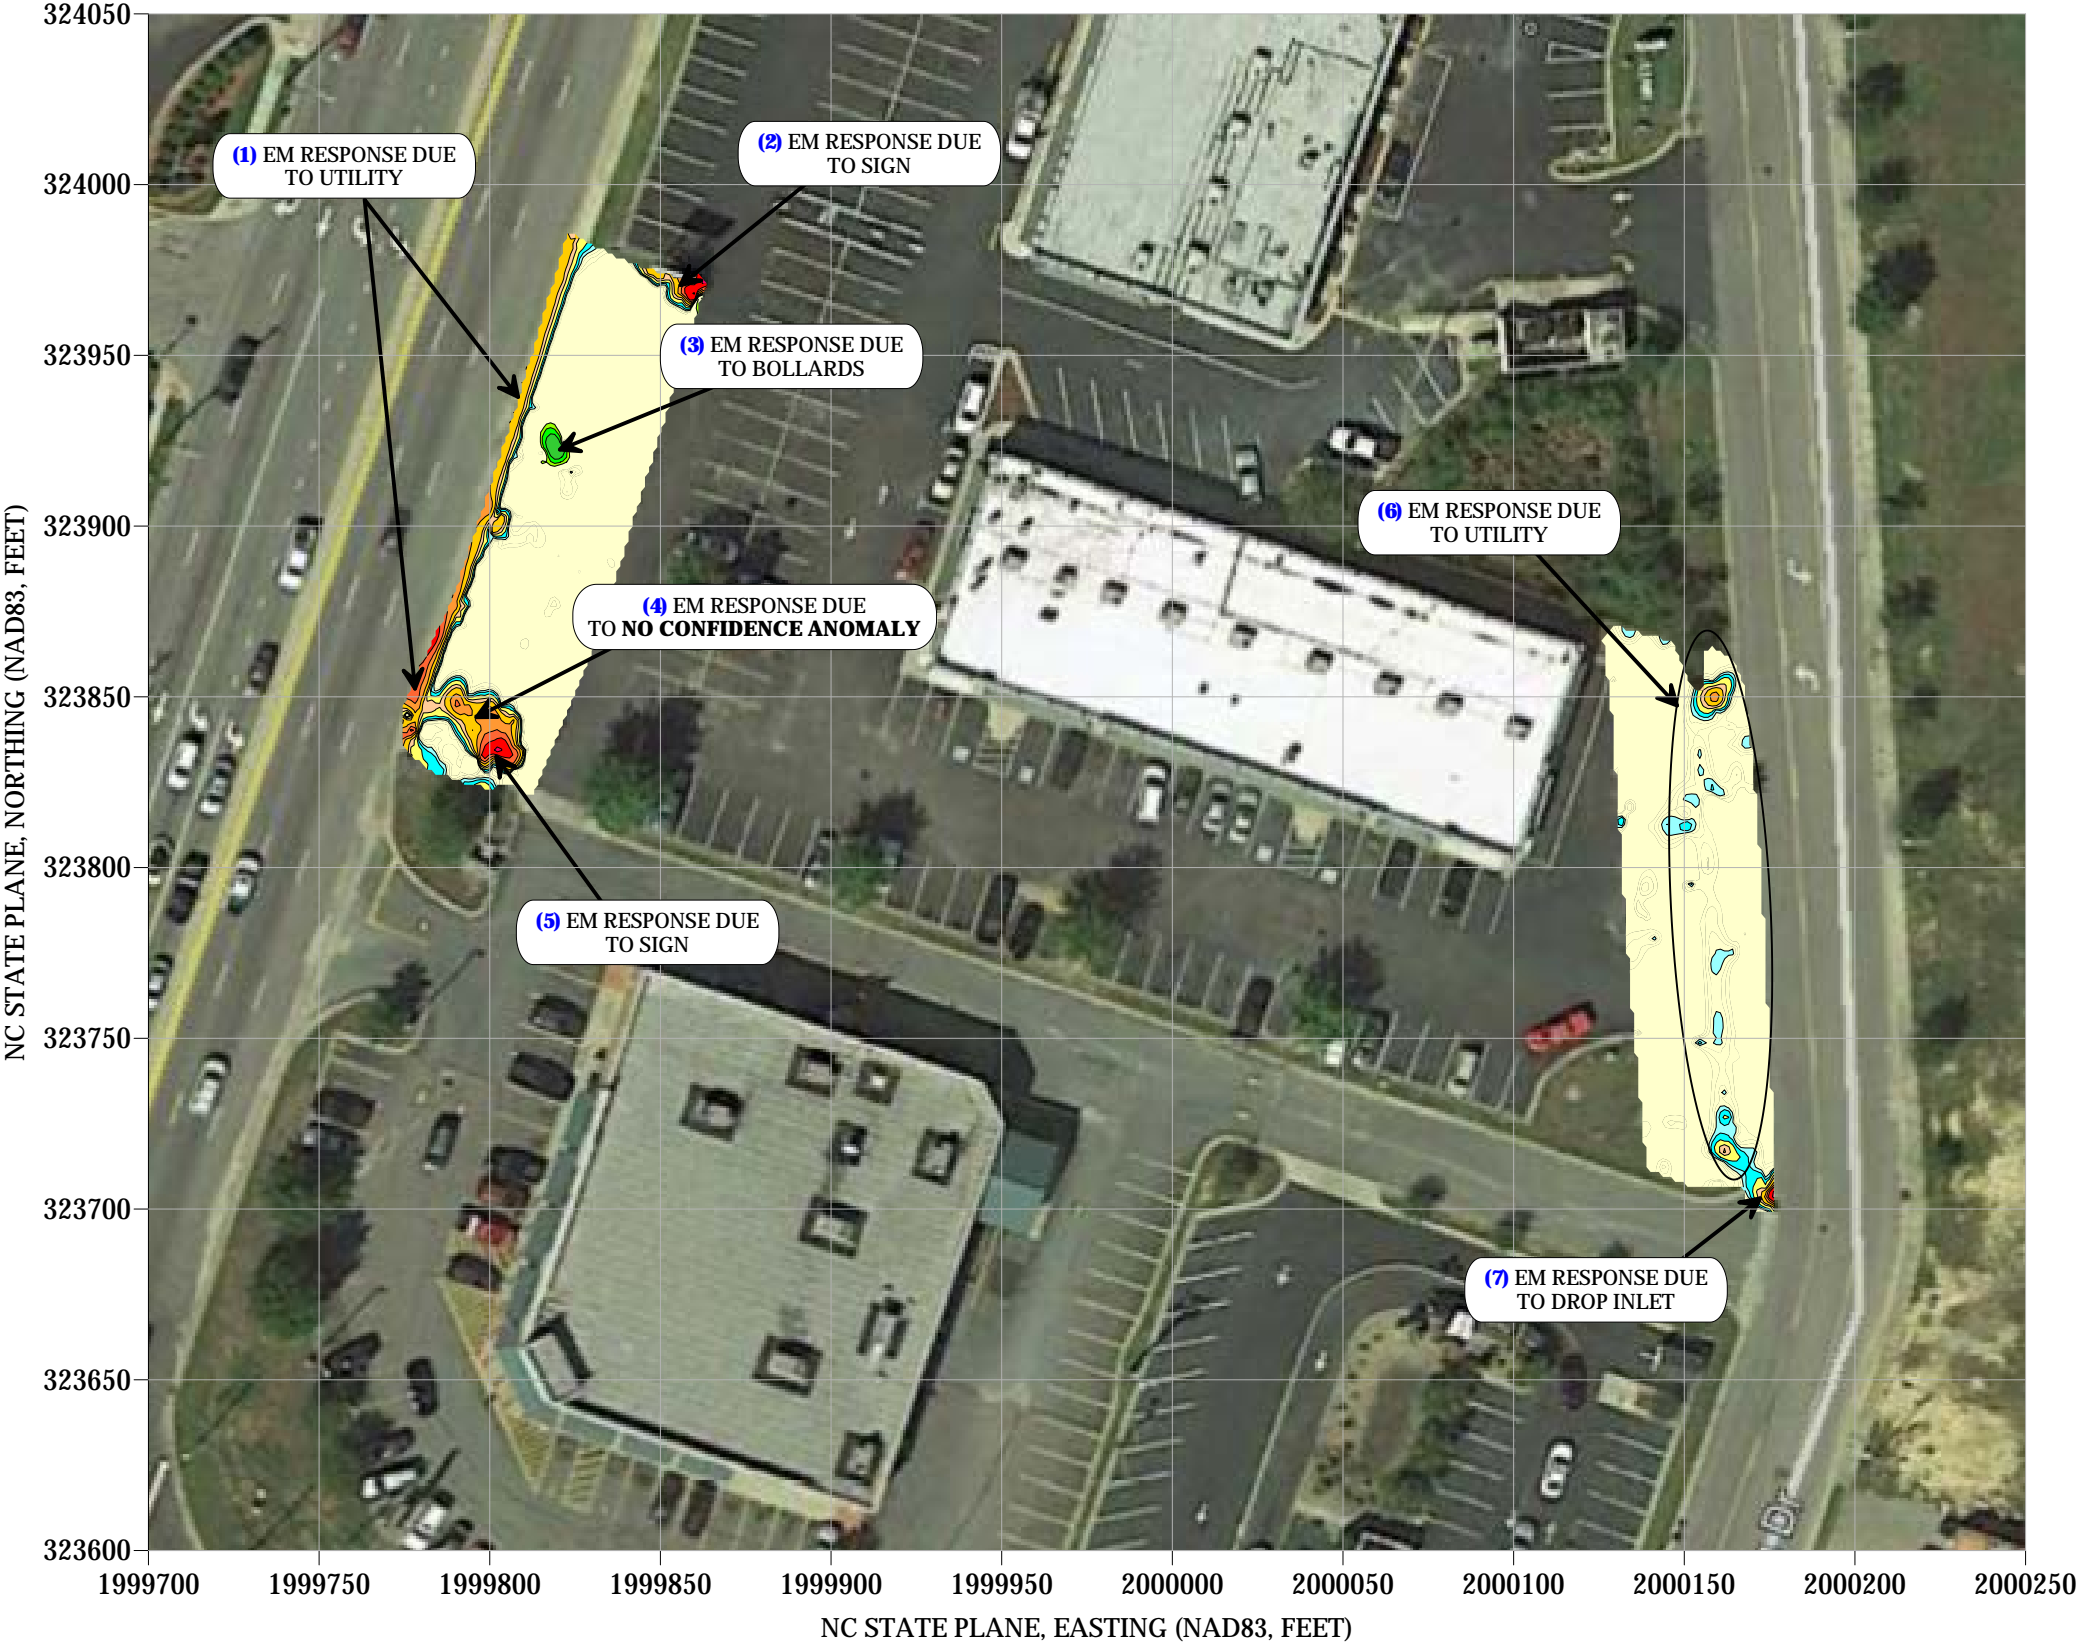
CLIENT
FALCON ENGINEERS
FIGURE 2

A contour plot of the EM61 results obtained across the survey area at the property is presented in **Figure 2**. Each EM anomaly is numbered for reference in the figure. The following table presents the list of EM anomalies and the cause of the metallic response, if known:

Metallic Anomaly #	Cause of Anomaly	Investigated with GPR
1	Utility	
2	Sign	
3	Bollards	
4	No Confidence Anomaly	☑
5	Sign	
6	Utility	
7	Drop Inlet

EM61 METAL DETECTION RESULTS

EVIDENCE OF ONE NO CONFIDENCE ANOMALY OBSERVED

The contour plot shows the differential results of the EM61 instrument in millivolts (mV). The differential results focus on larger metallic objects such as USTs and drums. The EM data were collected on March 19, 2019, using a Geonics EM61-MK2 instrument. Verification GPR data were collected using a GSSI UtilityScan DF instrument with a dual frequency 300/800 MHz antenna on March 27, 2019.

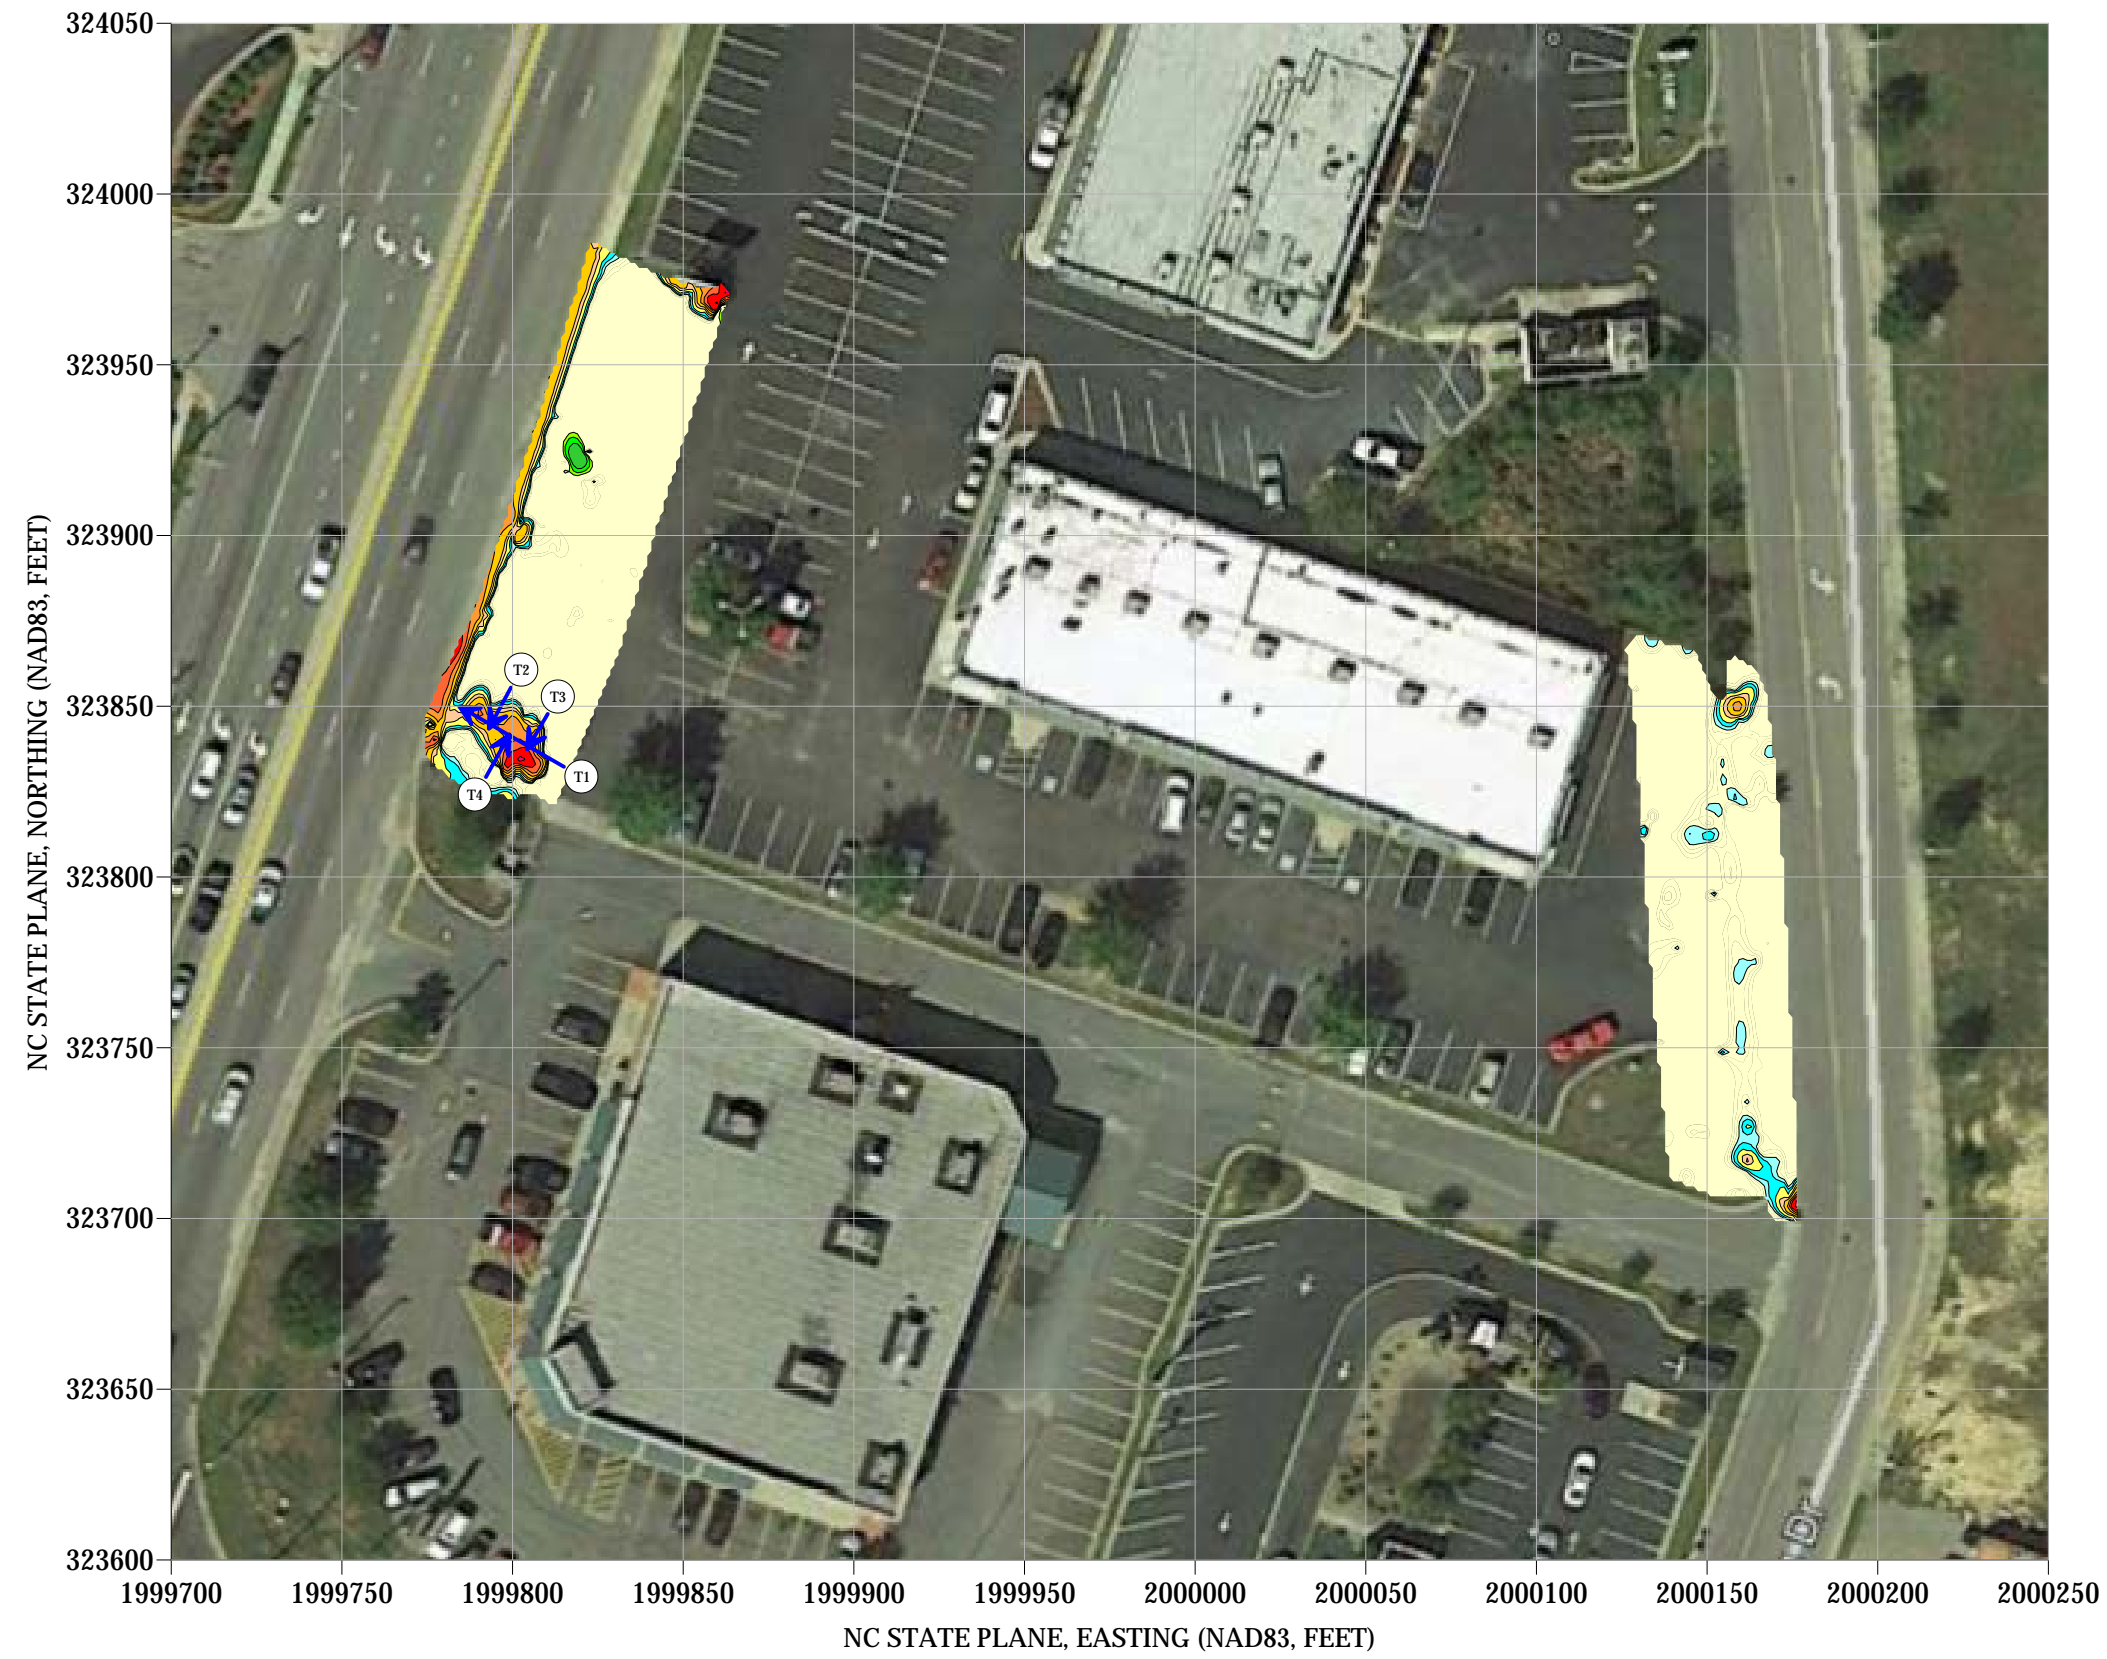
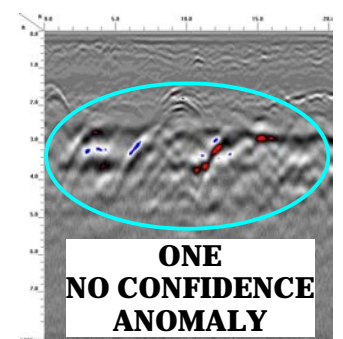
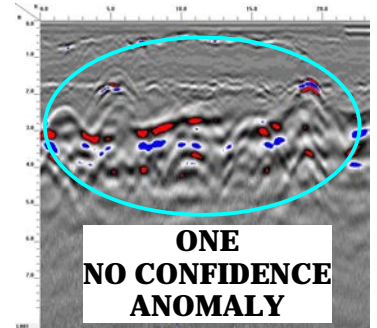
Figure 3 presents the locations of the formal GPR transects performed at the property as well as the transect images. A total of four formal GPR transects were performed at the site. GPR Transects 1-4 were performed across EM Anomaly 4. These transects isolated high-amplitude reflectors that lacked the size and characteristics typically associated with a UST. Some evidence of possible metal reinforcement was also observed, suggesting this feature may be associated with a buried reinforced slab. Therefore, this feature is classified as a No Confidence anomaly. This anomaly was approximately 18 feet long by 15 feet wide. **Figure 4** provides the location and size of the No Confidence anomaly overlain on an aerial, along with ground-level photographs.

LOCATIONS OF GPR TRANSECTS

GPR TRANSECT 1 (T1)

GPR TRANSECT 2 (T2)

GPR TRANSECT 3 (T3)

GPR TRANSECT 4 (T4)

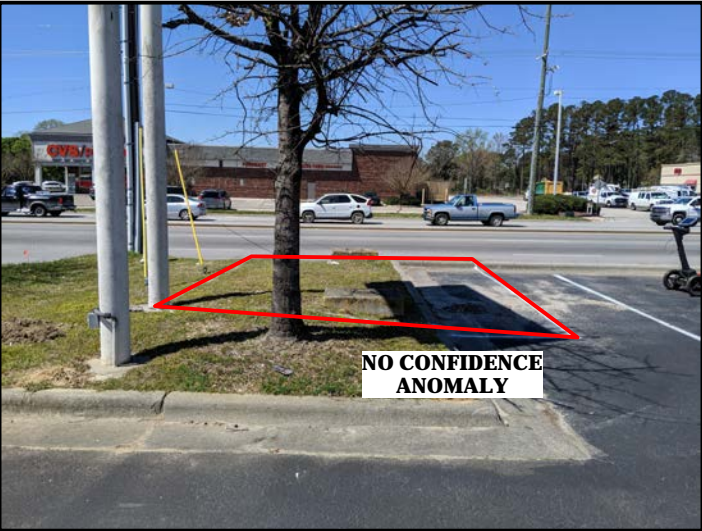
CLIENT
FALCON ENGINEERS
FIGURE 4

LOCATION OF ONE NO CONFIDENCE ANOMALY

View of One No Confidence Anomaly Facing Approximately West

View of One No Confidence Anomaly Facing Approximately South

Collectively, the geophysical data recorded evidence of one No Confidence anomaly within the geophysical survey area at Parcel 26. **Figure 5** provides an overlay of the EM61 metal detection contour map, and one No Confidence anomaly, onto the NCDOT MicroStation engineering plans for reference.
